**VIRGIN ISLANDS NATIONAL PARK**  
**Cruz Bay, St. John, U.S. Virgin Islands**

**CANEEL BAY**  
**STRUCTURAL ASSESSMENT REPORT**

NATIONAL PARK SERVICE (NPS)  
SOUTH EAST REGION (SER)

July 2025

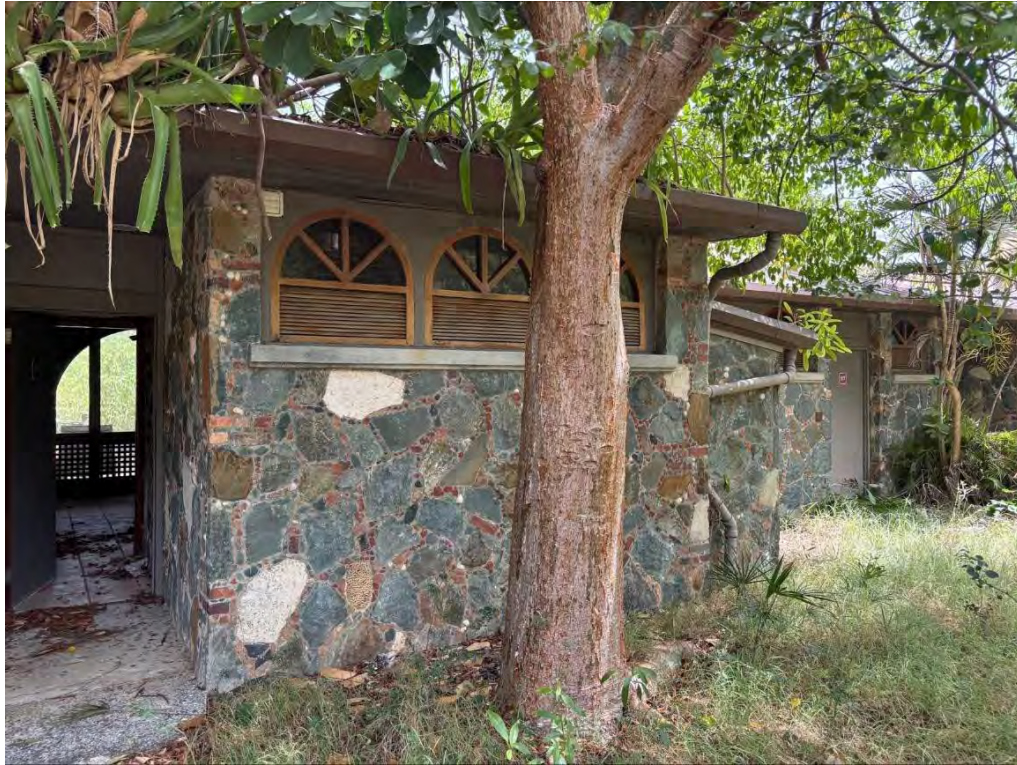
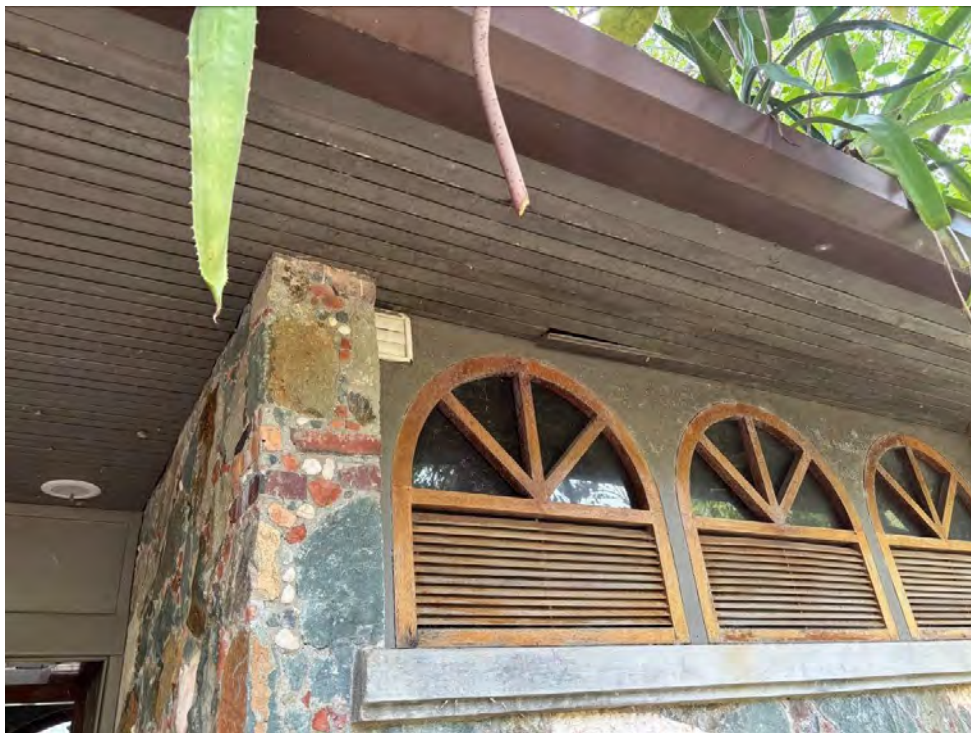
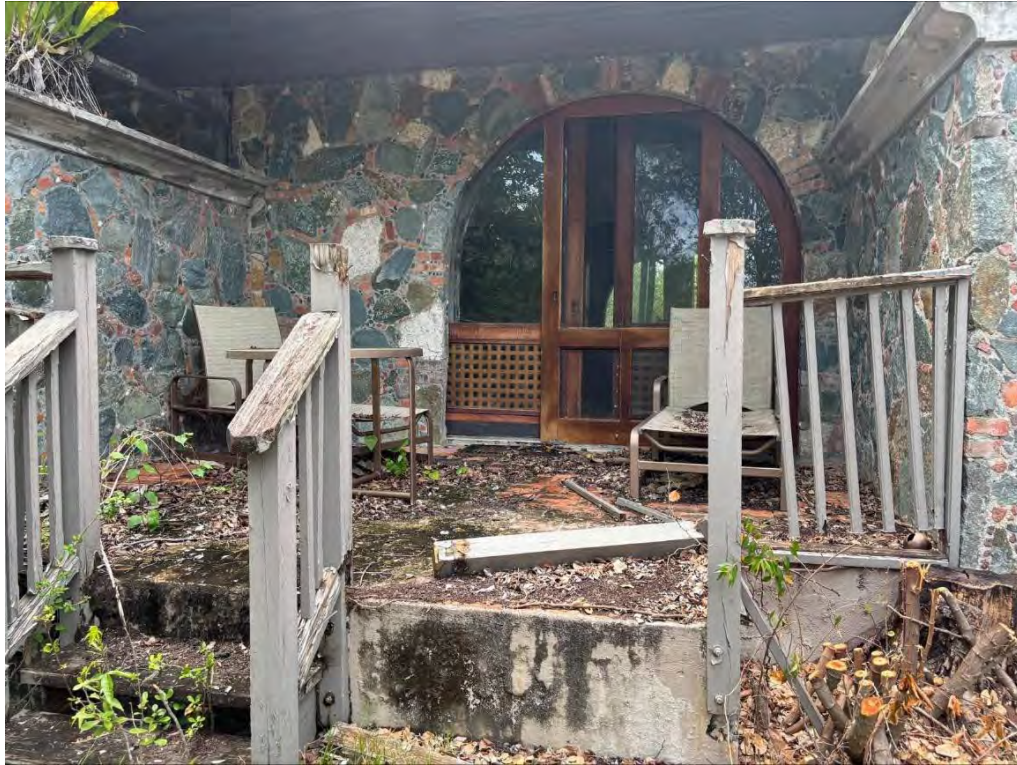
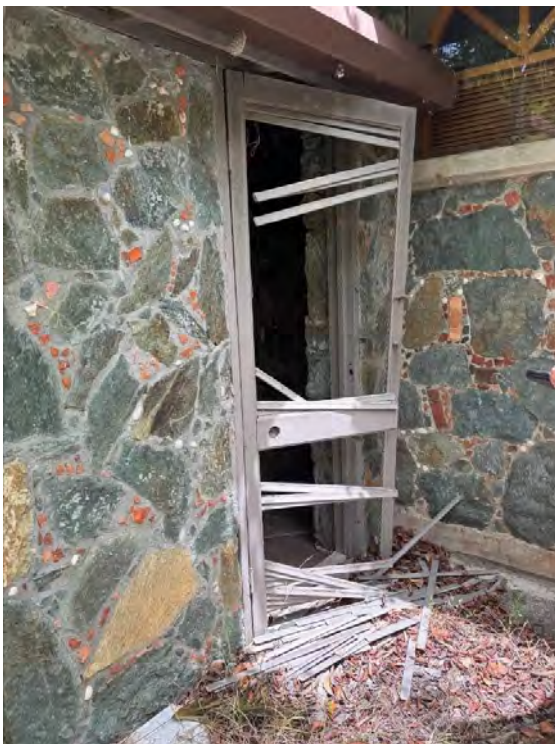
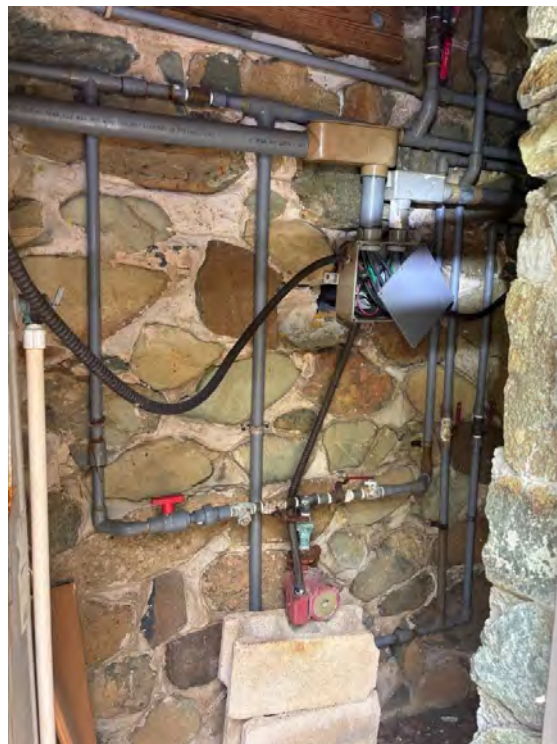
**Building: 54 Garden View Unit 158 and Attached Utility Room**

| Component | Material | Notes |
|---|---|---|
| Walls (Non-Structural) | Stone | Exterior concrete cap is spalling. |
| Roof | Wood Framed /<br>Metal Roof | Vegetation growing in gutter. Potential termite damage. |
| Stairs/Railings | Wood | Severely deteriorated. |

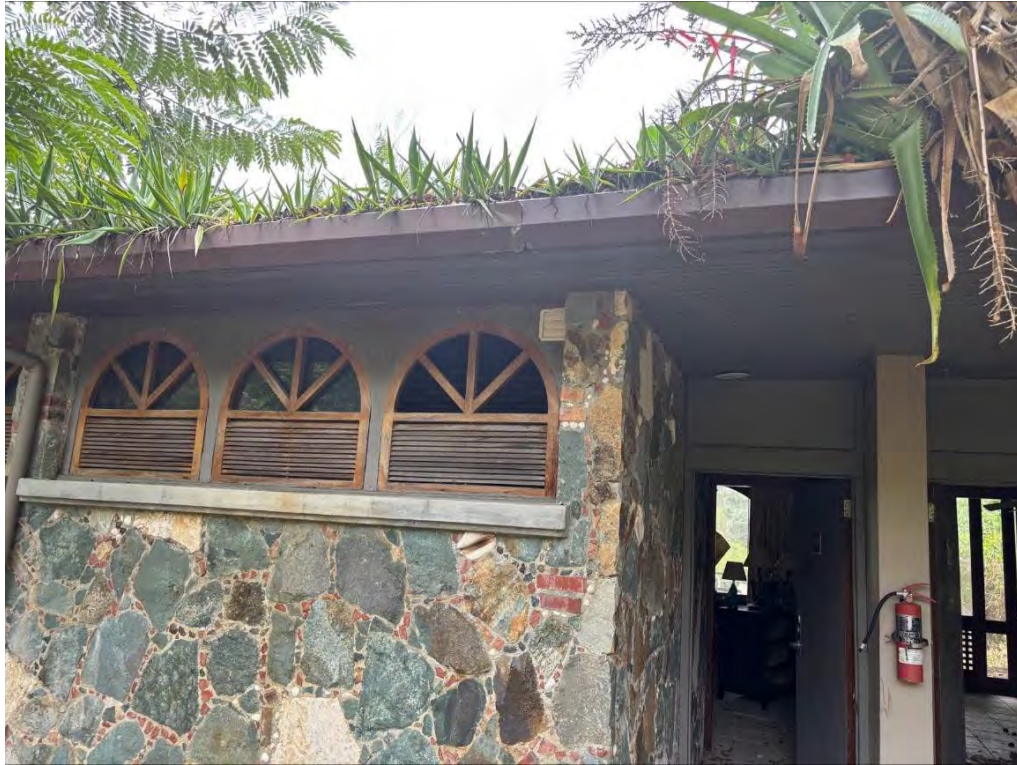
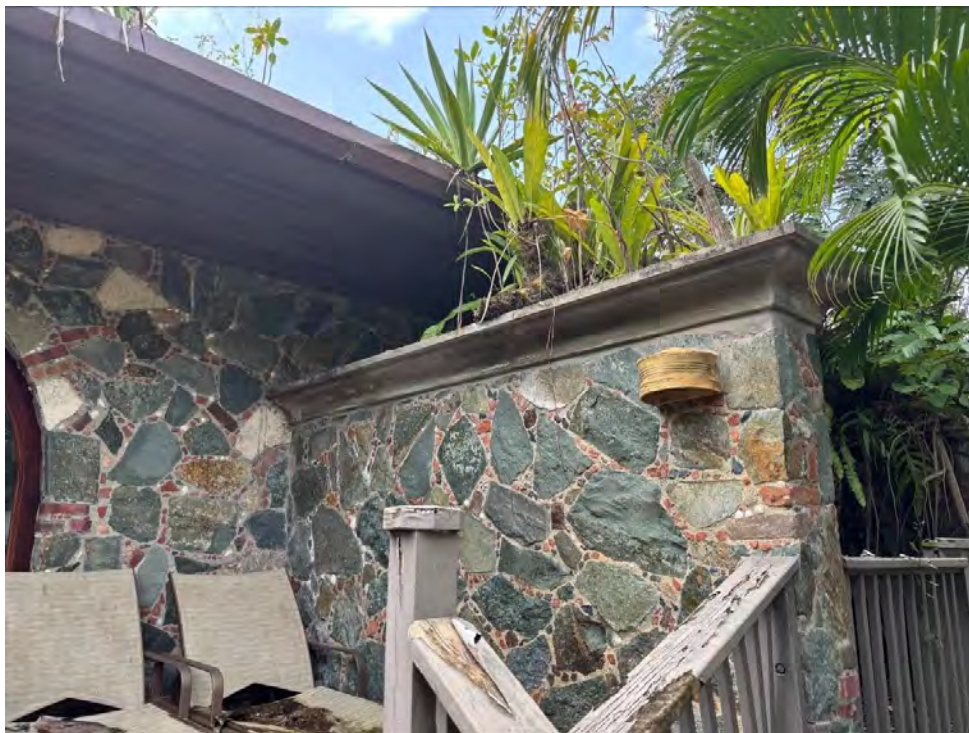
**Building: 54 Garden View Unit 159**

| Component | Material | Notes |
|---|---|---|
| Roof | Wood Framed /<br>Metal Roof | Vegetation growing in gutter. Potential termite damage. |
| Stairs/Railings | Wood | Severely deteriorated. |

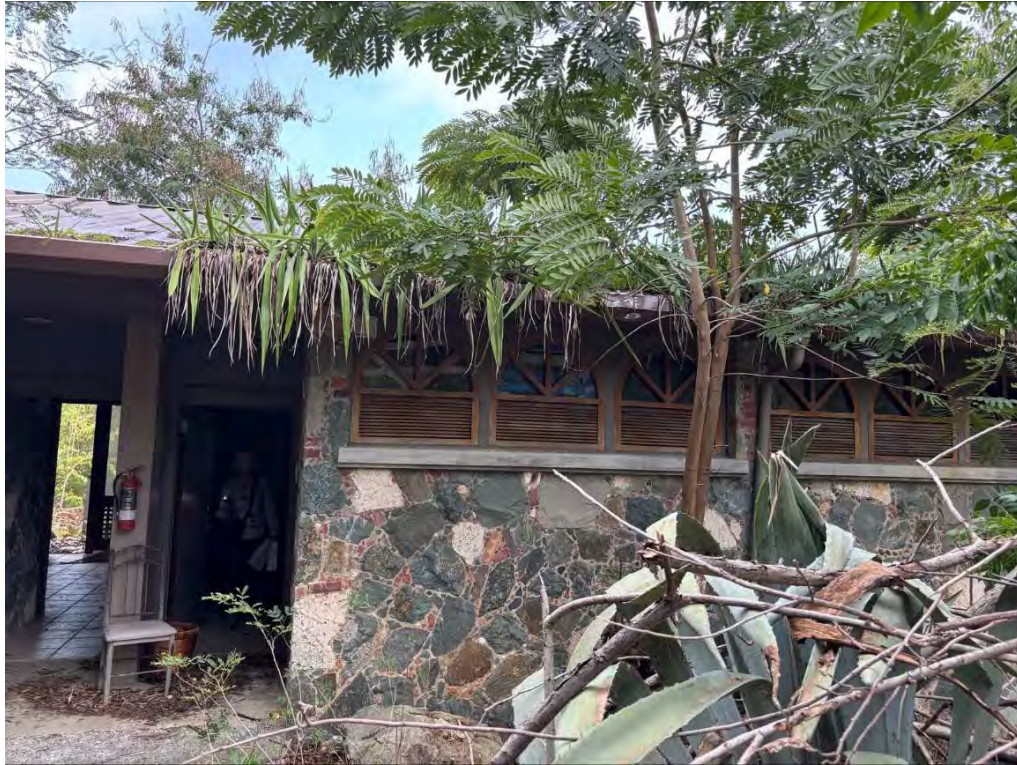
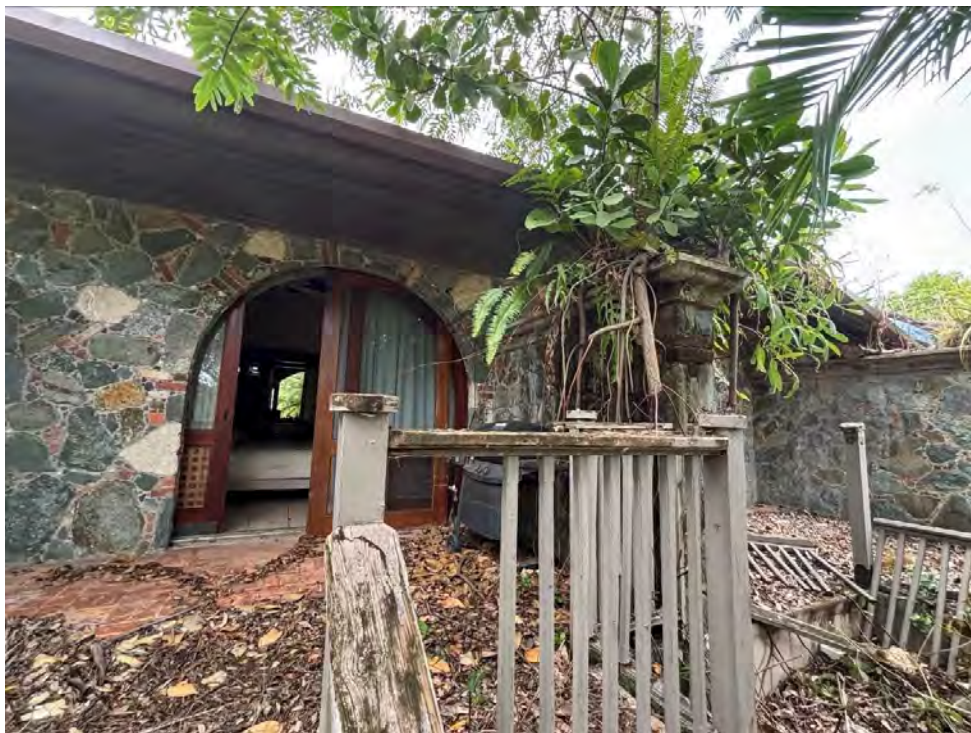
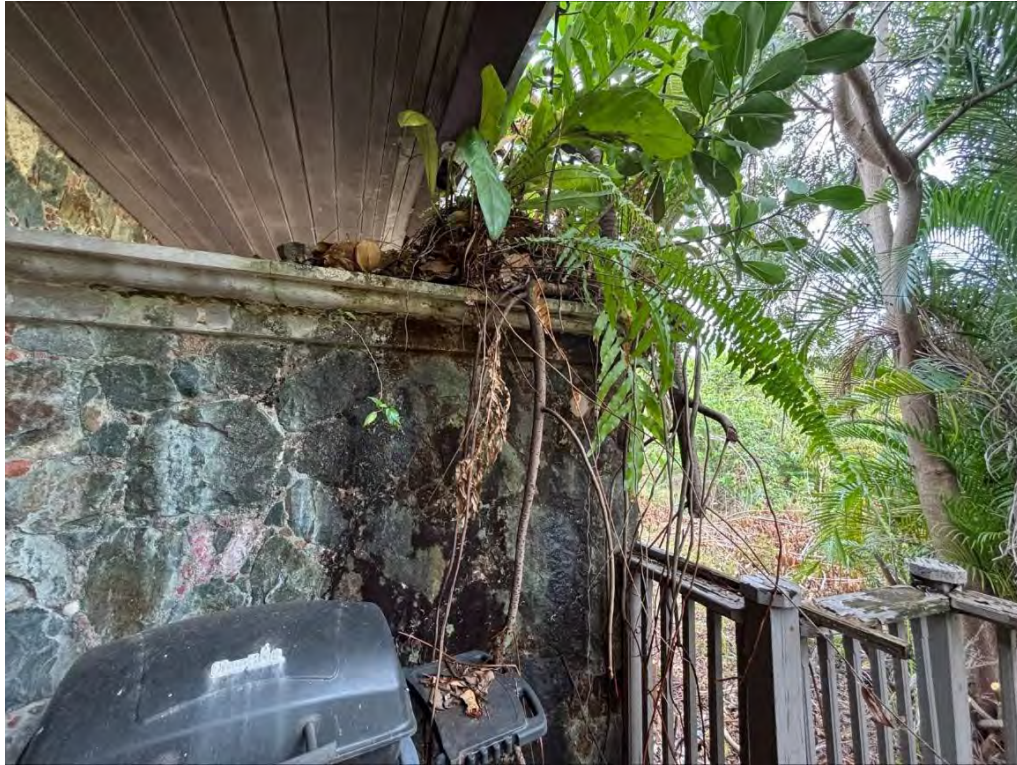
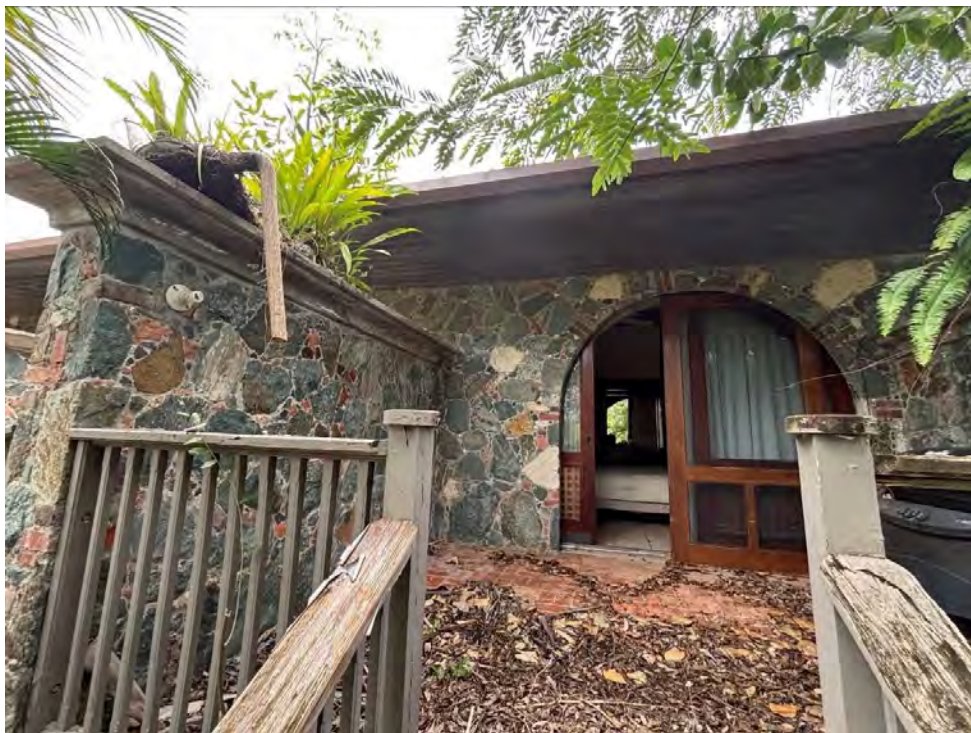
**Building: 54 Garden View Unit 160**

| Component | Material | Notes |
|---|---|---|
| Walls (Structural) | Stone | Vertical cracks near rear exterior wall joint. |
| Walls (Non-Structural) | Stone | Exterior concrete cap is spalling. |
| Roof | Wood Framed /<br>Metal Roof | Vegetation growing in gutter. Potential termite damage. |
| Stairs/Railings | Wood | Severely deteriorated. |

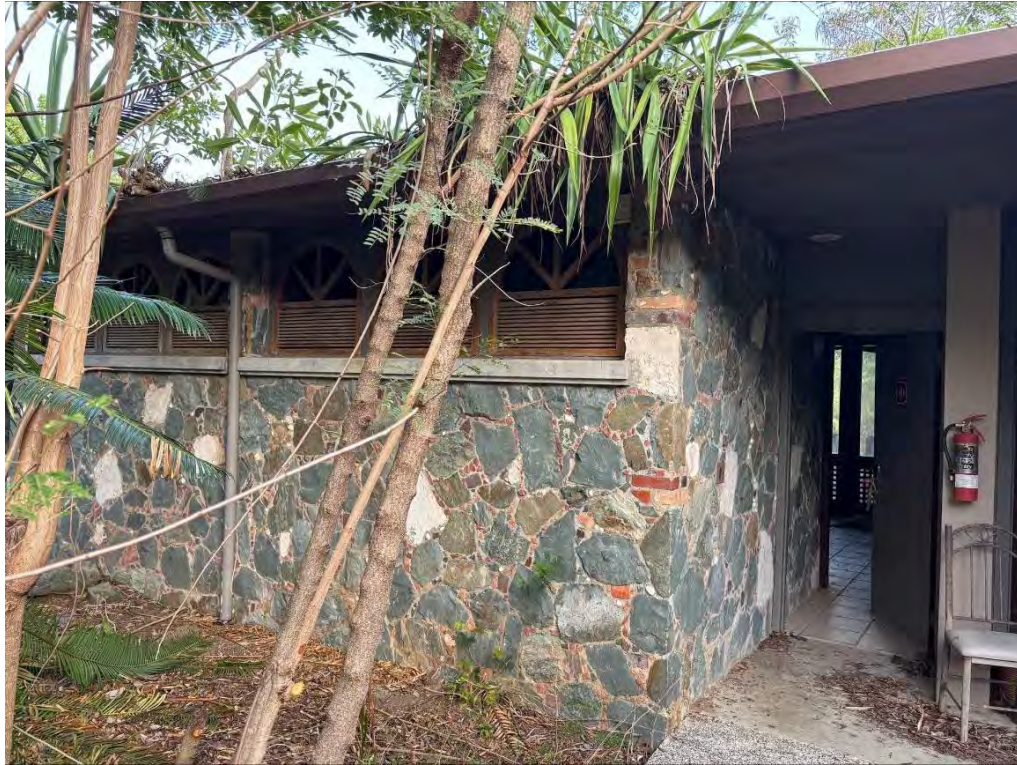
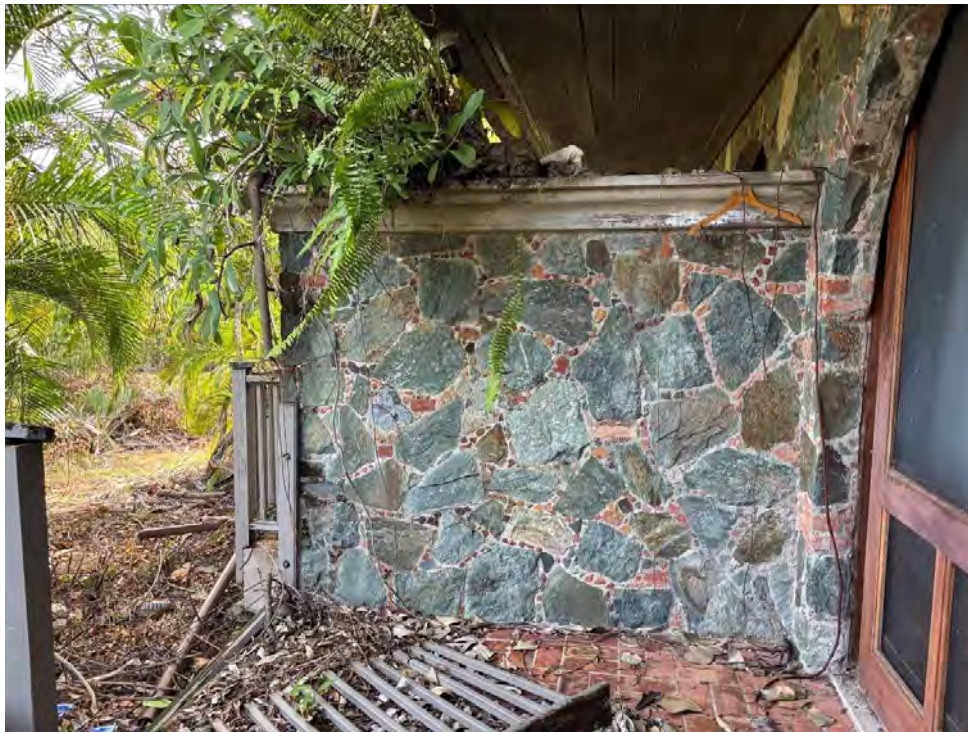
**Building: 54 Garden View Unit 161**

| Component | Material | Notes |
|---|---|---|
| Walls (Non-Structural) | Stone | Exterior concrete cap is spalling. |
| Roof | Wood Framed /<br>Metal Roof | Partially collapsed roof at rear of building.<br>Vegetation growing in gutter. Potential<br>termite damage. |
| Stairs/Railings | Wood | Severely deteriorated. |

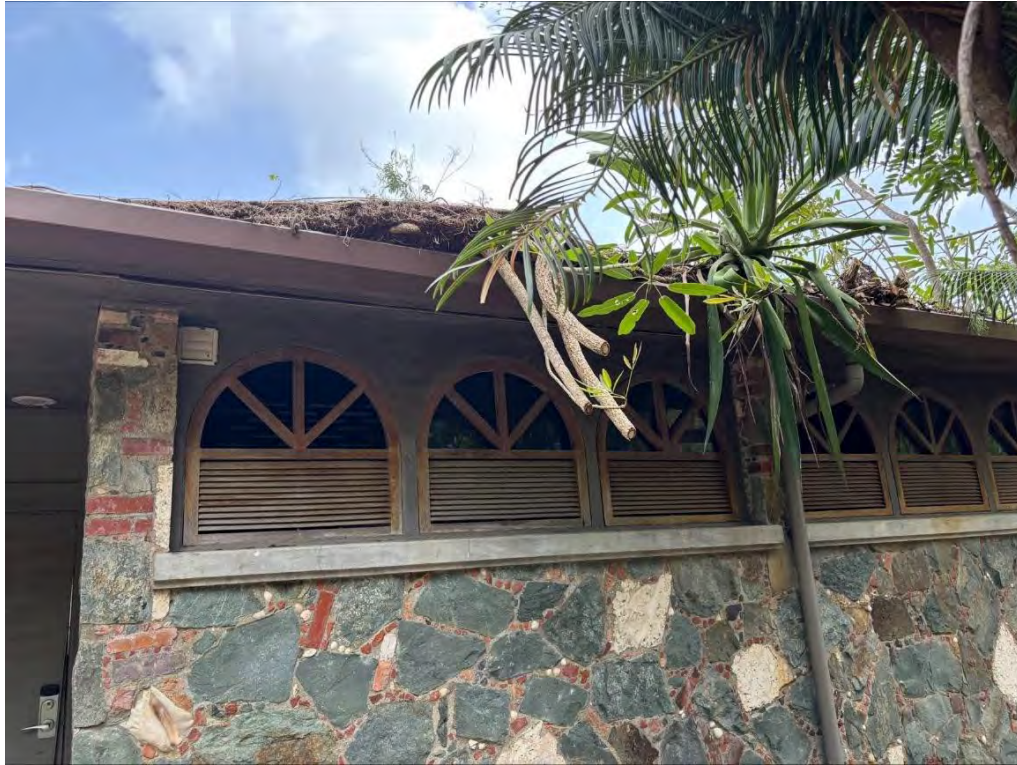
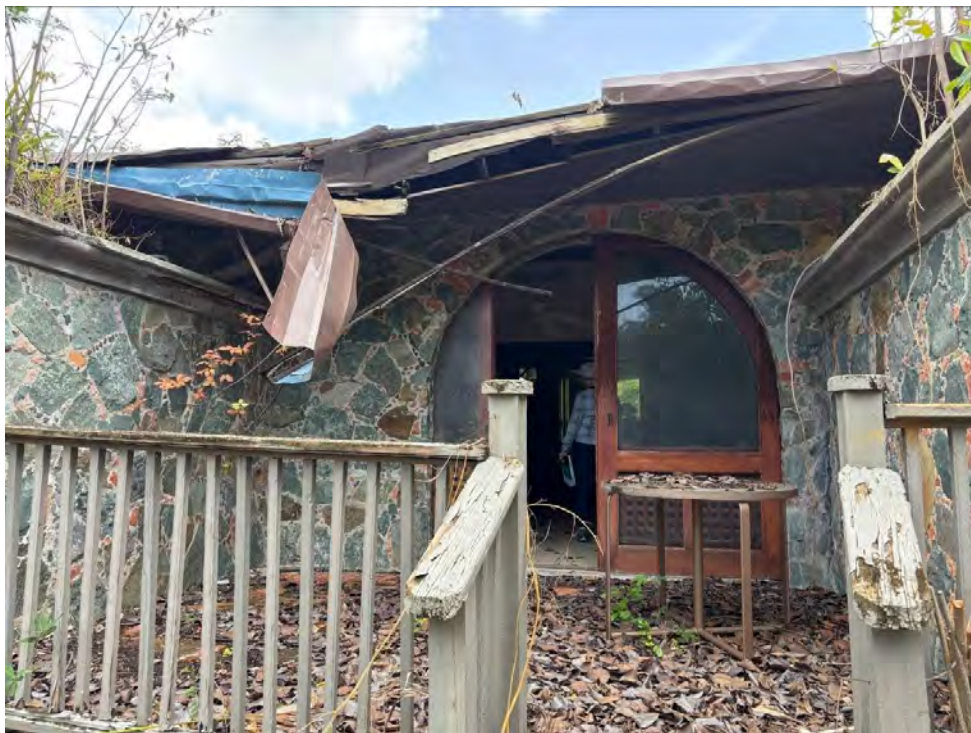
**Building: 54 Garden View Unit 162**

| Component | Material | Notes |
|---|---|---|
| Walls (Non-Structural) | Stone | Exterior concrete cap is spalling. |
| Roof | Wood Framed / Metal Roof | Vegetation growing in gutter. Potential termite damage. |
| Stairs/Railings | Wood | Severely deteriorated. |

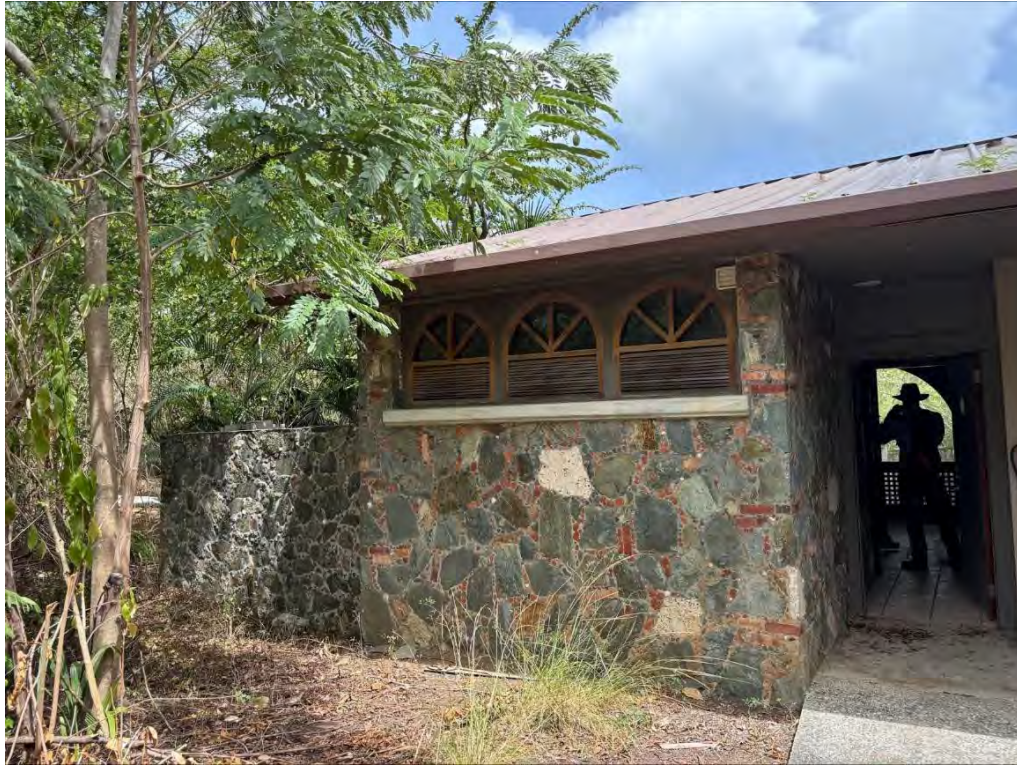
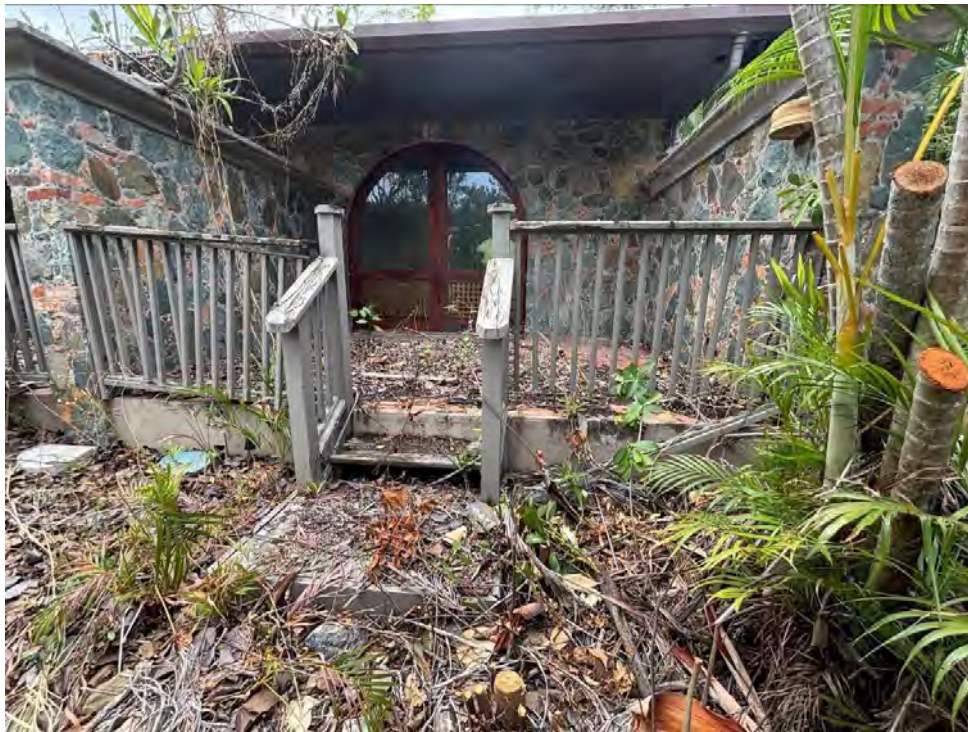
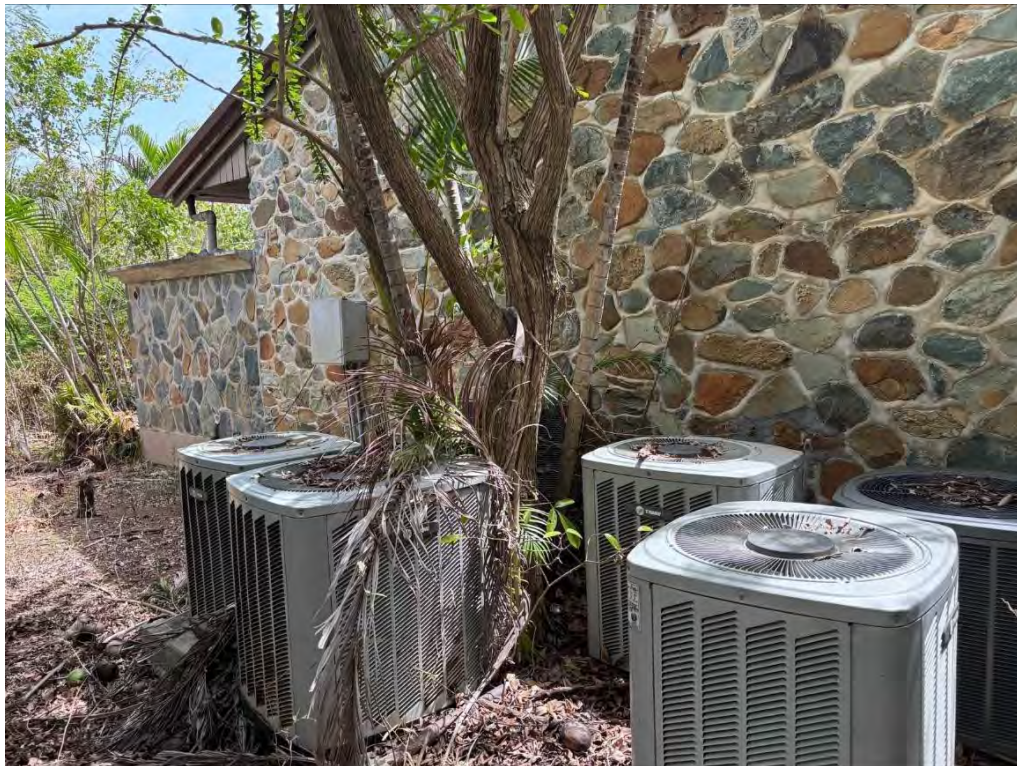
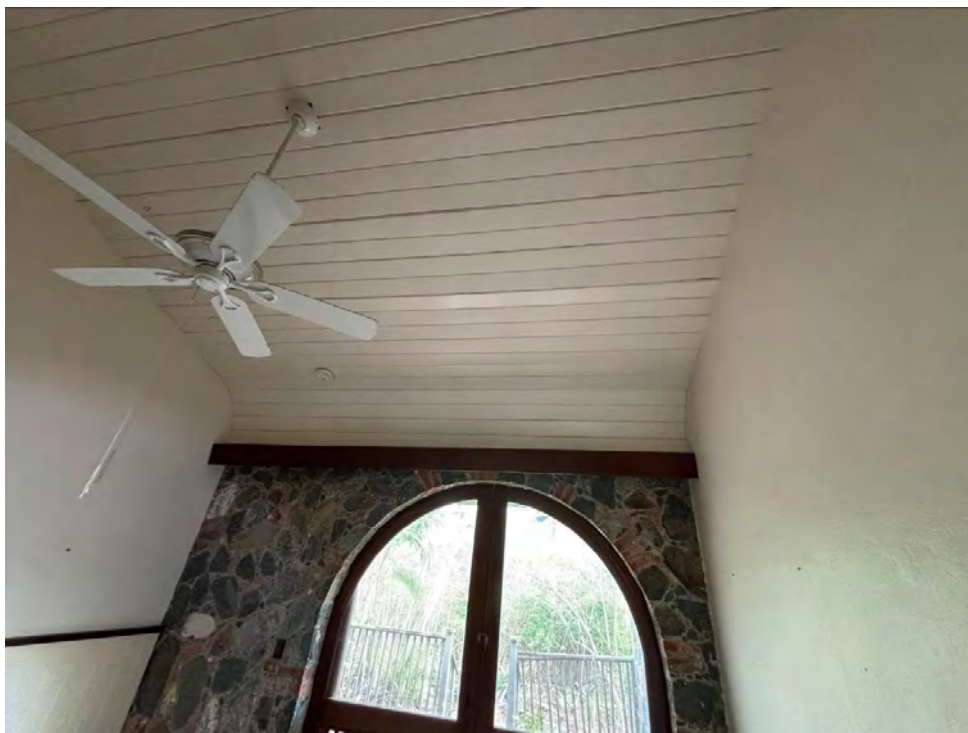
**Building: 54 Garden View Unit 163**

| Component | Material | Notes |
|---|---|---|
| Walls (Non-Structural) | Stone | Exterior concrete cap is spalling. |
| Roof | Wood Framed /<br>Metal Roof | Vegetation growing in gutter.<br>Interior cladding at underside of roof is<br>buckling. Potential termite damage. |
| Stairs/Railings | Wood | Severely deteriorated. |

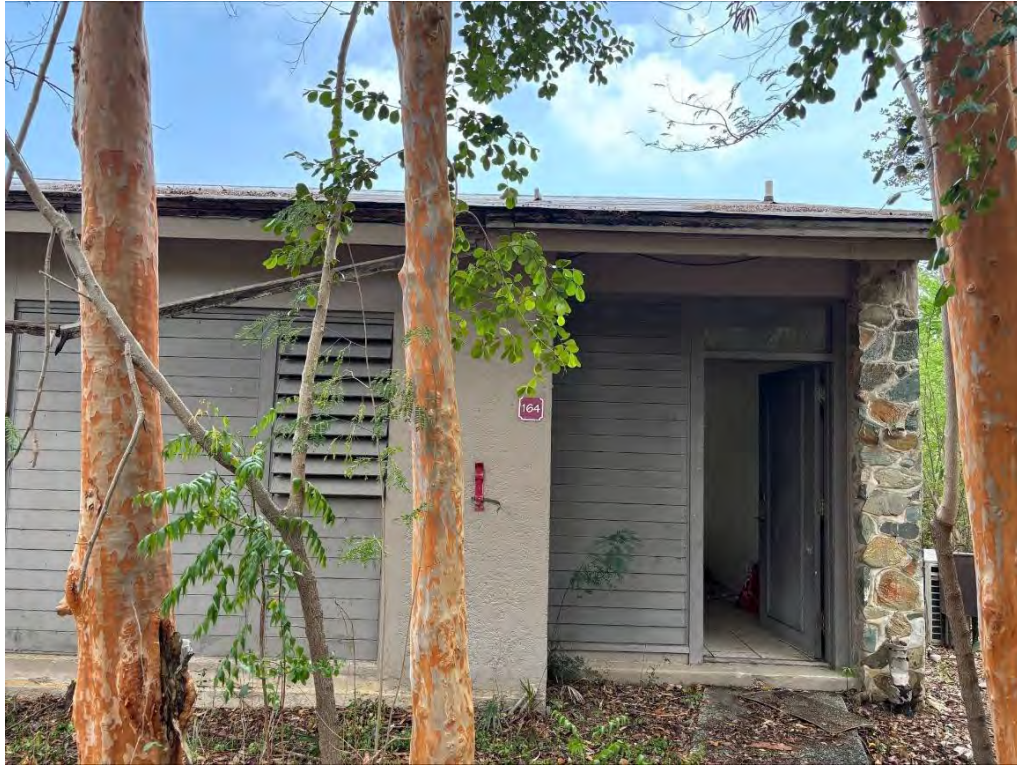
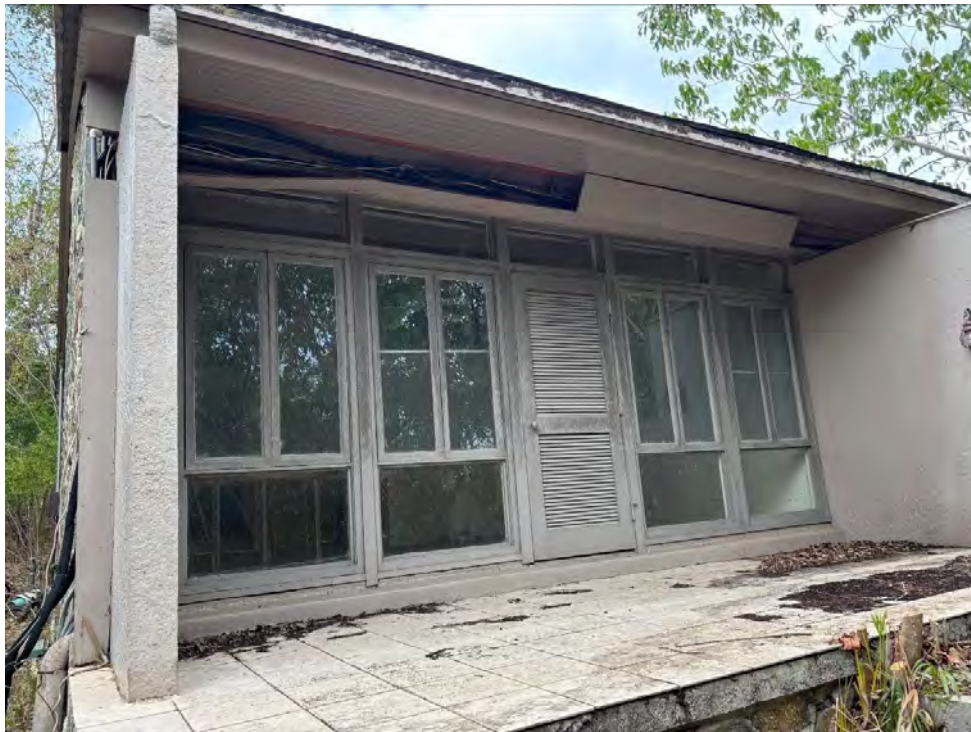
**Building: 55 Garden View Unit 164**

| Component | Material | Notes |
|---|---|---|
| Roof | Wood Framed /<br>Metal Roof | Vegetation growing in gutter. Potential termite damage. |
| Stairs/Railings | Wood | Severely deteriorated. |

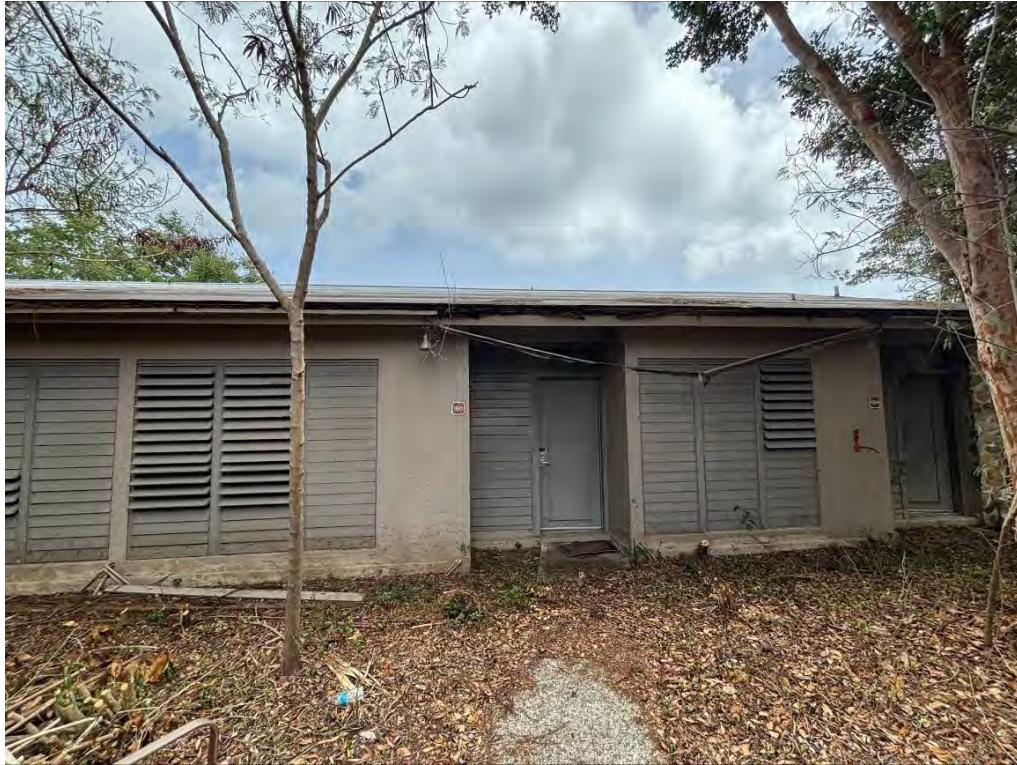
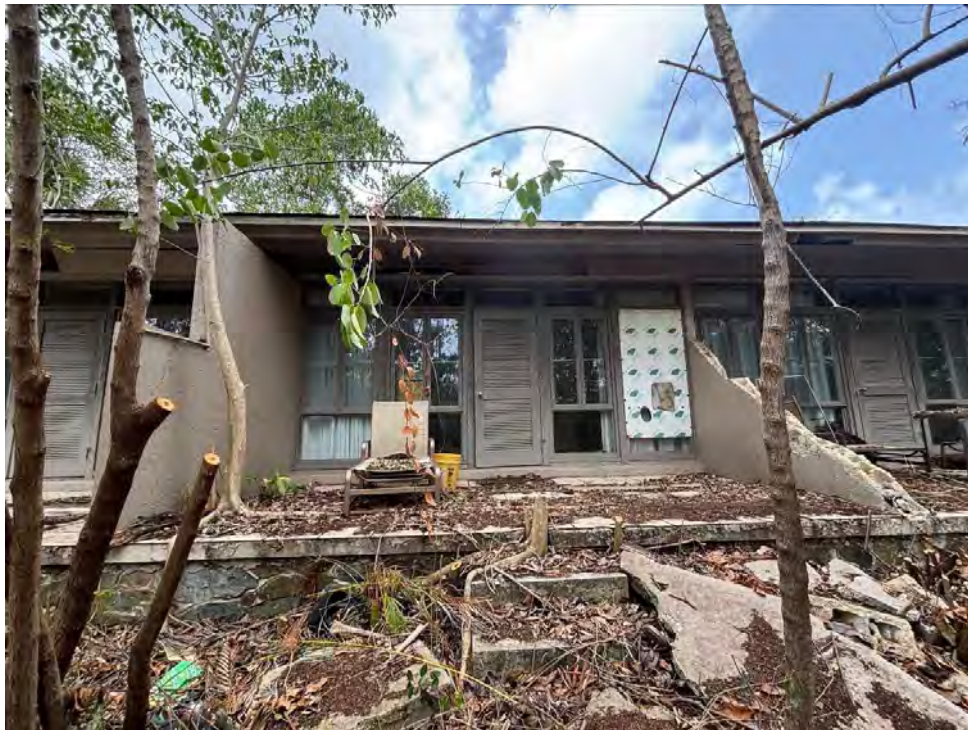
**Building: 55 Garden View Unit 165**

| Component | Material | Notes |
|---|---|---|
| Walls (Non-Structural) | Masonry (CMU) | Severely damaged exterior partition wall between 165 and 166. |
| Roof | Wood Framed / Metal Roof | Vegetation growing in gutter. Potential termite damage. |
| Stairs/Railings | Wood | Severely deteriorated. |

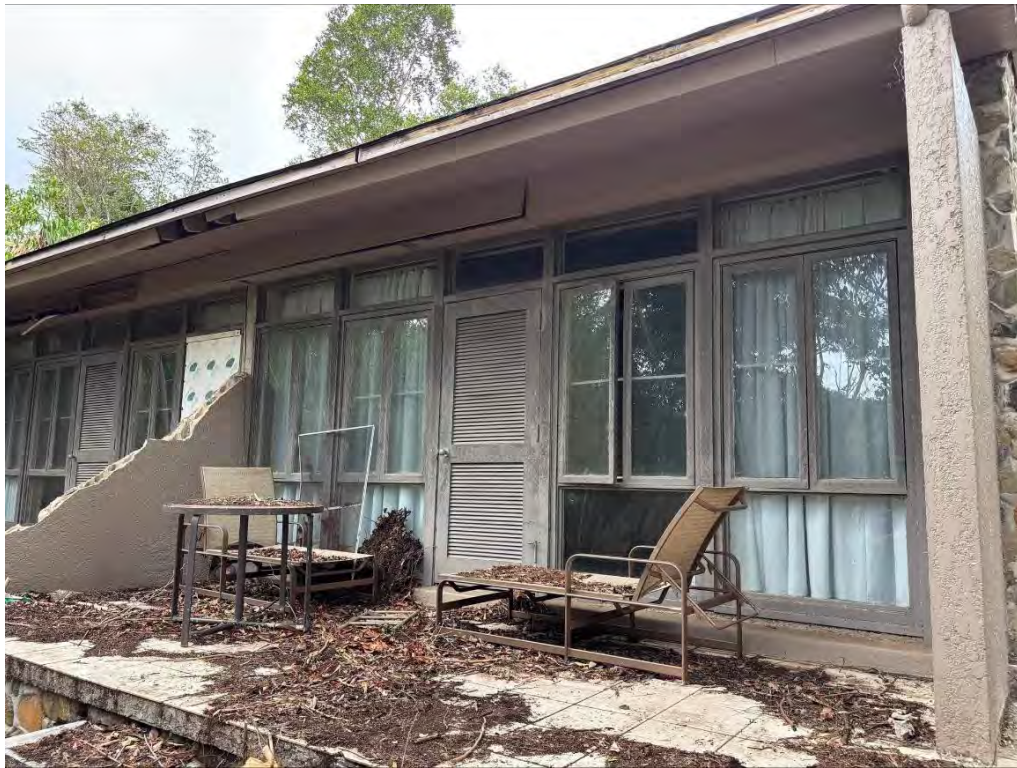
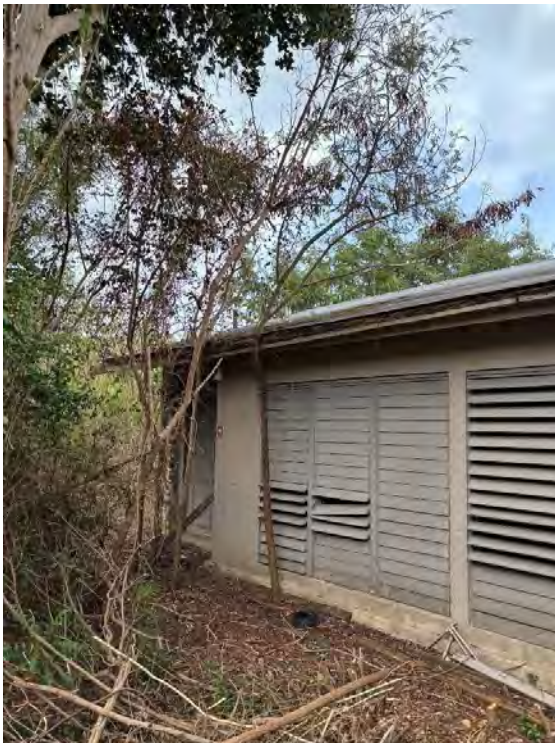
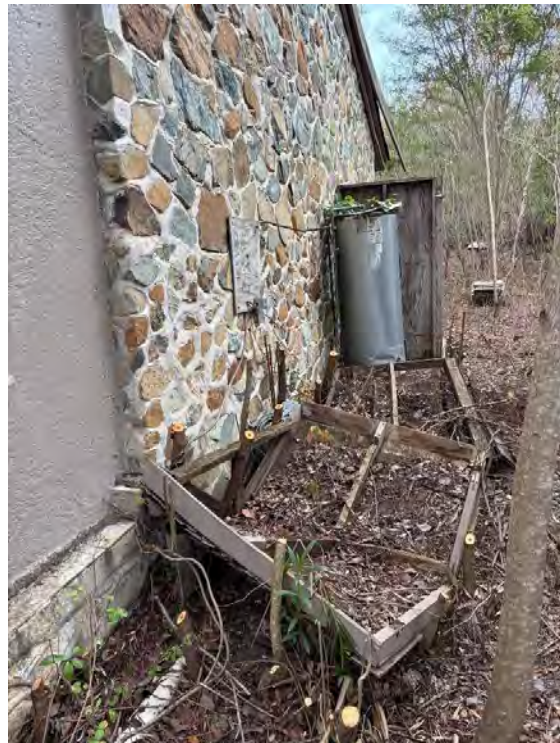
**Building: 55 Garden View Unit 166**

| Component | Material | Notes |
|---|---|---|
| Walls (Structural) | Stone | Interior water damage. |
| Walls (Non-Structural) | Masonry (CMU) | Severely damaged exterior partition wall between 165 and 166. |
| Roof | Wood Framed / Metal Roof | Vegetation growing in gutter. Potential termite and water damage. |
| Stairs/Railings | Wood | Severely deteriorated. |
