**Building: 56 Fitness Center**

**Structural Assessment: Structurally Sound**

**National Park Service**  
Virgin Islands National Park | Caneel Bay  
Structural Assessment Report

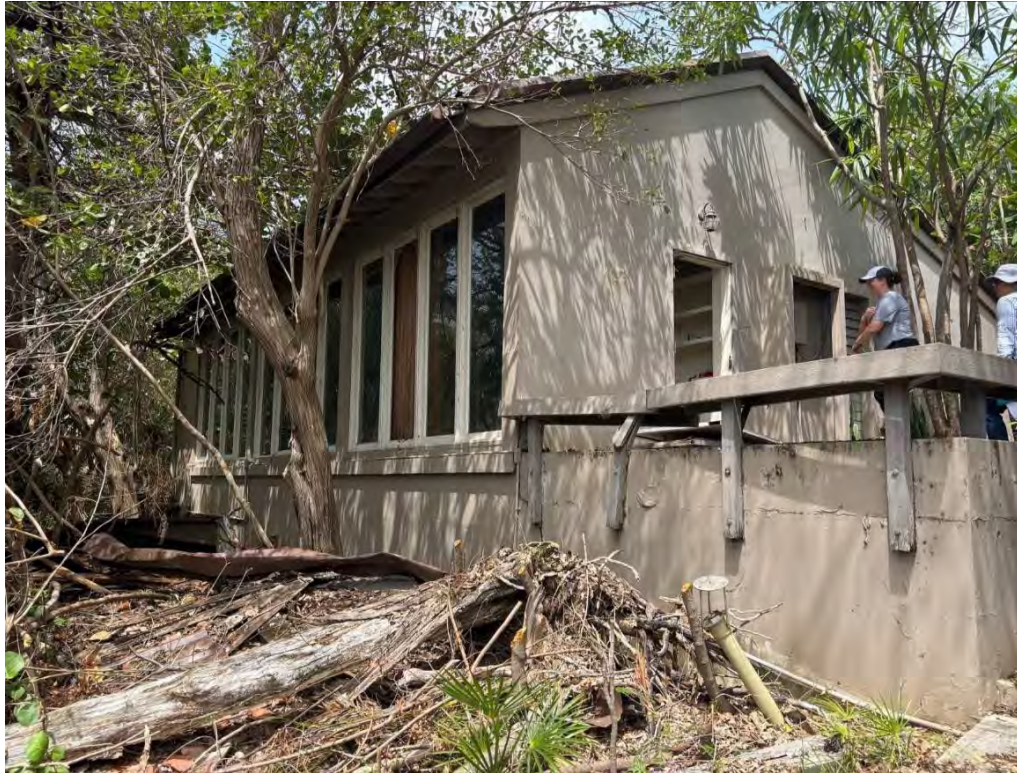
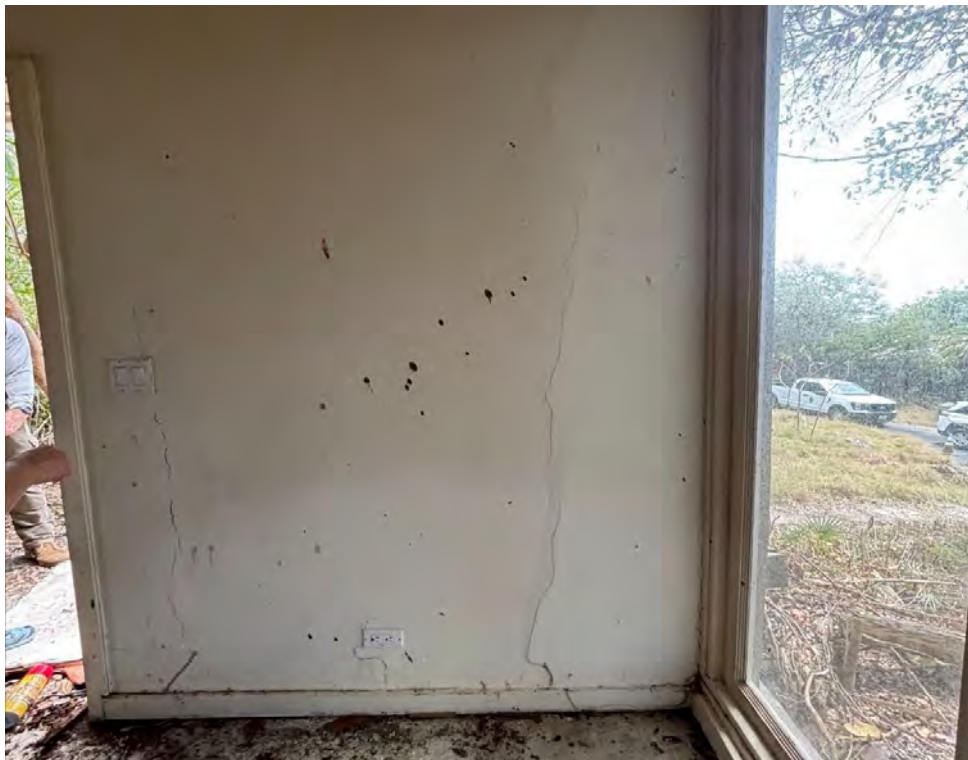
| Component | Material | Notes |
|---|---|---|
| Walls (Structural) | Concrete | Small, vertical cracks observed in three corners. No signs of settlement or out of plane movement was observed. |
| Walls (Non-Structural) | N/A | Rot observed at some fascia boards and window frames. |
| Roof | Wood Framed / Metal Roof | Potential termite damage. |
| Stairs/Railings | Wood | Benches, which were serving as railings, are damaged. |

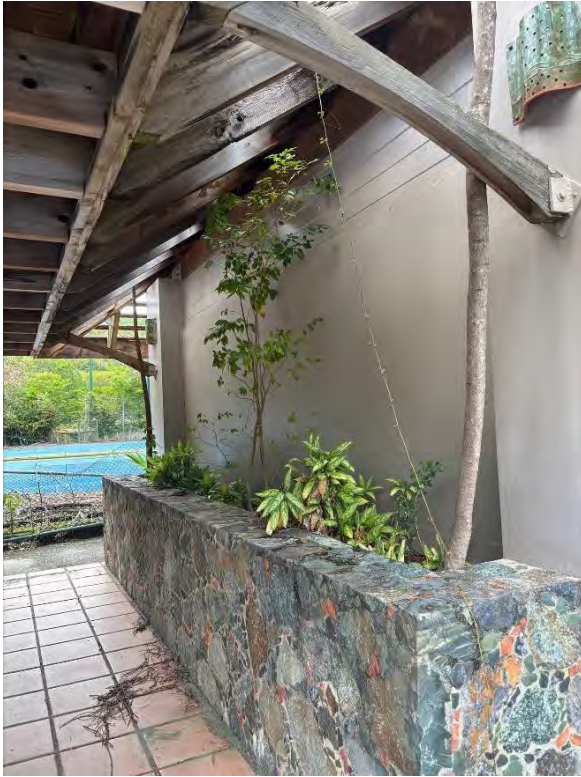
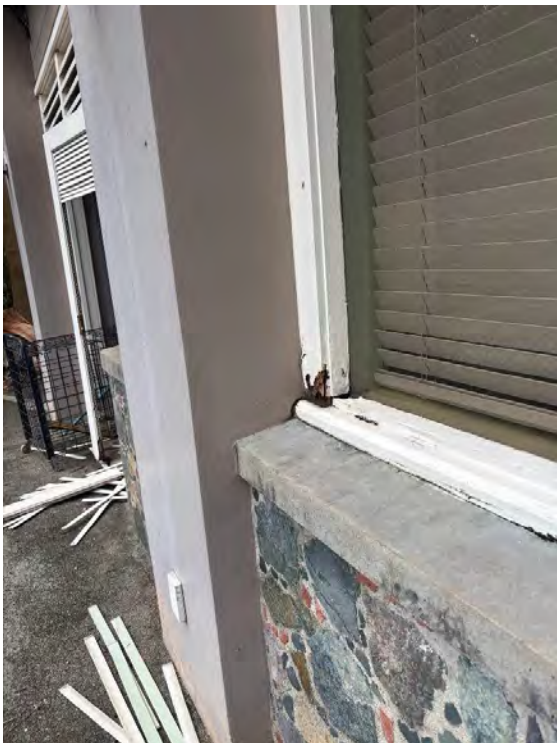
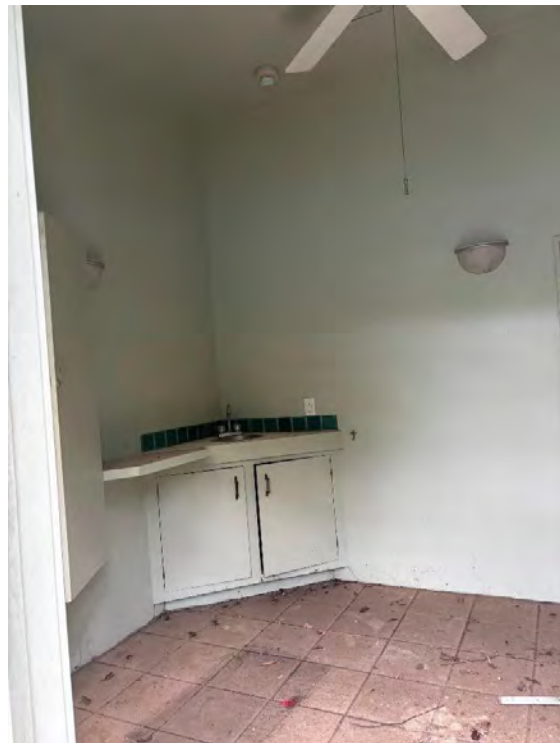
| Component | Material | Notes |
|---|---|---|
| Walls (Non-Structural) | Stone / wood infill | Wood section of walls is deteriorated. Potential termite damage. |
| Roof | Wood framed / wood shingles | Roof failed. Wooden bracing is rotted/termite damaged. Potential termite damage. |

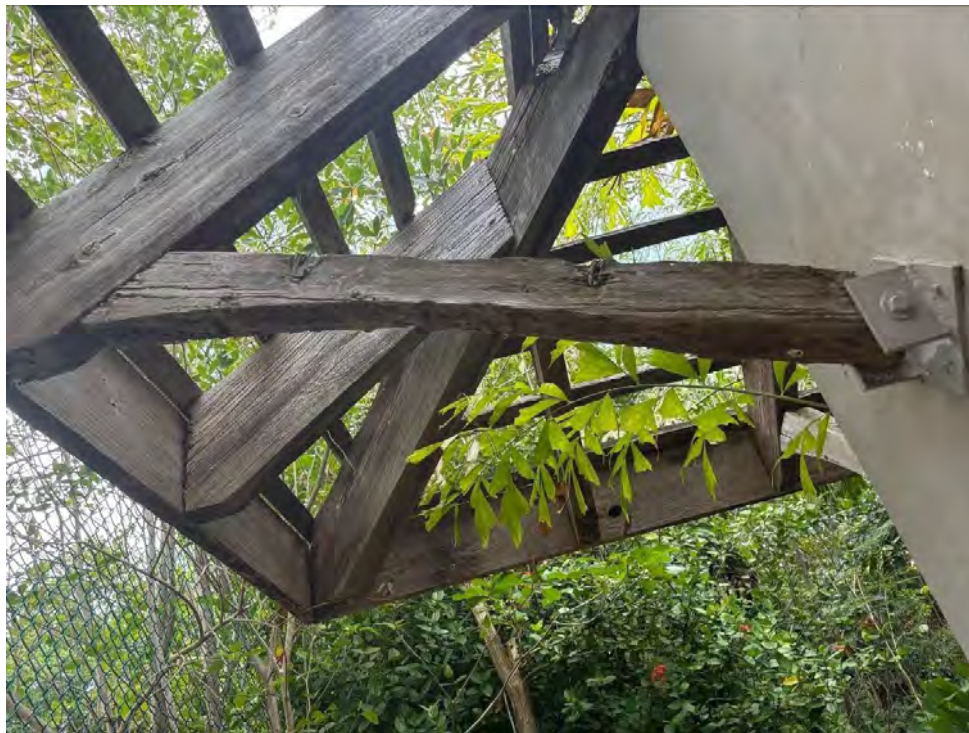
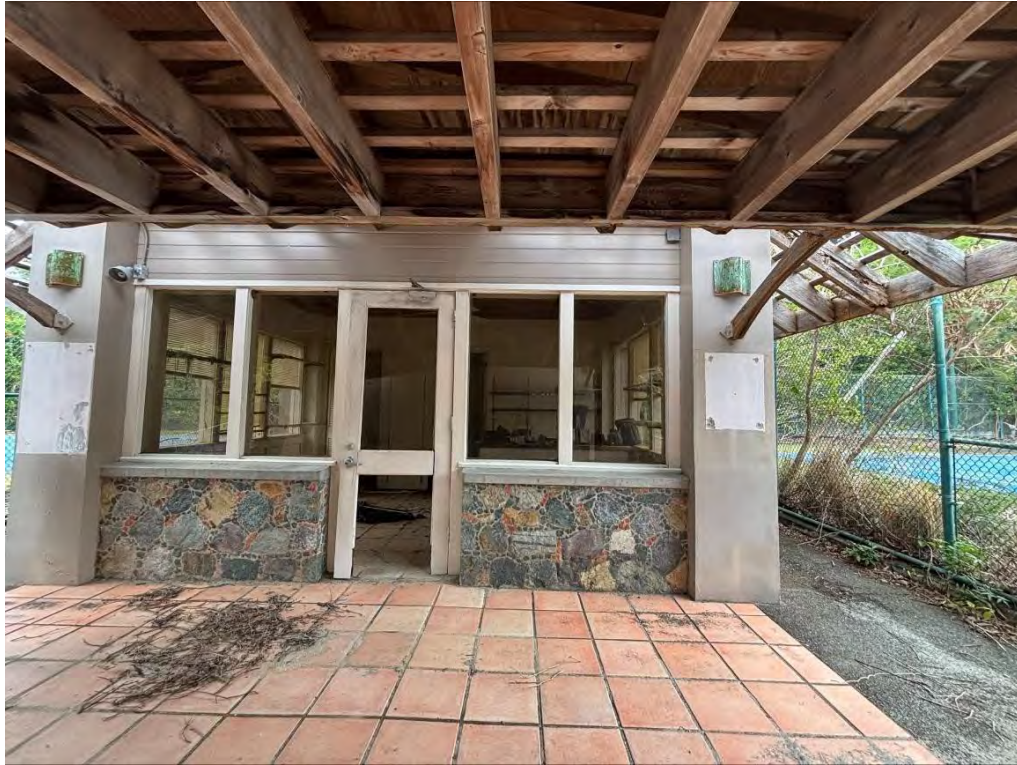
| Component | Material | Notes |
|---|---|---|
| Walls (Non-Structural) | Stone /<br>wood infill | Wood section of walls is deteriorated.<br>Potential termite damage. |
| Roof | Wood framed /<br>wood shingles | Roof failed. Wooden bracing is<br>rotted/termite damaged. Potential termite<br>damage. |

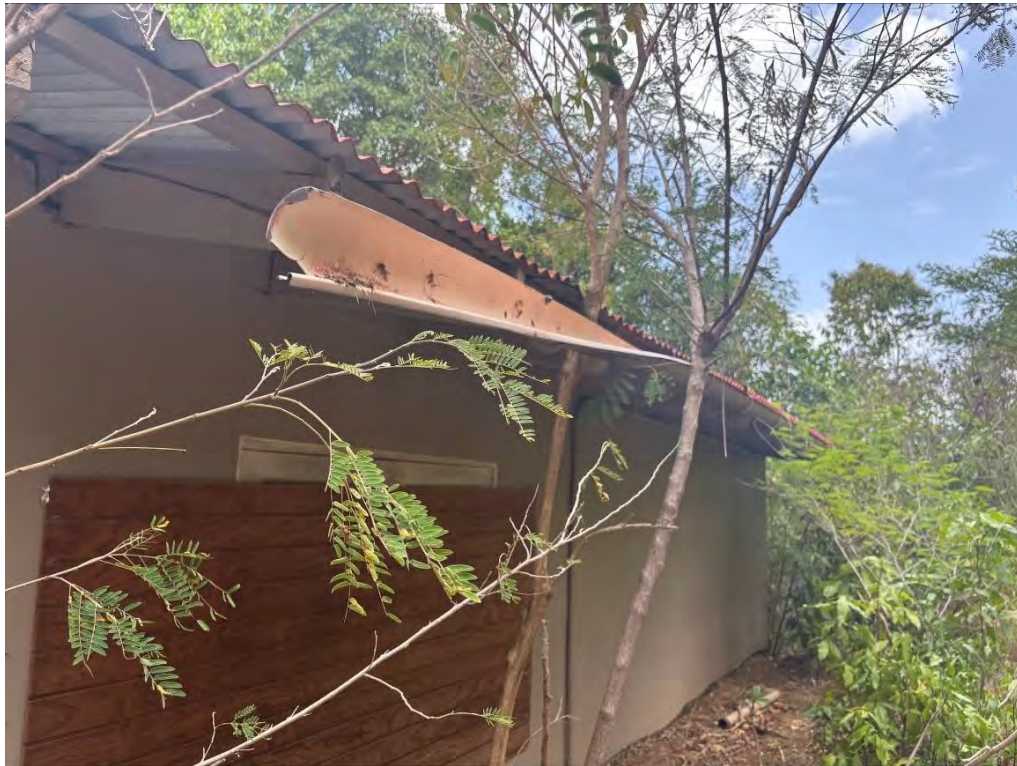
| Component | Material | Notes |
|---|---|---|
| Walls (Structural) | Concrete | Minor spalling at exterior walls. |
| Roof | Wood /<br>Metal Roof | Two rafter tails cracked at eaves. Metal roof attached directly to rafters (no plywood sheathing). |

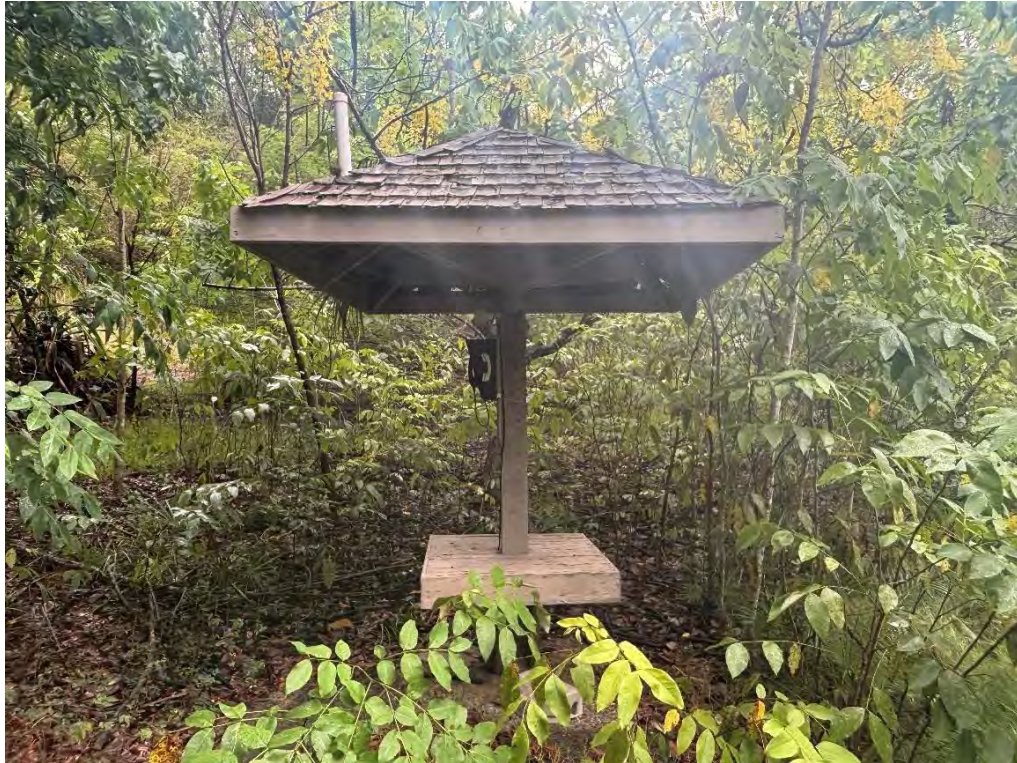
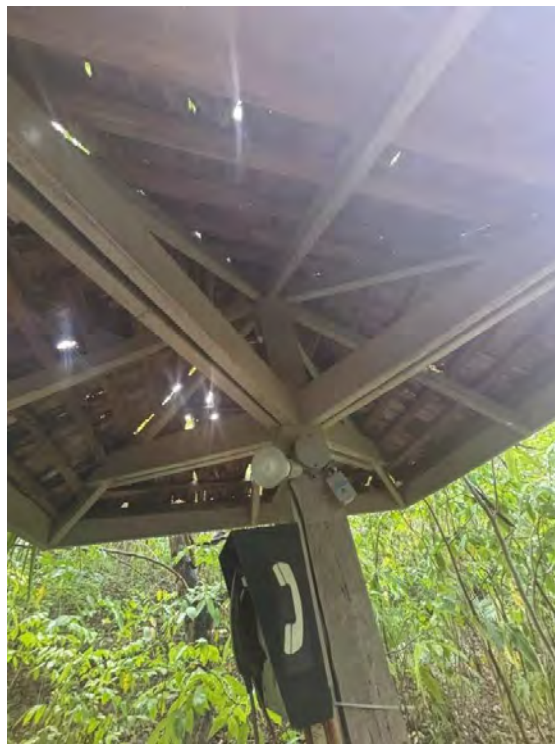
| Component | Material | Notes |
|---|---|---|
| Floor | Concrete | Concrete pad previously trenched for utilities. |
| Roof | Wood framed/<br>Wood shingles | Shingles deteriorated. |

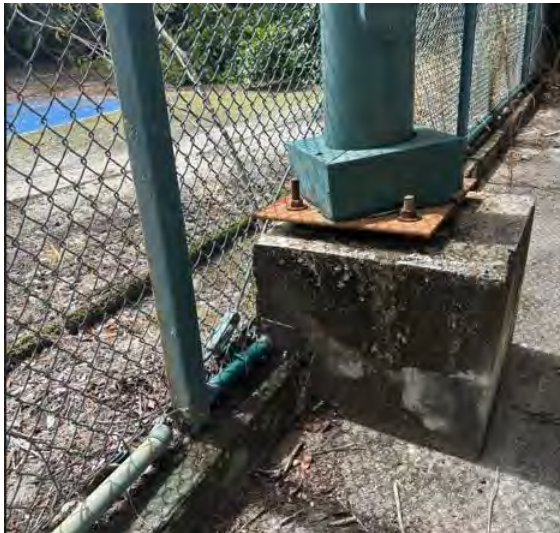
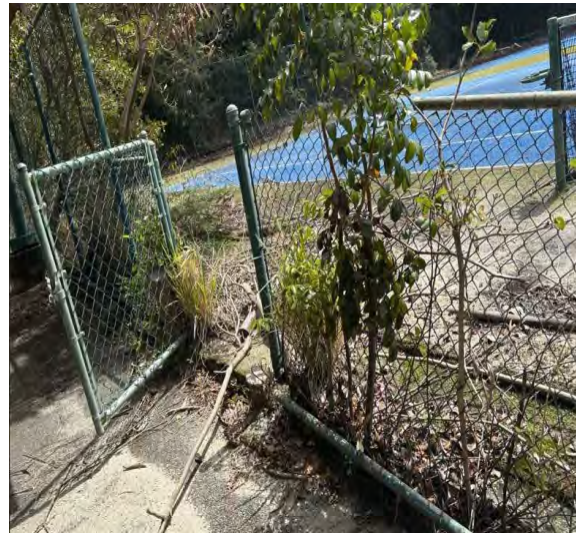
| Component | Material | Notes |
|---|---|---|
| Floor | Turf | Tennis court turf has shifted, wrinkled, ripped, and is damaged. |

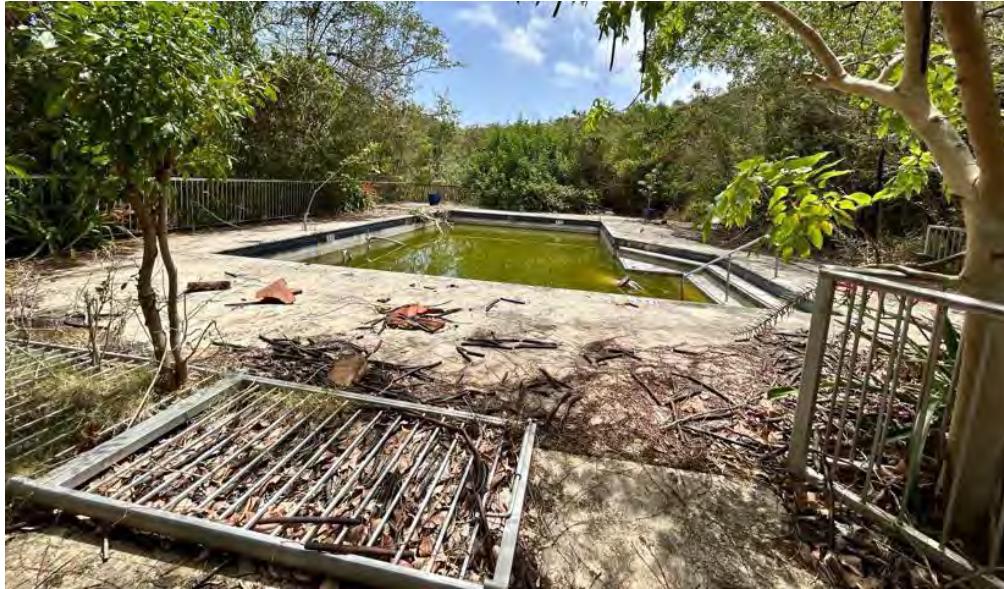
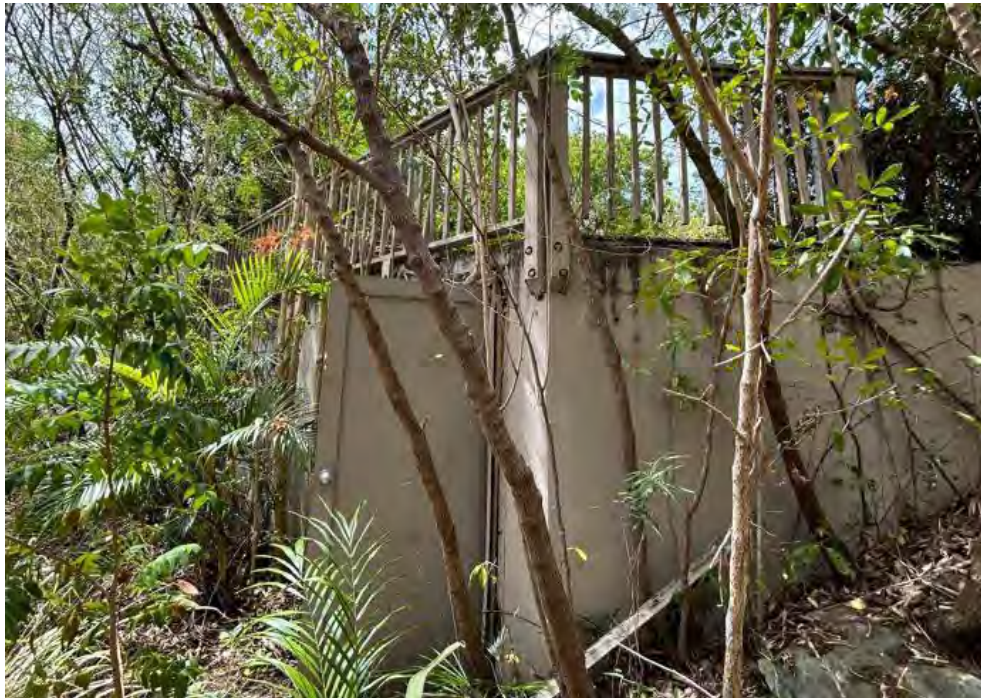
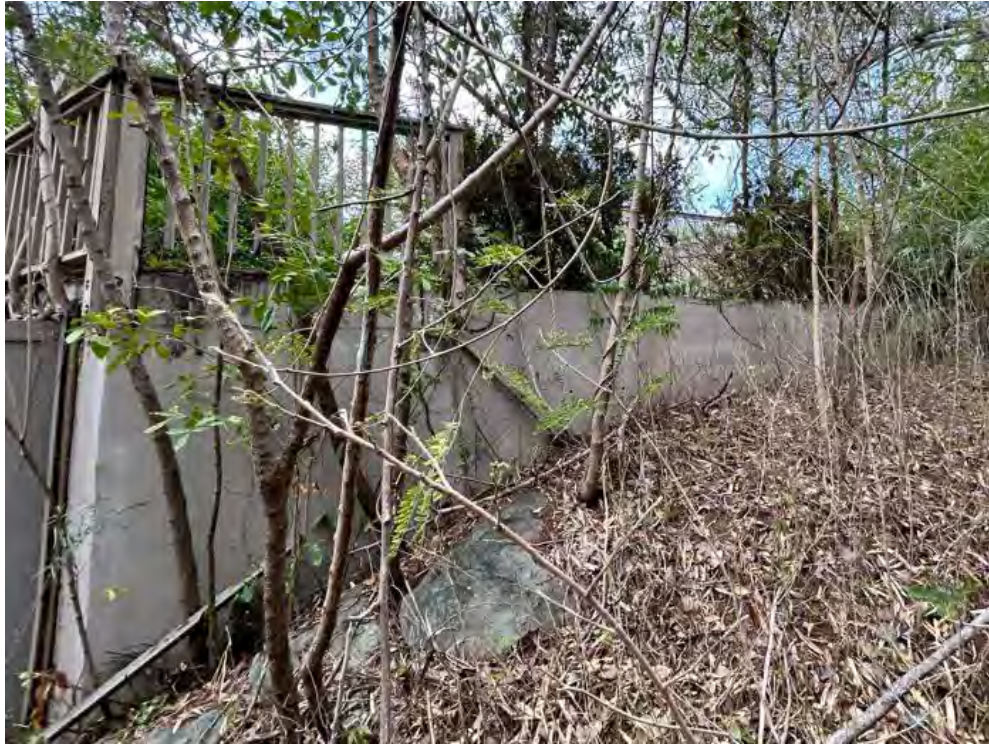
| Component | Material | Notes |
|---|---|---|
| Structure | Concrete | Pool is holding water and appears to be in good condition. |
| Railings | Aluminum | Some railings have shifted / failed. |

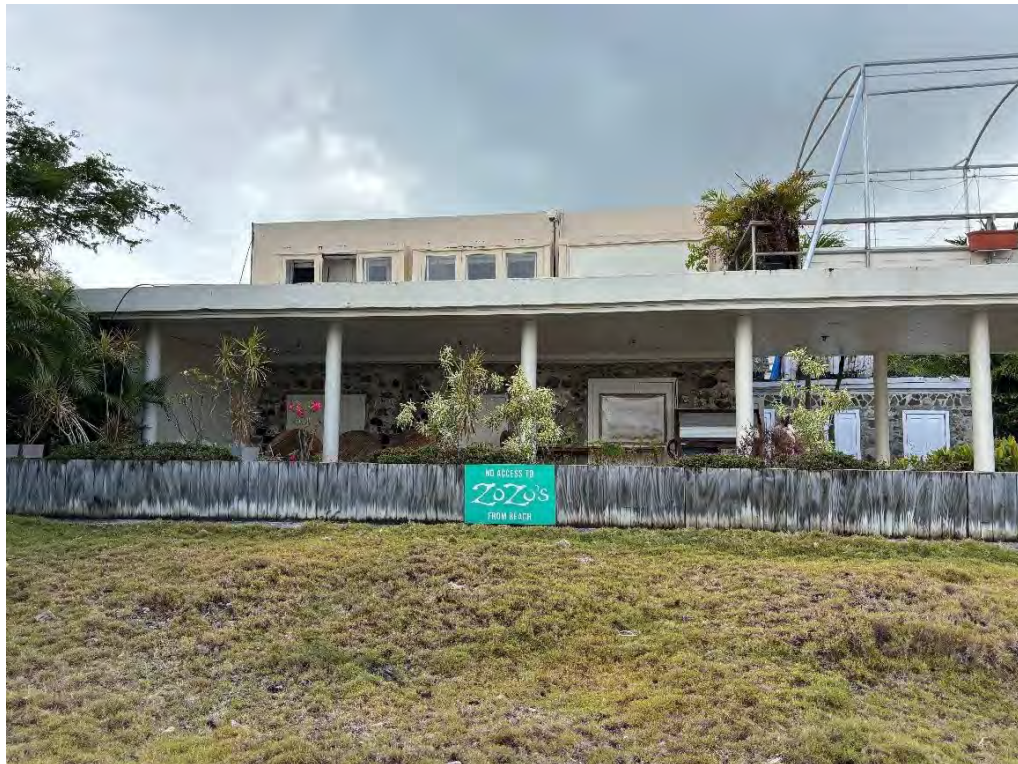
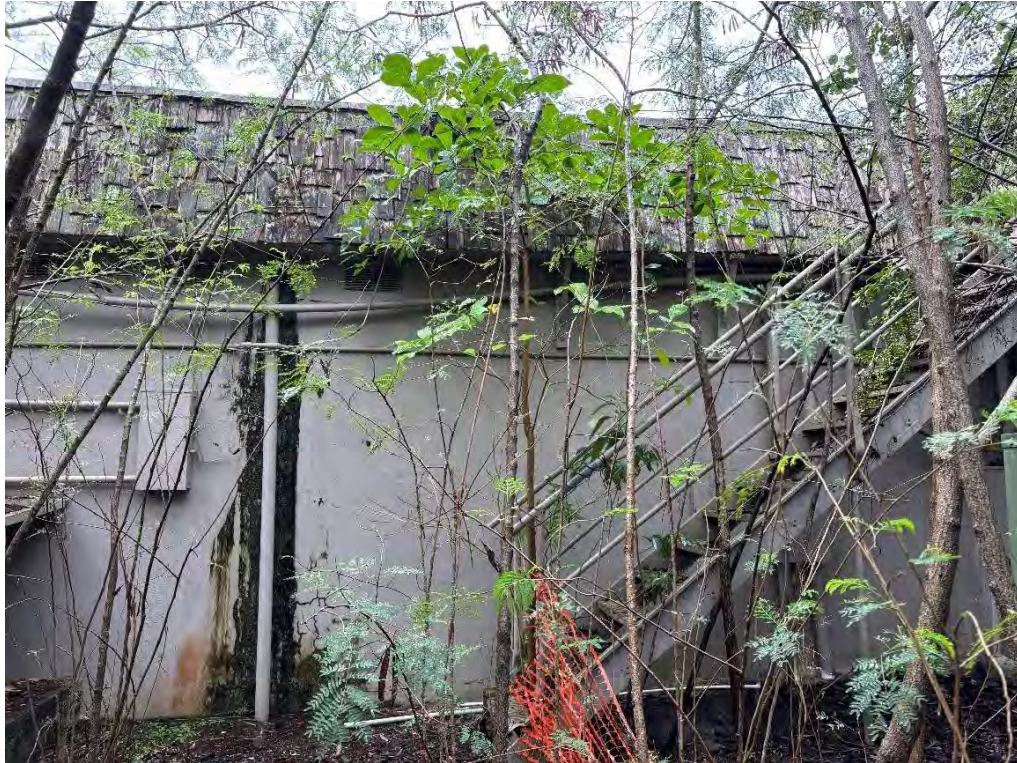
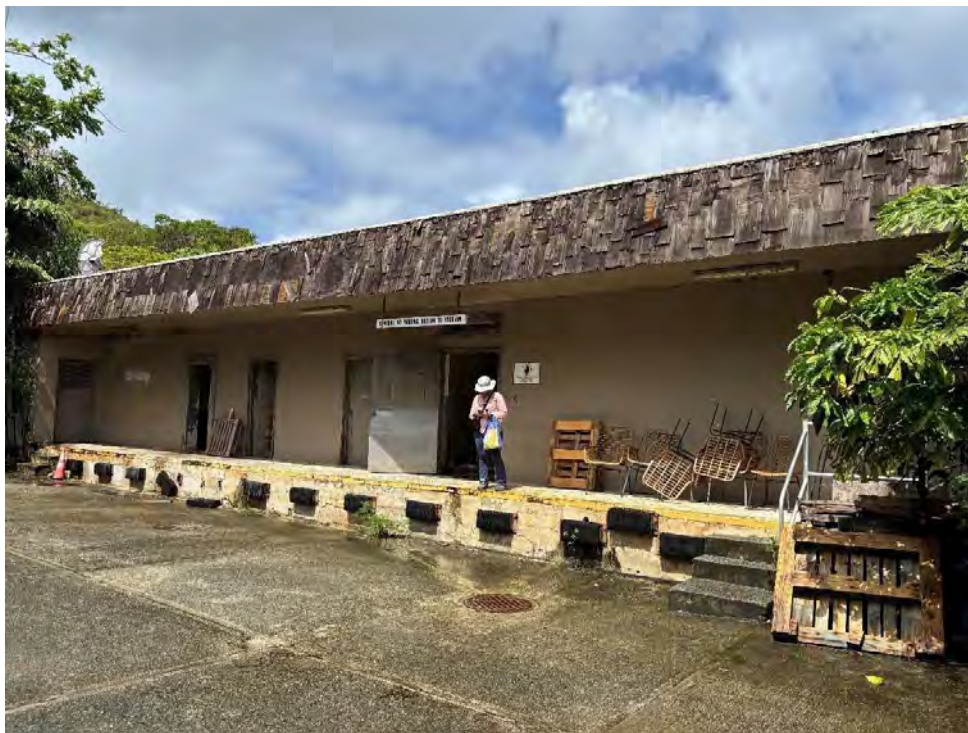
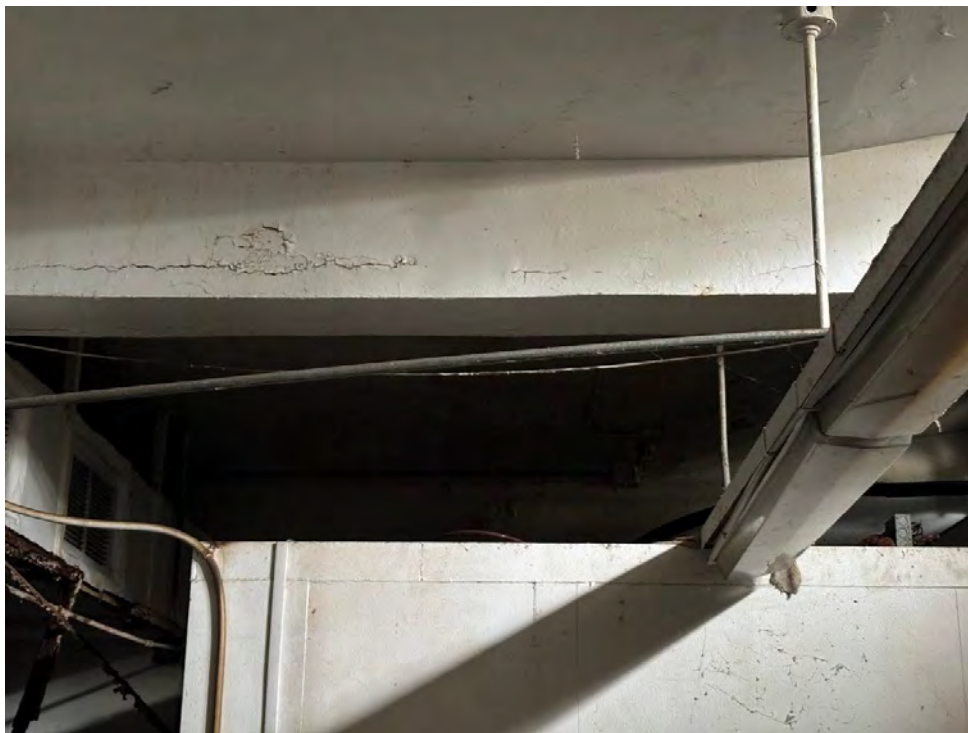
| Component | Material | Notes |
|---|---|---|
| Walls (Structural) | First Floor:<br>Stone/Concrete<br>Second Floor:<br>Concrete on west side, steel framing on east side, and wood framed shed addition further east. | Concrete beams supporting second floor cracked in kitchen area. Spalled beam to column connection with exposed, corroded rebar.<br><br>Tile finishes in kitchen area covered most walls and ceilings, so some structural conditions may be hidden.<br><br>Questionable construction design second floor. |
| Roof | Membrane on Concrete/Metal Decking<br><br>Mansard wood shingle roof on second floor admin offices | First floor roof is functionally failed, numerous areas of water infiltration and large hole in south east corner.<br><br>Wood shingles deteriorated and visible biological growth. |
| Stairs/Railings | Metal Stairs to Roof | Wood planks on roof catwalk deteriorated. Possibly an egress pathway due to occupancy on second floor. |

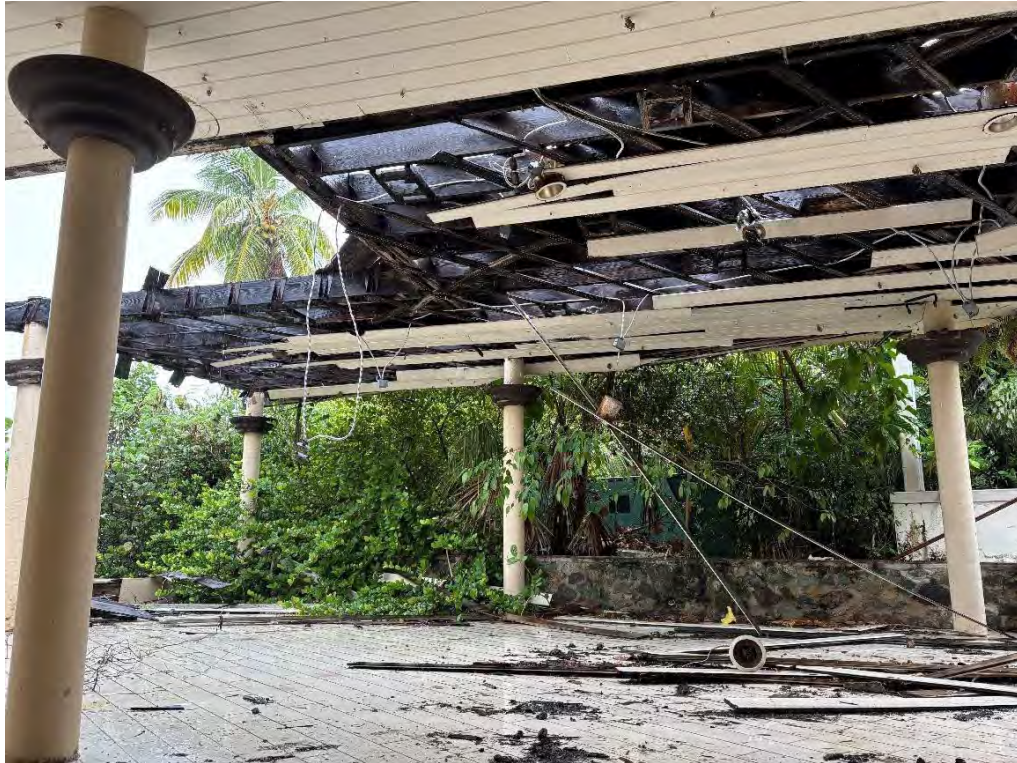
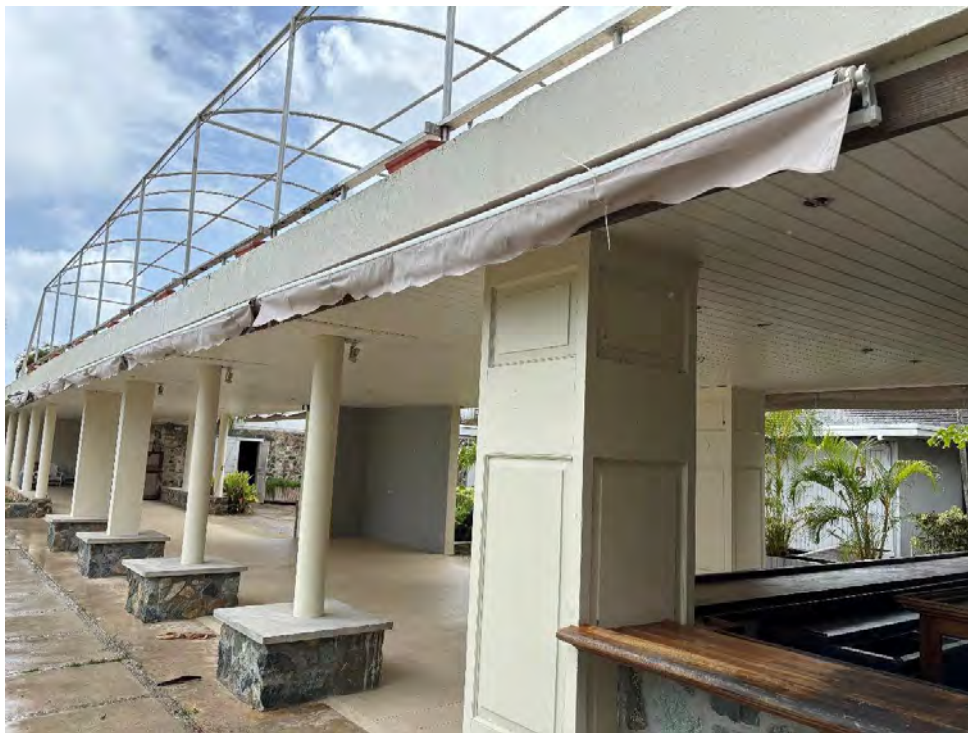
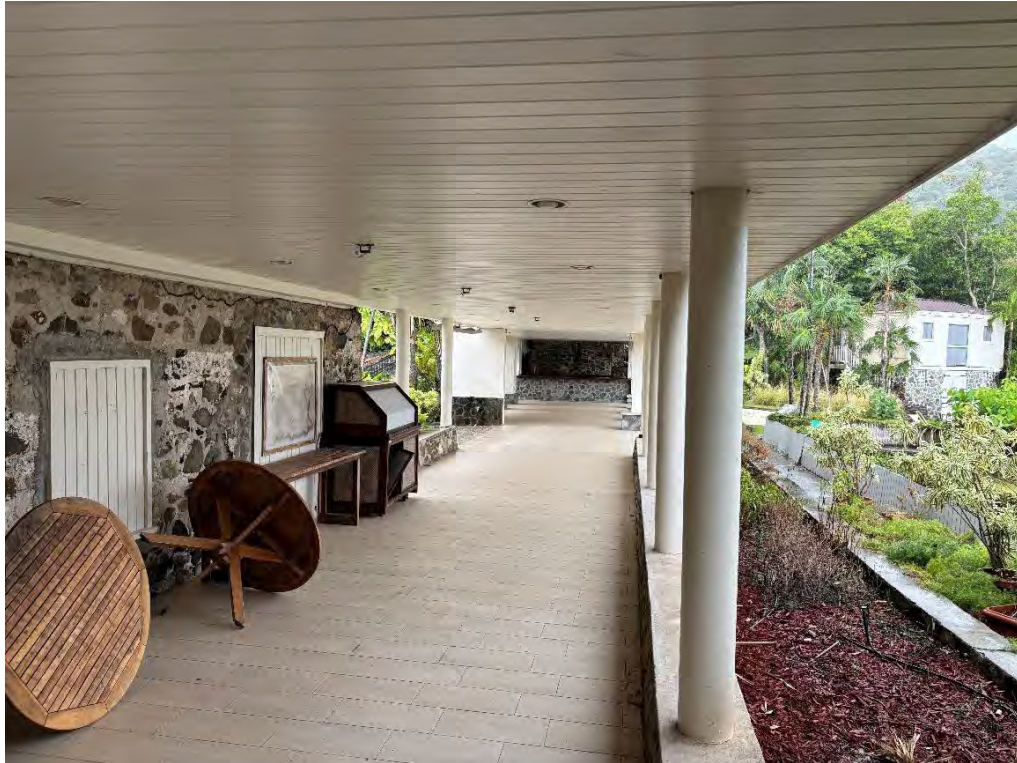
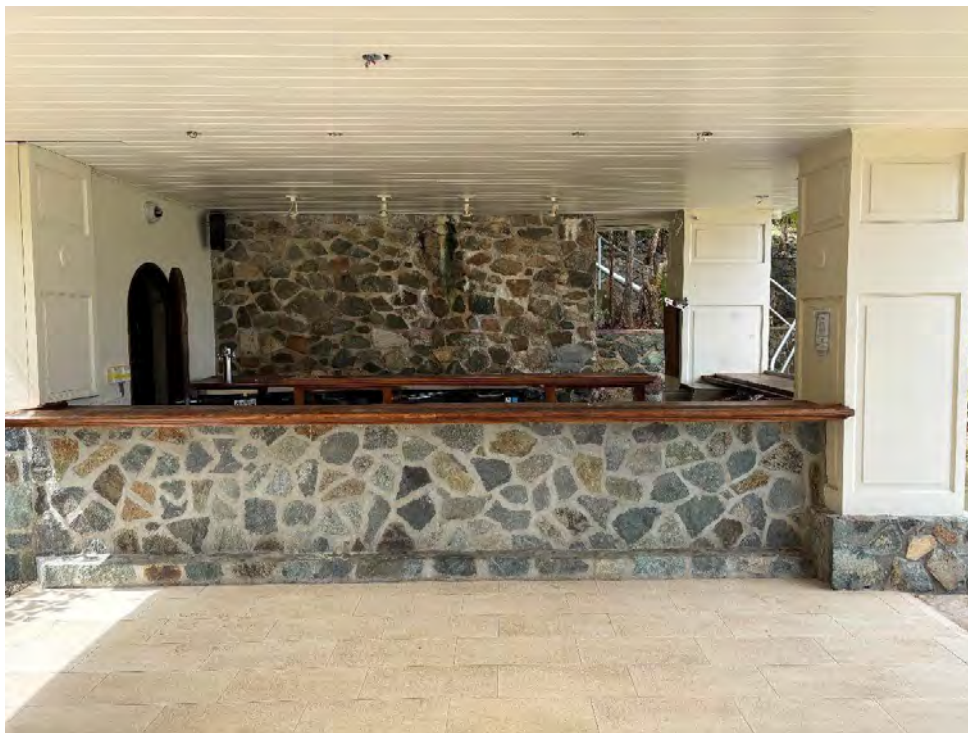
| Component | Material | Notes |
|---|---|---|
| Walls (Structural) | Concrete Piers | Structure is semi-attached to portions of the admin building. The concrete piers are the primary structural system, no pier deterioration was observed. |
| | Steel/wood-framed addition | Wood-framed additions were hung from the roof at the north end of the structure from a post-installed steel lintel. Questionable construction design of additions. |

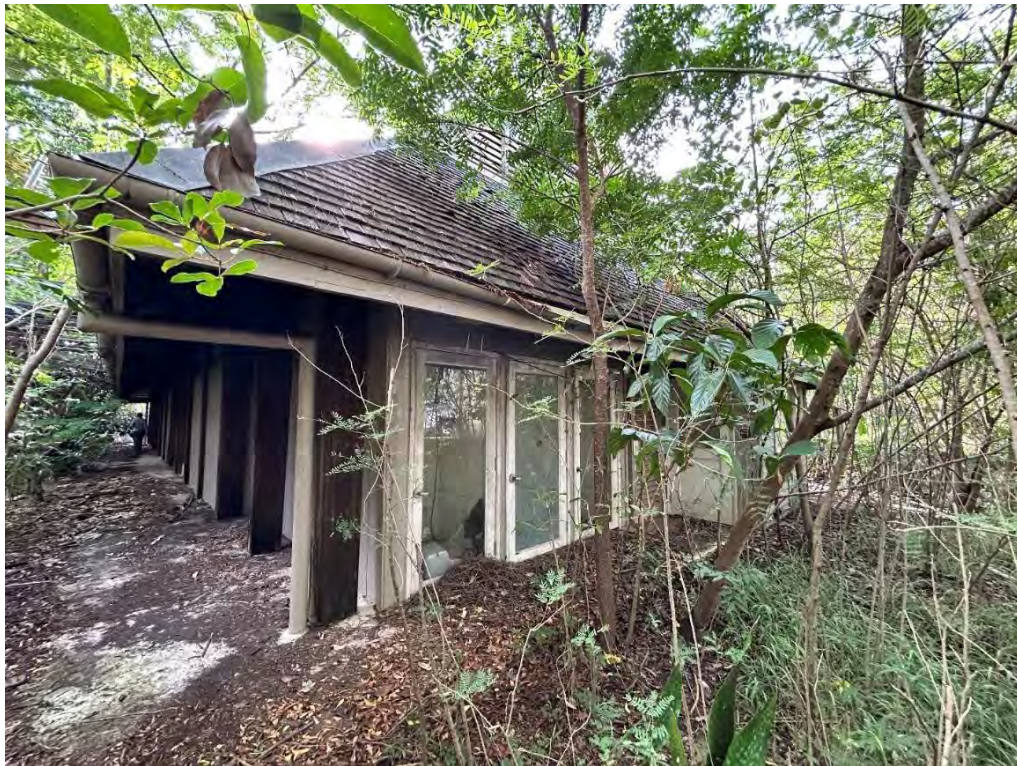
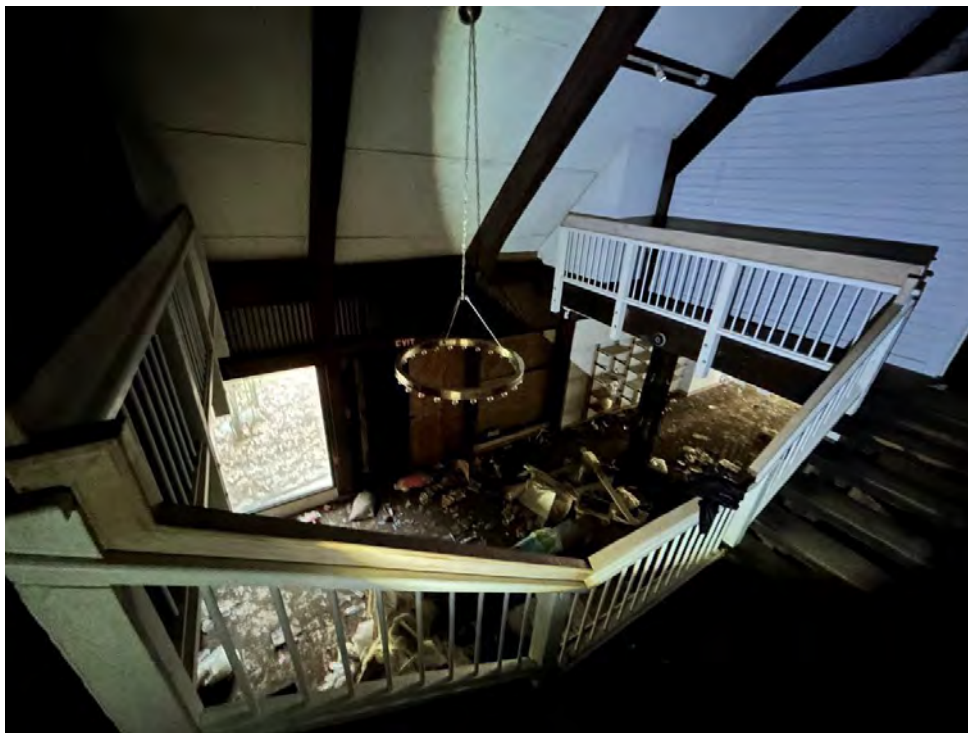
| Component | Material | Notes |
|---|---|---|
| Framing (Structural) | Laminated Wood / Timber | Bottom of exterior, laminated wood columns have moisture damage. |
| Walls (Non-Structural) | Wood Framed | Termite activity observed on partition walls by kitchen.<br>Exterior partition walls on south side have sill plate and sheathing damage near base. |
| Roof | Wood Framed / Wood Shingles | Sporadic sheathing damage and missing wood shingles at roof.<br>Vegetation on roof. |
| Pergolas | Wood Framed | Attached wood pergola on north side with damaged rafters and posts.<br>Detached wood pergola on east side with sever drift and failed connectors. |

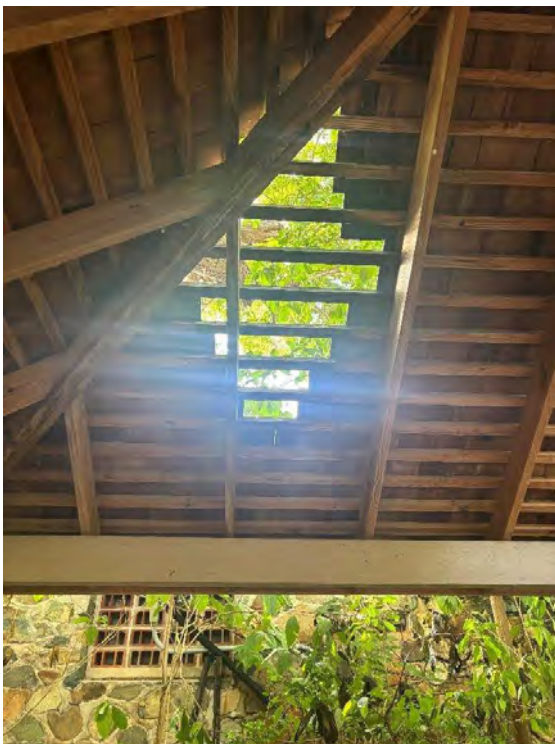
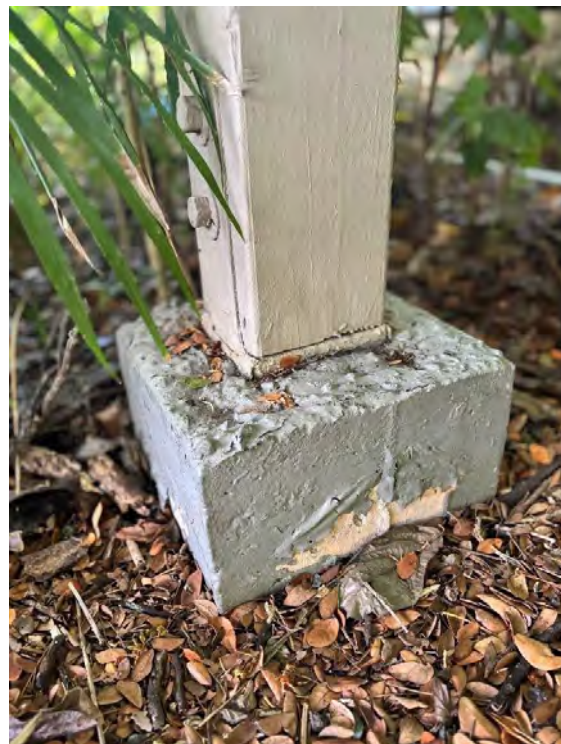
| Component | Material | Notes |
|---|---|---|
| Roof | Wood Framed /<br>Wood Shingles | Missing roof sections. Potential termite damage. |

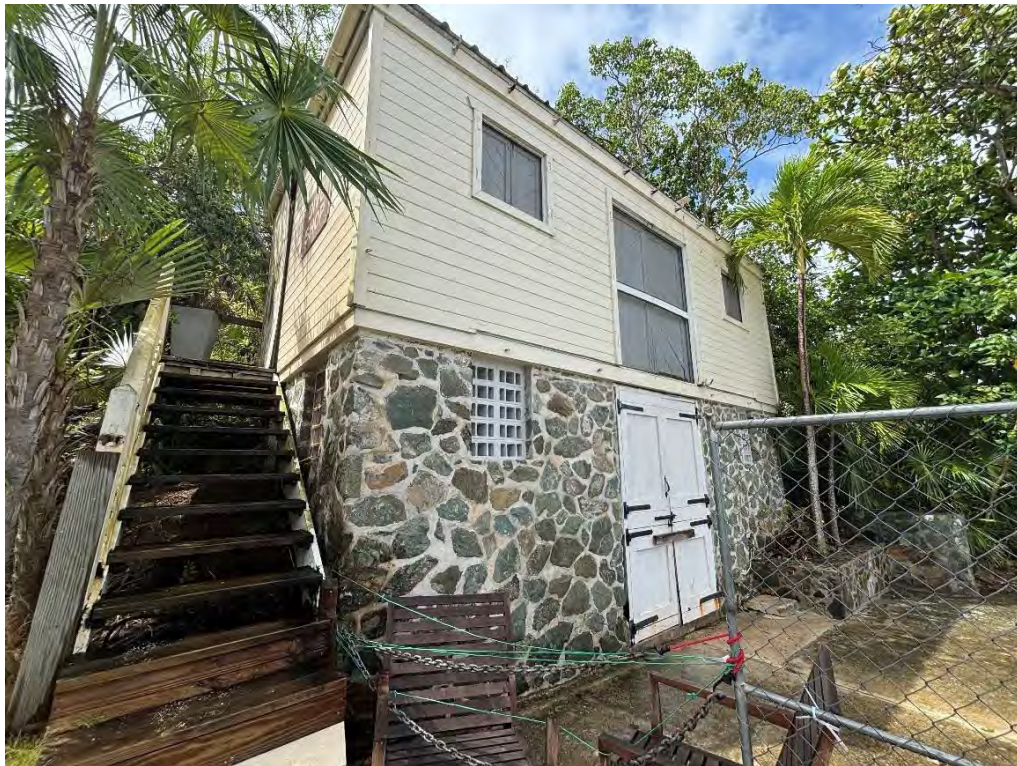
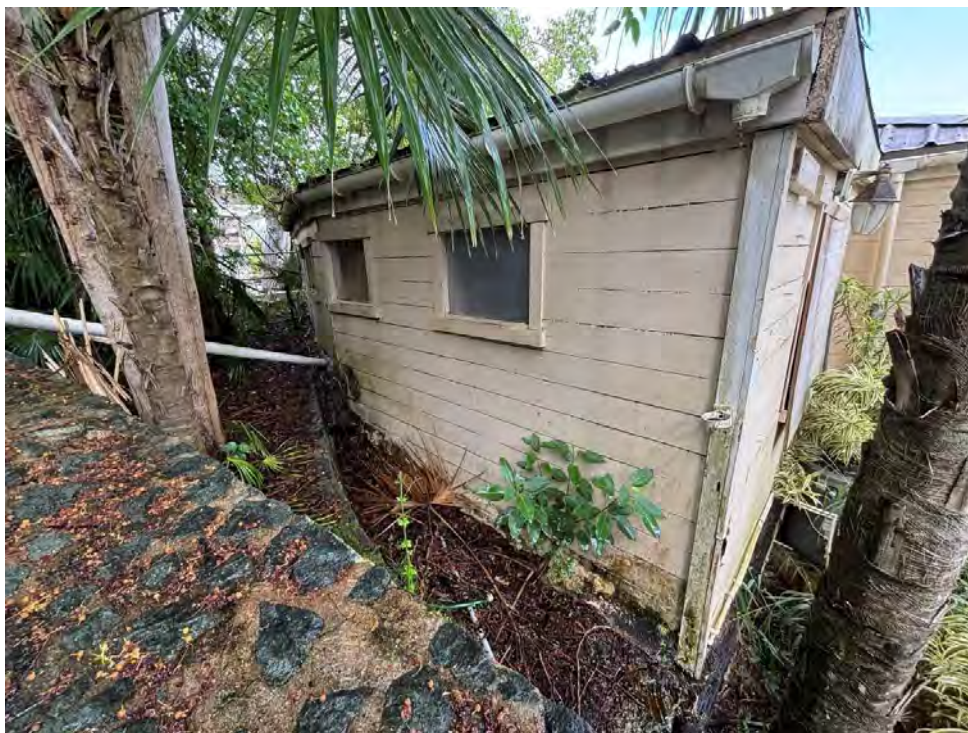
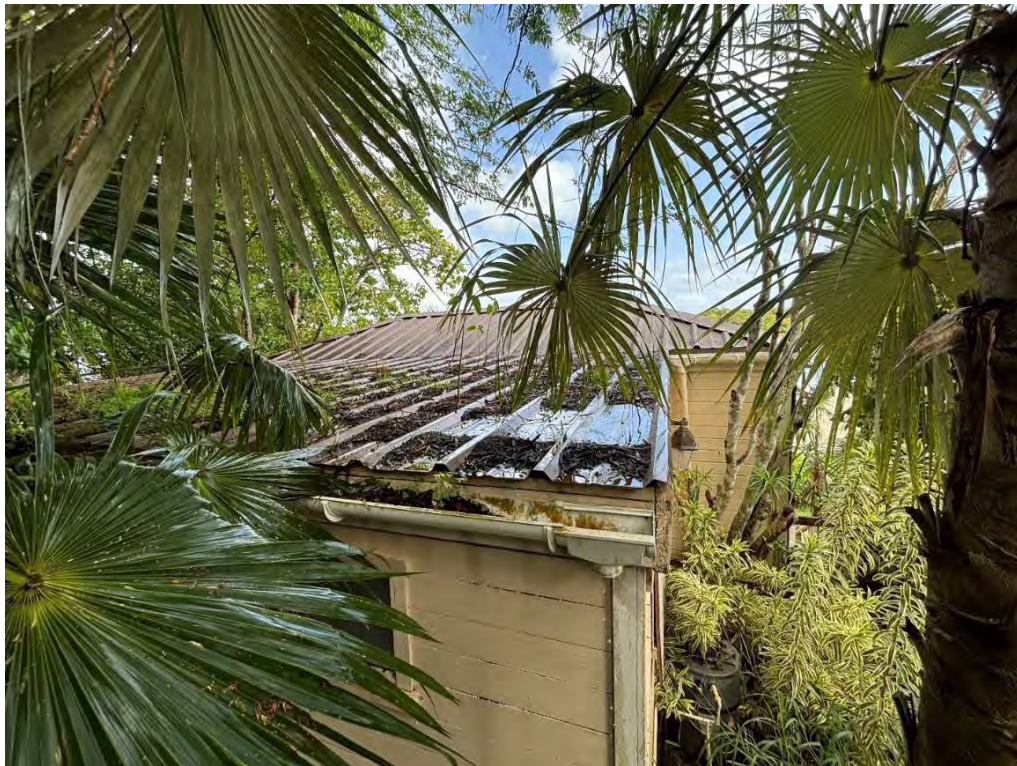
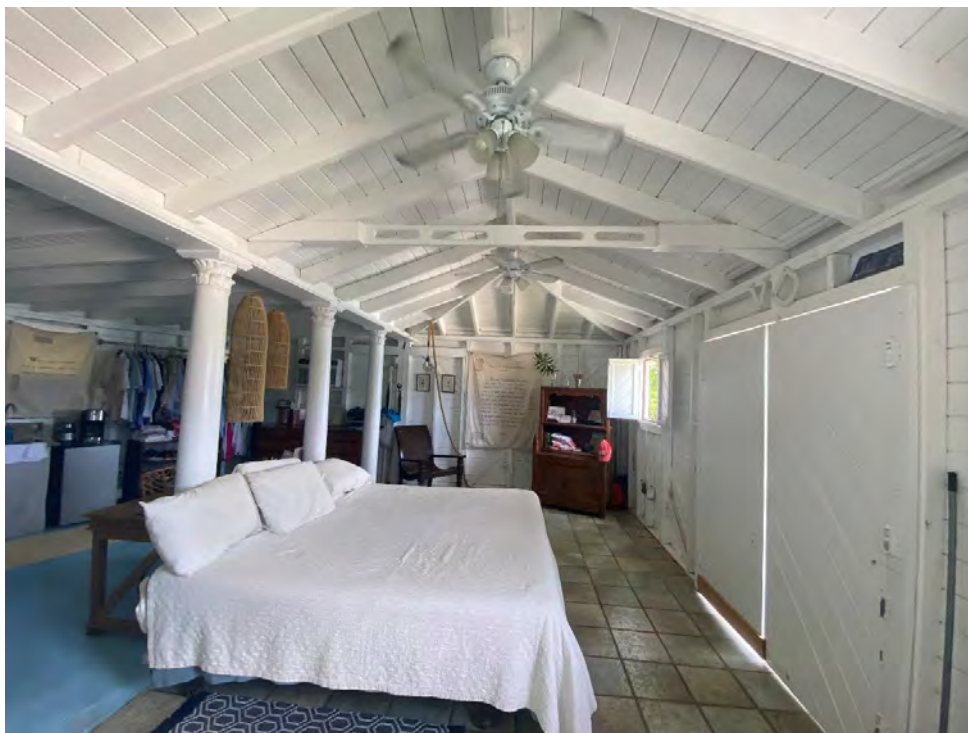
| Component | Material | Notes |
|---|---|---|
| Walls (Structural) | Stone 1 <sup>st</sup> Floor /<br>Wood 2 <sup>nd</sup> Floor | Exterior sheathing on east side of building is showing signs of rot at base of wall. |
| Roof | Wood Framed /<br>Metal Roof | Vegetation on low roof.<br>Roof at rear building has a very low slope for a metal roof. |
| Stairs/Railings | Wood | Exterior wood railings have failed. |
