**Building: 56 Fitness Center**

**Structural Assessment: Structurally Sound**

**National Park Service**  
Virgin Islands National Park | Caneel Bay  
Structural Assessment Report

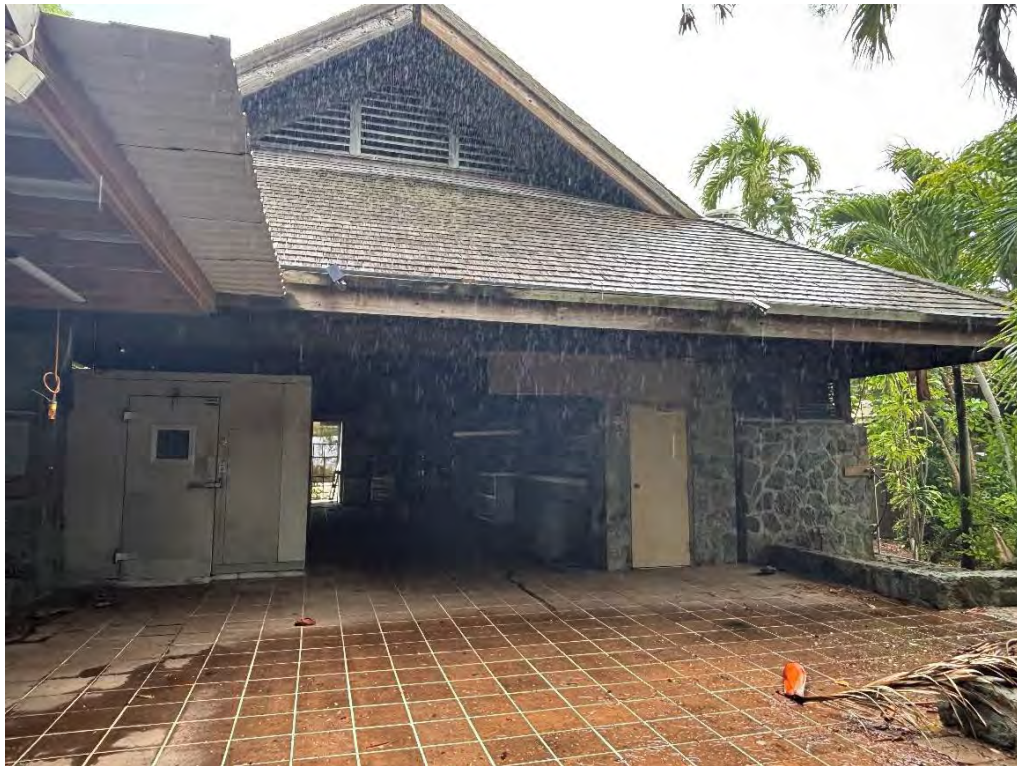
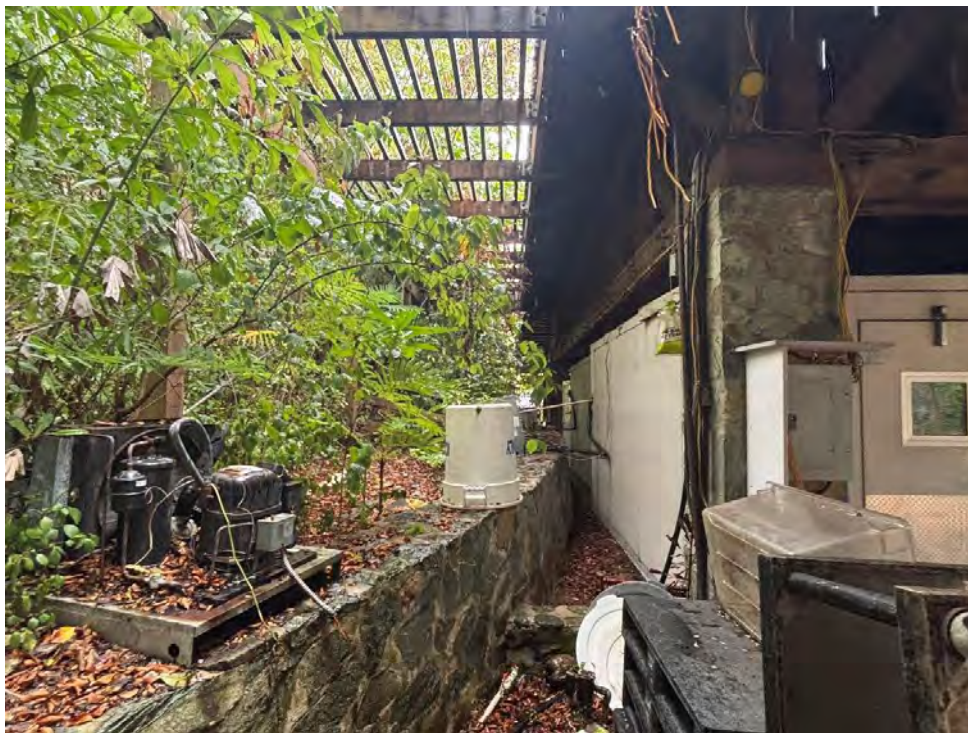
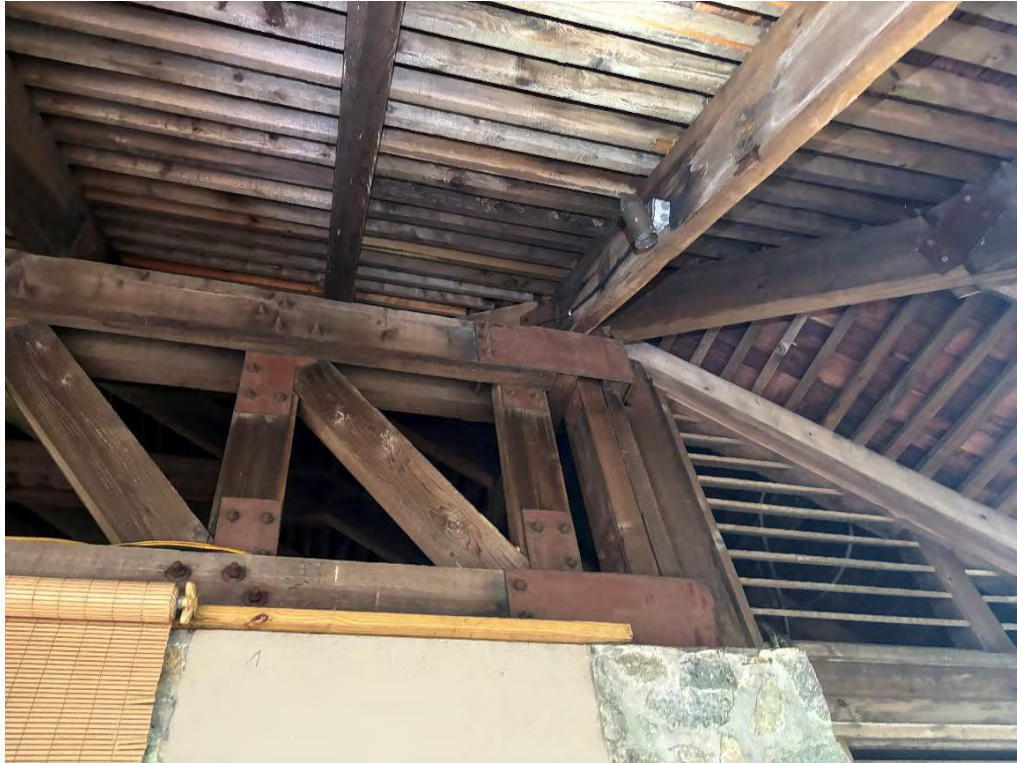
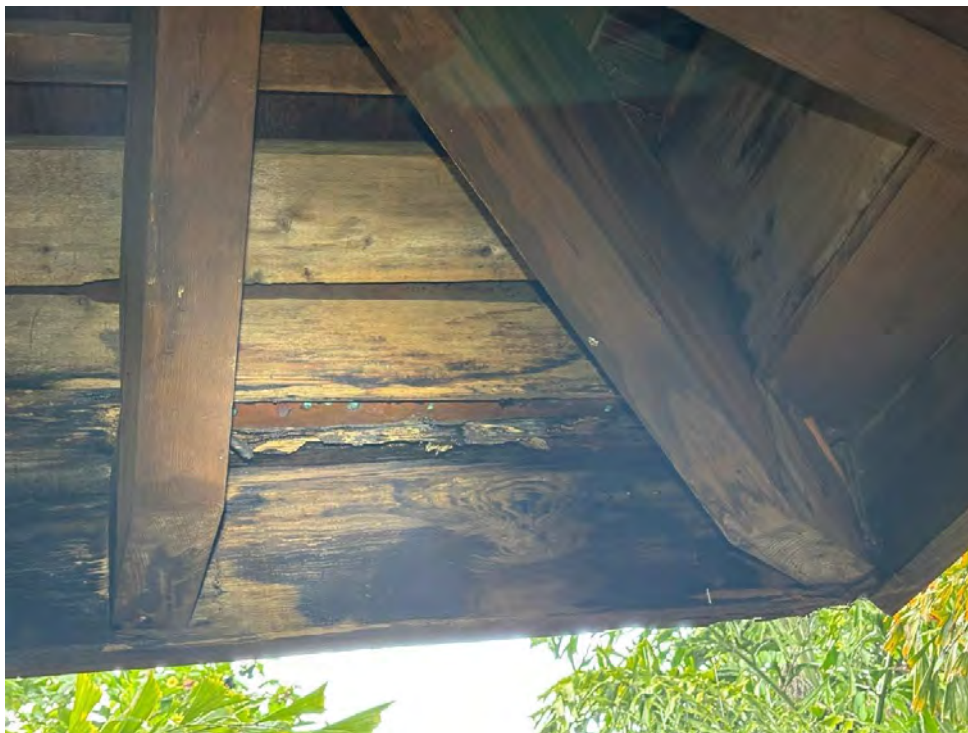
| Component | Material | Notes |
|---|---|---|
| Roof | Wood Framed /<br>Wood Shingles | Rafters at north-east corner shows signs of termite damage and rotted wood.<br>Minor missing wood shingles throughout roof structure. |

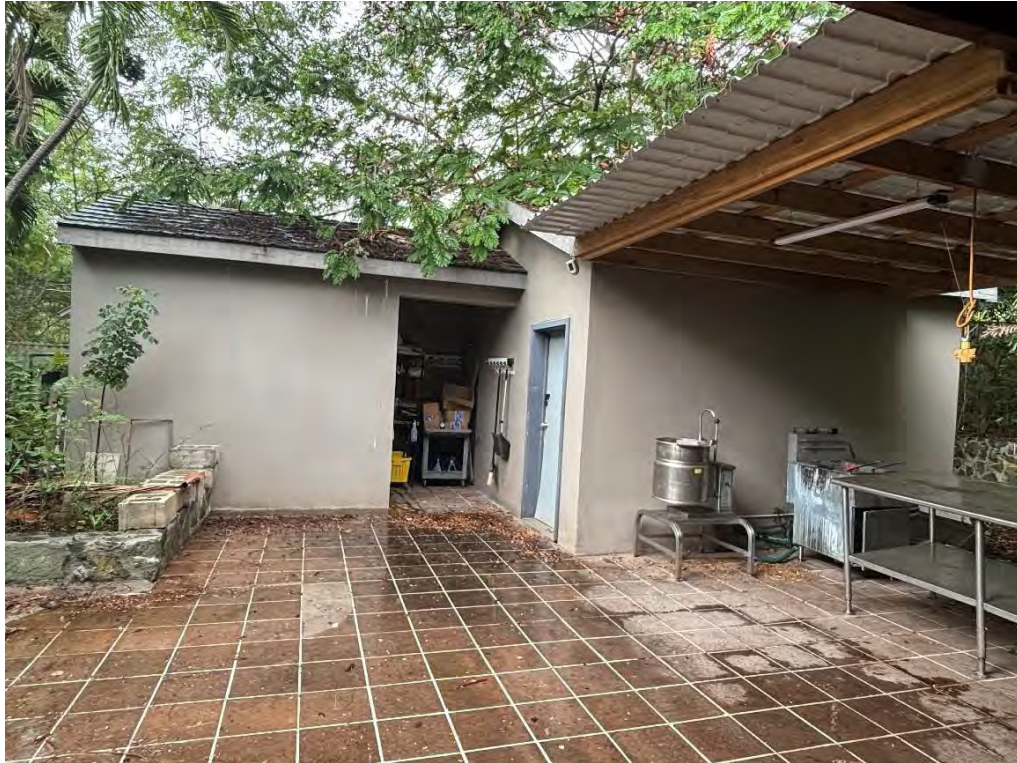
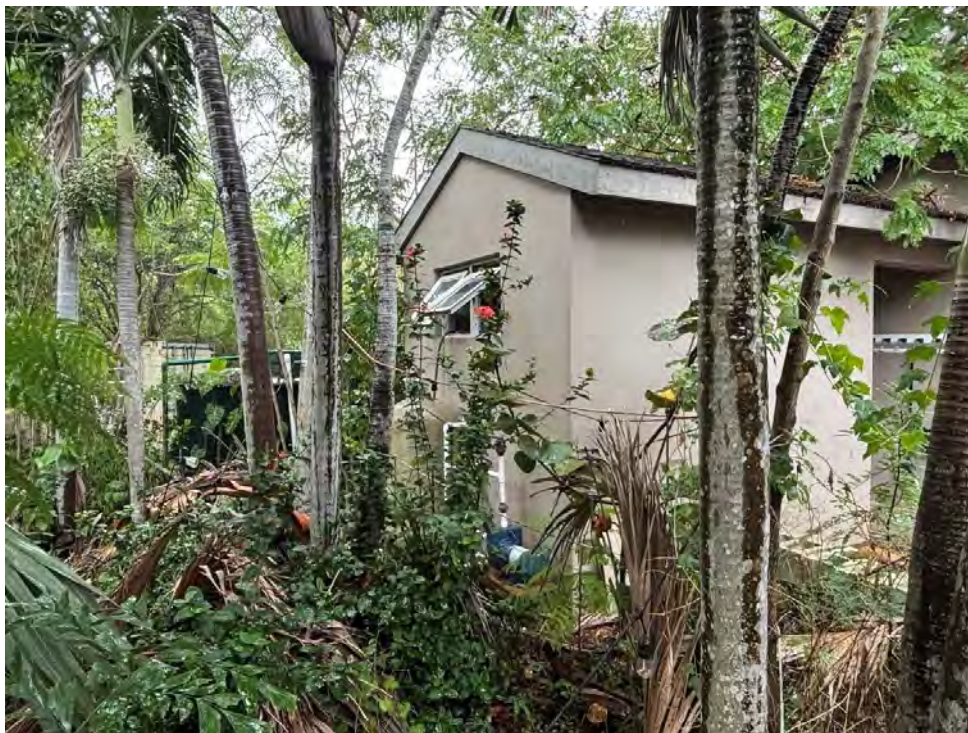
| Component | Material | Notes |
|---|---|---|
| Walls (Structural) | Concrete | Minor rot of wood frames around exterior door. |

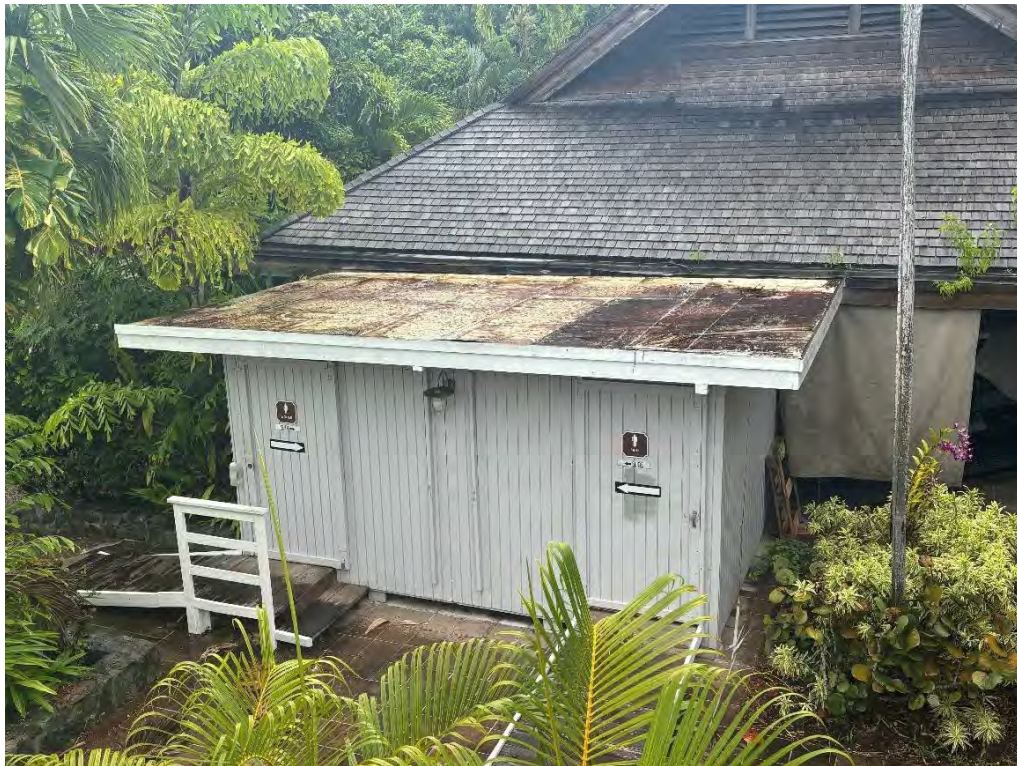
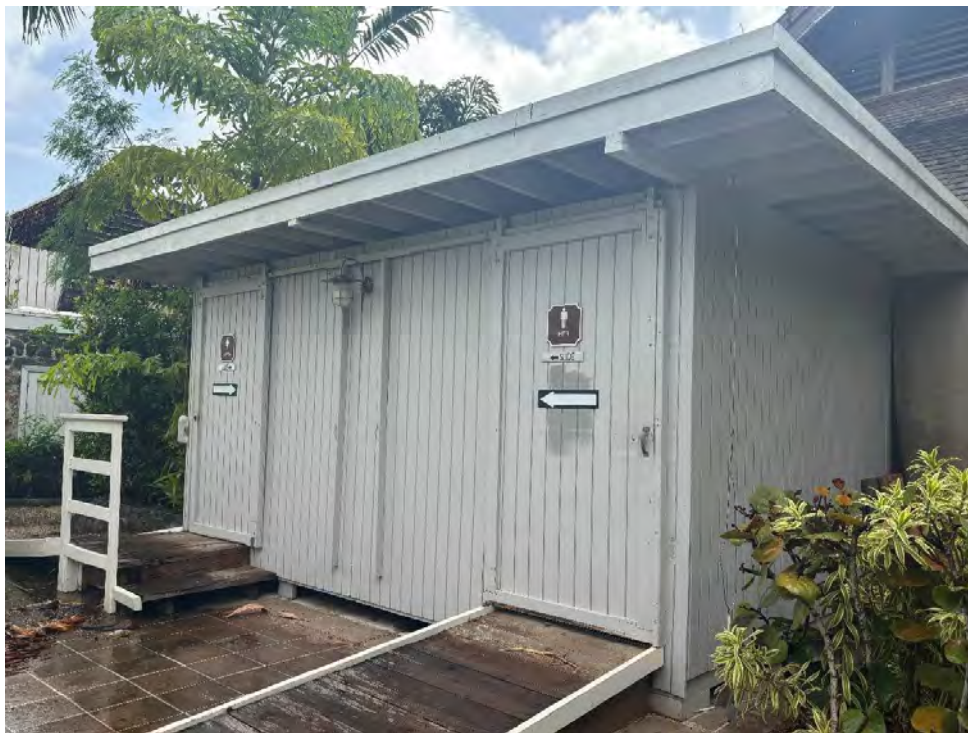
| Component | Material | Notes |
|---|---|---|
| Roof | Wood Framed /<br>Membrane | Minor damage at flashing edge and<br>membrane roof. |

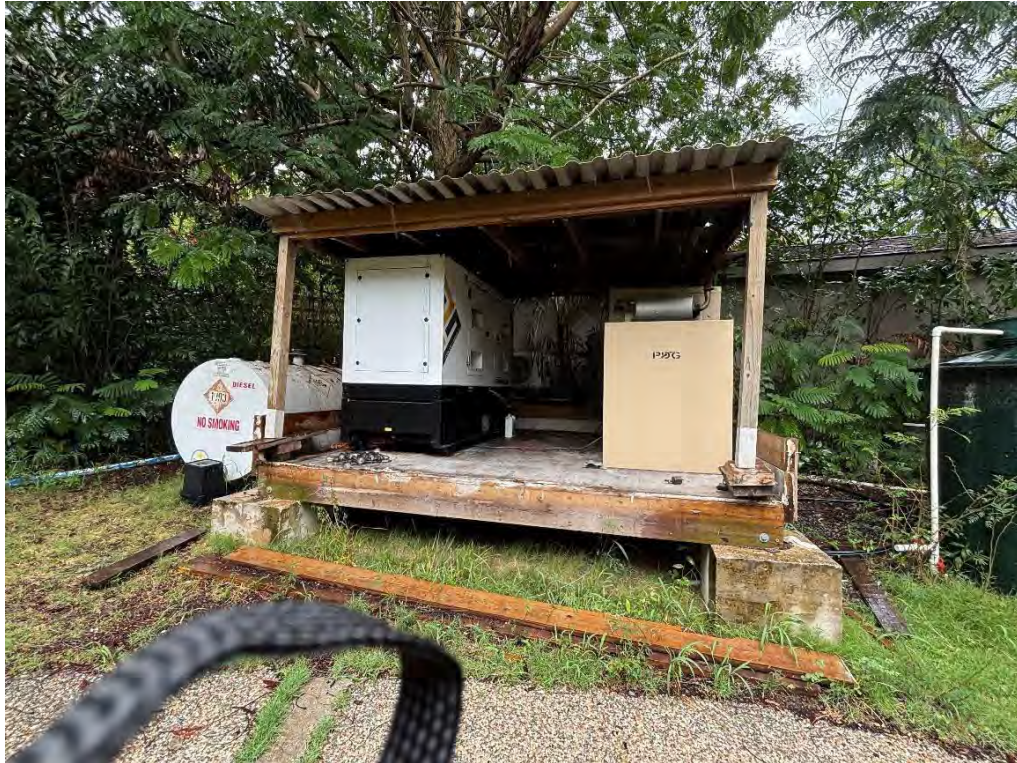
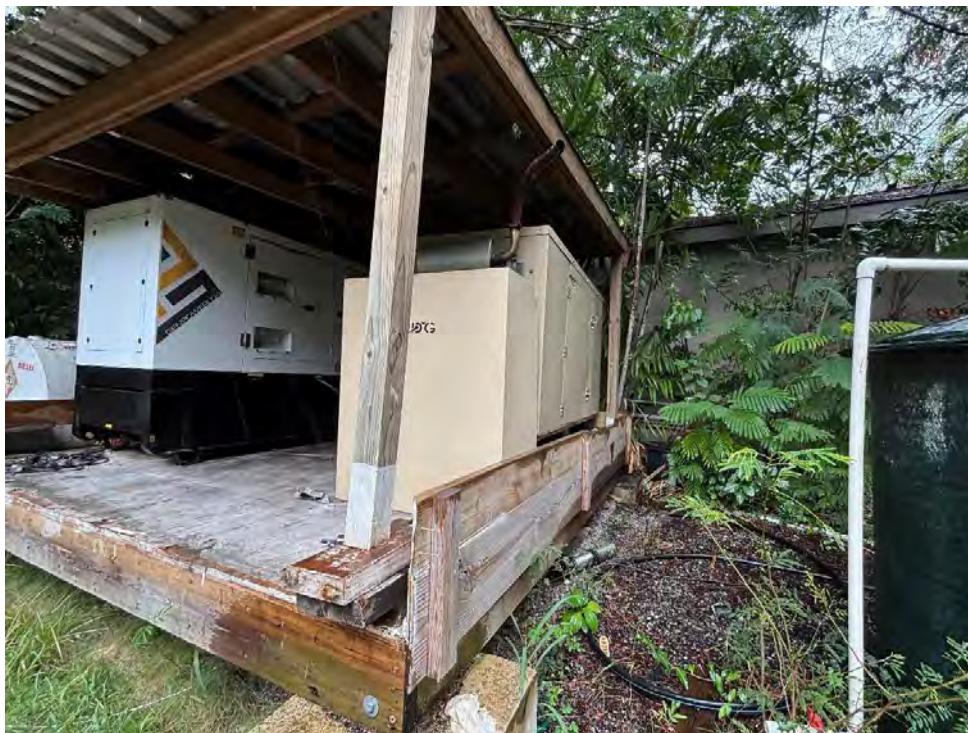
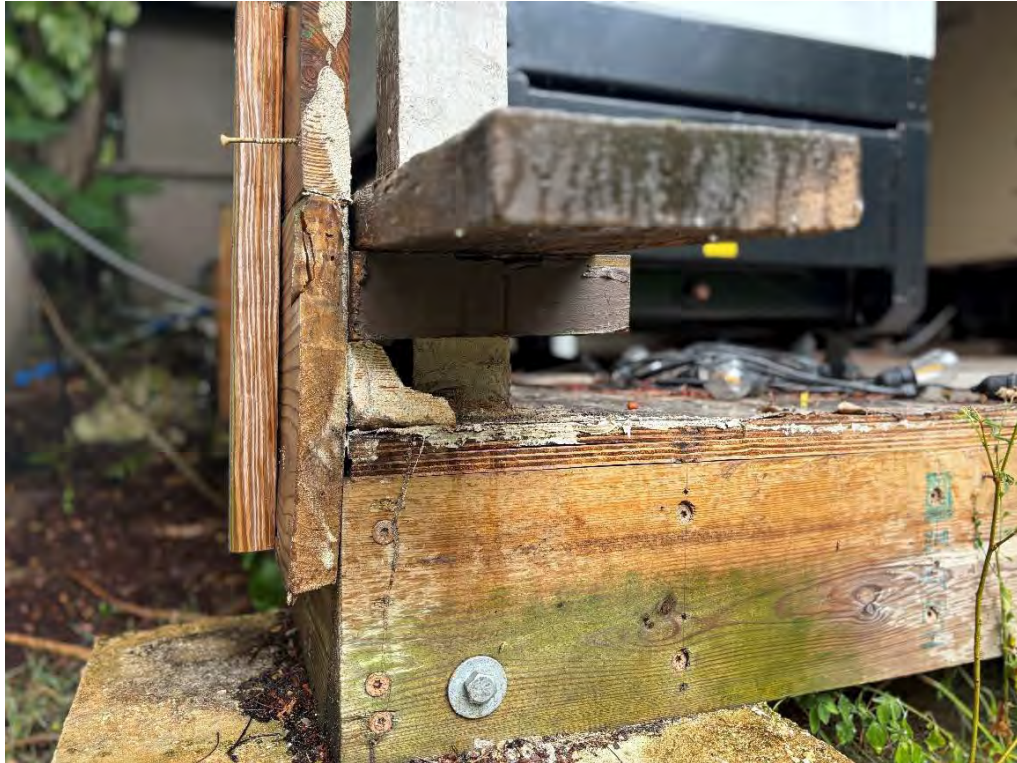
| Component | Material | Notes |
|---|---|---|
| Structure | Wood | Open structure with a wood post at each of the 4 corners.<br>The front two posts have been cut and are supported on stacked wood scraps. The posts are leaning and have no positive connection to the blocking or deck below. |
| Roof | Wood Framed / Plastic Corrugated Deck | Minor damage to roof deck. |

- Structure appears to not meet requirements of National Fire Protection Association (NFPA) regarding supporting generators on flammable surfaces and clearance surrounding generators. Further review recommended to assess code compliance for generator structure.

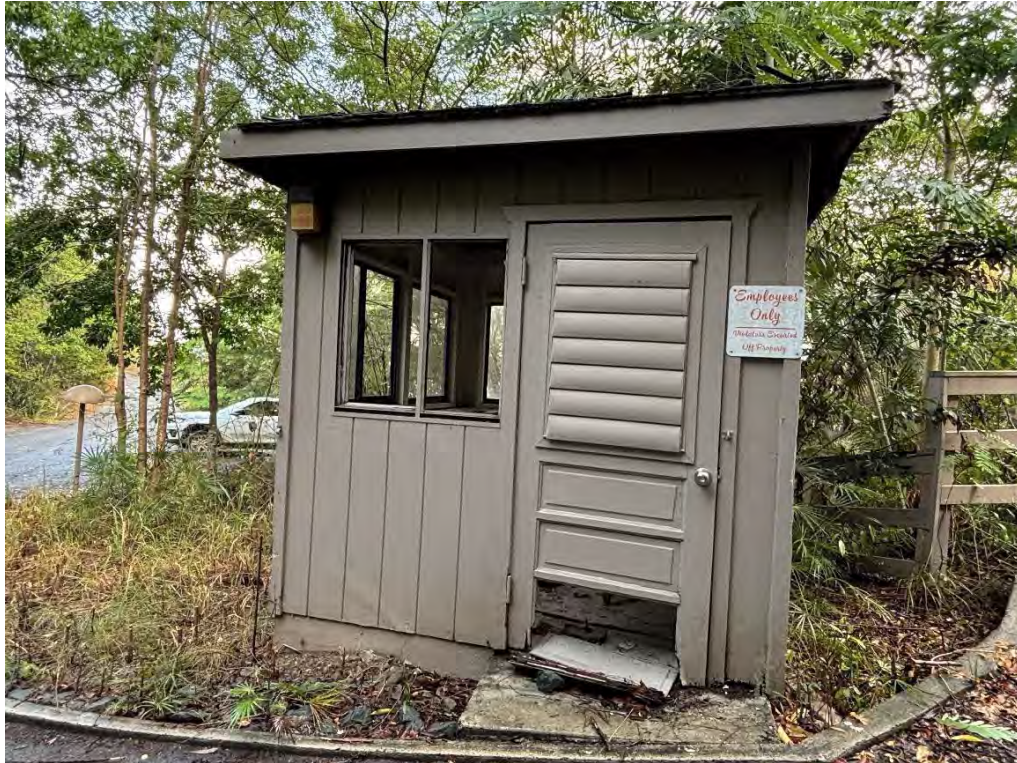
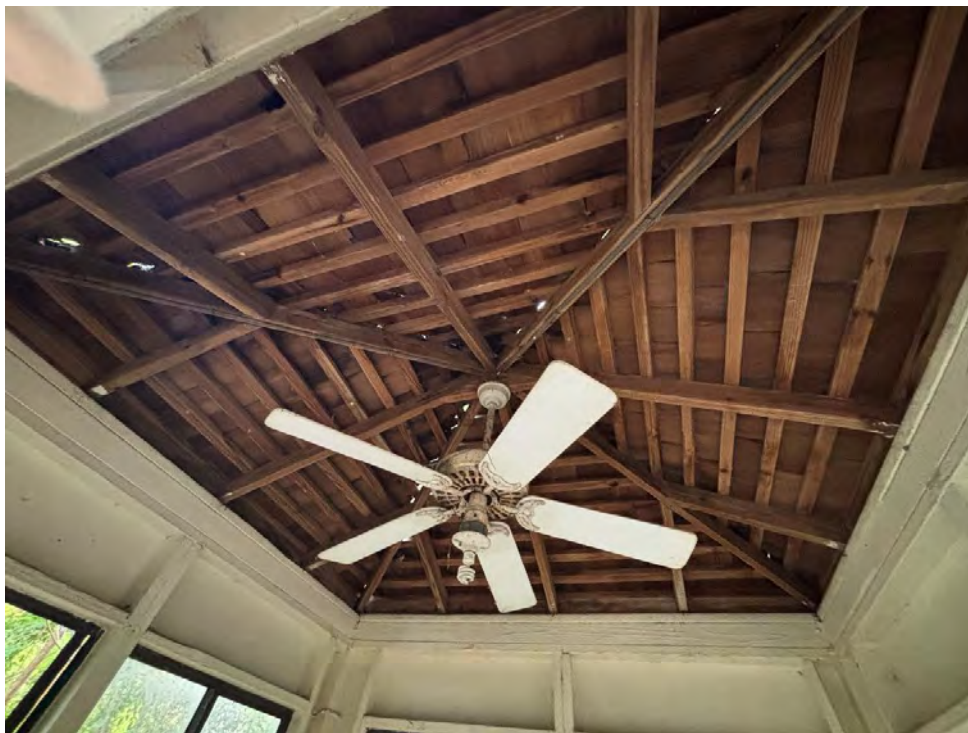
| Component | Material | Notes |
|---|---|---|
| Walls (Structural) | Wood | Minor rot at base of exterior sheathing. |
| Roof | Wood<br>framed/<br>Wood<br>shingles | Missing some shingles.<br>Missing fascia board at one corner. |

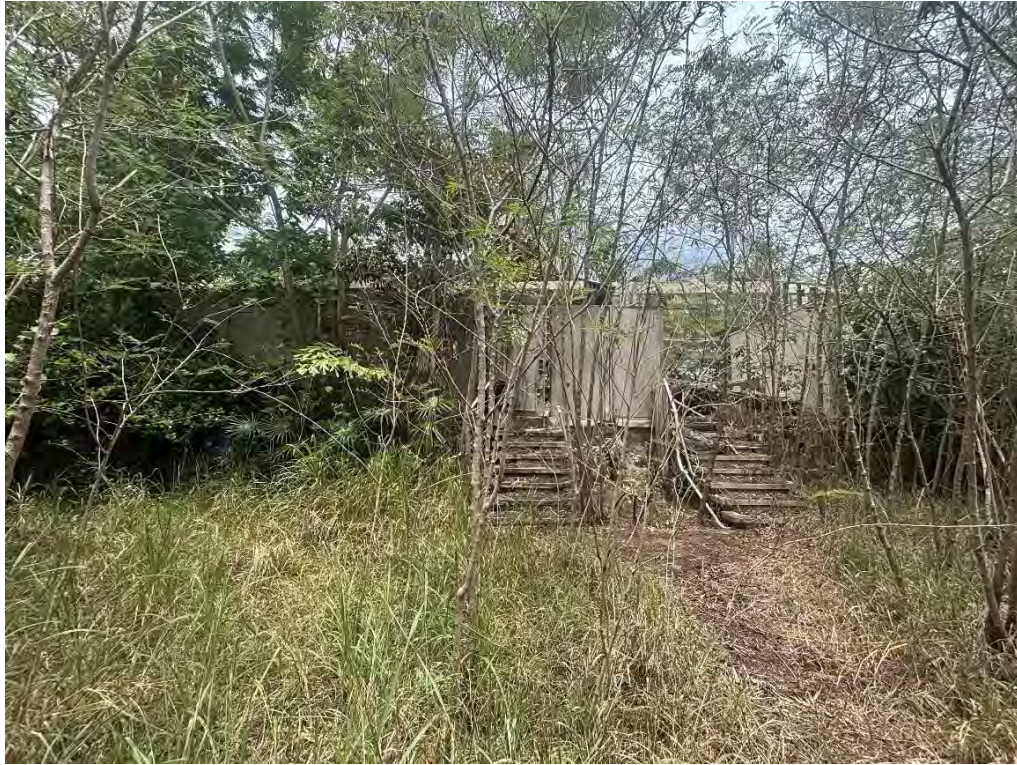
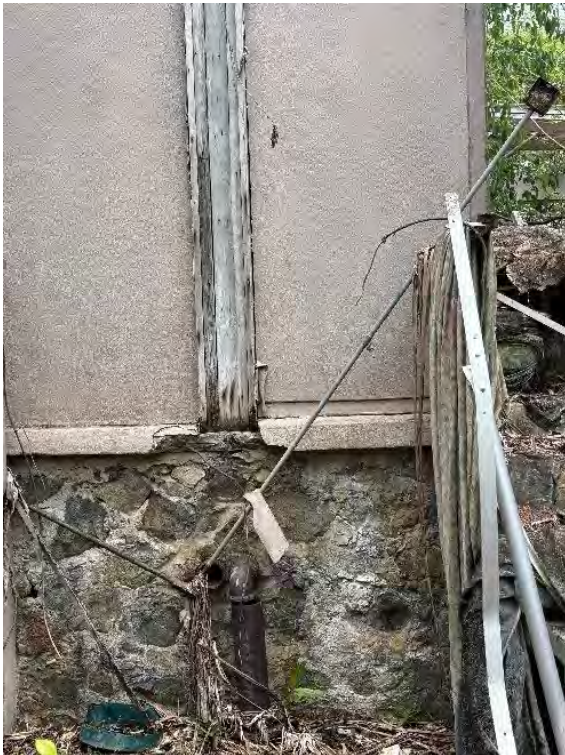
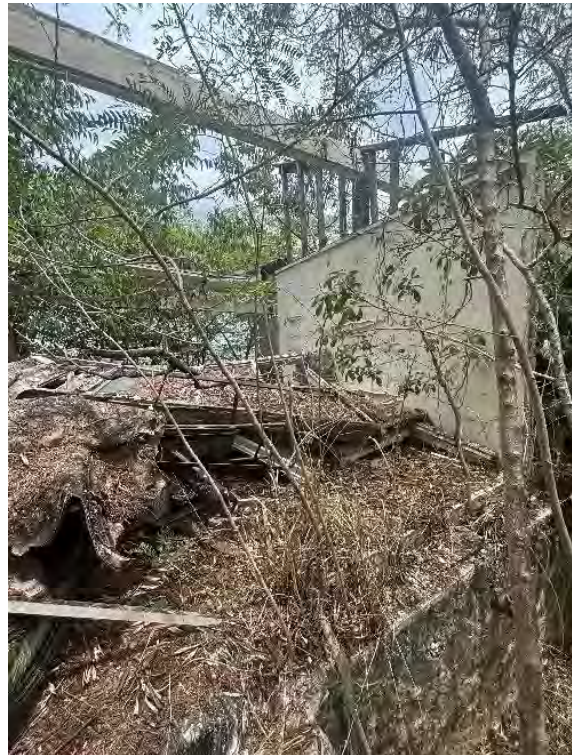
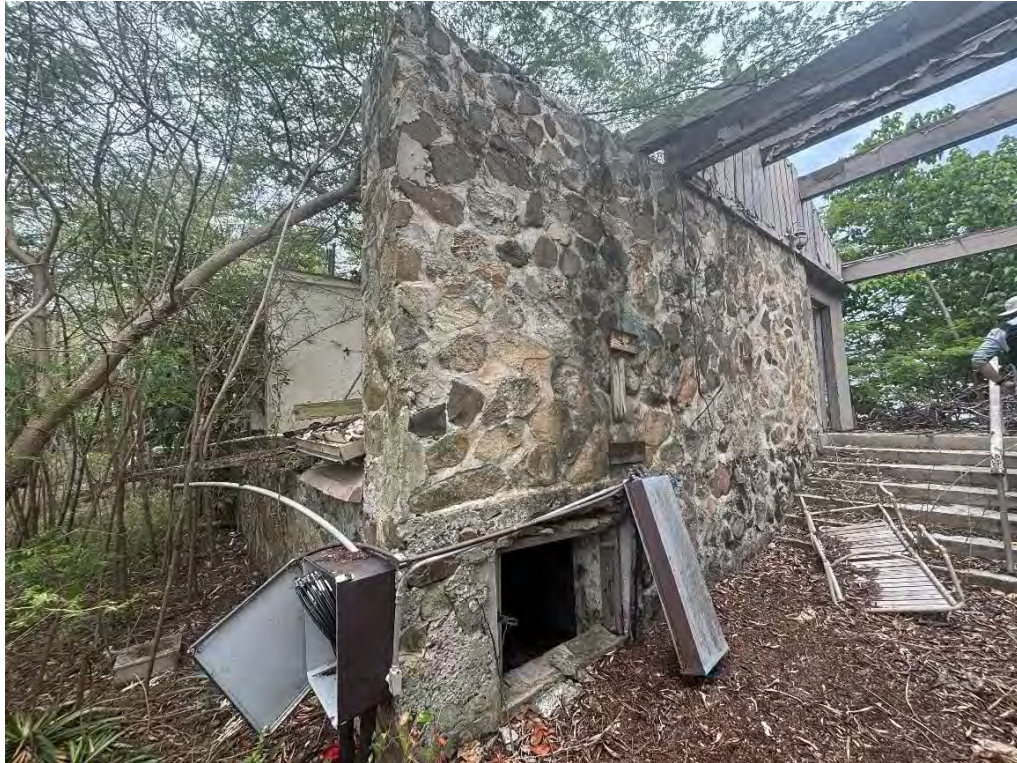
| Component | Material | Notes |
|---|---|---|
| Floor | Concrete /<br>Hollow Core<br>Concrete | Concrete damage and exposed rebar<br>east side of slab in Unit 15. |
| Walls (Structural) | Stone /<br>Concrete / Steel<br>Columns | Concrete cracking at door to Unit 17.<br>Steel columns corroded at base. |
| Walls (Non-Structural) | Wood | Collapsed. |
| Roof | Wood | Roof collapsed. |
| Stairs/Railings | Concrete /<br>Aluminum | Railings damaged. |

- This building has significant corrosion of the embedded steel structure and corrosion of the concrete encased steel piers and rebar within the concrete bearing walls.

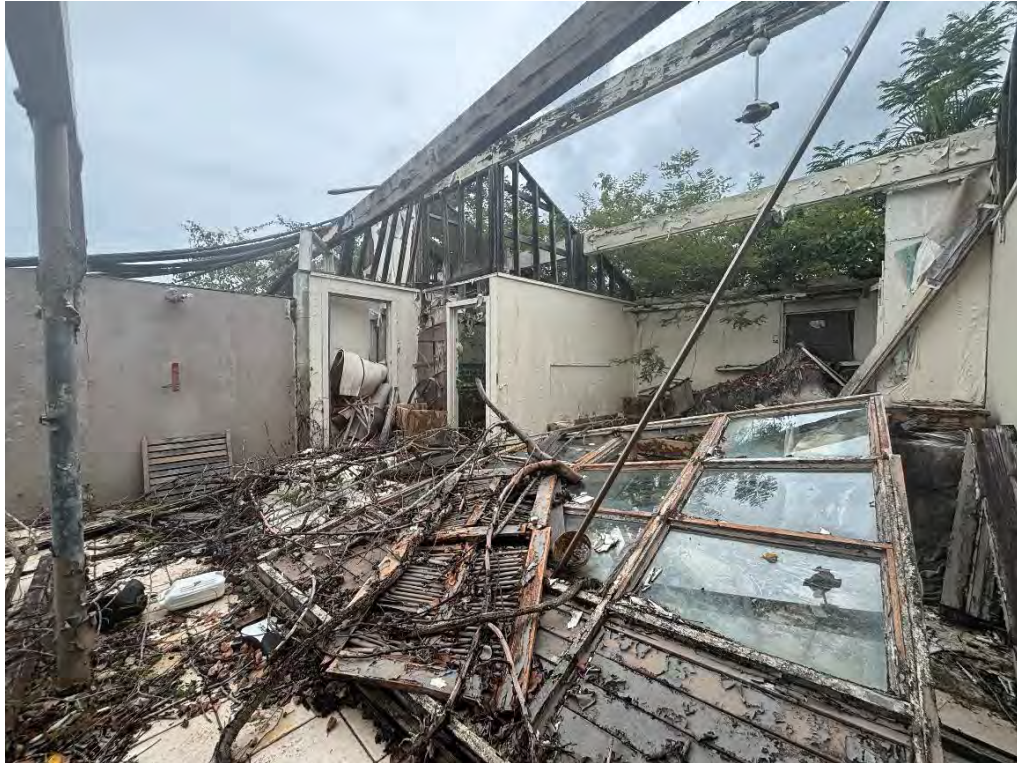
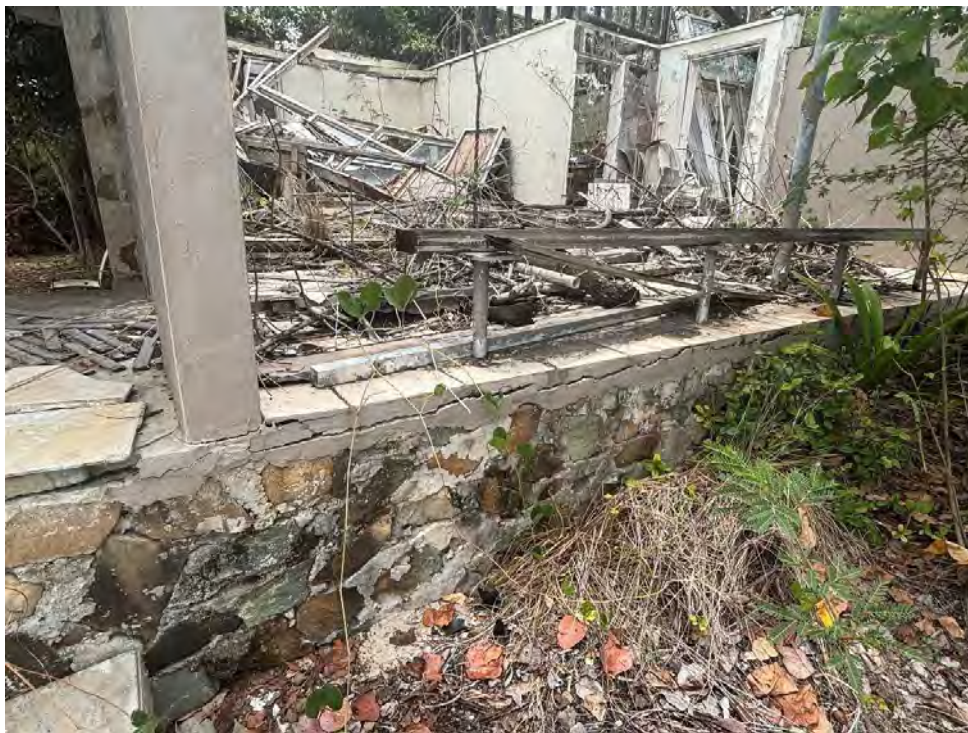
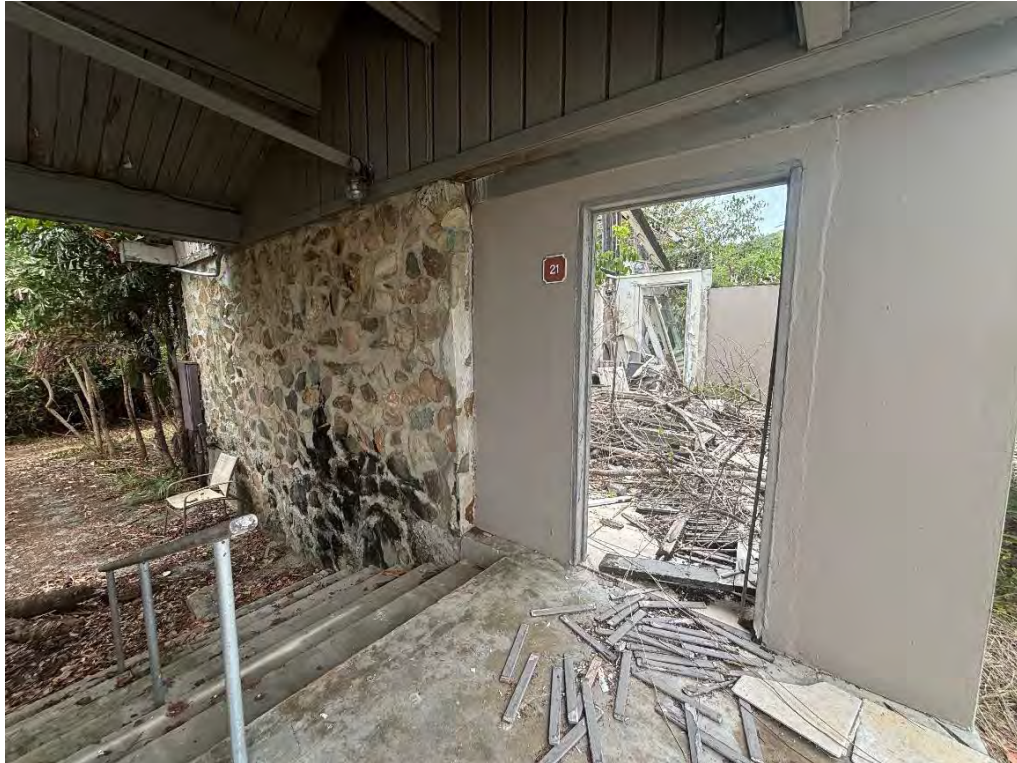
| Component | Material | Notes |
|---|---|---|
| Floor | Concrete /<br>Hollow Core<br>Concrete | Hollow core concrete plank in Units 19<br>and 20 collapsed. |
| Walls (Structural) | Stone /<br>Concrete /<br>Steel<br>Columns | Concrete wall collapsed between Units<br>19 and 20.<br>Foundation walls on west side have mortar<br>deterioration.<br>Steel columns corroded at base. |
| Roof | Wood | Roof collapsed. |

- Severely corroded steel columns at base, collapse of exterior slabs, and collapsed concrete wall.

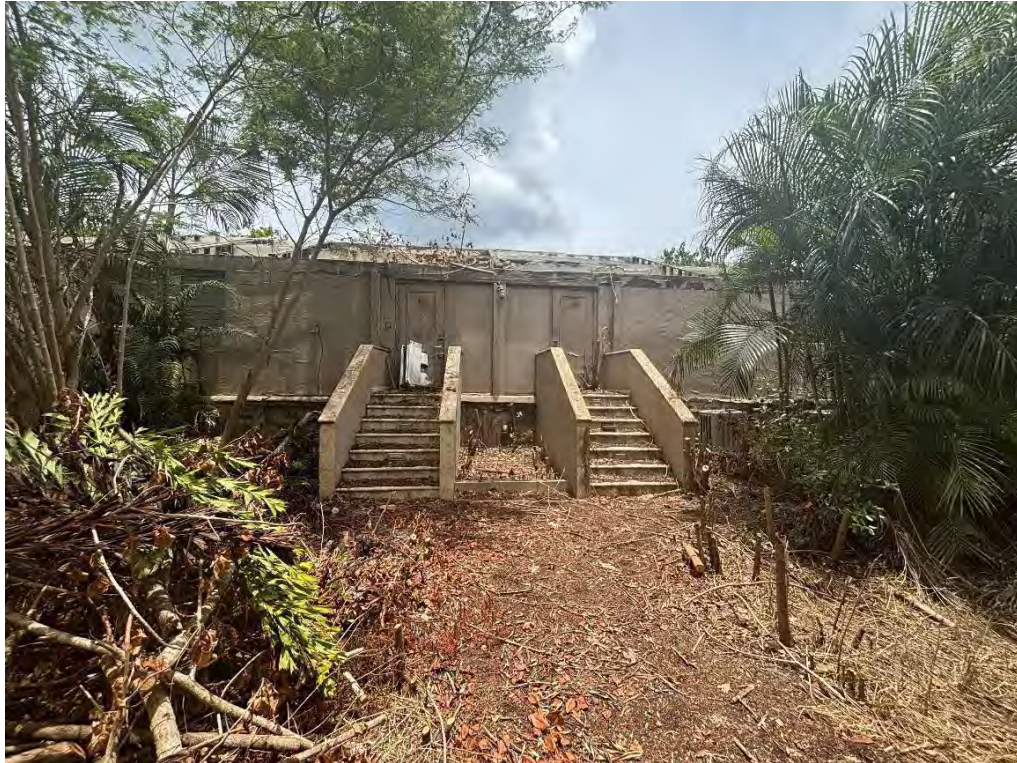
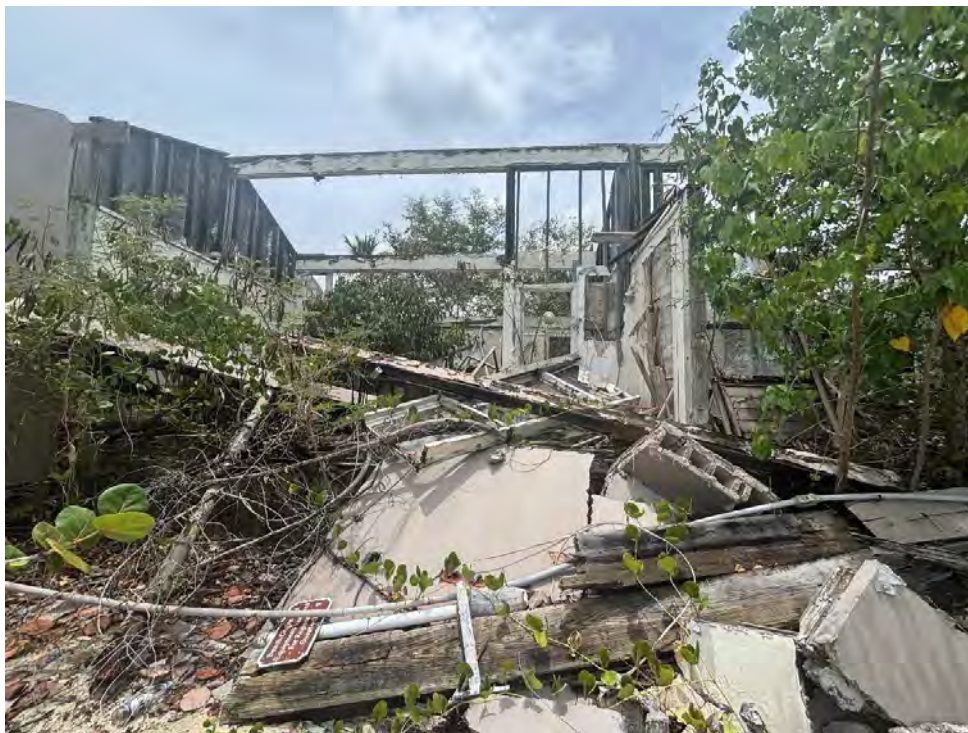
| Component | Material | Notes |
|---|---|---|
| Floor | Concrete /<br>Hollow Core<br>Concrete | Hollow core concrete plank in units 22-23 collapsed.<br>8" topping slab added over hollow core concrete plank creating significant risk of overburdening structure and causing sudden collapse. |
| Walls (Structural) | Stone /<br>Concrete /<br>Steel<br>Columns | Concrete wall displaced.<br>Shear crack in wall between units 24 and 25.<br>Steel columns corroded at base. |
| Roof | Wood | Roof collapsed. |

- Severely corroded steel columns at base, collapse of exterior slabs, and collapsed concrete walls.
