**National Park Service**  
Virgin Islands National Park | Caneel Bay  
Structural Assessment Report

**Building: 28 Caneel Beach Units 26-29**

**Structural Assessment: Structurally Sound**

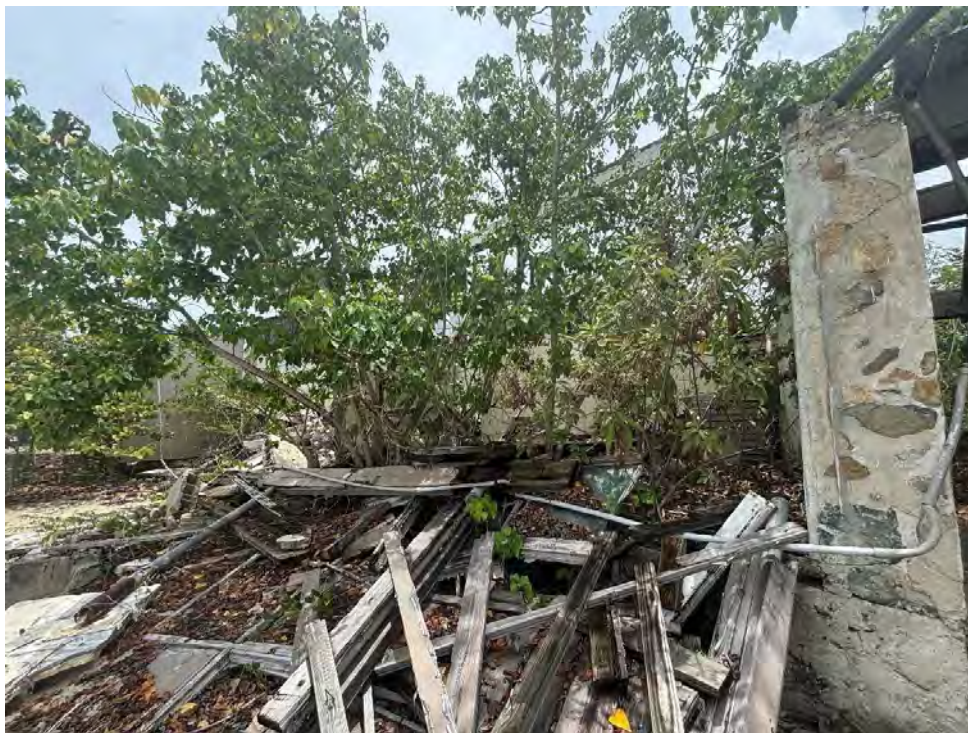
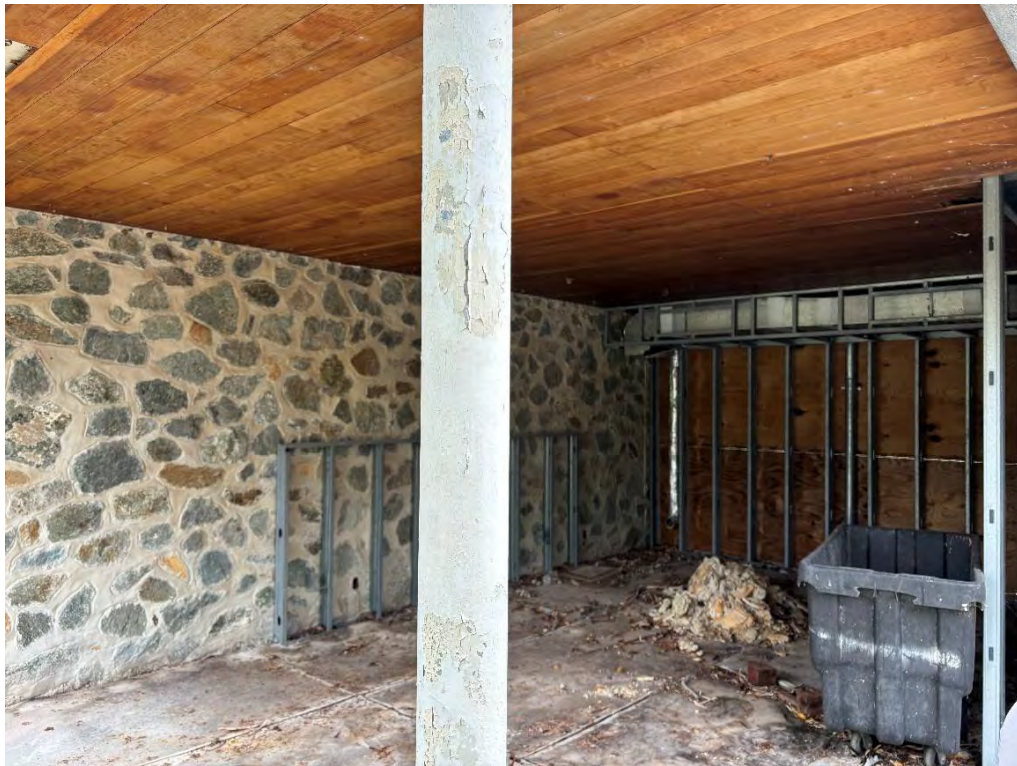
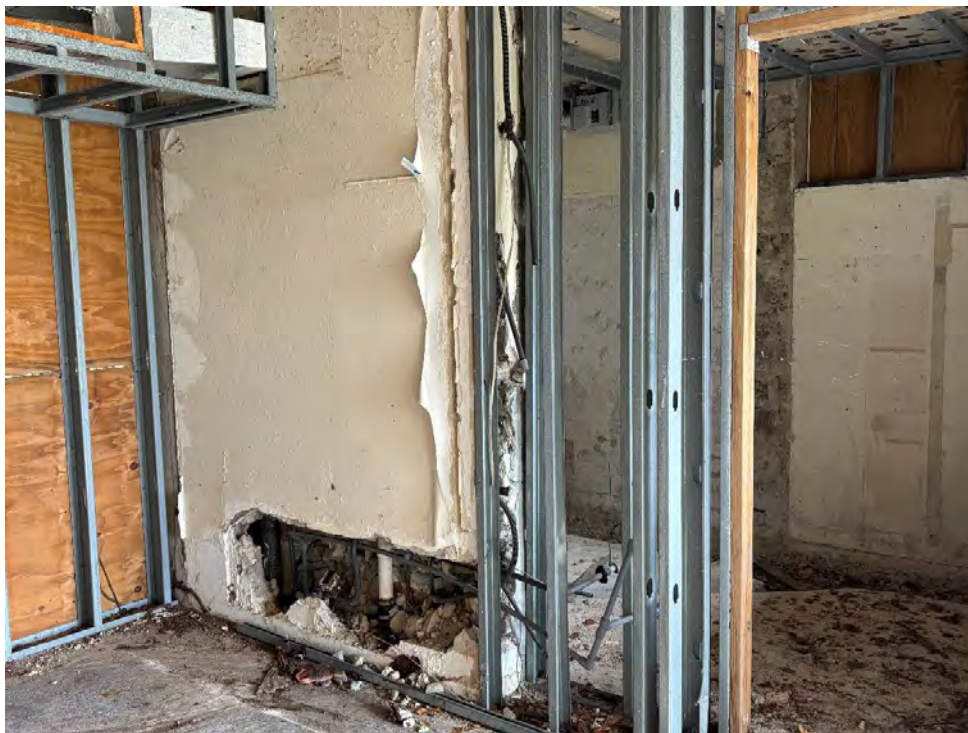
| Component | Material | Notes |
|---|---|---|
| Floor | Concrete | Slab surface cracking observed in units 28 and 29. |
| Walls (Non-Structural) | Wood/Masonry<br>(CMU)/Concrete | Some infill walls were previously demolished and reframed with steel studs for a prior renovation which was underway and paused.<br>Remaining concrete infill walls had cracks. |
| Stairs/Railings | Concrete /<br>Aluminum | Concrete stair nosing cracked/failing. |

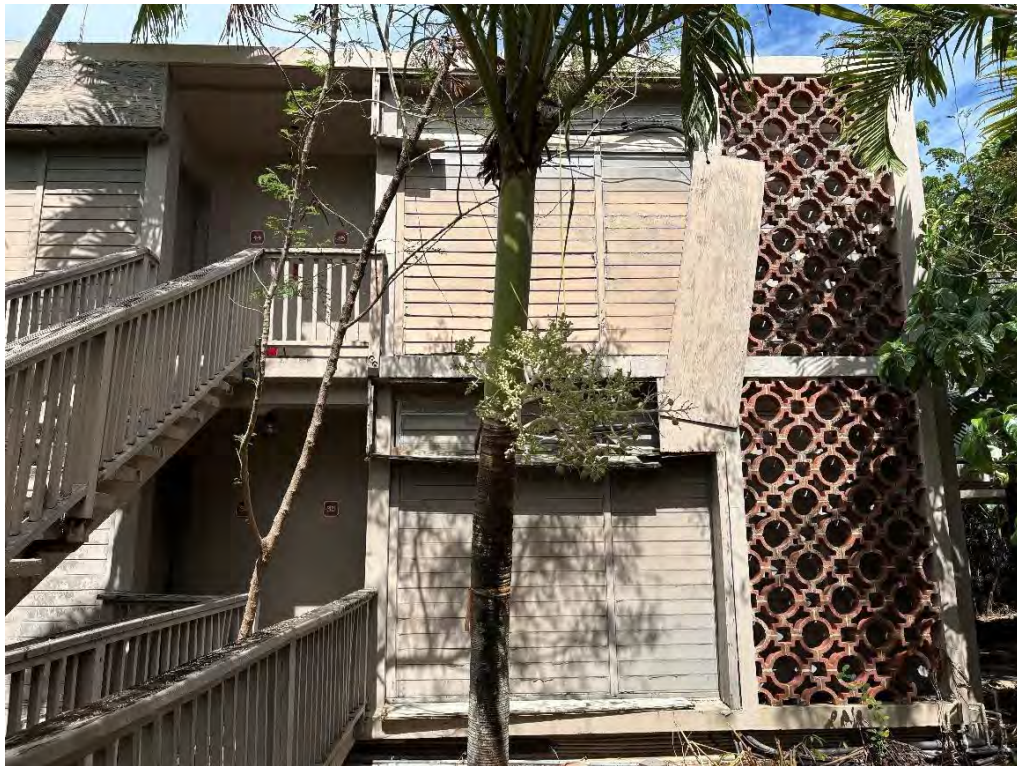
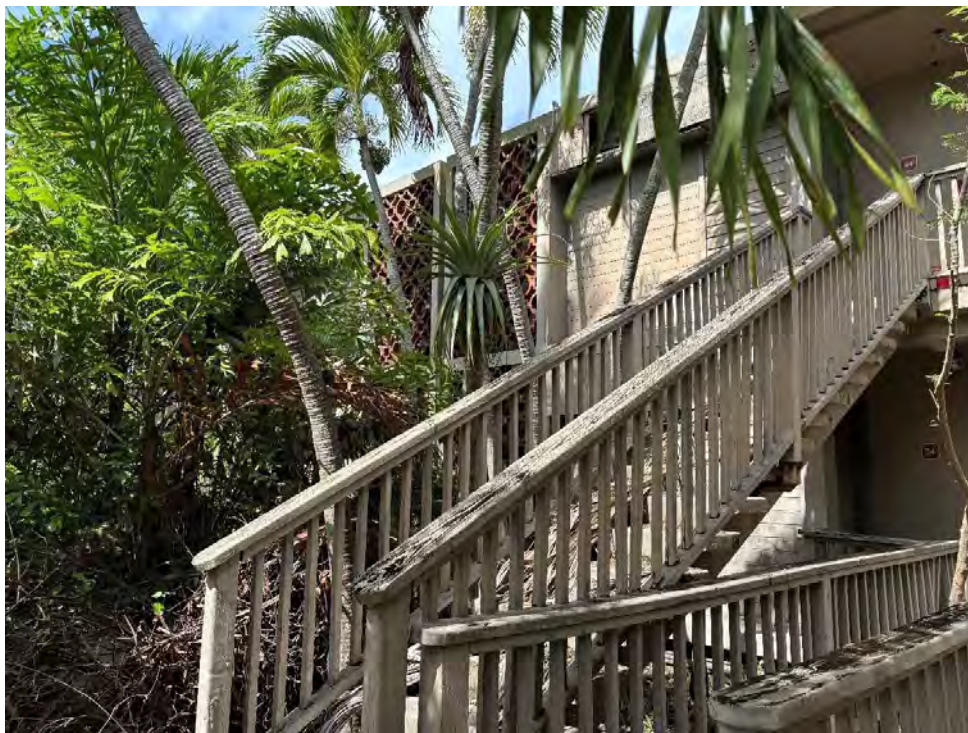
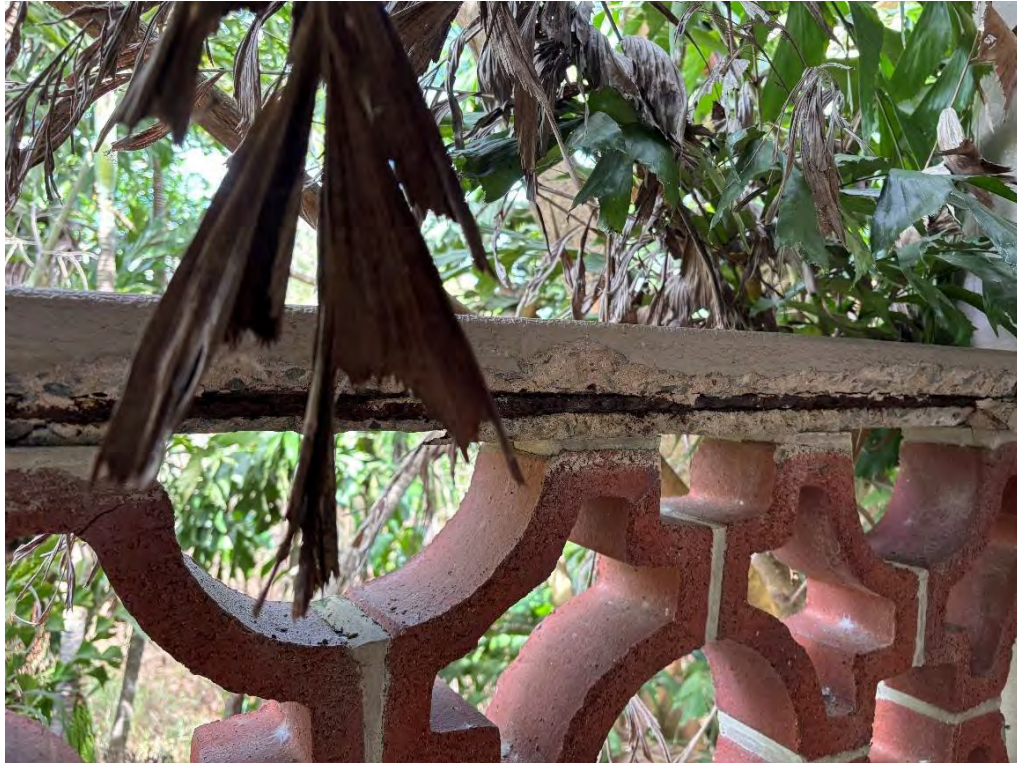
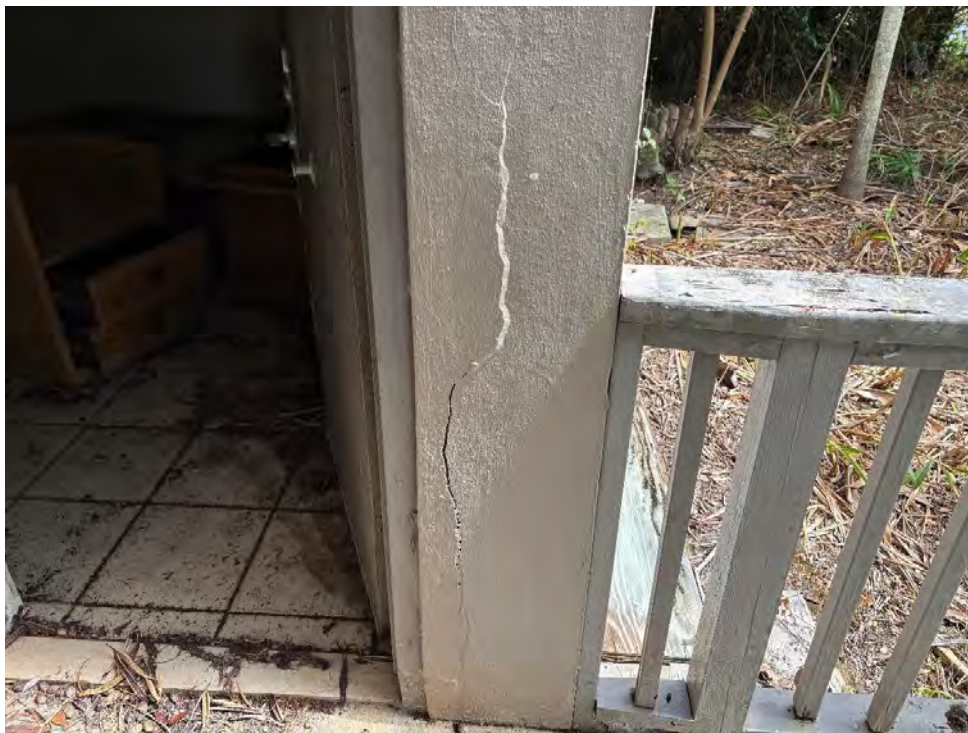
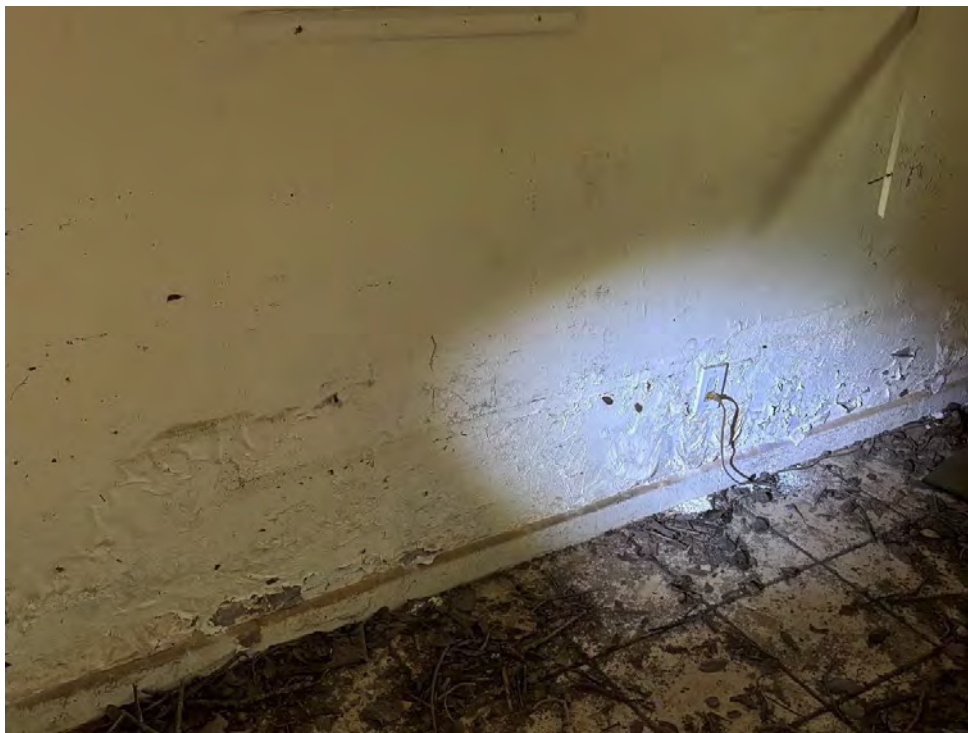
| Component | Material | Notes |
|---|---|---|
| Floor | Concrete | Slab edges deteriorated between units 31, 31, 32, and 33. |
| Walls (Structural) | Concrete | Moisture wicking into bottom 2' of each concrete bearing wall. Spalling at embedded electrical outlets from moisture wicking.<br>Column cracked between units 34 and 35 on east side. |
| Walls (Non-Structural) | Concrete / Wood | Concrete walls at mechanical room over low roof are severely cracked. Steel columns around opening in the low roof have severely corroded and failed.<br>Missing blocks at open CMU partition at north corner, room 39.<br>Exterior plywood mechanical chase failed in multiple locations.<br>Rotten wood noted at wood frames around exterior doors and windows. |
| Stairs/Railings | Concrete / Ornamental Masonry Railing | Ornamental masonry railings deteriorated at 41 and 42. Concrete caps on masonry railings deteriorated at all units. |

| <b>Component</b> | <b>Material</b> | <b>Notes</b> |
|---|---|---|
| Pergola | Wood | Wood pergola framed to building on beach (west) side. Pergola has failed along length of building. |

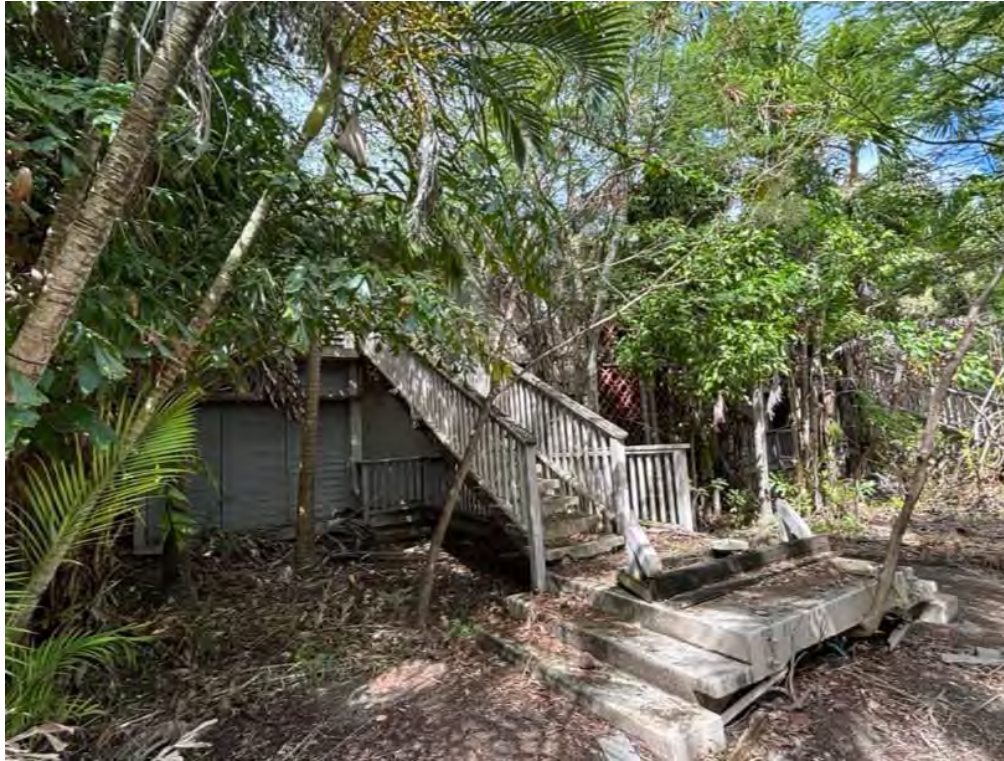
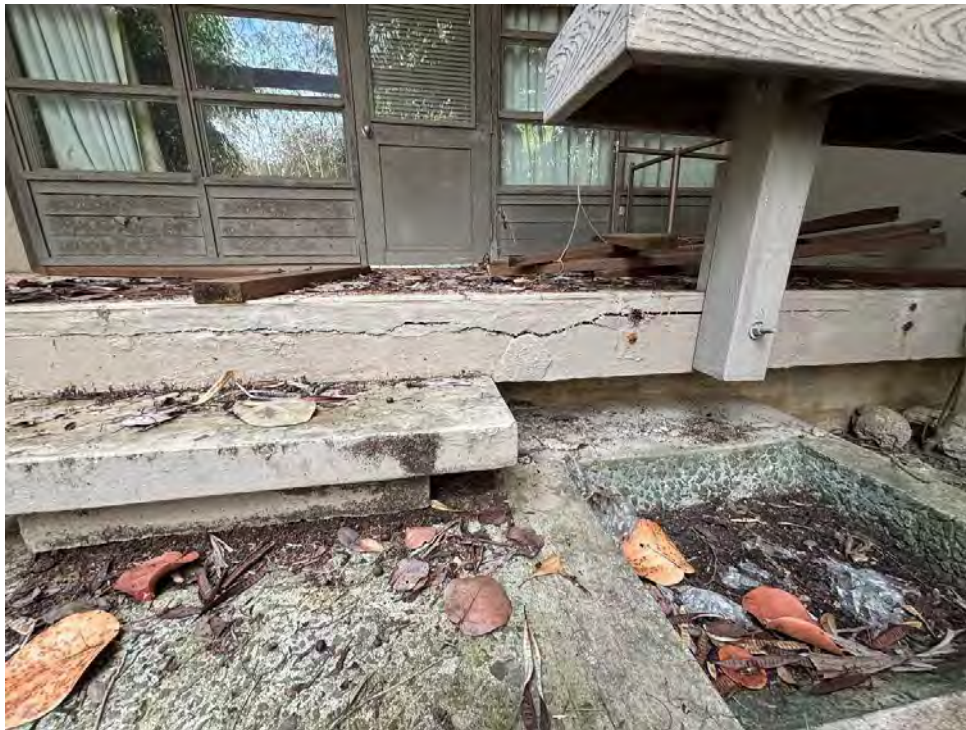
| Component | Material | Notes |
|---|---|---|
| Floor | Concrete | Exterior slab at unit 46 delaminated on porch. |
| Walls (Non-Structural) | Concrete / Wood | Concrete walls at mechanical room over low roof are severely cracked. Steel columns around opening in the low roof have severely corroded and failed. Missing blocks at open CMU partition at north corner, room 39. Exterior plywood mechanical chase failed in multiple locations. Rotten wood noted at wood frames around exterior doors and windows. |
| Stairs/Railings | Concrete / Wood Railing | 2 <sup>nd</sup> floor balconies have open CMU railings with cracked and decaying rebar precast concrete cap. Wood railings at stairs failed. |
| Pergola | Wood | Wood pergola framed to building on beach side. Pergola has failed along length of building. |

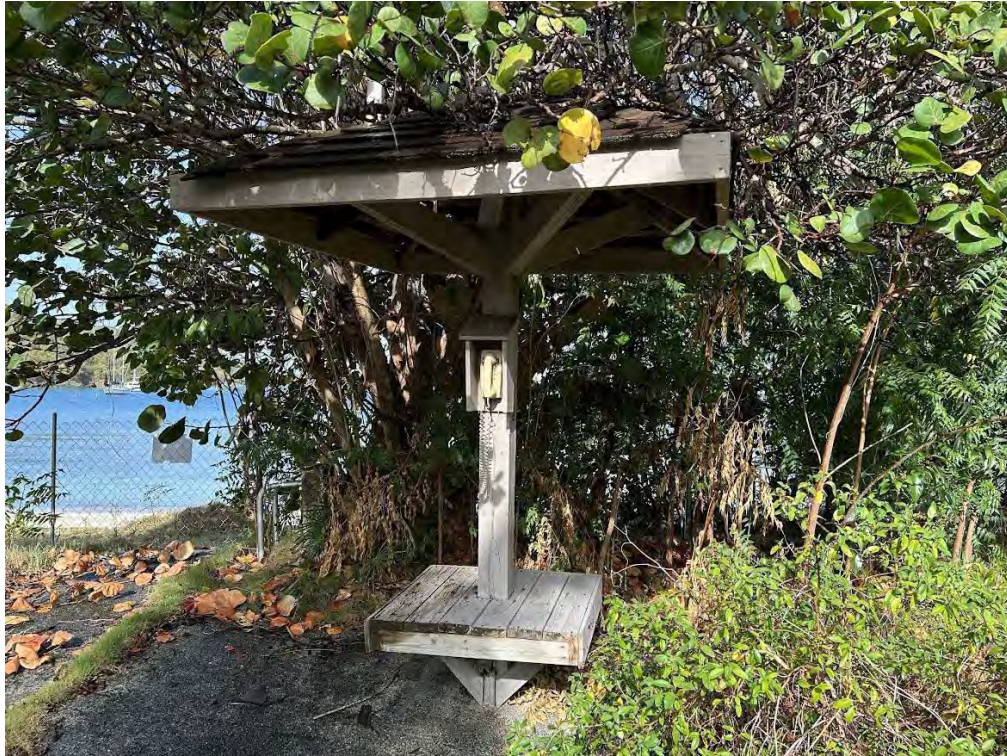
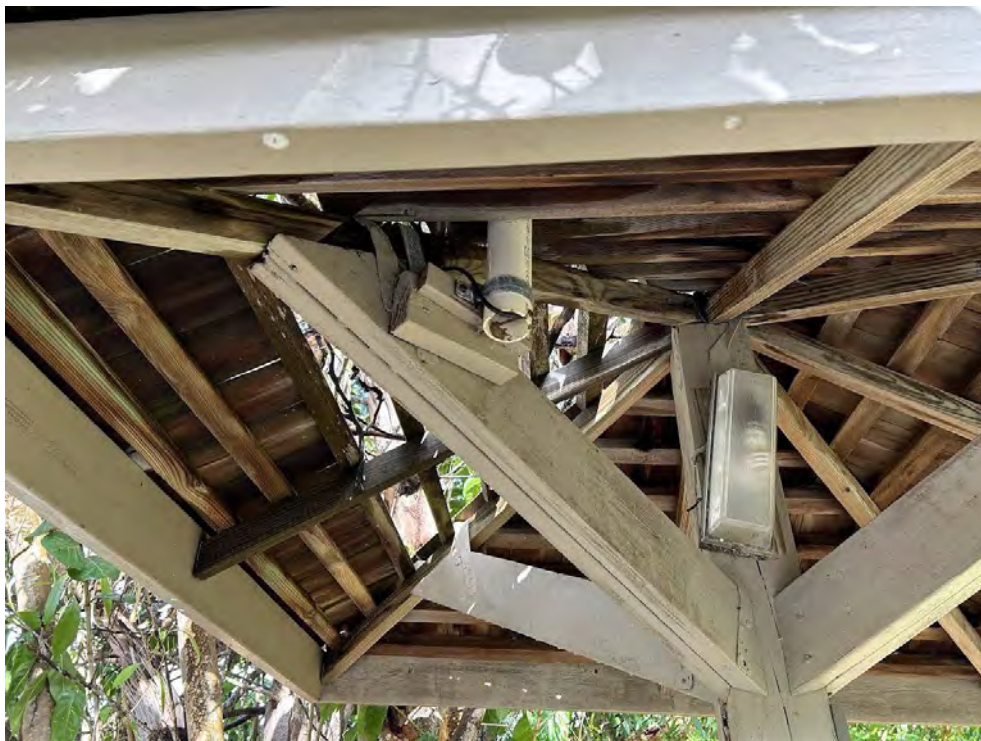
| Component | Material | Notes |
|---|---|---|
| Roof | Wood framed/<br>Wood shingles | Roof has deteriorated, causing seat to deteriorate. |

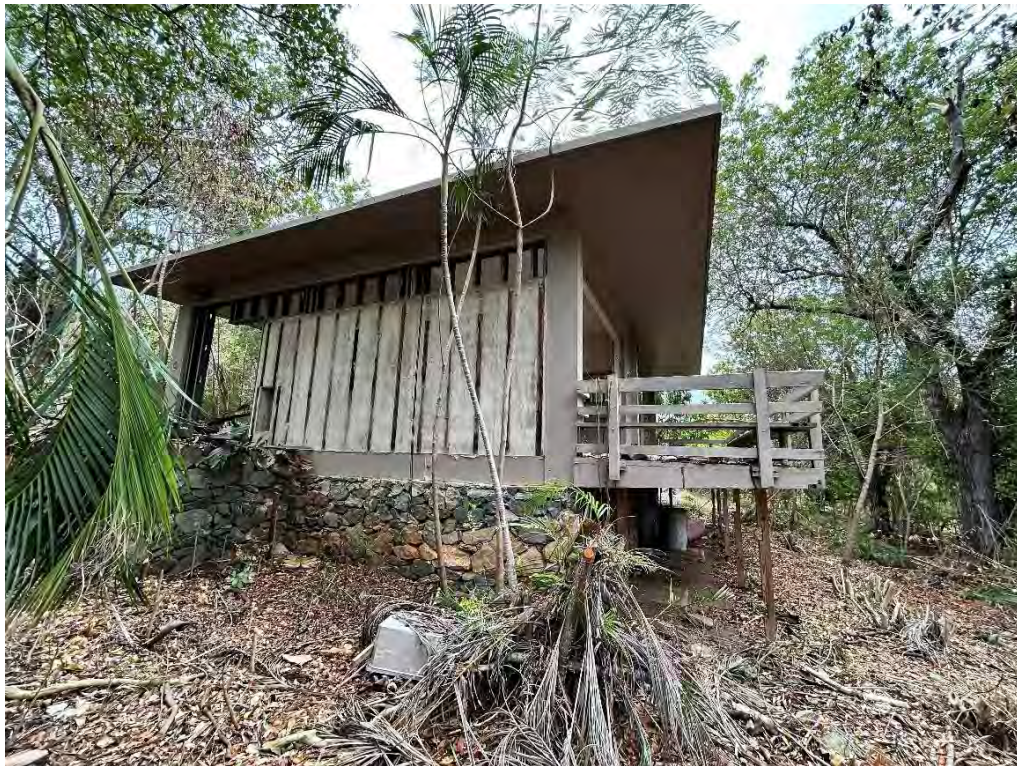
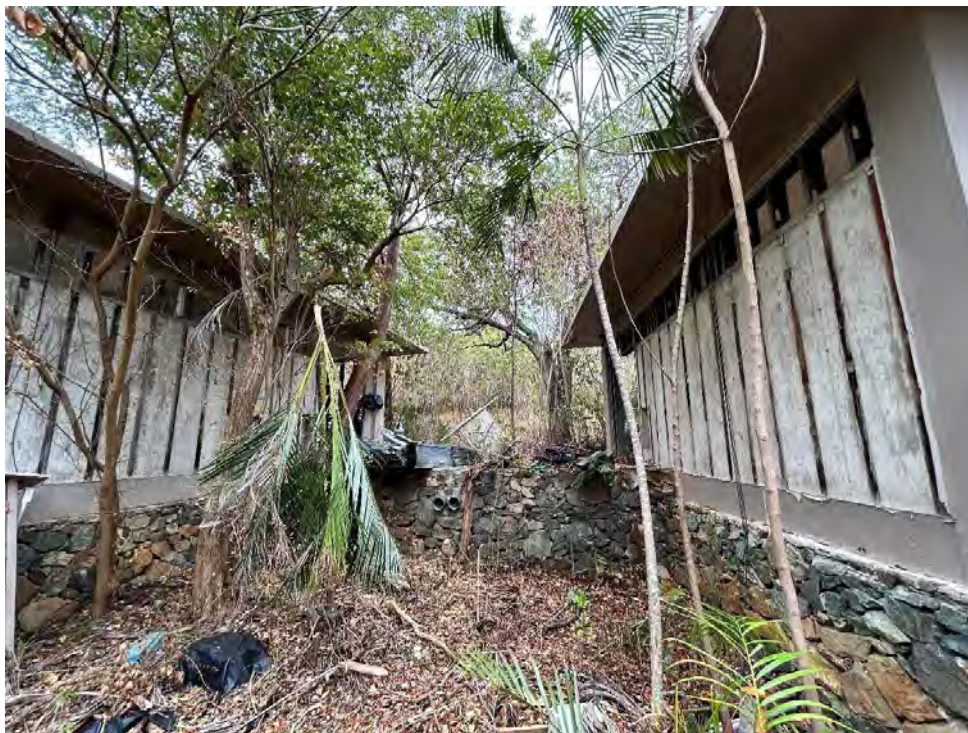
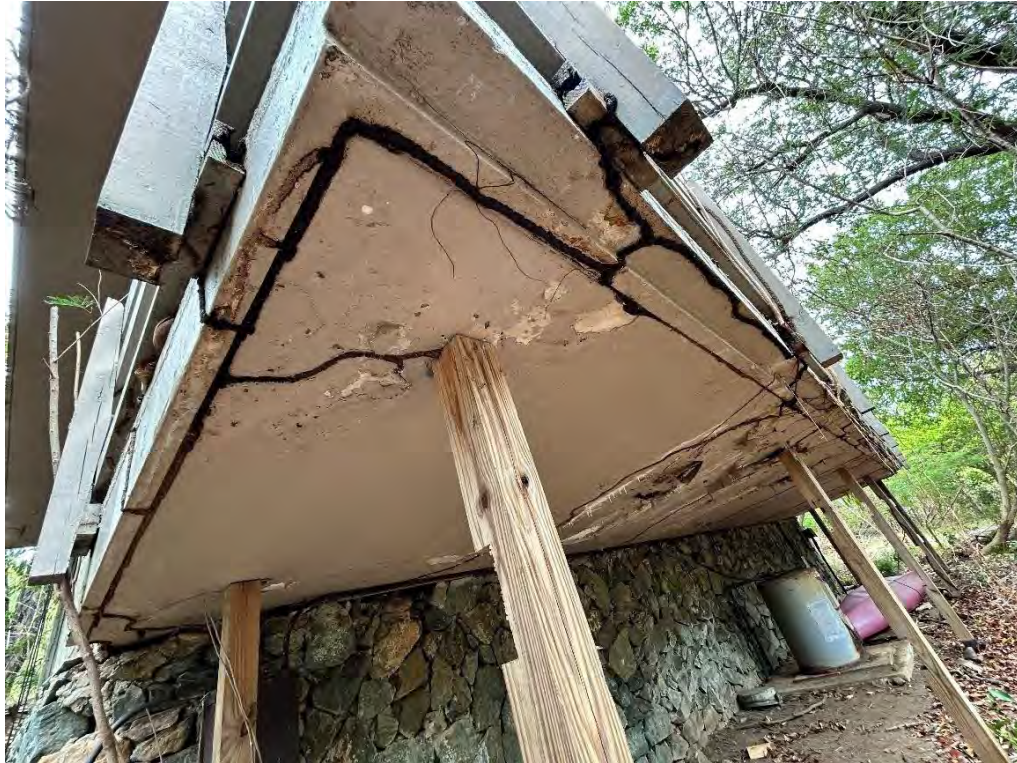
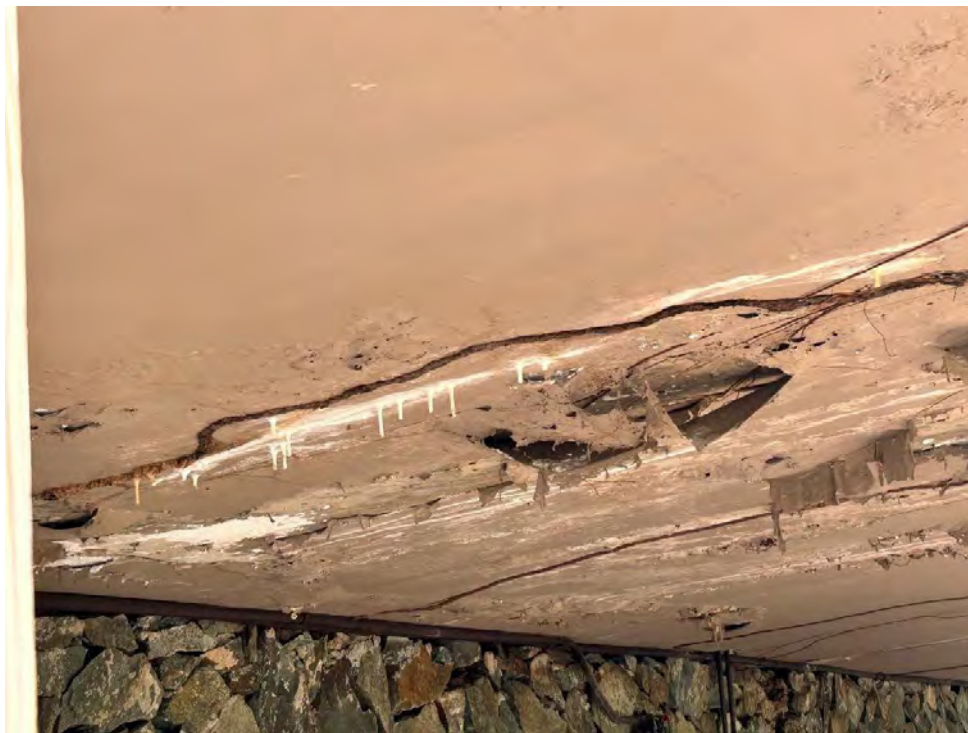
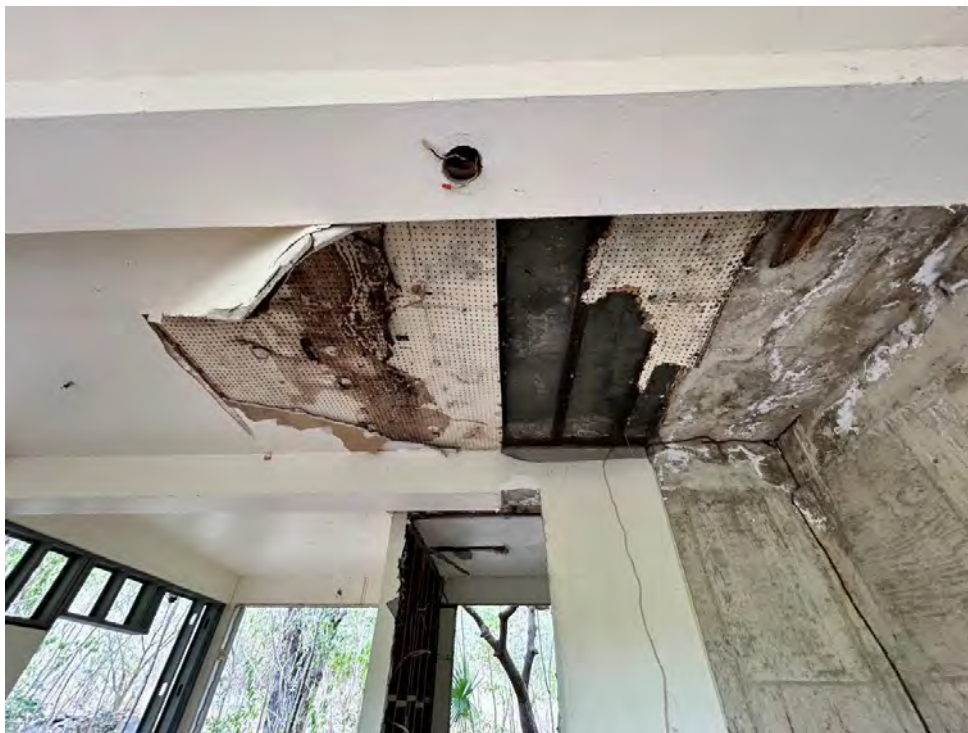
| Component | Material | Notes |
|---|---|---|
| Floor | Concrete | Signs of efflorescence with stalactites at underside of porch slab. |
| Walls (Structural) | Concrete / Steel Posts | Unable to verify condition of steel pipes where they framed into wall. |
| Roof | Concrete / Membrane | Spalling at underside of concrete roof where ceiling finishes had been removed. Unable to determine extent of spalls where finishes remained. Signs of previous renovations which cut back the wall creating a longer beam span. It is unknown if this modification with properly designed. |
| Stairs/Railings | Wood Railings / Benches | Wooden benches and railings on south side have failed. Posts under porch concrete slab are notched. |

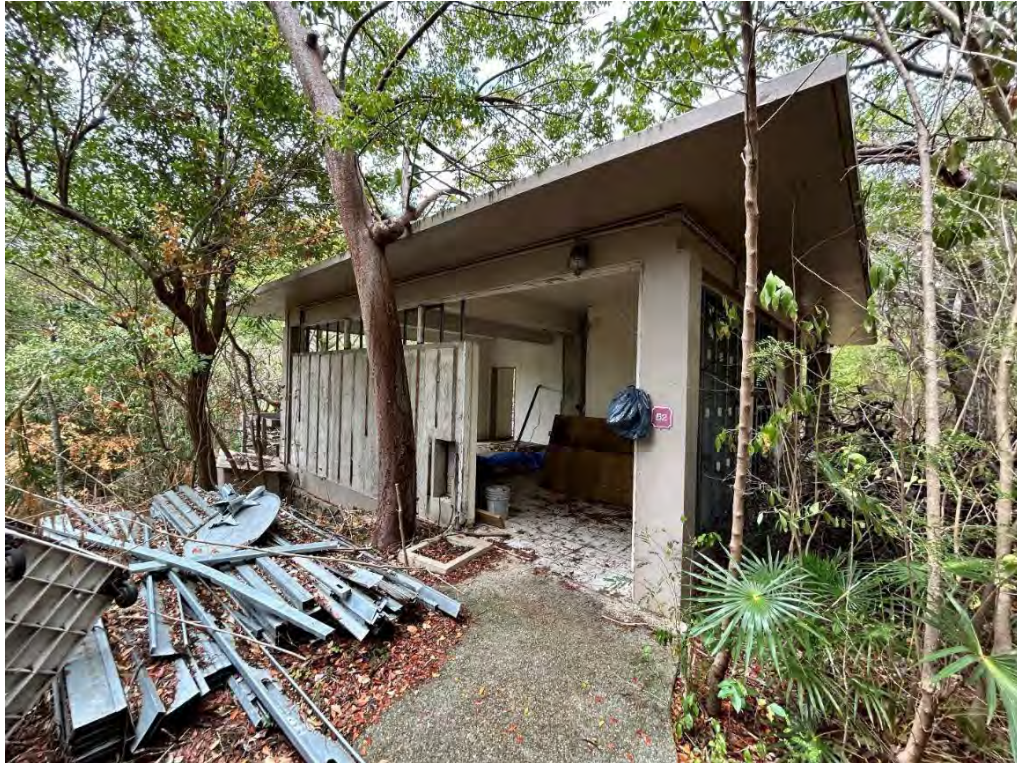
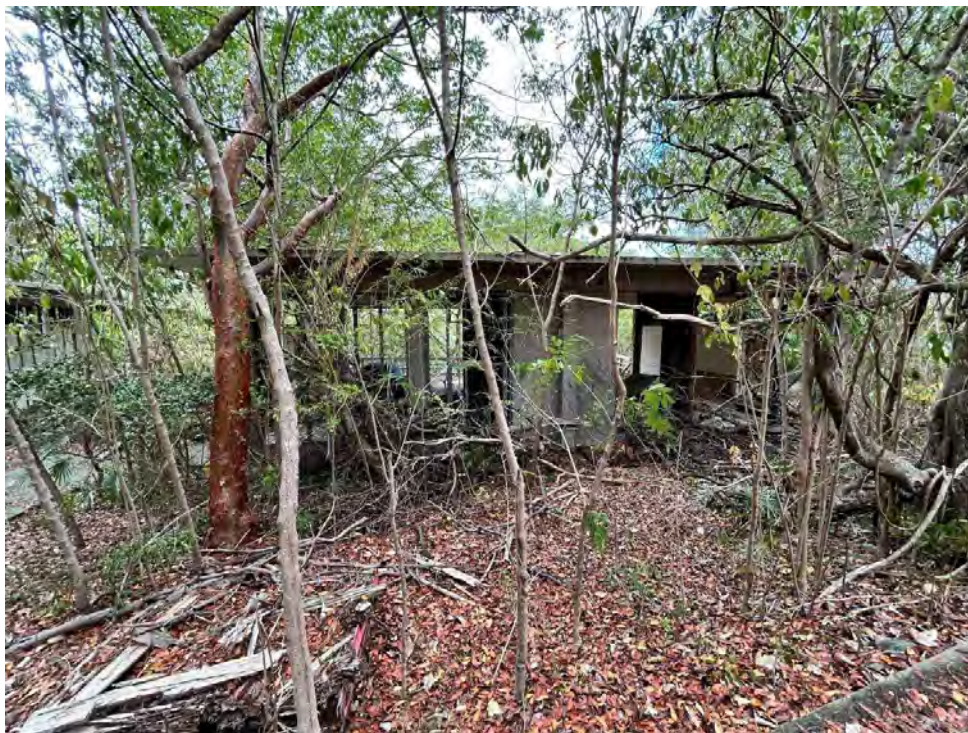
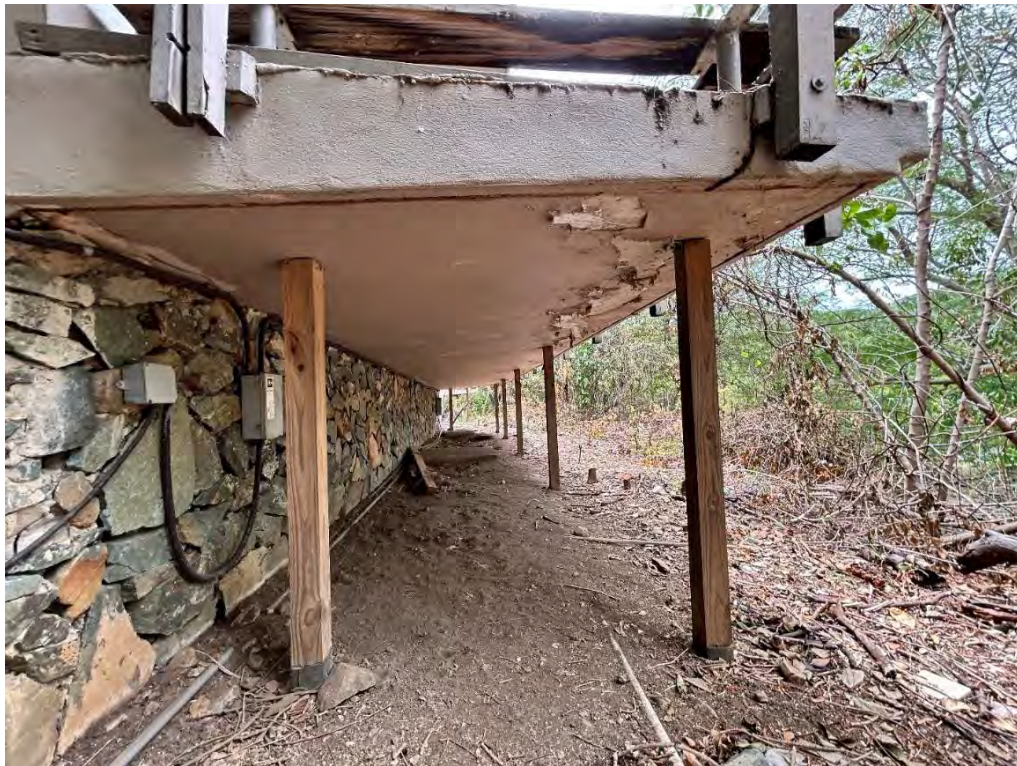
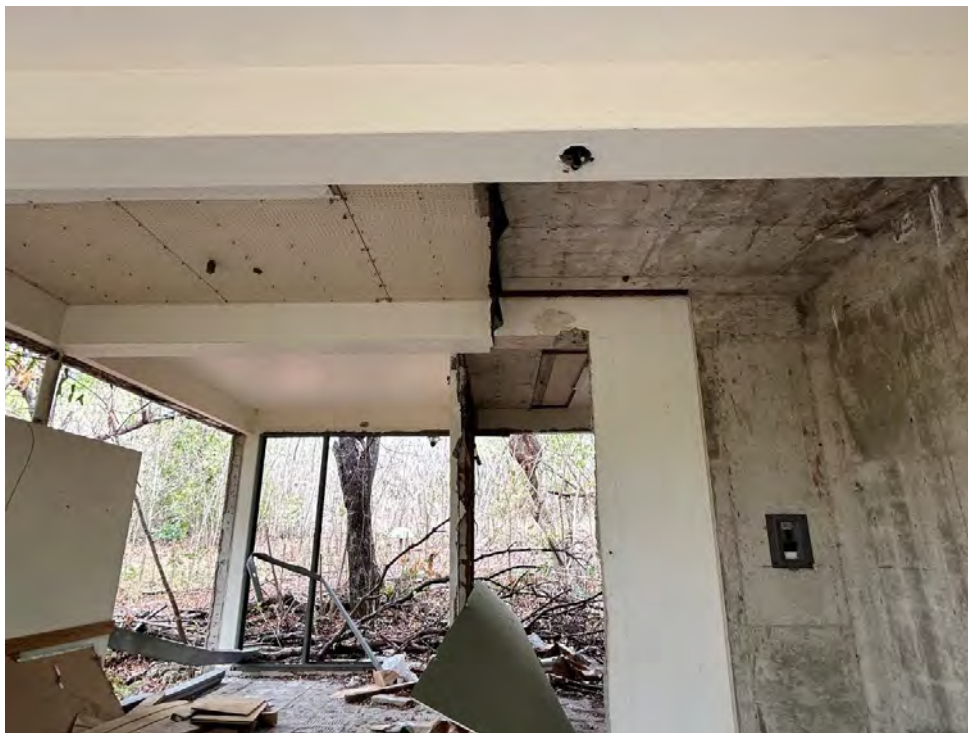
| Component | Material | Notes |
|---|---|---|
| Walls (Structural) | Concrete / Steel Posts | Unable to verify condition of steel pipes where they framed into wall. |
| Roof | Concrete / Membrane | Spalling at underside of concrete roof where ceiling finishes had been removed. Unable to determine extent of spalls where finishes remained. Signs of previous renovations which cut back the wall creating a longer beam span. It is unknown if this modification with properly designed. |
| Stairs/Railings | Wood Railings / Benches | Wooden benches and railings on south side have failed. Posts under porch concrete slab are notched. |

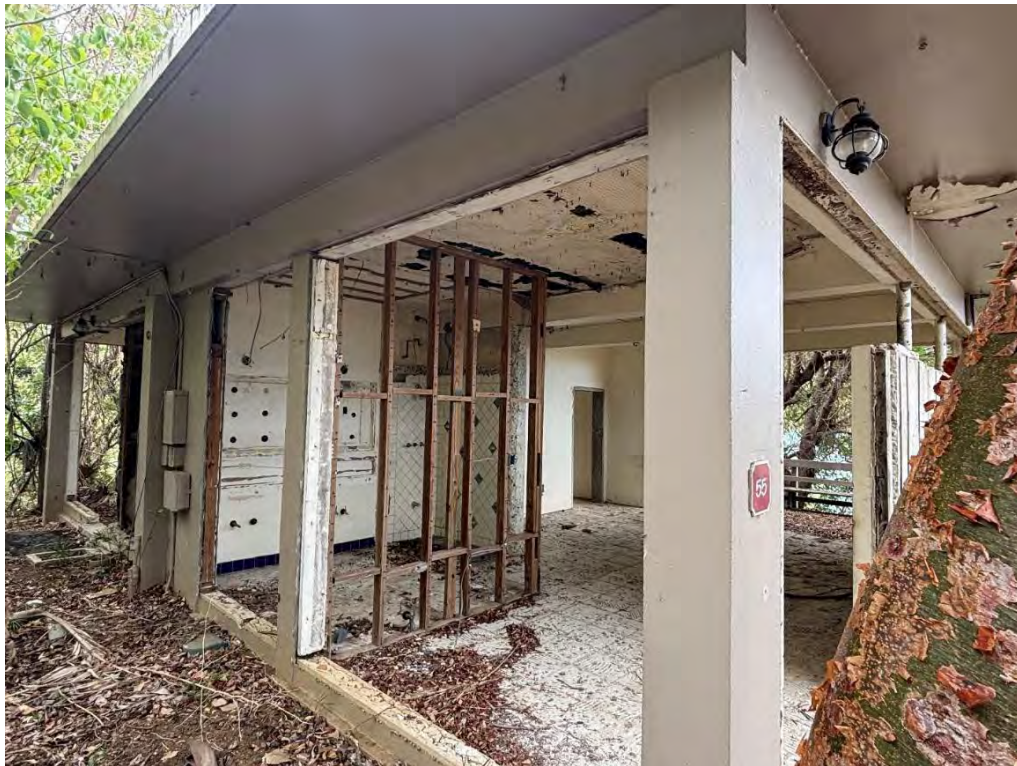
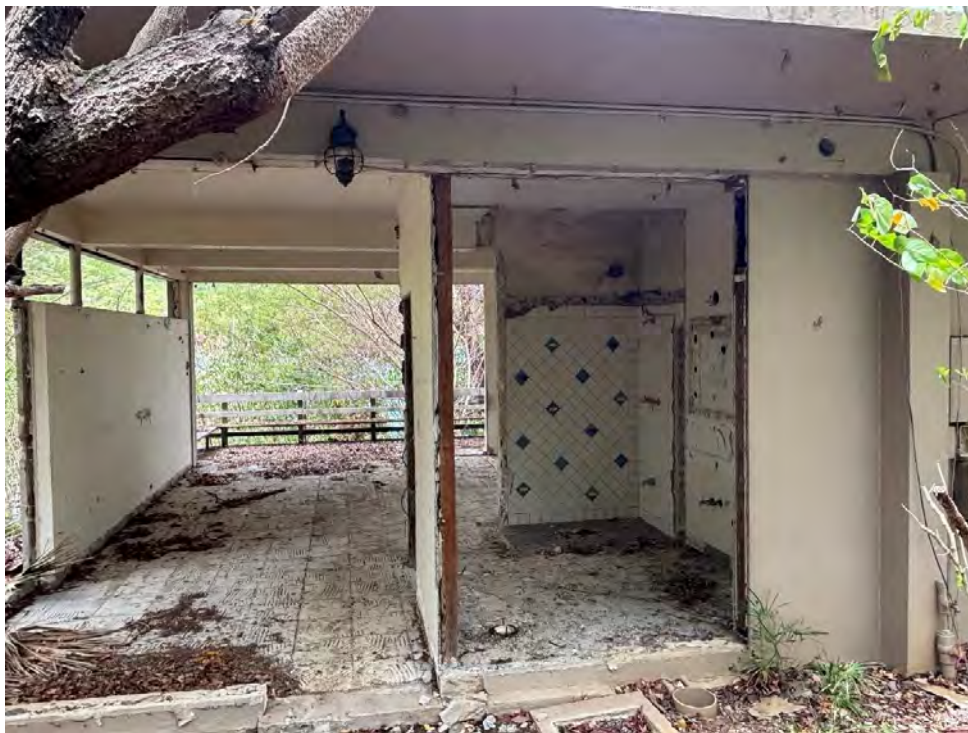
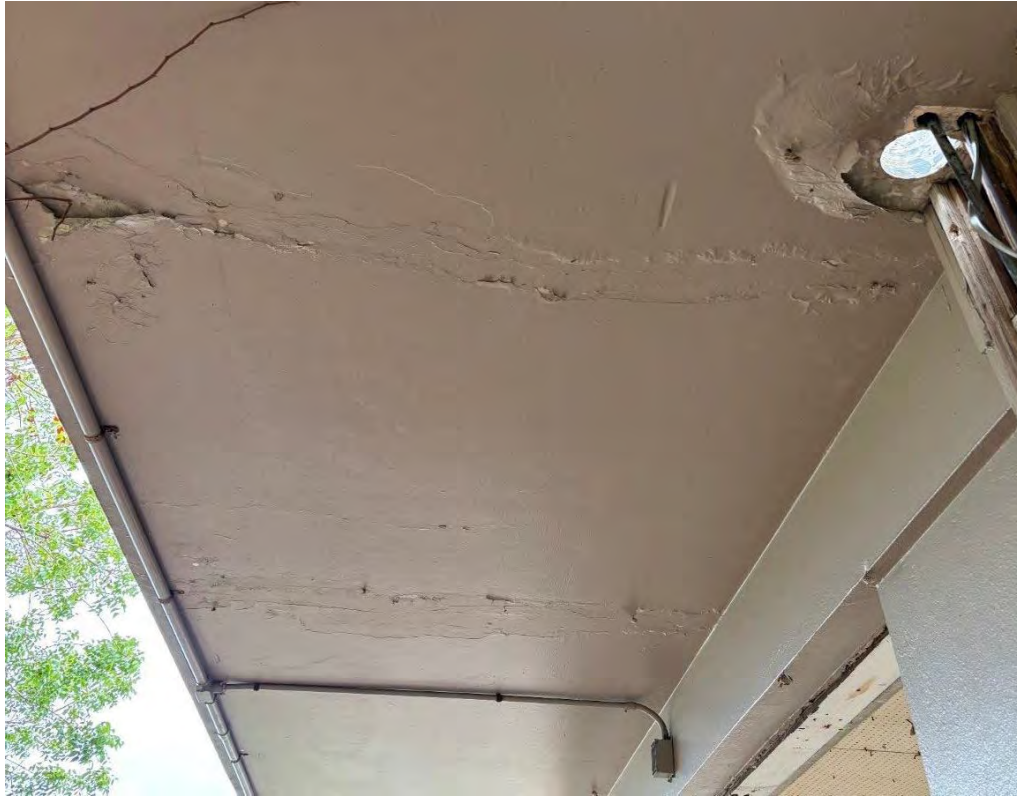
| Component | Material | Notes |
|---|---|---|
| Roof | Concrete / Membrane | Significant spalling at underside of concrete roof slabs. Multiple beams cracked.<br><br>Previous renovations cut back the wall creating a longer beam span. It is unknown if this modification with properly designed. |
| Stairs/Railings | Wood Railings | Wooden railings deteriorated. |

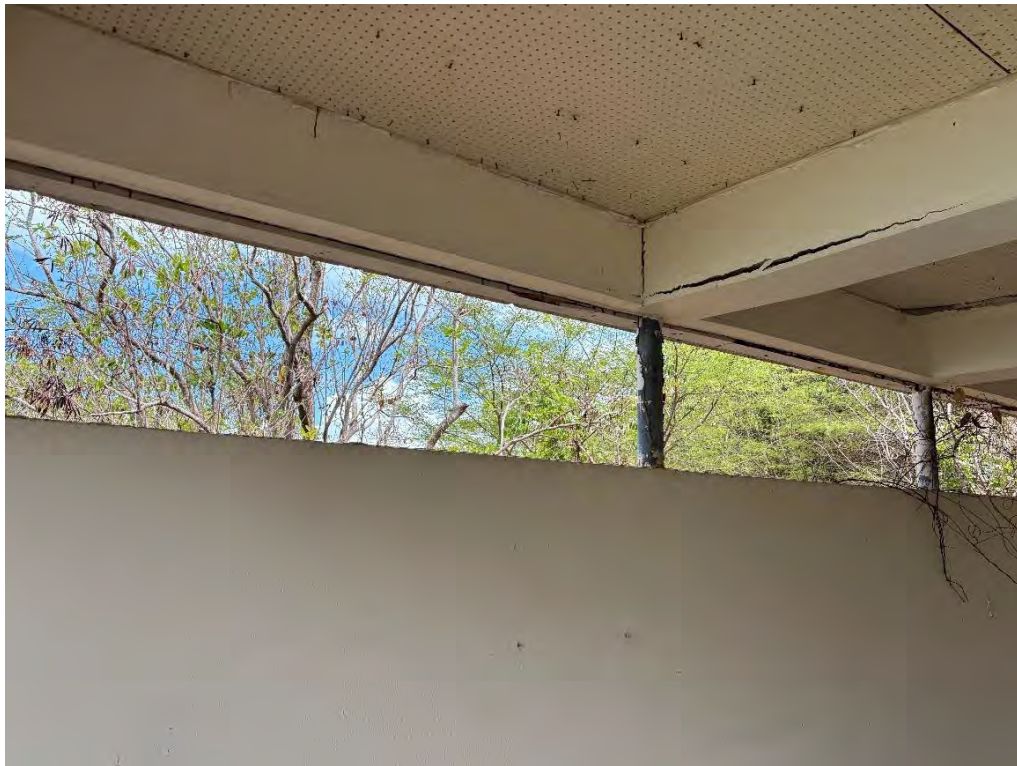
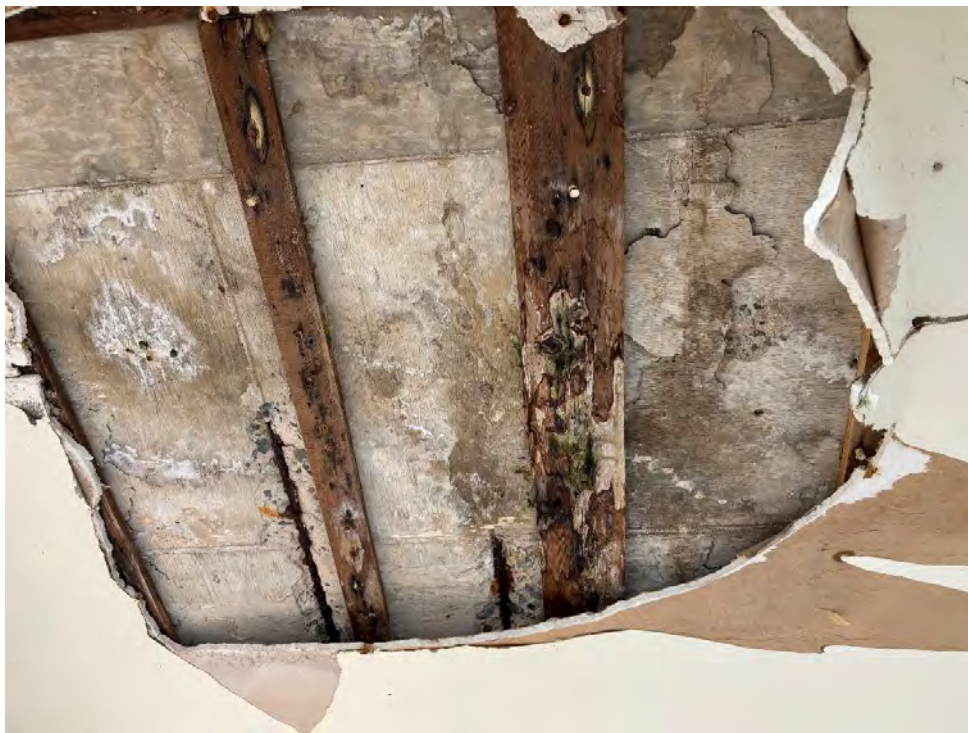
| Component | Material | Notes |
|---|---|---|
| Roof | Concrete / Membrane | Significant spalling at underside of concrete roof slabs. Beam cracked.<br><br>Previous renovations cut back the wall creating a longer beam span. It is unknown if this modification with properly designed. |
| Stairs/Railings | Wood Railings | Wooden railings deteriorated. |
