**National Park Service**  
Virgin Islands National Park | Caneel Bay  
Structural Assessment Report

**Building: 28 Caneel Beach Units 26-29**

**Structural Assessment: Structurally Sound**

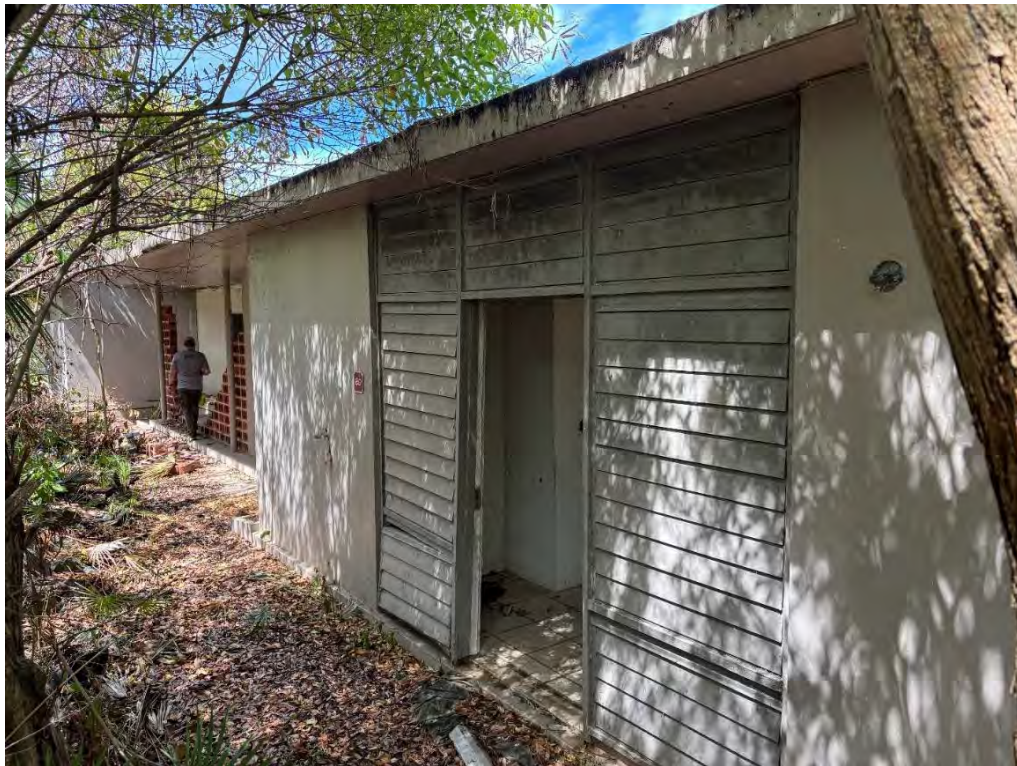
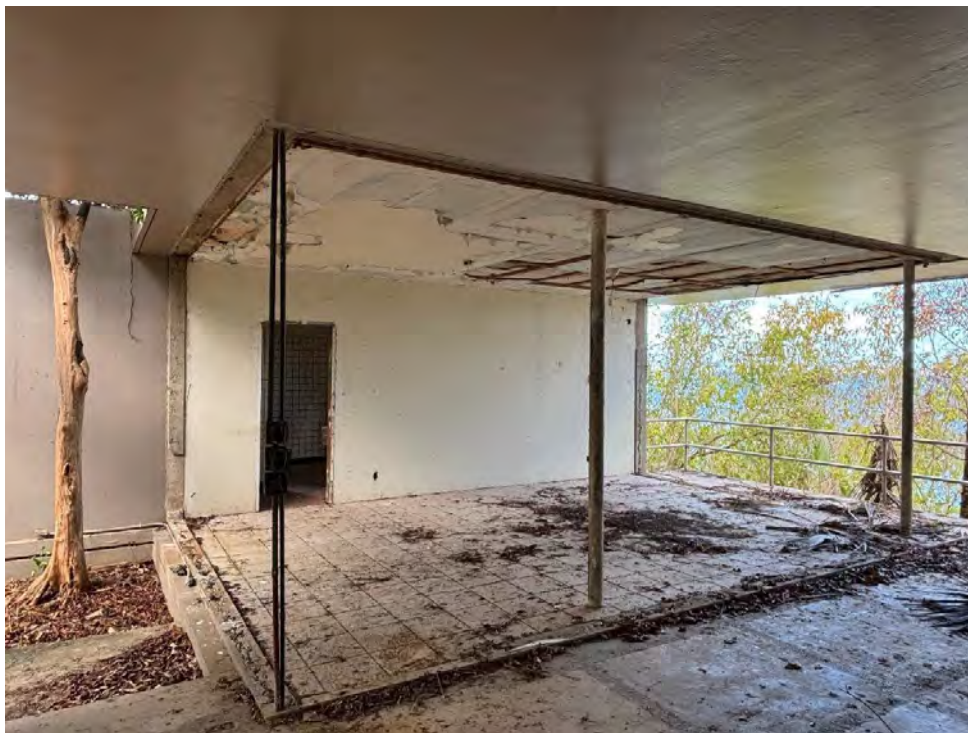
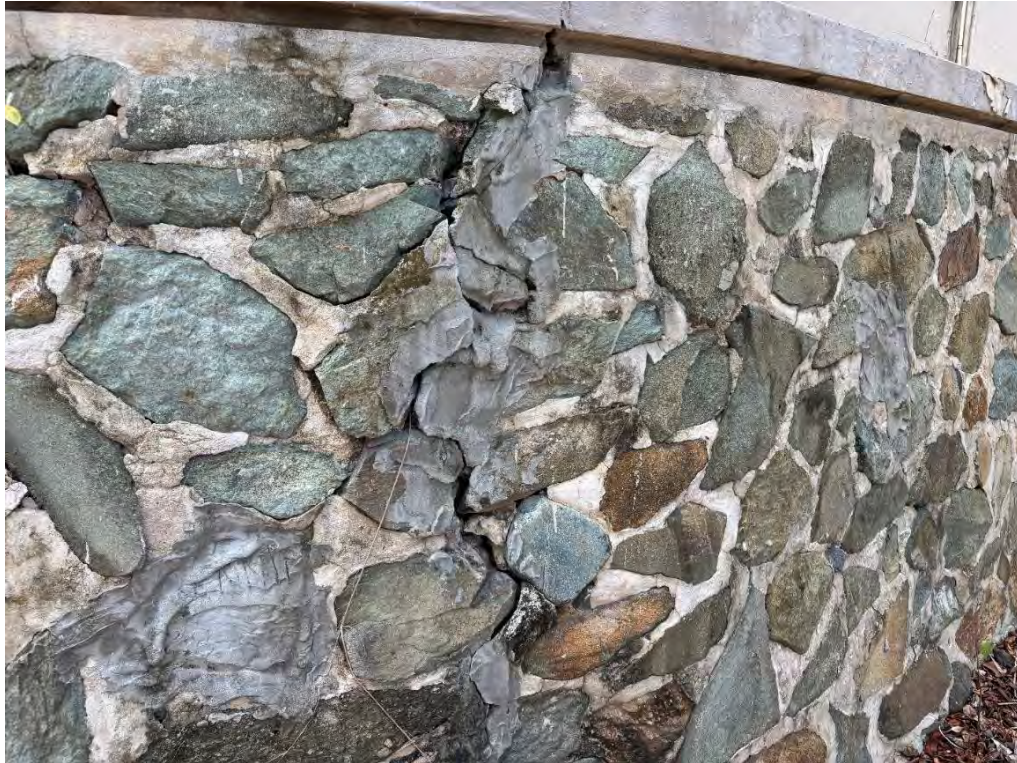
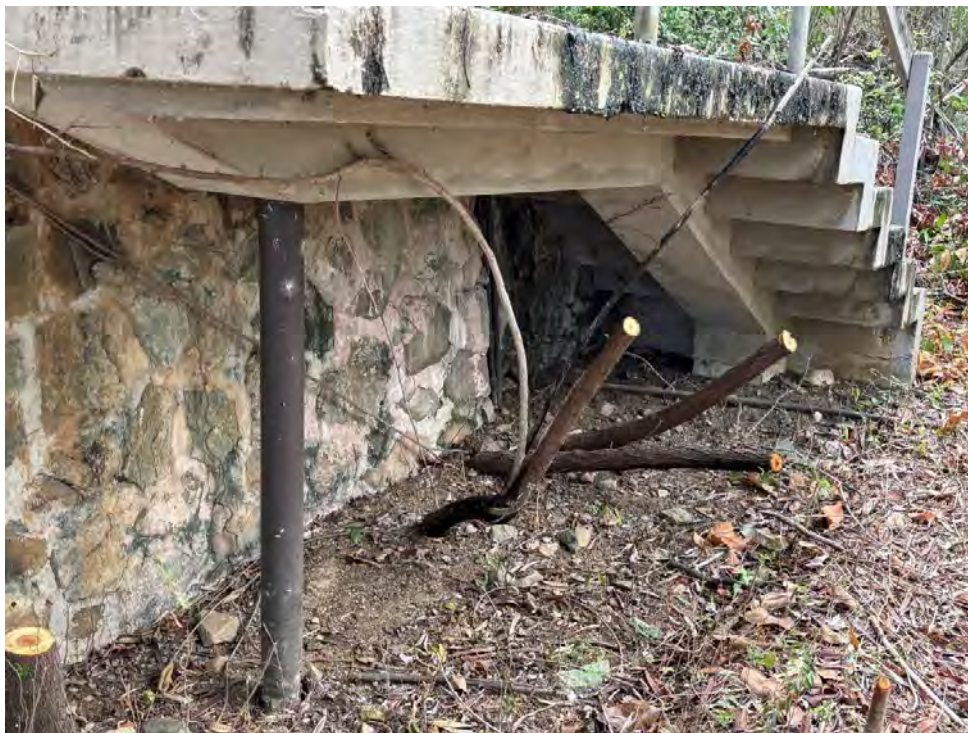
| Component | Material | Notes |
|---|---|---|
| Floor | Concrete | Balcony slab cracked. |
| Roof | Concrete /<br>Membrane | Cracks in roof overhang and ceiling between units. |
| Stairs/Railings | Aluminum<br>Railings<br>Concrete Steps | Concrete steps leaning due to corrosion of steel post. |

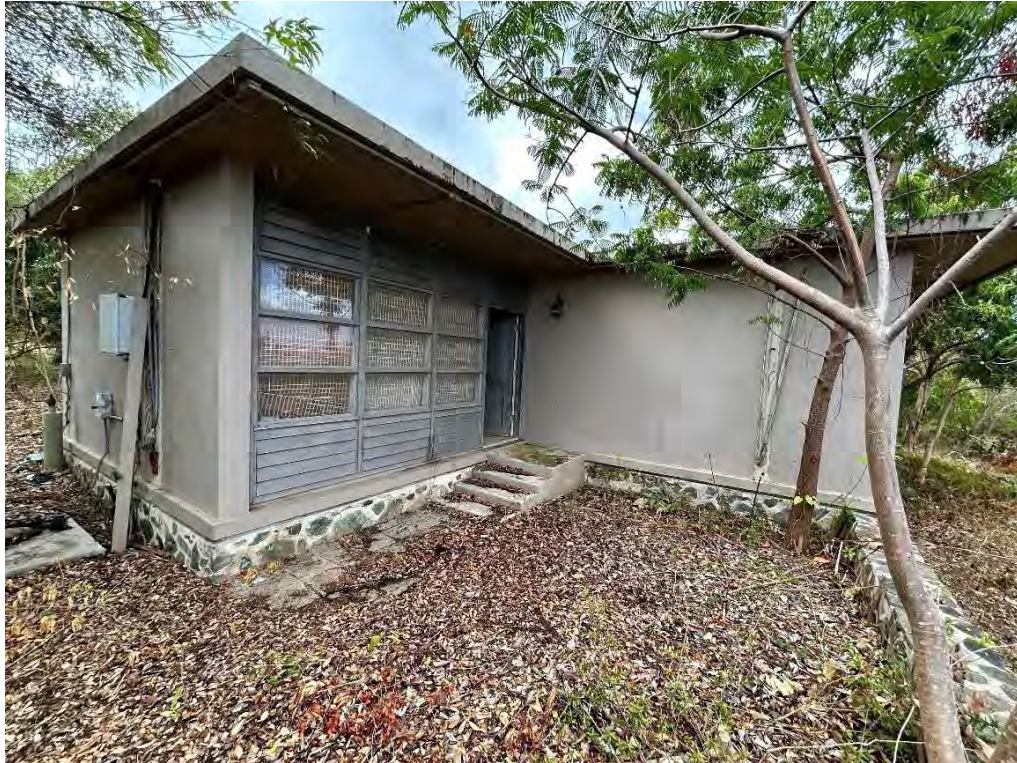
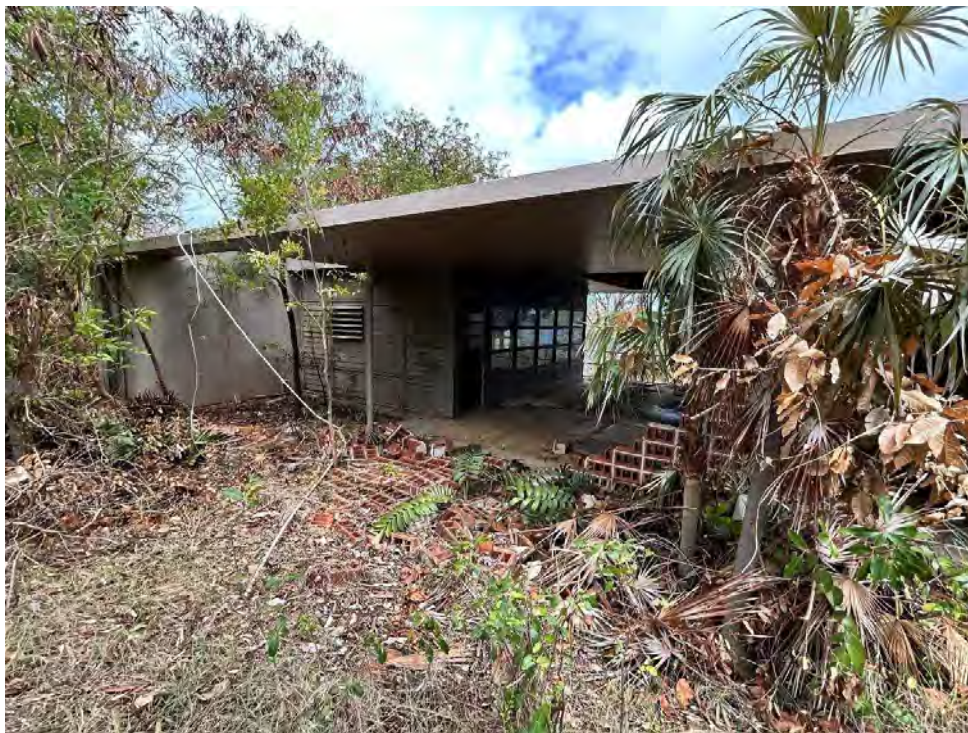
| Component | Material | Notes |
|---|---|---|
| Floor | Concrete | Exterior cantilevered concrete slab at Unit 61 shows signs of hairline cracks throughout the slab. Unable to access underside of slab for further investigation. |
| Walls (Structural) | Concrete | Minor concrete cracking with signs of previous repairs observed. Spalled concrete at breezeway. Moisture pockets observed. |
| Walls (Non-Structural) | Wood Framed / Open CMU Walls | CMU wall collapsed. |
| Stairs/Railings | Concrete | Concrete steps from Unit 63 to north porch is damaged.<br>Deck missing from Unit 62 creating large drop from north door. |
| Retaining Wall | Stone | Stones missing at stone retaining wall. |

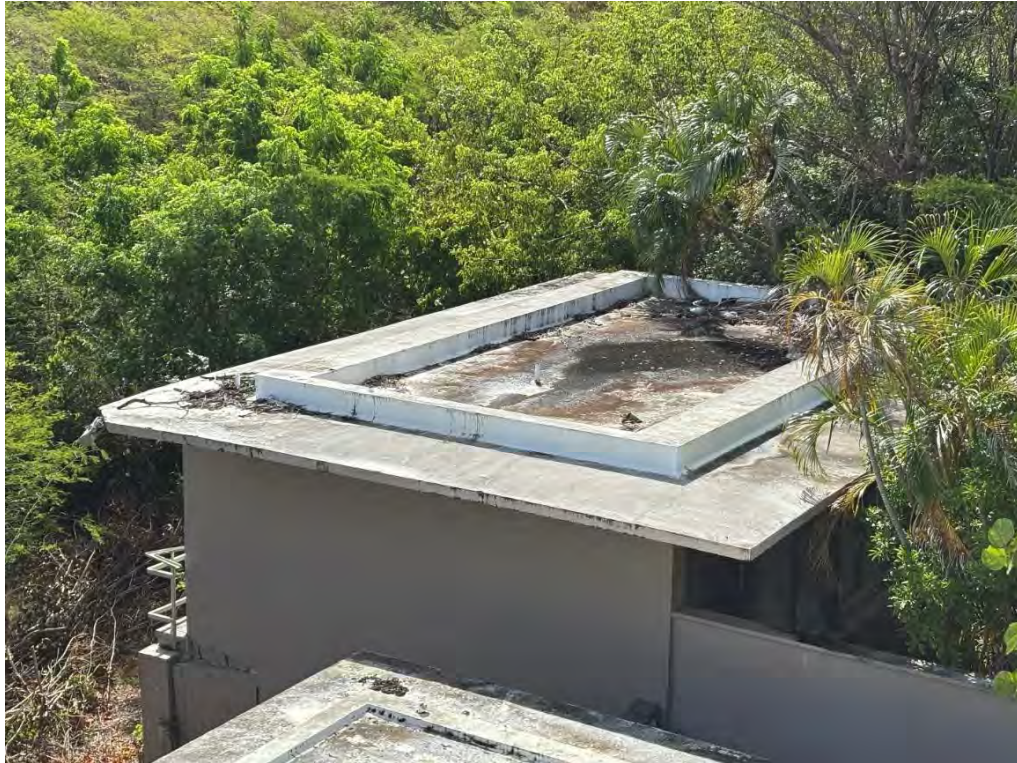
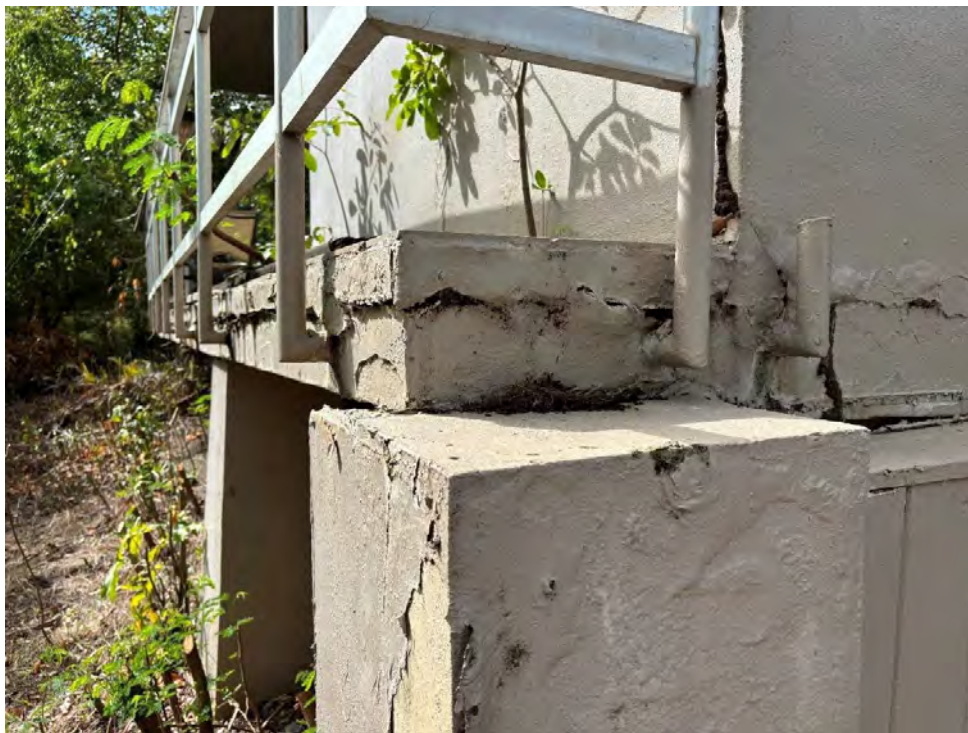
| Component | Material | Notes |
|---|---|---|
| Floor | Concrete | Slab separation/cracking along entire north side. |
| Walls (Structural) | Concrete | Concrete cracks around north window. |
| Stairs/Railings | Wooden Steps<br>/ Aluminum<br>Railing | Wooden steps deteriorated and leaning. |

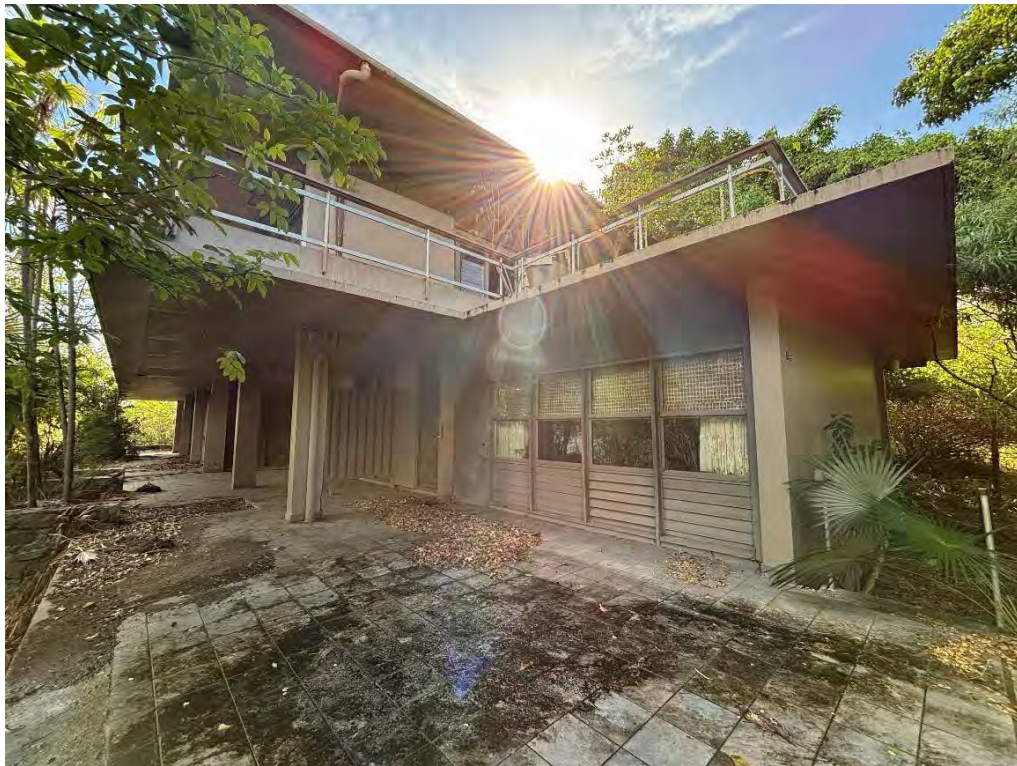
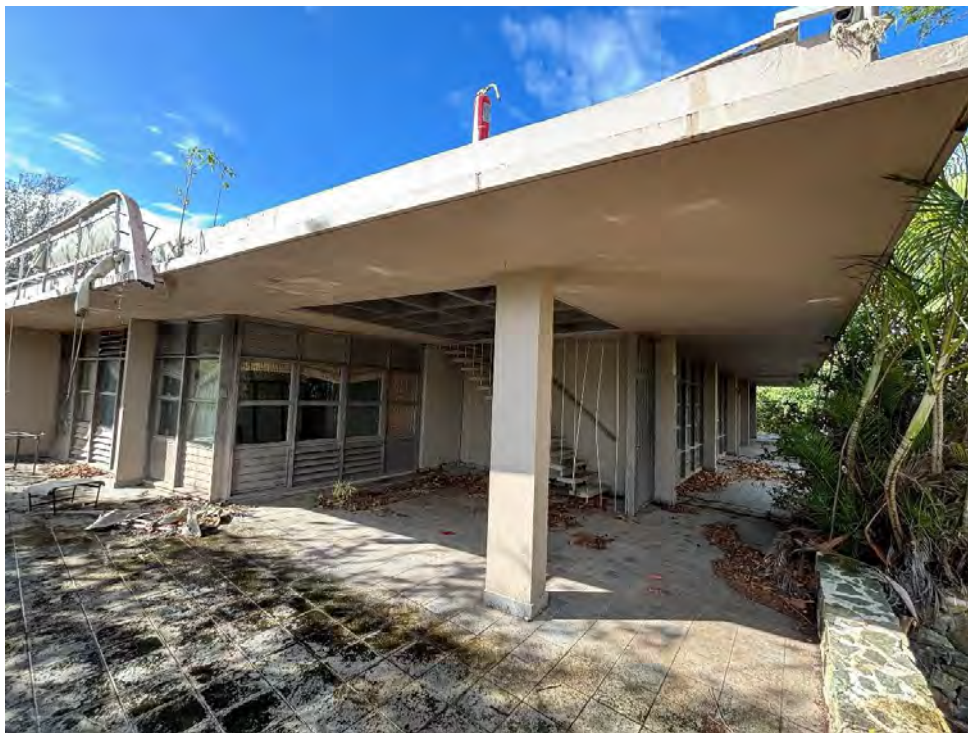
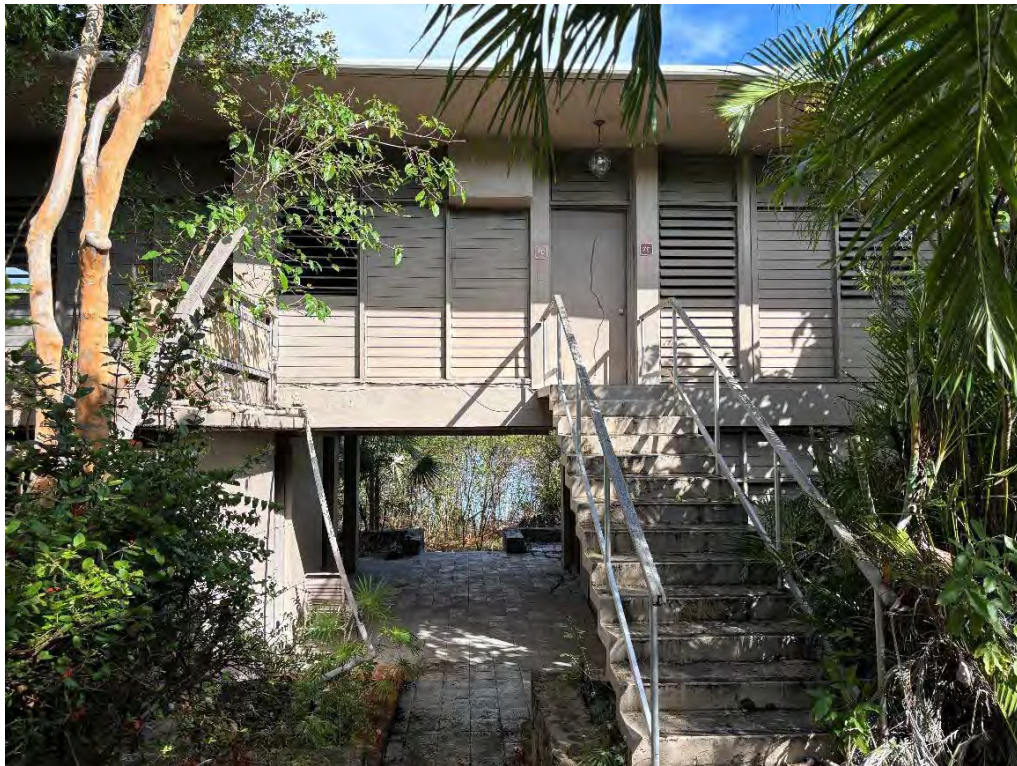
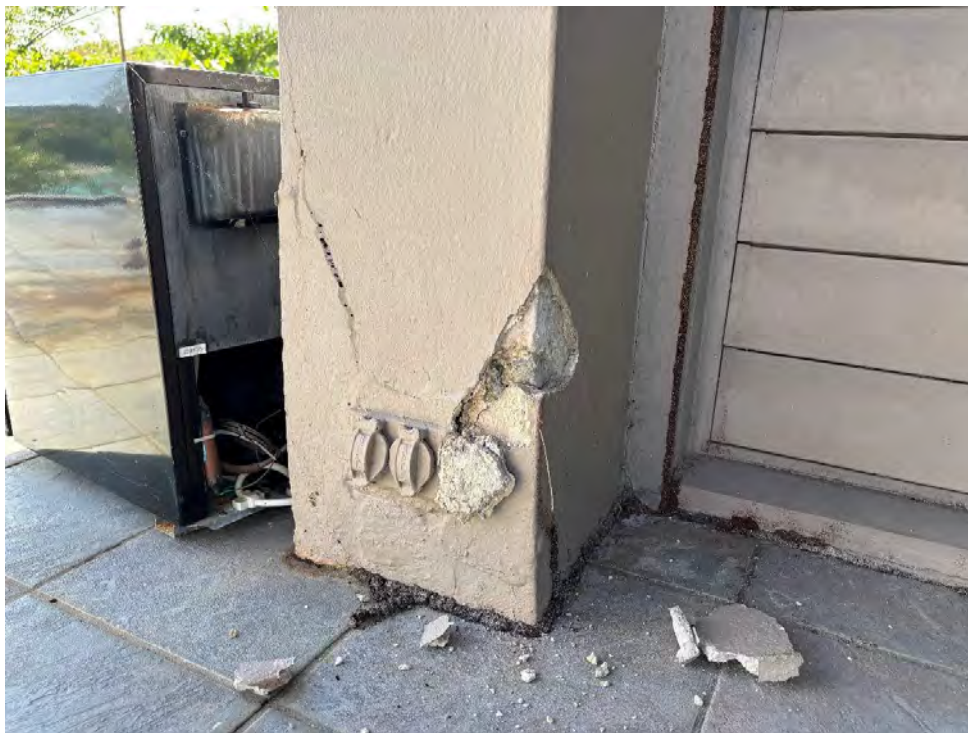
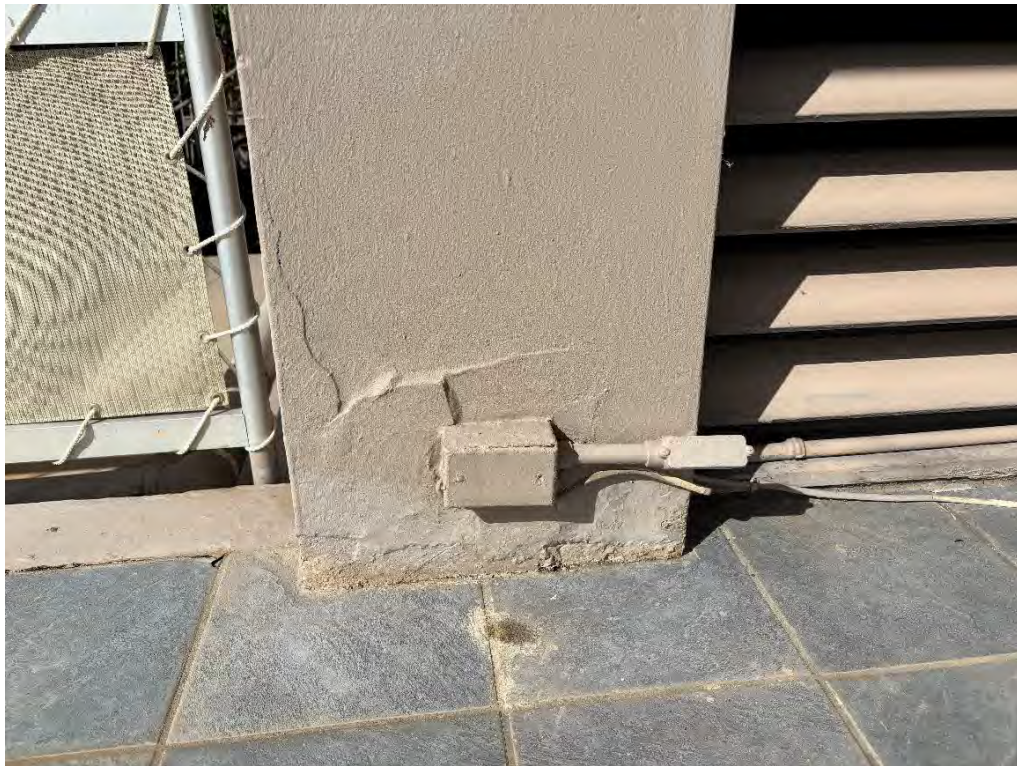
| Component | Material | Notes |
|---|---|---|
| Walls (Structural) | Concrete | Concrete columns on beach side (NW) of building show signs of minor cracking and spalling on the 1 <sup>st</sup> and 2 <sup>nd</sup> floor.<br>Cracks at exterior concrete wall of unit 7D and 7B. |
| Walls (Non-Structural) | Wood | Wood finishes show signs of severe termite activity. |
| Roof | Concrete | Minor cracks in concrete roof overhang |
| Stairs/Railings | Concrete / Aluminum Railing | Exterior floating stairs near units 7F and 7B show signs of damage to the treads and hanging support rods.<br>Aluminum railings at perimeter of second floor are damaged and missing. The railings relied on canvas infill within the aluminum frame to provide fall protection. Most of the canvas panels are gone. |
| Basement | Concrete | Standing water in basement.<br>Potential wall cracks (unable to access due to water). |

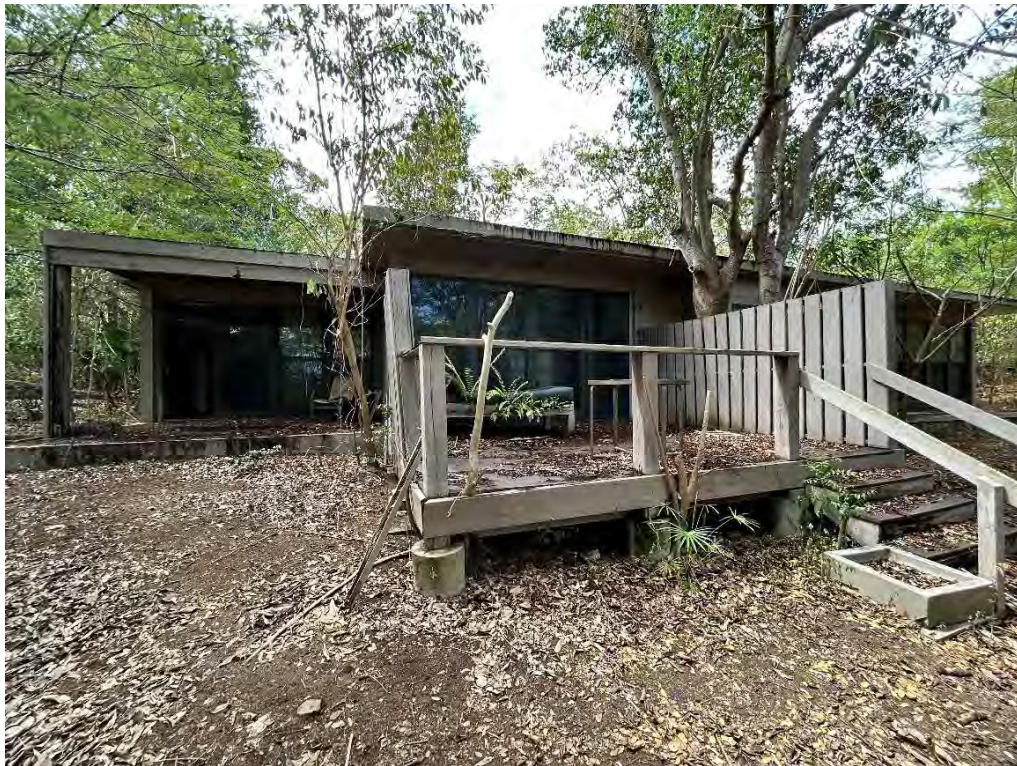
| Component | Material | Notes |
|---|---|---|
| Walls (Structural) | Concrete | Minor concrete cracking, some cracks show signs of previous repairs.<br>Spalled concrete at breezeway.<br>Potential soil loss at foundation support for Unit 65 NW wall. |
| Roof | Concrete and Wood/ Membrane | Wood framed roof over Unit 66 porch.<br>Roots growing from ceiling in Unit 65 (unable to access interior of unit)<br>Vegetation on roof.<br>Moisture pockets in paint at underside of roof overhang. Roof cracks. |

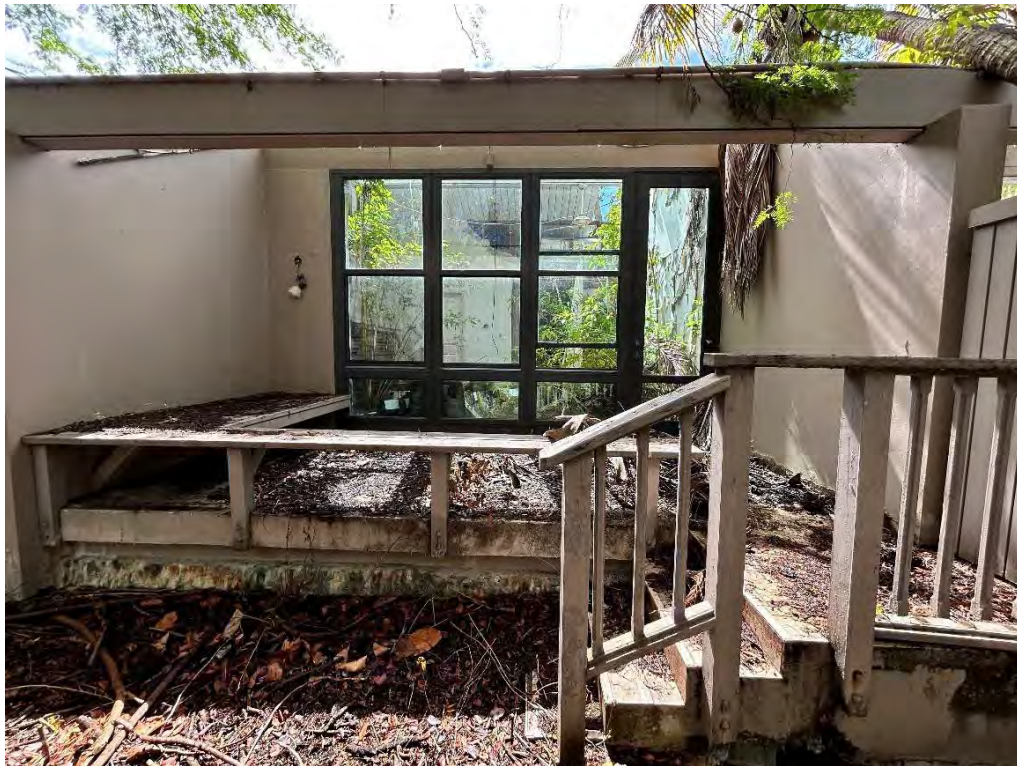
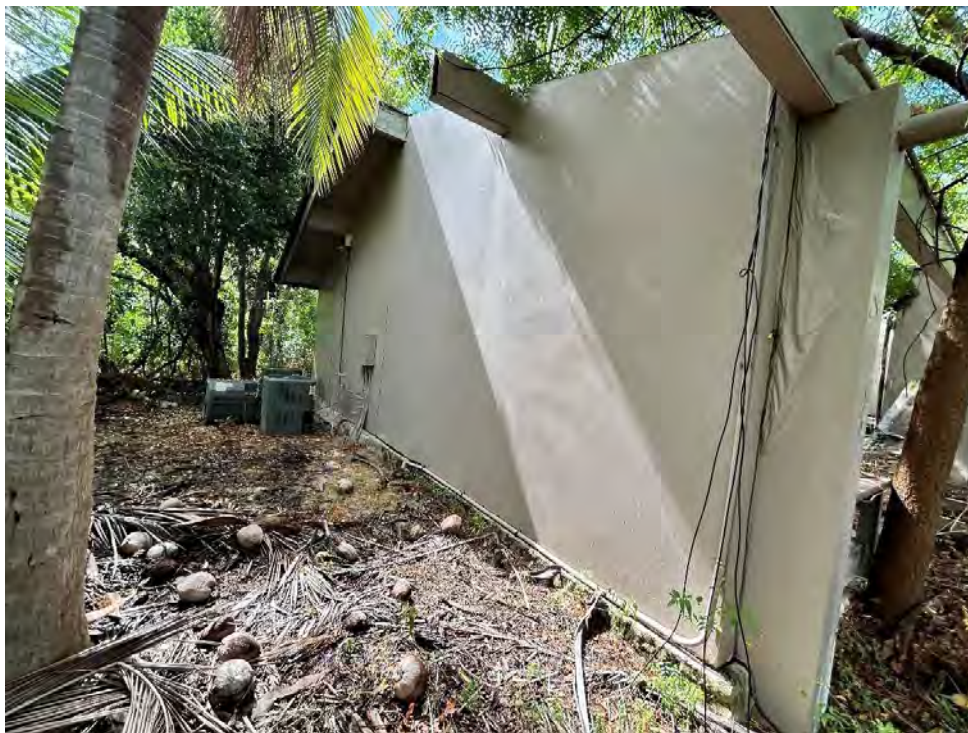
| Component | Material | Notes |
|---|---|---|
| Floor | Concrete | Efflorescence with stalactites forming at bottom of west concrete porch edge. Vegetation growth. |
| Walls (Structural) | Concrete | Concrete spalled at exterior wall between units 69 and 70.<br>Signs of termite activity.<br>Efflorescence with stalactites forming at bottom of east walls. |
| Roof | Wood Framed / Metal Sheathing | Roof collapsed completely at Unit 67. Partial roof collapse for Units 68, 69, and 70. |

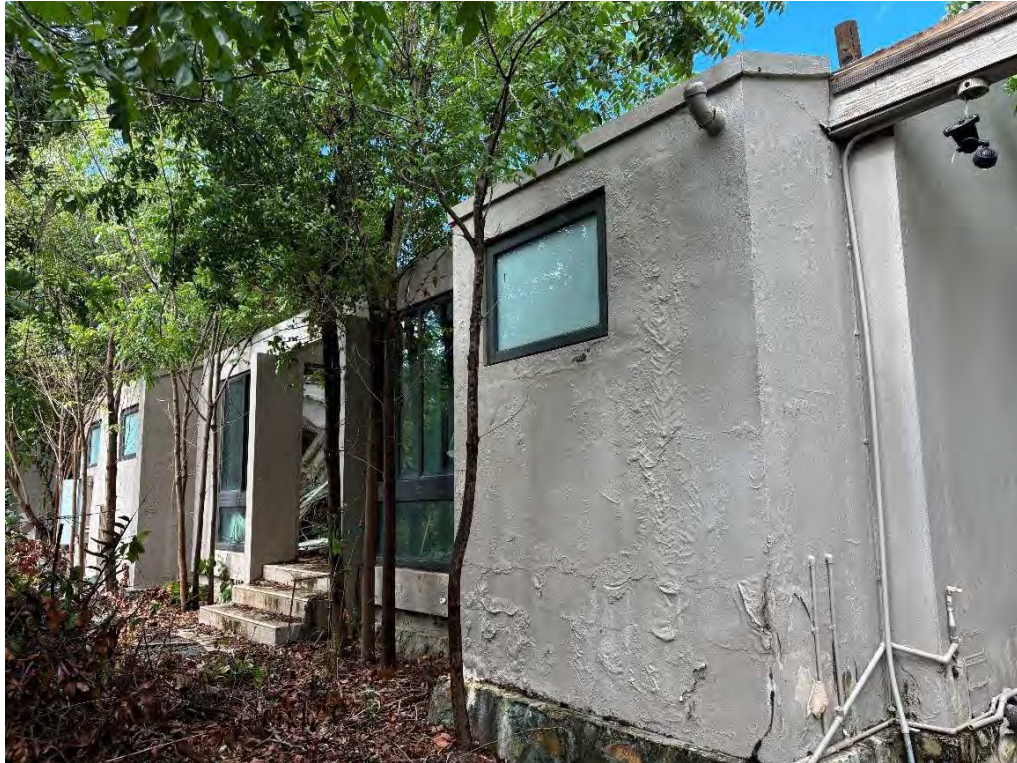
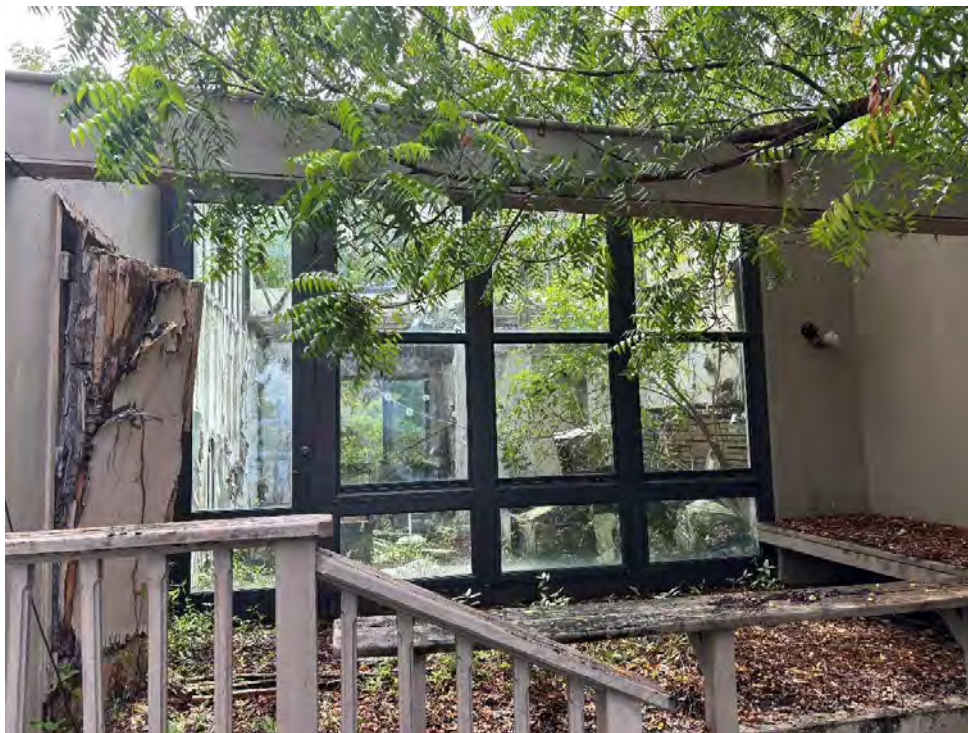
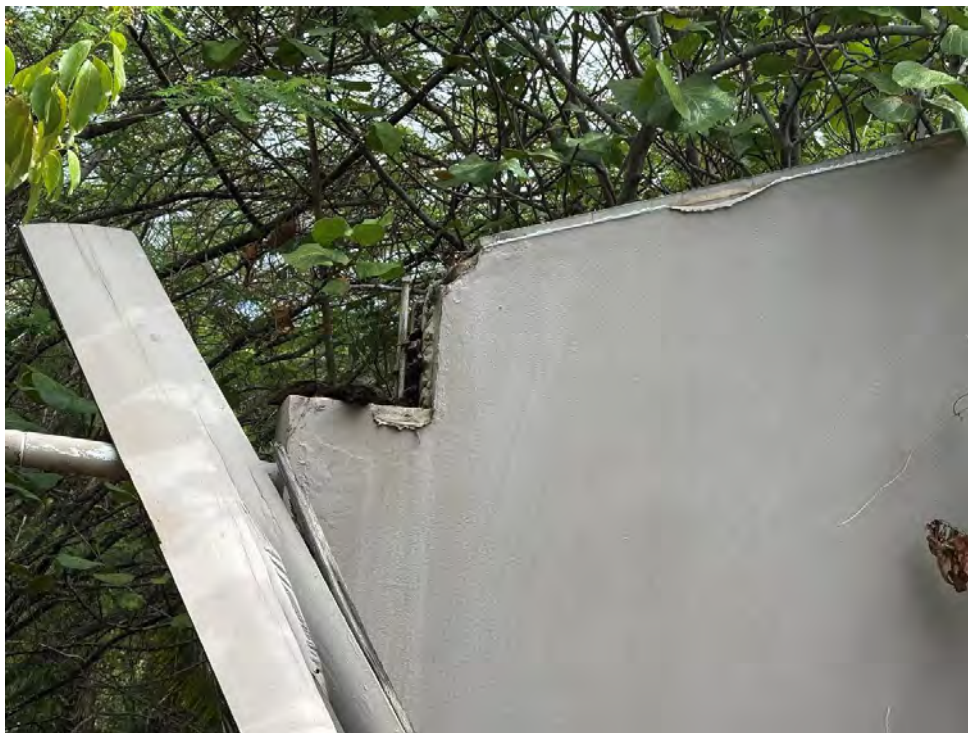
| Component | Material | Notes |
|---|---|---|
| Walls (Structural) | Concrete | Beam pocket damage at rear wall of unit 74.<br>Signs of termite activity.<br>Efflorescence with stalactites forming at bottom of east walls. |
| Roof | Wood Framed /<br>Metal<br>Sheathing | Roofs collapsed. |

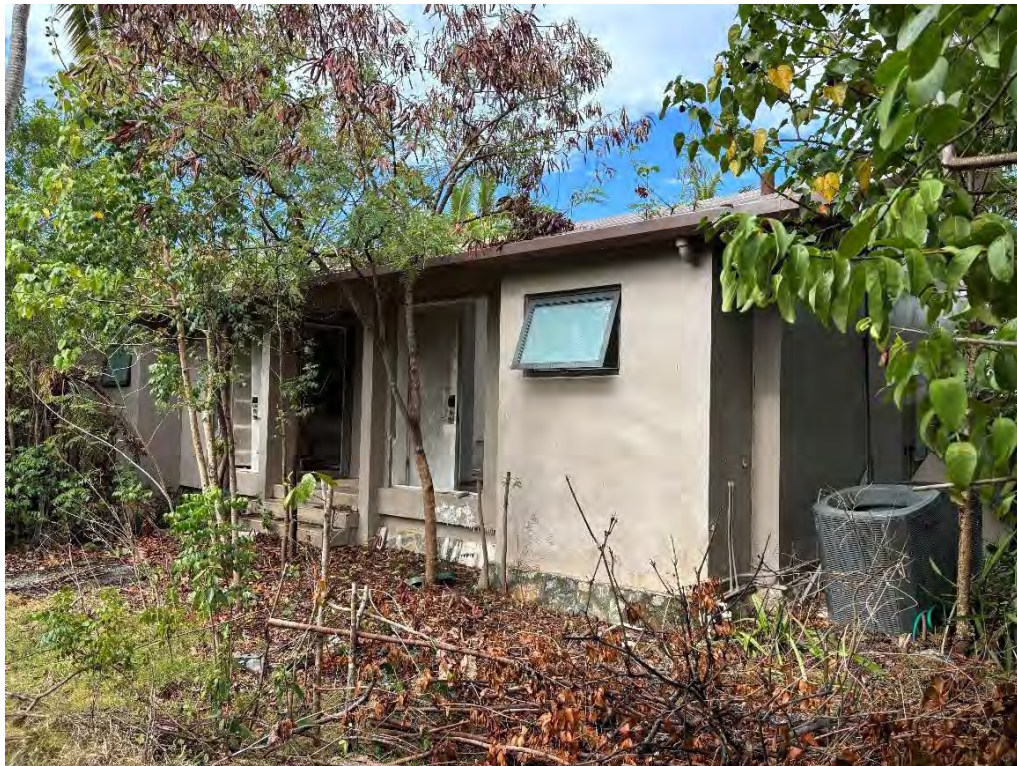
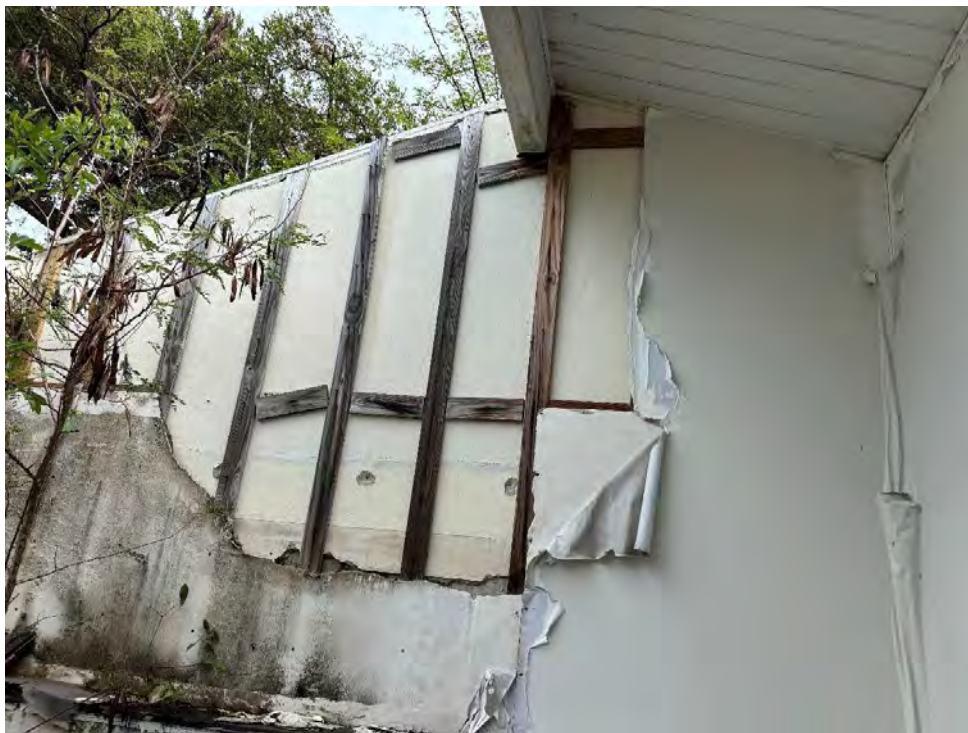
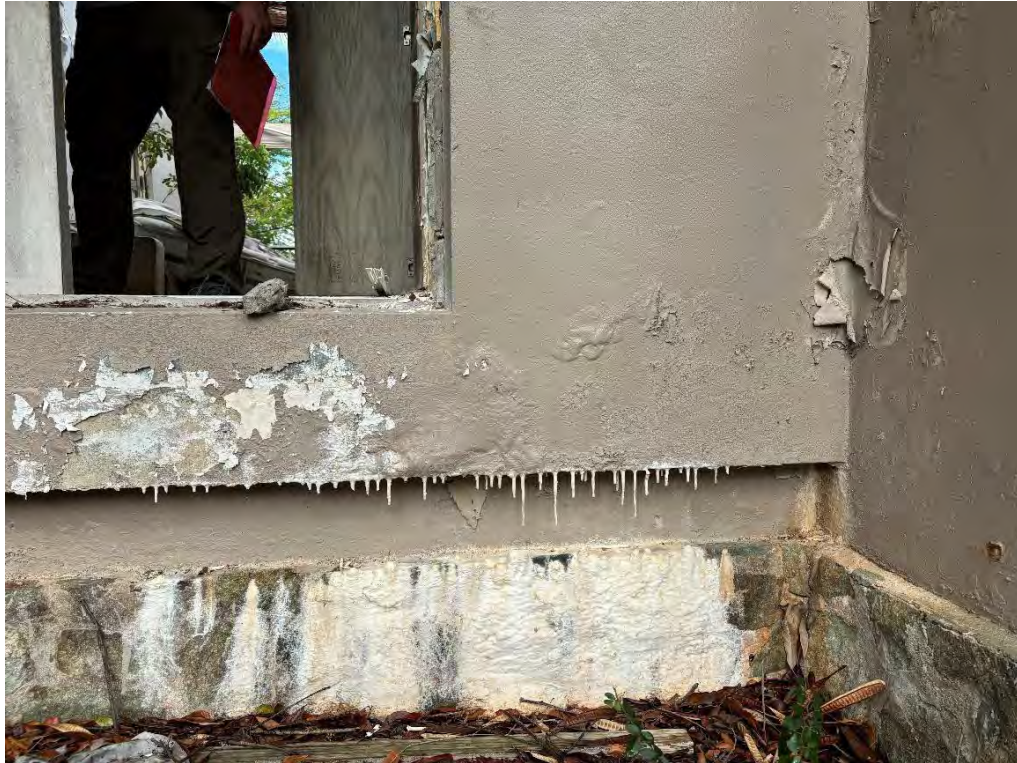
| Component | Material | Notes |
|---|---|---|
| Walls (Structural) | Concrete | Beam pocket damage at front wall of unit 75.<br>Signs of termite activity.<br>Efflorescence with stalactites forming at bottom of east walls.<br>Concrete bearing walls were covered with drywall for architectural cladding. |
| Roof | Wood Framed / Metal Sheathing | Roof collapsed completely at Unit 75. Partial roof collapse for Units 76, 77, and 78. |
| Stairs/Railings | Concrete | Railings deteriorated. |

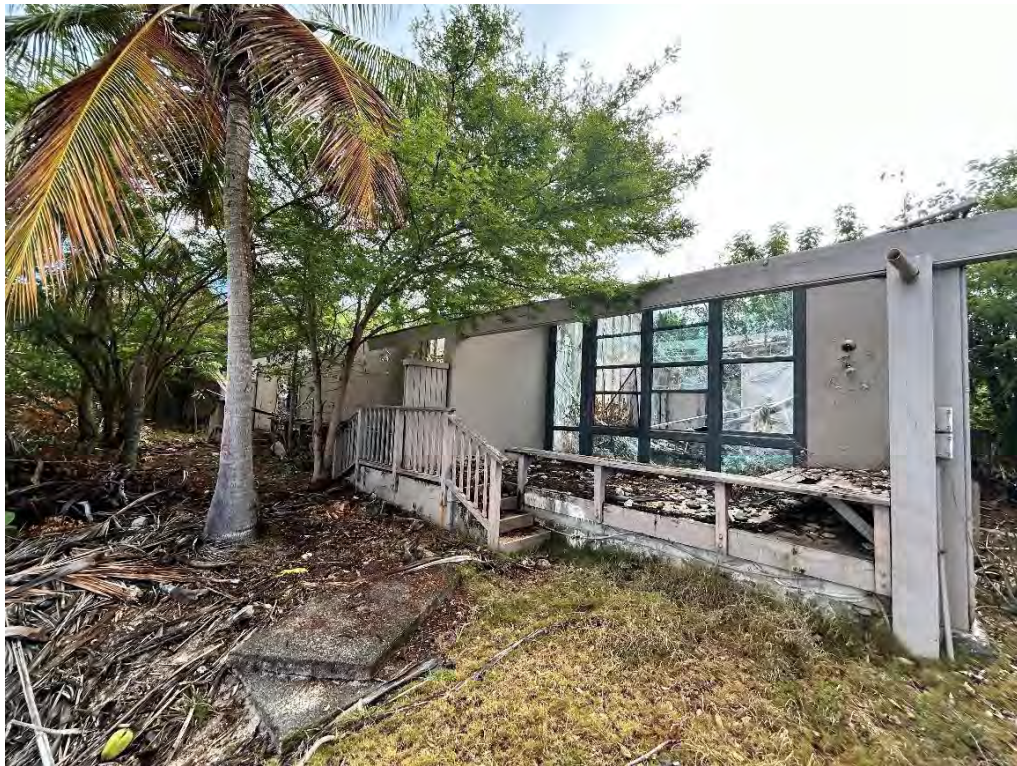
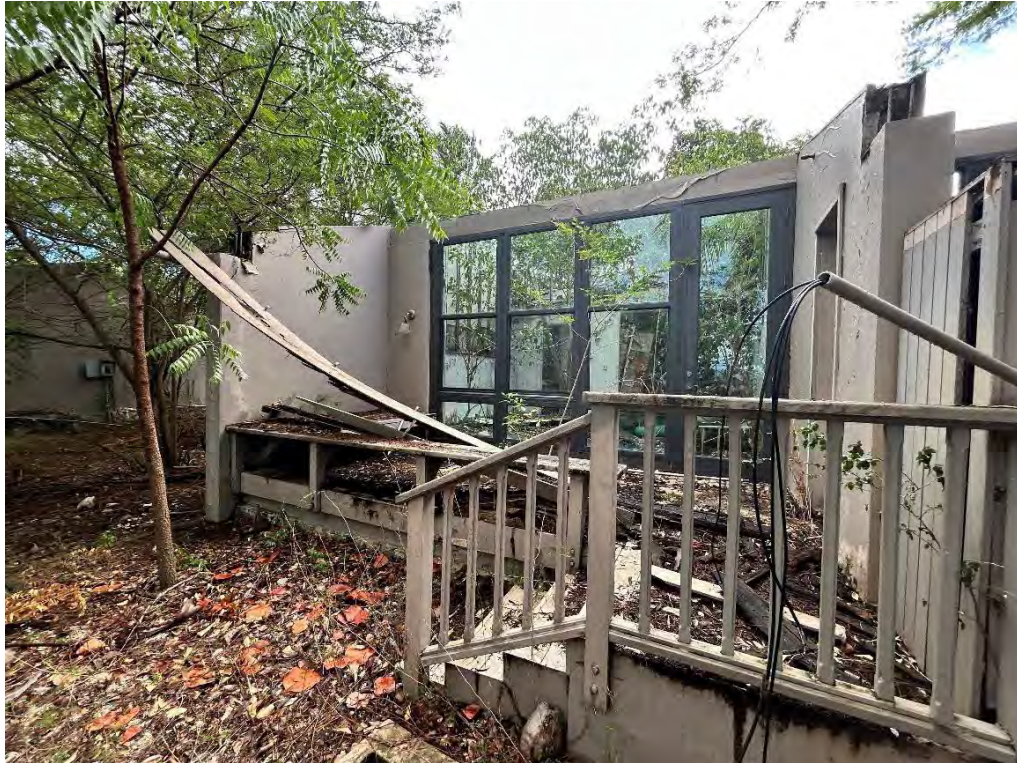
| Component | Material | Notes |
|---|---|---|
| Walls (Structural) | Concrete | Concrete spall at end walls (exterior walls of units of 79 and 82).<br>Signs of termite activity. |
| Walls (Non-Structural) | Metal Framed Window Wall | Blown out exterior partition wall at Unit 81, west side. |
| Roof | Wood Framed / Metal Sheathing | Roof collapsed for all units. |

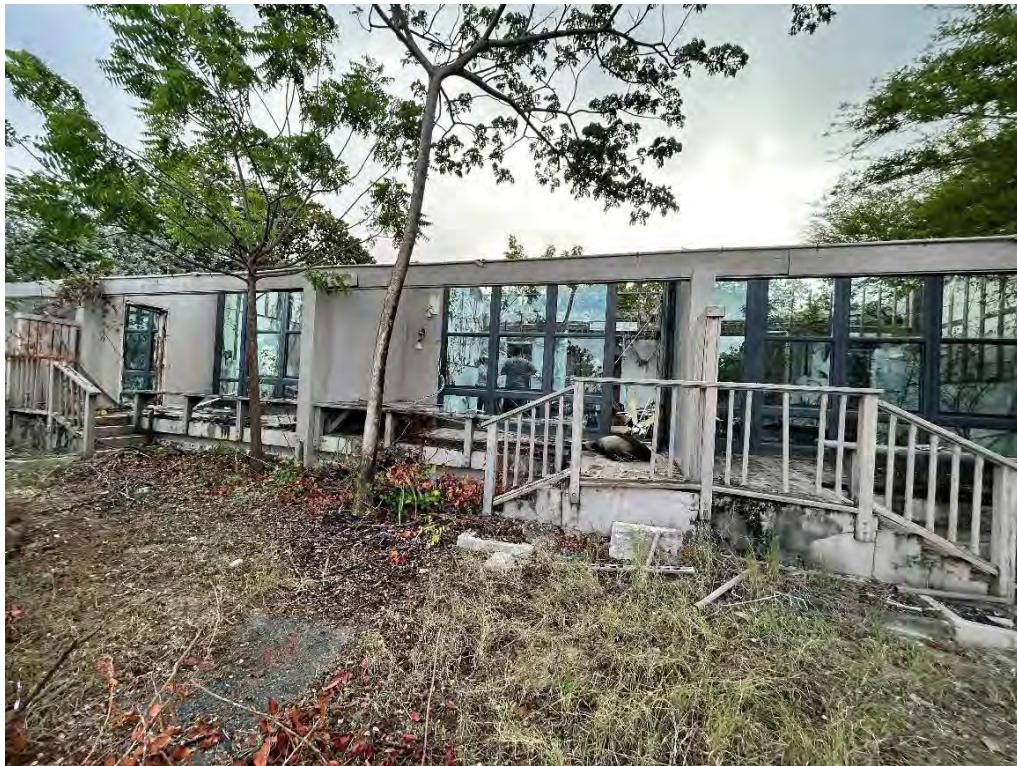
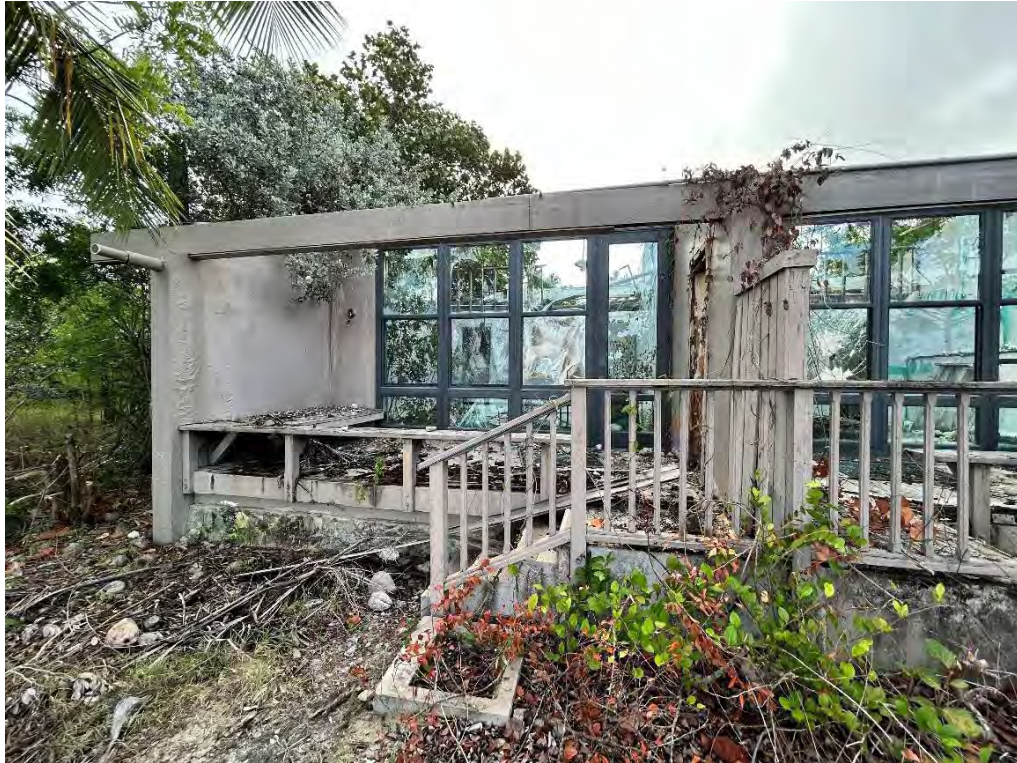
| Component | Material | Notes |
|---|---|---|
| Floor | Concrete | Standing water observed in crawl space below building. |
| Walls (Structural) | Concrete | Concrete spall at exterior wall between units 83-84.<br>Signs of termite activity.<br>Efflorescence with stalactites forming at bottom of east walls. |
| Walls (Non-Structural) | Metal Framed Window Wall | Missing stones at stone veneer wall on exterior side of Unit 86. |
| Roof | Wood Framed / Metal Sheathing | Roof collapsed for all units. |

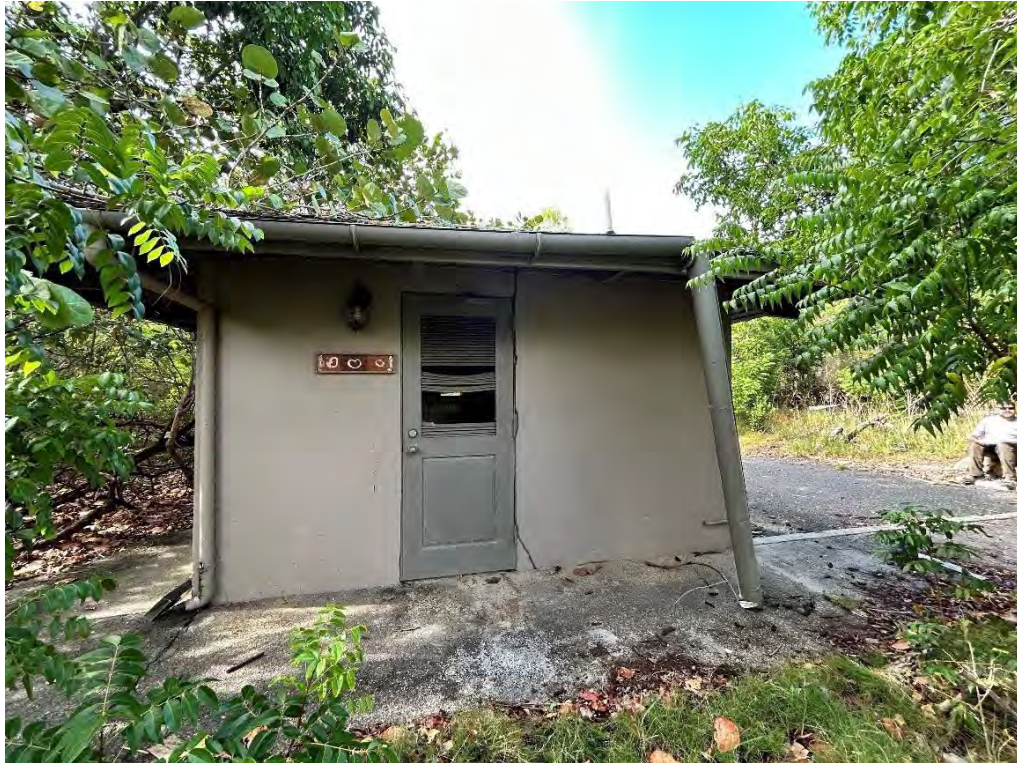
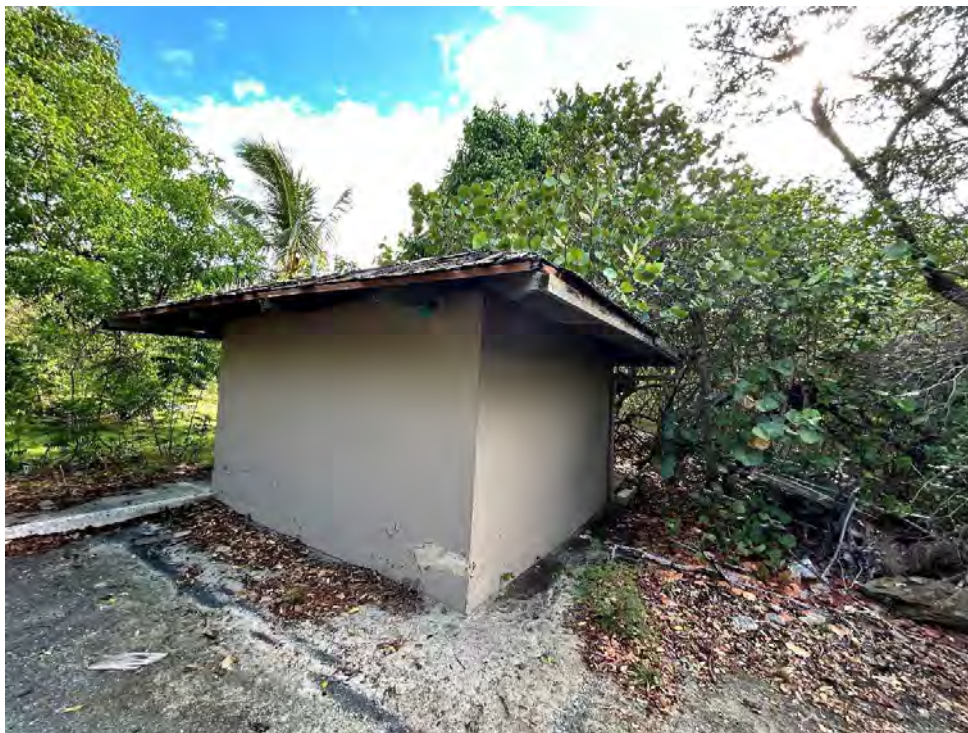
| Component | Material | Notes |
|---|---|---|
| Walls (Structural) | Concrete | Concrete spall adjacent to door on east side. |
| Roof | Wood Framed /<br>Wood Shingles | Rafter Deterioration at exterior overhang at NW corner. |
