**National Park Service**  
Virgin Islands National Park | Caneel Bay  
Structural Assessment Report

**Building: Turtle Bay Bus Stop (Adjacent to Units 87-98)**

**Structural Assessment: Structurally Sound**

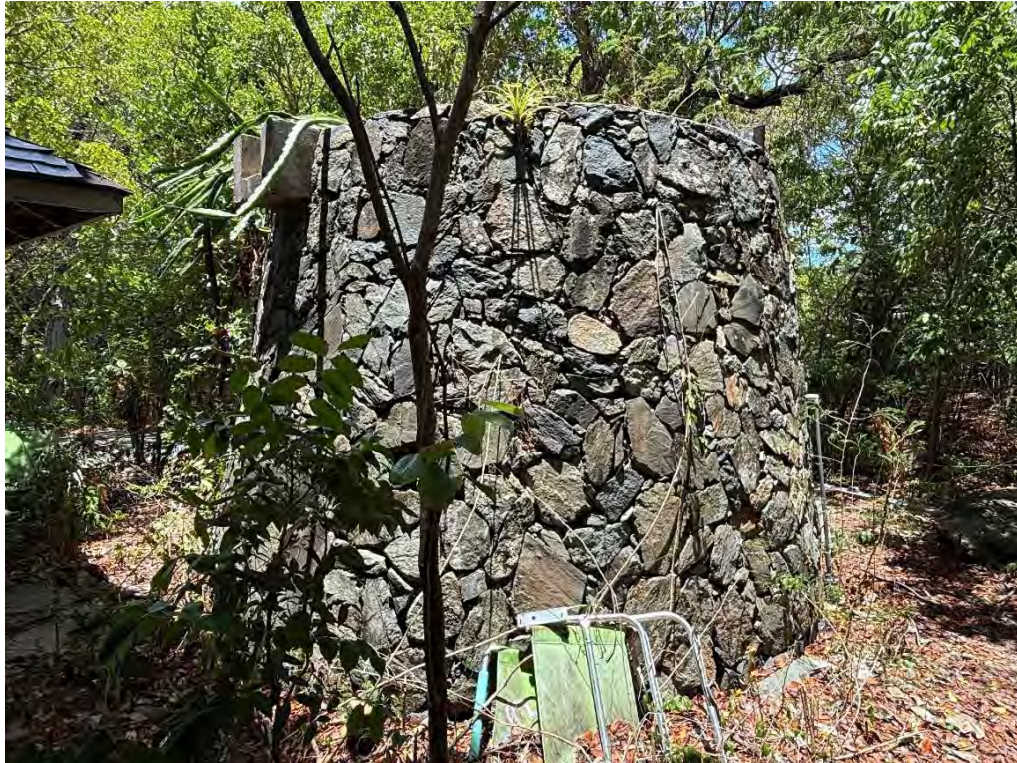
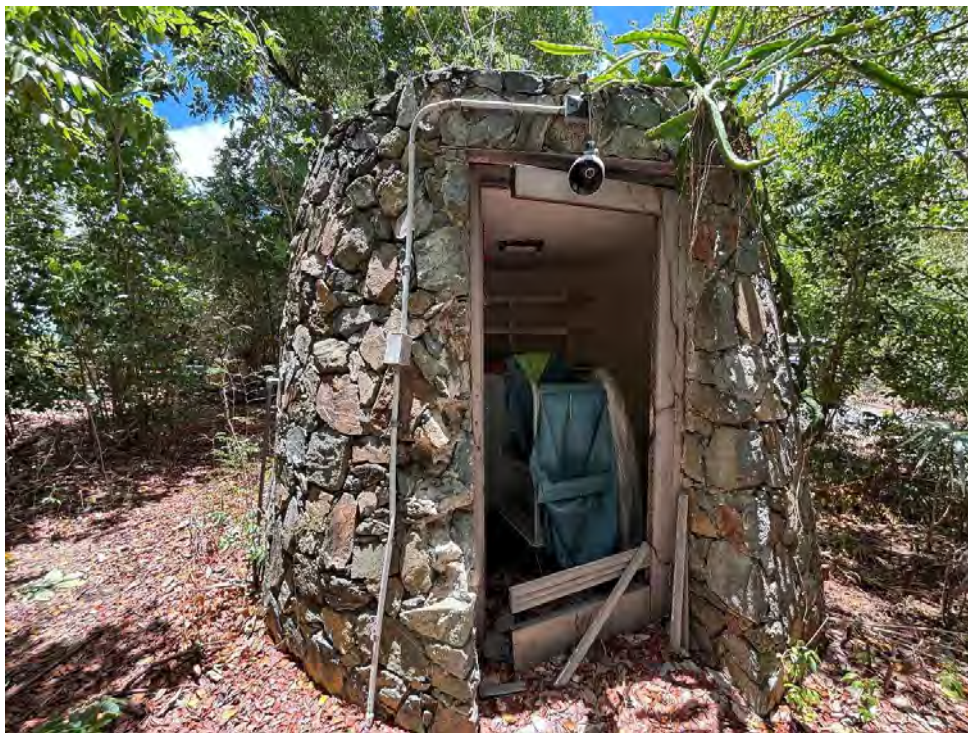
| Component | Material | Notes |
|---|---|---|
| Walls (Structural) | Stone | Minor stones missing. |
| Roof | Concrete | Minor cracking at roof. |

- Verify integrity of roof slab from above.

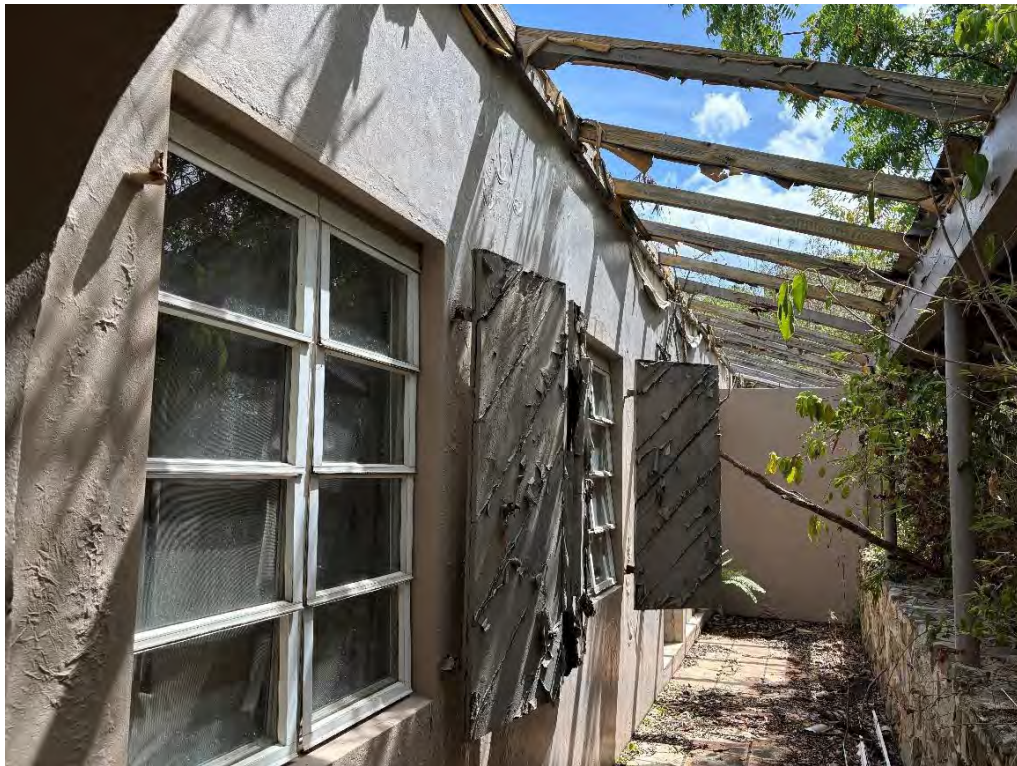
| Component | Material | Notes |
|---|---|---|
| Walls (Structural) | Stone/Concrete | Concrete window lintel deteriorated. |
| Roof | Wood<br>framed/<br>unknown | Roof collapsed. Potential termite damage. |
| Deck / Railings | Wood | Decks and railings have failed. |

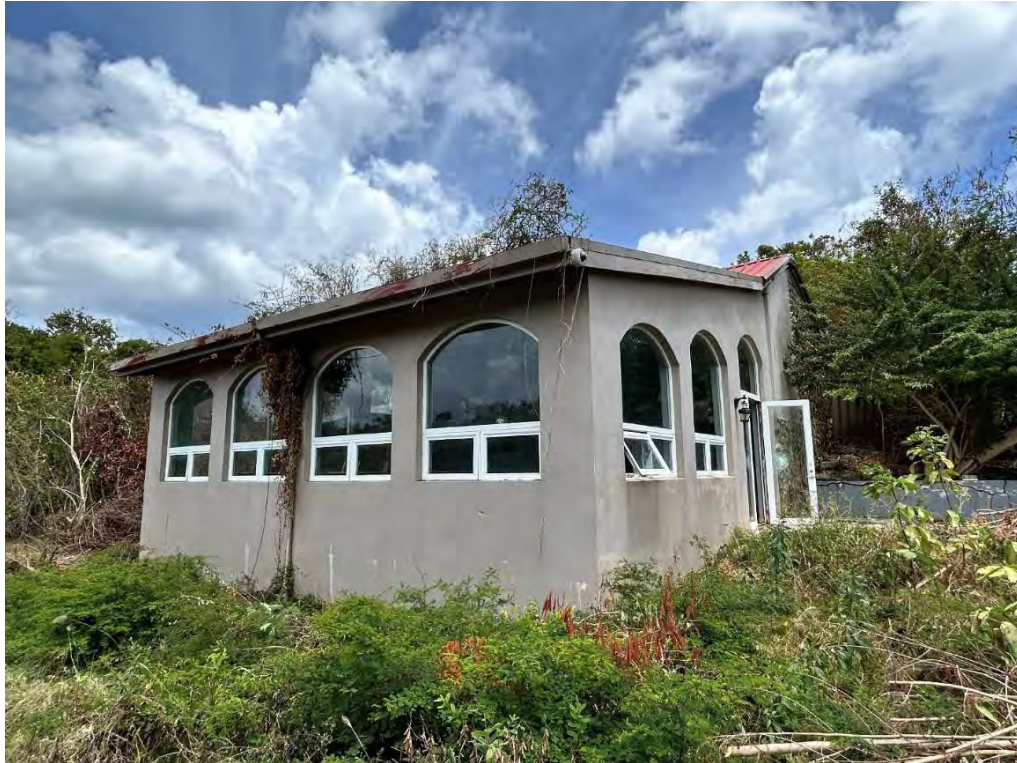
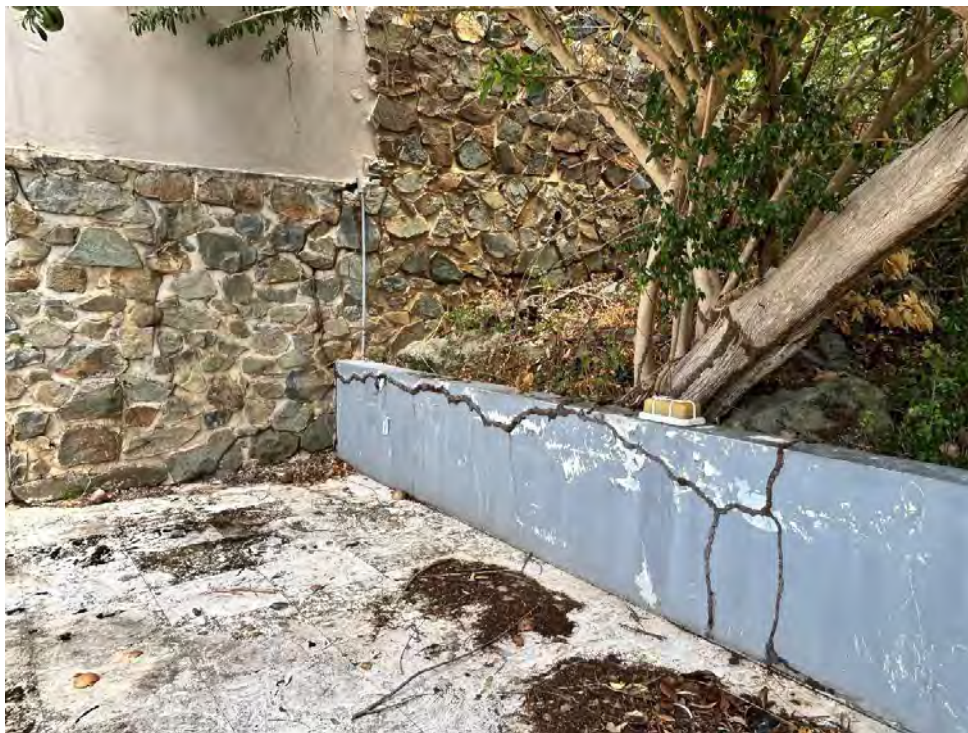
| Component | Material | Notes |
|---|---|---|
| Walls (Structural) | Stone (rear)<br>Concrete | Cracking observed at stone base and stone lintel; repoint.<br>Exposed rebar in capstone near bathroom addition. |
| Walls (Non-Structural) | Wood framed | Potential termite damage. |
| Roof | Wood<br>framed/<br>Metal | Potential termite damage. |

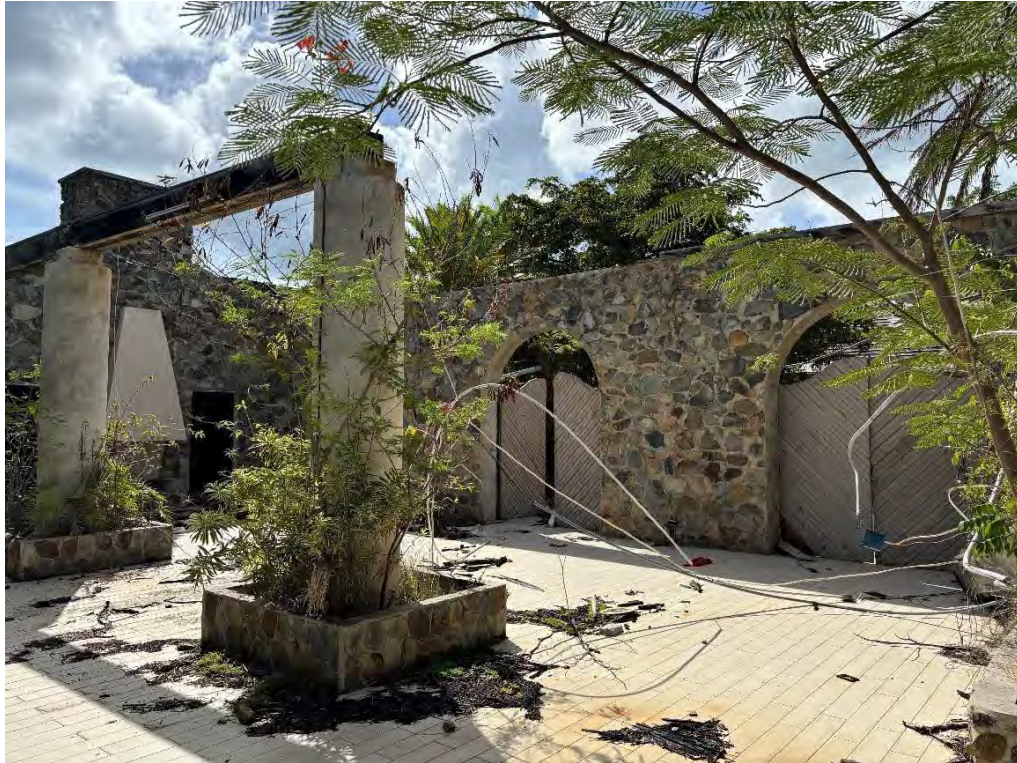
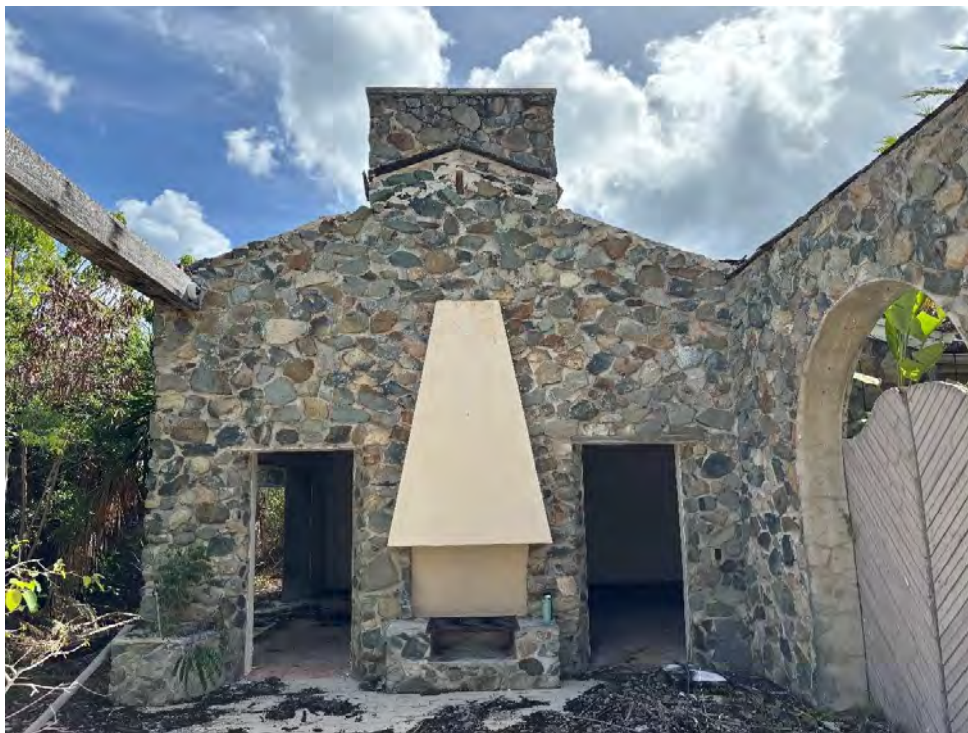
| Component | Material | Notes |
|---|---|---|
| Walls (Structural) | Stone Walls and Concrete Piers | Concrete piers in good condition, aesthetic cracking is superficial. Stone arches need minor repointing. |
| Roof | Unknown | Roof collapsed. |

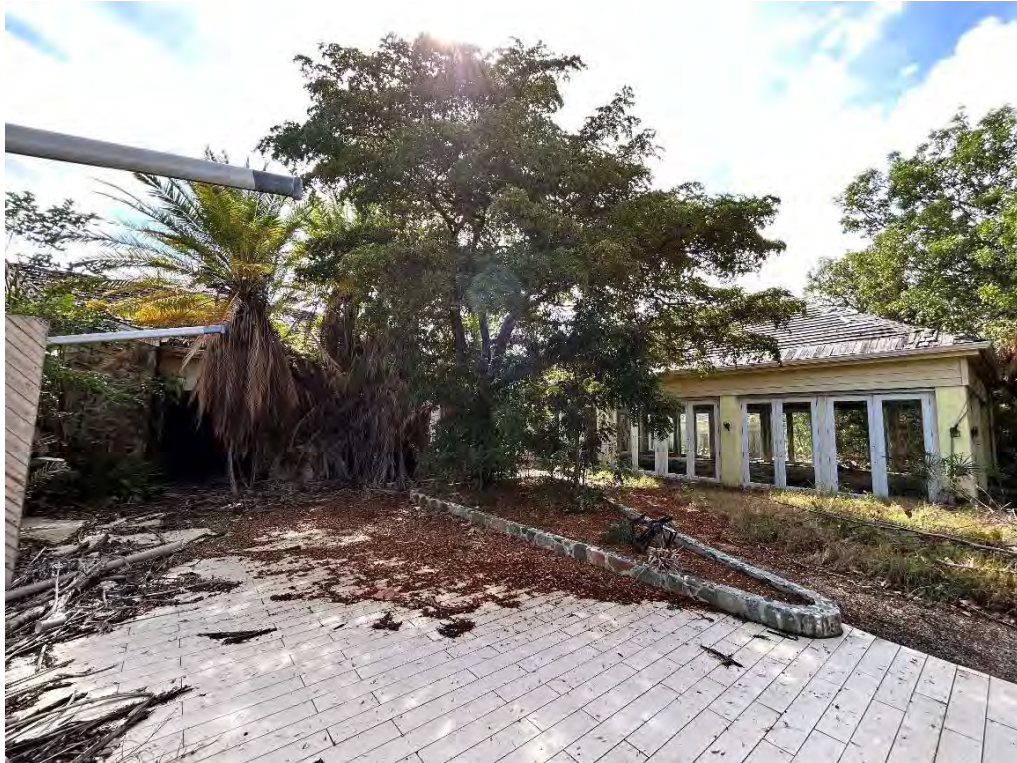
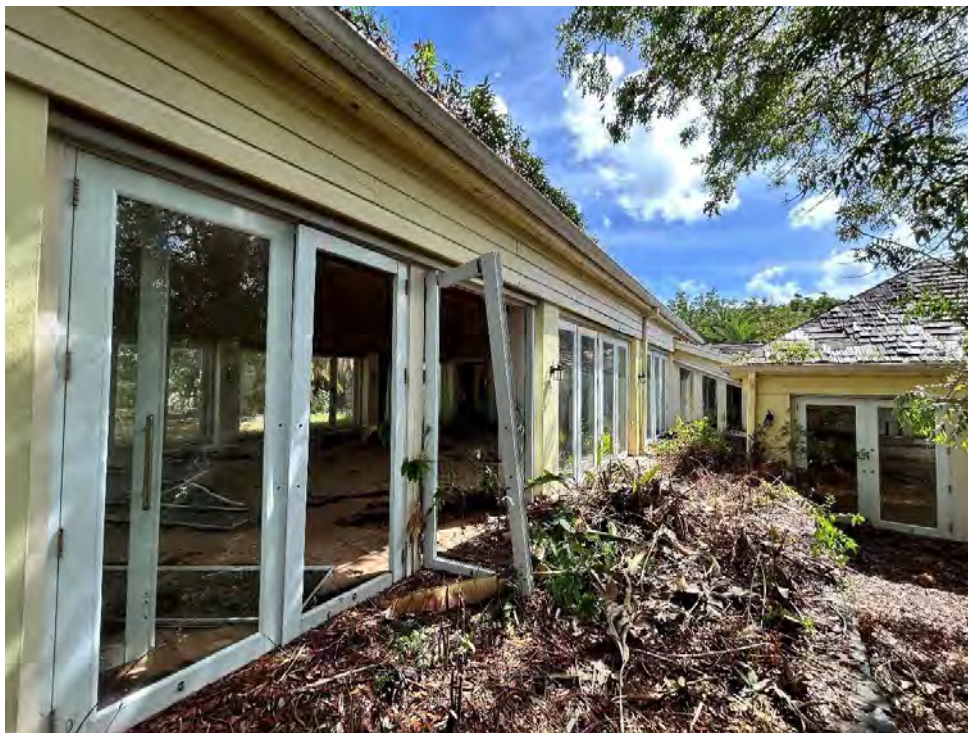
| Component | Material | Notes |
|---|---|---|
| Floor | Concrete | Standing water in restroom/hallway area. |
| Walls (Structural) | Concrete / Stone | Missing stones in stone walls.<br>Spalling concrete with corroded rebar at south wall.<br>Mortar missing, loose, and cracked at south wall.<br>Rusted lintel at exterior stairs. |
| Walls (Non-structural) | Wood / Doors | Rotten wood at base of infill walls between doors. |
| Roof | Wood Framed / Wood Singles | Some missing wood shingles.<br>Signs of water intrusion and moisture damage on interior finishes.<br>Signs of termite activity.<br>Wood shed roof over exterior stairs is missing major support beam and has failed. |

- Wood framing at roof was not visible. Given water damage and signs of termite activity, it is likely there is additional wood damage not observed at this time. Future renovations should evaluate the structure further.

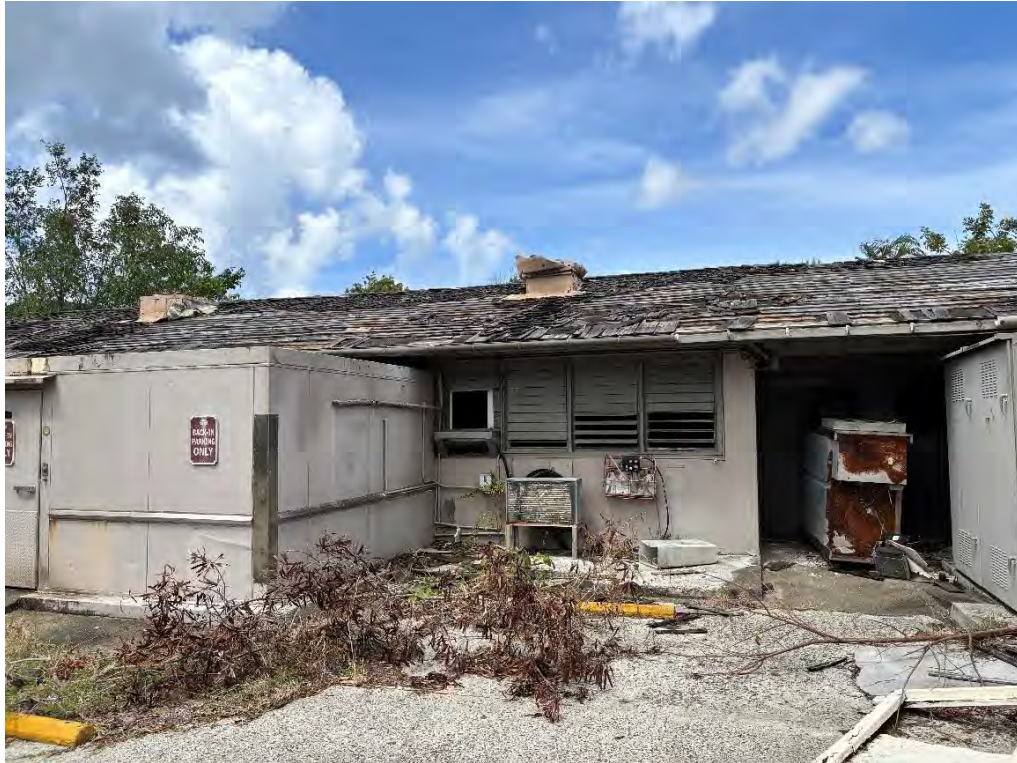
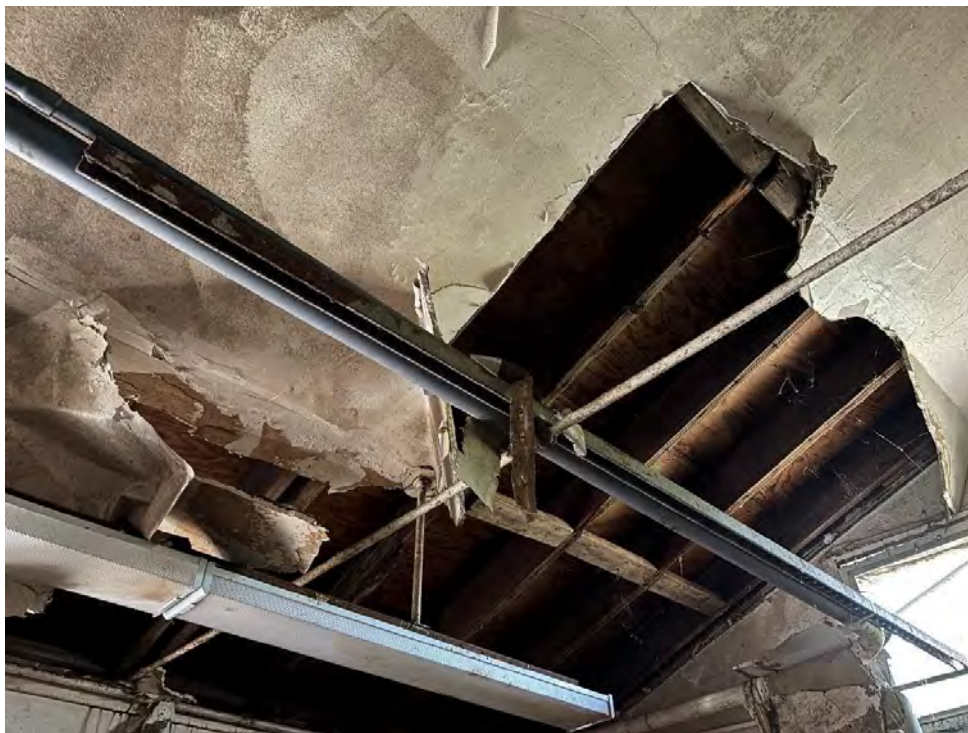
| Component | Material | Notes |
|---|---|---|
| Walls (Structural) | Concrete | Vertical crack in concrete end wall at Nail Salon. (Nail salon shares roofline and structural walls with kitchen area). |
| Walls (Non-Structural) | Wood framed | Wood frame infill walls above concrete knee walls. Water and termite damage. |
| Roof | Wood framed/<br>Wood shingles | Roof damaged, not watertight. Water and termite damage. |

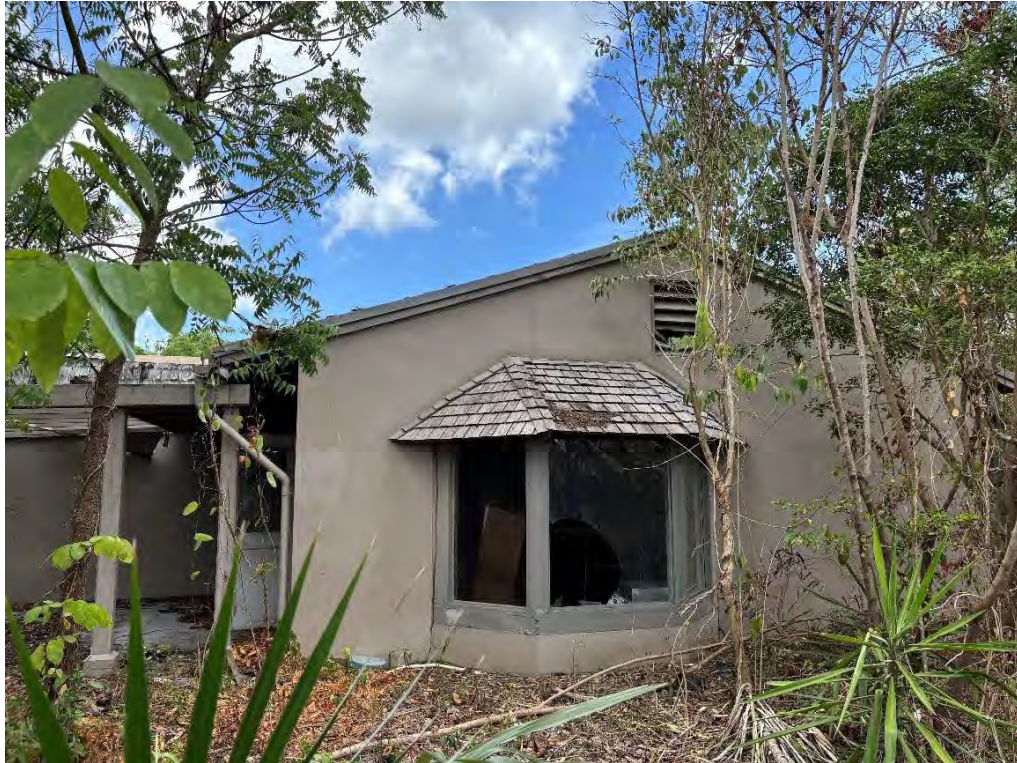
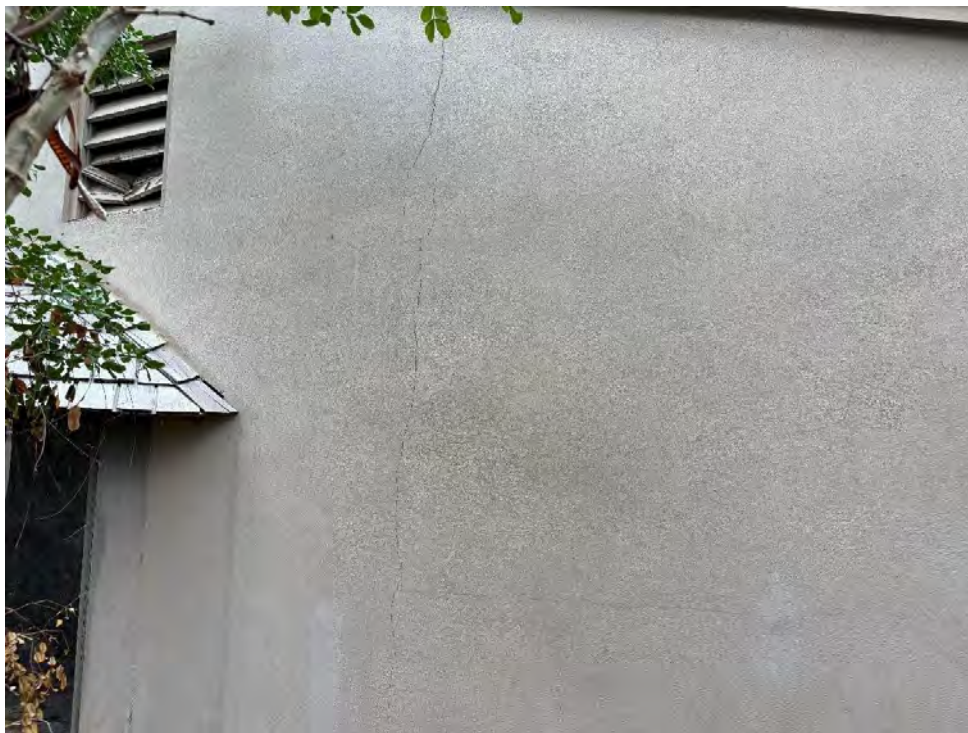
| Component | Material | Notes |
|---|---|---|
| Floor | Concrete | Horizontal cracks in concrete wall may be signs of potential foundation rotation or differential movement. |
| Walls (Structural) | Concrete / Stone Retaining Walls | Missing stones in retaining walls. Horizontal cracks on north wall. |
| Walls (Non-structural) | Wood / Doors | Rotten wood at base of infill walls between doors. |
| Roof | Wood Framed / Wood Singles | Some missing wood shingles. Signs of water intrusion on interior finishes. |

Wood framing at roof was not visible. Given water damage and signs of termite activity, it is likely there is additional wood damage not observed at this time.

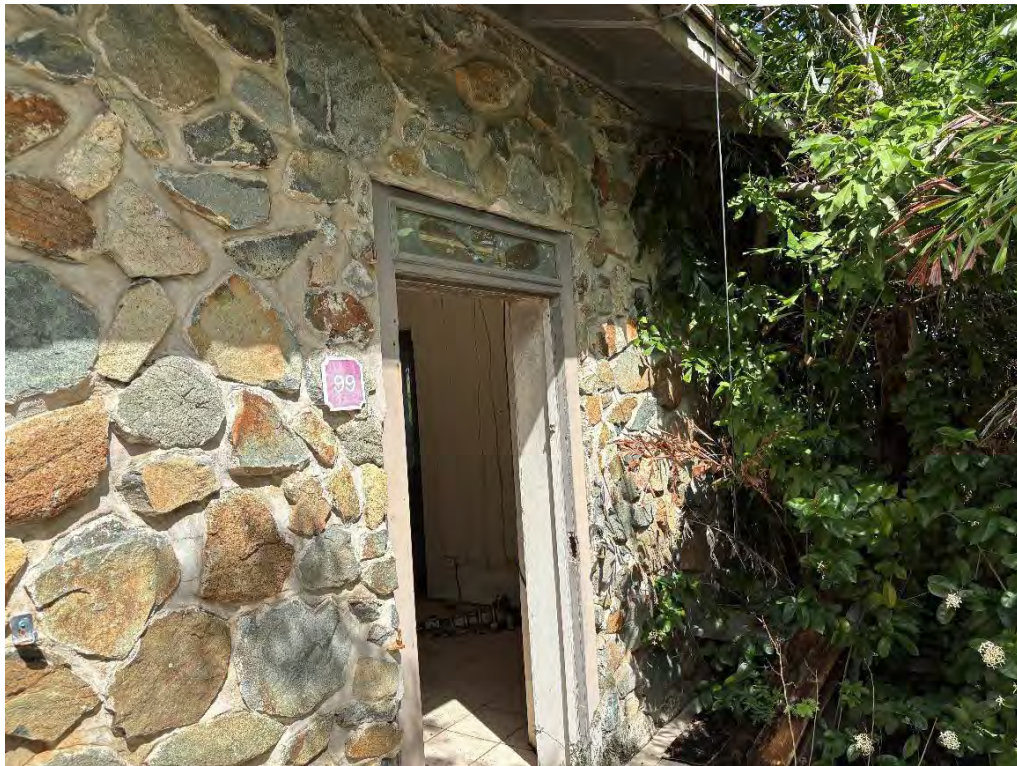
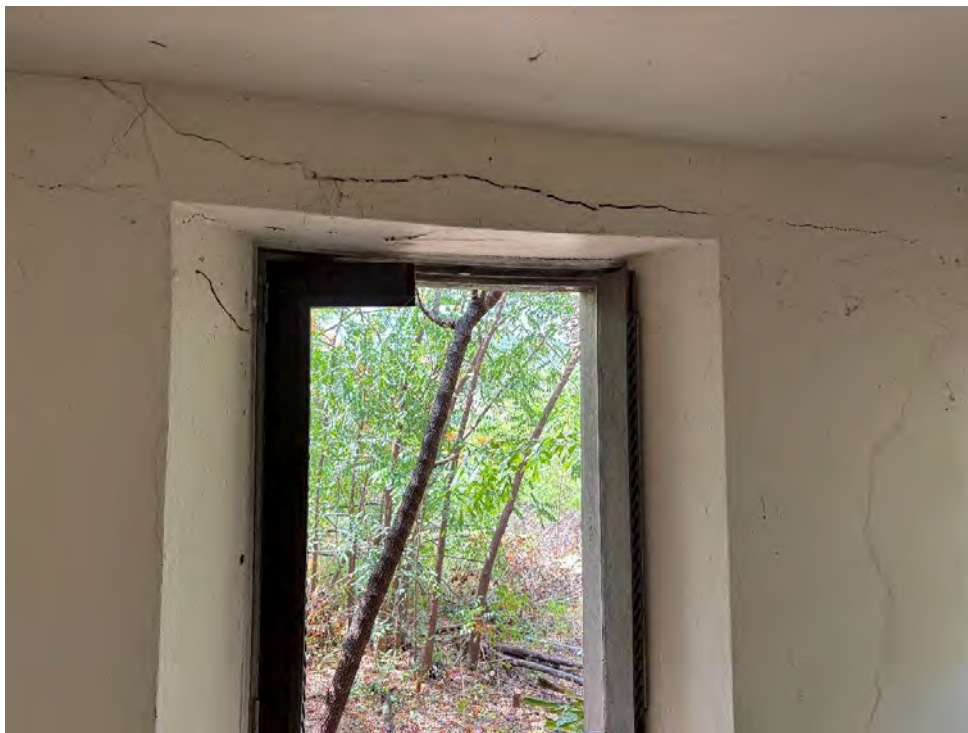
| Component | Material | Notes |
|---|---|---|
| Walls (Structural) | Stone/Concrete | Door lintels cracked and displaced in 99. Window lintels cracked in 100. Wall and lintel cracks in Multi Purpose Room. |
| Walls (Non-Structural) | Wood framed | Demolish partitions due to termite activity. Potential termite damage. |
| Roof | Wood framed/<br>unknown | Roof collapsed. Potential termite damage. |
| Deck / Railings | Wood | Decks and railings have failed. |

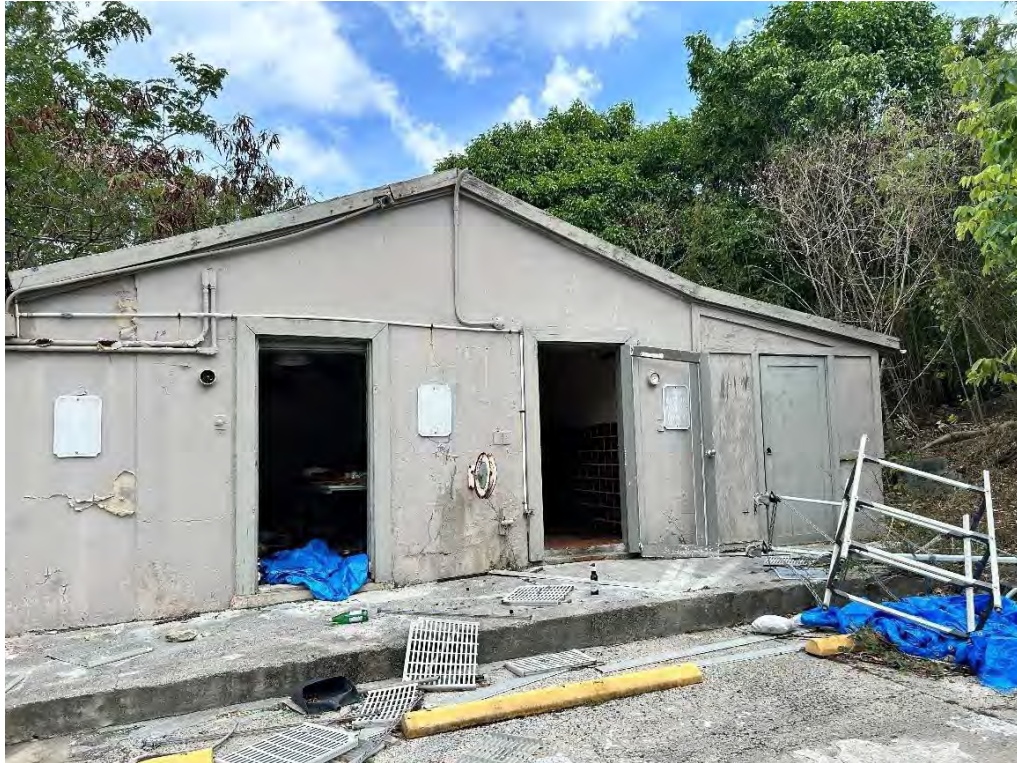
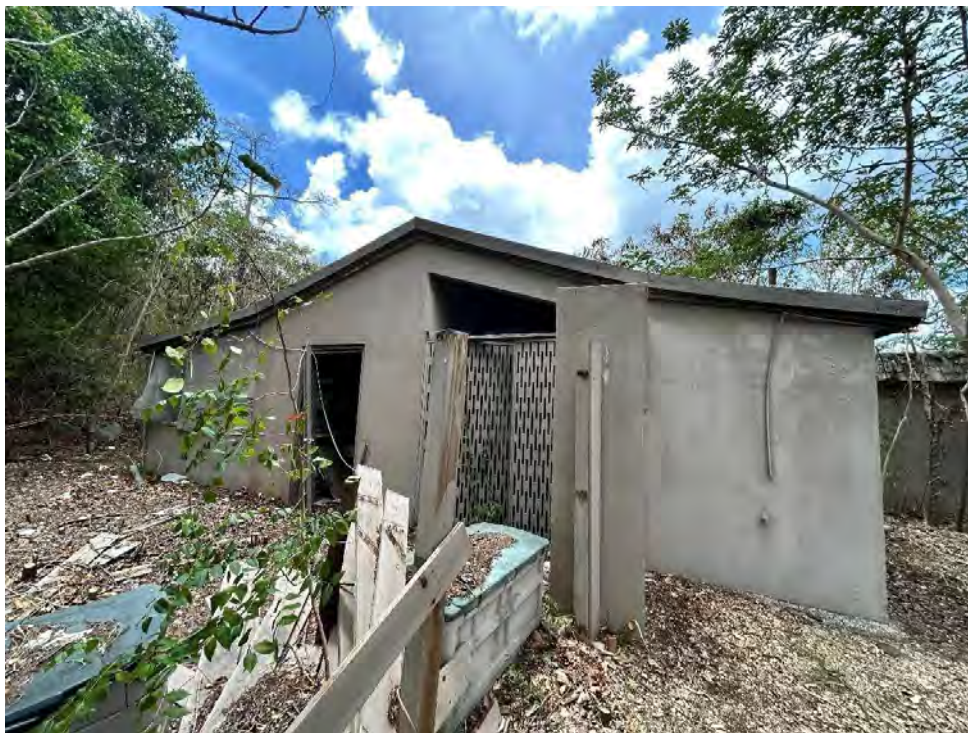
| Component | Material | Notes |
|---|---|---|
| Walls (Structural) | Concrete | Some moisture staining and cracking in skim coat on front concrete wall. |
| Walls (Non-Structural) | Concrete | Wood frame infill walls above concrete knee walls on right shed addition. |

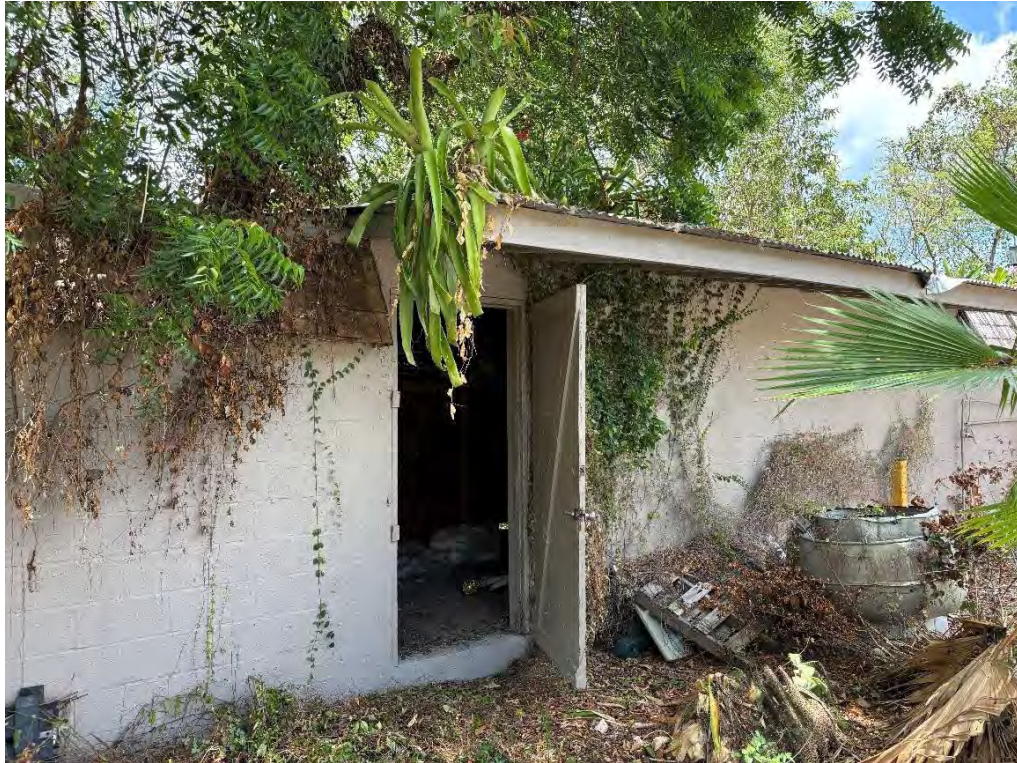
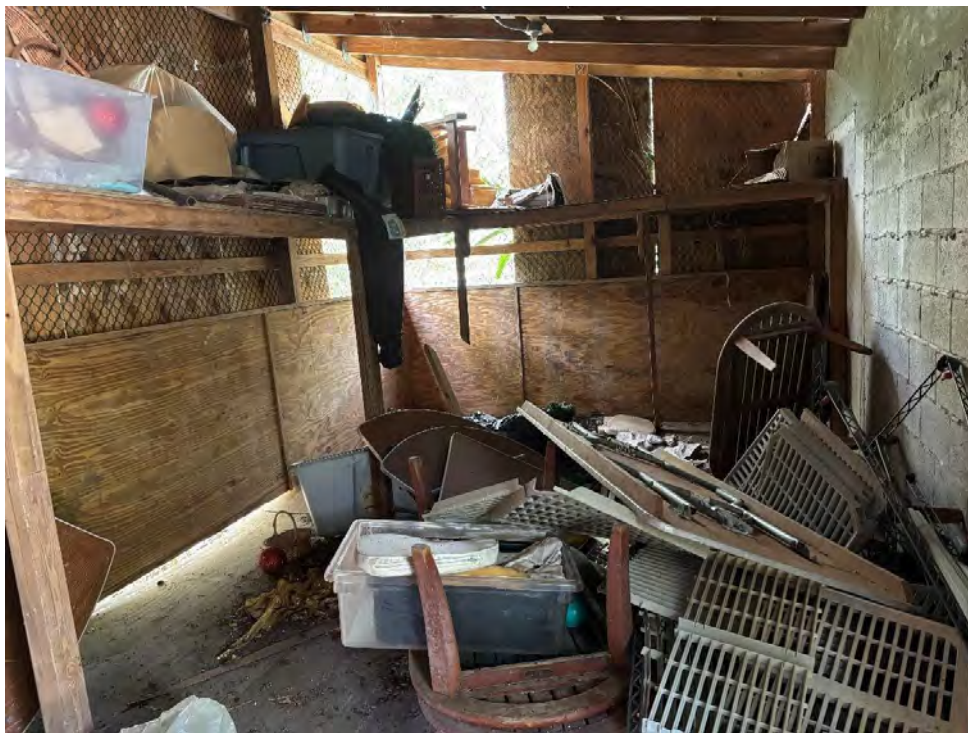
| Component | Material | Notes |
|---|---|---|
| Floor | Wood Framed / Plywood | Floor partially collapsed. |
| Walls (Structural) | Wood 3 Sides / CMU 1 side | Signs of termite damage. |

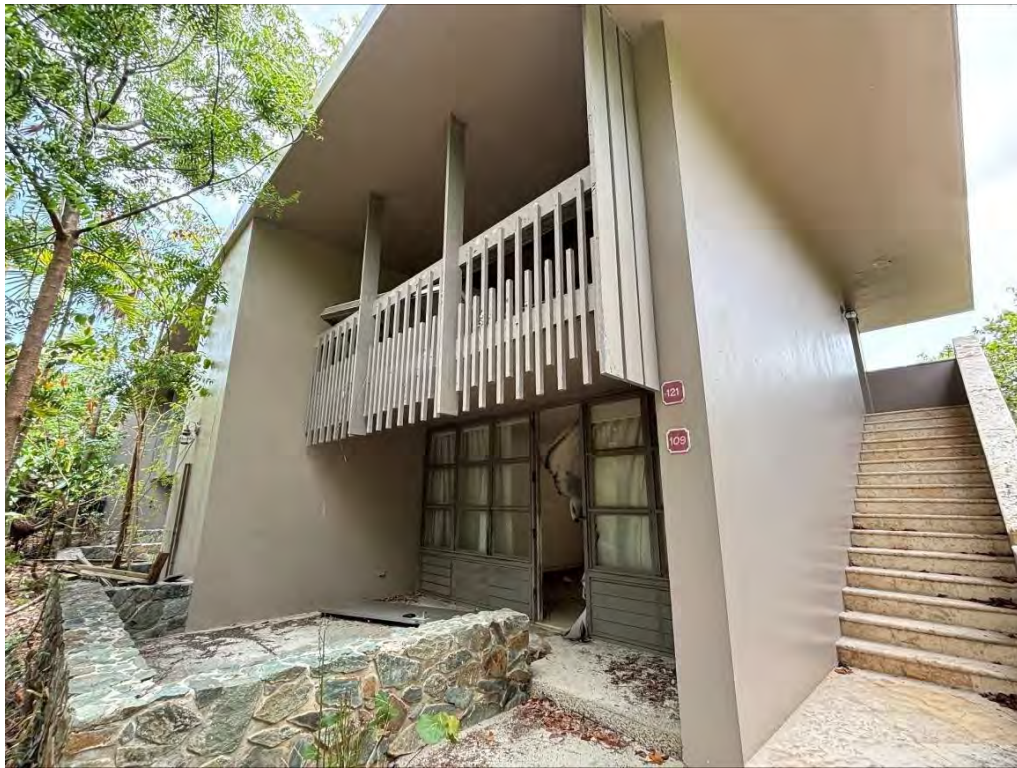
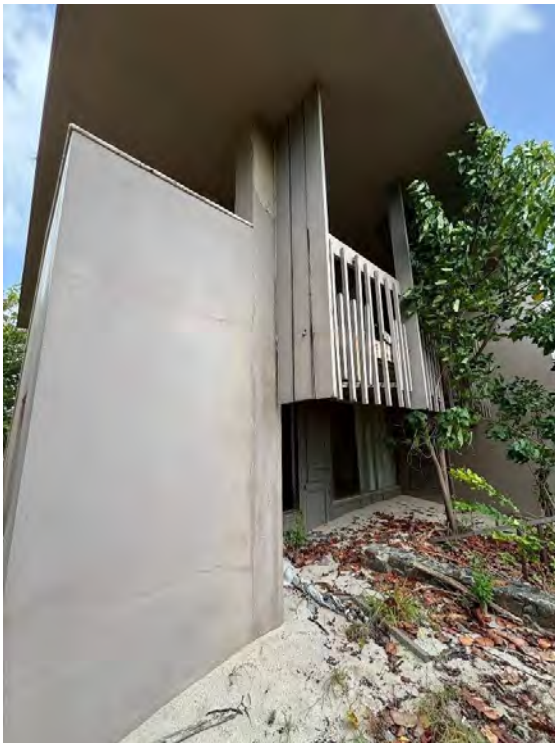
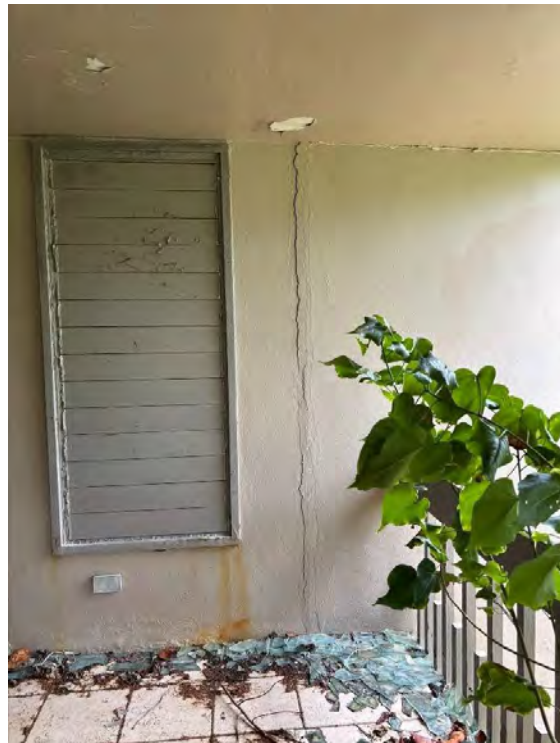
| Component | Material | Notes |
|---|---|---|
| Floor | Concrete | First floor has significant sand blown into the rooms. |
| Walls (Structural) | Concrete | Spalling on concrete columns with exposed rebar at east side between rooms 107 and 108.<br>Vertical cracks at geometry changes typical east and west side of second floor rooms (118, 119, 120, 121). |
| Walls (Non-Structural) | Wood and Windows | Windows blown out (106 east, 107 west, 108 east, 109 east, 121 east).<br>Walls collapsed (106 west, 107 east). |
| 2nd Floor | Concrete | Spalling and exposed rebar at edge of concrete slab where railing attached (120 east & west, 121 east).<br>Localized spalling at underside of slab throughout the building. At some locations rusted rebar is visible. |
| Roof | Concrete & Wood Framed / Membrane | Spalling on underside of slabs with exposed rebar in some locations.<br>Localized spalling at underside of slab throughout the building. At some locations rusted rebar is visible. |
| Stairs/Railings | Concrete / Wood Railings | Railing connections to slabs have failed. |

- Concrete walls and slabs, including underside of slabs, should be fully sounded to detect all areas of spalling and delamination.
- Remove existing railings and fully review edge of concrete slabs for damage.
- Repairs may consist of replacing damaged rebar with new rebar, cleaning and coating rebar with zinc rich paint, and repairing concrete.

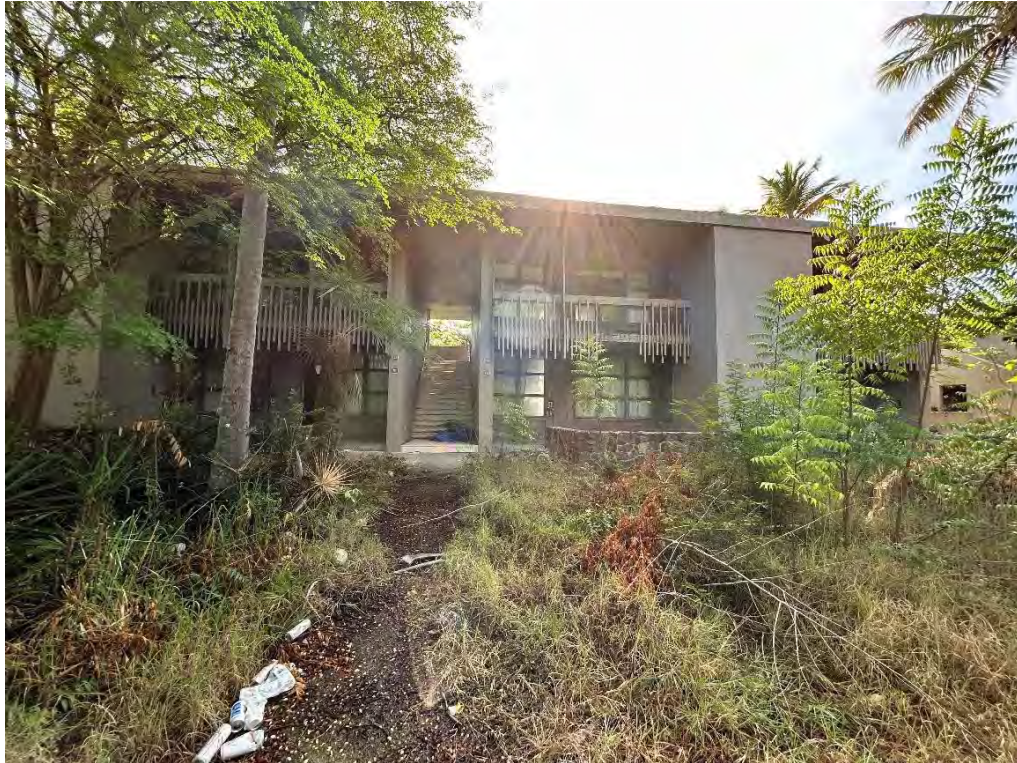
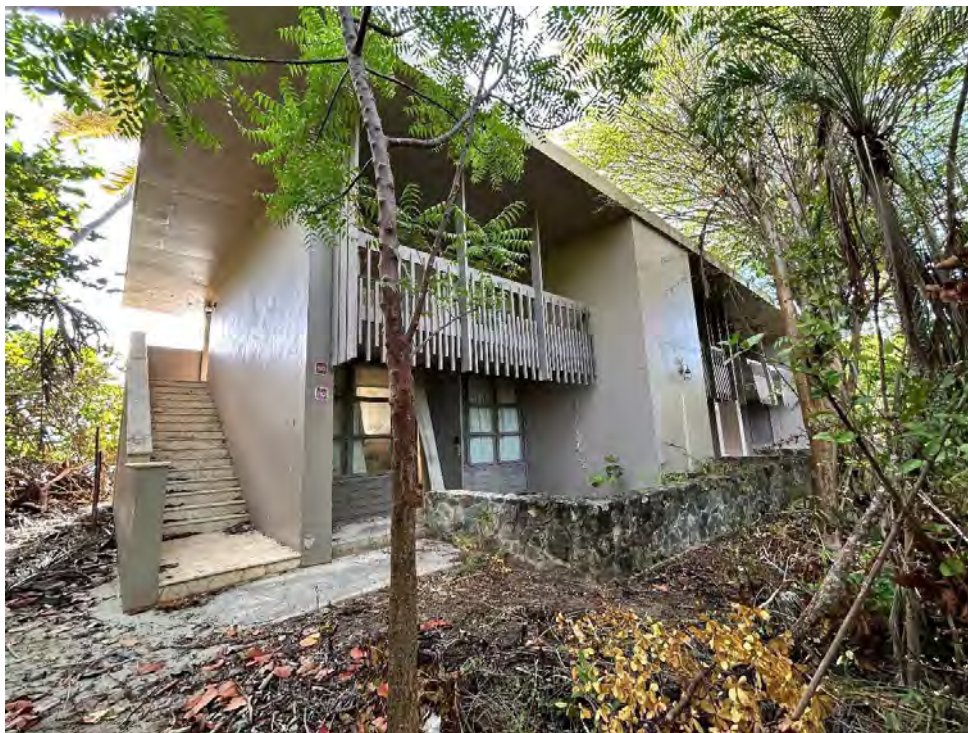
| Component | Material | Notes |
|---|---|---|
| Floor | Concrete | First floor has significant sand blown into the rooms. |
| Walls (Structural) | Concrete | Spalling on concrete columns with exposed rebar at east side between room 111 and the stairwell.<br>Vertical cracks at geometry changes typical east and west side of second floor rooms (122, 123, 124, 125).<br>Hairline crack in wall at second floor slab elevation between room 125 and stairwell wall.<br>Spalled concrete noted at base of all stairwells. |
| Walls (Non-Structural) | Wood and Windows | Windows blown out (112 east, 113 east, 123 east).<br>Walls collapsed (110 east). |
| 2nd Floor | Concrete | Spalling and exposed rebar at edge of concrete slab where railing attached (122 east, 123 east, 124 east).<br>Localized spalling at underside of slab throughout the building. At some locations rusted rebar is visible. |
| Roof | Concrete & Wood Framed / Membrane | Spalling on underside of slabs with exposed rebar in some locations.<br>Localized spalling at underside of slab throughout the building. At some locations rusted rebar is visible. |

| Component | Material | Notes |
|---|---|---|
| Stairs/Railings | Concrete / Wood Railings | Railing connections to slabs have failed, predominantly on beach side. Stair walls have vertical crack at geometry change. |

- Concrete walls and slabs, including underside of slabs, should be fully sounded to detect all areas of spalling and delamination.
- Remove existing railings and fully review edge of concrete slabs for damage.
- Repairs may consist of replacing damaged rebar with new rebar, cleaning and coating rebar with zinc rich paint, and repairing concrete.

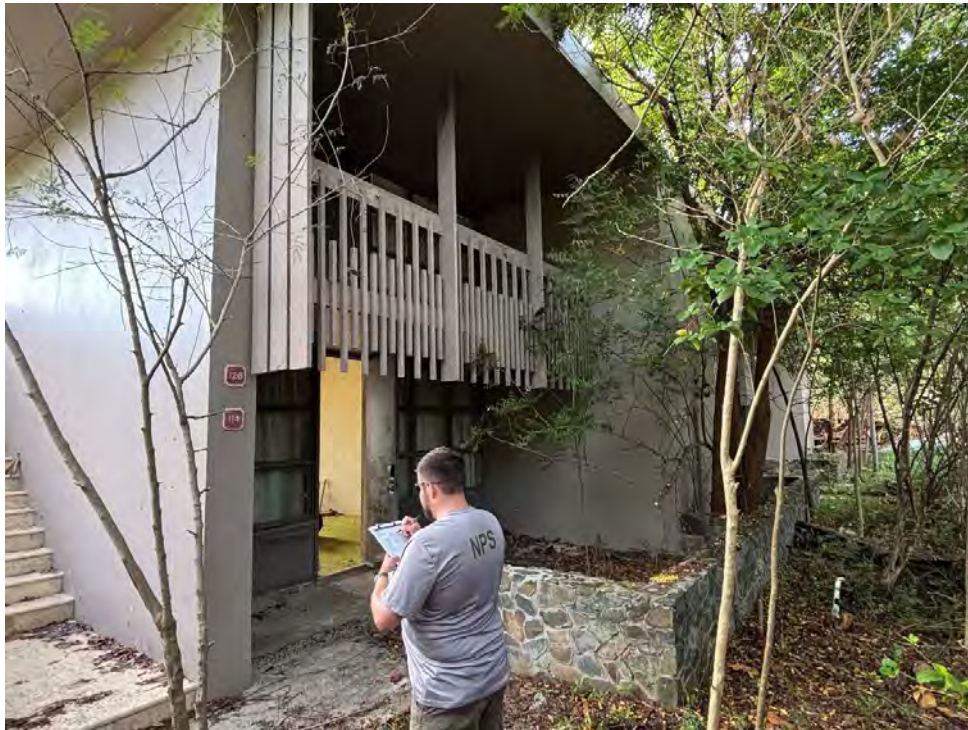
| Component | Material | Notes |
|---|---|---|
| Floor | Concrete | First floor has significant sand blown into the rooms. |
| Walls (Structural) | Concrete | Spalling on concrete columns with exposed rebar at east side between rooms 127 and 128.<br>Vertical cracks at geometry changes typical east and west side of concrete balconies. |
| Walls (Non-Structural) | Wood and Windows | Windows blown out (114 east, 126 east, 127 east, 128 east).<br>Walls collapsed (117 east). |
| 2nd Floor | Concrete | Spalling and exposed rebar at edge of concrete slab where railing attached (126 east, 127 east, 128 east, 129 east).<br>Localized spalling at underside of slab throughout the building. At some locations rusted rebar is visible. |
| Roof | Concrete & Wood Framed / Membrane | Spalling on underside of slabs with exposed rebar in some locations. Significant spalling at top of middle stairs to second floor, between units 127 and 128. |
| Stairs/Railings | Concrete / Wood Railings | Railing connections to slabs have failed. |

- Concrete walls and slabs, including underside of slabs, should be fully sounded to detect all areas of spalling and delamination.
- Remove existing railings and fully review edge of concrete slabs for damage.
- Repairs may consist of replacing damaged rebar with new rebar, cleaning and coating rebar with zinc rich paint, and repairing concrete.

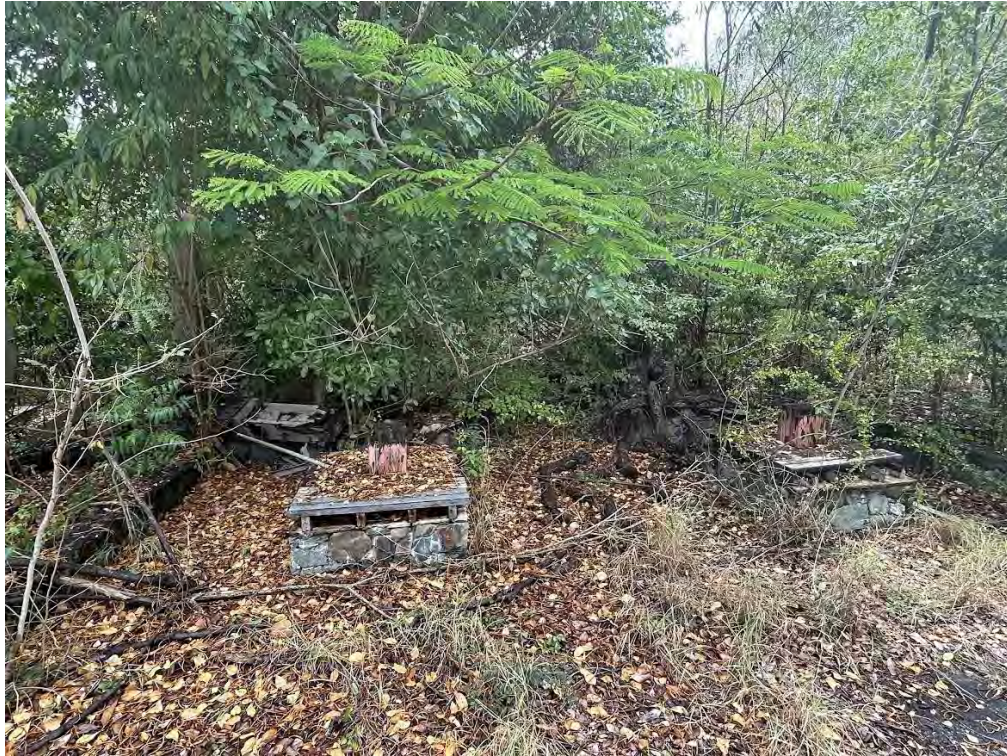
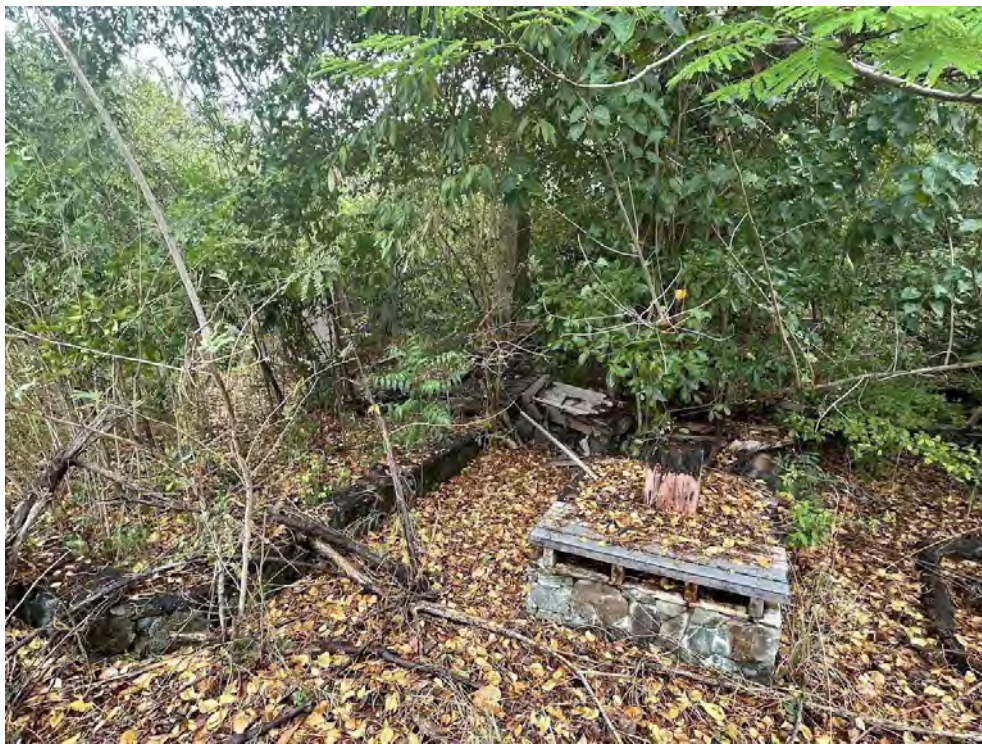
| Component | Material | Notes |
|---|---|---|
| Roof | Wood framed /<br>Wood shingles | Roof collapsed. |

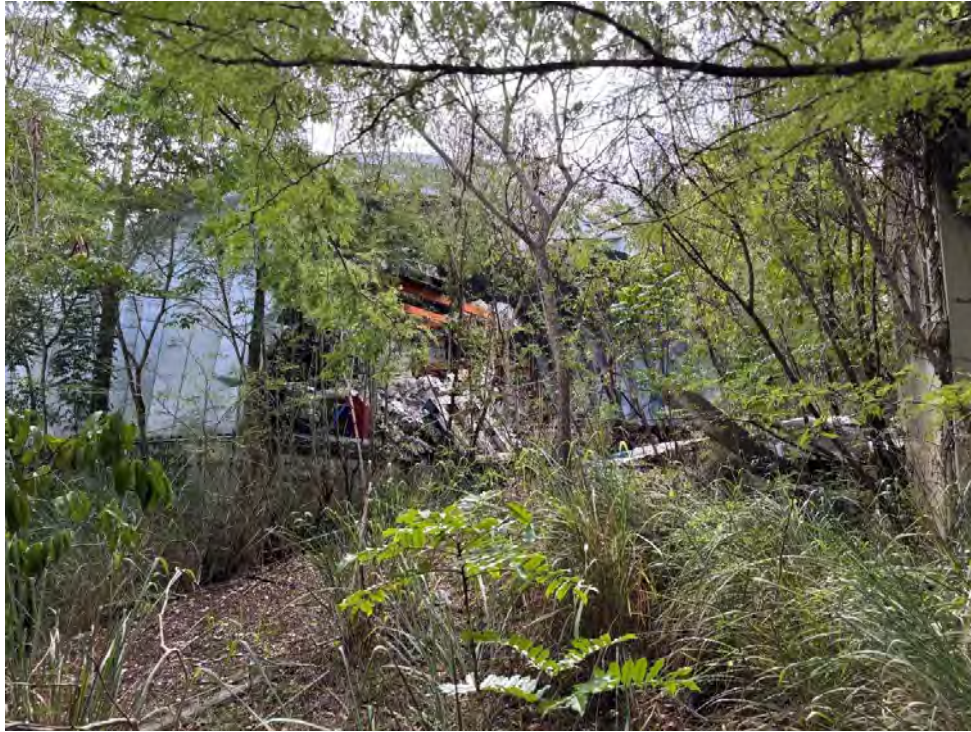
| Component | Material | Notes |
|---|---|---|
| Walls (Structural) | Corrugated Galvanized Steel | Structure is arched, semi-circular structure forming walls and roof structure.<br>End wall has completely collapsed. On the entrance side and end wall side, portions of the arch have collapsed. The remaining portion of the structure shows signs of buckled flutes and holes. |
