**National Park Service**  
Virgin Islands National Park | Caneel Bay  
Structural Assessment Report

**Building: Turtle Bay Bus Stop (Adjacent to Units 87-98)**

**Structural Assessment: Structurally Sound**

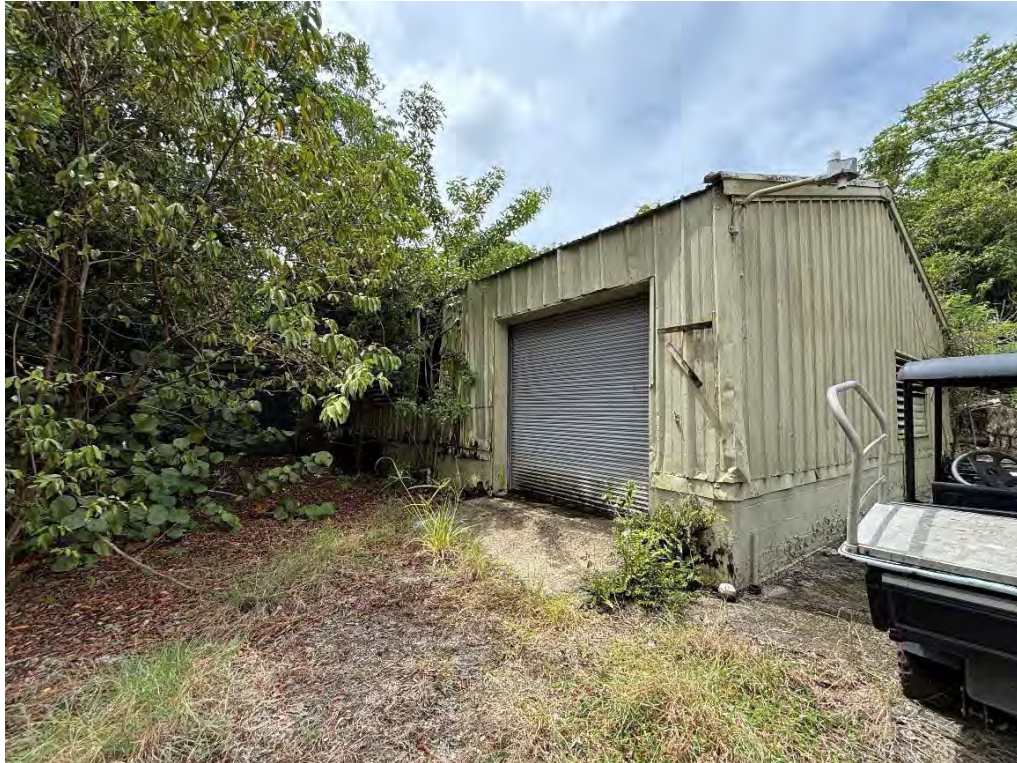
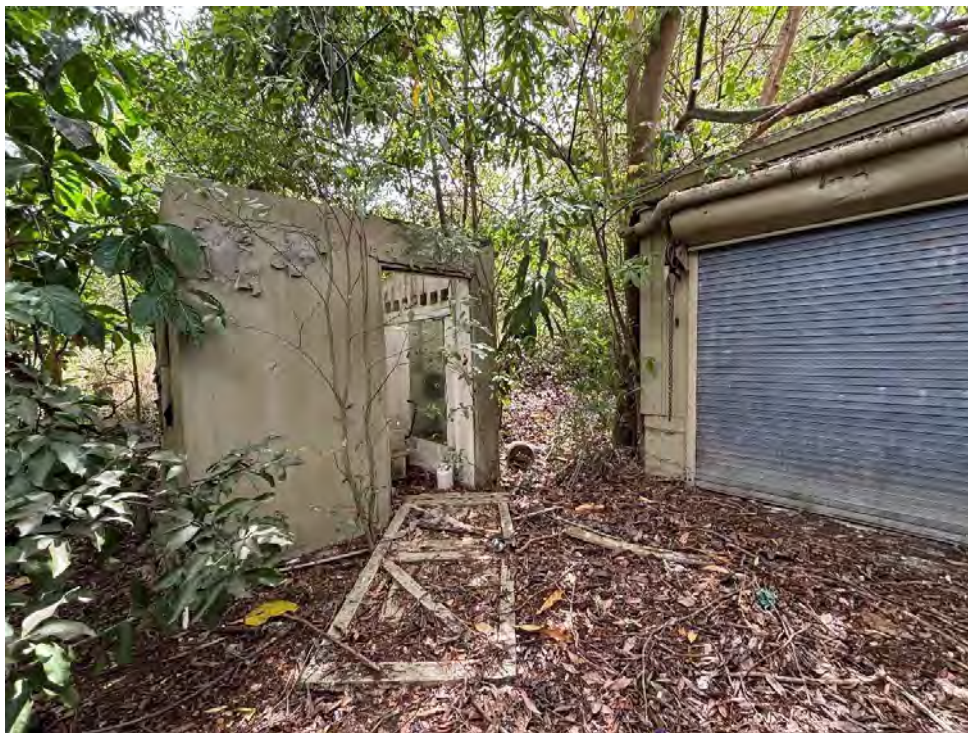
| Component | Material | Notes |
|---|---|---|
| Walls (Structural) | Steel | Corroded bracing and metal framing members. |
| Roof | Steel Framed / Metal Roof | Vegetation on roof. |
| Stand Alone Bathroom | Concrete | No roof. |

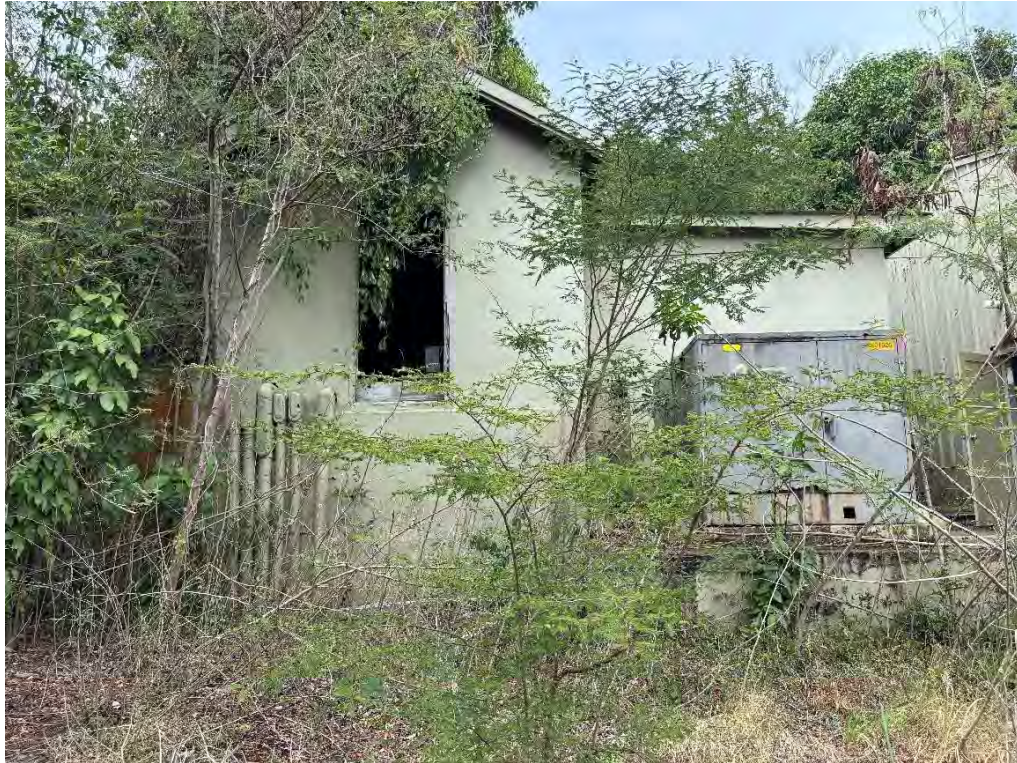
| Component | Material | Notes |
|---|---|---|
| Walls (Structural) | Concrete | No cracks were noted from the outside. |
| Roof | Wood Framed /<br>Metal Roof | Vegetation on roof.<br>Unable to gain access to inspect roof from<br>the interior. |
