**Building: 13B Generator Building**

**Structural Assessment: Potentially**

**Repair or Rebuild**

**National Park Service**  
Virgin Islands National Park | Caneel Bay  
Structural Assessment Report

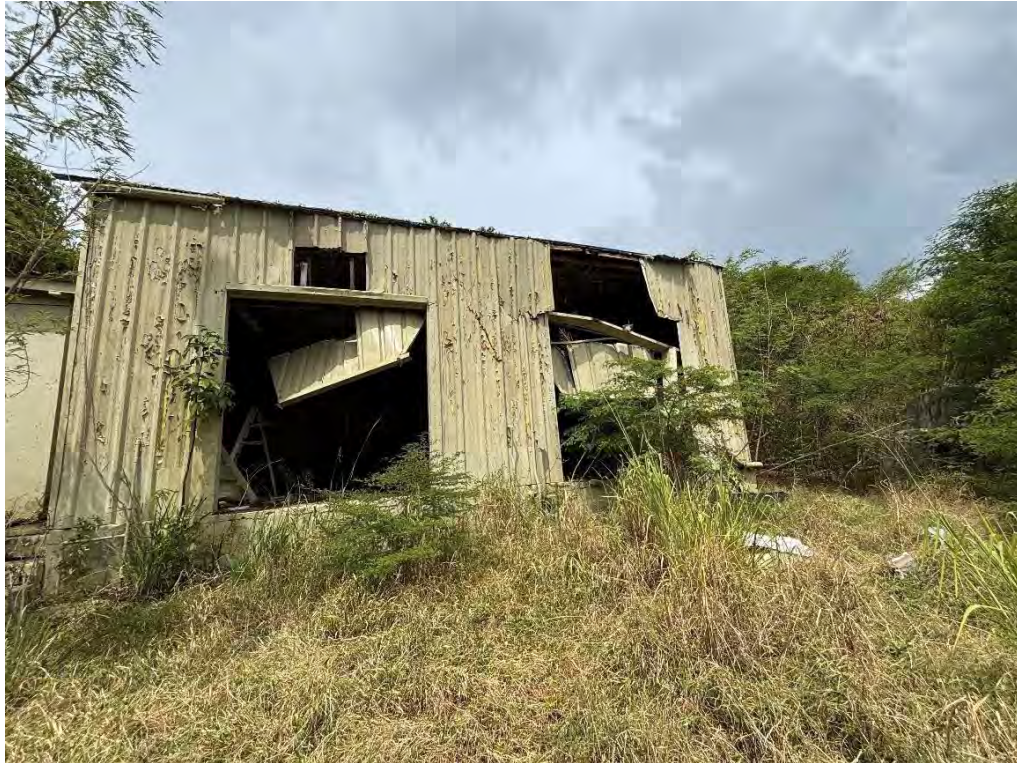
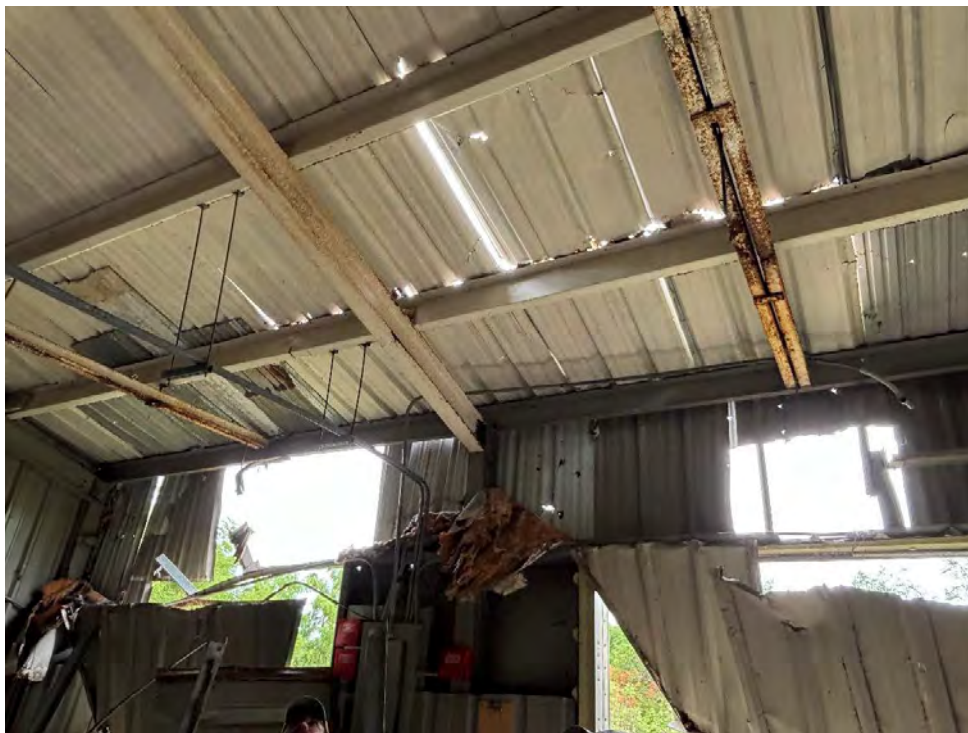
| Component | Material | Notes |
|---|---|---|
| Walls (Structural) | Steel | Two bay, steel framed structural building. Severe corrosion of structural members (noticeable section loss) and base plates, especially at building columns. |
| Roof | Steel Framed / Metal Roof | Main roof members appeared in acceptable condition. Secondary steel members showed signs of localized corrosion. |

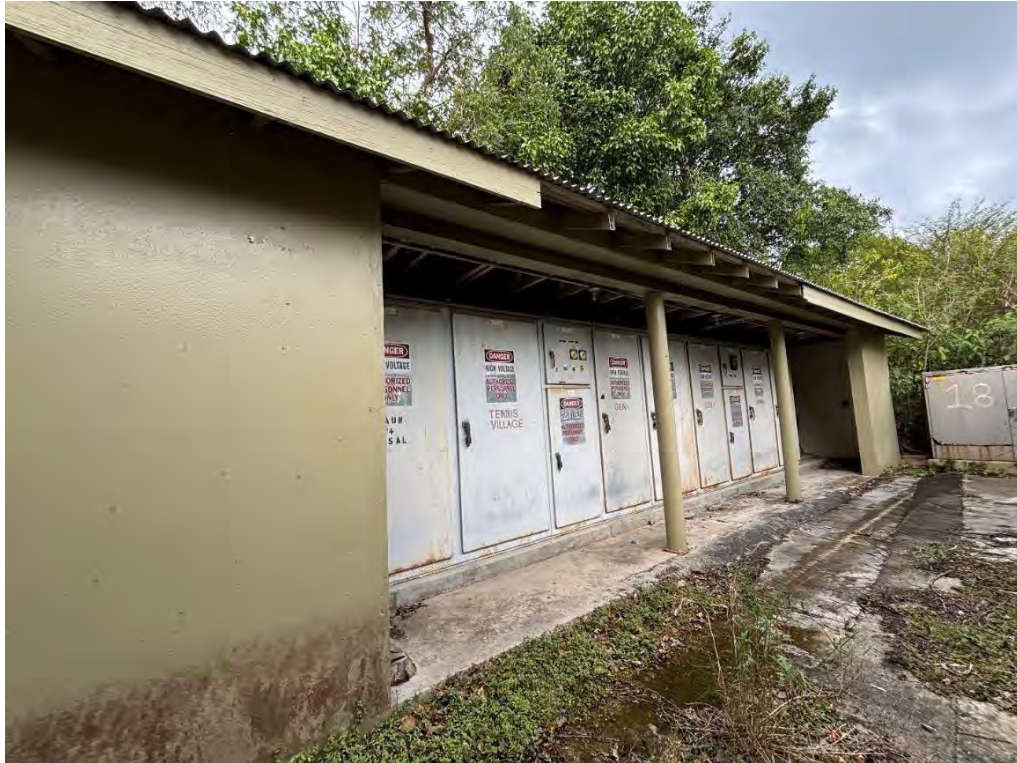
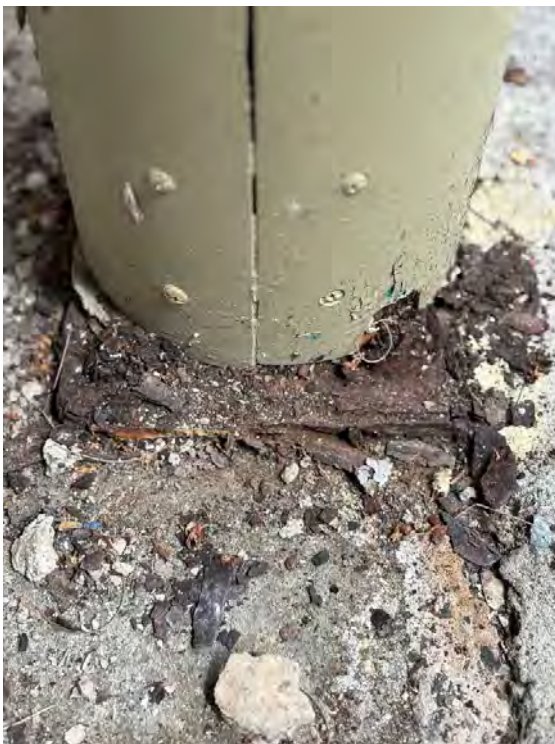
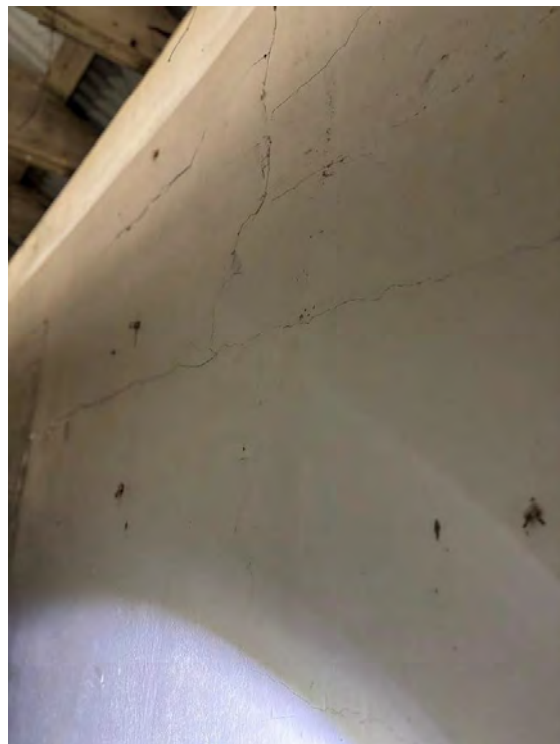
**Building: 13C Electrical Distribution**

| Component | Material | Notes |
|---|---|---|
| Walls (Structural) | Concrete on 3 Sides / Steel Columns and Beams 1 Side | Base of steel columns corroded. Minor concrete cracking on rear wall. |
| Roof | Wood Framed / Metal Roof | End of one wood truss deteriorated. |

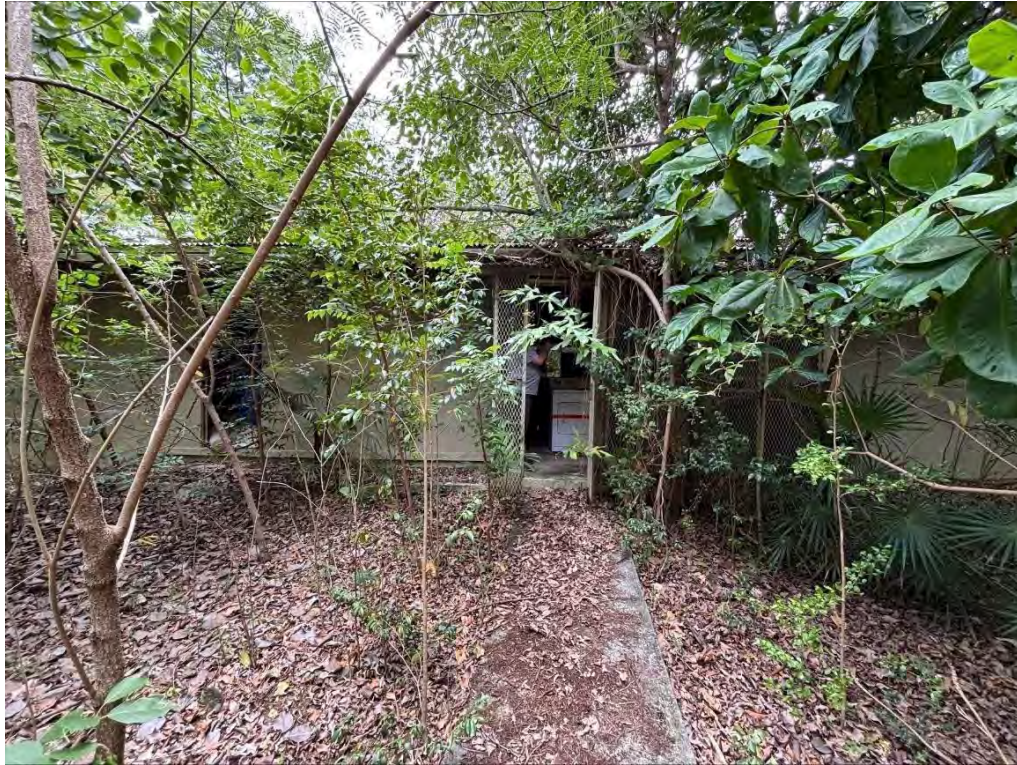
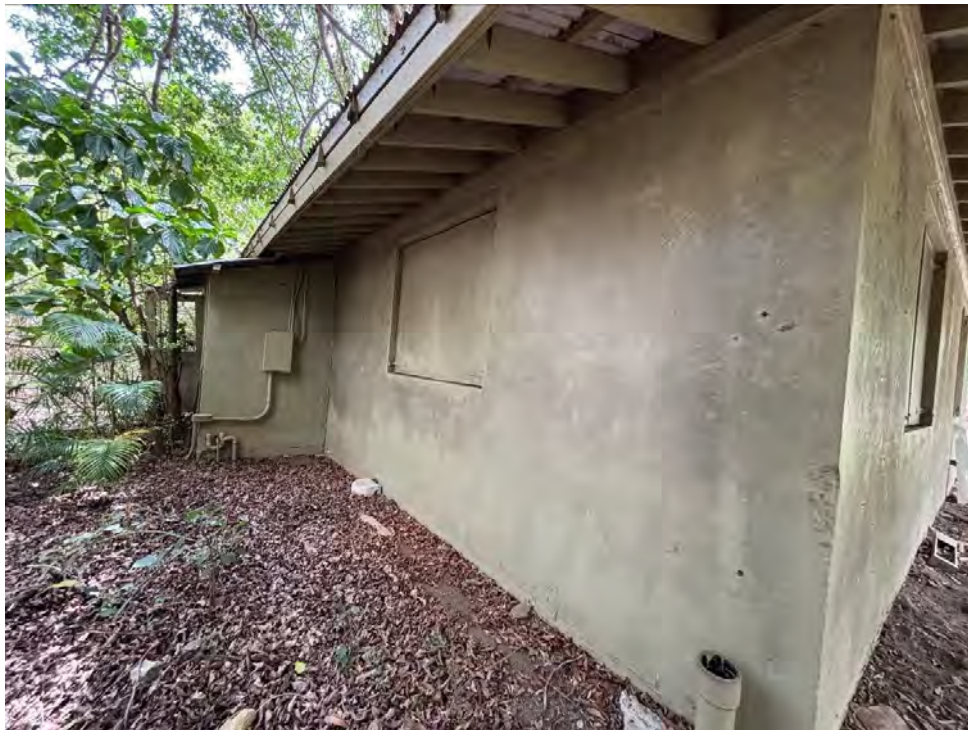
**Building: 15 Uniform and Room Service**

| Component | Material | Notes |
|---|---|---|
| Walls (Structural) | Concrete | Minor concrete cracking above windows on north side. |

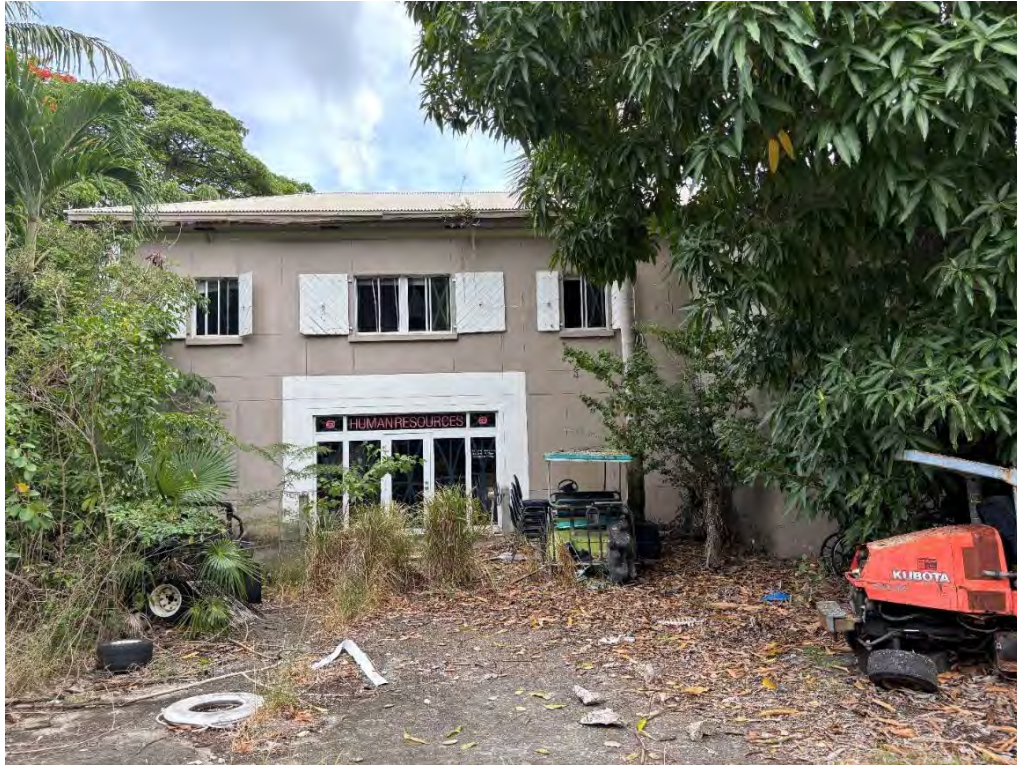
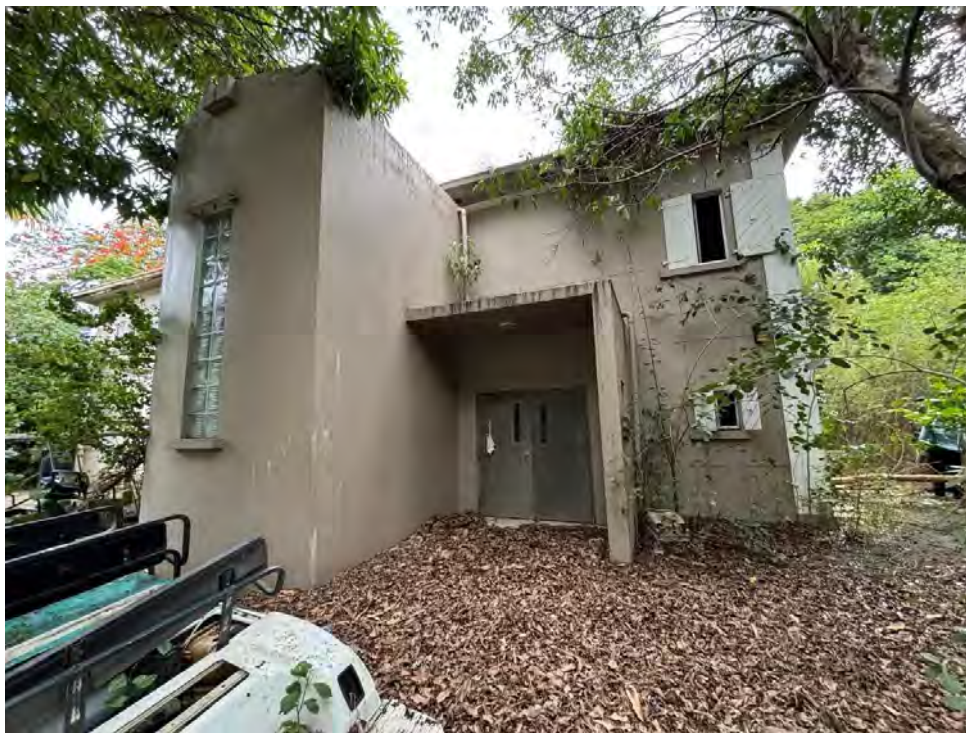
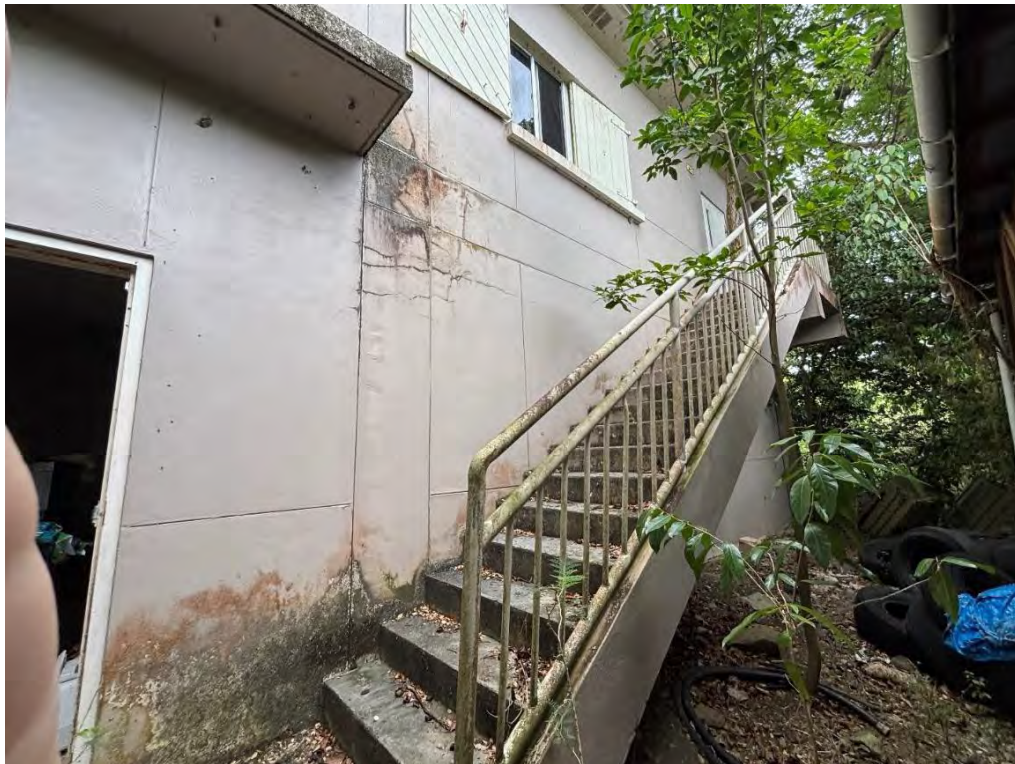
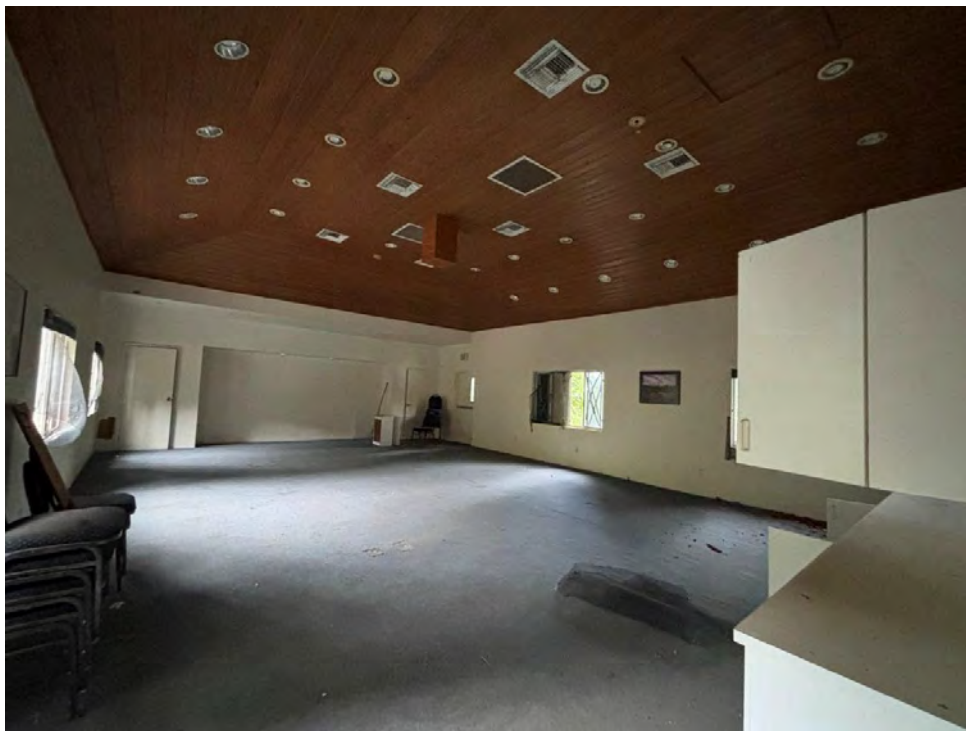
**Building: 16 Housekeeping Building (Human Resources 2)**

| Component | Material | Notes |
|---|---|---|
| Walls (Structural) | Concrete | Minor concrete cracking. |
| Walls (Non-Structural) | Concrete | Minor termite tubes observed. |
| Roof | Unknown w/<br>Metal Deck | Roof is sloped. Unable to verify construction.<br>Vegetation on roof.<br>Low concrete roof over exterior entrance has standing water. |

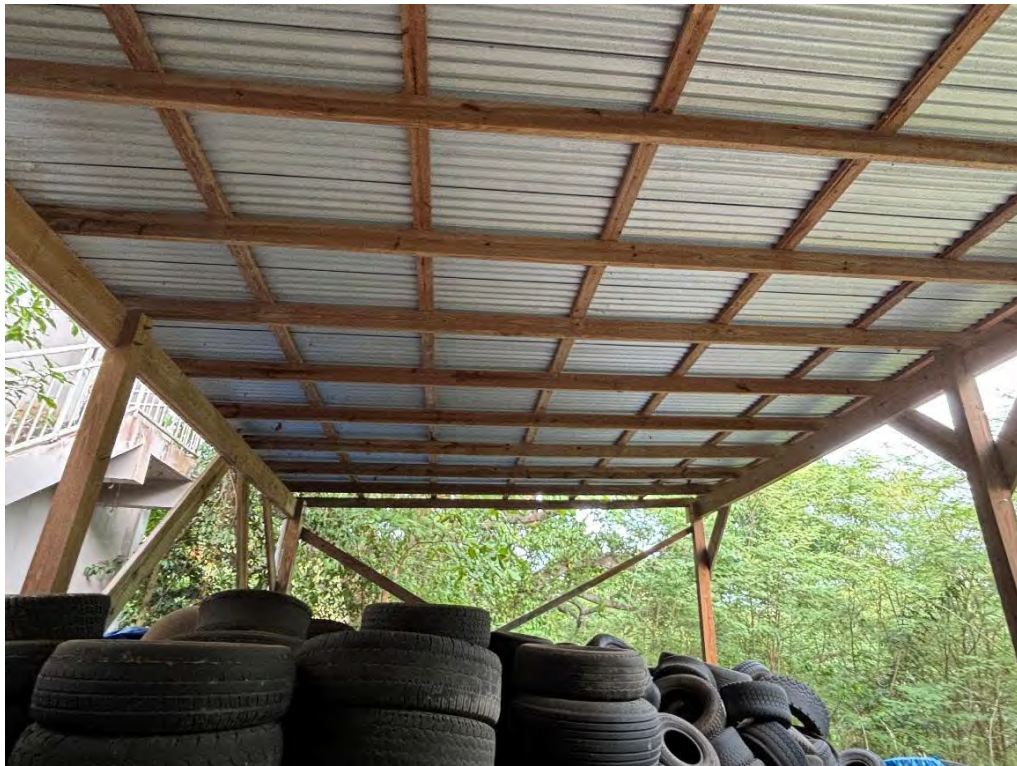
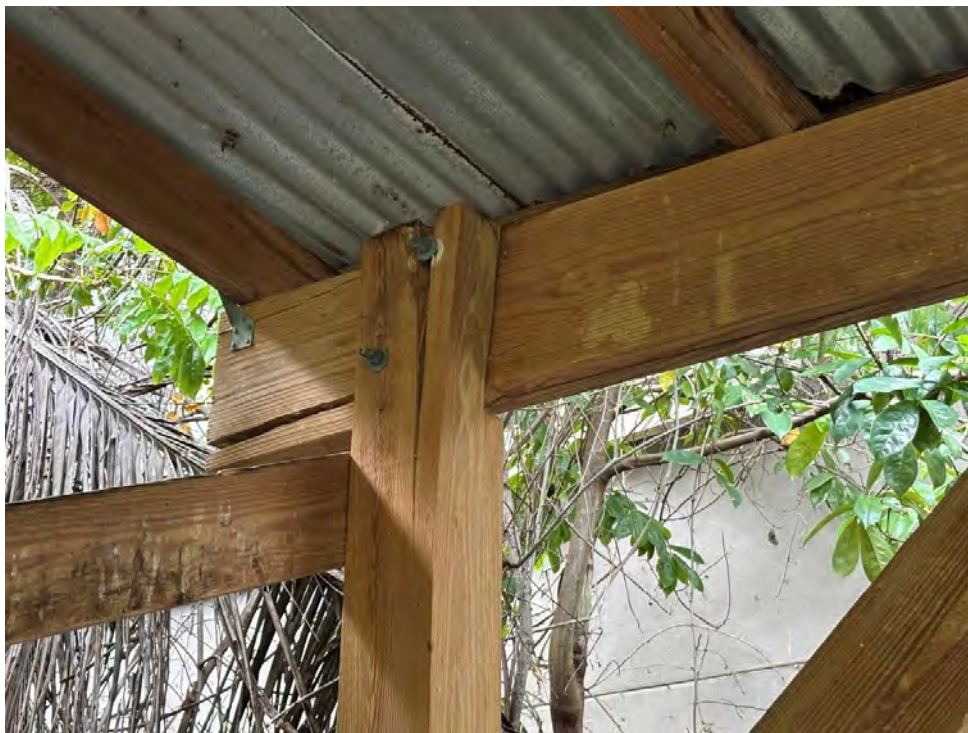
**Building: Housekeeping HR2 Pole Barn**

| Component | Material | Notes |
|---|---|---|
| Framing | Wood | Wood framed pole barn.<br>Bolted connections at top of 4 of the 6 posts failed. Top bolt split the post and bottom bolt split the rafter tail. |

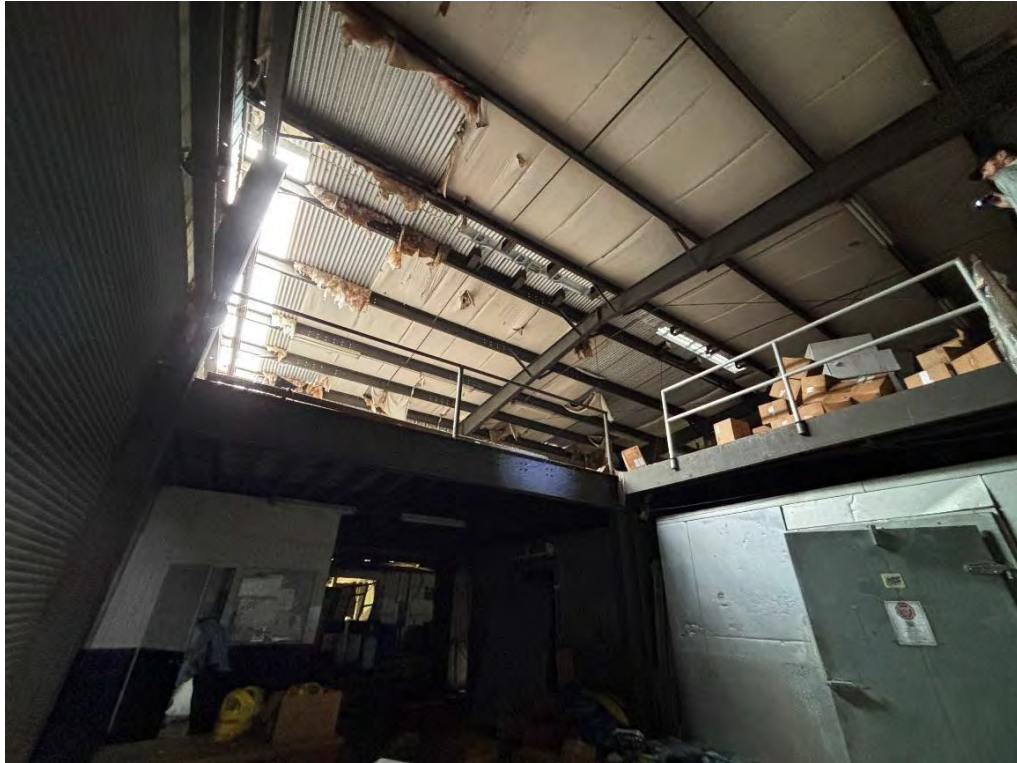
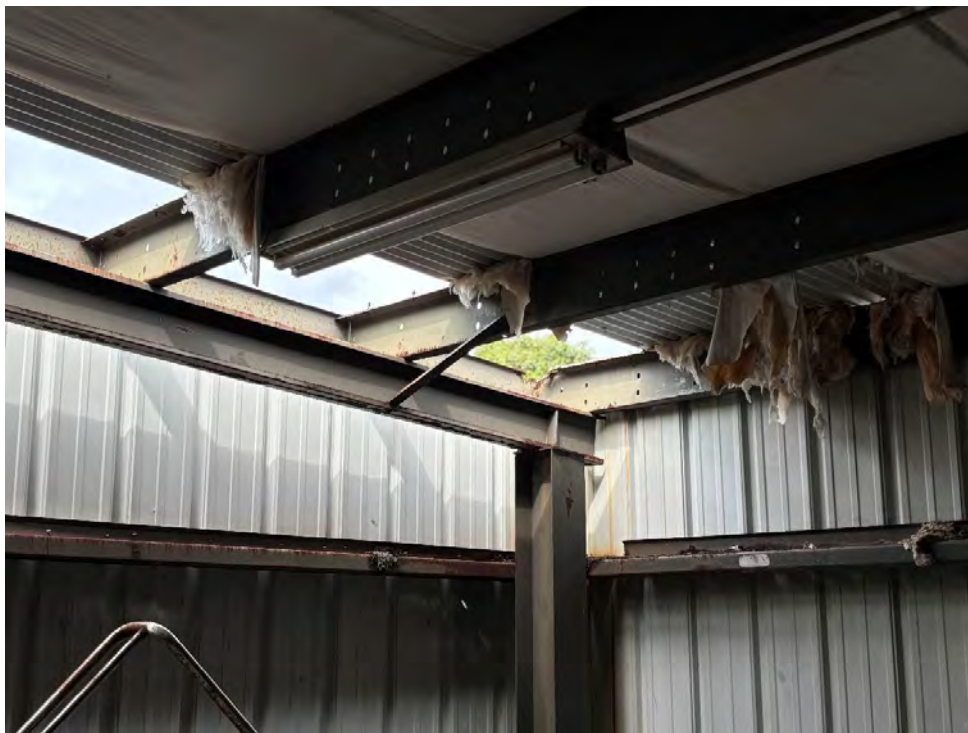
**Building: 17E Central Storage**

| Component | Material | Notes |
|---|---|---|
| Structure | Steel Framed | Minor exterior cladding missing. |
| Roof | Steel Framed /<br>Metal Deck | Minor roof deck missing exposing steel<br>frame to elements.<br>Exterior tie-rod at overhang damaged. |

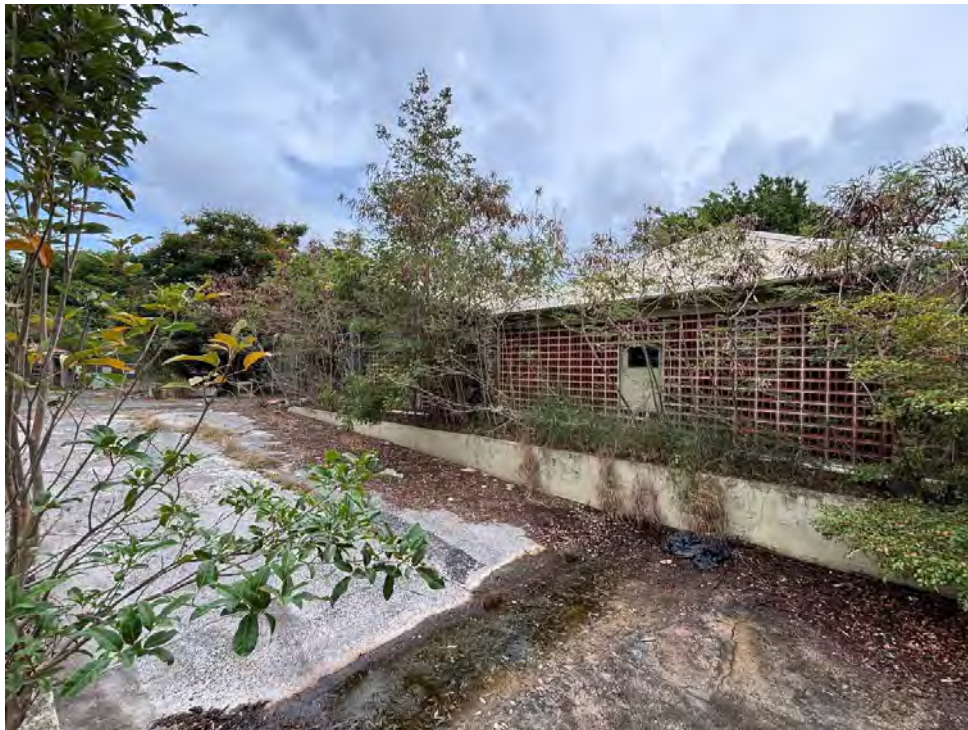
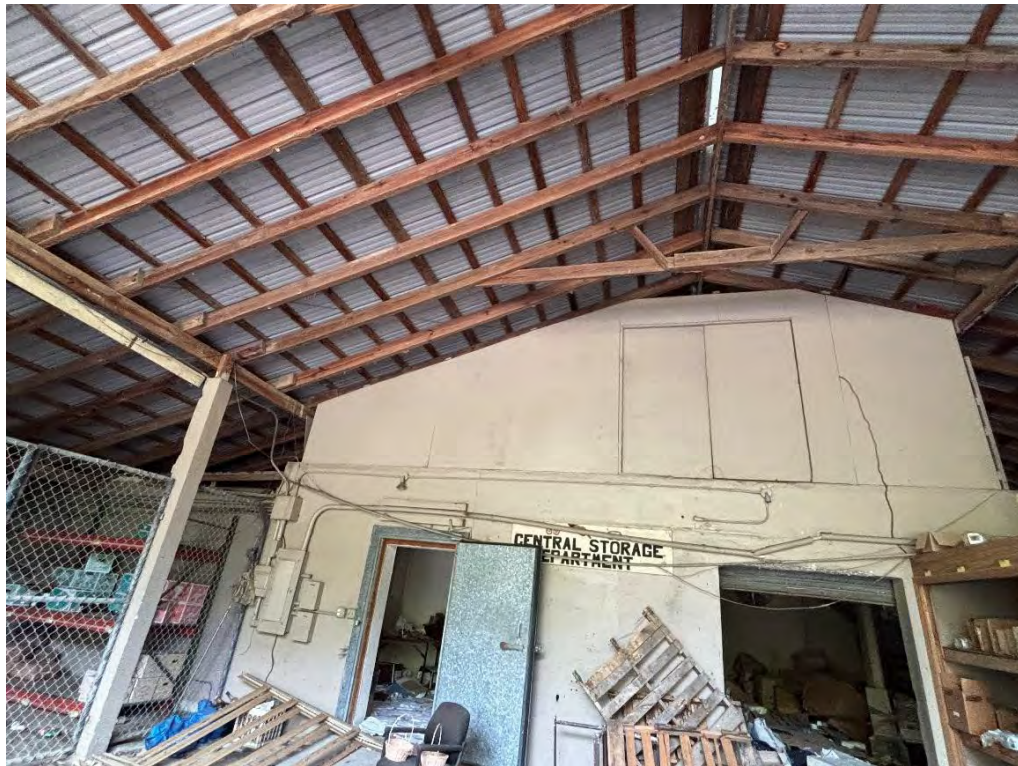
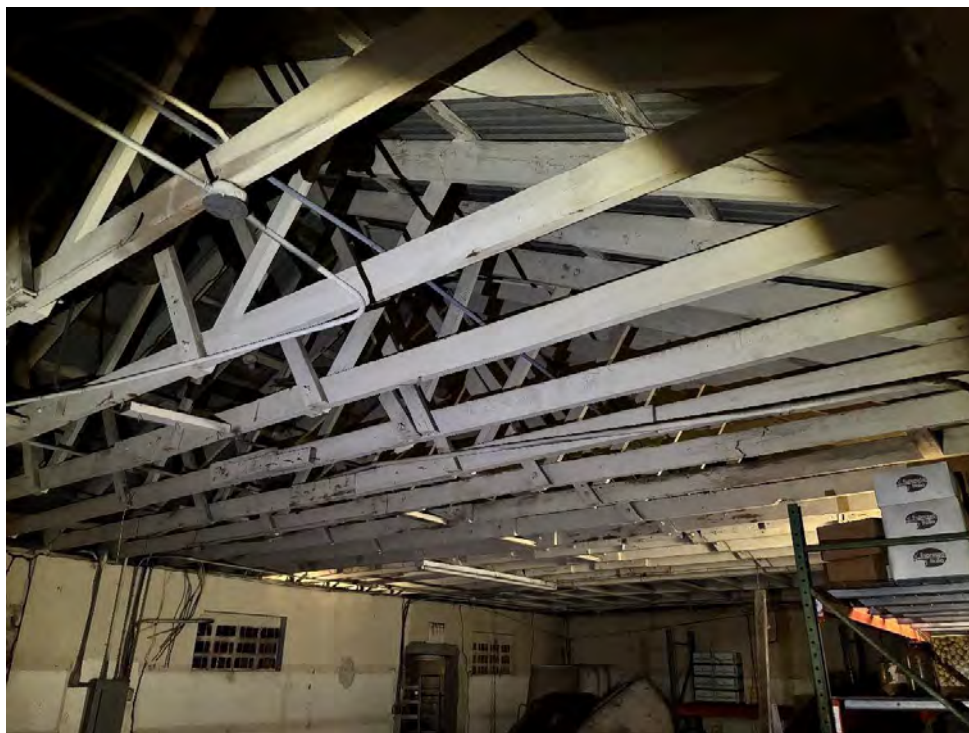
**Building: 17W Central Storage**

| Component | Material | Notes |
|---|---|---|
| Walls (Structural) | Stone / Interior Concrete Columns with Wood Posts | Impact damage to concrete column base with exposed, rusted rebar. |
| Roof | Wood / Metal Deck | Isolated wood beam and truss member failures.<br>Significant termite activity.<br>Some displaced cladding allowing moisture intrusion. |
| Stairs/Railings | Wood | Support posts appear to have shifted. |

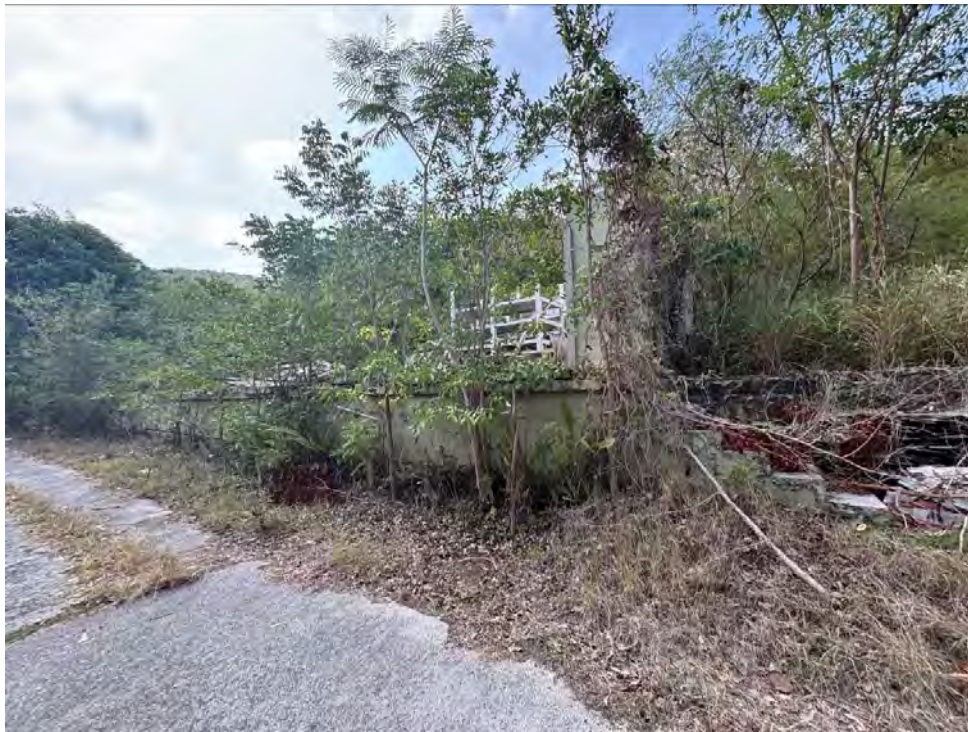
**Building: 77 Gift Shop Warehouse**

| Component | Material | Notes |
|---|---|---|
| Walls (Structural) | Wood Framed | Building collapsed, walls not standing. |
| Roof | Unknown | Roof collapsed. |

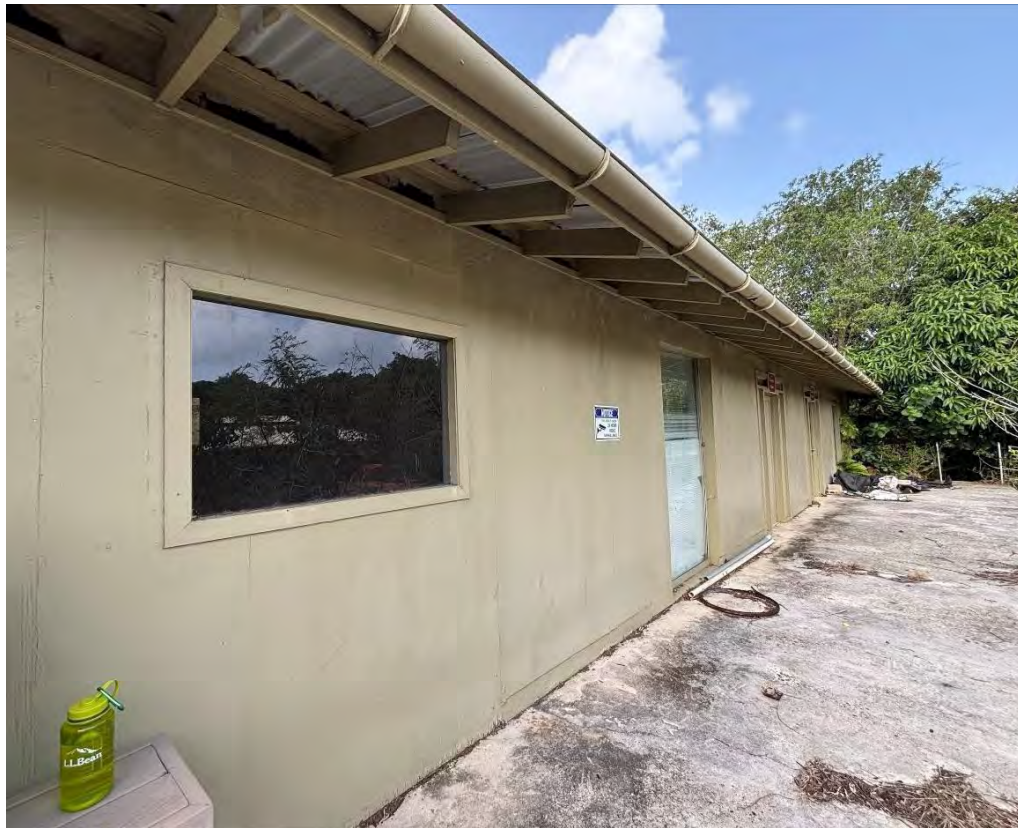
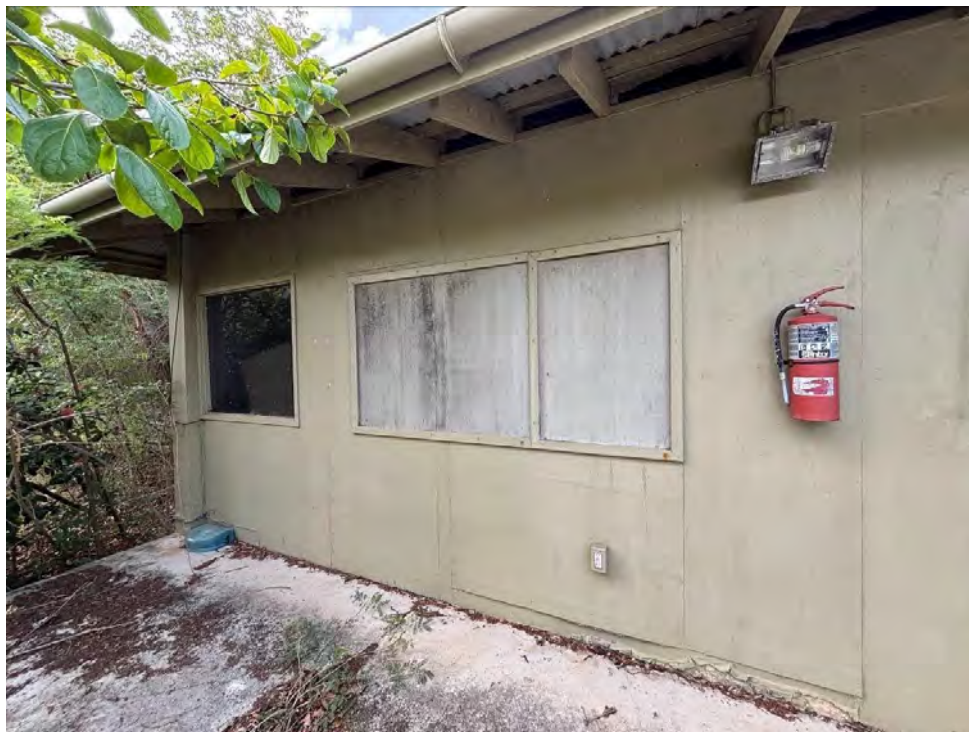
**Building: 78 Facilities Office**

| Component | Material | Notes |
|---|---|---|
| Walls (Structural) | Wood | Rotted sill plate noted in select locations. |

- Potential mold in building.

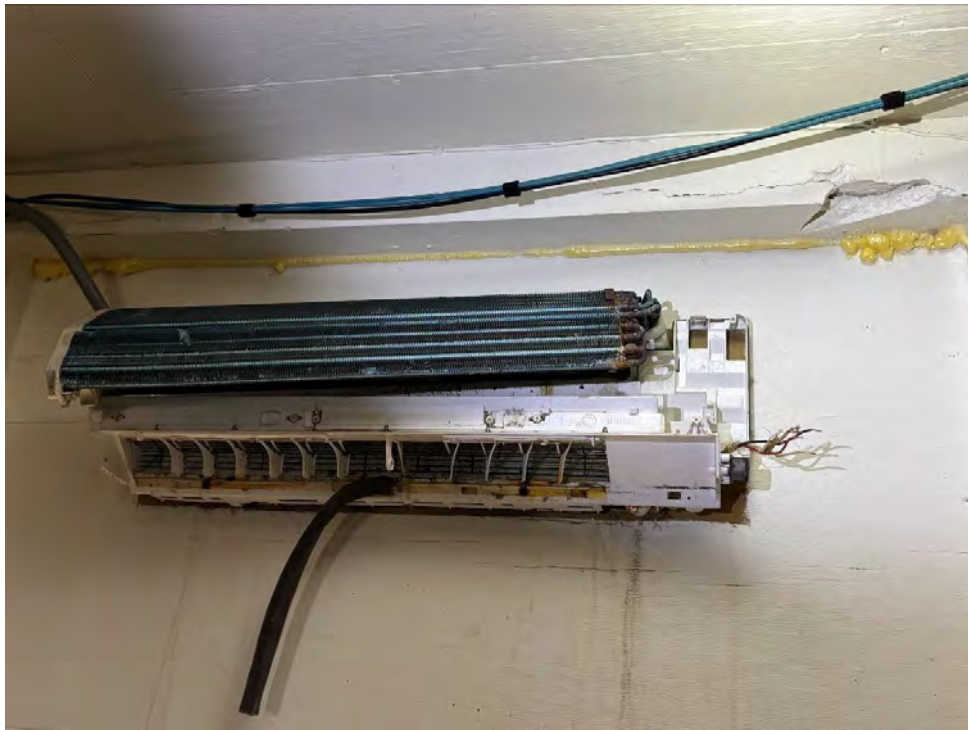
**Building: 79 Engineering Warehouse**

| Component | Material | Notes |
|---|---|---|
| Walls (Structural) | Concrete | Horizontal crack in lintel.<br>Cracks at joint between dive storage addition and main building.<br>Failed walls at small shed addition to west of dive storage room. |
| Roof | Wood Framed / Metal Deck | Roof collapsed at small shed addition to west of dive storage room. |

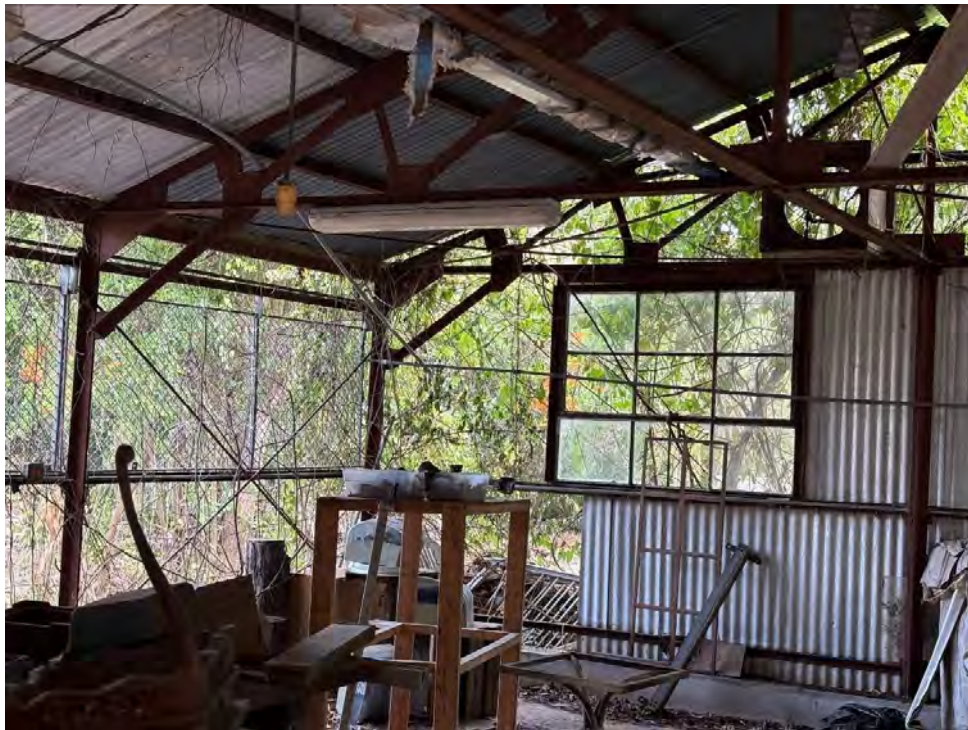
**Building: 80 Carpenter Shop**

| Component | Material | Notes |
|---|---|---|
| Walls (Structural) | Steel | Rusted base plates, rust jacking between steel framing members. |
| Walls (Non-Structural) | Metal Cladding | Missing non-structural cladding. Section loss from rust in some horizontal bracing elements. |
| Roof | Metal Framed/<br>Metal Roof | Missing metal roof cladding. |

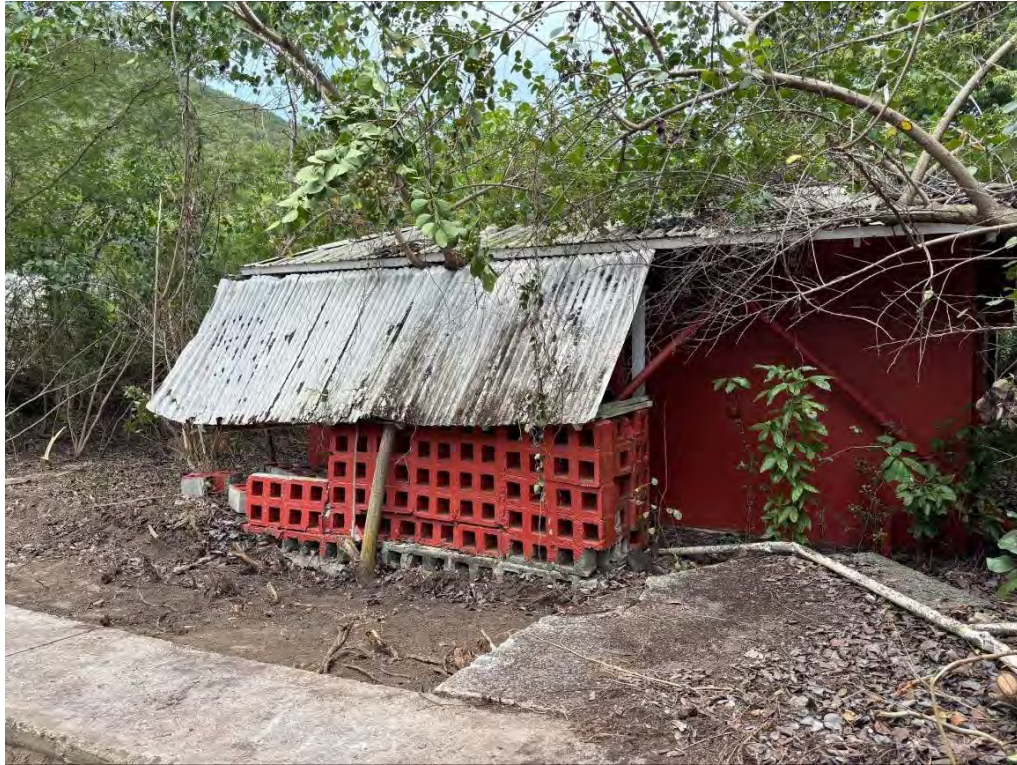
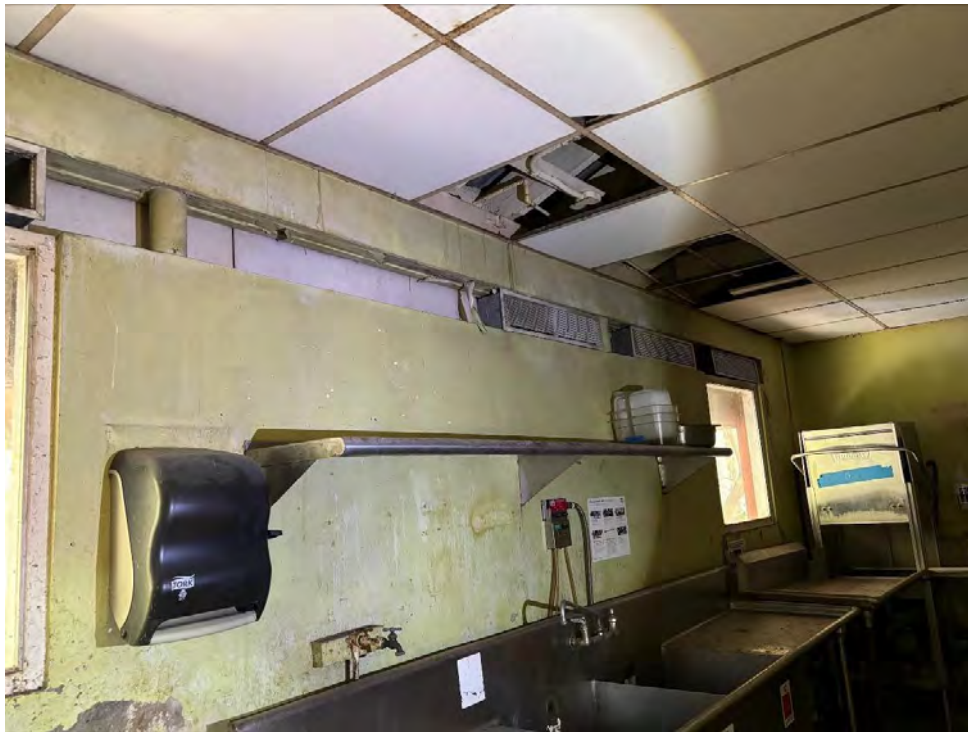
**Building: 81 Staff Dining Facility**

| Component | Material | Notes |
|---|---|---|
| Walls (Structural) | Masonry (CMU) on south, steel columns on north | Steel columns severely corroded and failed. |

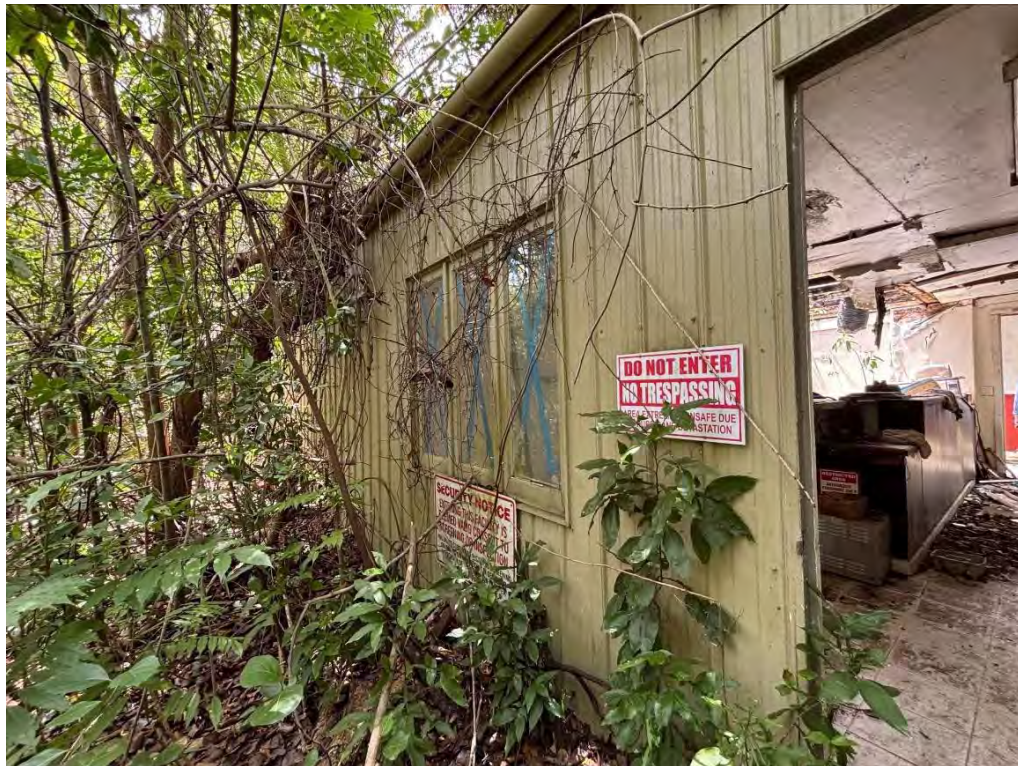
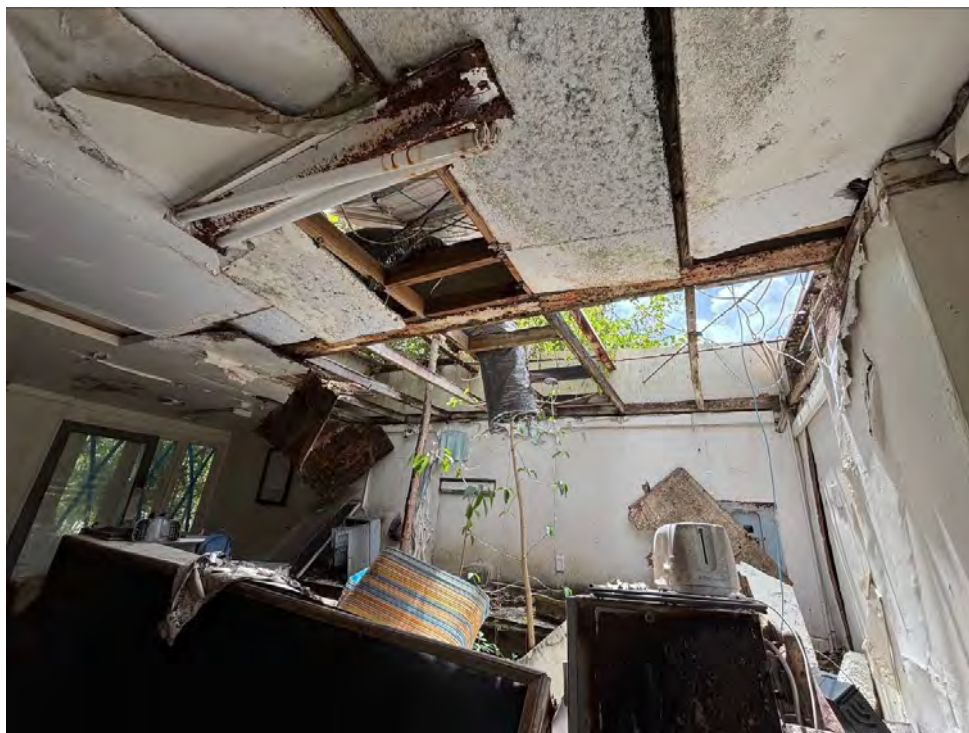
**Building: 82 Security Office**

| Component | Material | Notes |
|---|---|---|
| Walls (Structural) | Steel | Major section loss in structural steel. |
| Roof | Metal Framed/<br>Metal Roof | Failed/collapsed. |

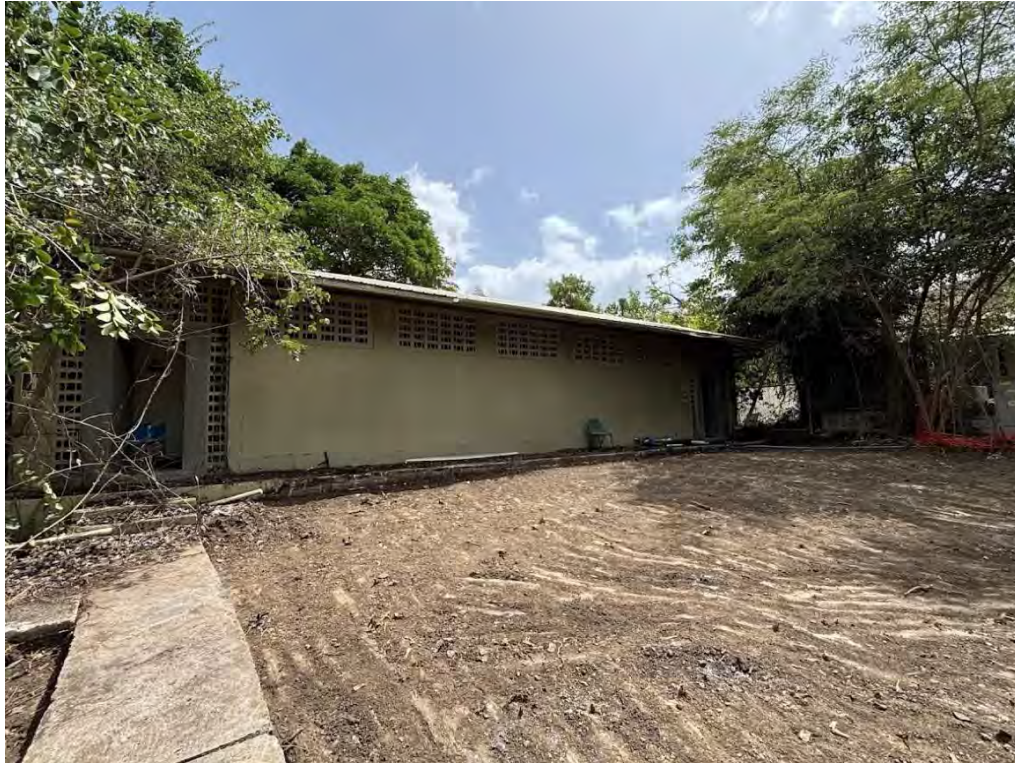
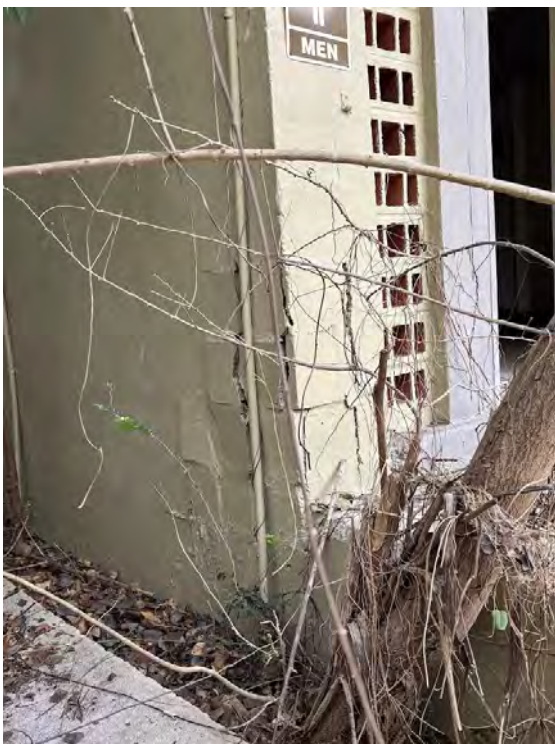
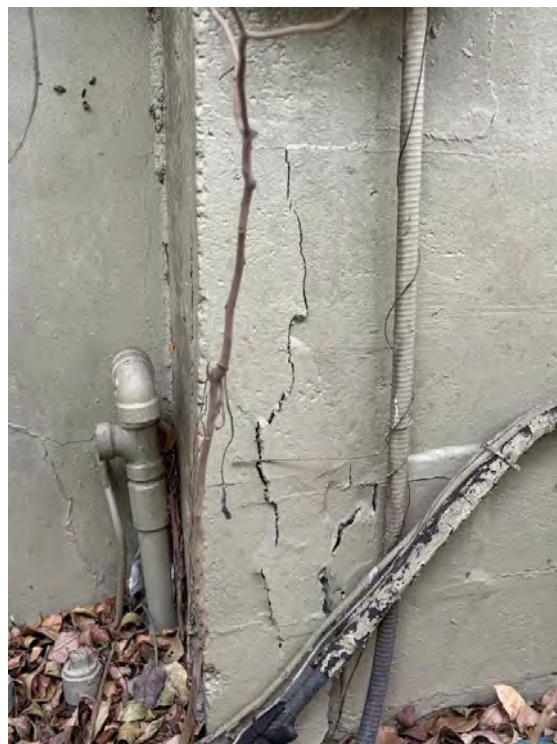
**Building: 83 Staff Locker Rooms**

| Component | Material | Notes |
|---|---|---|
| Walls (Structural) | Masonry (CMU) | CMU cracking due to potential differential settlement. |
