**Building: 13B Generator Building**

**Structural Assessment: Potentially**

**Repair or Rebuild**

**National Park Service**  
Virgin Islands National Park | Caneel Bay  
Structural Assessment Report

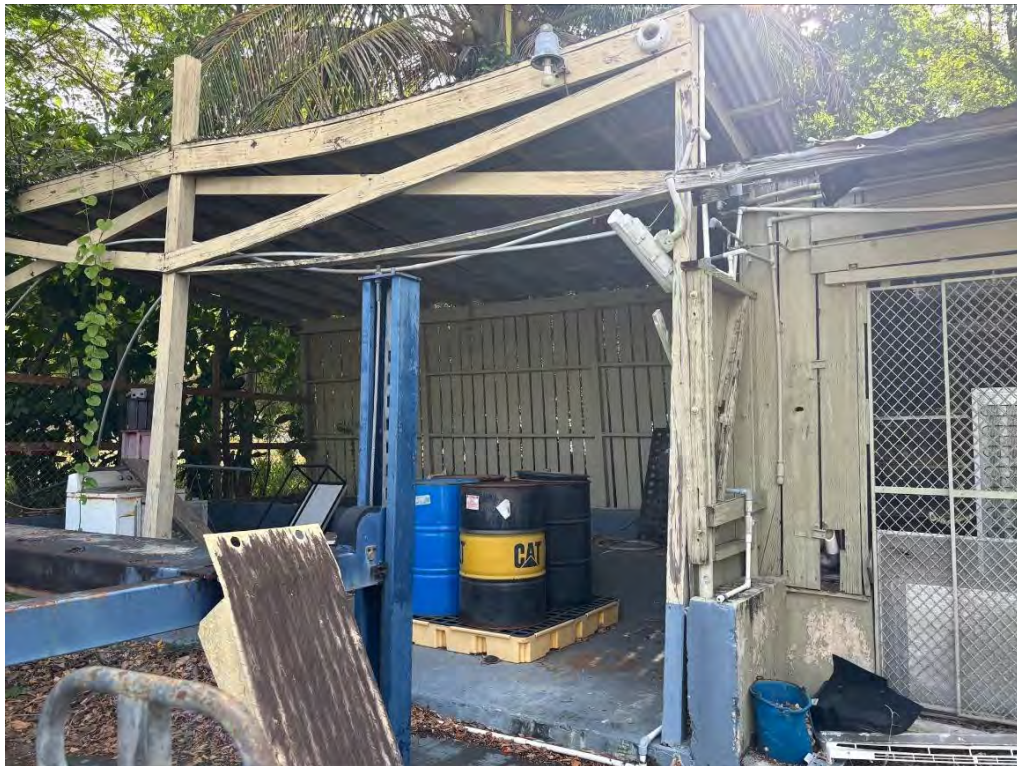
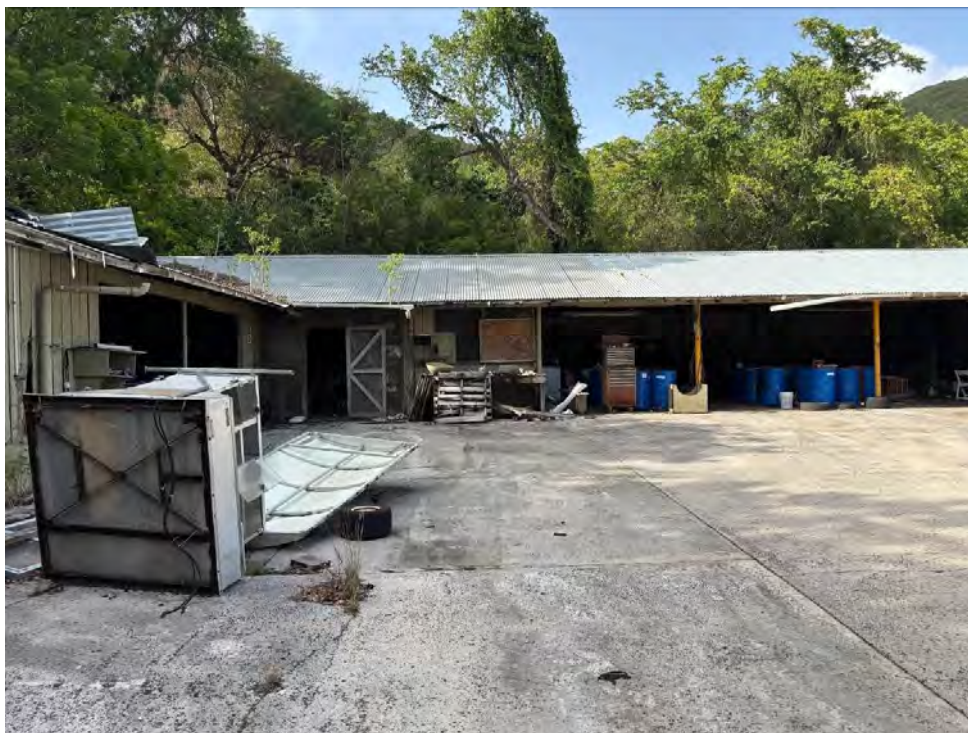
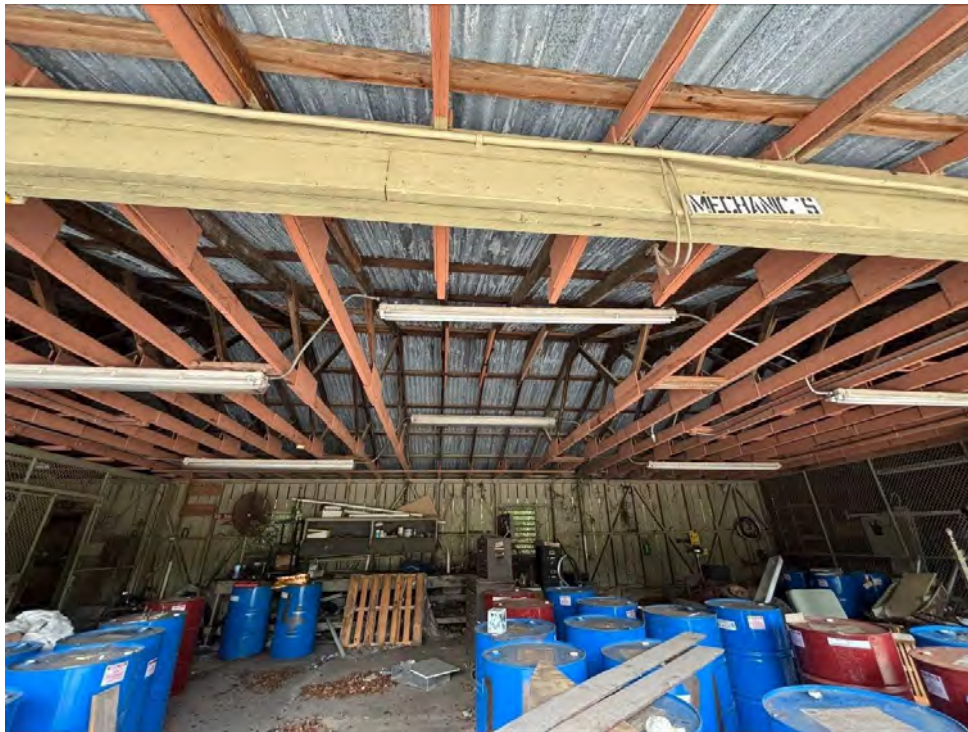
**Building: 84 Motor Pool**

| Component | Material | Notes |
|---|---|---|
| Walls (Structural) | Wood | Deteriorated rafter tails, deteriorated sill plates, trusses cut in south wing, truss end bearing deteriorated in 2 locations, portion of east wall inadequately framed. |

- Note the east wall between the north and south wings of the building where the wall framing was previously removed was reframed improperly. Current framing does not provide adequate support for the rafters.

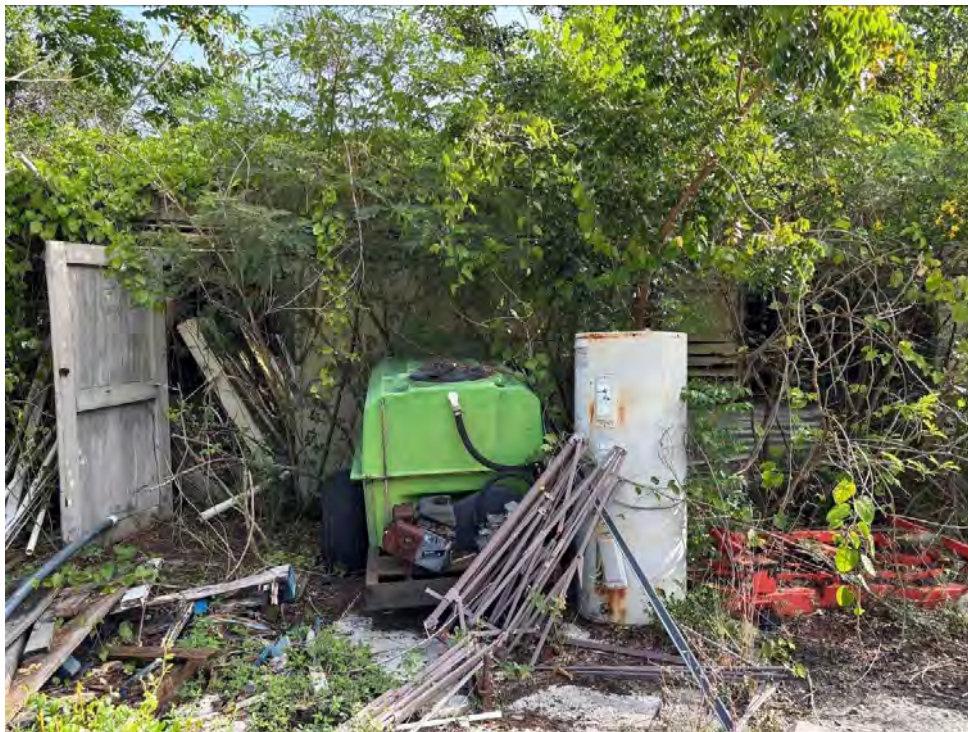
**Building: 85 Engineering Storage**

| Component | Material | Notes |
|---|---|---|
| Walls (Structural) | Steel | Appears to have rust on structural elements, unable to fully verify due to vegetation and materiel preventing access. |
| Walls (Non-Structural) | Metal Cladding | Missing non-structural cladding. Section loss from rust in some horizontal bracing elements. |
| Roof | Metal Framed/<br>Metal Roof | Roof finishes severely damaged/missing.<br><br>Building is exposed to elements due to failed roof. This may lead to increased deterioration of steel. |

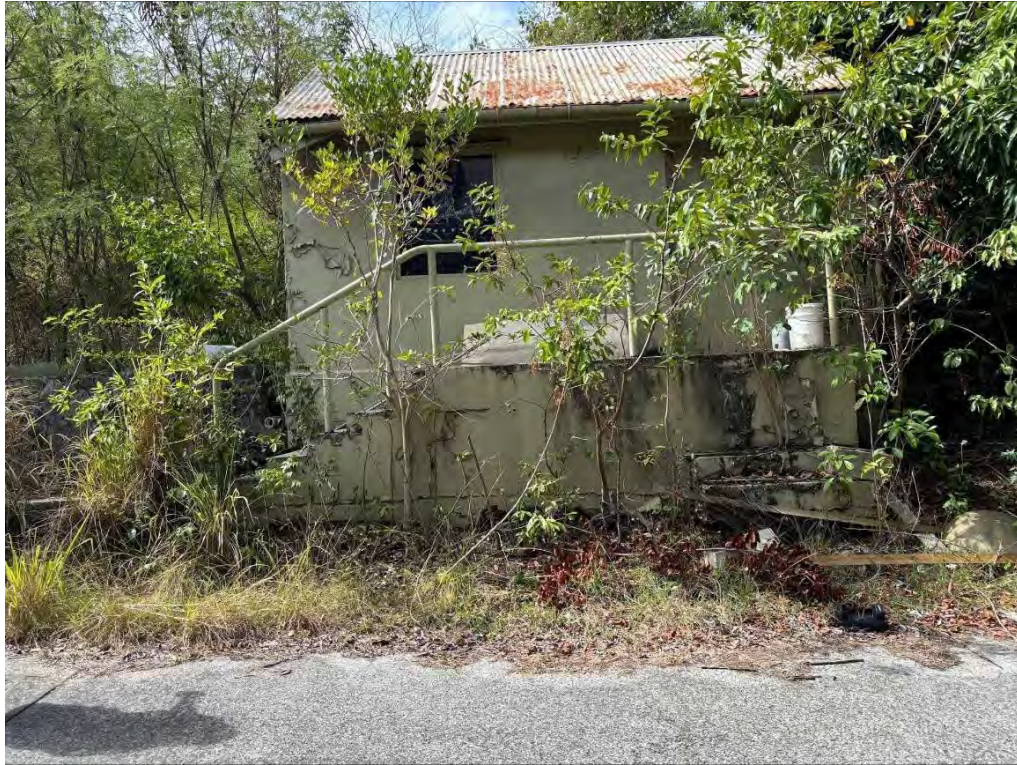
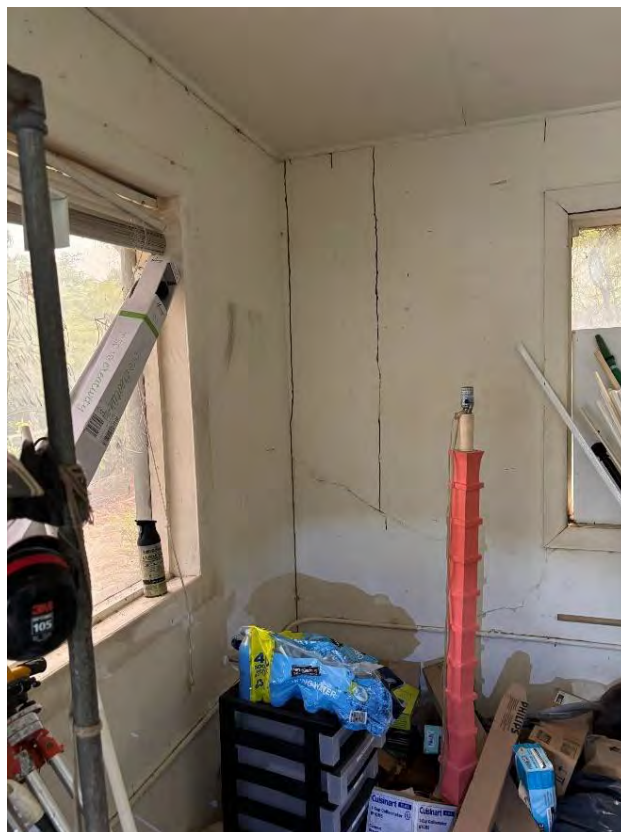
**Building: 86 Employee Lounge**

| Component | Material | Notes |
|---|---|---|
| Walls (Structural) | Concrete /<br>wood framed<br>addition | Small horizontal crack between windows on<br>north and east wall. |
| Roof | Wood framed /<br>metal deck | Adjacent Quonset hut wall fell on addition<br>roof. |

- Unable to access the rear shed addition to evaluate for roof damage. Further investigation required to determine condition of the roof.

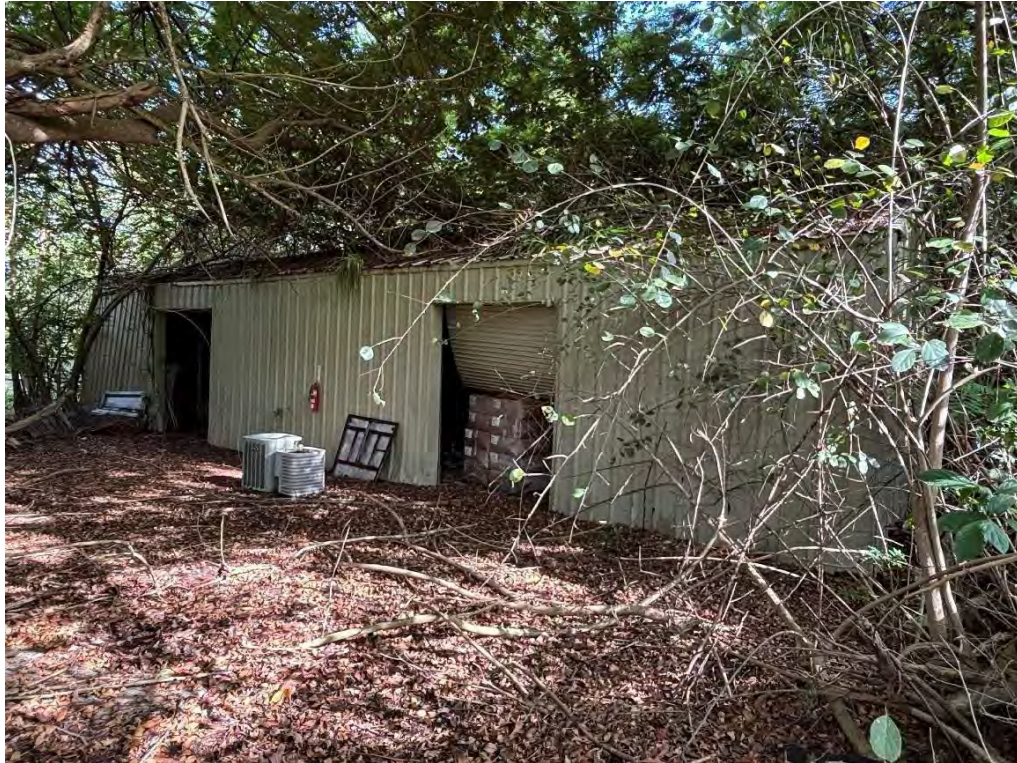
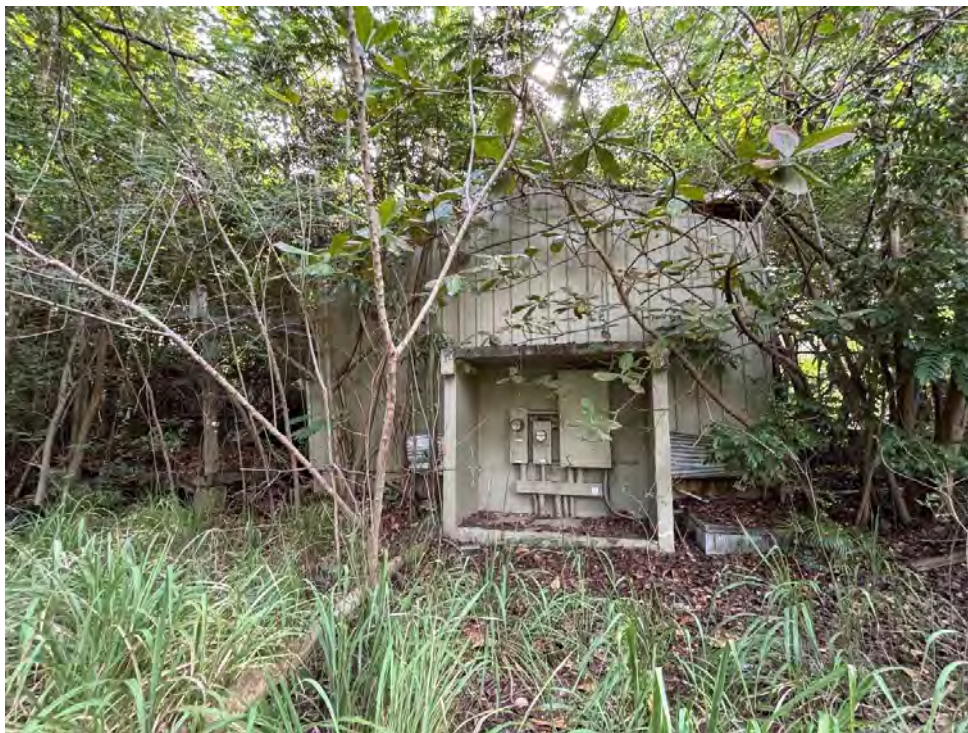
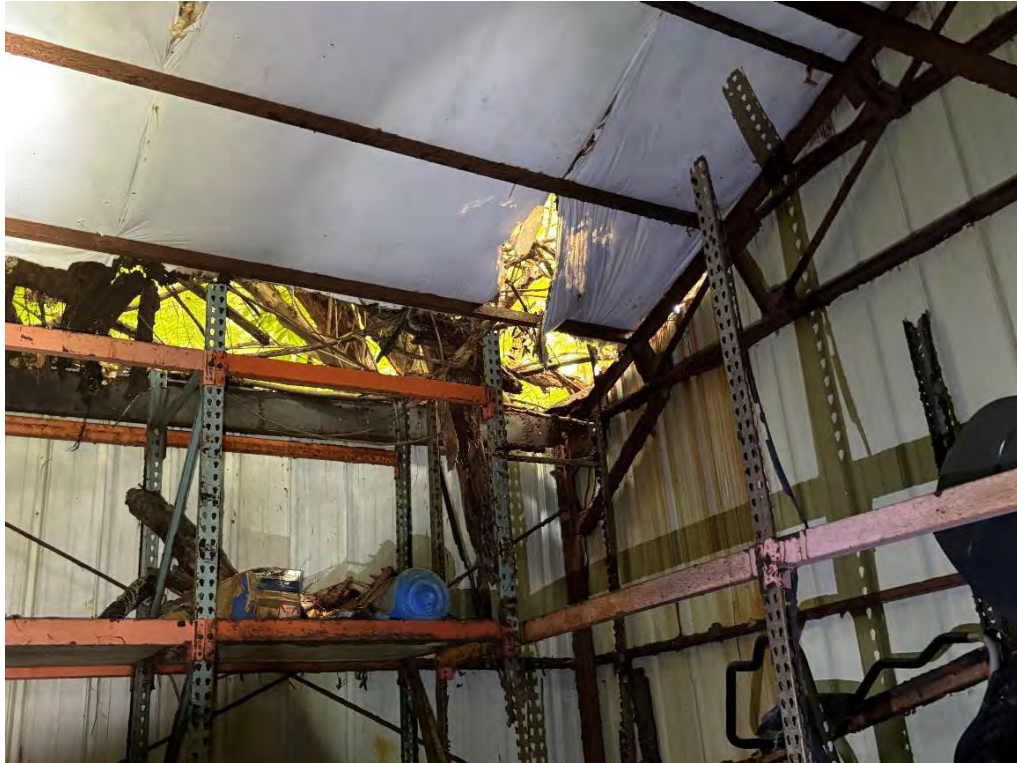
**Building: 90 Carpenter Shop 2**

| Component | Material | Notes |
|---|---|---|
| Walls (Structural) | Steel | SW corner of building failed.<br>Steel columns corroded and have significant section loss. Some columns have completely rusted at base plate. |
| Roof | Steel Framed / Metal Deck | Failed/collapsed. |

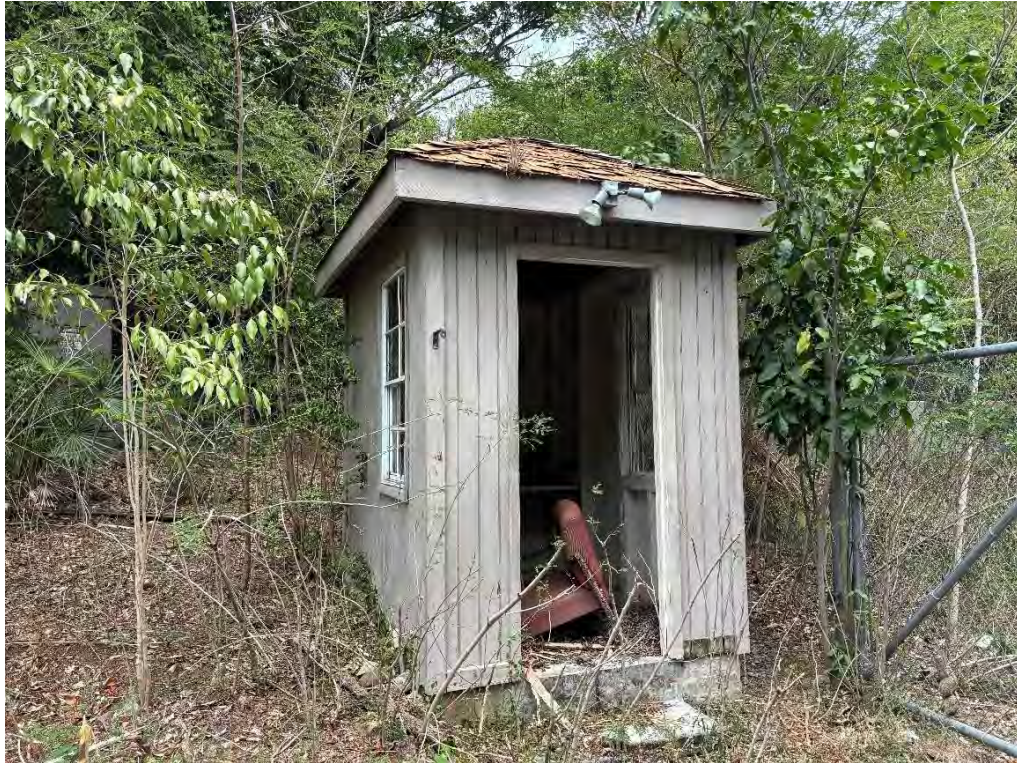
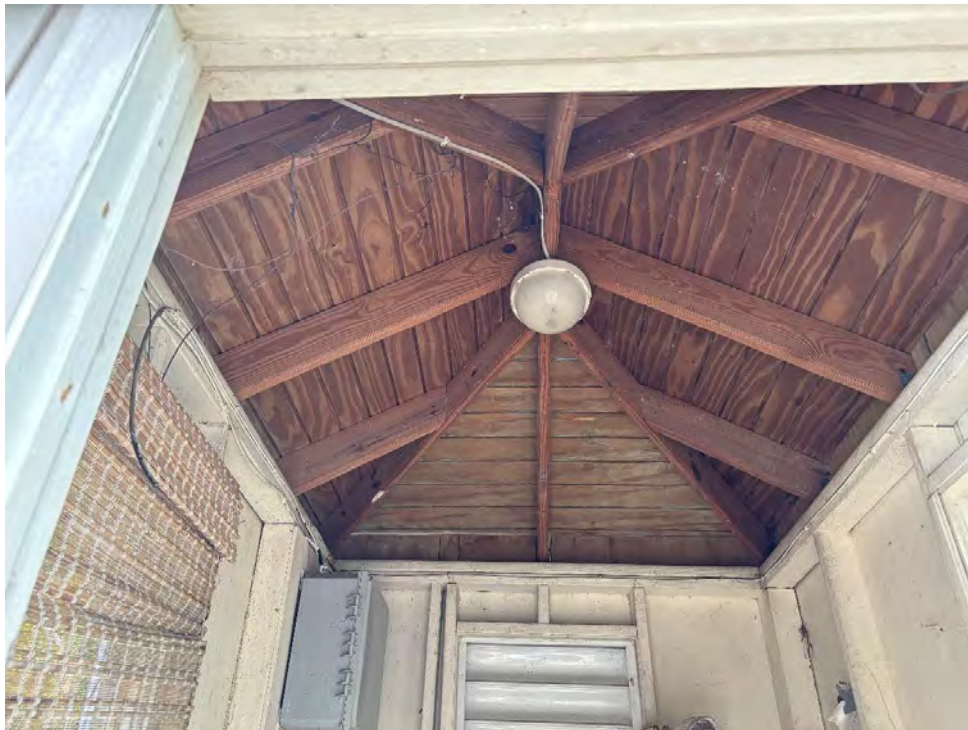
**Building: Maintenance Area Guard Shack**

| Component | Material | Notes |
|---|---|---|
| Walls (Structural) | Wood | Potential termite damage. |
| Walls (Non-Structural) | Wood | Potential termite damage. |
| Roof | Wood<br>Framed/<br>Wood<br>Shingles | Potential termite damage. |

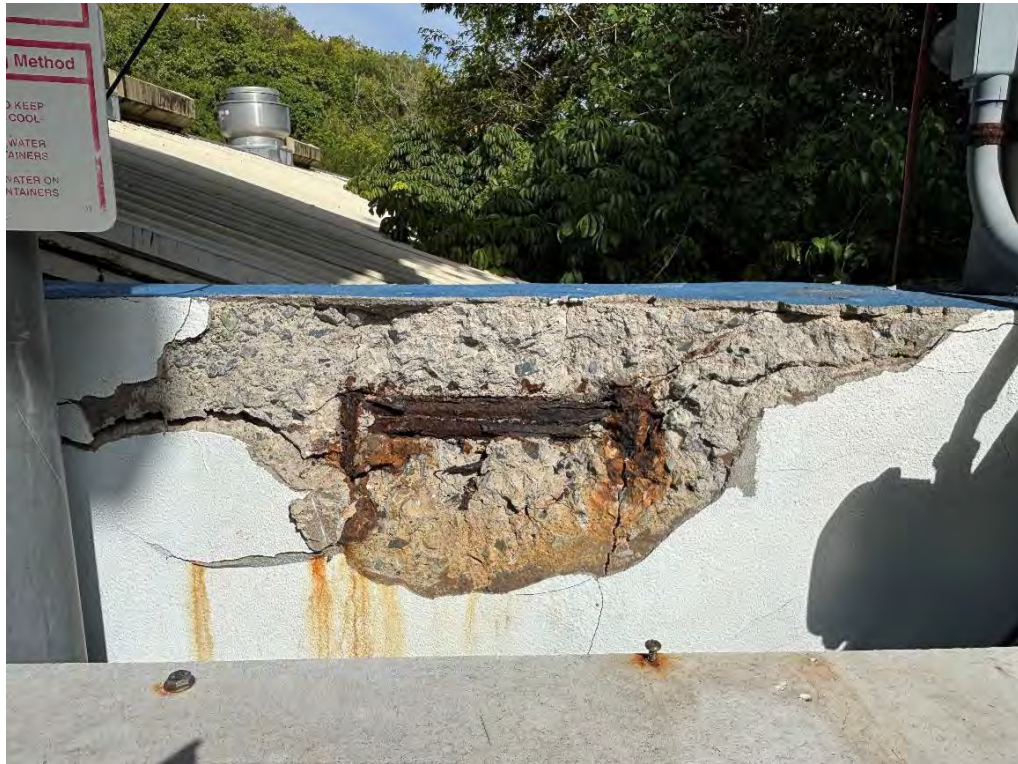
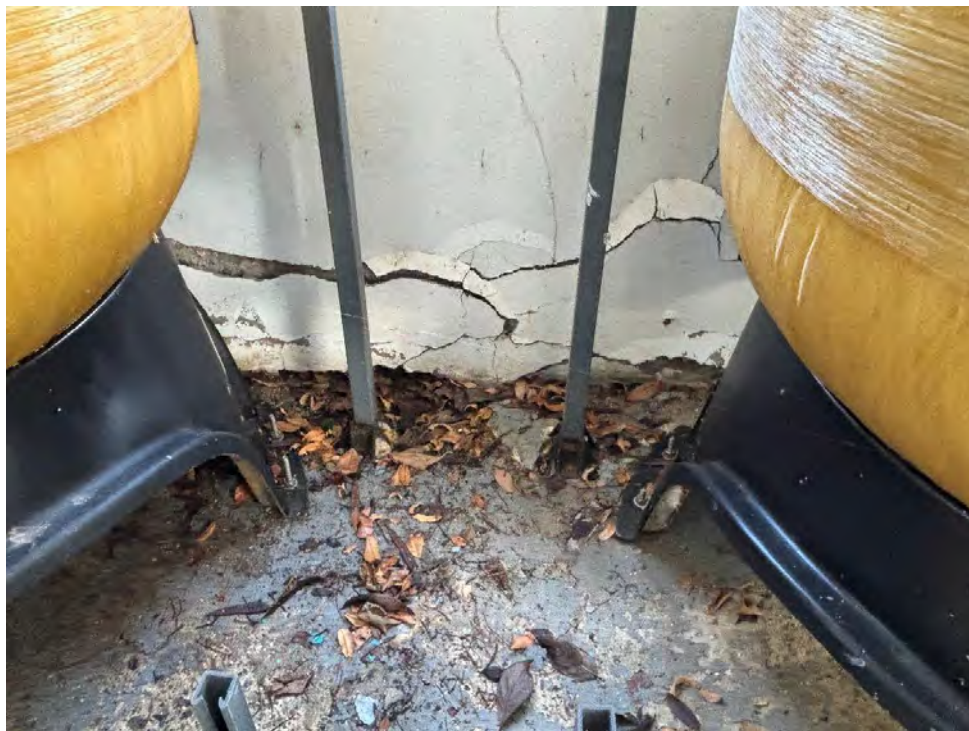
**Building: R.O. Plant**

| Component | Material | Notes |
|---|---|---|
| Plant Walls (Structural) | Concrete Knee Walls / Steel Columns Encased in Concrete | Concrete walls on north side are cracked, spalled and have severely rusted rebar. Concrete around steel columns has spalled. CMU wall on south side is acting as a retaining wall and has horizontal cracks along the length of the wall. |
| Roof | Steel / Metal Roof | Roof has severely corroded in one location and rusted completely through. Bottom flange of "Z" purlins have various degrees of corrosion on the bottom flange throughout the structure. |

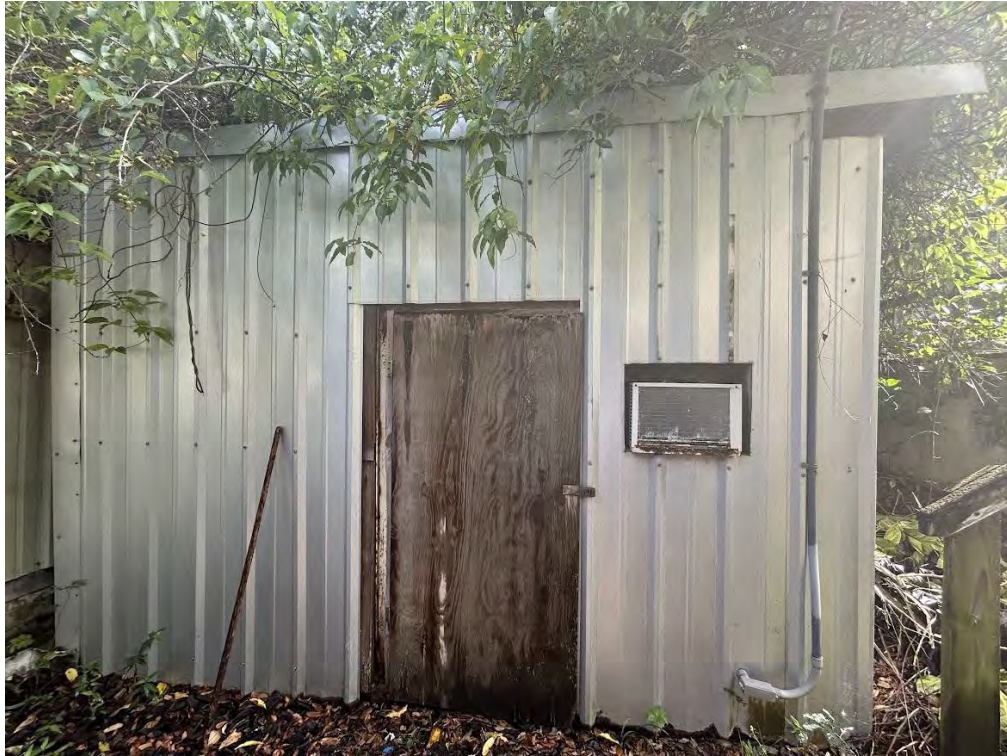
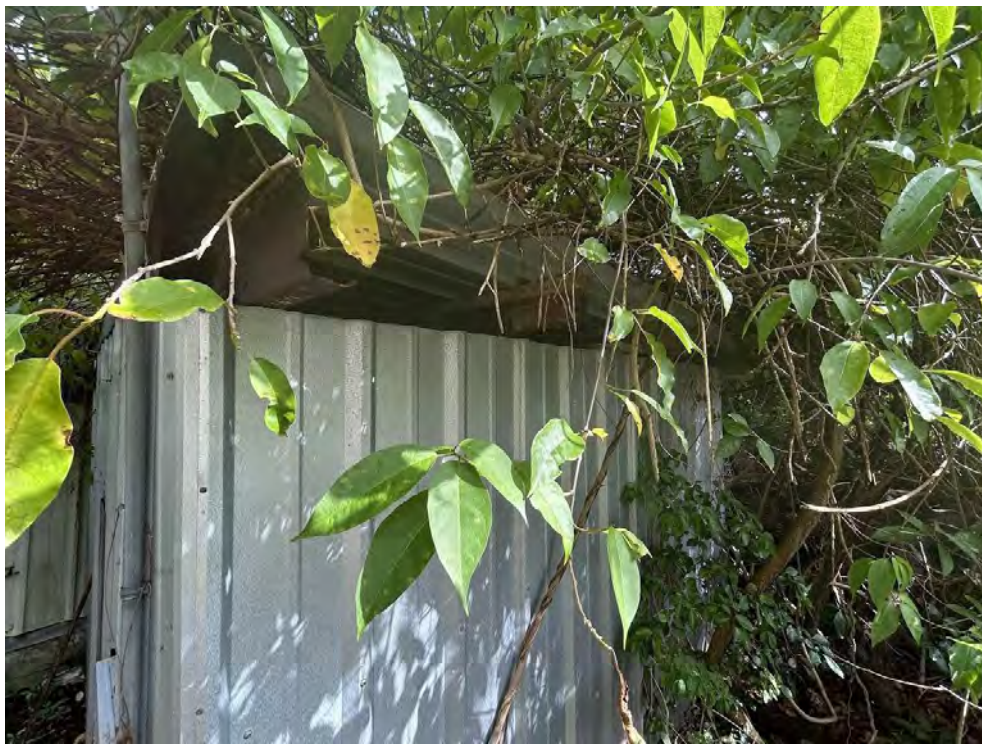
**Building:** R.O. Storage Shed

| Component | Material | Notes |
|---|---|---|
| Walls (Structural) | Steel | Corrosion visible on steel framing. |

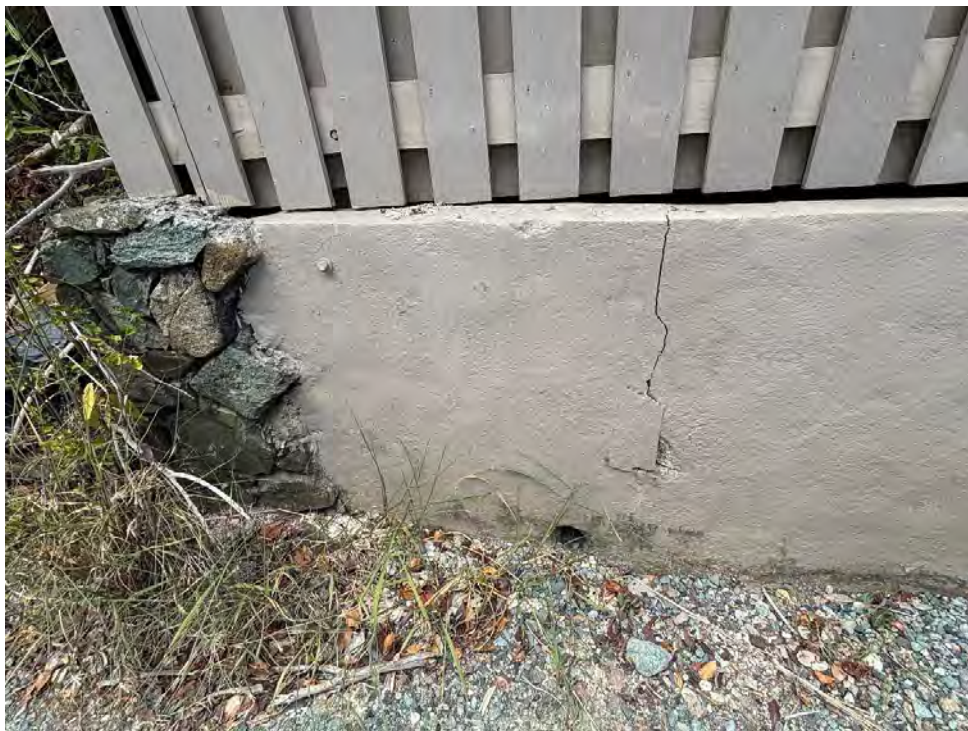
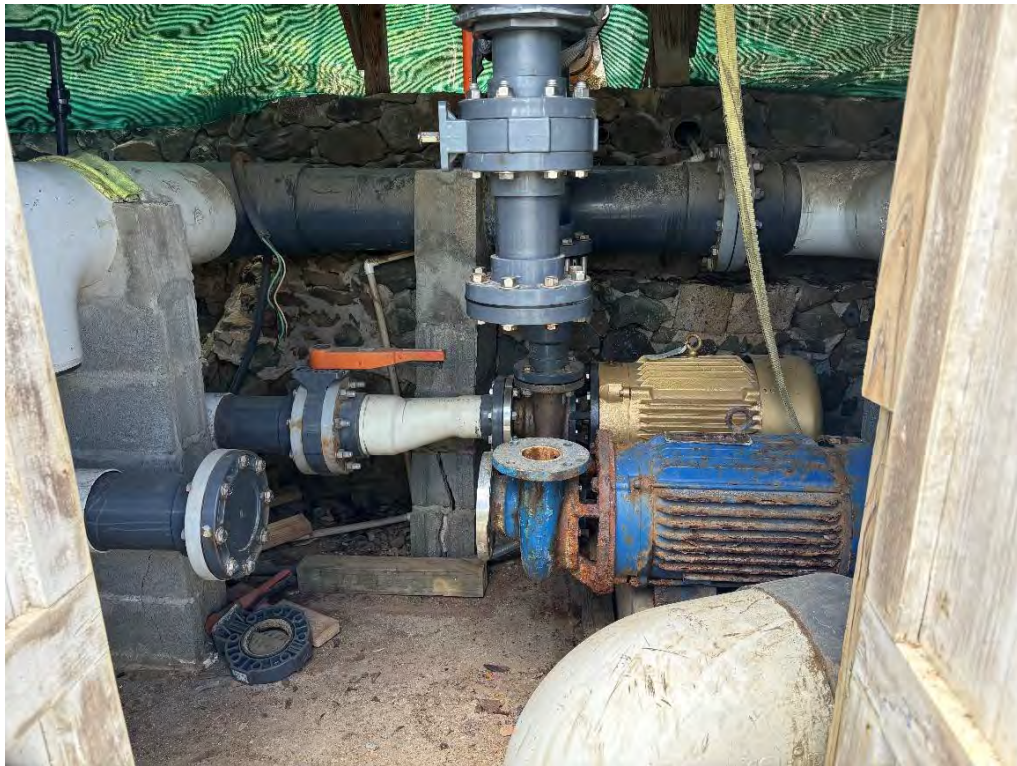
**Building: R.O. Pump House by Honeymoon Beach**

| Component | Material | Notes |
|---|---|---|
| Walls (Structural) | Stone / CMU / Wood | The structure consists of a CMU wall parallel to the road and 3 stone walls. The wall extend up partial height and have a wood framed shed structure for the top half. Wood posts partially supported on unstable rocks / wood scraps. Beas have insufficient bracing and are leaning/rotating. Wood posts are leaning. CMU at wall has a crack either side. |
| Roof | | Wood beams framed into posts are unstable. |
