**National Park Service**  
Virgin Islands National Park | Caneel Bay  
Structural Assessment Report

## Structural Assessment Summary Virgin Islands National Park Caneel Bay

**CANEEL BAY**  
**ADDITIONAL STRUCTURES**  
**STRUCTURAL ASSESSMENT REPORT**

**Building: Pier (May 2024)**

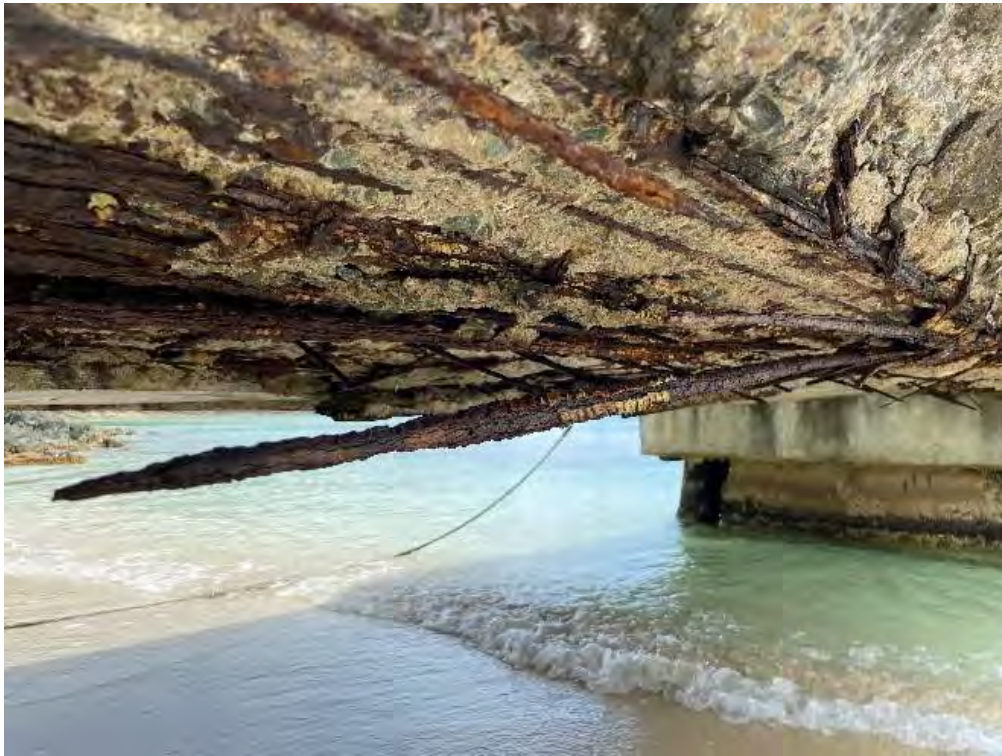
The topping slab on the planks is cracked and not bonded to the planks in some locations. The planks appear to be in generally good condition when viewed from the pier. However, inspection from the underside shows there is some significant damage to the underside of the planks. The concrete planks of the first full bay are in the worst condition. The bottom concrete has completely spalled off, the epoxy coating on most of the exposed rebar is completely gone and the rebar is severely corroded. The next bay of planks shows signs of delaminated concrete and rusting rebar but is less severe than the first bay. Conditions for the remainder of the pier range from good condition to severely corroded.

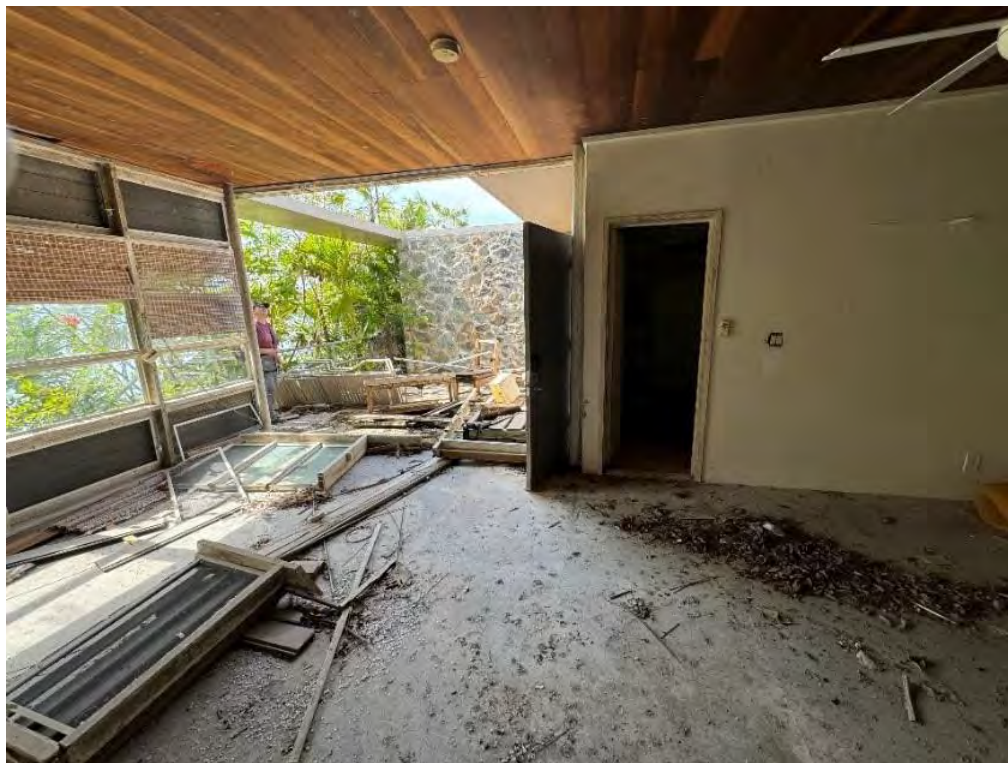
Figure 2 - Failed Return Wall

| Cottage # | Observations |
|---|---|
| 6 | Return wall has collapsed. North facing window wall in good condition. |

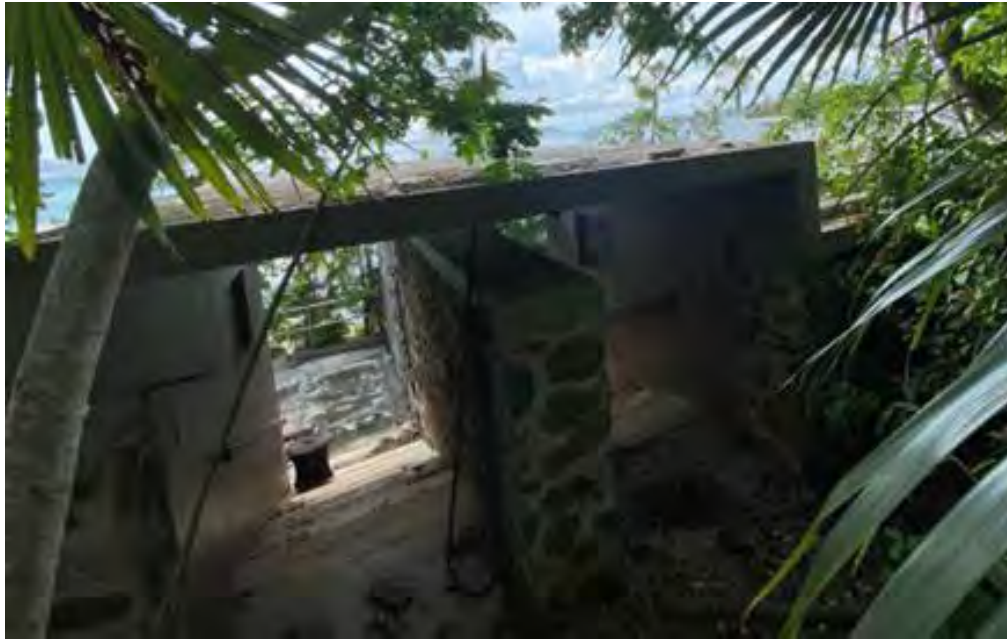
Figure 5 – Flat Roof over Breezeway Stairs

The roof was not accessible for examination. The exact age and type of the existing roof coating material is unknown. Based on existing documentation the roof is thought to have waterproof elastomeric paint system with approximately a 10 year life span. Standing water on some roofs indicate clogged drains. Water damage on the interior ceiling finishes indicate the roof system is failing in some locations.

| Cottage # | Observations |
|---|---|
| 5 | a. Standing water on roof.<br>b. Ceiling with water damage to interior plaster finishes. |

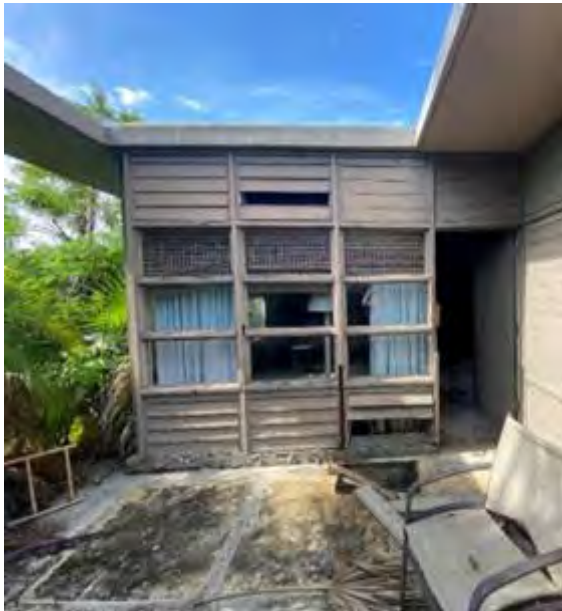
Figure 7 - Return Wall in Poor Condition

The wood exterior framing walls are non-load bearing. The north facing walls consist of wood framed glass, and louvered walls. The return walls consist of the entrance door and wood framed glass and louvered walls. The wood framing of the return walls show signs or significant damage including complete failure and extensive insect damage. The condition of these walls is important for maintaining the building envelope system.
