KAMEHAMEHA I SCULPTURE CONSERVATION TREATMENT REPORT

CONSERVATION TREATMENT REPORT

TITLE: Kamehameha I

DATE OF REPORT: 20 September 2001

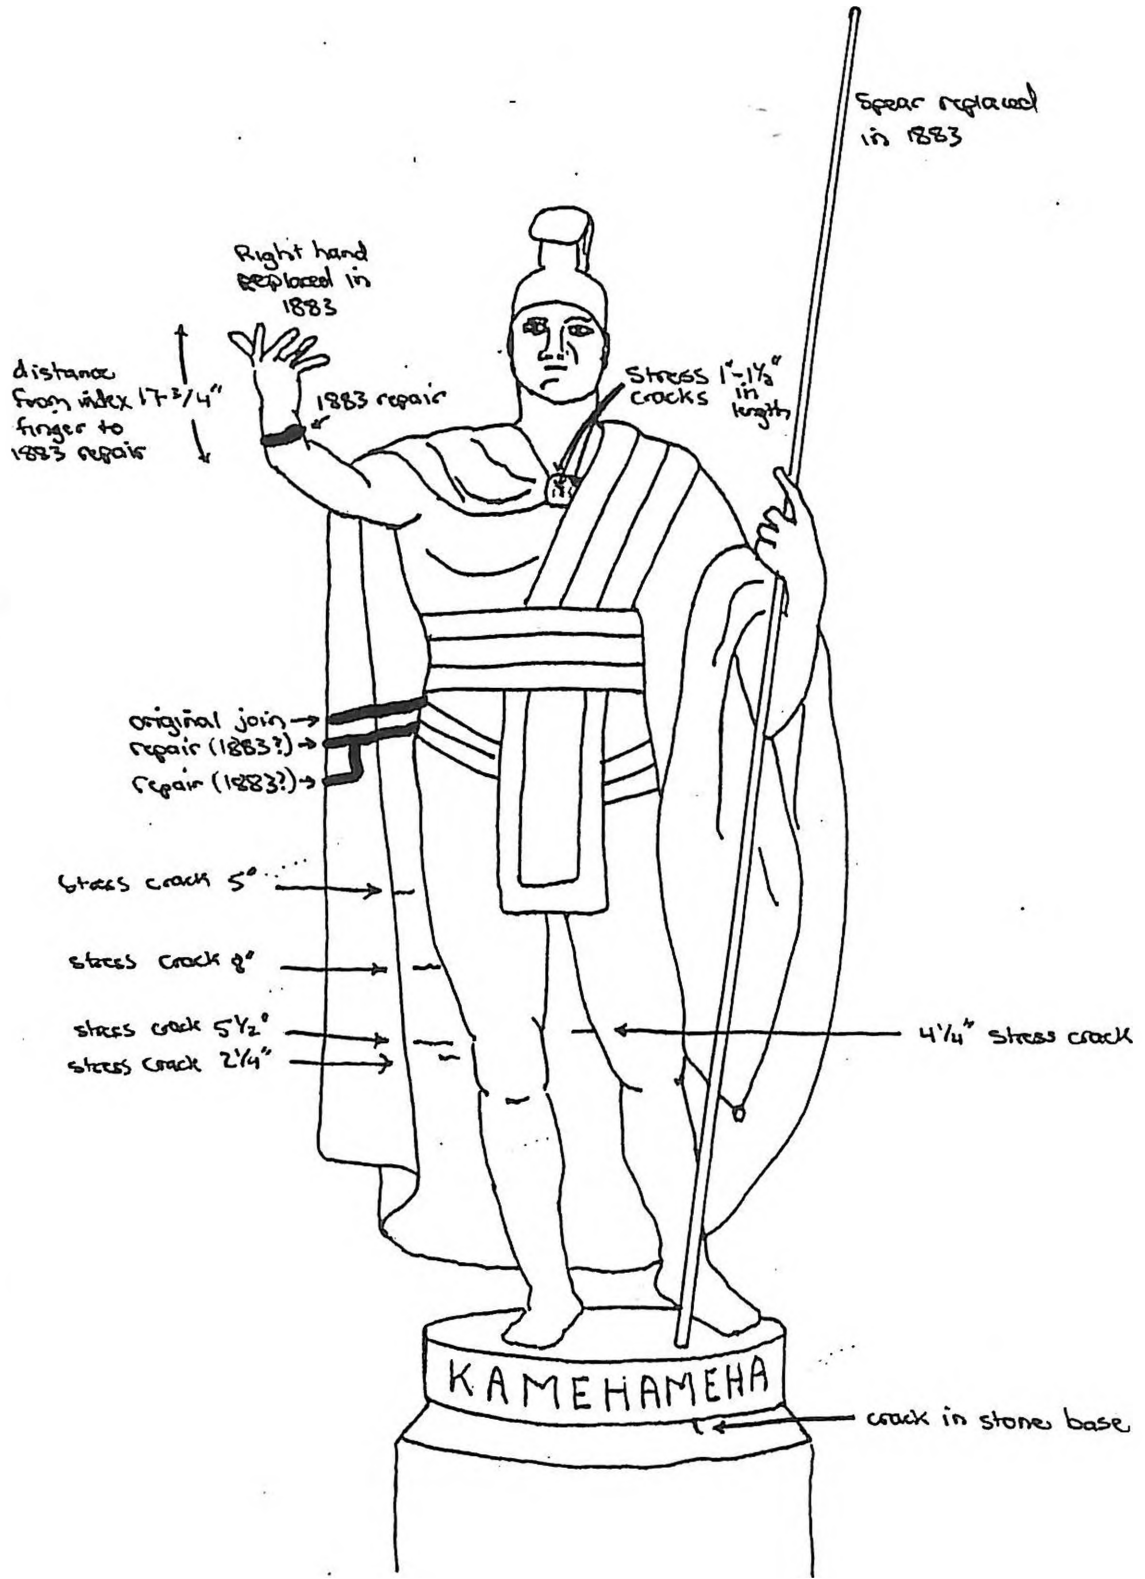
Condition Notes from March 2001 Conservation Project: FRONT

The sculpture is structurally in sound condition. The previous repairs and original welds are secure, although there are gaps along some of the weld lines. There are four areas of stress cracking, as noted on the attached diagram. The circular base is dented and cracked on the top and proper right side (see diagram). The crack is open in some areas. It is not known when this damage occurred, although it is not recent. Corrosion has developed within the cracks, and there are no signs of recent advances.

There are two areas of damage on the back proper right side of the cloak (see attached diagram). One of these was reported in newspaper articles from 1883, when it was noted that the cloak was damaged either during the shipwreck or from knocking against the boat as it was raised from the sea. One of these areas consists of a rectangular cast panel

6. After paint removal, the condition of the monument was further assessed. Old repairs and original welded joints were found to be structurally secure. Four areas of stress cracking, gaps between the separately cast sections, small casting flaws, the tear on the proper right back side of the cape and the crack through the circular base were noted on the attached diagram for future monitoring

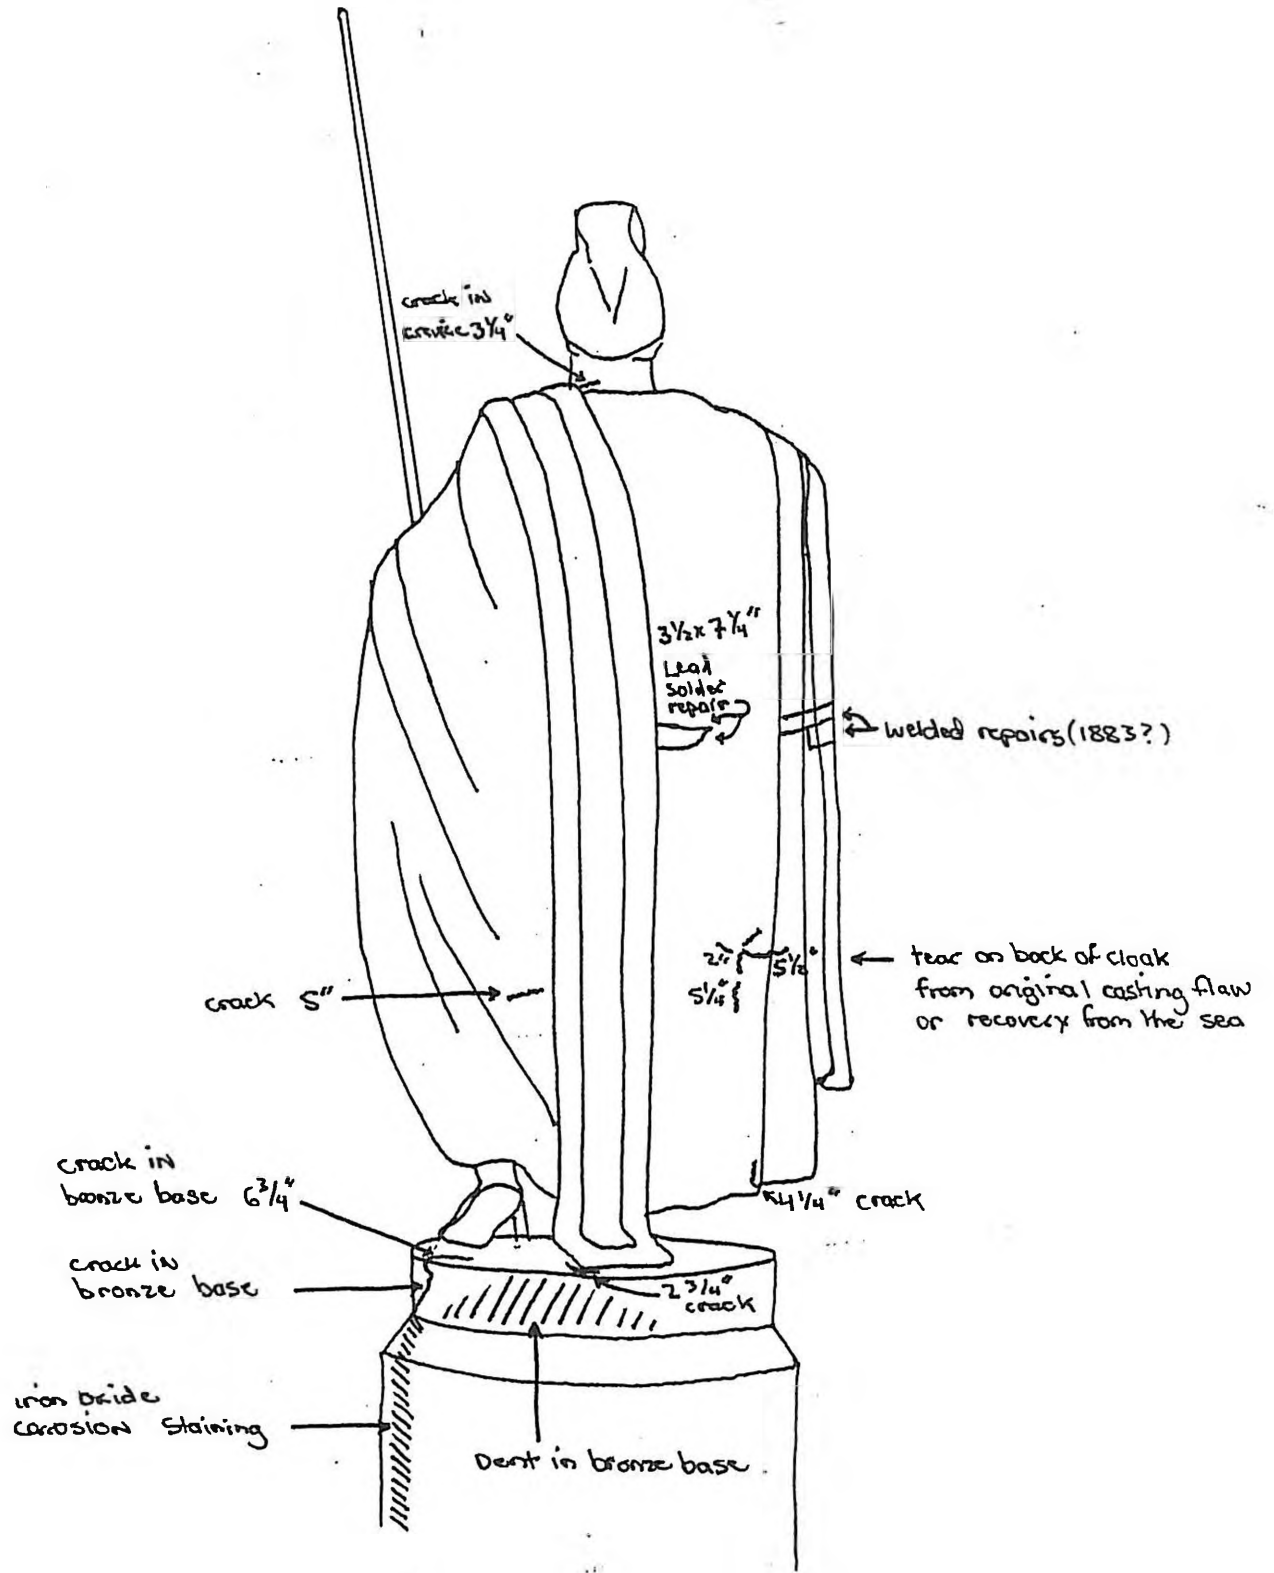
Condition Notes from March 2001 Conservation Project: BACK

that has been lead soldered in place. A small sample of solder was analyzed by x-ray fluorescence, and indicates an alloy of 89.5% Sn, 10.44% Pb, a few parts per million of copper and antimony, and no iron. (David Scott, The Getty Conservation Institute). The other is a complex open crack. This complex crack could be a casting flaw, since the metal is very thin along its edges. There are many round plugs in the cast that were inserted by the foundry to cover casting flaws. Some are carefully chased to match the adjacent surface, and some are not. There are approximately 25 small holes in the brass from air pockets in the original cast.

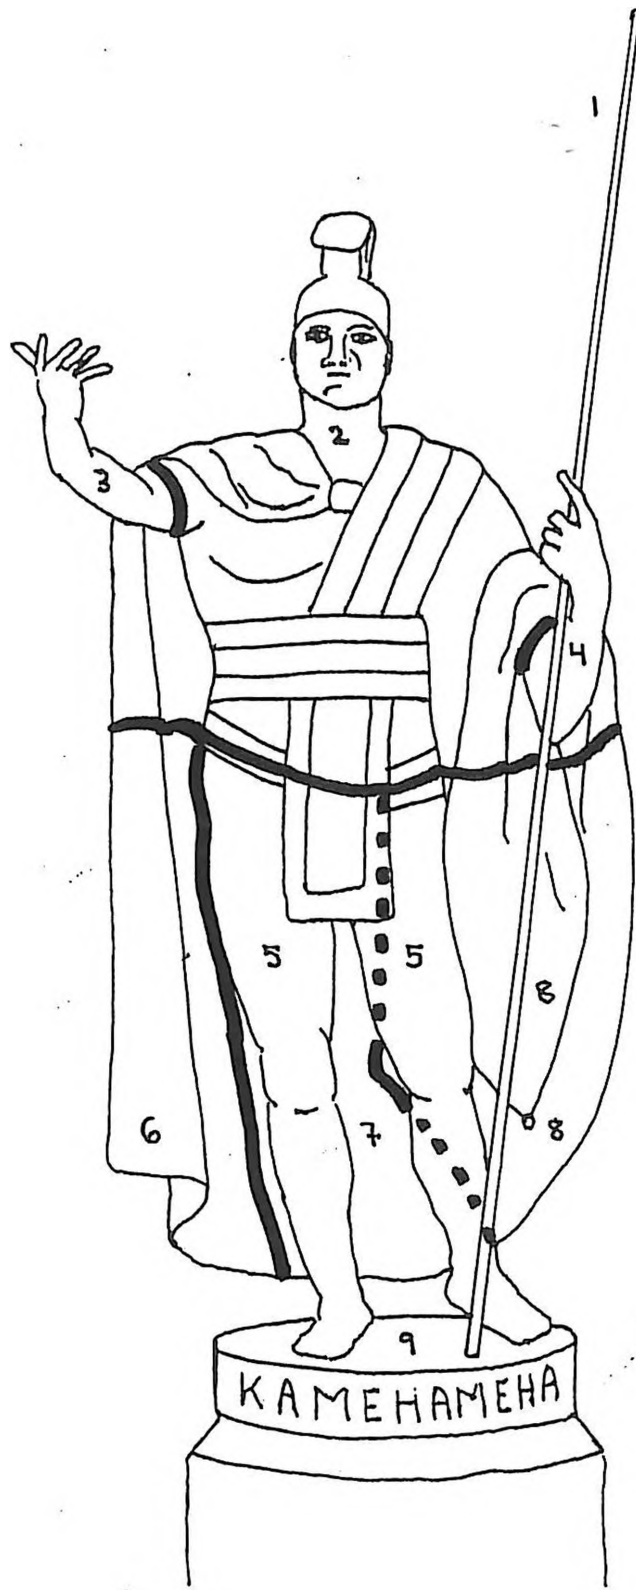
Original Fabrication in Nine Separately Cast Elements: FRONT

The monumental figure of King Kamehameha I is hollow cast in brass over an iron armature. The cast was made in nine separate sections, then welded together (see attached diagram). The figure of the King wears a *kīhei* (cloak), *mahiōle* (helmet), *kā'ei* (sash), and Western classical style sandals. His left hand holds a copper alloy *pololū* spear (unlike the original), which was fabricated during the restoration, and loosely inserted into the hand and welded to the circular base. His right arm is outstretched with an open palm, in a Western gesture of welcome.
