Ft. Livingston, Grand Terre Island Field Report | 2010-03

Field Report
Fort Livingston, Grand Terre Island
Jefferson Parish, Louisiana
Site Visit: June 16, 2010

Report prepared by Carol Chin and Jason Church
National Center for Preservation Technology and Training
Final Report revised July 12, 2010
645 University Parkway, Natchitoches, Louisiana 71457
<http://www.ncptt.nps.gov>

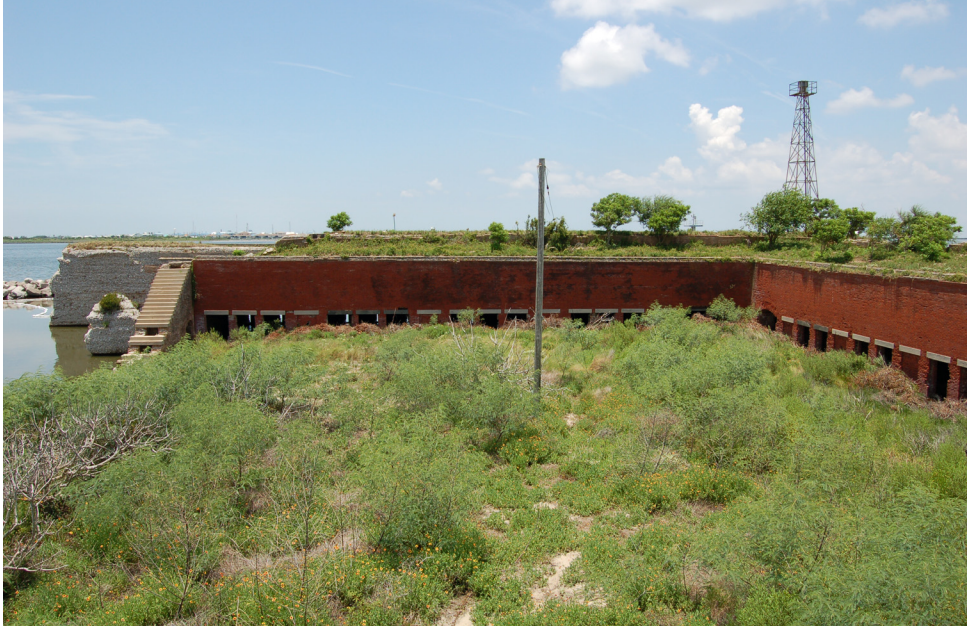
View across the courtyard looking southwest from the terreplein on the east side of the fort. Note the buildup of sand in the foreground, the light colored granite steps (left) and lintels over the openings in the brick walls, and the exposed tabby in the broken outer wall in the background, left of center. Barataria Pass and Grand Isle are visible beyond the fort. (Photo: NCPTT, Jason Church.)

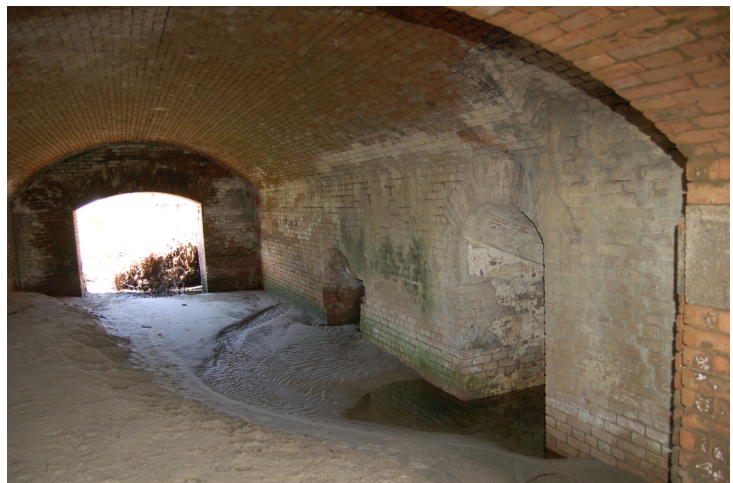
Barrel-vaulted passageway between the courtyard and the moat on the northwest side of the fort. Photo taken looking southeast toward the courtyard. Note the sand that has covered the floor and partially filled the space. Water has intruded as well, as seen on to the right in the photo, and evident from the flow channels in the sand. Oil has not contaminated this space. (Photo: NCPTT, Jason Church.)

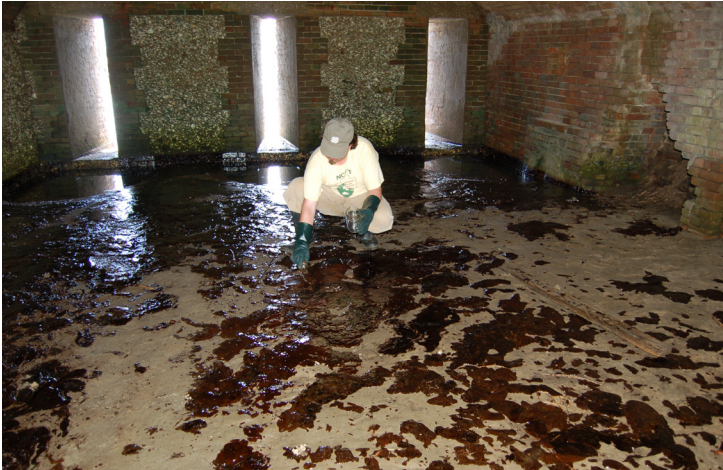
Location 2, inside the southernmost casemate. The cooler temperatures inside the casemate allow the oil to become more viscous so that it remains on top of the wet sand. Note the tabby walls with brick quoining in the background. (Photo: NCPTT, Carol Chin.)

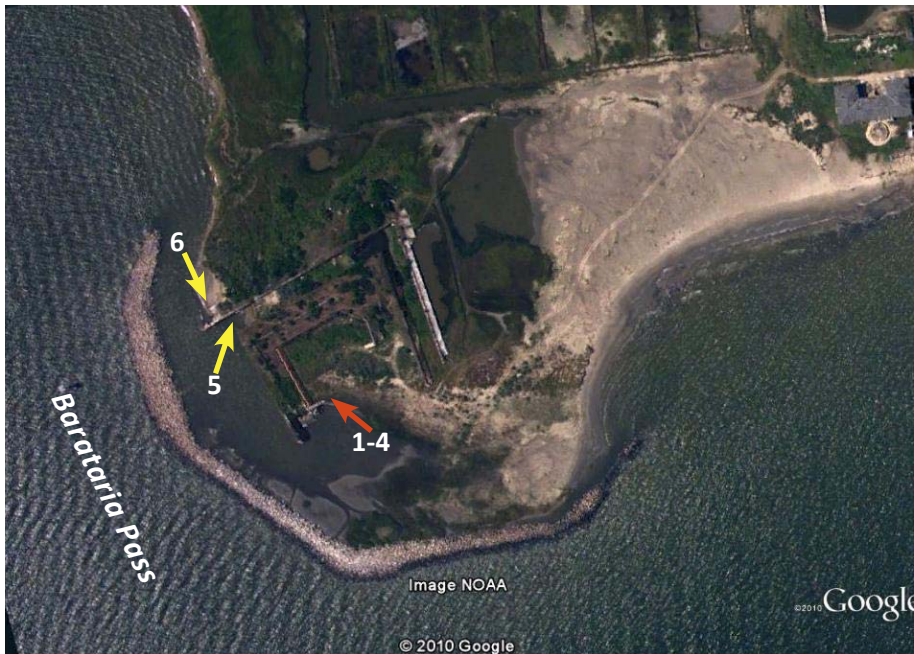
Aerial view of Fort Livingston. The red arrow shows the general location of stations 1 through 4. The yellow arrows show stations 5 and 6. The southeast wall of the fort, facing the gulf, was initially destroyed in a hurricane in 1915. A wavebreak protects the structure on the gulf side. Today the wavebreak is breached on the northwest side at the shoreline. Structures in the northeast corner of the photo are part of the Louisiana Department of Wildlife and Fisheries' (LDWF) Lyle St. Amant Marine Research Lab which closed in 2008 after hurricane Gustav. (Image modified from Google Earth.)

Oil is expected to continue to arrive on the shores of Grand Terre Island over the coming months. The breakwater on the gulf side of Fort Livingston provides an opportunity to prevent a significant amount of additional oil from reaching the fort. If resources are available, additional sand could be added to the breakwater to help prevent the oil from penetrating the riprap in the breakwater and reaching Fort Livingston. This sand would fill gaps and voids in the breakwater, trapping oil. The continued use of booms is also recommended.

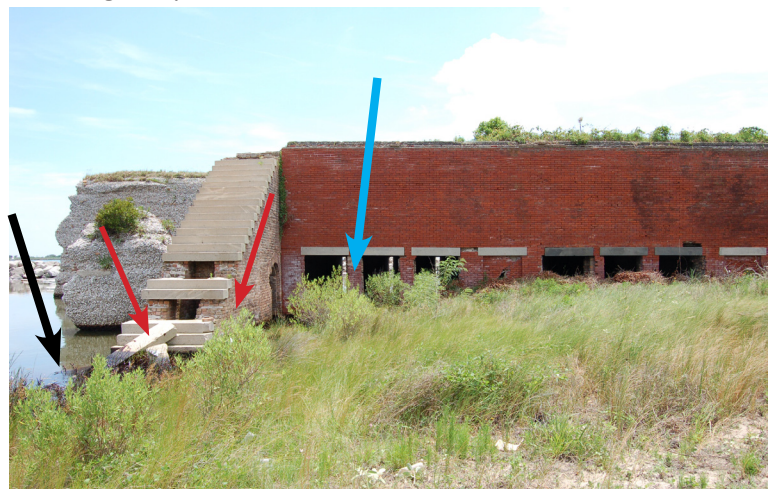
Fort Livingston Courtyard. The red arrows indicate the locations of poultice applications (Station 1), the black arrow shows the sampling location for oil/mousse and water (Station 3), and the blue arrow shows the location of the cleaning tests (Station 4). (Photo: NCPTT, Jason Church.)

The poultice was effective at lifting/removing the surface soiling from both brick and granite. Because of the short time for the poultice to “cure,” some staining remained from oil that had penetrated deeper into the material. A poultice applied over a longer period would be more effective at removing such a stain. It should also be noted that large area application of a poultice is not practical, and that poultices are normally used for small areas and more stubborn stains.

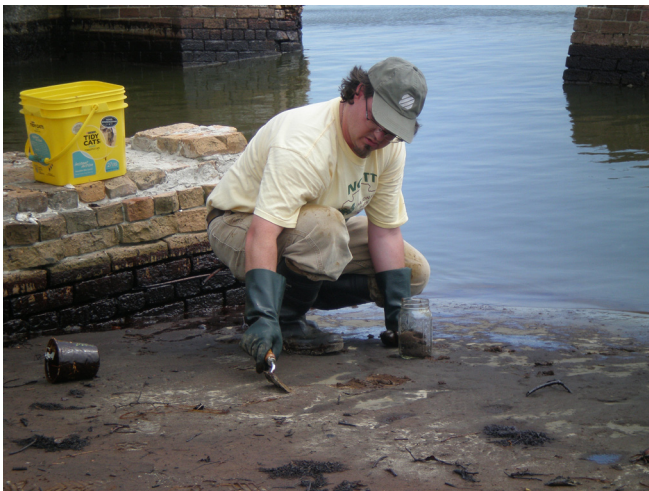
Jason Church collecting samples of oiled sand; station 6, northwest of the exterior wall of Fort Livingston. Note the oil on the bricks on the left side of the photo and in the background on the fort's outer wall. (Photo: NCPTT, Carol Chin.)
