Tech Notes

WINDOWS

NUMBER 8

Thermal Retrofit of Historic Wooden Sash Using Interior Piggyback Storm Panels

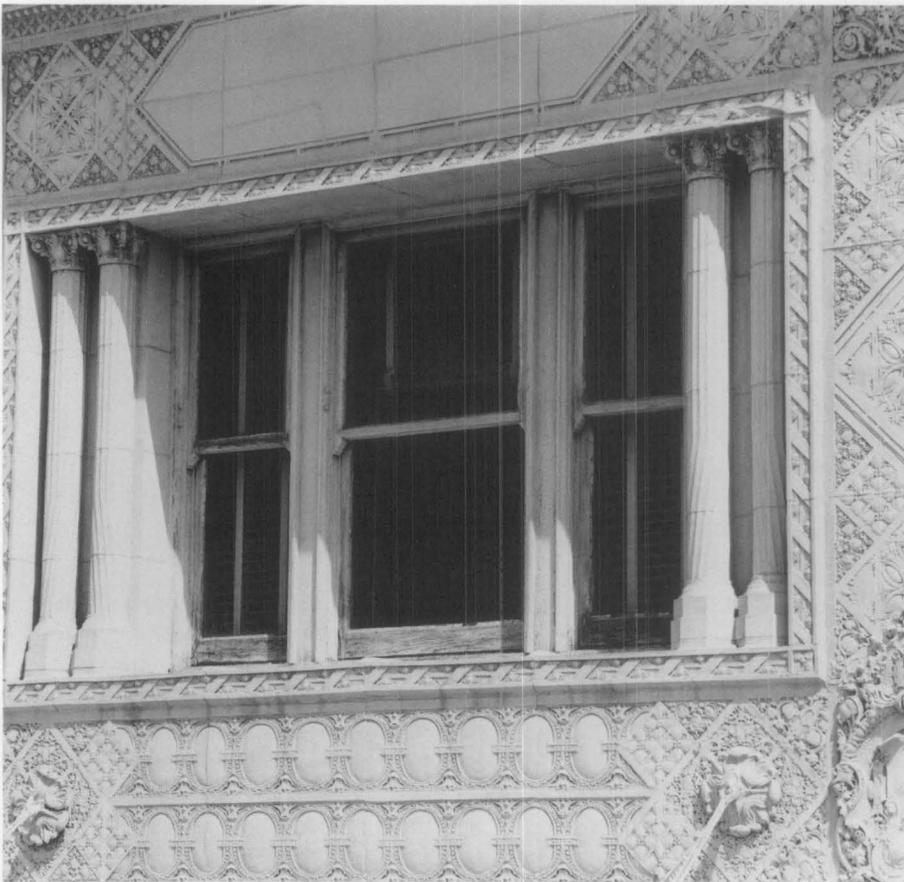
Figure 1. Deeply recessed windows with ornamental terra-cotta surrounds were character-defining features of the building which the owner wanted to retain. Photo: Jack Graves, AIA

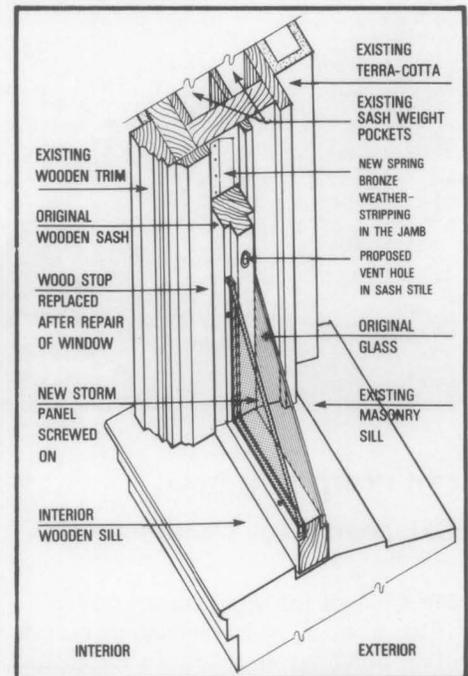
This approach would necessitate routing or cutting out a portion of the historic wooden sash and would add to the weight of the sash due to the attached storm panel. The sash rails and stiles measured 1-7/8" deep by 2" wide and were in sound condition. They were therefore capable of tolerating the required cut—3/8" deep by 1/2" wide. The issue of the additional weight of the storm panels was directly related to the choice of materials selected for the piggyback units. Since acrylics are purported to be 40% lighter than glass and 15% more thermally efficient for the same thickness, the architect investigated their use. Because of expense and the tendency of acrylic to bow or discolor due to sun

Figure 2. Cutaway view of the proposed retrofit solution showing how the historic sash would receive a recessed storm panel through routing or cutting an inside rabbet. Drawing: Sharon C. Park, AIA

While researching new window units, the architect found a commercially available wooden replacement window that incorporated a removable storm panel piggybacked onto the single glazed sash. This second layer of glazing was recessed on the inside of the primary wooden sash, allowing the double-hung window to operate without interference from the applied panel. The architect applied this concept to the Colcord Building's windows and proposed to retrofit a recessed storm panel to each existing sash, provided it would not structurally weaken the sash in the process (see figure 2).

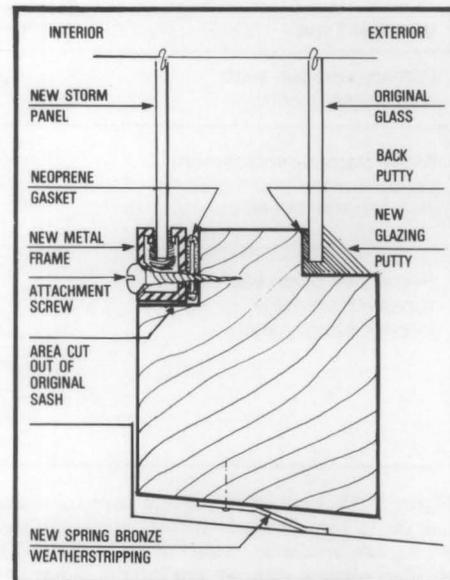
Figure 3. The completed retrofit shows the storm panel screwed onto the historic window. Photo: Tamara Coombs

As the panels would only be removed for maintenance purposes, the architect determined that the panels simply could be screwed in place, using a neoprene gasket set on the back side of the panel as a seal (see figure 3). Should the panels ever need to be removed, an electric screw gun would do the job quickly (see figure 4).

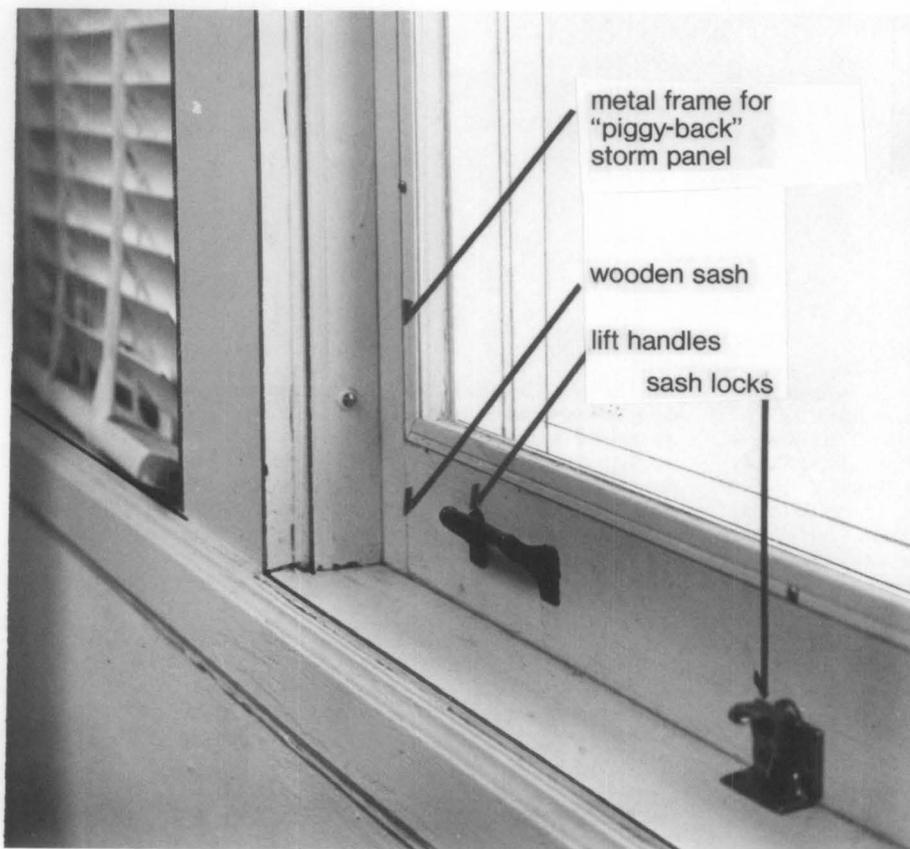
Figure 4. The applied interior storm panel was screwed in place. Note the use of the neoprene gasket, which provides an air seal between the storm panel and the historic wooden window. Drawing: Sharon C. Park, AIA

The use of interior storm panels affixed to a sash can create a potential problem of trapped condensation. To avoid this possibility, the architect specified two features. The first was a neoprene gasket as an air seal between the wooden sash and the aluminum frame of the storm panel; the second was the creation of ventilation holes in the wooden sash stiles. The vent holes, drilled laterally through the stiles, were to provide a minimum of air circulation should moist air condense between the layers of glazing.
