Subject: Slate Roof Treatments

- Applicable Standards:**
- 2. Retention of Historic Character
 - 6. Repair/Replacement of Deteriorated or Missing Features Based on Evidence

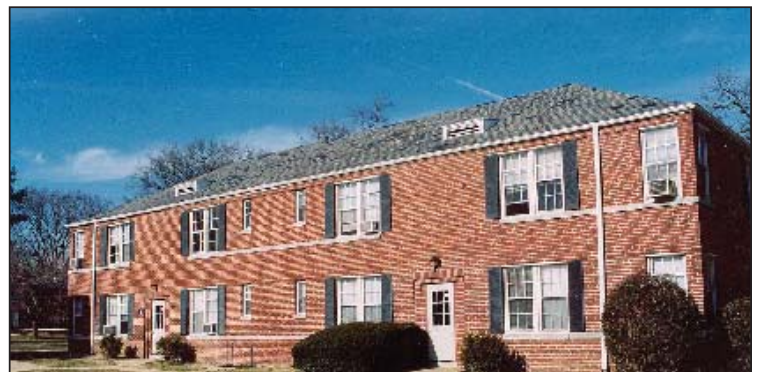
Application 1 (Compatible Treatment): After surveying approximately fifty buildings in this Colonial Revival-Style apartment complex, it was determined that the 80-year old slate roofing was in poor condition. As a result, the owner proposed that all the slate be removed and replaced with a polymer-based substitute. The most distinctive features of these simple 2-1/2 story brick garden apartments are their hipped and gabled slate roofs, which are very visible within the complex. Therefore, replacement with a substitute material was deemed incompatible and the owner agreed to use new slate from the original quarry. The new slate roofs, which require only seasonal maintenance, are a sound investment and historically appropriate.

Typical view of Colonial-Revival apartment building in complex before rehabilitation. Note the mottled appearance of original slate due to numerous past repairs.

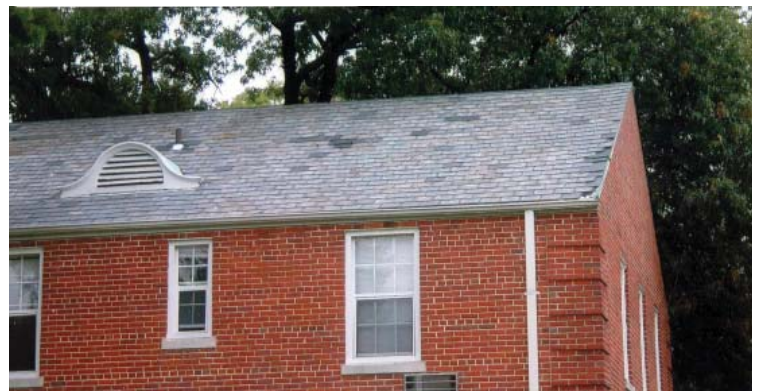
Close up of damaged and previously repaired slate.

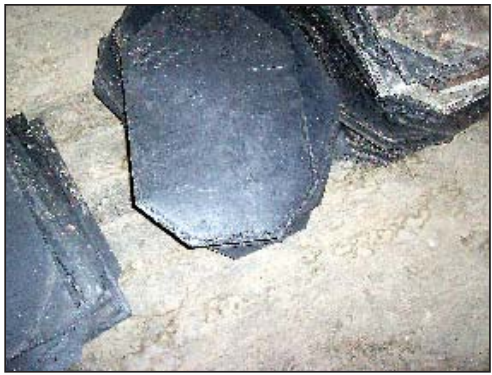
Right: New rubber slate (center; left) next to historic slate (right).

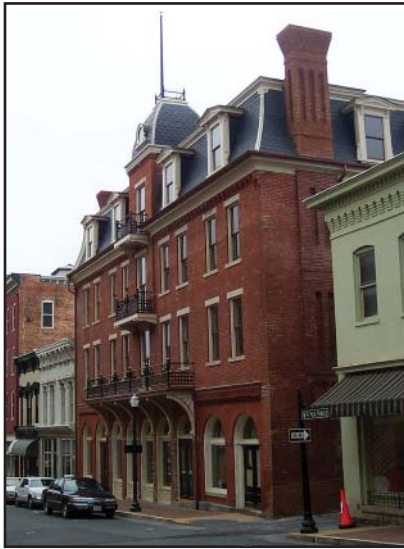
Application 2 (Compatible Treatment): This 1894 example of Second Empire architecture is “high style” with pedimented dormers, balconies, corbelled cornices, a dominant central tower, and a small mansard roof covered in slate. Prior to rehabilitation the property was in extremely deteriorated condition and although some of the slate on the mansard was still there, it was delaminating, fractured, and partially painted. Since the roof is only one of many decorative elements making up the primary façade and not the sole defining feature of the building, replacing the slate with a polymer-based substitute slate was an acceptable alternative. Although the replacement slate is visible,

Left: Second Empire former hotel, built in 1894.

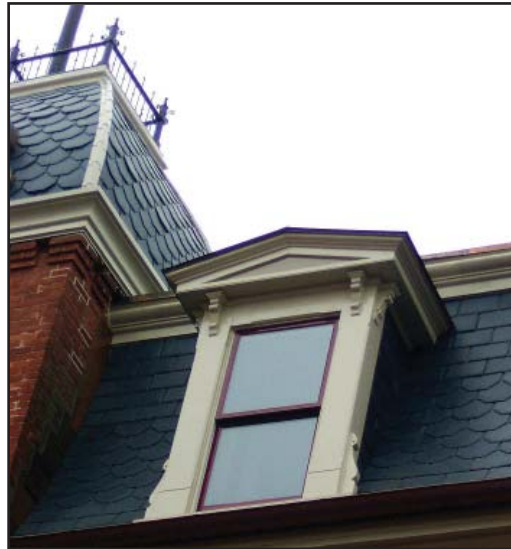
it replicates the decorative fish-scale pattern of the historic slate and, thus, has the same appearance as the original roof. Because the building is on a narrow street and is generally viewed at an angle rather than head on, the mansard roof is not the major focal point.

Right: Close-up of substitute slate after installation.

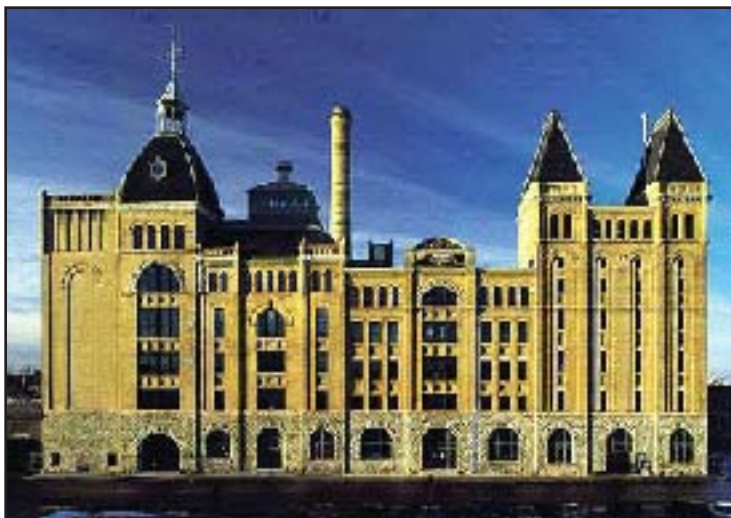
Application 3: (Compatible Treatment): After careful inspection, the slate roof of this circa 1895 former brewery was determined to be beyond repair and during rehabilitation was replaced with high quality asphalt-based fiberglass shingles. The new asphalt shingles are the same size and color as the original slate and have similar shadow lines. The roof, with its many towers, turrets and monitors, is clearly a distinctive and prominent feature, but because of the massive scale and height of the building, it can only be viewed at a considerable distance. For this reason, a substitute roofing material was acceptable in this instance.

Above: Close up of the replacement roof after installation.

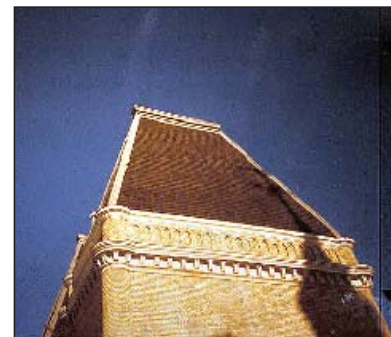
Left: View of the historic brewery taken from a distance after rehabilitation.
