# Existing Conditions

This chapter describes through narrative text, contemporary photographs, labeled base mapping, and analytical diagrams, the current conditions and extant landscape features associated with the Vicksburg National Military Park landscape. The first section—Environmental and Cultural Context and Setting—describes the battlefield within a regional and local context, including hydrological, geographical, and geological features, as well as the demographics and other traits that characterize the park’s contemporary setting and surrounding community. The second section—Site Description—describes the primary organizing elements and features that characterize the Vicksburg National Military Park landscape, including former park lands quitclaimed to the City of Vicksburg and Warren County in the 1960s. The third section—Landscape Description by Characteristic—depicts the individual extant landscape features and resources that together compose the Vicksburg National Military Park battlefield landscape. (See Fig. 7 and Fig. 8 for site location and context and study area boundary maps.)

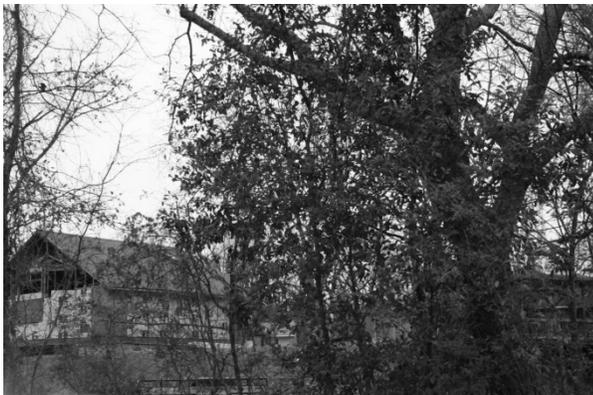
**FIGURE 61.** View of development encroaching on the park boundary, on the northwest portion of Confederate Avenue, west of Thayer's Approach, looking south.

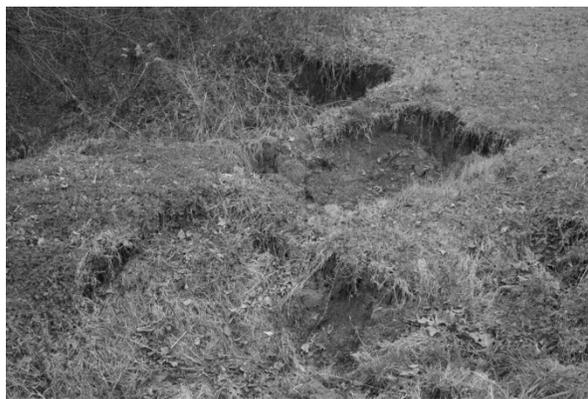
**FIGURE 62.** Example of erosion of the local loess soils, south of the walkway leading to the Stockade Redan Attack tour stop.

Over millennia, runoff water carved out deep ravines in all directions. The slopes dropping into the ravines are quite steep in many places.<sup>150</sup> The current condition of the park bluffs ranges from fair to good.

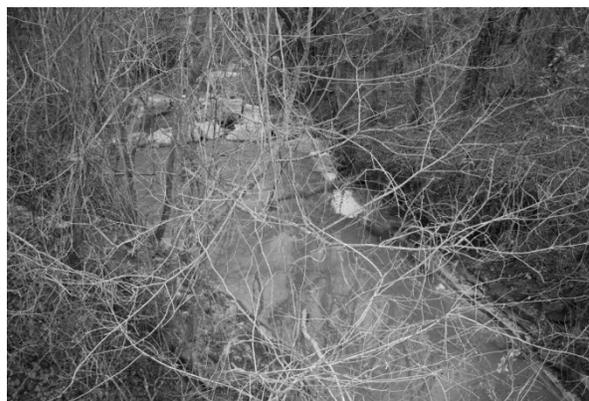
temperatures in Mint Spring Bayou (Fig. 63).<sup>155</sup> Currently, “restoration of Mint Spring Bayou [is] recommended to aid in re-introduction of native fish species, currently deficient due to invasion of a fathead minnow population, and depletion of streamside vegetation.”<sup>156</sup>

**FIGURE 63.** Looking west and down at Mint Spring Bayou from the Connecting Avenue bridge between Vicksburg National Cemetery and Fort Hill; recent studies have been tracking sedimentation in the streams of the park.

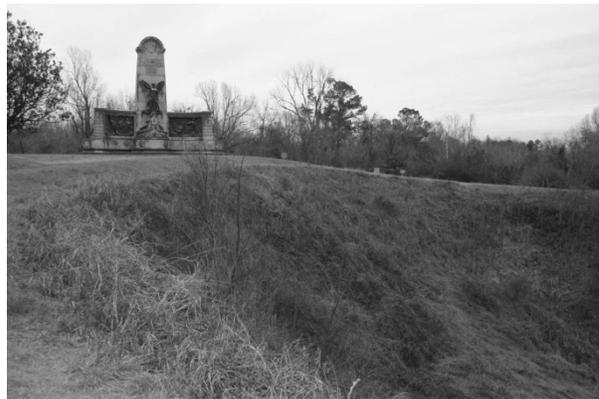
**FIGURE 70.** The highly erodible, steep slopes within the park are stabilized with vegetation. This view is of a slope east of Confederate Avenue, near the Missouri State Monument, looking east.

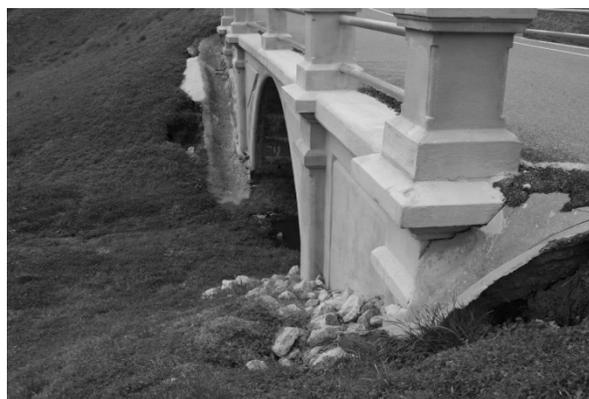
Today, the park continues to experience problems with sinkholes, cave-ins, and erosion (Fig. 73). A borrow pit behind the maintenance area is sometimes utilized to obtain material for repair of erosion problems (Fig. 74).

**FIGURE 73.** Erosion around the footings of historic Melan Arch Bridge No. 2 along Union Avenue north of Pemberton Avenue, looking southwest.

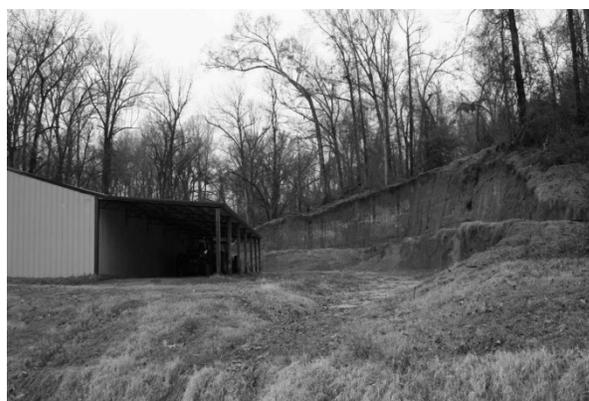
**FIGURE 74.** A borrow pit behind the maintenance complex, north of the visitor center, from which fill is used to repair erosion, an ongoing maintenance concern at the park.

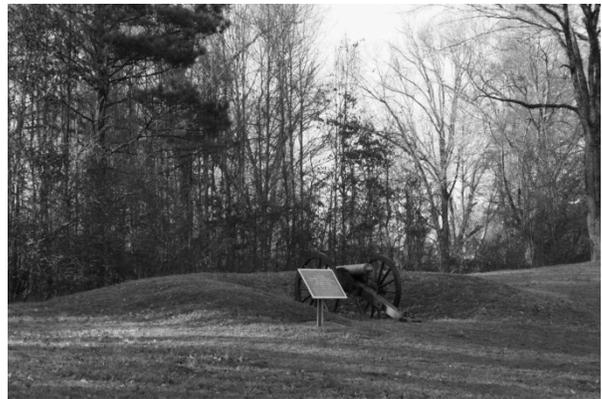
**FIGURE 76.** A cannon sitting into woodland, an example of how current vegetation is not consistent with historic conditions. There are many such examples within the park; this particular cannon is on Union Avenue, just south of Pemberton Avenue. This view is looking northwest.

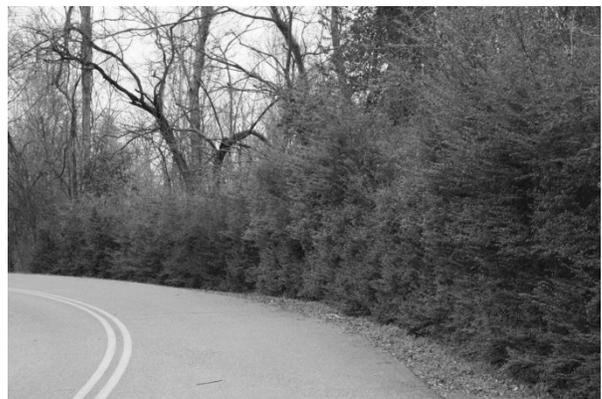
**FIGURE 77.** Privet forms a screen planting along the park boundary to the northeast of Grant Avenue.

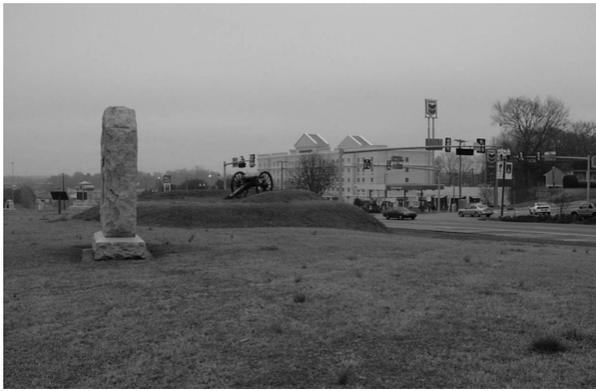
**FIGURE 80.** Clay Street is a heavily utilized municipal road that bisects the park, and services its main entrance. Commercial development on this road is visually intrusive to the historic character of the park. An overpass conveys Clay Street over an internal park tour road. This view is from south of the visitor center parking lot, looking southeast.

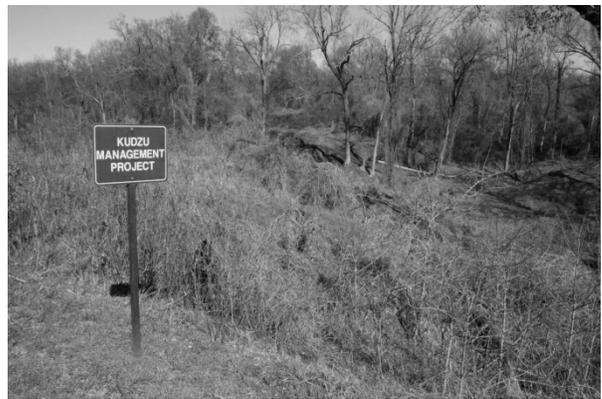
**FIGURE 92.** Looking northwest down into one of the park’s kudzu management areas, off the South Loop, north of Fort Garrott. The NPS is waging a constant battle to protect native vegetation from invasive species.

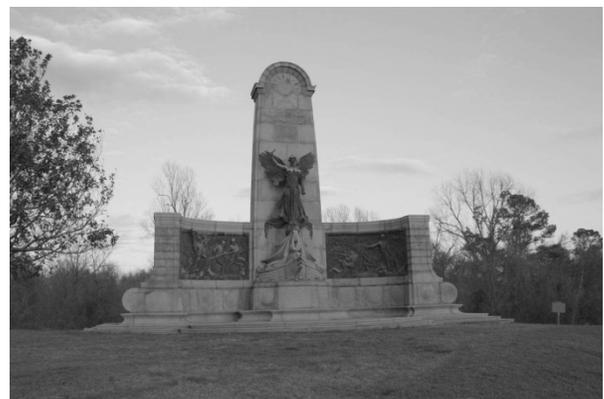
**FIGURE 107.** The Missouri State Memorial is one of the monuments that have been affected by the change in orientation of the tour road. Approached by Confederate Avenue as it curves gently to the west south of Graveyard Road, the monument is at first viewed from behind. This view is looking back toward the east.
