**President William Jefferson Clinton
Birthplace Home National Historic Site**
Hope, Arkansas

Historic Structures Report

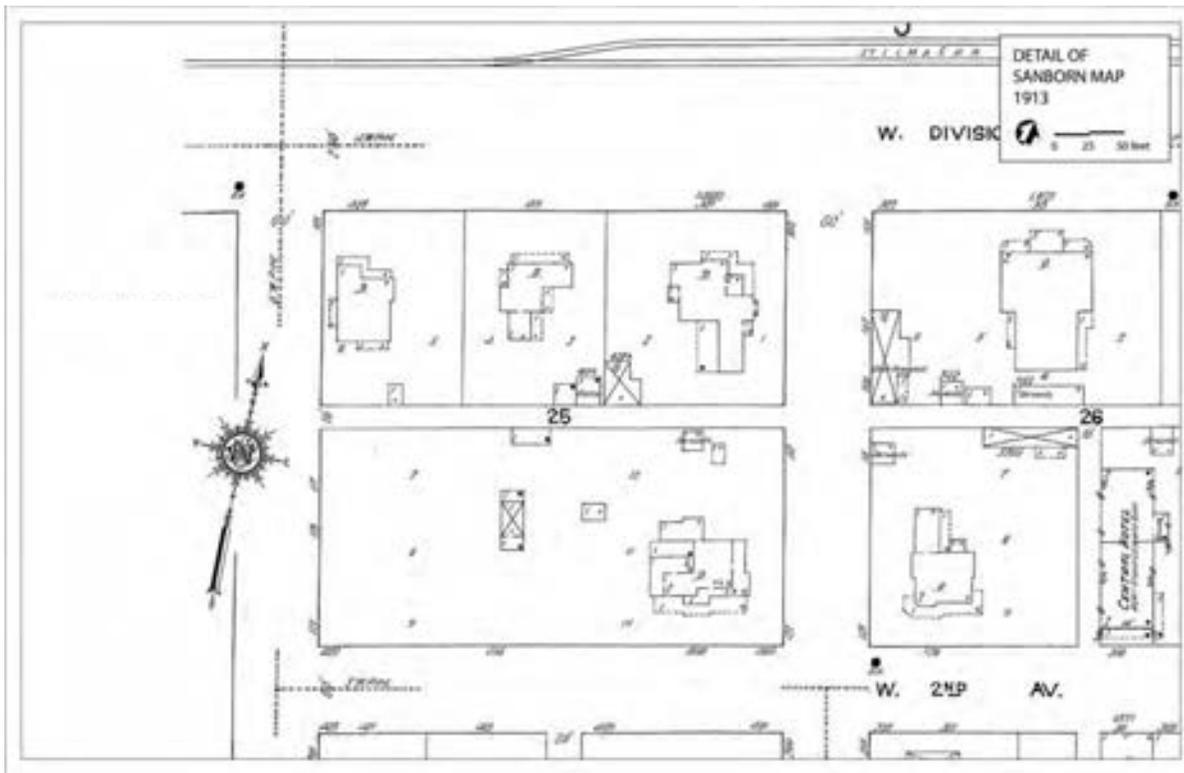
FIGURE 1. Detail of Sanborn Map, Hope, Arkansas, 1913. None of the buildings depicted in Block 25 exists today.

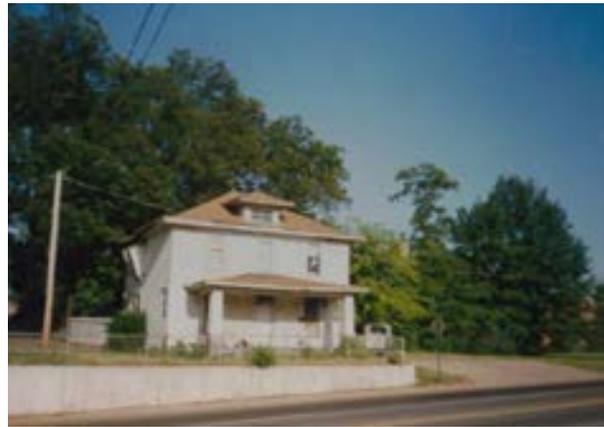
FIGURE 5. The Cassidy House, circa 1993. Photo from Clinton Birthplace Foundation collection, stored in NPS visitor center.

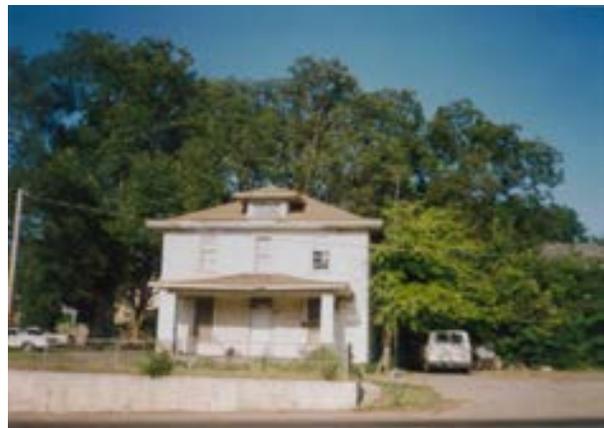
FIGURE 6. The Cassidy House, circa 1993. Photo from Clinton Birthplace Foundation collection, stored in NPS visitor center.

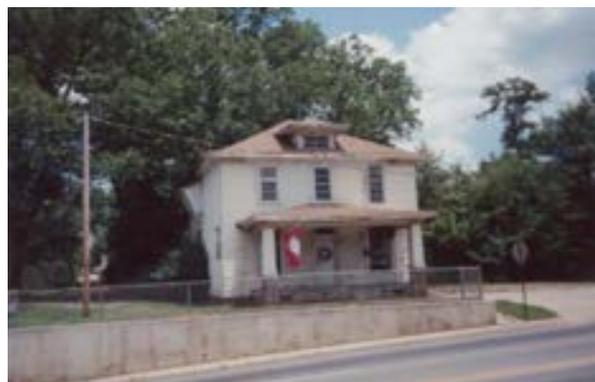
FIGURE 7. The Cassidy House, circa 1994. Photo from Clinton Birthplace Foundation collection, stored in NPS visitor center.

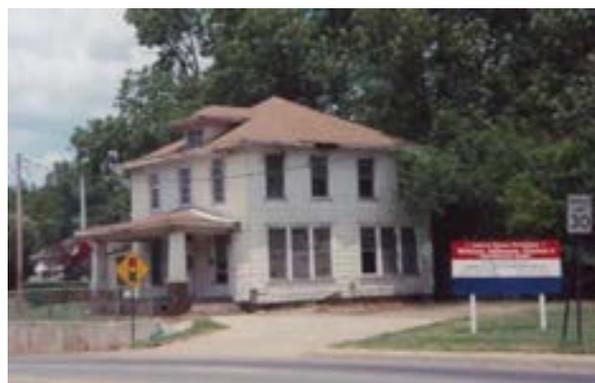
FIGURE 8. The Cassidy House, circa 1994. Photo from Clinton Birthplace Foundation collection, stored in NPS visitor center.

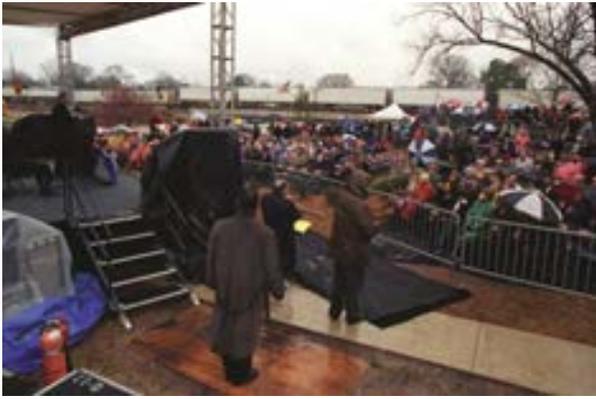
FIGURE 9. Bill Clinton speaks at the dedication of the Cassidy House, March 12, 1999. White House photograph, P70697_18.

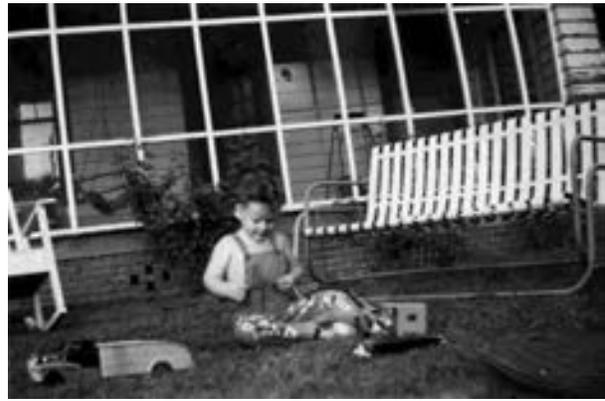
FIGURE 17. Three-year-old Billy Blythe playing in the front yard of the Cassidy House, August 25, 1949. The screened front porch is visible in the background. Note the divided light front door visible behind the porch screen, and the brick house foundation with vent detail. Also note porch light to the south of the door opening. Photo courtesy of the Clinton Family Photo Collection, William J. Clinton Presidential Library and Museum Archives, Little Rock, Arkansas.

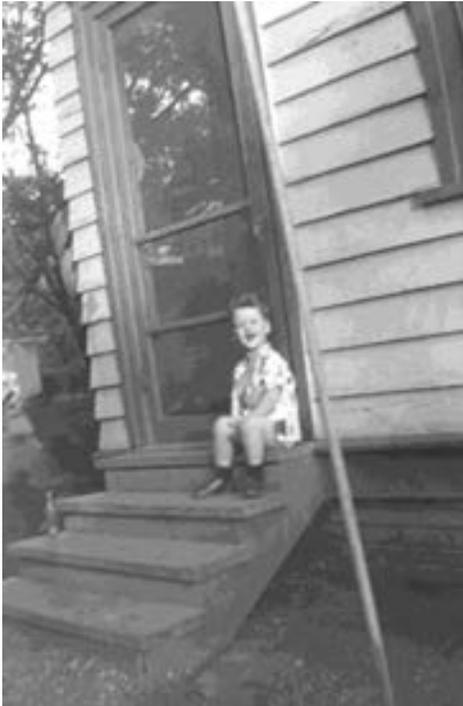
FIGURE 16. Billy Blythe sitting on the back porch steps of the Cassidy House, circa 1949, view looking southeast. The steps, screen door, and siding of the enclosed back porch are visible. Also visible in the background (and through the porch screens) are some of the large trees in the backyard of the house. Photo courtesy of the Clinton Family Photo Collection, William J. Clinton Presidential Library and Museum Archives, Little Rock, Arkansas.

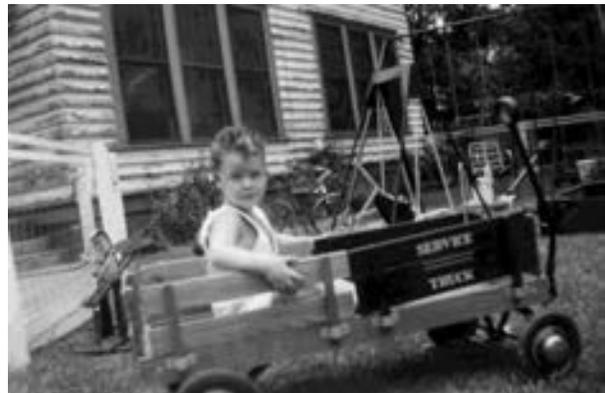
FIGURE 18. Three-year- old Billy Blythe in his wagon in the south side yard of the Cassidy House, with the house and play equipment visible in the background. Photo courtesy of the Clinton Family Photo Collection, William J. Clinton Presidential Library and Museum Archives, Little Rock, Arkansas.

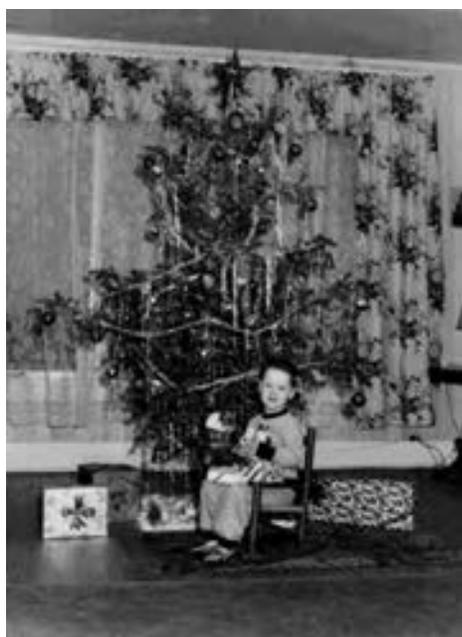
FIGURE 19. Billy Blythe in front of the family Christmas tree in the living room of the Cassidy House, December 7, 1949. This image shows the fabric and pattern of the curtains as well as the wallpaper. Photo courtesy of the Clinton Family Photo Collection, William J. Clinton Presidential Library and Museum Archives, Little Rock, Arkansas.

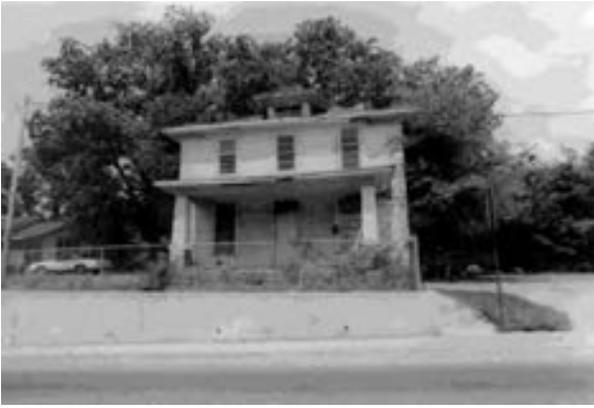
FIGURE 21. West facade of Cassidy House, June 1993. Note the poor condition of the roof overhangs, the non-historic windows at the west side of the second floor, and the flat panel entrance door. Photo from National Register Nomination, Bill Clinton Birthplace, 1994.

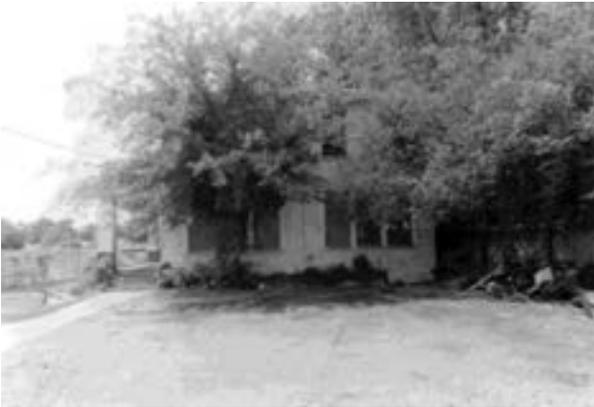
FIGURE 22. South exterior side of the Cassidy House, June 1993. Note the concrete sidewalk and steps leading to the front porch and the wall-mounted utilities between the first floor windows. Photo from National Register Nomination, Bill Clinton Birthplace, 1994.

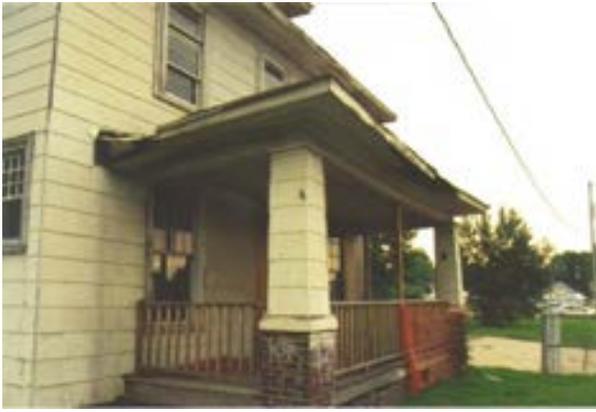
FIGURE 25. Main facade of Cassidy House prior to renovation, circa 1994–1995. Note the non-original window sash at the second floor and unpainted porch railing. Photo by Charley Penix from the Clinton Home Restoration Scrapbook by Cromwell Architects, 1997, page 13.

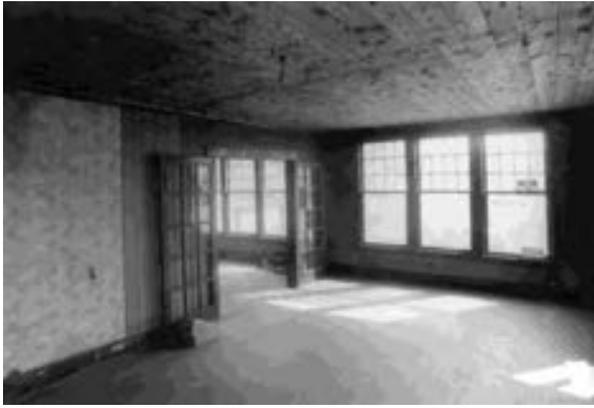
FIGURE 26. Interior of the living room, June 1993. Note the dark painted wood trim, wood veneer paneling over wallpaper, and previously removed ceiling finish. The French doors to the dining room are intact. Photo from National Register Nomination, Bill Clinton Birthplace, 1994.

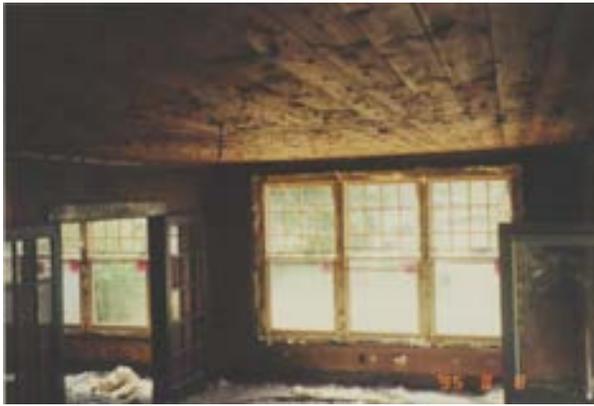
FIGURE 27. View of interior living room looking south, August 8, 1995. The windows have already been replaced as part of the exterior renovation. Photo by Terry Huitt from the Clinton Home Restoration Scrapbook prepared by Cromwell Architects, 1997, page 20.

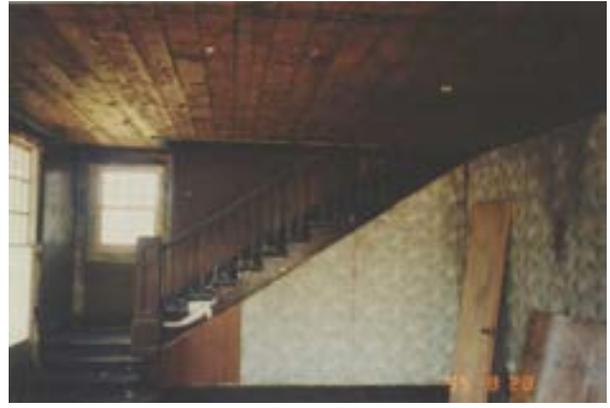
FIGURE 28. View of interior living room looking north toward the staircase, August 28, 1995. This view shows the appearance of the interior after the removal of ceiling wallpaper finishes. At the walls, portions of non-original wood veneer paneling have been removed, exposing older wallpaper finishes. The wall at the right side of the image is where the fireplace is located. Photo by Terry Huitt from the Clinton Home Restoration Scrapbook prepared by Cromwell Architects, 1997, page 20.

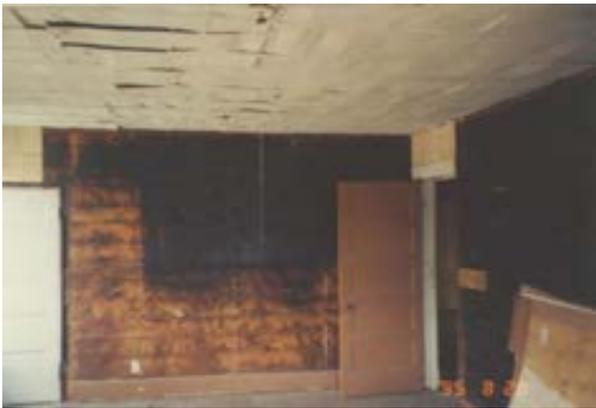
FIGURE 31. View of the west bedroom looking north, August 28, 1995. Note the fire damage, acoustic tile ceiling, and remnants of wood veneer paneling. Photo by Terry Huitt from the Clinton Home Restoration Scrapbook prepared by Cromwell Architects, 1997, page 22.

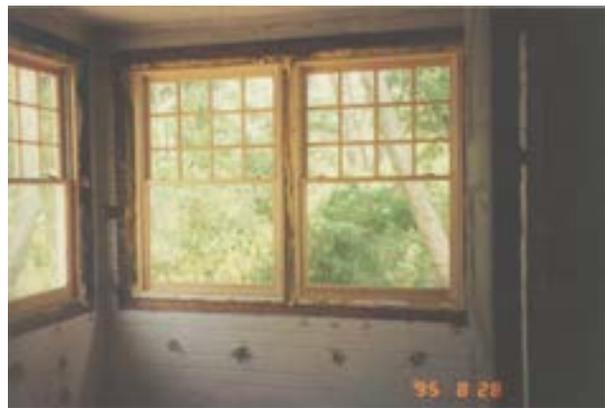
FIGURE 33. View of the north bedroom looking east, August 28, 1995. Photo by Terry Huitt from the Clinton Home Restoration Scrapbook prepared by Cromwell Architects, 1997, page 23.

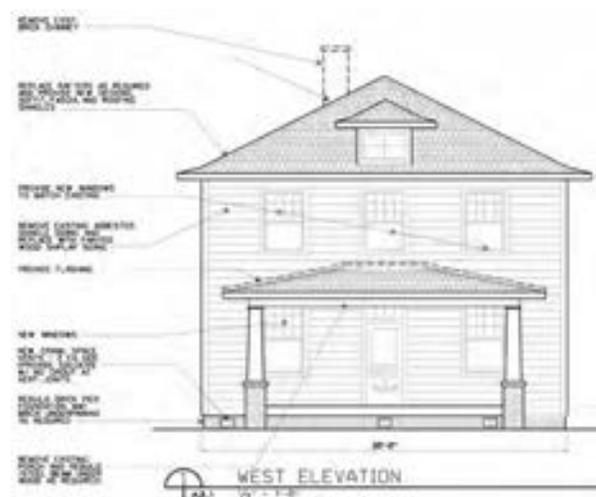
FIGURE 34. Excerpt of Cromwell Architects Engineers drawing A3.1 showing the west elevation renovation. Although removal of the chimney is indicated on these drawings, photographs from prior to the project indicate that the chimney had already been removed prior to the work. Refer to Figure 5 through Figure 8.

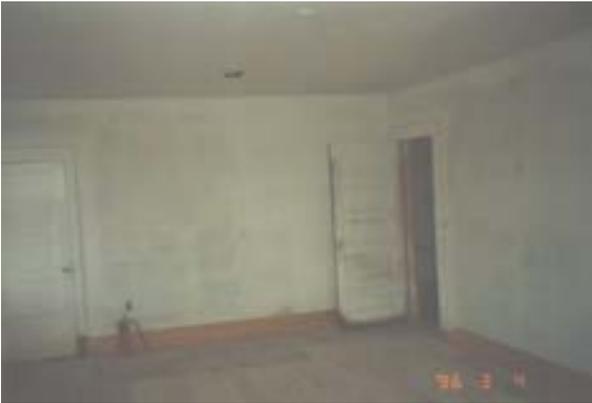
FIGURE 56. Interior of the west bedroom, March 4, 1996. New gypsum board finishes have been primed, and fire-damaged portions of the hardwood floor have been replaced. Photo by Terry Huitt from the Clinton Home Restoration Scrapbook prepared by Cromwell Architects, 1997, page 30.

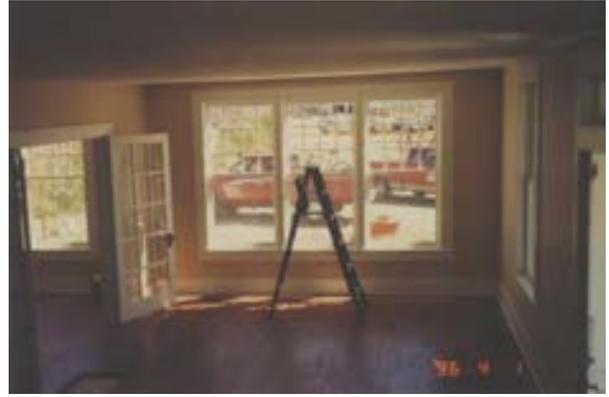
FIGURE 57. View of interior living room looking south showing the room near completion, April 1, 1996. Interior finishes are in place, new windows have been installed, new wood trim has been installed and painted, and the floor refinshed. Photo by Terry Huitt from the Clinton Home Restoration Scrapbook prepared by Cromwell Architects, 1997, page 31.

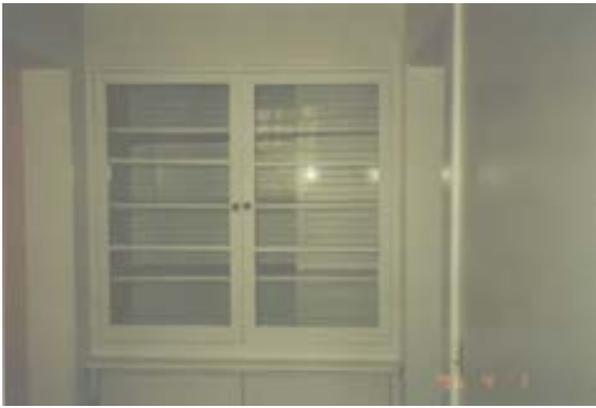
FIGURE 60. Interior of the hallway near completion, April 1, 1996, showing repainted built-in china cabinet. Photo by Terry Huiitt from the Clinton Home Restoration Scrapbook prepared by Cromwell Architects, 1997, page 32.

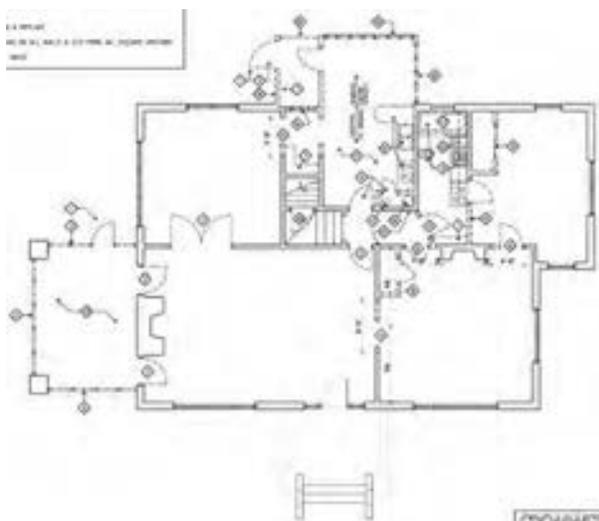
FIGURE 61. Excerpt of Cromwell Architects Engineers drawing A1.2 showing the first floor demolition for the visitor center.

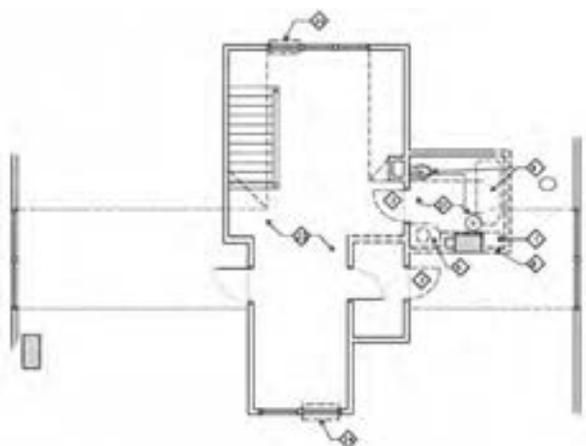
FIGURE 62. Excerpt of Cromwell Architects Engineers drawing A1.2 showing the second floor demolition for the visitor center.

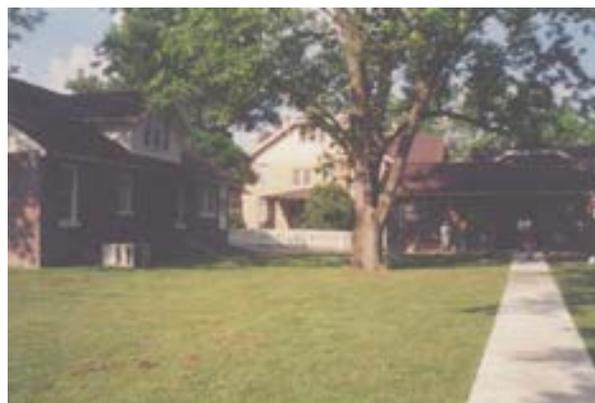
FIGURE 63. View of the visitor center and comfort station from the west, circa summer 1997. Photo by Terry Huitt from the Clinton Home Restoration Scrapbook prepared by Cromwell Architects, 1997, page 39.

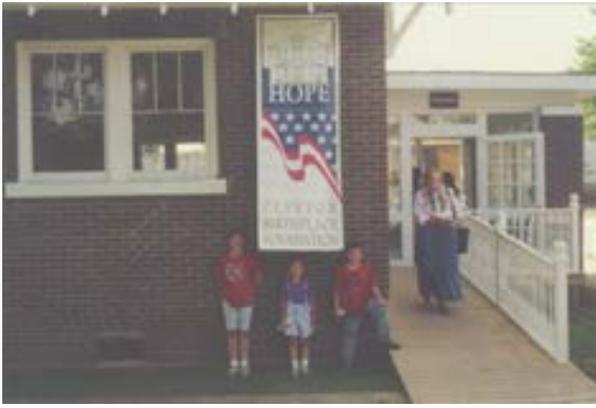
FIGURE 64. View of the south side of the visitor center showing east porch entrance ramp, circa summer 1997. Photo by Terry Huitt from the Clinton Home Restoration Scrapbook prepared by Cromwell Architects, 1997, page 39.

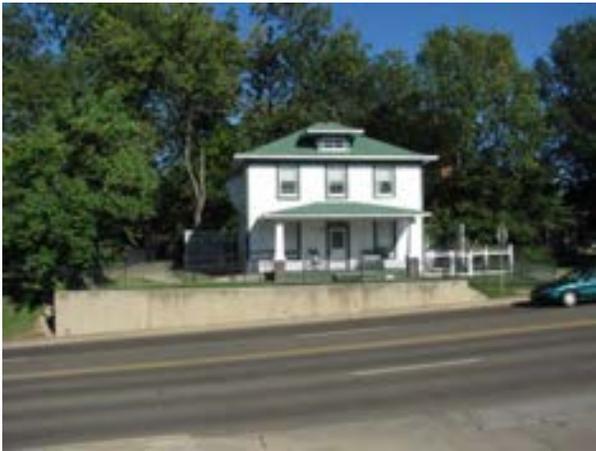
FIGURE 65. A view of the Cassidy House from the west with Hervey Street in the foreground. Photograph by WJE, October 15, 2012.

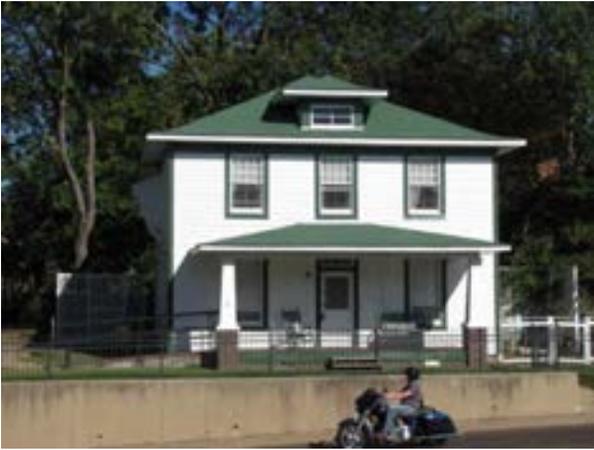
FIGURE 66. The west elevation of the Cassidy House. Photograph by WJE, October 15, 2012.

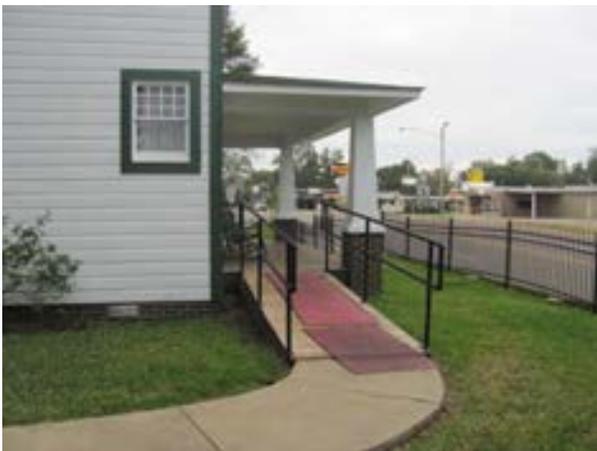
FIGURE 71. A view of the wood ramp leading to the front porch. Photograph by WJE, October 16, 2012.

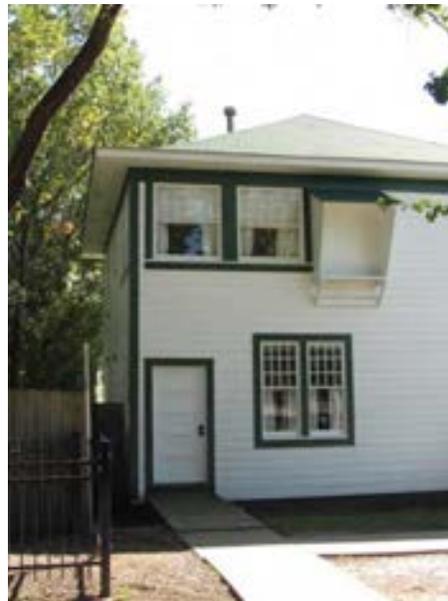
FIGURE 72. A view of the end of the north elevation showing the two, eighteen-over-one windows at the second floor and the wood fan enclosure. Photograph by WJE, October 15, 2012.

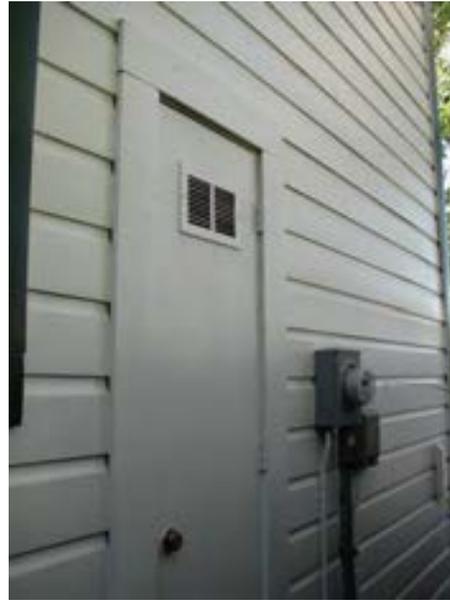
FIGURE 75. A view of the mechanical closet door and the building's gas and electric meters. Photograph by WJE, October 15, 2012.

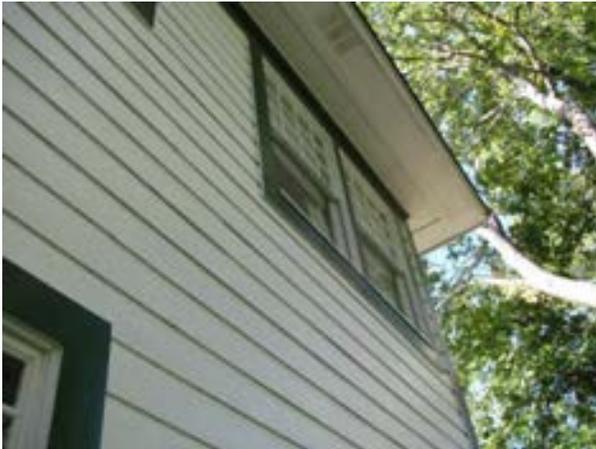
FIGURE 77. The set of double-hung windows at the north end of the east elevation. Photograph by WJE, October 15, 2012.

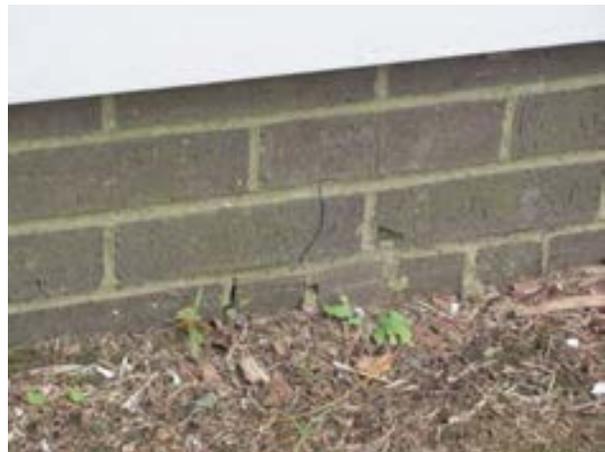
FIGURE 78. Step cracking is present in the brick masonry foundation. Photograph by WJE, October 16, 2012.

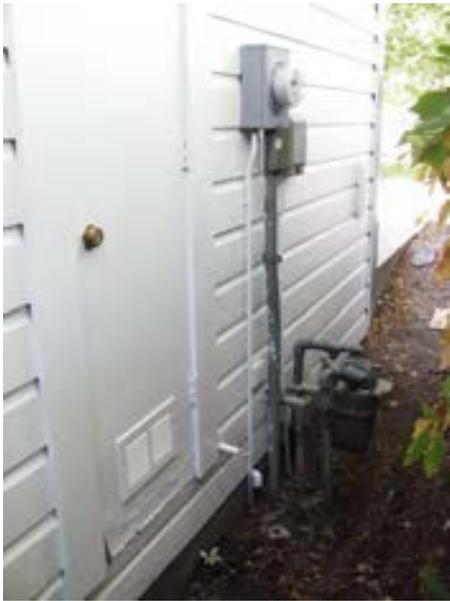
FIGURE 79. The base of the mechanical closet door shows signs of water damage. Photograph by WJE, October 15, 2012.

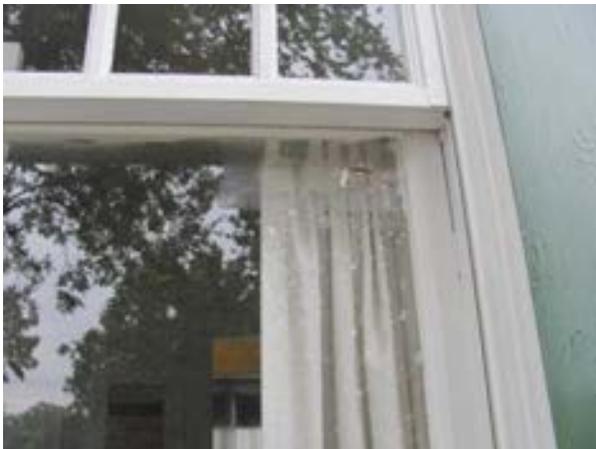
FIGURE 80. Cracked window glass was observed in several locations. Photograph by WJE, October 16, 2012.

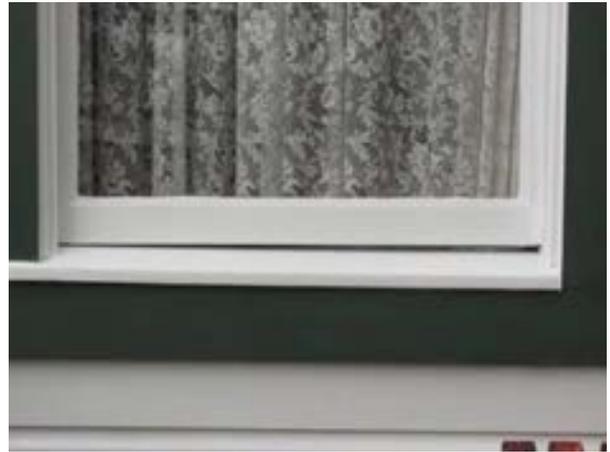
FIGURE 81. View of a window that is unable to fully close due to the settlement of the house. Photograph by WJE, October 16, 2012.

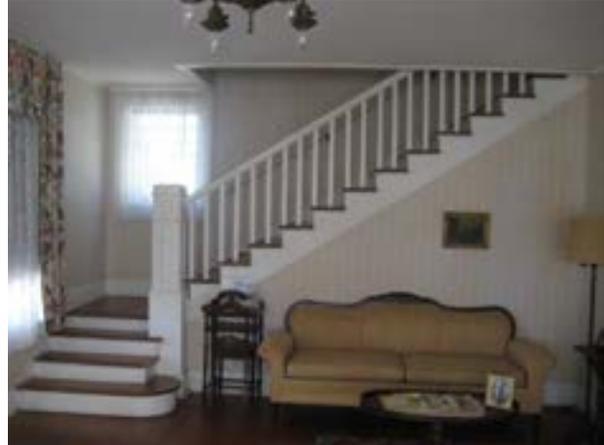
FIGURE 84. Living room looking north. Photograph by BVH, October 16, 2012.

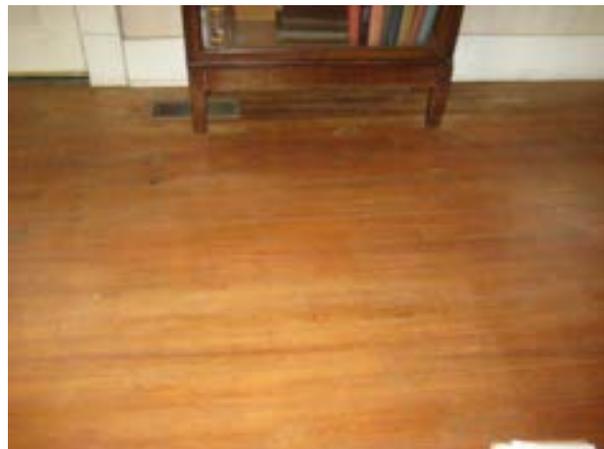
FIGURE 85. Living room floor looking west at front door. Photograph by BVH, October 16, 2012.

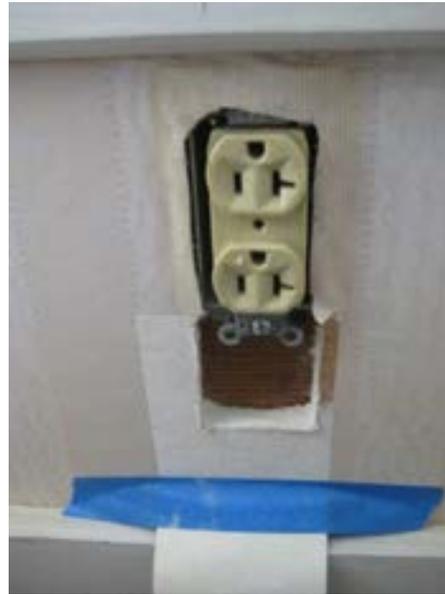
FIGURE 87. Material assembly of wall construction, showing the horizontal half-lap wood wall boards behind the gypsum board, located below the south window of the living room. Photograph by BVH, October 16, 2012.

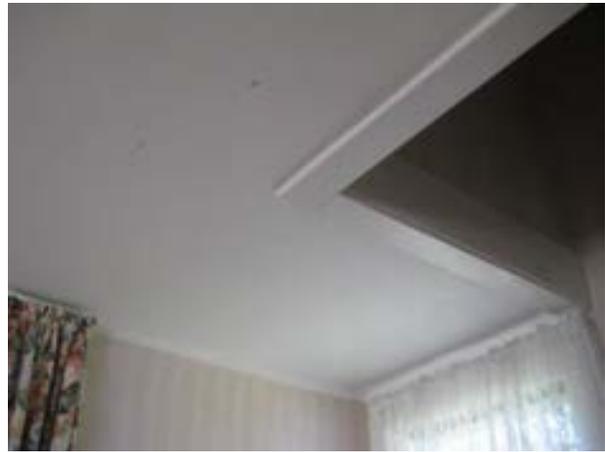
FIGURE 91. Ceiling cornice and trim at stair opening, replaced at time of the 1996 work, looking northwest in the living room. Photograph by BVH, October 16, 2012.

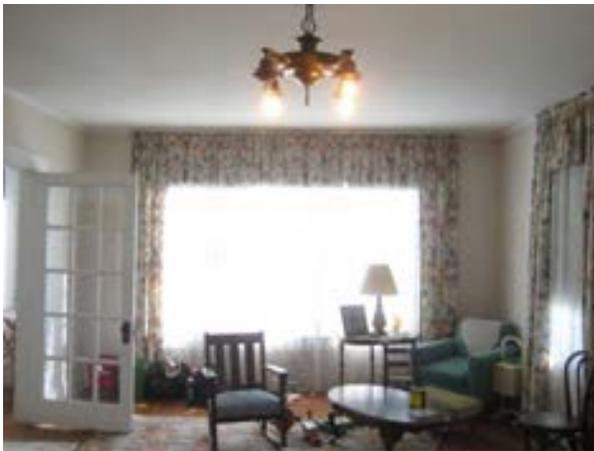
FIGURE 92. Living room ceiling looking south, with chandelier in the center of the room. Photograph by BVH, October 16, 2012.

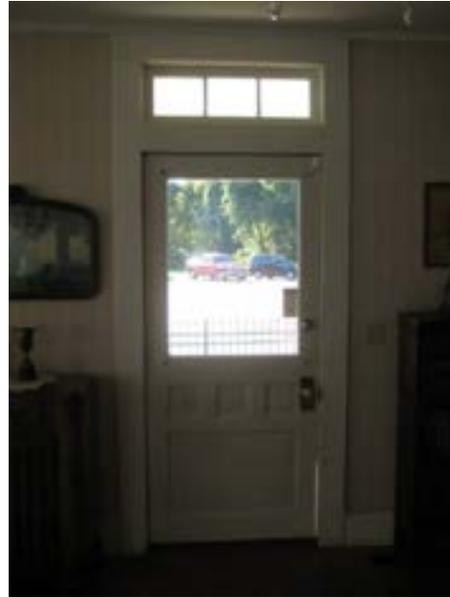
FIGURE 93. Front door of the house looking west. Photograph by BVH, October 16, 2012.

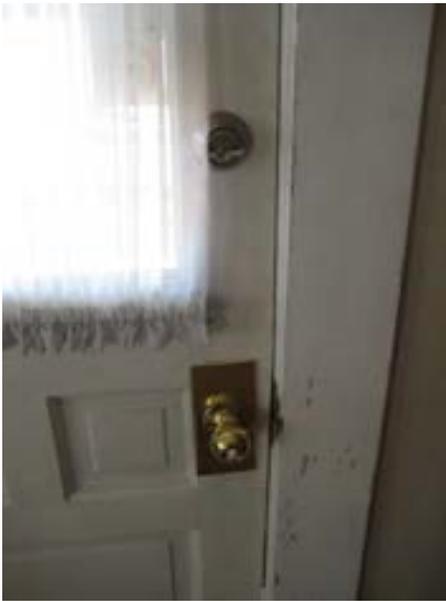
FIGURE 94. Front door hardware. Photograph by BVH, October 16, 2012.

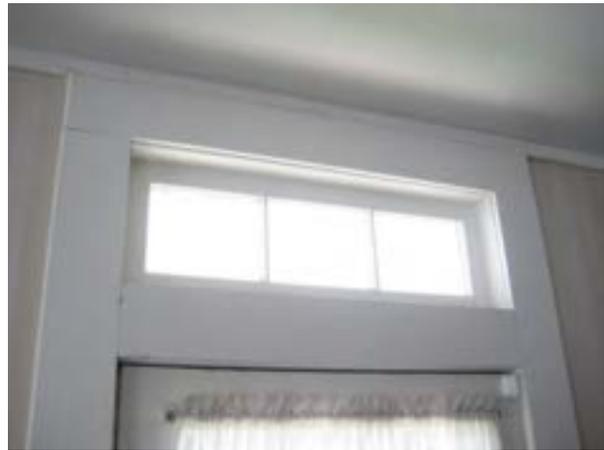
FIGURE 95. Front door transom. Photograph by BVH, October 16, 2012.

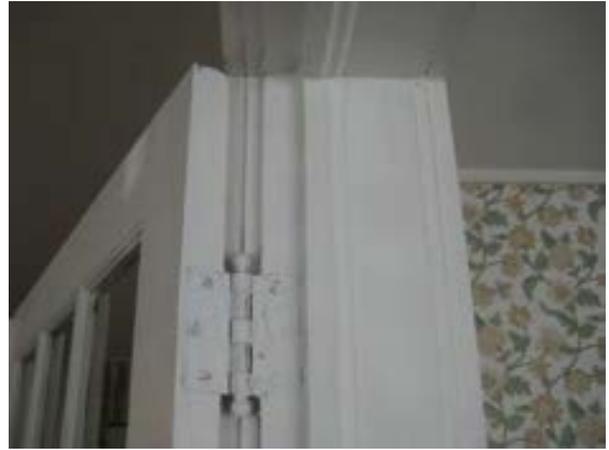
FIGURE 99. Built up layers of wall assembly, looking north. Photograph by BVH, October 16, 2012.

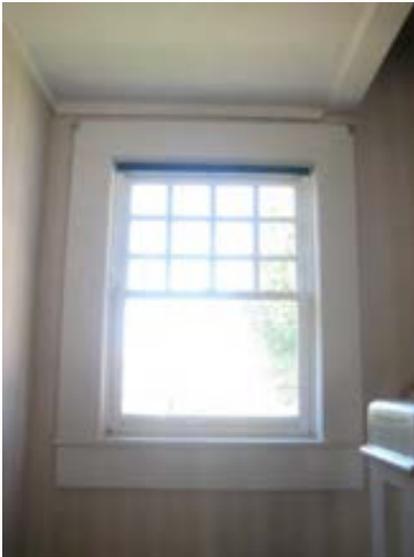
FIGURE 100. Small window at stair landing, north wall of living room. Photograph by BVH, October 16, 2012.

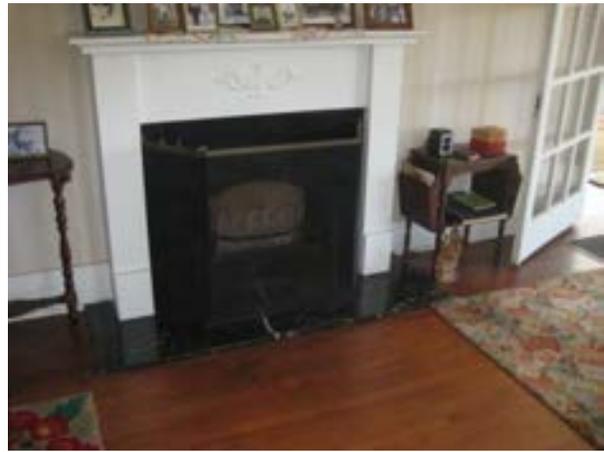
FIGURE 101. Fireplace in the living room located on the east wall. Photograph by BVH, October 16, 2012.

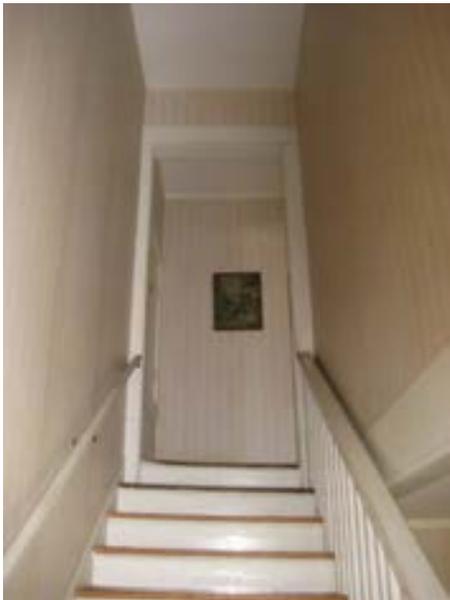
FIGURE 103. Upper run of stairs with original rail at right, and added safety rail at left, looking east. Photograph by BVH, October 16, 2012.

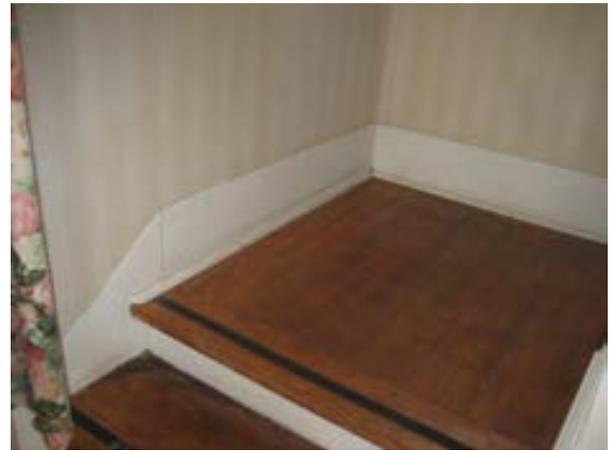
FIGURE 104. Note that the wall base in the northwest corner is original and flush with later added gypsum board. Photograph by BVH, October 16, 2012.

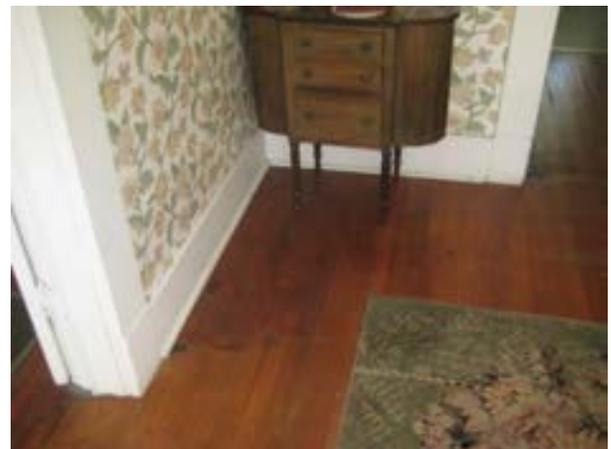
FIGURE 105. Note the flooring along the east wall of the dining room is not staggered, denoting a patch in the floor. Photograph by BVH, October 16, 2012.

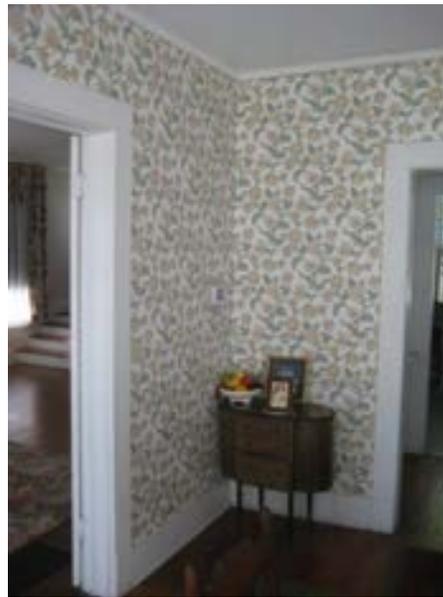
FIGURE 107. Northwest corner of the dining room. Photograph by BVH, October 16, 2012.

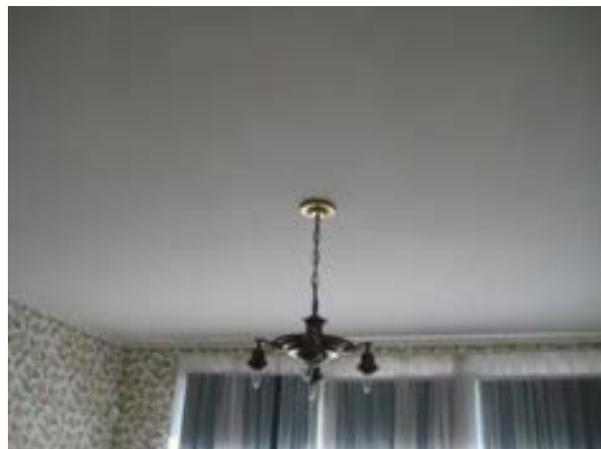
FIGURE 108. Ceiling and chandelier in the dining room. Photograph by BVH, October 16, 2012.

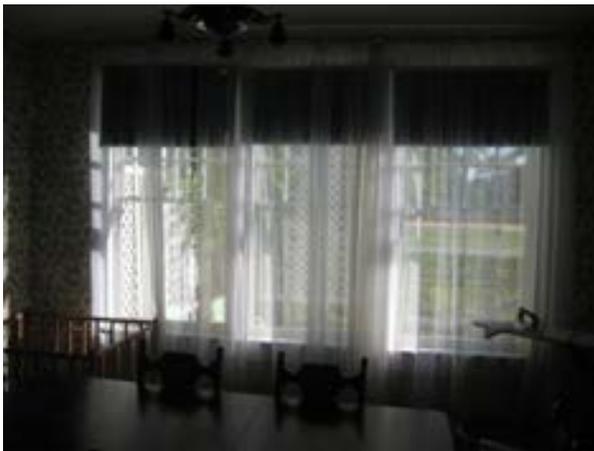
FIGURE 109. South window group in the dining room. Photograph by BVH, October 16, 2012.

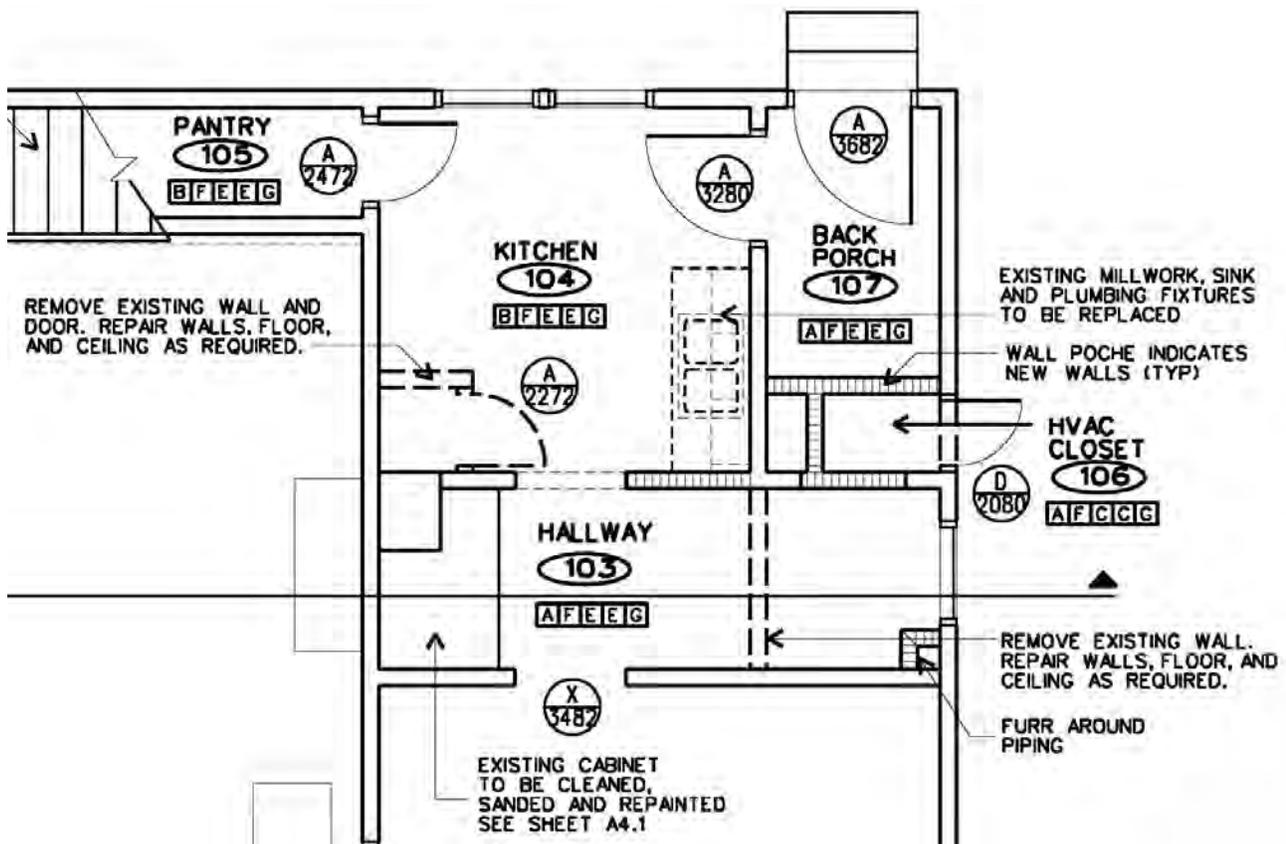
FIGURE 110. Excerpt of Cromwell Architects Engineers drawing A1.1, project 93-074, showing changes to the partitions and layout of the hallway, kitchen, and back porch as implemented in 1996.

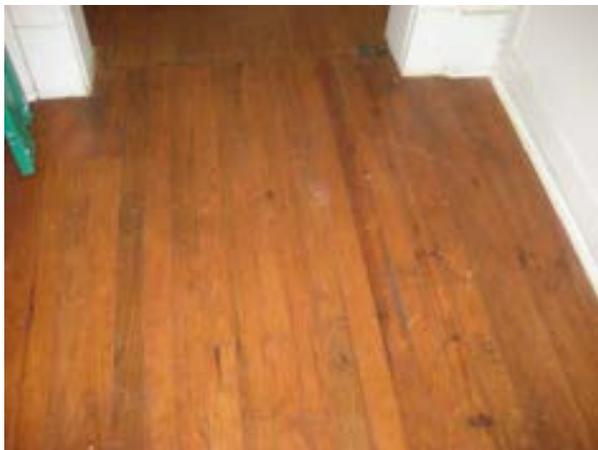
FIGURE 111. Transition of original floor of dining room at top, and hallway floor at bottom, looking south. Photograph by BVH, October 16, 2012.

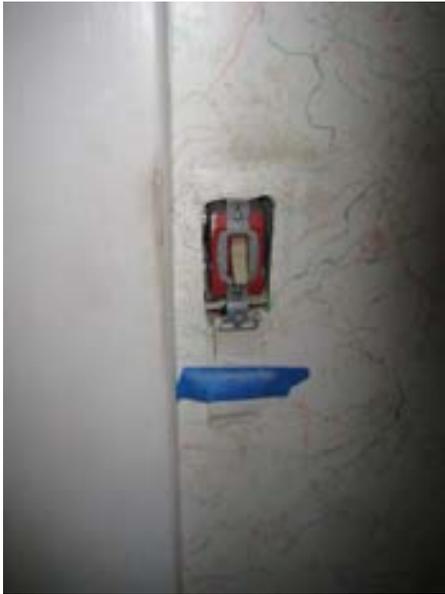
FIGURE 112. Material assembly of wall construction, showing the new wood wall studs behind the gypsum board, located on the north wall. Photograph by BVH, October 16, 2012.

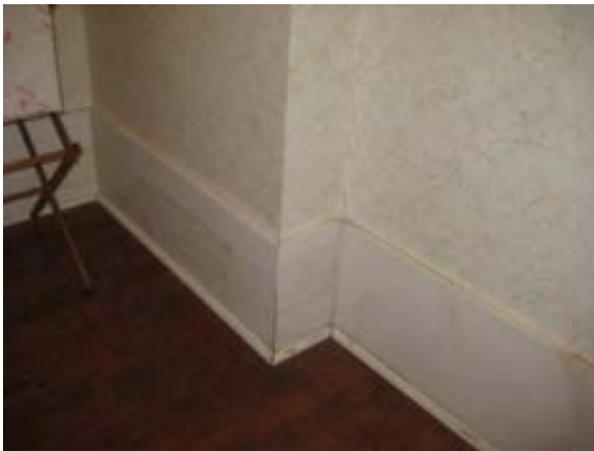
FIGURE 113. Southeast corner of the hallway showing replacement base that is considerably taller than elsewhere in the house. Photograph by BVH, October 16, 2012.

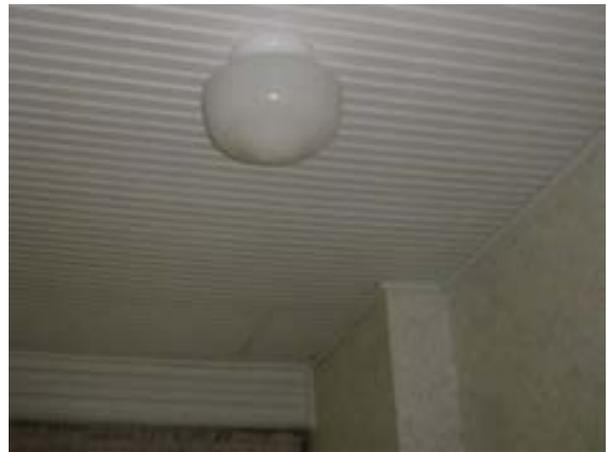
FIGURE 114. Hallway ceiling and light fixture. Photograph by BVH, October 16, 2012.

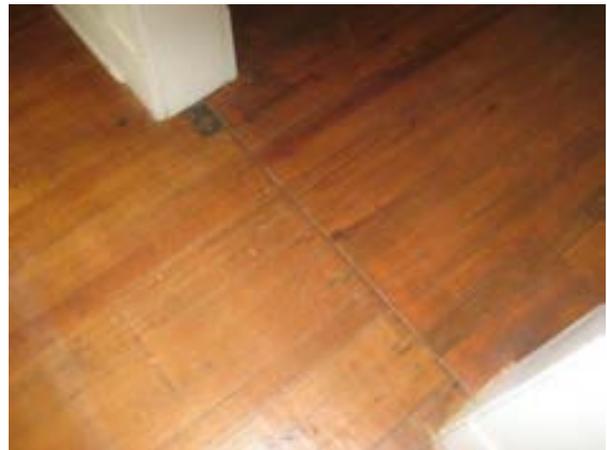
FIGURE 115. Evidence of hardware for a pivot pin where a swinging door was located, between the dining room and hallway. Photograph by BVH, October 16, 2012.

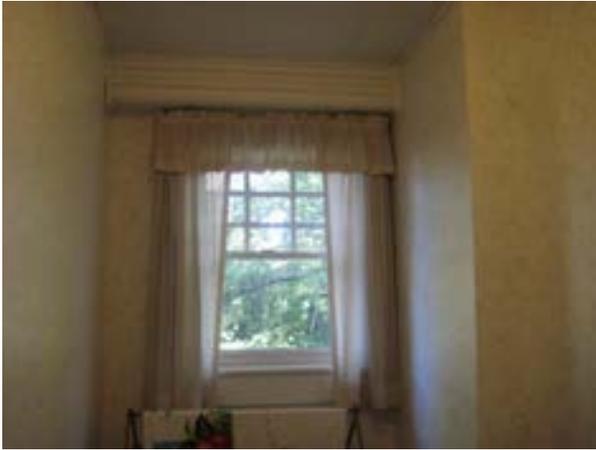
FIGURE 116. The nine-over-one window located on the east wall of the hallway. Photograph by BVH, October 16, 2012.

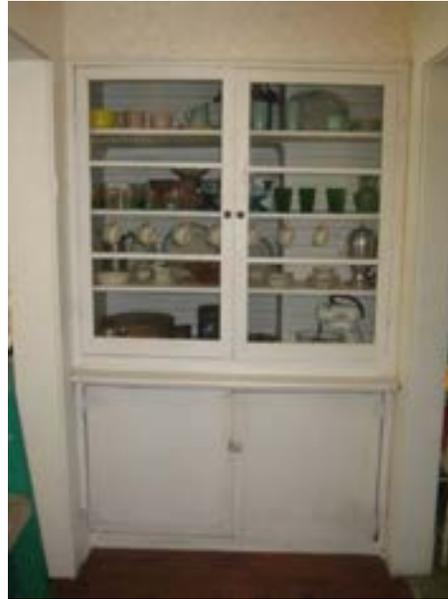
FIGURE 117. China cabinet located across the west wall of the hallway. Photograph by BVH, October 16, 2012.

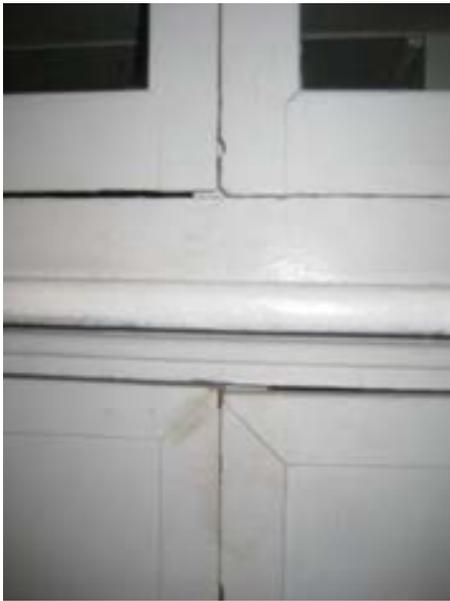
FIGURE 119. Two types of door construction; the lower doors are replacements. Photograph by BVH, October 16, 2012.

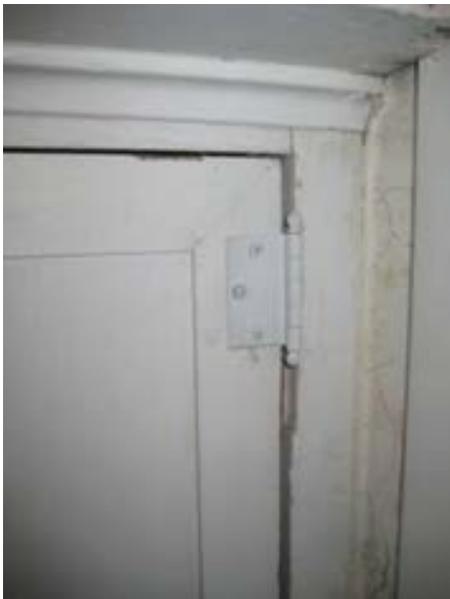
FIGURE 120. Newer face hinges, and evidence where previous hinges were located evidenced by the mortise in the frame below. Photograph by BVH, October 16, 2012.

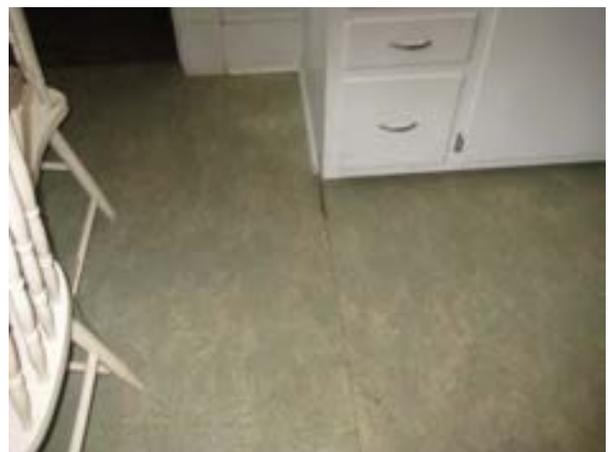
FIGURE 122. Seam between sheets of flooring in the kitchen running east and west is showing signs of wear. Photograph by BVH, October 16, 2012.

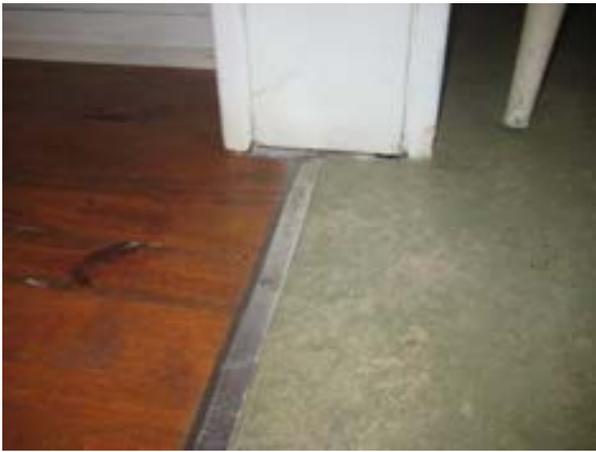
FIGURE 123. Metal transition strip between kitchen and hallway floors. Photograph by BVH, October 16, 2012.

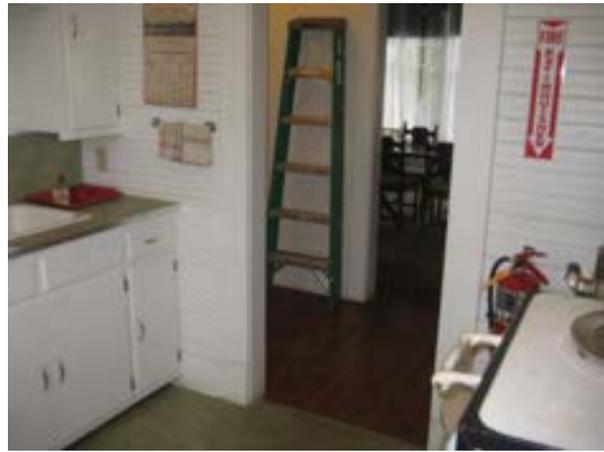
FIGURE 124. The south wall of the kitchen in the foreground was removed after the period of significance, and rebuilt as part of the 1996 work. Photograph by BVH, October 16, 2012.

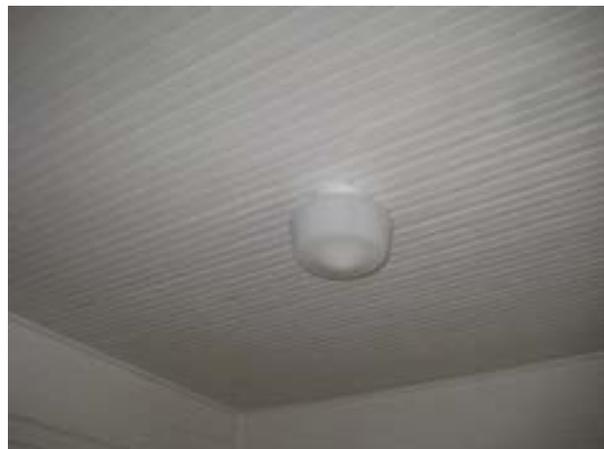
FIGURE 125. Tongue-and-groove kitchen ceiling. Photograph by BVH, October 16, 2012.

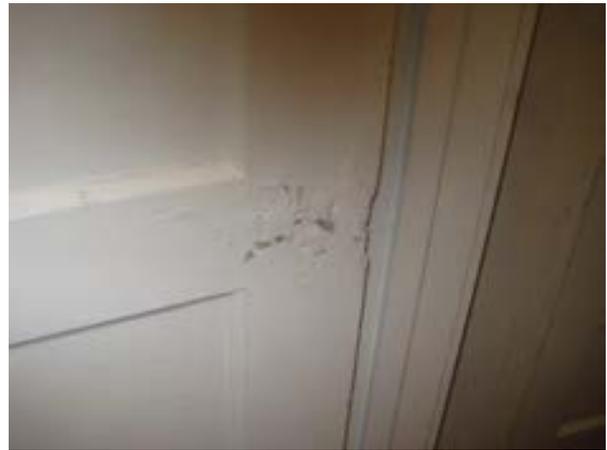
FIGURE 127. Back porch door located in the northeast corner of the kitchen. Note that the panels are not raised, and the infilled door knob at the hinge side of the door. Photograph by BVH, October 16, 2012.

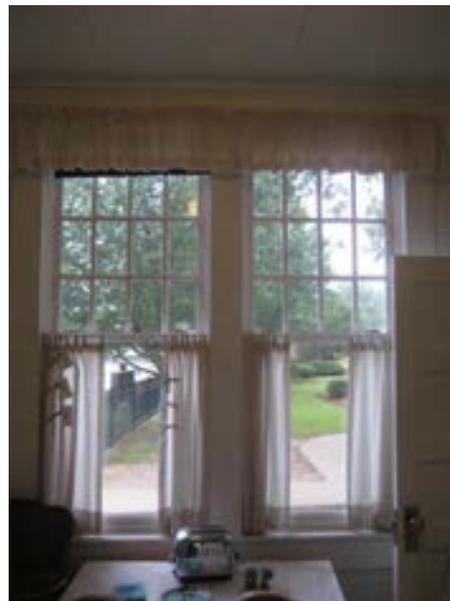
FIGURE 128. Two twelve-over-one windows on the north wall of the kitchen. Photograph by BVH, October 16, 2012.
