**President William Jefferson Clinton
Birthplace Home National Historic Site**
Hope, Arkansas

Historic Structures Report

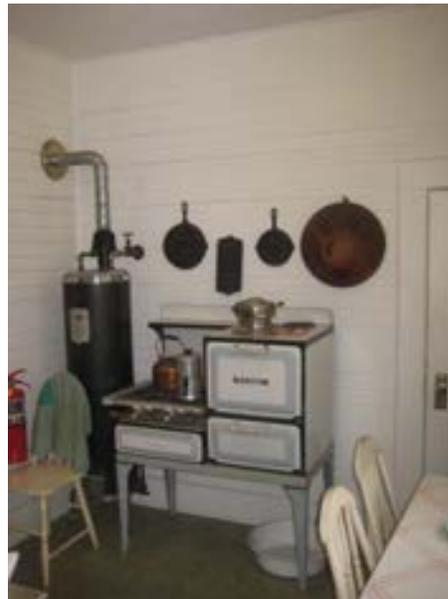
FIGURE 131. Kitchen appliances located on the west wall of the kitchen. Photograph by BVH, October 16, 2012.

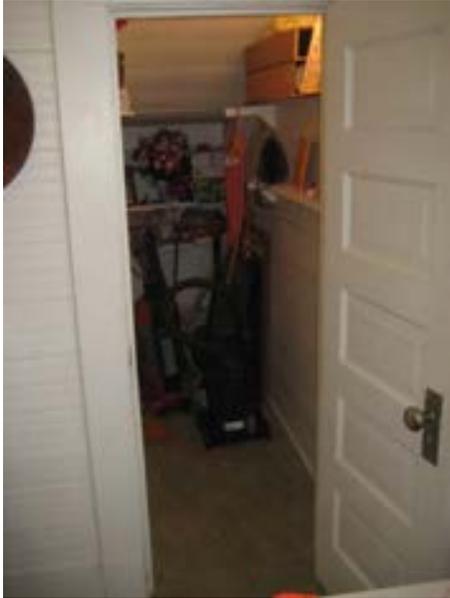
FIGURE 132. Pantry located under the stairs, accessed from the northwest corner of the kitchen. Photograph by BVH, October 16, 2012.

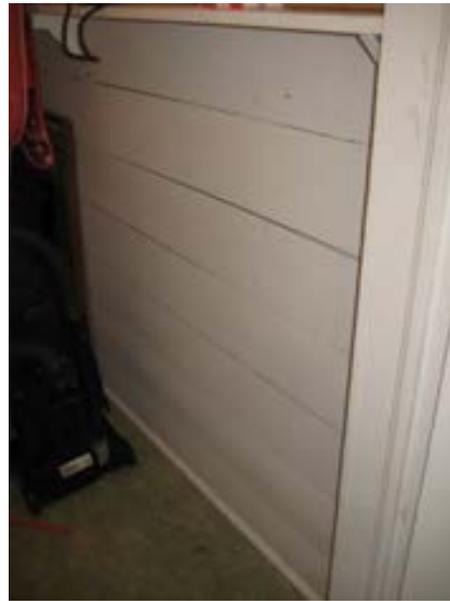
FIGURE 133. Wall assembly in the pantry, looking north. Photograph by BVH, October 16, 2012.

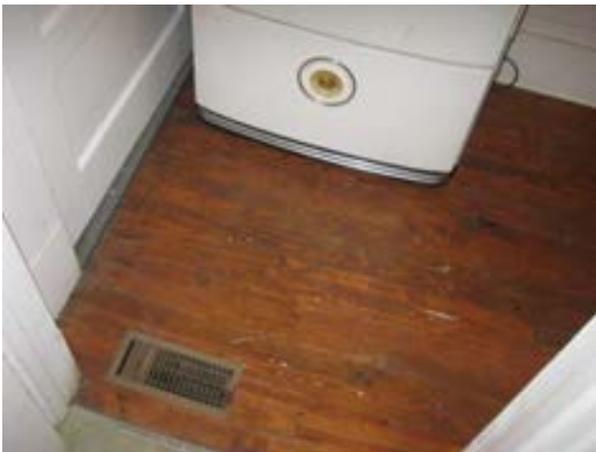
FIGURE 135. Floor of the back porch looking east. Photograph by BVH, October 16, 2012.

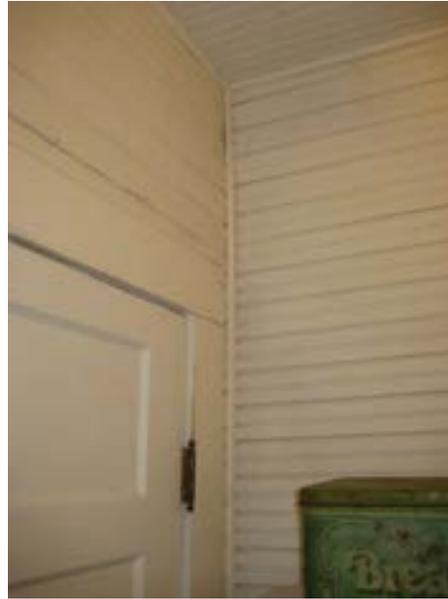
FIGURE 136. The beadboard on the wall above the door on the north wall is original, but the beadboard on the east wall dates from the 1996 work. Photograph by BVH, October 16, 2012.

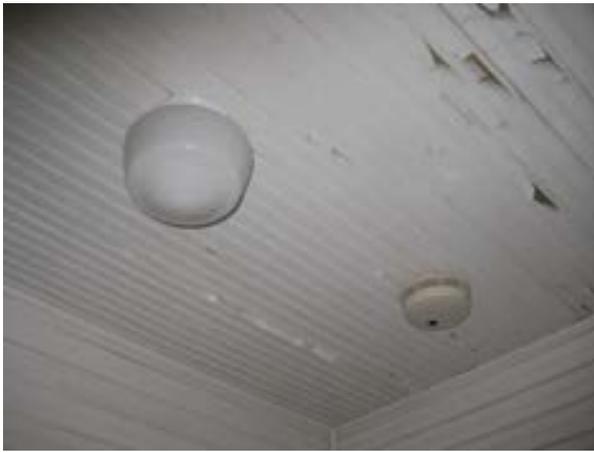
FIGURE 137. Light fixture and peeling paint of the ceiling of the back porch. Photograph by BVH, October 16, 2012.

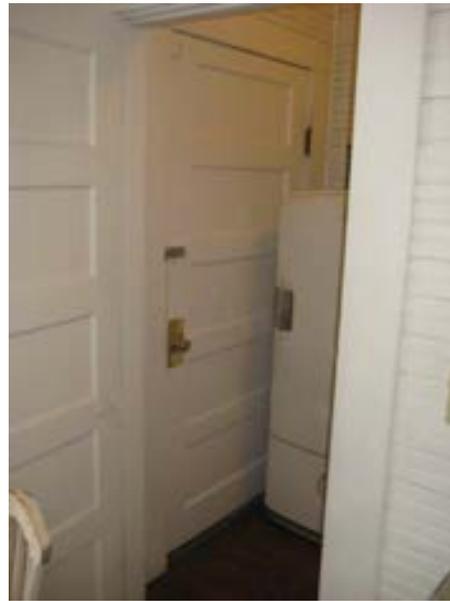
FIGURE 138. Exterior north door on the north side of the back porch. Photograph by BVH, October 16, 2012.

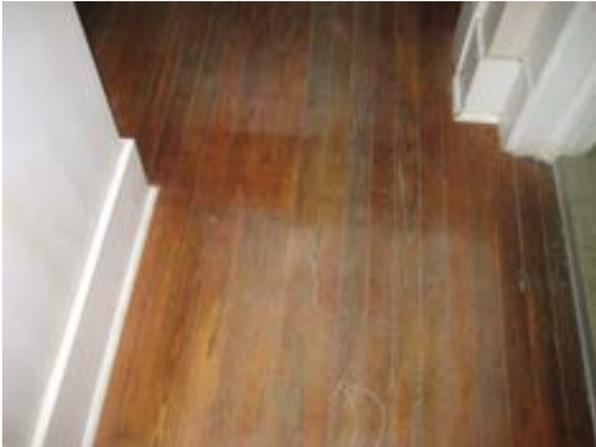
FIGURE 139. Floor of the second floor hall looking north. Photograph by BVH, October 16, 2012.

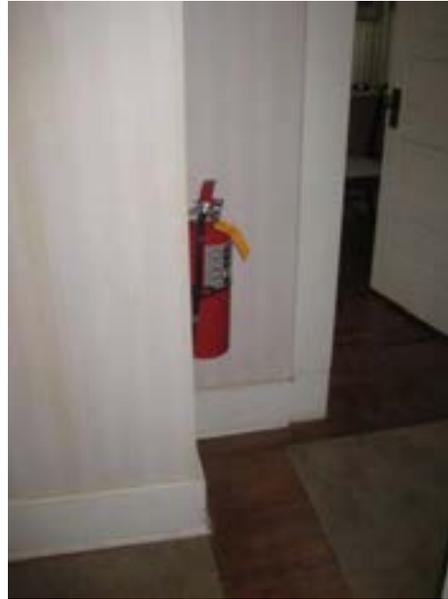
FIGURE 140. West wall assembly of the second floor hall. Photograph by BVH, October 16, 2012.

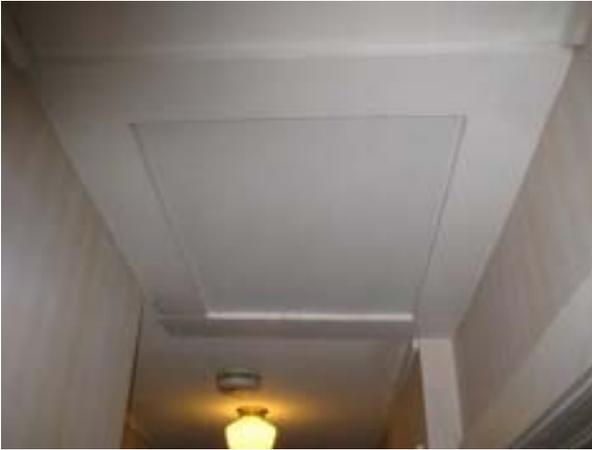
FIGURE 142. Ceiling of the second floor hall with hatch to the attic looking north. Photograph by BVH, October 16, 2012.

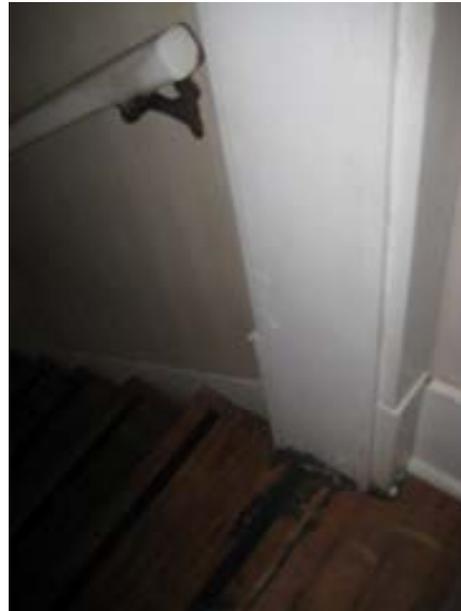
FIGURE 143. Door frame with missing stop and door at the top of the stairs, looking north. Photograph by BVH, October 16, 2012.

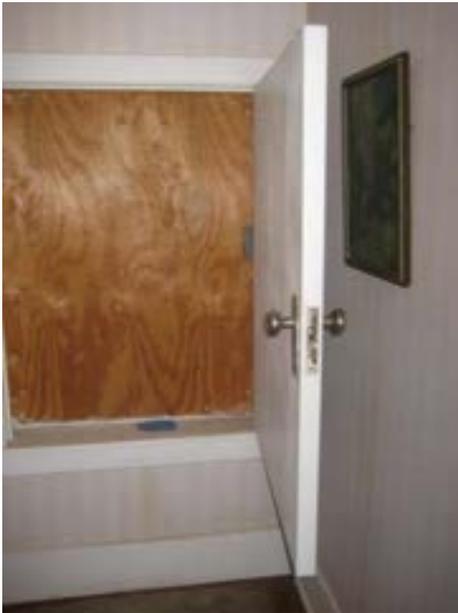
FIGURE 144. Hollow core door and plywood north wall where the exhaust fan used to be. Photograph by BVH, October 16, 2012.

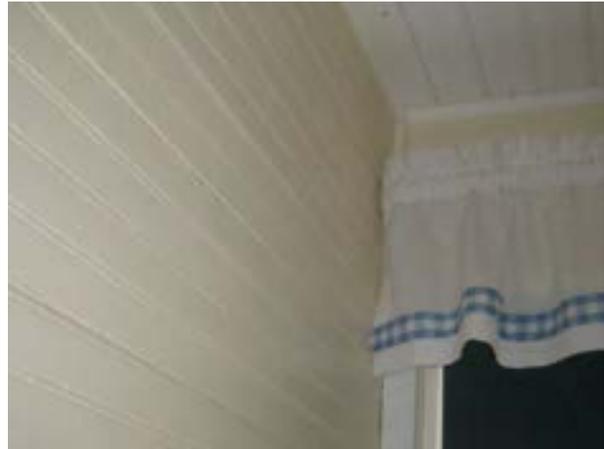
FIGURE 145. Wall assembly of the west wall in bedroom 202. Photograph by BVH, October 16, 2012.

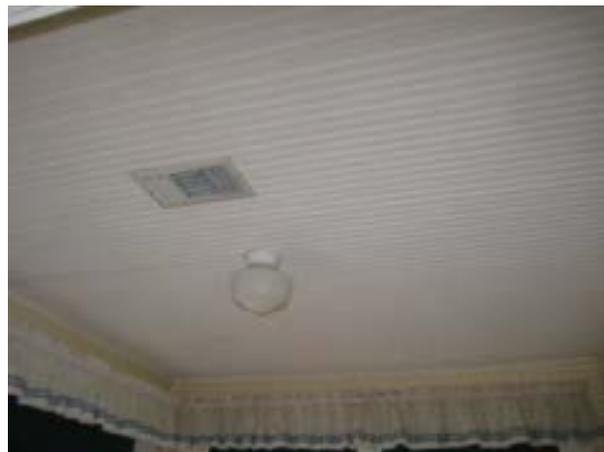
FIGURE 146. Ceiling of the bedroom with light fixture, looking east. Photograph by BVH, October 16, 2012.

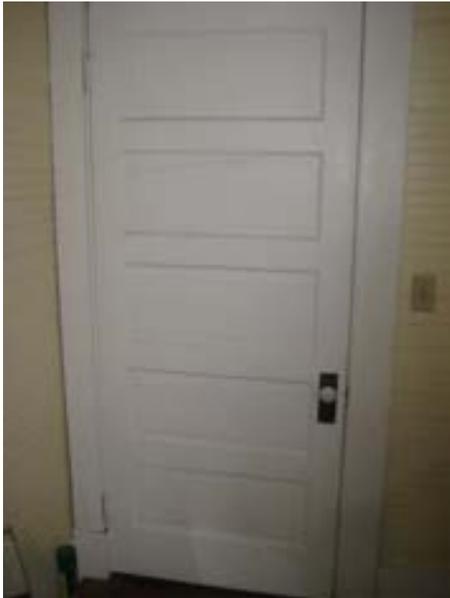
FIGURE 147. Raised panel door on the west wall with porcelain knob. Photograph by BVH, October 16, 2012.

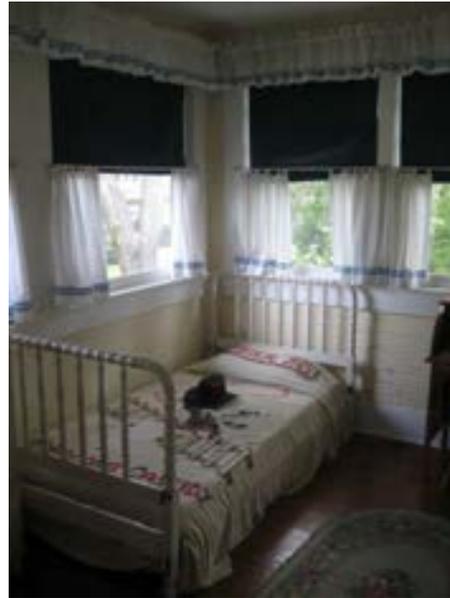
FIGURE 148. The windows of the bedroom virtually fill the east and north walls of the room. Photograph by BVH, October 16, 2012.

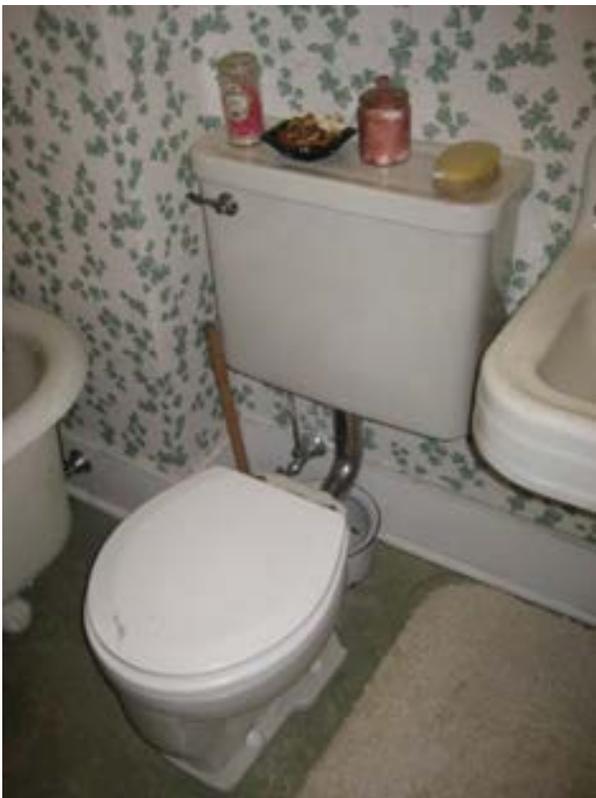
FIGURE 150. Toilet located along the center of the south wall of the bathroom. Photograph by BVH, October 16, 2012.

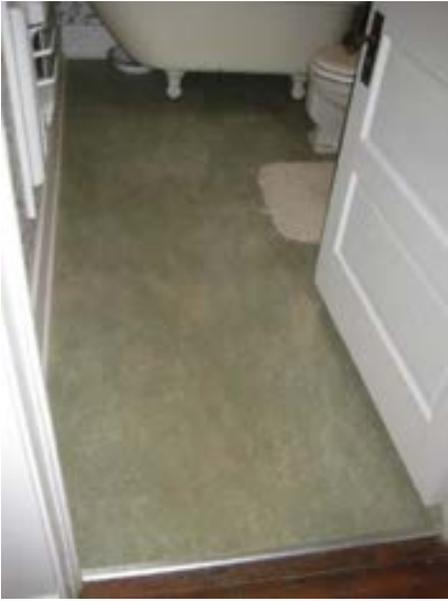
FIGURE 152. Flooring in the bathroom with a metal transition strip at the door to the hall, looking east. Photograph by BVH, October 16, 2012.

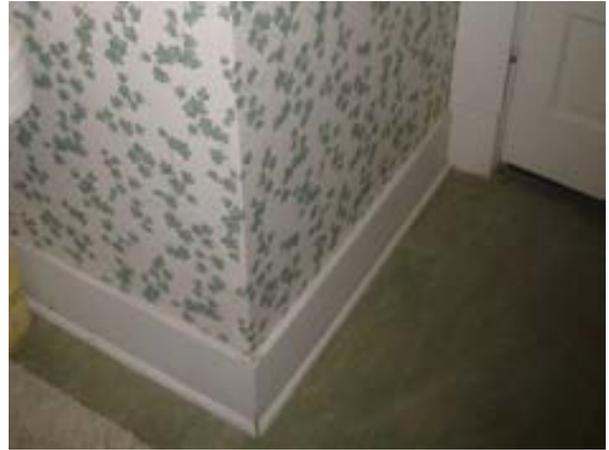
FIGURE 153. Bathroom walls with wall base, looking south. Photograph by BVH, October 16, 2012.

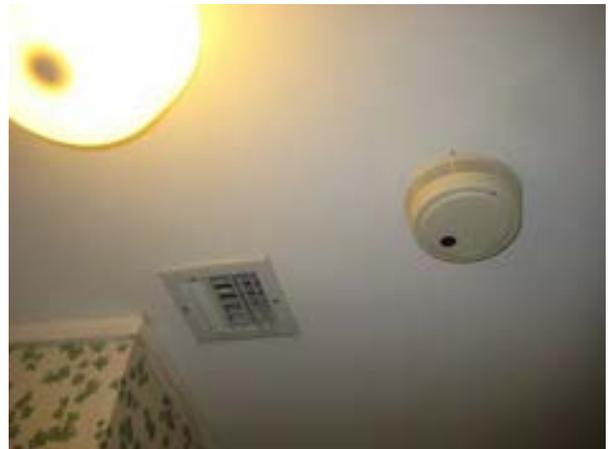
FIGURE 154. Ceiling and light fixture in the bathroom. Photograph by BVH, October 16, 2012.

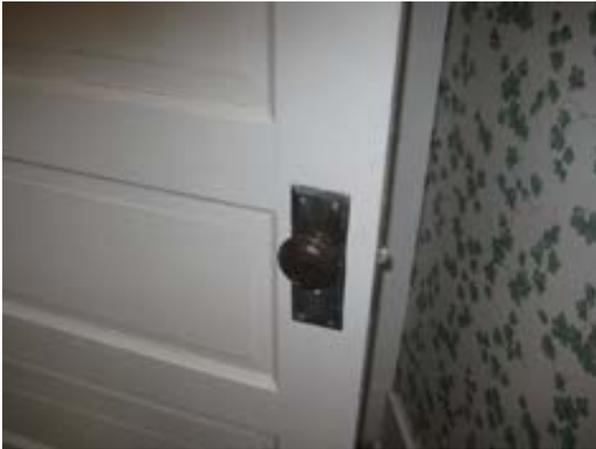
FIGURE 155. Bathroom door located on the west wall of the bathroom. Photograph by BVH, October 16, 2012.

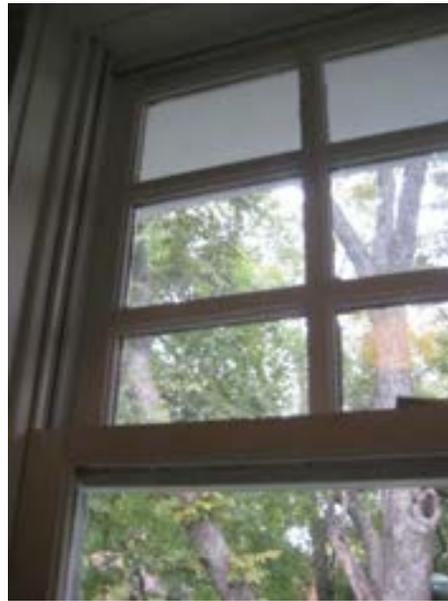
FIGURE 156. Bathroom window located on the east wall of the room. Photograph by BVH, October 16, 2012.

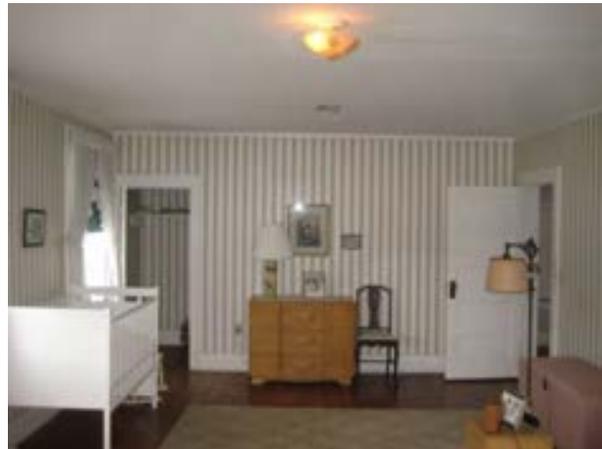
FIGURE 157. North wall of Virginia Blythe's bedroom. Photograph by BVH, October 16, 2012.

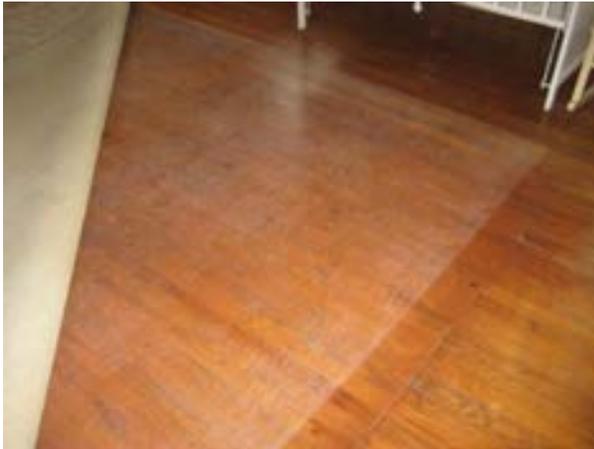
FIGURE 158. The continuous seam in the floor denotes the replacement portion of the floor due to the fire. The original flooring is at right, looking west. Photograph by BVH, October 16, 2012.

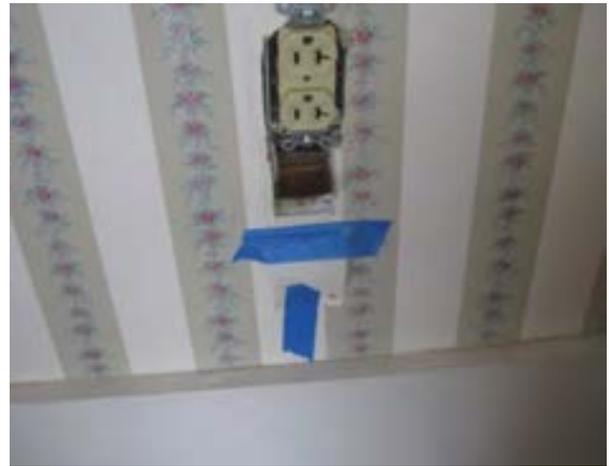
FIGURE 159. Material assembly of wall construction, showing the horizontals half-lap wood wall boards behind the gypsum board, located south of the door on the east wall. Photograph by BVH, October 16, 2012.

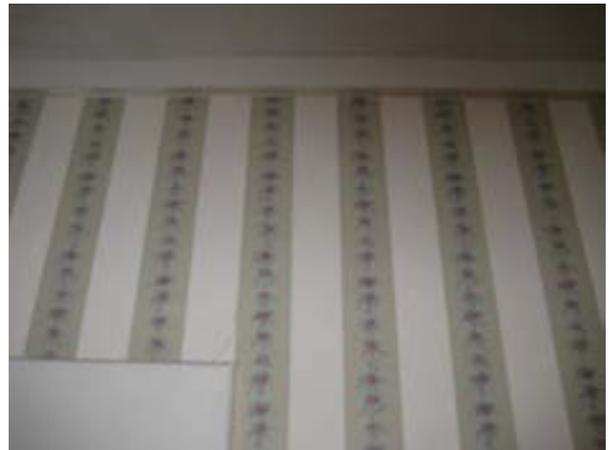
FIGURE 160. Wallpaper and new cornice on the east wall of bedroom 204. Photograph by BVH, October 16, 2012.

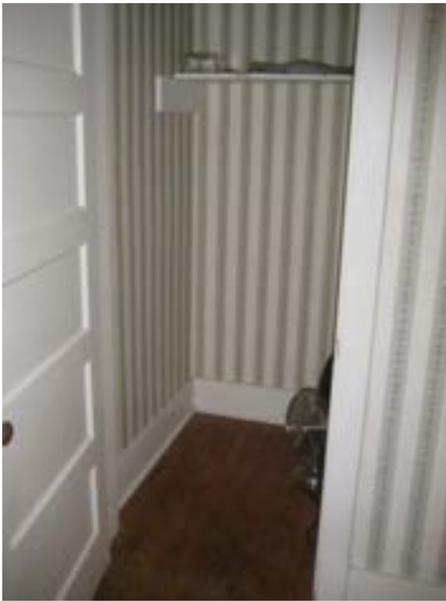
FIGURE 161. Walls of the closet, located in the northwest corner of the room, which were originally exposed half-lap boards, painted, much like the pantry. Photograph by BVH, October 16, 2012.

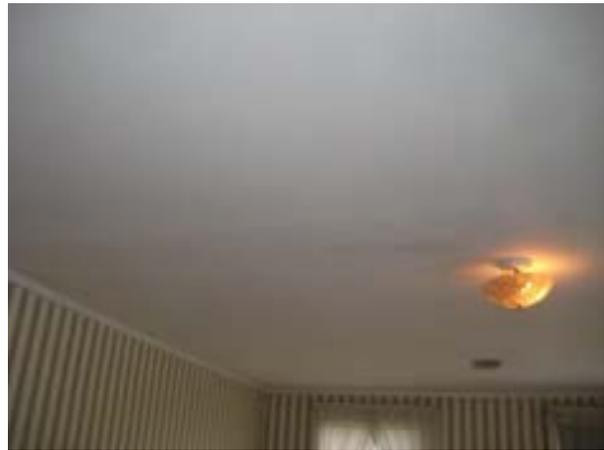
FIGURE 162. The ceiling and pink glass light shade in bedroom 204. Photograph by BVH, October 16, 2012.

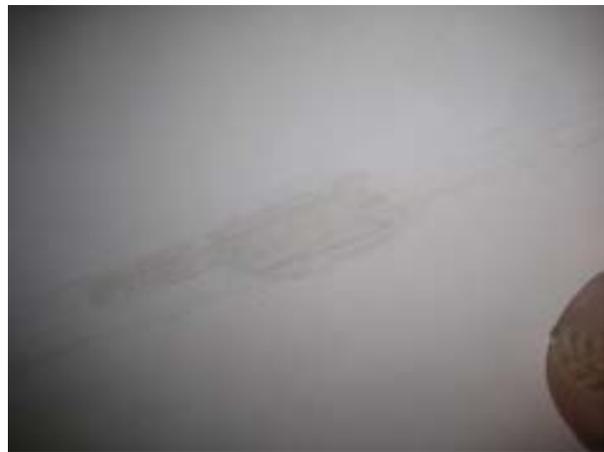
FIGURE 163. Water staining on the ceiling. Photograph by BVH, October 16, 2012.

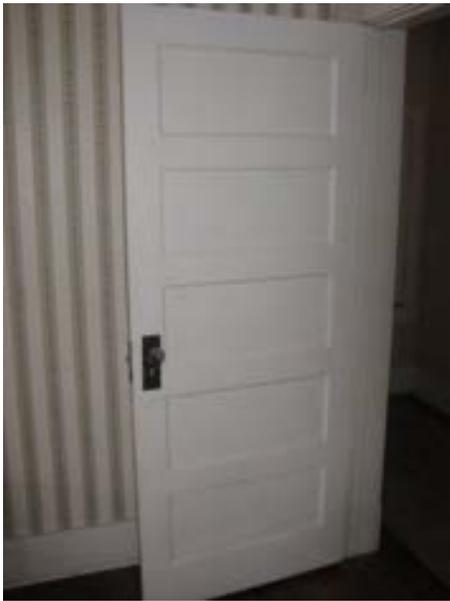
FIGURE 164. Bedroom 204 door on the east wall of the room. Photograph by BVH, October 16, 2012.

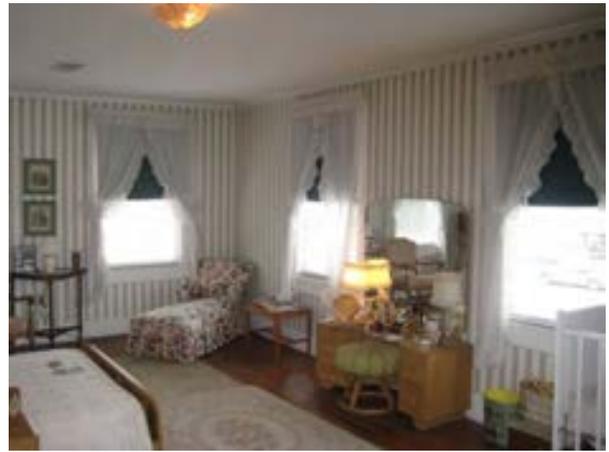
FIGURE 165. A south and two of the west windows in bedroom 204. Photograph by BVH, October 16, 2012.

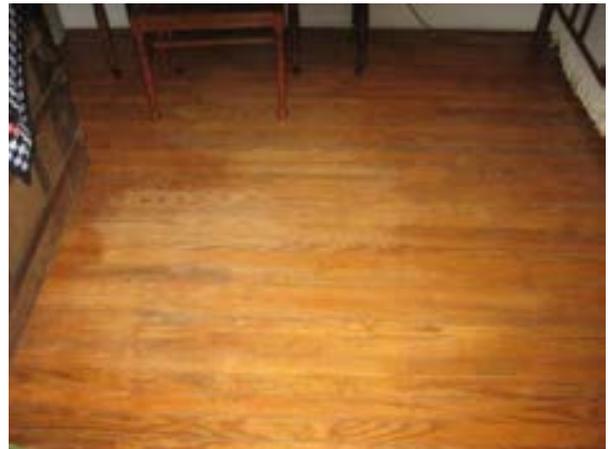
FIGURE 166. Floor of bedroom 205, looking east. Photograph by BVH, October 16, 2012.

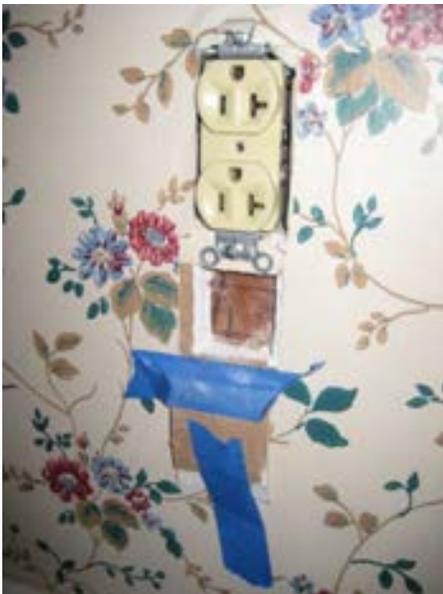
FIGURE 167. Material assembly of wall construction, showing the horizontal half-lap wood wall boards behind the gypsum board, located between the south windows. Photograph by BVH, October 16, 2012.

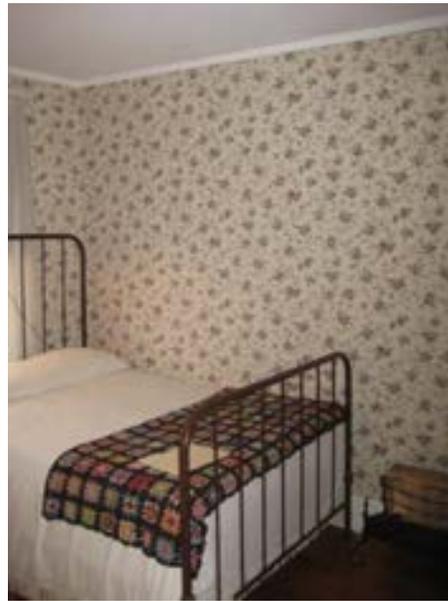
FIGURE 168. West wall of bedroom 205. Photograph by BVH, October 16, 2012.

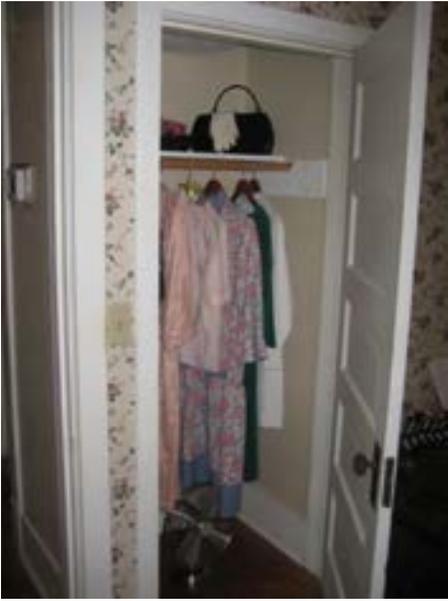
FIGURE 169. Bedroom 205 closet on the north wall. Photograph by BVH, October 16, 2012.

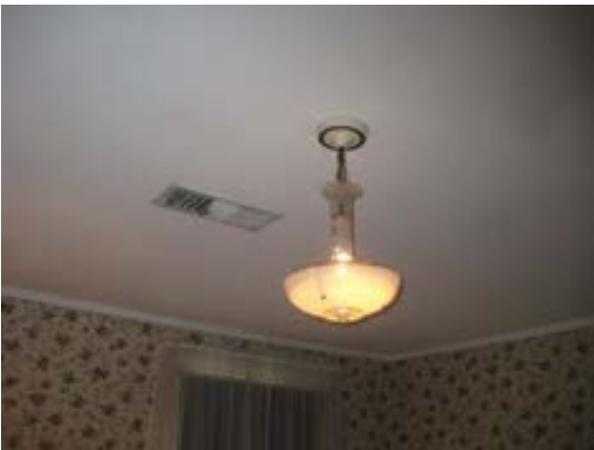
FIGURE 170. Ceiling and light fixture in bedroom 205, looking south. Photograph by BVH, October 16, 2012.

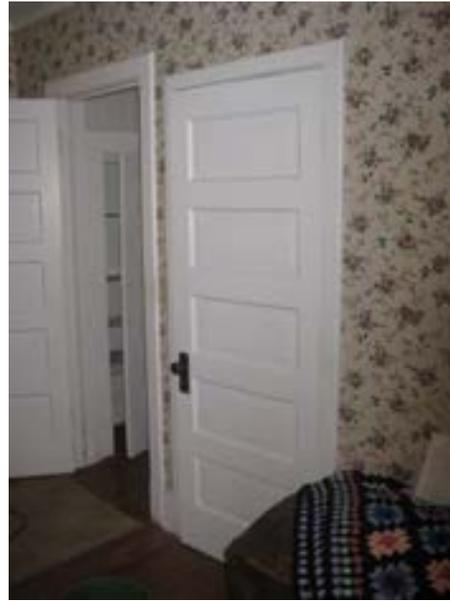
FIGURE 171. Main door at left and closet door at right on the north wall of the room. Photograph by BVH, October 16, 2012.

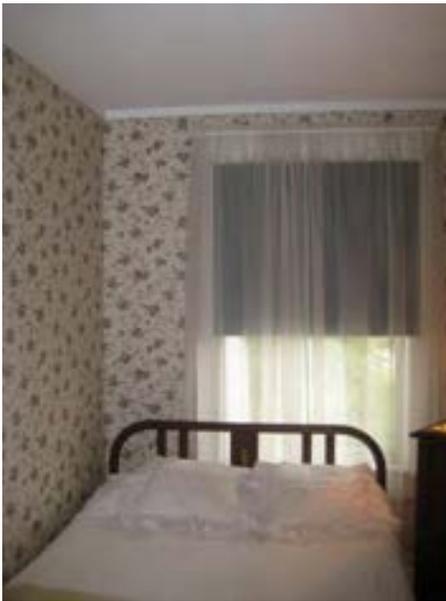
FIGURE 172. One of the south windows of bedroom 205. Photograph by BVH, October 16, 2012.

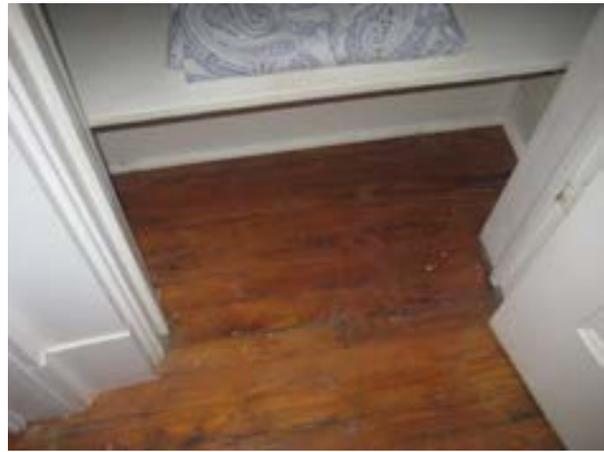
FIGURE 173. Floor of the linen closet, looking west. Photograph by BVH, October 16, 2012.

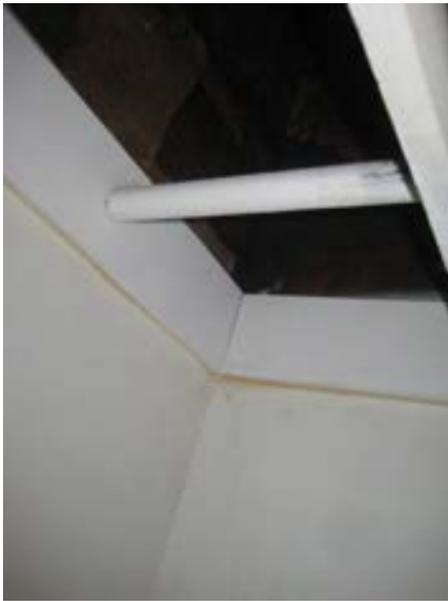
FIGURE 174. North plywood wall within the closet from the floor to a level above the door, painted white. Photograph by BVH, October 16, 2012.

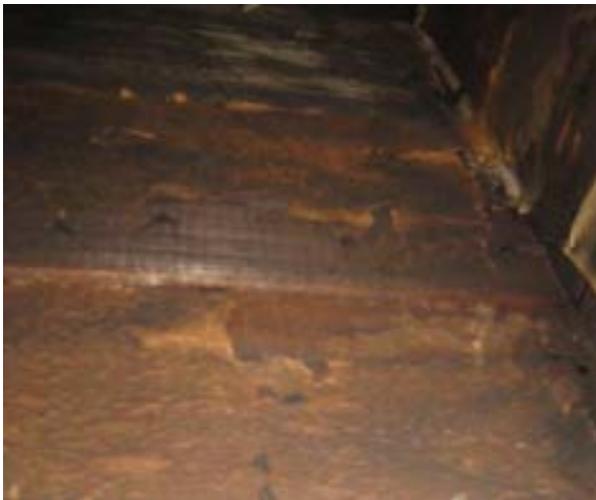
FIGURE 175. Horizontal half-lap boards with remnants of fabric and paper on the west wall. Photograph by BVH, October 16, 2012.

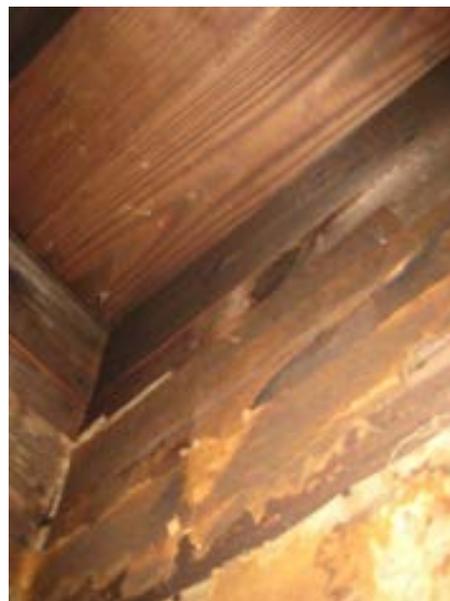
FIGURE 177. Ceiling of the linen closet, unfinished tongue-and-groove boards, original to the construction of the house. Photograph by BVH, October 16, 2012.

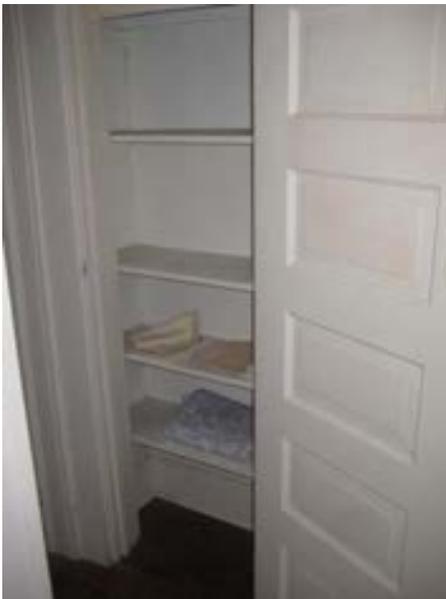
FIGURE 178. The raised panel door of the linen closet. Photograph by BVH, October 16, 2012.

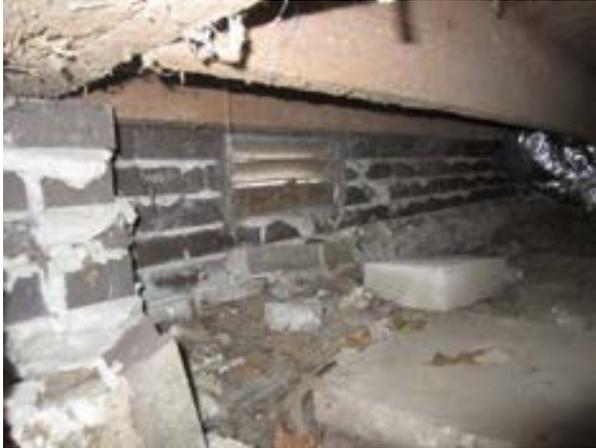
FIGURE 180. The brick masonry foundation consists of 1-foot-square piers and a one-wythe perimeter wall, which were rebuilt above grade during the 1995 work, view looking southwest. Photograph by WJE, October 16, 2012.

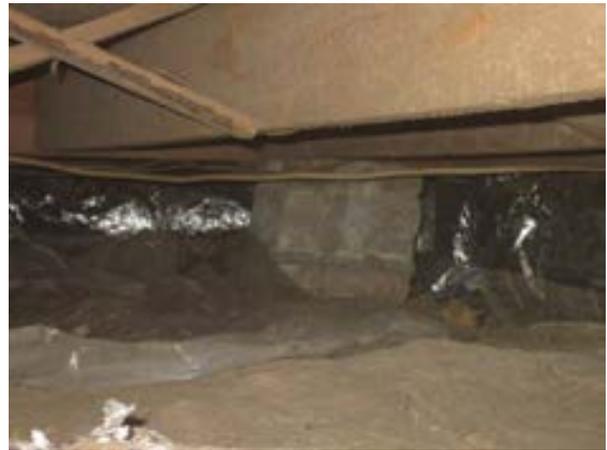
FIGURE 181. Detached 1-foot-square piers were observed along the north-south centerline of the house, view looking west. Photograph by WJE, October 16, 2012.

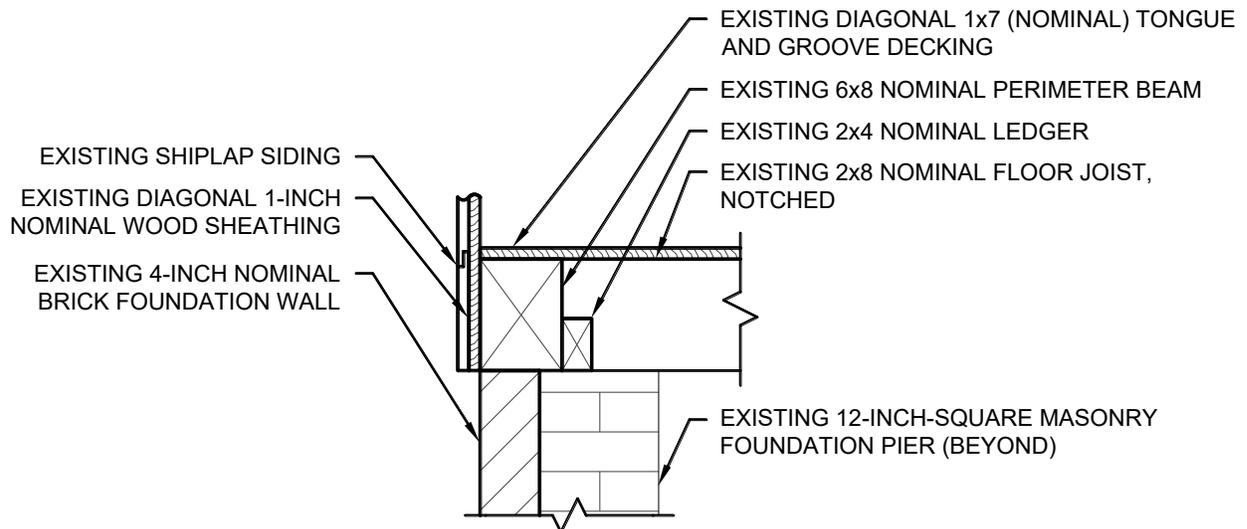
FIGURE 182. Diagram of first floor framing of the Cassidy House.

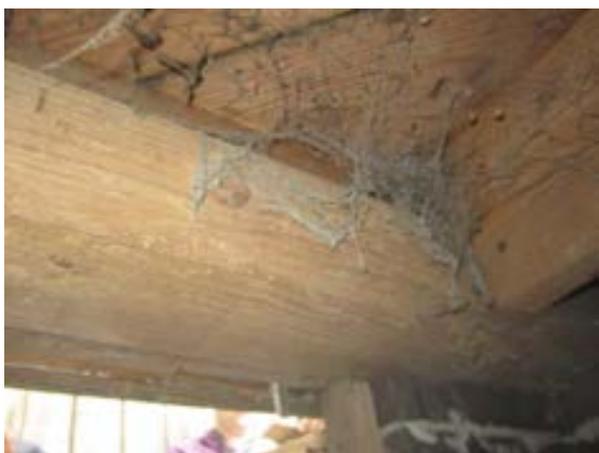
FIGURE 184. Typical joist support condition notched over a 6x8 perimeter beam with a 2 by 4 ledger, view looking east. Photograph by WJE, October 16, 2012.

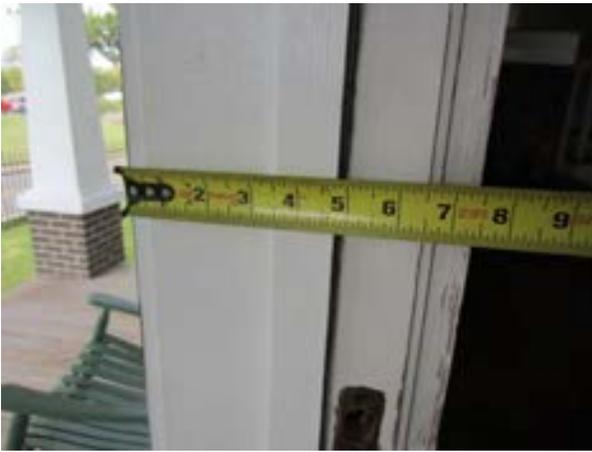
FIGURE 185. Perimeter wall measuring approximately 7-1/2 inches at the first floor indicates stud wall framing, view looking north. Photograph by WJE, October 17, 2012.

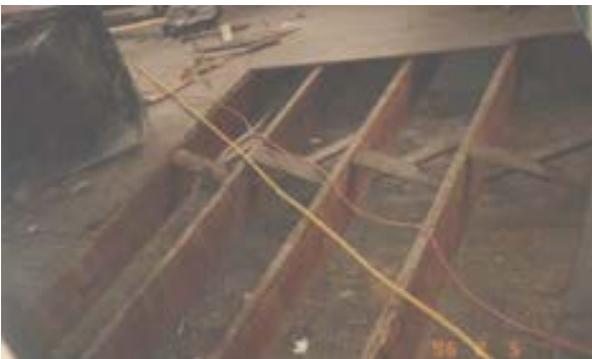
FIGURE 186. Interior of the west bedroom, February 5, 1996. Removal of the fire-damaged finish floor exposed the structural joists, bridging, and plank sheathing of the first floor ceiling below. Photo by Terry Huitt from the Clinton Home Restoration Scrapbook prepared by Cromwell Architects, 1997, page 27.

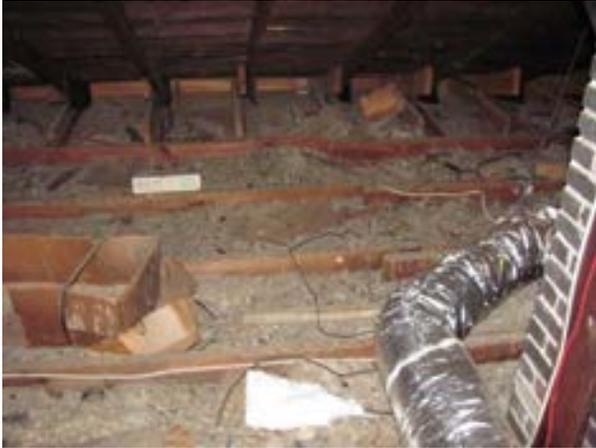
FIGURE 187. Second floor ceiling joists span east-west, with kicker joists framing to the north and south to support the soffit framing, view looking north. Photograph by WJE, October 17, 2012.

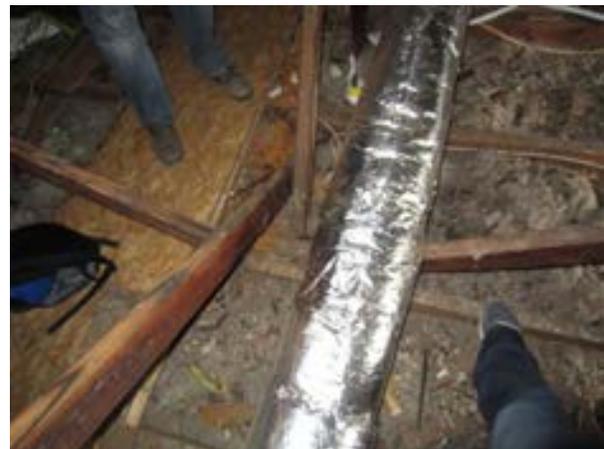
FIGURE 190. Bearing conditions of cross-bracing over the central bearing wall in the north-south and east-west conditions, view looking south. Photograph by WJE, October 16, 2012.

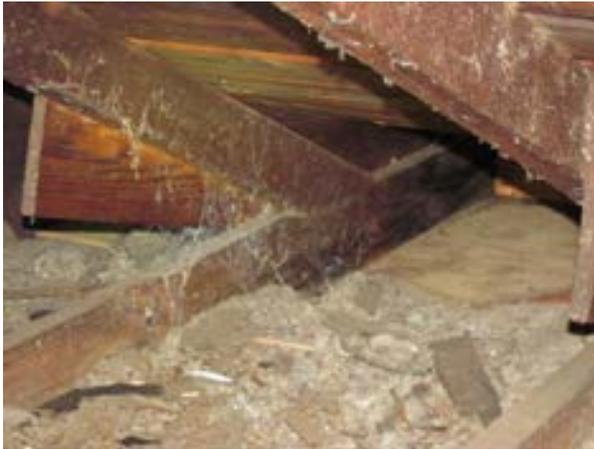
FIGURE 191. Typical roof rafter connection detail at ceiling joist, view looking west. Photograph by WJE, October 17, 2012.

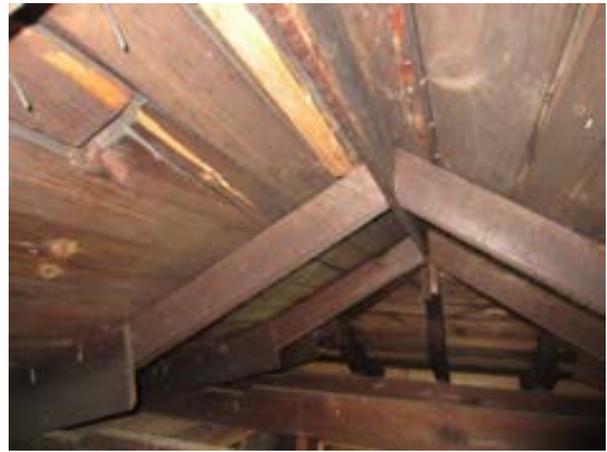
FIGURE 192. View of roof framing at the hipped dormer on the west side of the roof, view looking west. Photograph by WJE, October 16, 2012.

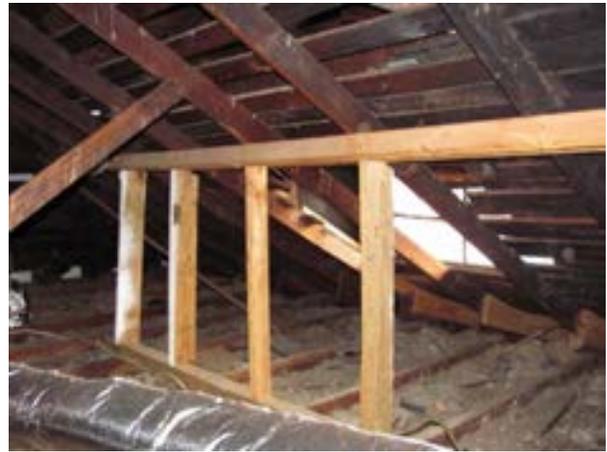
FIGURE 193. Common and hip jack rafters, which continue through the dormer opening at the west elevation, are supported on a non-original 2 by 4 knee wall frame, view looking southwest. Photograph by WJE, October 16, 2012.

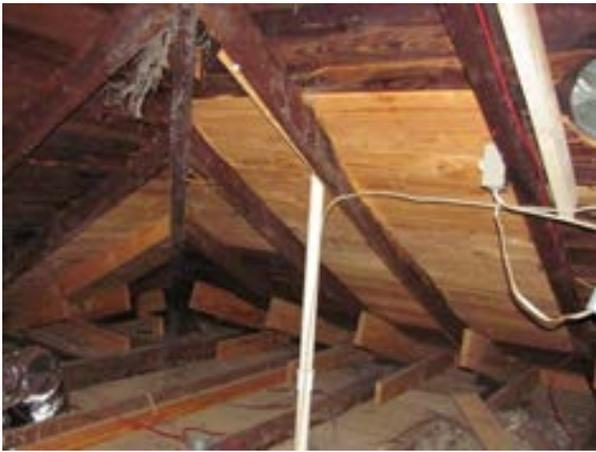
FIGURE 194. Northeast corner of the attic where portions of the roof and soffit framing were previously repaired or replaced, view looking northeast. Photograph by WJE, October 16, 2012.

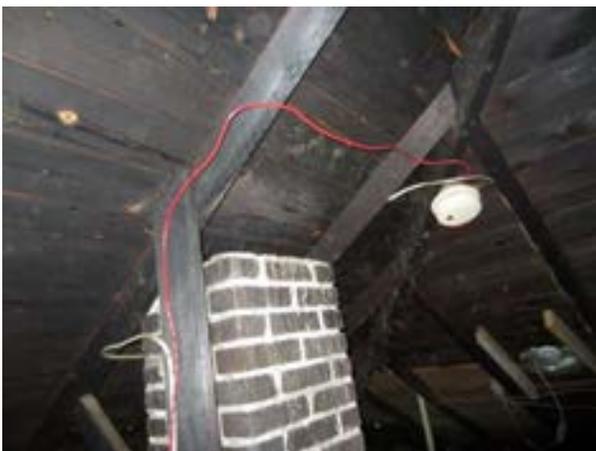
FIGURE 195. A 16-inch-square brick chimney was noted to have been cut below the roofline prior to the 1992 fire, evidenced by the charred wood planking directly above it, view looking northeast. Photograph by WJE, October 16, 2012.

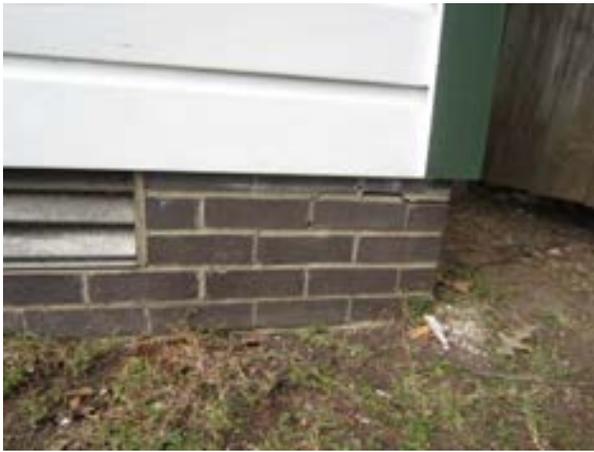
FIGURE 196. Typical cracking and deflections up to 3/8 inch observed at the masonry foundation, view looking north. Photograph by WJE, October 16, 2012.

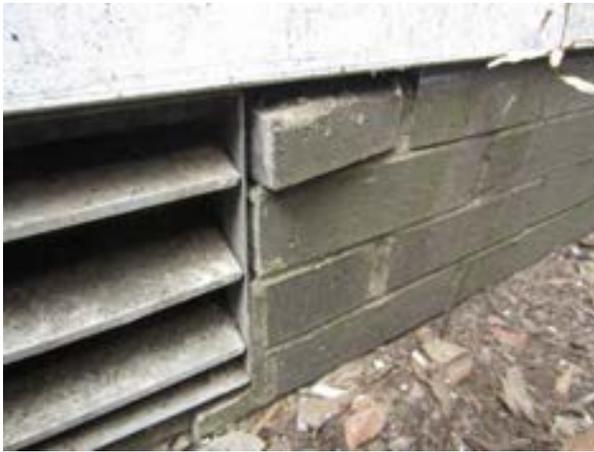
FIGURE 197. Loose brick observed at the east side of the masonry foundation, view looking west. Photograph by WJE, October 16, 2012.

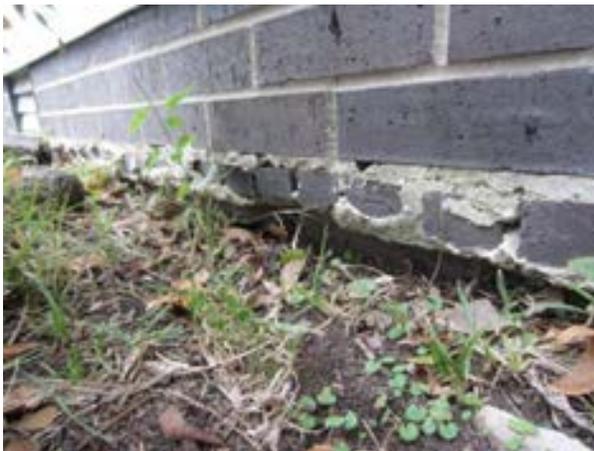
FIGURE 198. Misaligned transition between the new foundation (above) and old foundation bricks (below) observed at the south elevation, view looking northeast. Photograph by WJE, October 16, 2012.

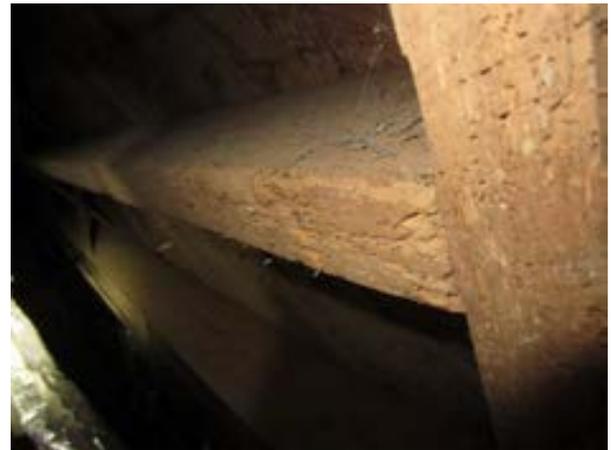
FIGURE 199. Evidence of termite damage was observed at the first floor framing, view looking northwest. Photograph by WJE, October 16, 2012.

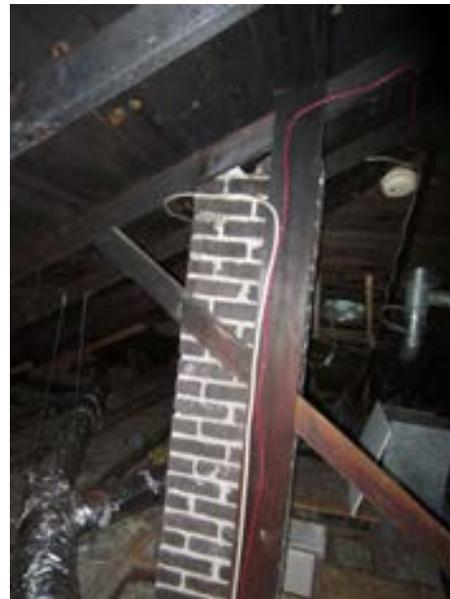
FIGURE 200. Roof framing was discolored and exhibited surface charring due to the 1992 fire at the second floor. Note, the discoloration is mostly limited to the upper portion of the attic, view looking west. Photograph by WJE, October 16, 2012.

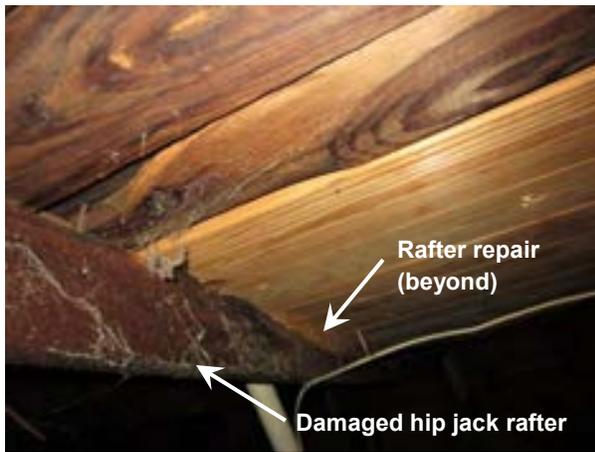
FIGURE 201. Previously repaired hip jack rafter at location of severe section loss, view looking east. Photograph by WJE, October 16, 2012.

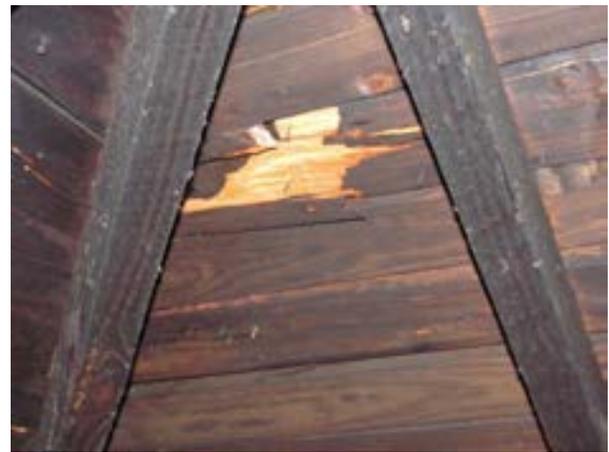
FIGURE 204. Typical area of localized cracking observed at roof planking, view looking southwest. Photograph by WJE, October 16, 2012.

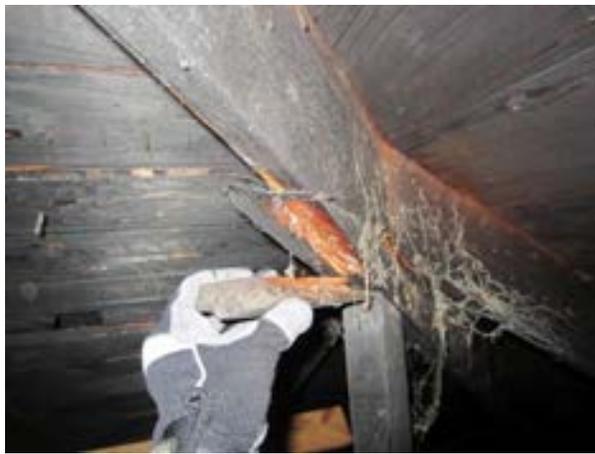
FIGURE 202. Split and displacement observed at the northwest hip rafter. Note, a post repair had been implemented prior to the 1992 fire. Looking northwest. Photograph by WJE, October 17, 2012.

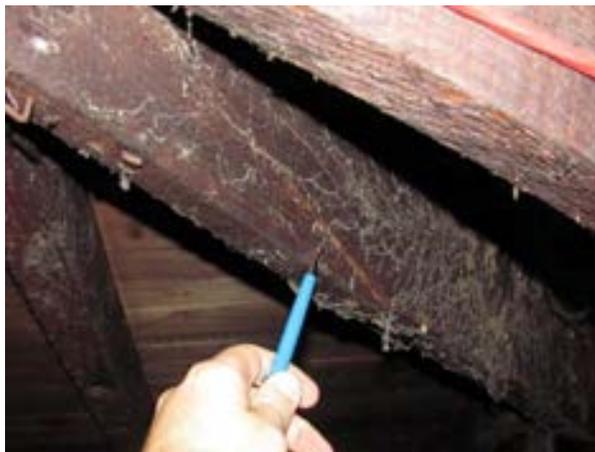
FIGURE 203. Northeast hip rafter with a break through the entire cross-section, view looking northeast. Photograph by WJE, October 16, 2012.

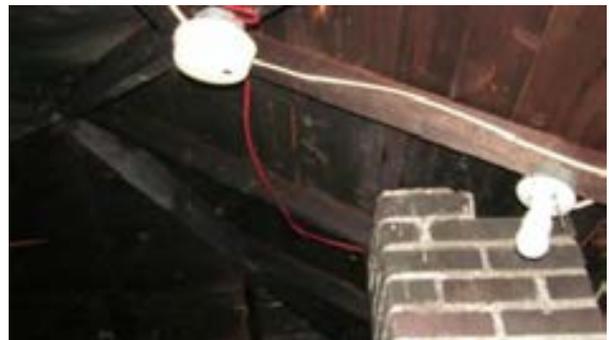
FIGURE 206. In the attic of the Cassidy House, the existing chimney has been removed to below the level of the attic ceiling. Also note the existing lighting fixture. Photograph by Alvine, May 15, 2013.

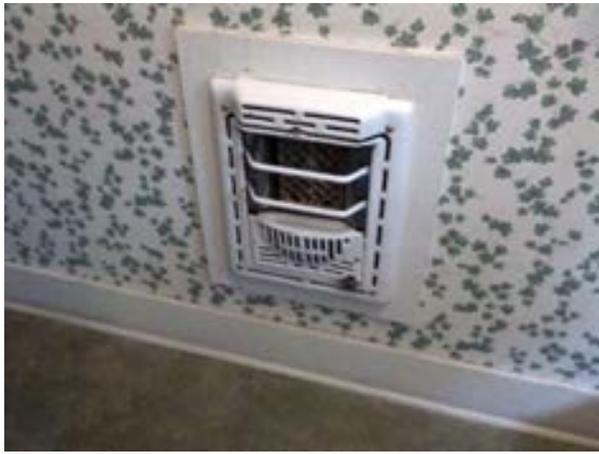
FIGURE 207. Second floor wall-located heater in bathroom 203 of the Cassidy House. Photograph by Alvine, May 15, 2013.

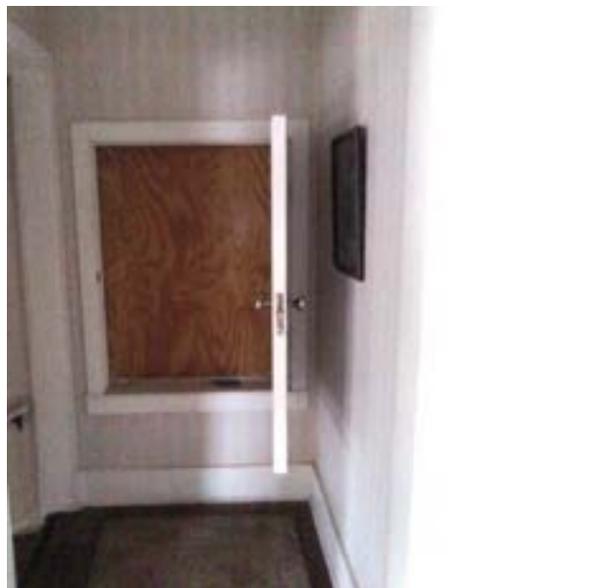
FIGURE 211. Second floor opening in exterior wall where the ventilation fan has been removed, now covered over with plywood. Photograph by Alvine, May 15, 2013.

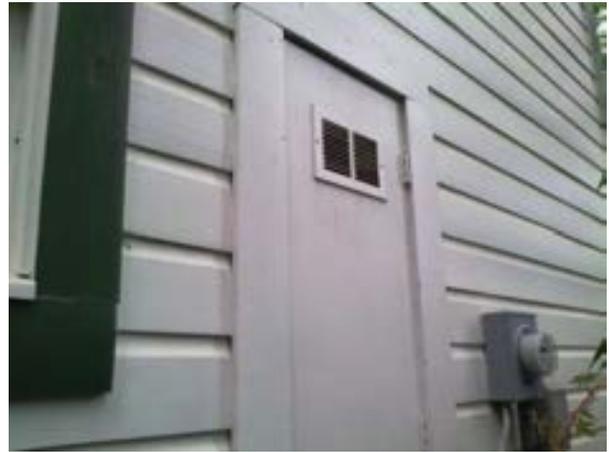
FIGURE 212. Top of HVAC closet door with ventilation grille in door. Photograph by Alvine, May 15, 2013.

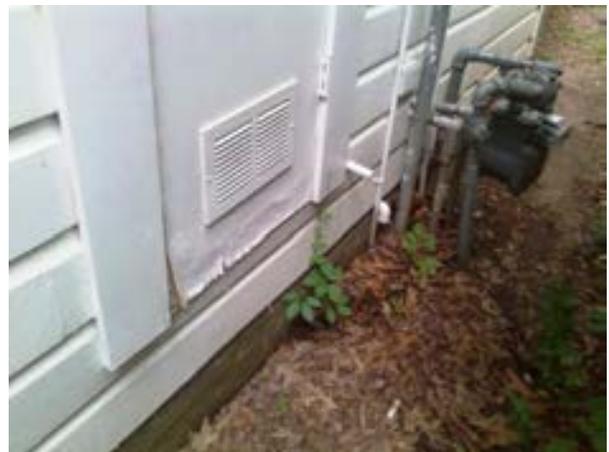
FIGURE 213. Bottom of exterior HVAC closet door indicating lower ventilation grille and door deterioration. Photograph by Alvine, May 15, 2013.

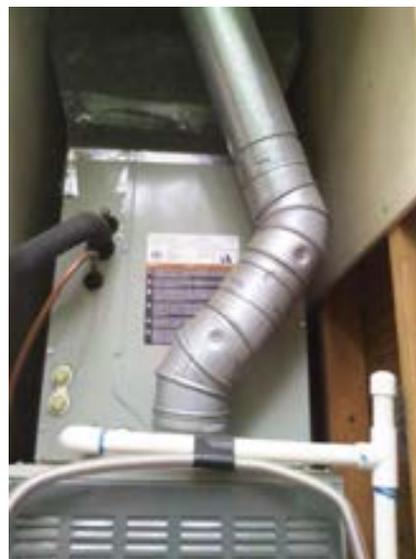
FIGURE 214. Furnace in Clinton House exterior equipment closet. Photograph by Alvine, May 15, 2013.

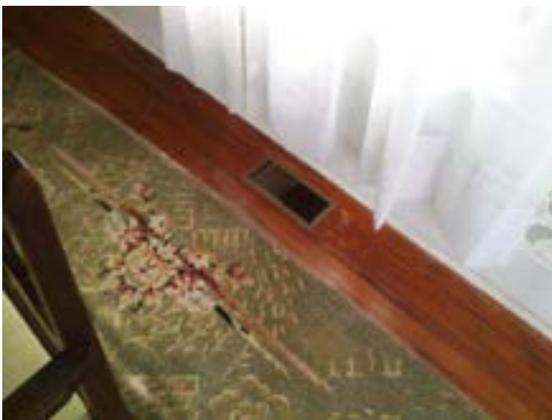
FIGURE 216. Floor supply air register in dining room 102 of the Cassidy House (typical of all first floor supply air registers). Photograph by Alvine, May 15, 2013.

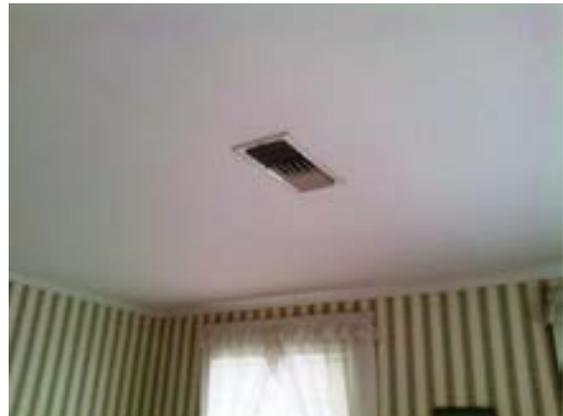
FIGURE 220. Ceiling-located supply air diffuser at second floor west bedroom 204 of Cassidy House (typical of all second floor rooms). Photograph by Alvine, May 15, 2013.
