**President William Jefferson Clinton
Birthplace Home National Historic Site**
Hope, Arkansas

Historic Structures Report

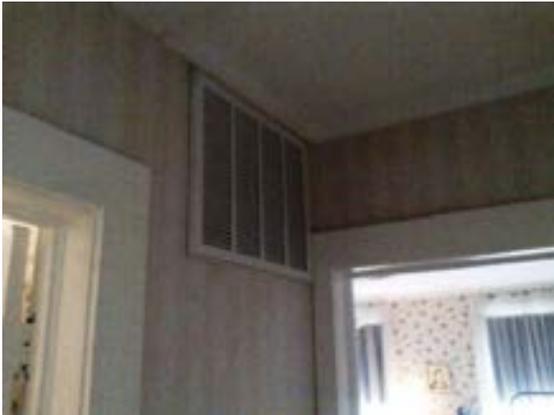
FIGURE 221. Return air filter grille in hallway 201 at second floor of Cassidy House. Photograph by Alvine, May 15, 2013.

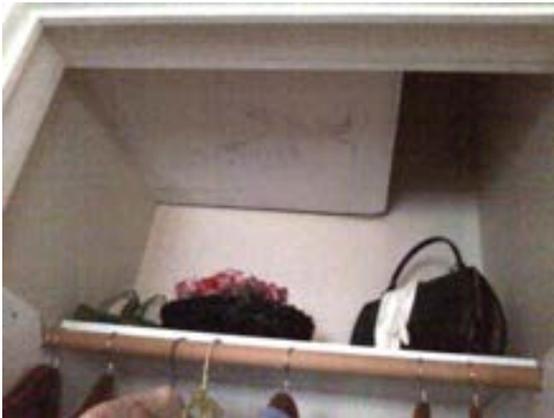
FIGURE 222. Return air duct connected to hallway return grille, located in the closet of southeast bedroom 205 of Cassidy House. Photograph by Alvine, May 15, 2013.

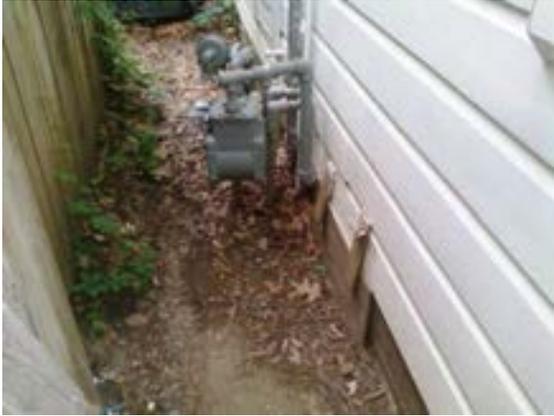
FIGURE 226. Cassidy House gas meter and service entrance location at east side of house. Photograph by Alvine, May 15, 2013.

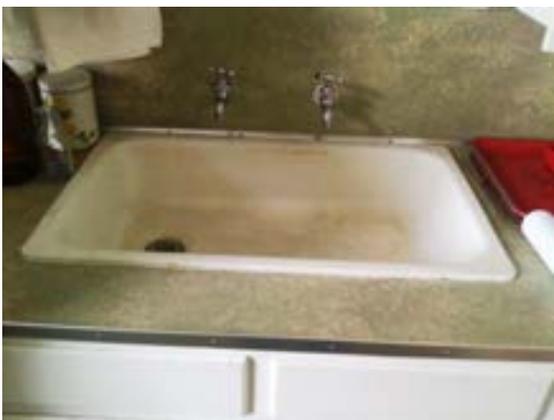
FIGURE 227. Counter-mounted sink and faucet located in kitchen 104. Photograph by Alvine, May 15, 2013.

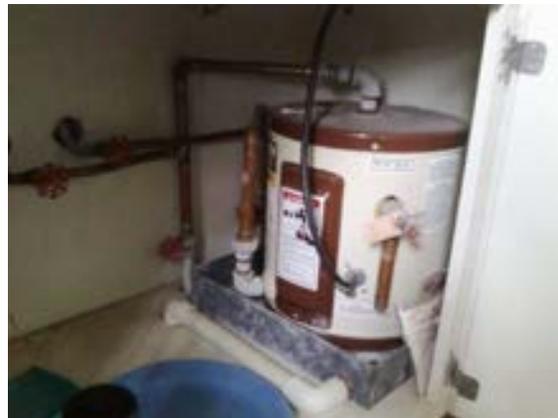
FIGURE 229. Cassidy House under-cabinet electric water heater serving kitchen counter-mounted sink. Photograph by Alvine, May 15, 2013.

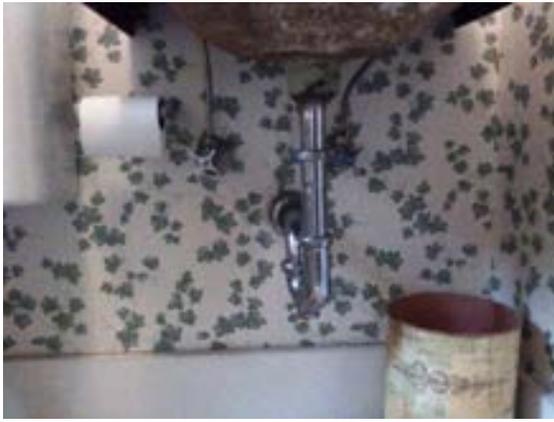
FIGURE 230. Waste and water supply piping serving lavatory at Cassidy House second floor bathroom 203. Photograph by Alvine, May 15, 2013.

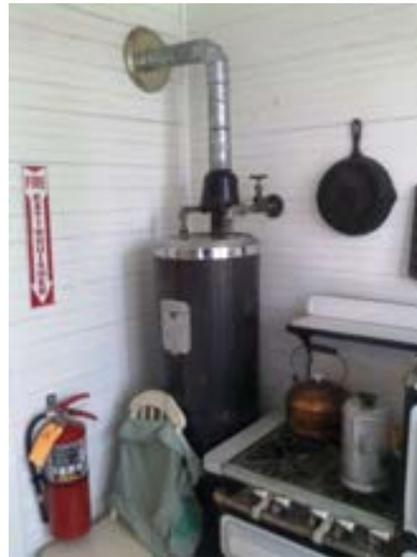
FIGURE 233. Existing non-functional water heater, flue duct, and water supply piping at first floor kitchen 201 of Cassidy House. Photograph by Alvine, May 15, 2013.

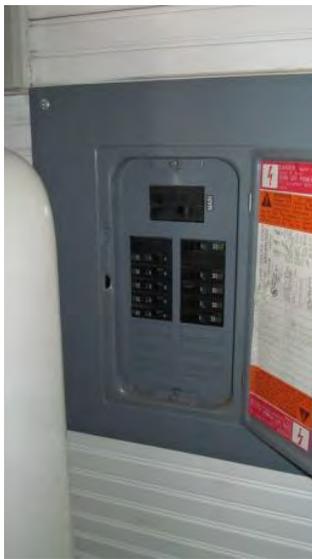
FIGURE 236. Cassidy house electrical load center. Photograph by Alvine, May 15, 2013.

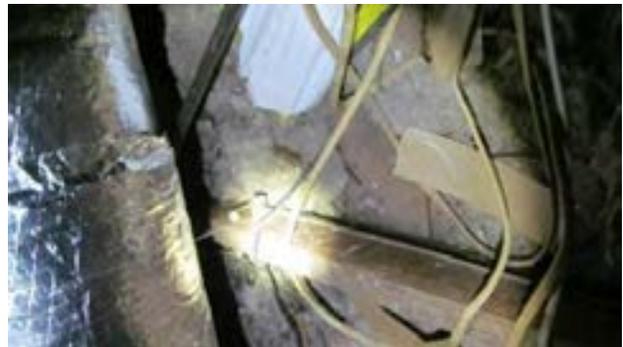
FIGURE 243. Inactive knob and tube wiring and incorrectly supported nonmetallic sheathed cable. Photograph by Alvine, May 15, 2013.

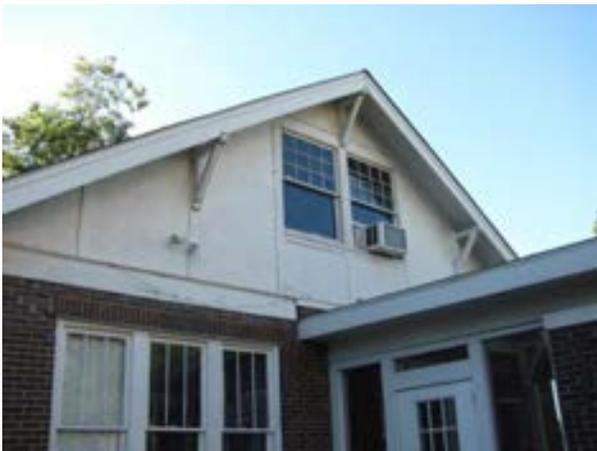
FIGURE 262. A view of the plastered gable end of the visitor center. Photograph by WJE, October 15, 2012.

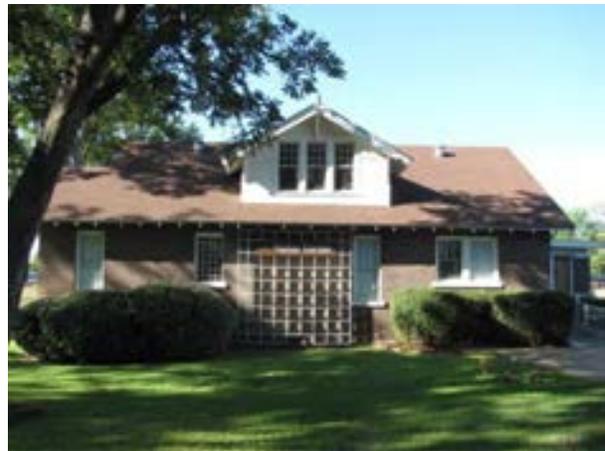
FIGURE 263. A view of the south elevation of the visitor center. The enclosed porch can be seen on the far right. Photograph by WJE, October 15, 2012.

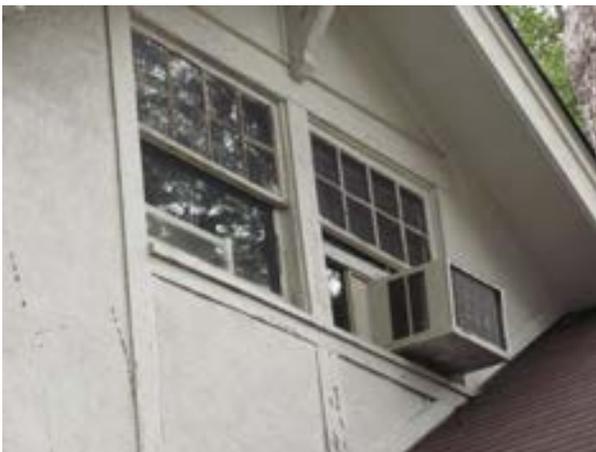
FIGURE 268. A view of the second floor windows at the west elevation. Photograph by WJE, October 16, 2012.

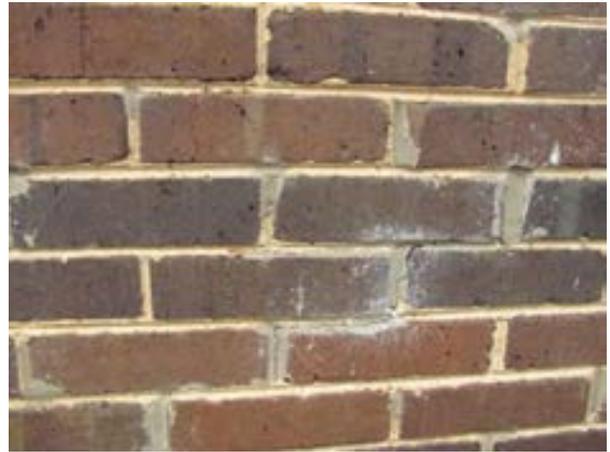
FIGURE 271. A view of stepped cracking on the field of an exterior wall. Photograph by WJE, October 16, 2012.

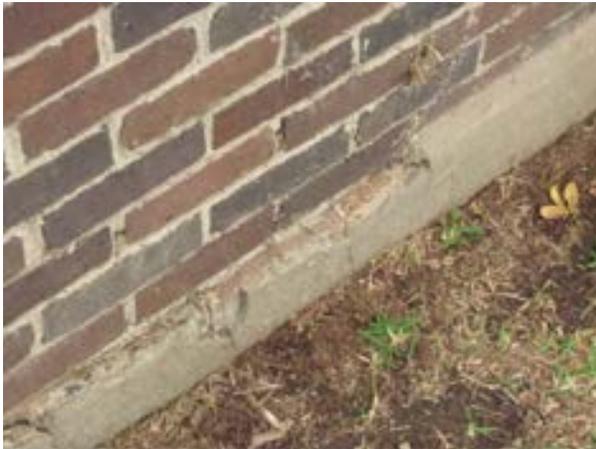
FIGURE 269. An instance of cracking at the cast concrete foundation. Photograph by WJE, October 16, 2012.

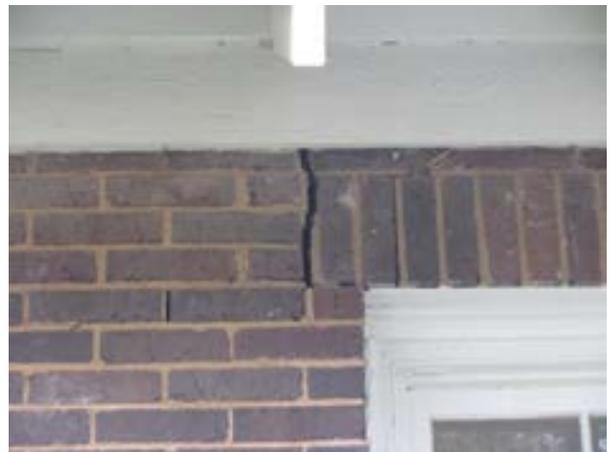
FIGURE 272. Cracking at the head of a window. Photograph by WJE, October 16, 2012.

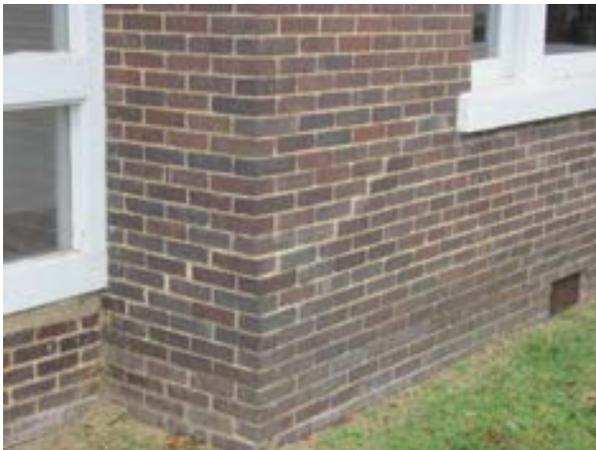
FIGURE 270. An example of stepped cracking at the northeast corner of the building. Photograph by WJE, October 16, 2012.

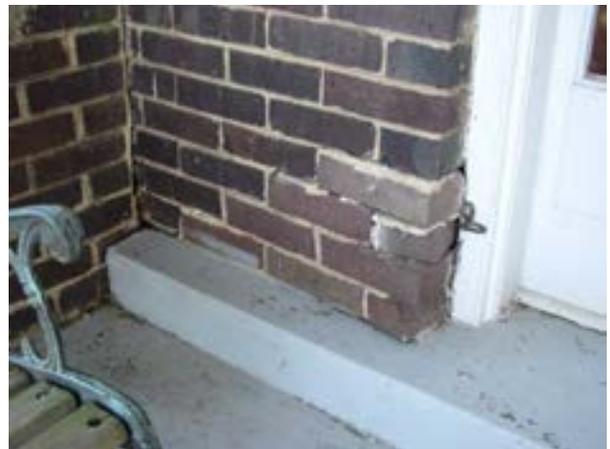
FIGURE 273. A view of displaced brick adjacent to the door on the north elevation. Photograph by WJE, October 15, 2012.

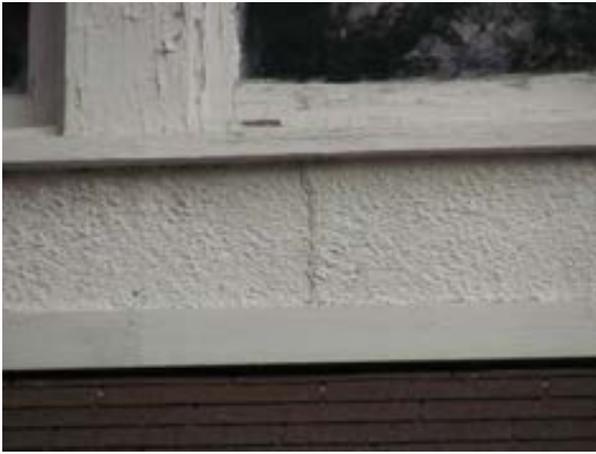
FIGURE 274. A repaired crack in the plaster at a dormer. Photograph by WJE, October 16, 2012.

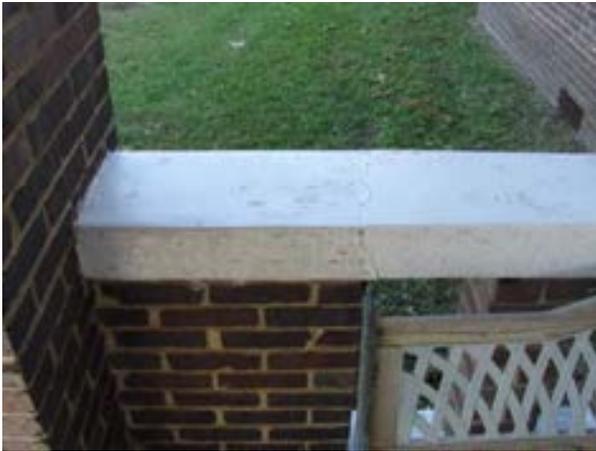
FIGURE 275. A crack in the precast concrete at the north porch. Photograph by WJE, October 15, 2012.

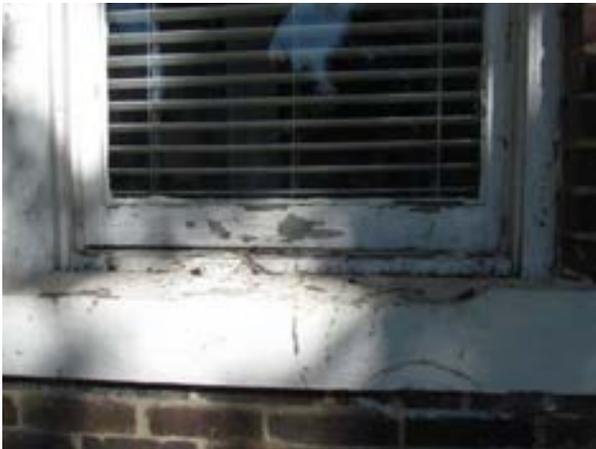
FIGURE 276. A view of a typical window showing paint and glazing putty failure. Photograph by WJE, October 15, 2012.

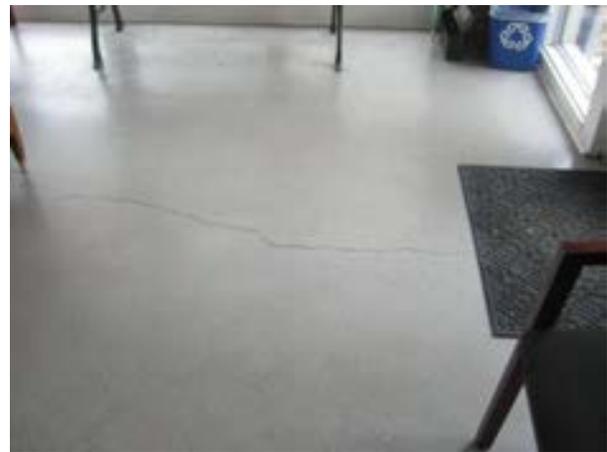
FIGURE 277. Concrete slab floor of the entry, looking north. Photograph by BVH, October 16, 2012.

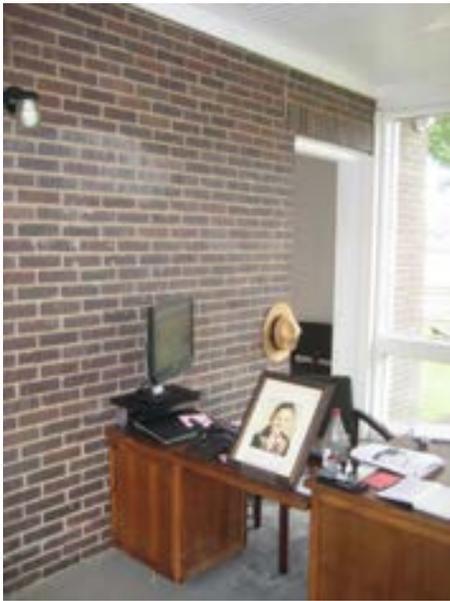
FIGURE 278. The west wall of the entry. The door openings remain but the doors were removed as part of the 1997 work. Photograph by BVH, October 16, 2012.

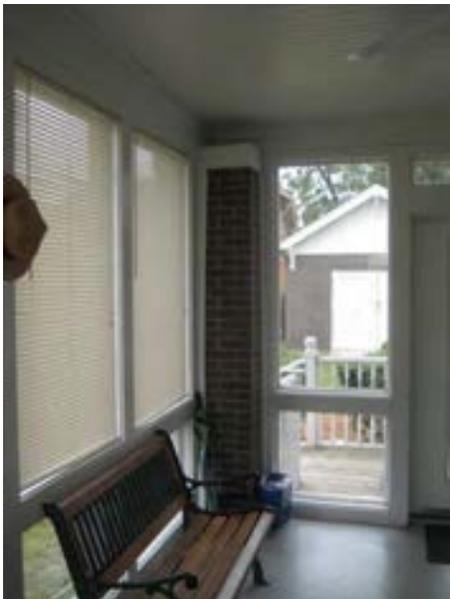
FIGURE 279. Corner brick pier at the southeast corner of the entry. Photograph by BVH, October 16, 2012.

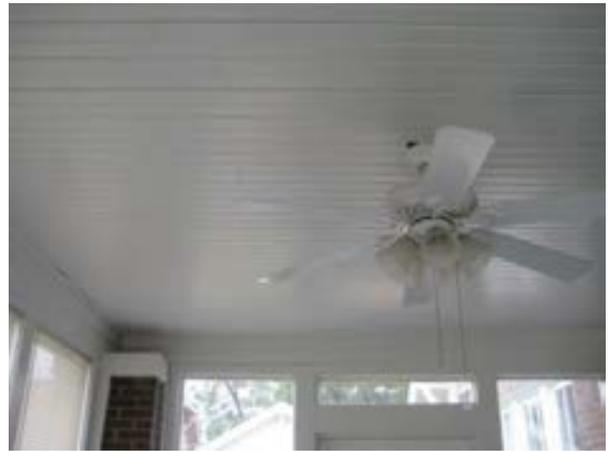
FIGURE 280. Tongue-and-groove ceiling with ceiling fan, looking south. Photograph by BVH, October 16, 2012.

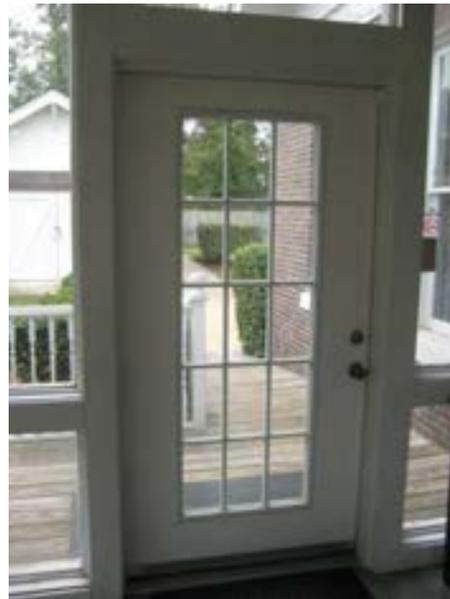
FIGURE 281. Main entry door of the visitor center on the south wall of the space. Photograph by BVH, October 16, 2012.

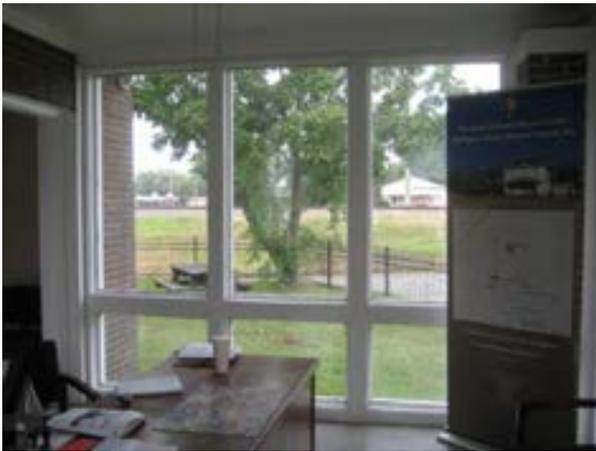
FIGURE 282. Fixed window assembly of the north wall of the entry. Photograph by BVH, October 16, 2012.

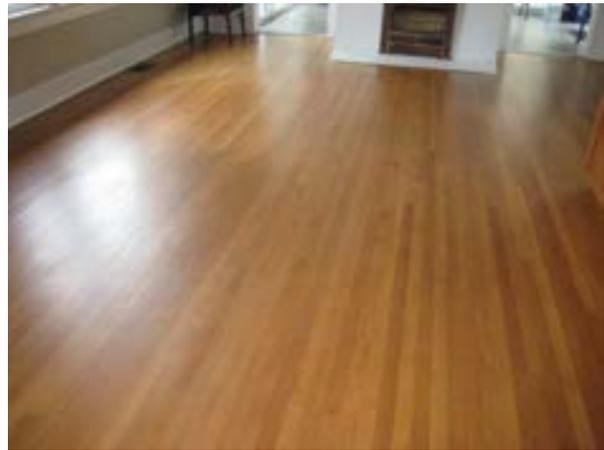
FIGURE 283. The hardwood floor of the reception area, looking east. Photograph by BVH, October 16, 2012.

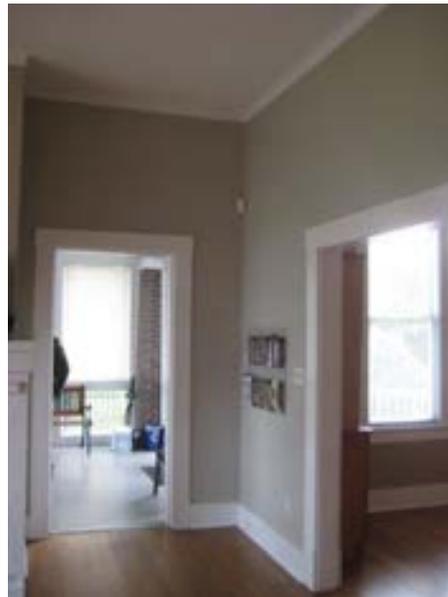
FIGURE 284. South and east walls of the reception area. Photograph by BVH, October 16, 2012.

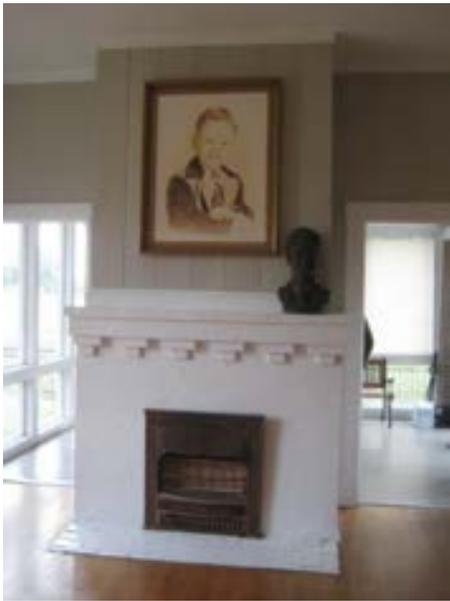
FIGURE 285. The vertical beadboard assembly above the mantel on the east wall. Photograph by BVH, October 16, 2012.

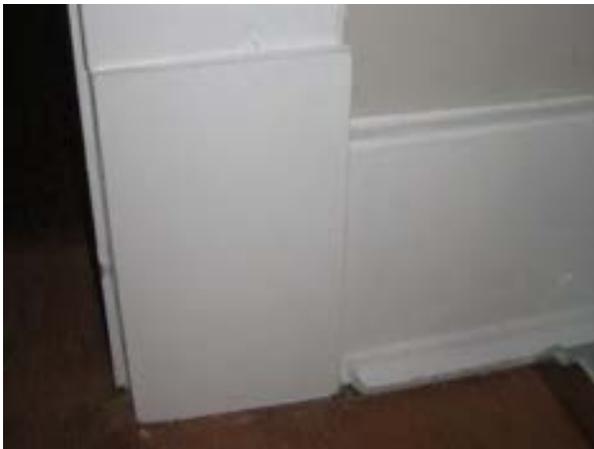
FIGURE 286. Wall base and base block at door opening on the west wall. Photograph by BVH, October 16, 2012.

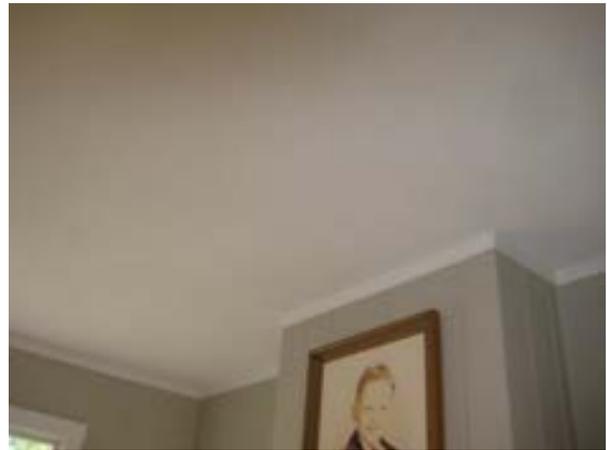
FIGURE 287. Ceiling of the reception space with cornice, looking east. Photograph by BVH, October 16, 2012.

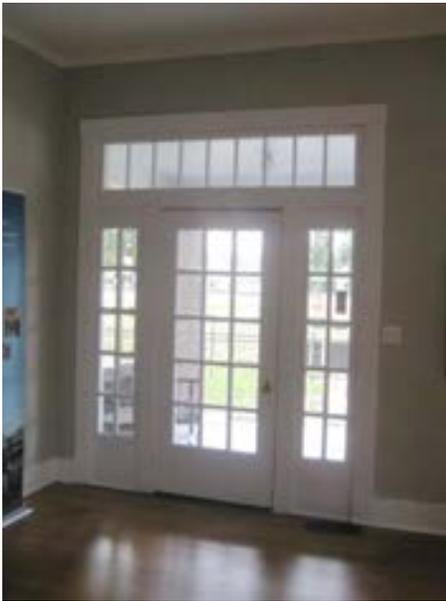
FIGURE 290. Front door assembly with sidelights on the north wall. Photograph by BVH, October 16, 2012.

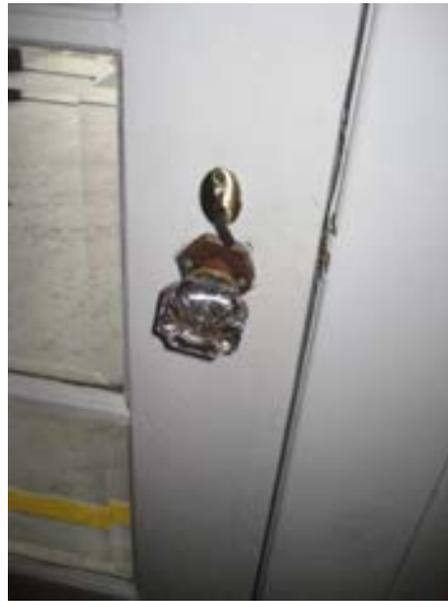
FIGURE 291. Hardware assembly of the door. Photograph by BVH, October 16, 2012.

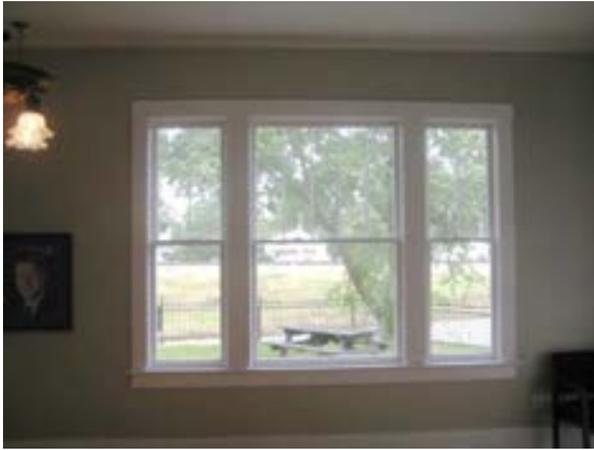
FIGURE 292. Triple window assembly on the north side of the room. Photograph by BVH, October 16, 2012.

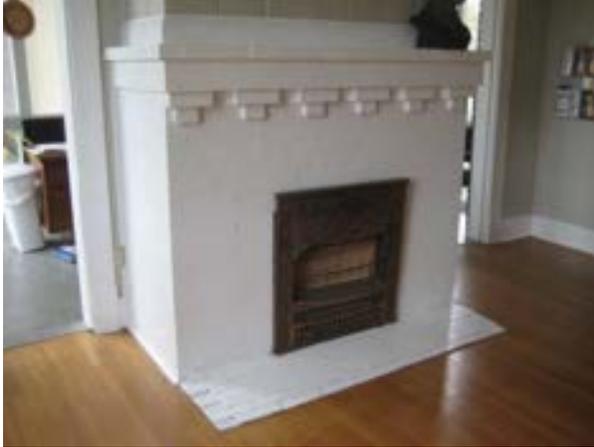
FIGURE 293. Fireplace on the east wall of reception. Photograph by BVH, October 16, 2012.

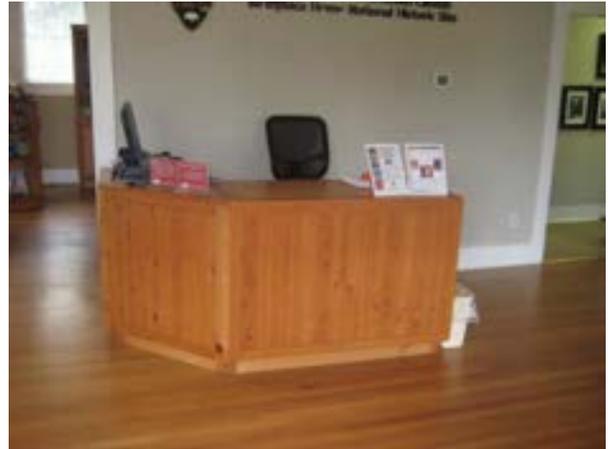
FIGURE 294. Cashier counter on the south wall of reception. Photograph by BVH, October 16, 2012.

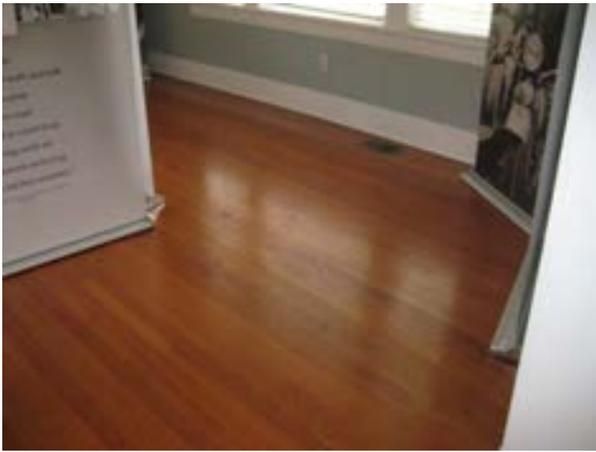
FIGURE 295. Hardwood floor of the exhibit room, looking north. Photograph by BVH, October 16, 2012.

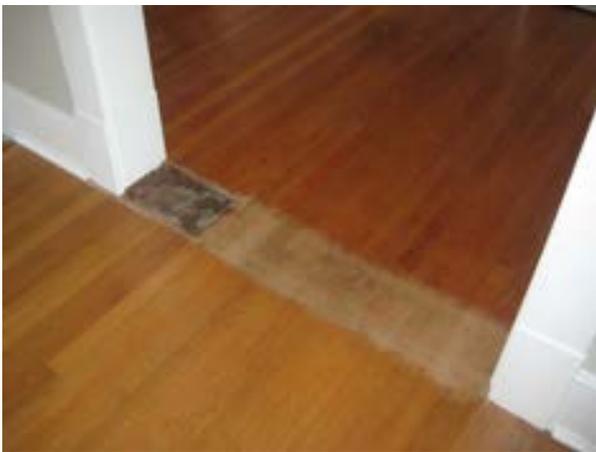
FIGURE 296. Patch denotes where opening was widened, looking west. Photograph by BVH, October 16, 2012.

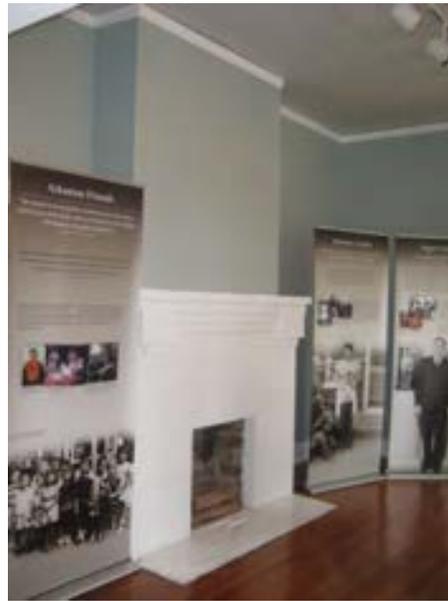
FIGURE 297. South wall of the exhibit space. Photograph by BVH, October 16, 2012.

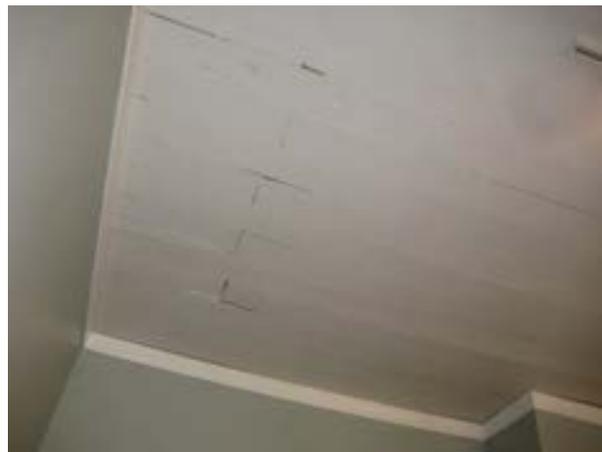
FIGURE 298. Tongue-and-groove ceiling looking south. Photograph by BVH, October 16, 2012.

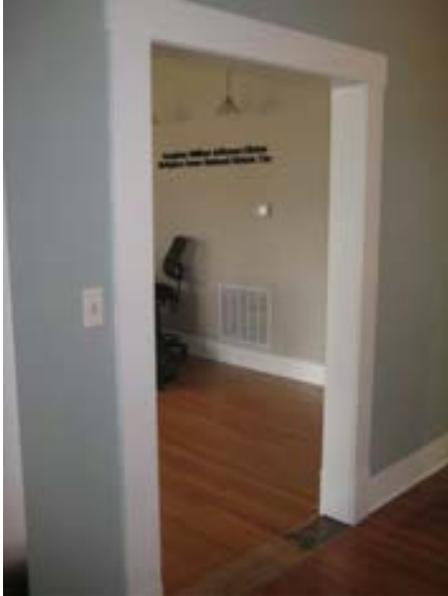
FIGURE 300. East wall door opening between the reception and exhibit spaces. The door was removed and the opening was widened as part of the 1997 work. Photograph by BVH, October 16, 2012.

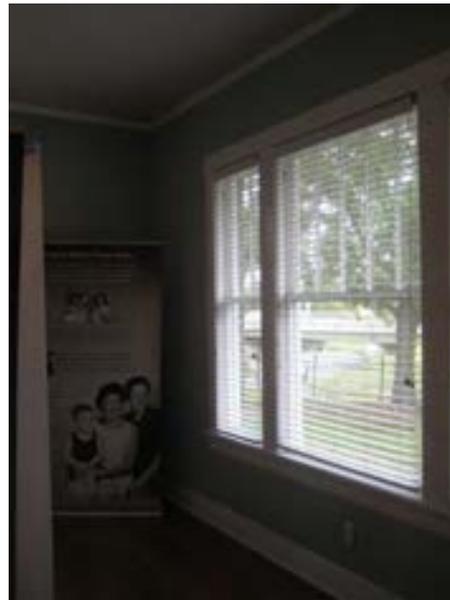
FIGURE 301. Triple window assembly on the north side of the room. Photograph by BVH, October 16, 2012.

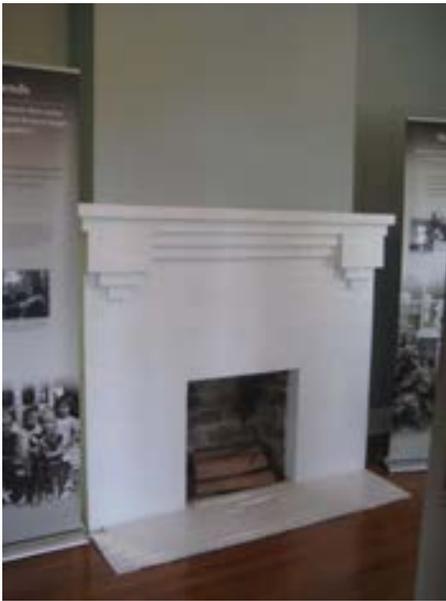
FIGURE 302. Fireplace on the south wall of the exhibit space. Photograph by BVH, October 16, 2012.

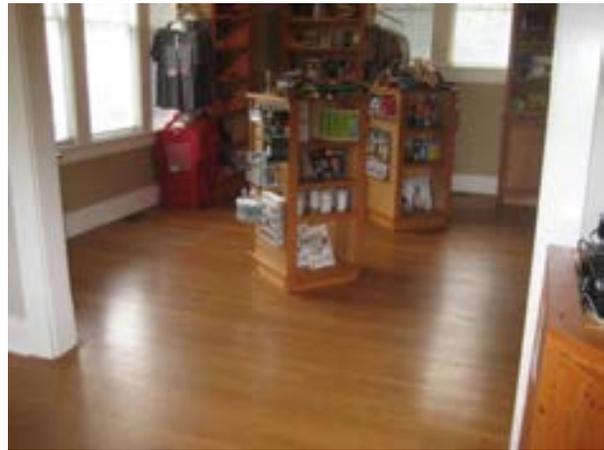
FIGURE 303. Hardwood floor in the bookroom, looking south. Photograph by BVH, October 16, 2012.

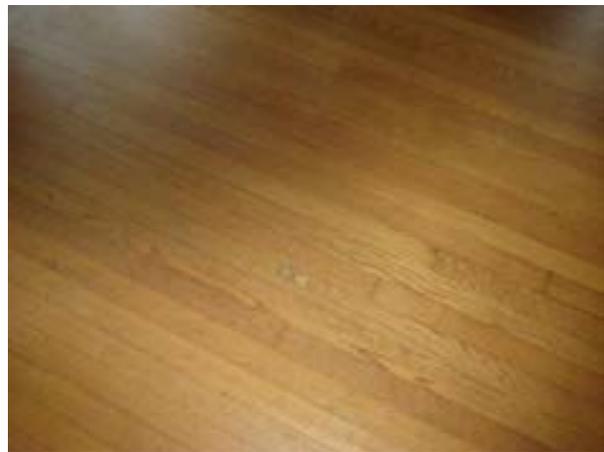
FIGURE 304. Infilled door pin location. Photograph by BVH, October 16, 2012.

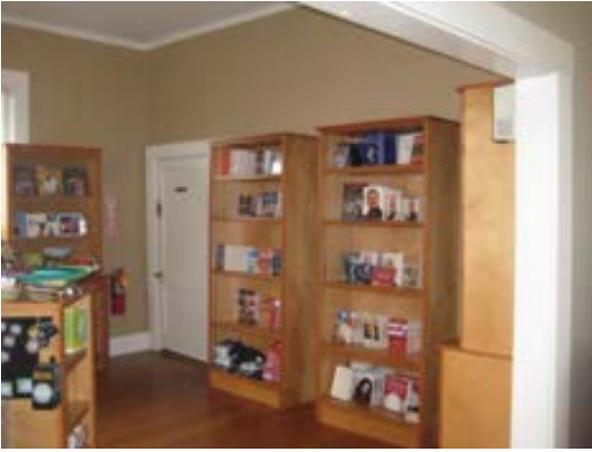
FIGURE 305. Gypsum board walls of the bookstore. Photograph by BVH, October 16, 2012.

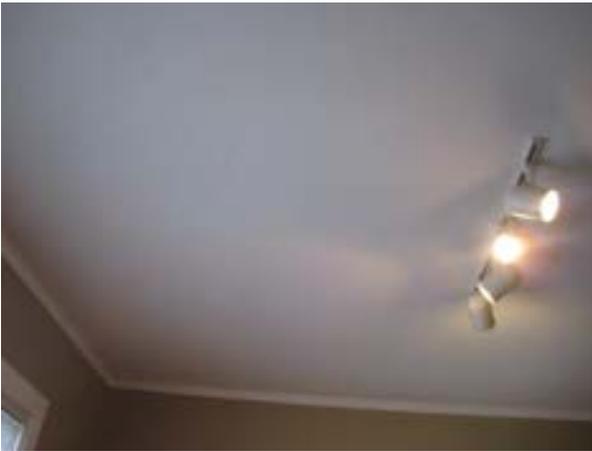
FIGURE 306. Gypsum board ceiling of the bookstore with track lighting, looking south. Photograph by BVH, October 16, 2012.

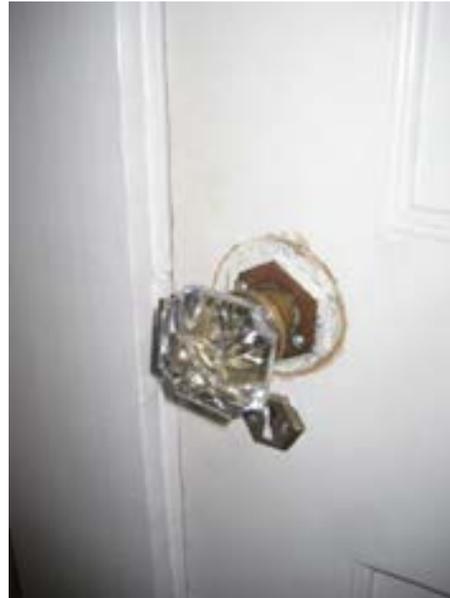
FIGURE 307. Door hardware of the west door in the bookstore. Photograph by BVH, October 16, 2012.

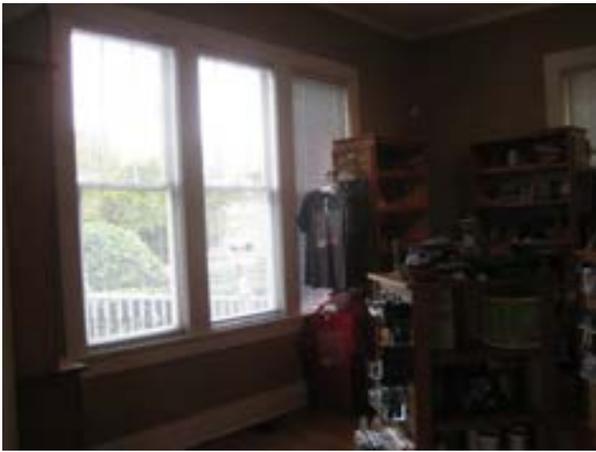
FIGURE 308. Triple window in the east side of the bookstore. Photograph by BVH, October 16, 2012.

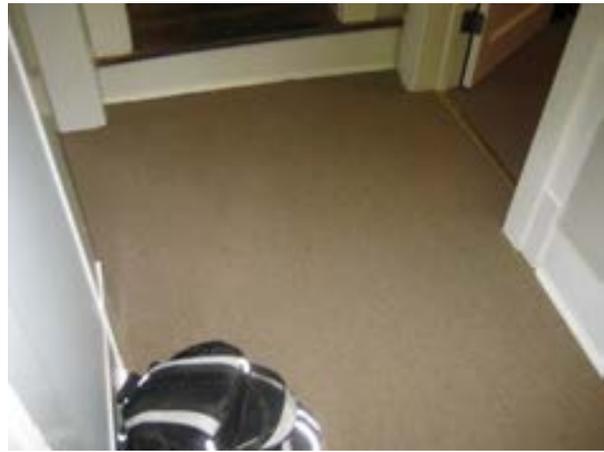
FIGURE 310. Carpet in the corridor with metal transition strips, looking east. Photograph by BVH, October 16, 2012.

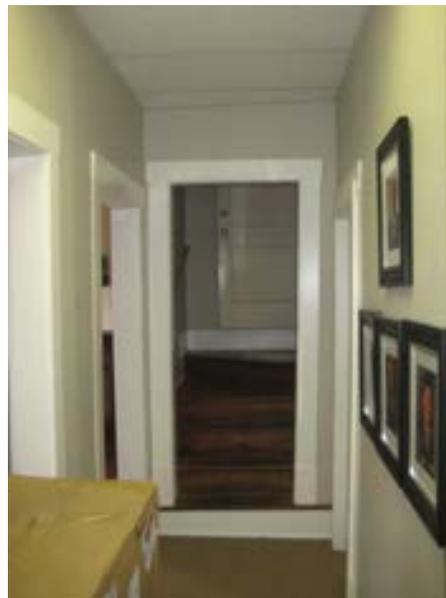
FIGURE 311. Gypsum board installed over the original plaster, making the profile of the trim shallow, looking east. Photograph by BVH, October 16, 2012.

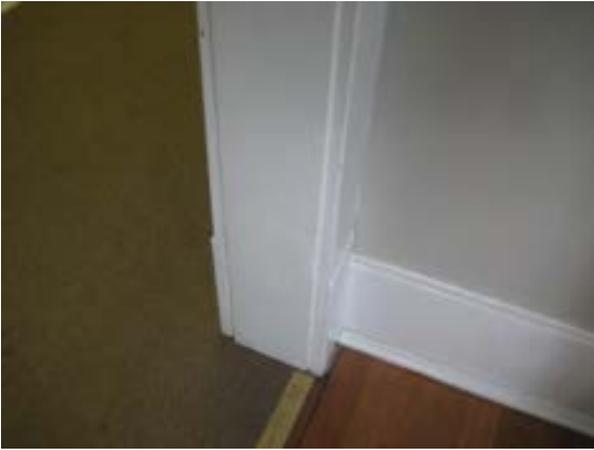
FIGURE 312. Wall base in the northeast corner of the corridor. Photograph by BVH, October 16, 2012.

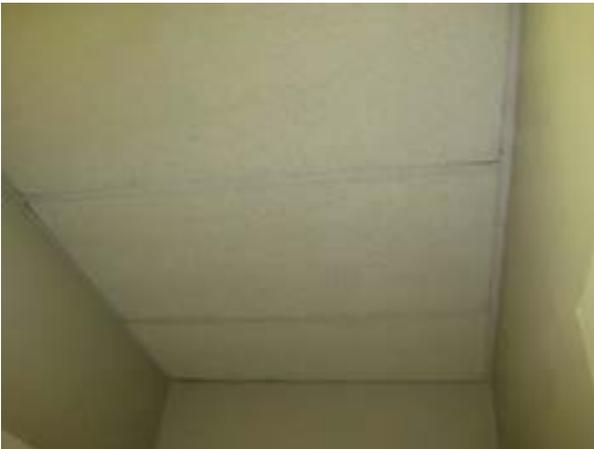
FIGURE 313. Suspended ceiling in the corridor looking west. Photograph by BVH, October 16, 2012.

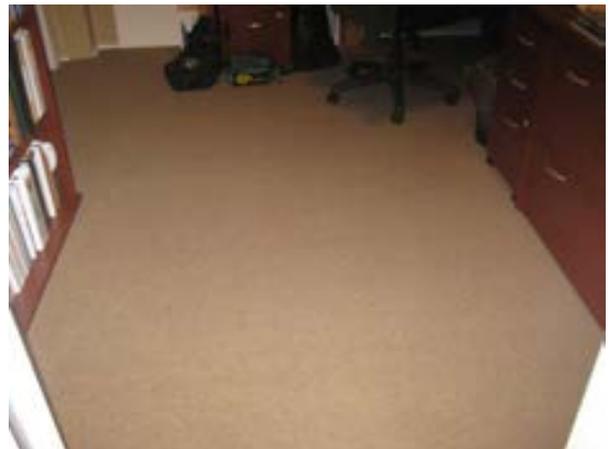
FIGURE 315. Carpeting in the superintendent office (room 106) looking south. Photograph by BVH, October 16, 2012.

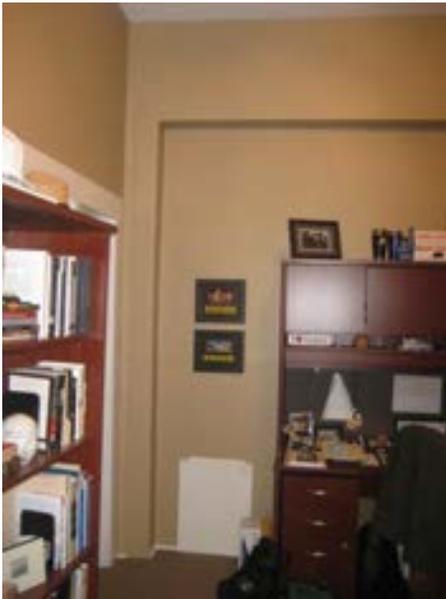
FIGURE 316. The inset portion of the wall is new construction, where the breakfast room once protruded from the south end of the house. Photograph by BVH, October 16, 2012.

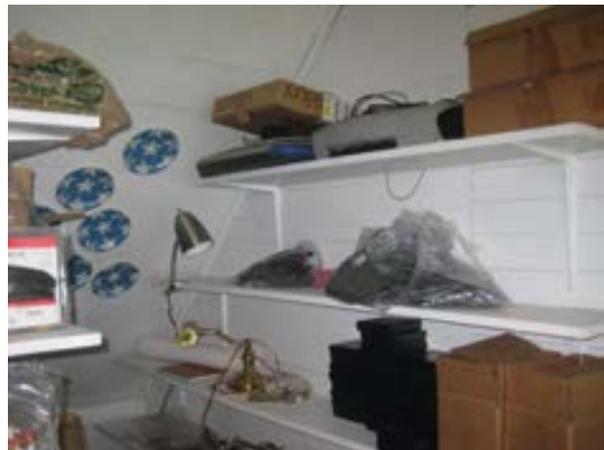
FIGURE 318. East wall of the storage closet within the superintendent office. Photograph by BVH, October 16, 2012.

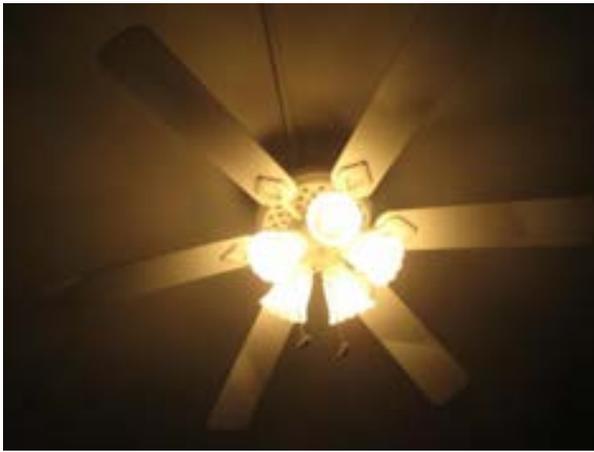
FIGURE 319. Ceiling fan in the superintendent office. Photograph by BVH, October 16, 2012.

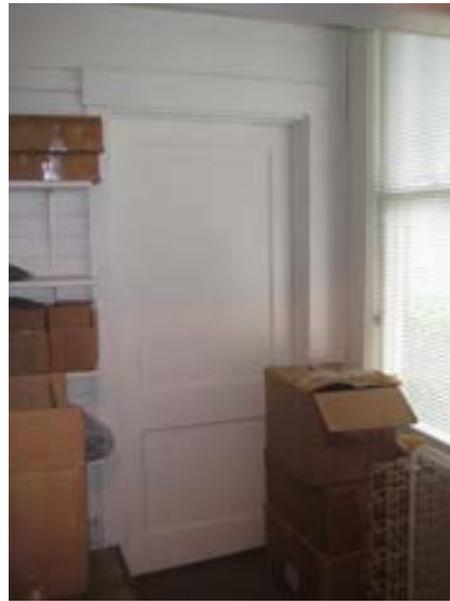
FIGURE 320. Bookstore door from the superintendent office on the east wall. Photograph by BVH, October 16, 2012.

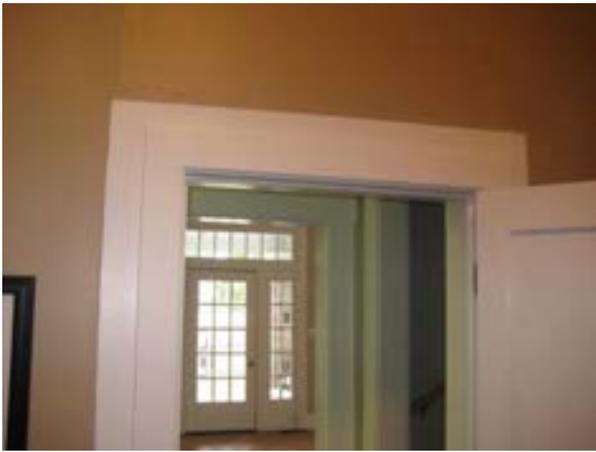
FIGURE 322. Built-up door frame to accommodate a smaller door. Photograph by BVH, October 16, 2012.

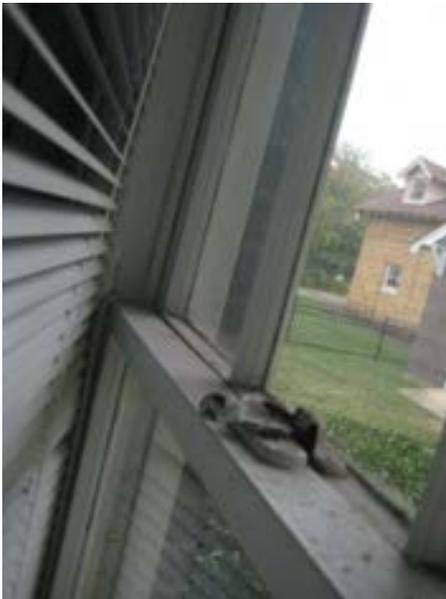
FIGURE 323. Detail of the window in the south wall of the closet of the superintendent office, showing the severed weight cord hanging. Photograph by BVH, October 16, 2012.

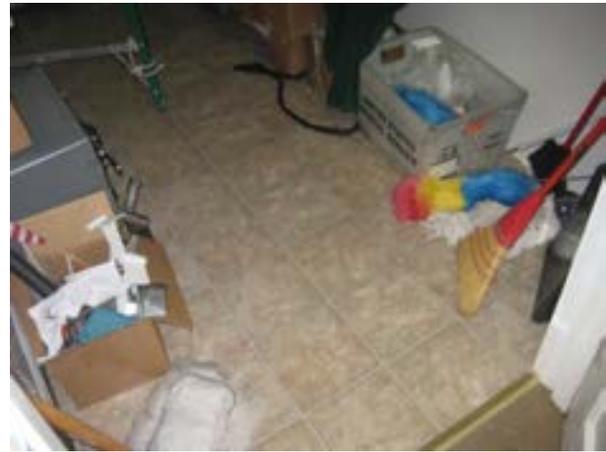
FIGURE 324. Vinyl flooring in storage (room 107) looking south. Photograph by BVH, October 16, 2012.

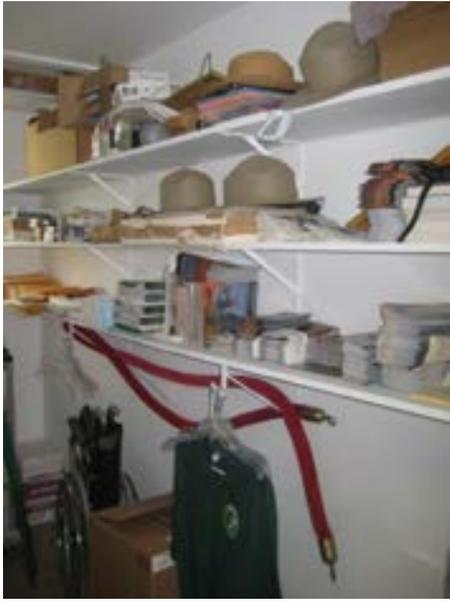
FIGURE 325. West wall of storage (room 107) with shelving. Photograph by BVH, October 16, 2012.

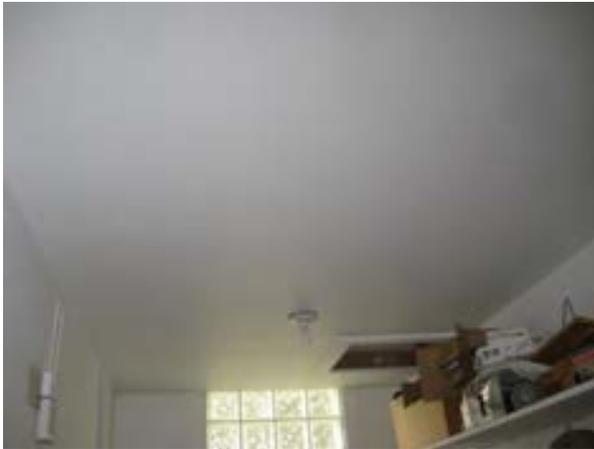
FIGURE 326. Ceiling in storage (room 107) with bare bulb light fixture, looking south. Photograph by BVH, October 16, 2012.

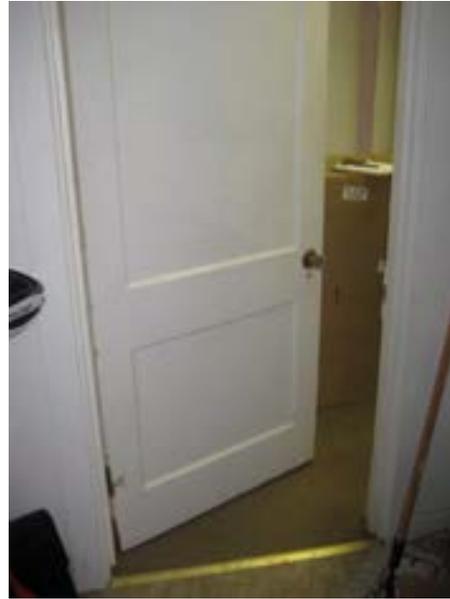
FIGURE 327. Door on the north wall of storage (room 107). Photograph by BVH, October 16, 2012.

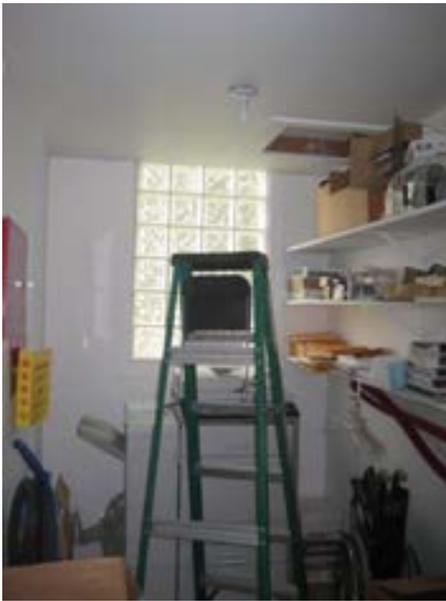
FIGURE 328. Glass block window in storage (room 107) on the south wall. Photograph by BVH, October 16, 2012.

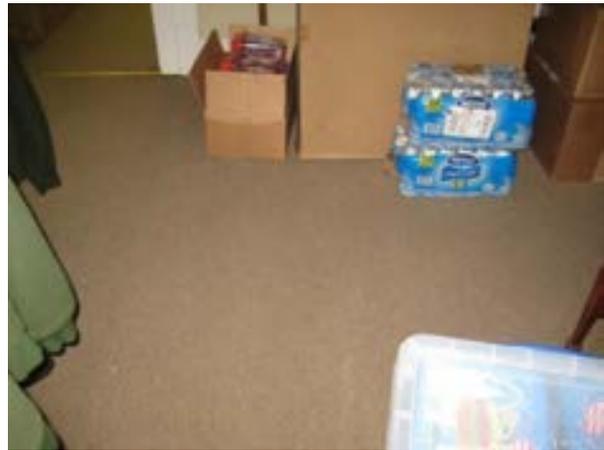
FIGURE 329. Carpet flooring of the north half of the floor of the office (room 108), looking east. Photograph by BVH, October 16, 2012.

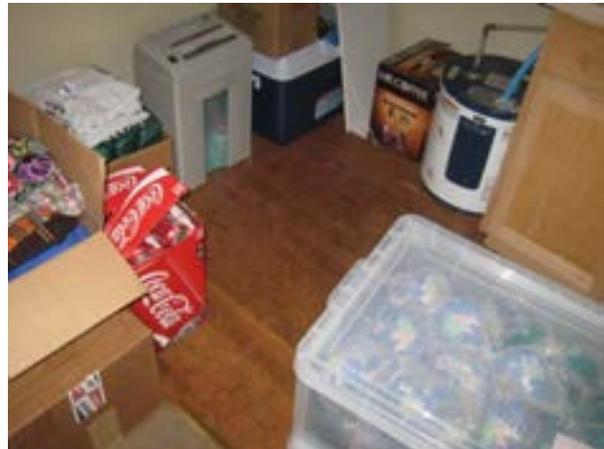
FIGURE 330. Hardwood flooring of the south half of the floor of the office (room 108), looking southeast. Photograph by BVH, October 16, 2012.

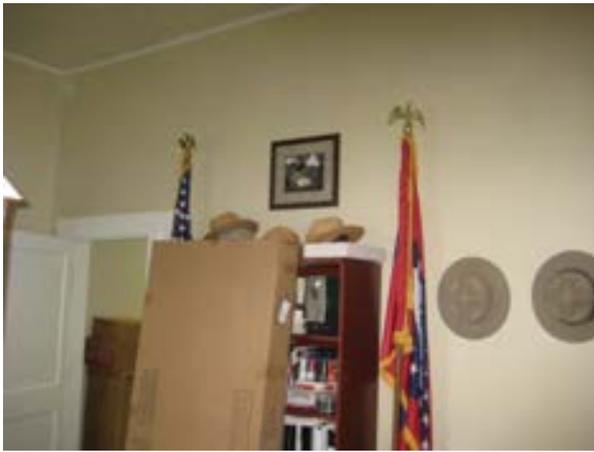
FIGURE 331. Wall finish of the office (room 108), looking north-east. Photograph by BVH, October 16, 2012.

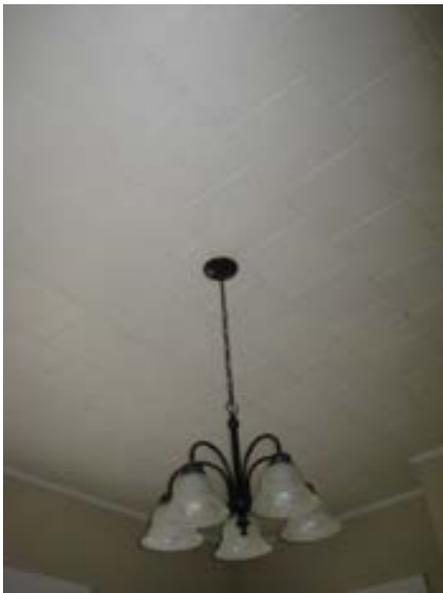
FIGURE 332. Chandelier and ceiling tile assembly, looking northwest. Photograph by BVH, October 16, 2012.

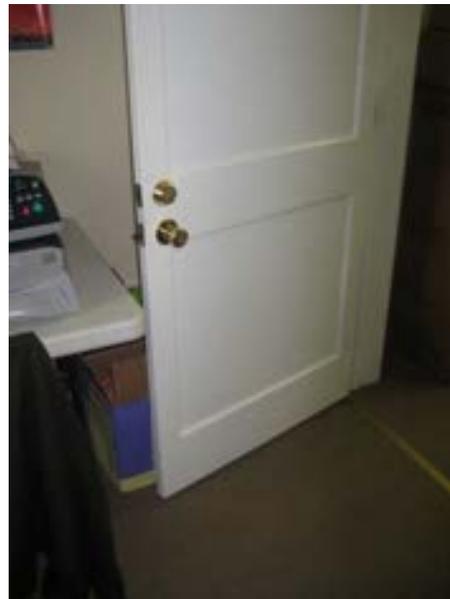
FIGURE 333. Panel door to the corridor with brass hardware, looking northeast. Photograph by BVH, October 16, 2012.

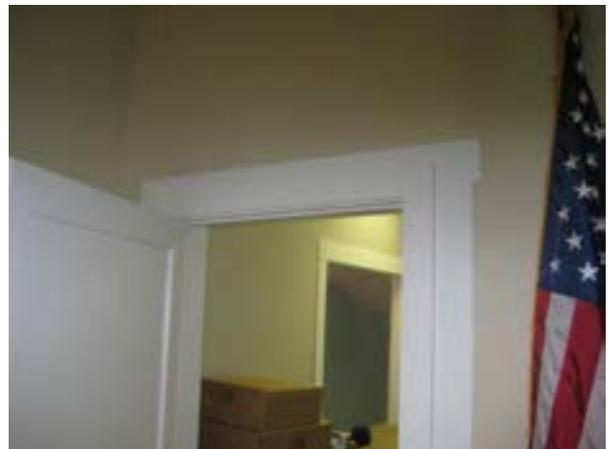
FIGURE 334. Double door frame, looking northeast. Photograph by BVH, October 16, 2012.

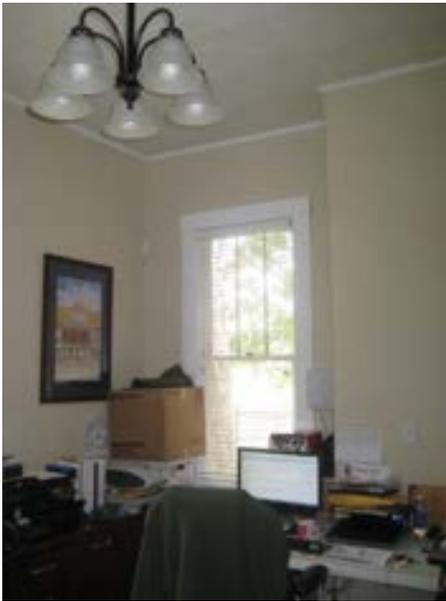
FIGURE 335. North window. Photograph by BVH, October 16, 2012.

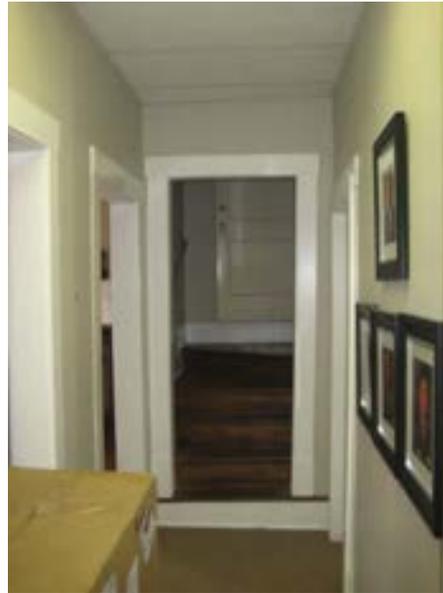
FIGURE 336. Door opening at the east end of the main floor corridor, open to the stairs. Photograph by BVH, October 16, 2012.

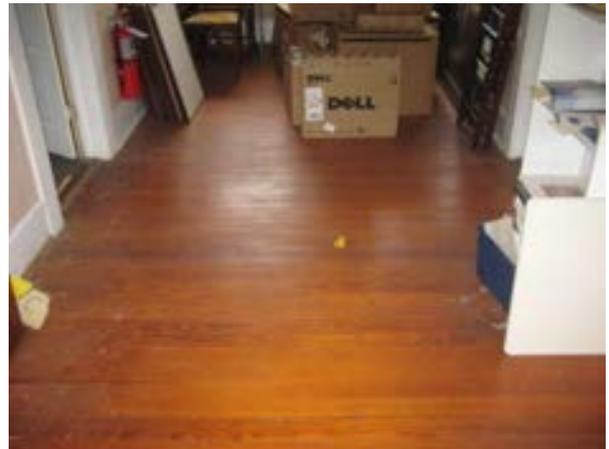
FIGURE 340. Hardwood flooring of storage (room 201), looking north. Photograph by BVH, October 16, 2012.

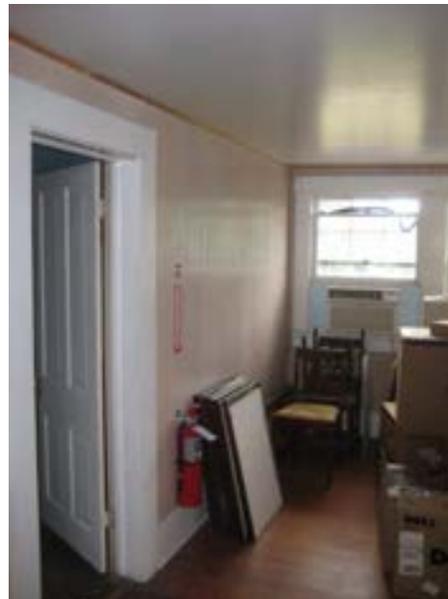
FIGURE 341. Wood veneer paneling, looking north. Photograph by BVH, October 16, 2012.

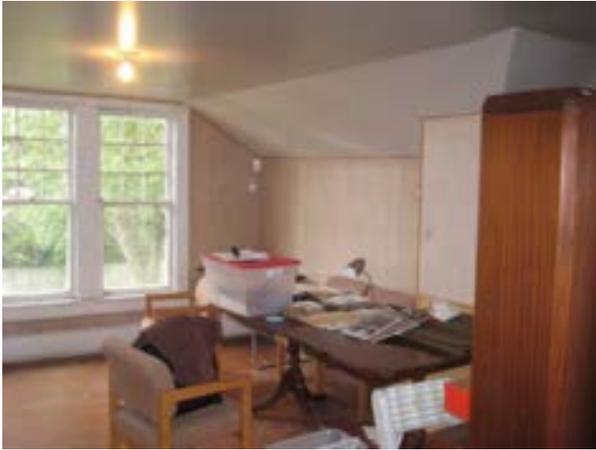
FIGURE 342. White painted plaster ceiling with bare bulb light fixture, looking south. Photograph by BVH, October 16, 2012.

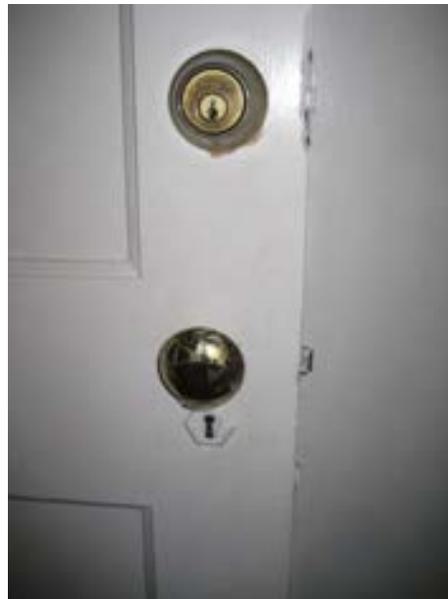
FIGURE 344. Door hardware. Photograph by BVH, October 16, 2012.

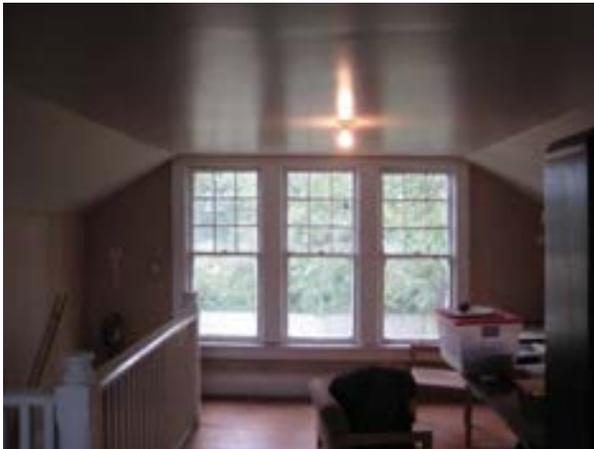
FIGURE 345. There are nine-over-one windows on the south wall of storage 201. Photograph by BVH, October 16, 2012.
