**President William Jefferson Clinton
Birthplace Home National Historic Site**
Hope, Arkansas

Historic Structures Report

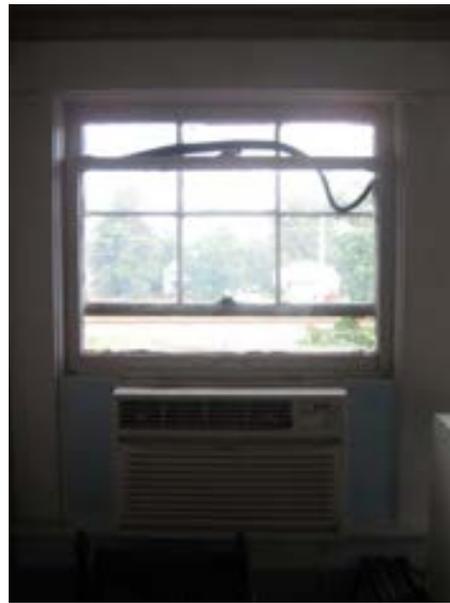
FIGURE 347. A north window with air conditioning unit. Photograph by BVH, October 16, 2012.

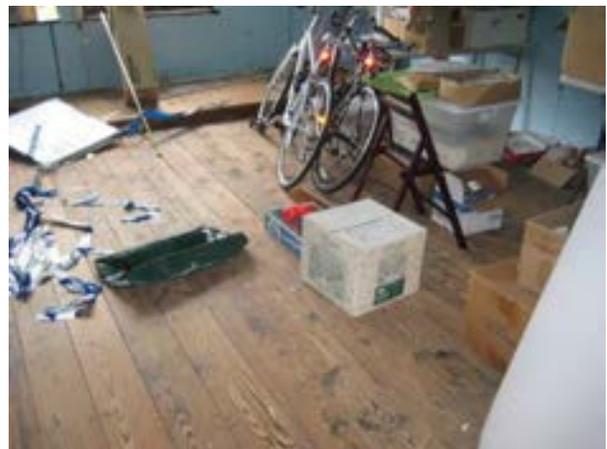
FIGURE 348. Face nailed softwood tongue-and-groove flooring of east storage (room 202), facing east. Photograph by BVH, October 16, 2012.

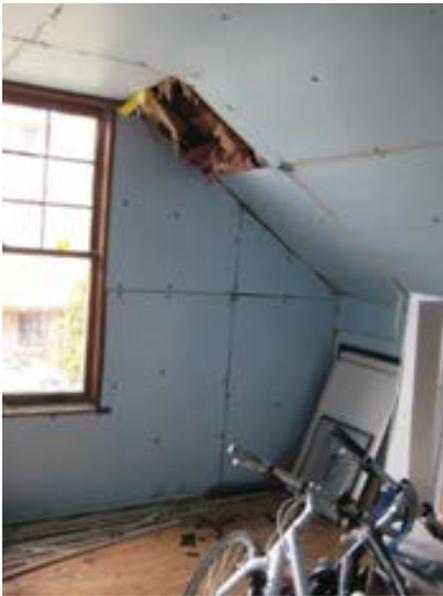
FIGURE 349. Walls of rigid insulation, with missing sections and rough seams, facing east. Photograph by BVH, October 16, 2012.

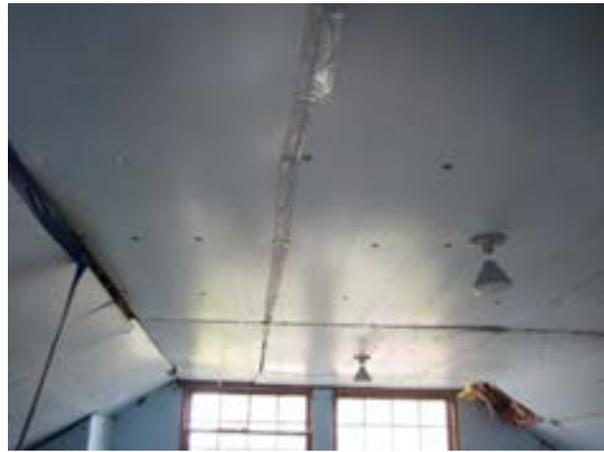
FIGURE 350. Ceiling finished with rigid insulation, with two bare bulbs for lighting, facing east. Photograph by BVH, October 16, 2012.

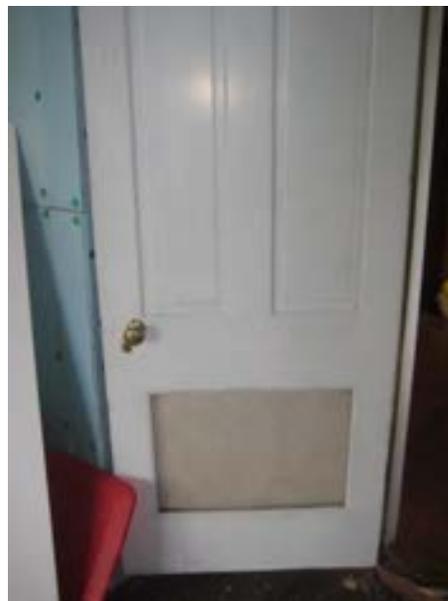
FIGURE 351. Three panel door with bottom panel replaced with air circulation grille, facing west. Photograph by BVH, October 16, 2012.

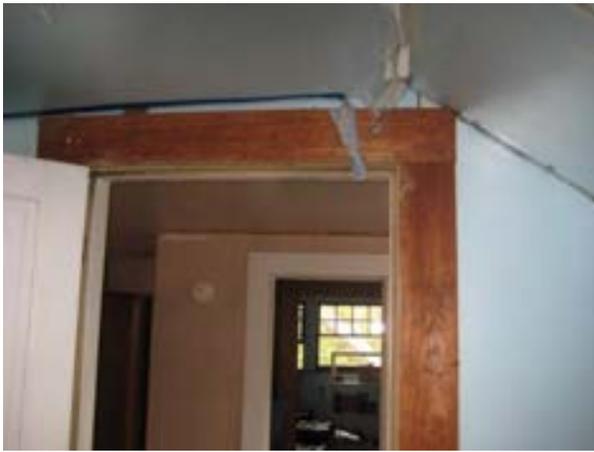
FIGURE 352. Flat stock wood trim surrounding the door, stained, facing west. Photograph by BVH, October 16, 2012.

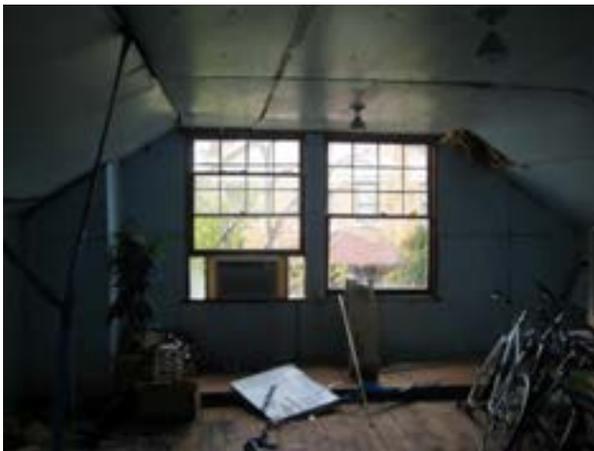
FIGURE 353. Two windows on the east wall, with an insert air conditioner. Photograph by BVH, October 16, 2012.

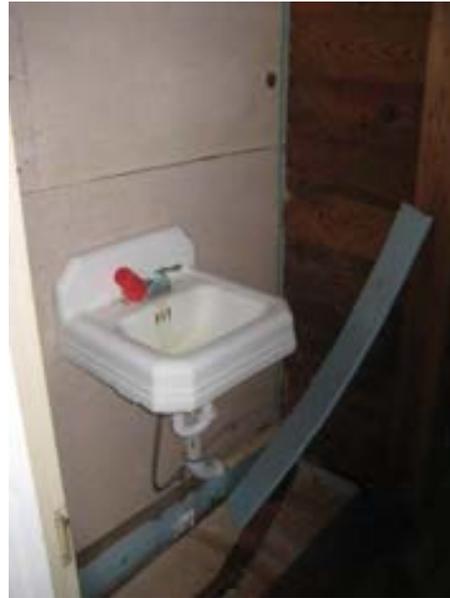
FIGURE 354. Wall hung lavatory in storage (room 203), facing south. Photograph by BVH, October 16, 2012.

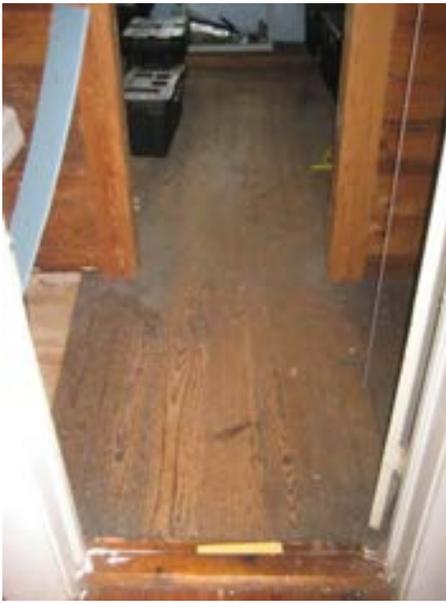
FIGURE 355. Tongue-and-groove flooring, facing west. Photograph by BVH, October 16, 2012.

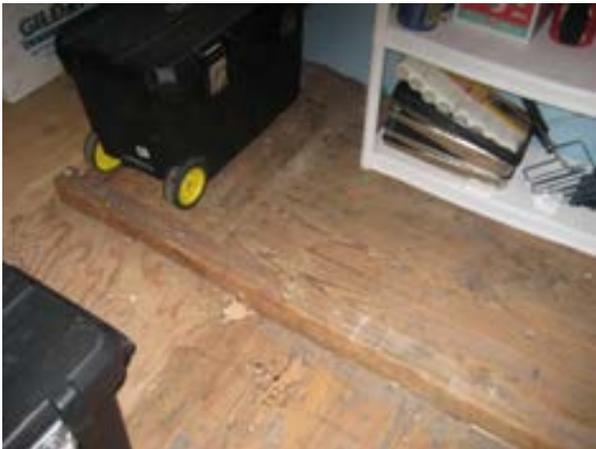
FIGURE 356. Plywood floor, facing south in room 203. Photograph by BVH, October 16, 2012.

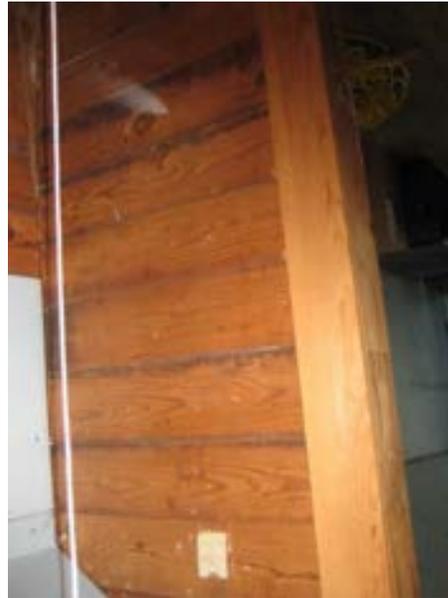
FIGURE 357. Horizontal half-lap wall boards, facing west. Photograph by BVH, October 16, 2012.

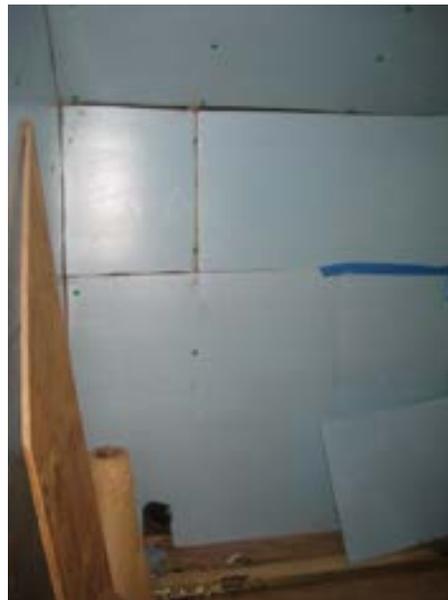
FIGURE 358. Walls of rigid insulation, with open seams, facing south. Photograph by BVH, October 16, 2012.

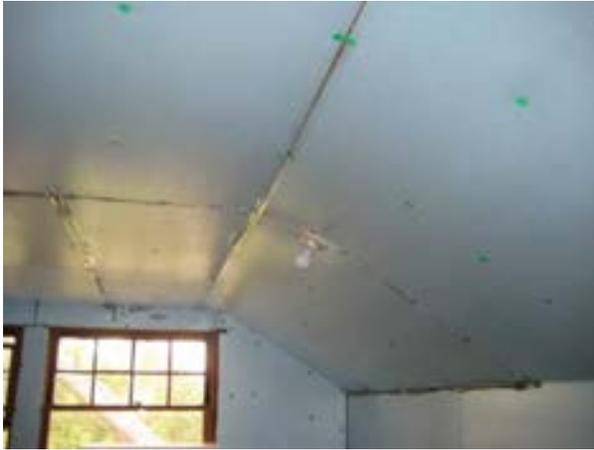
FIGURE 359. Ceiling with rigid insulation and bare bulb light fixtures, facing west. Photograph by BVH, October 16, 2012.

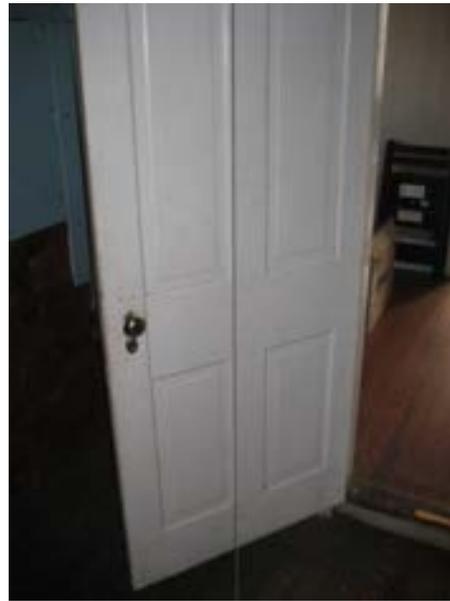
FIGURE 360. Four panel door in west storage (room 203, facing east. BVH, 2012

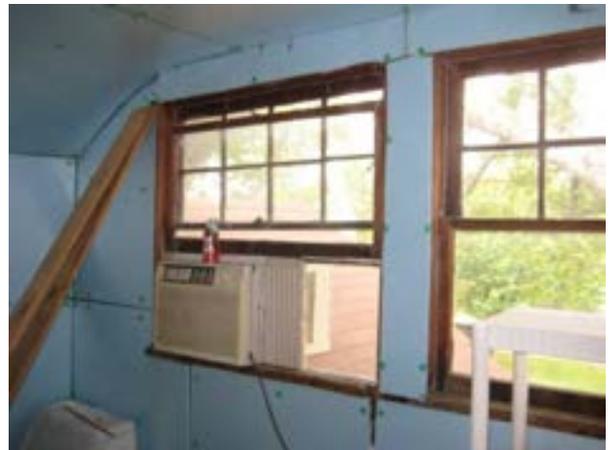
FIGURE 361. Two windows on the west wall, with an insert air conditioner. BVH, 2012.

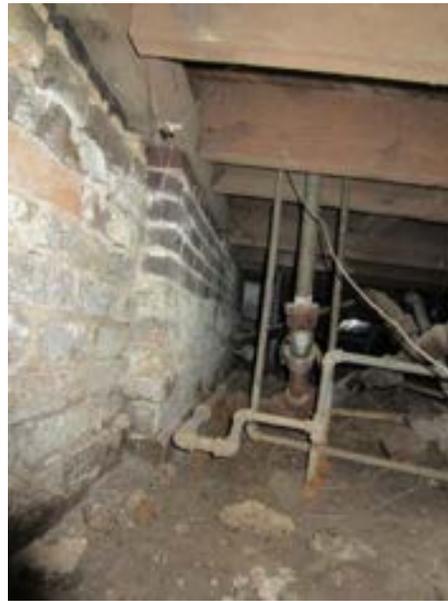
FIGURE 362. View of the interior face of the 3-wythe brick masonry foundation wall from the crawl space below the house, view looking west. Photograph by WJE, October 17, 2012.

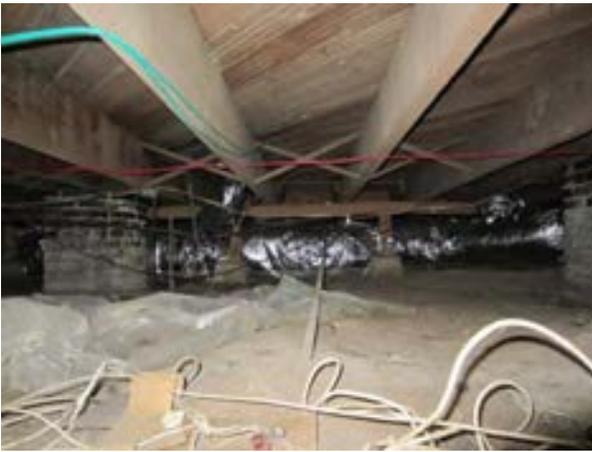
FIGURE 363. Brick masonry piers were partially visible behind HVAC ductwork at the centerline of the house, and supplemental masonry piers were observed supporting spliced joists at midspan. Additionally, concrete footings and 4 by 4 timber framing were later added to provide supplemental support to the first floor joists, view looking north. Photograph by WJE, October 17, 2012.

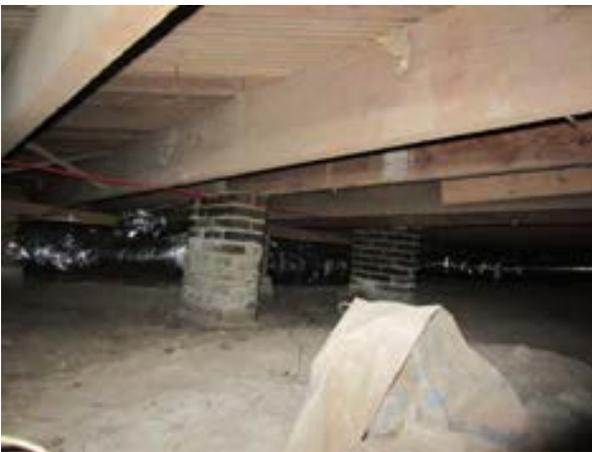
FIGURE 364. Additional masonry foundation piers were observed supporting the midspan of select first floor joists, view looking northeast. Photograph by WJE, October 17, 2012.

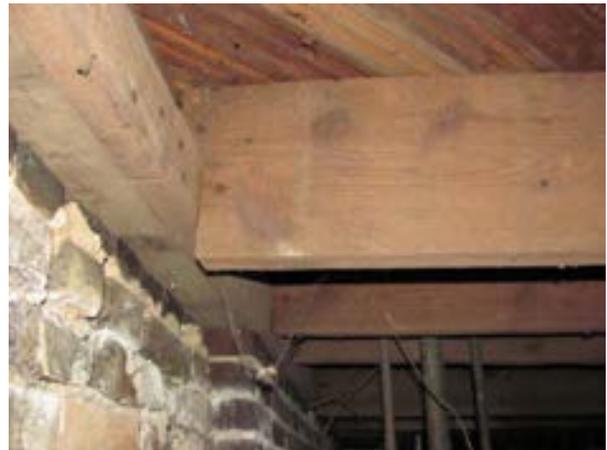
FIGURE 365. Typical first floor joists at 24 inches on center, notched over ledger at perimeter beam, which is in turn supported on a 3-wythe masonry foundation wall, view looking southwest. Photograph by WJE, October 17, 2012.

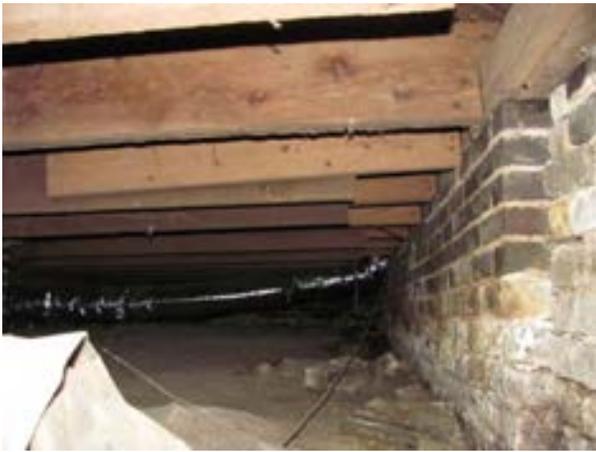
FIGURE 366. 2 by 8 sister joist retrofits observed at the south end of first floor joists, toenailed to the perimeter ledger beam, view looking east. Photograph by WJE, October 17, 2012.

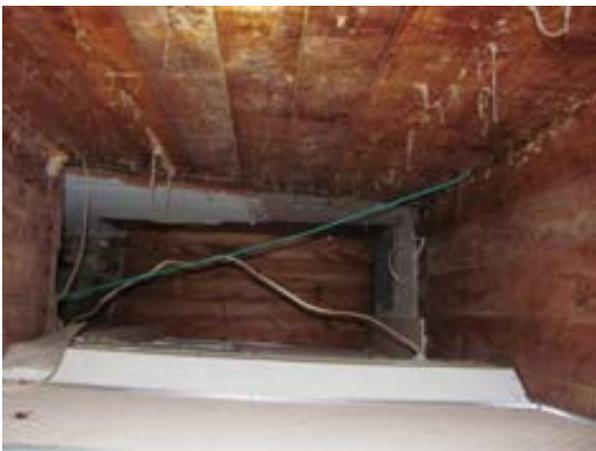
FIGURE 367. Wood sheathing at interior partition walls, viewed above the suspended ceiling of the first floor corridor, view looking west. Photograph by WJE, October 17, 2012.

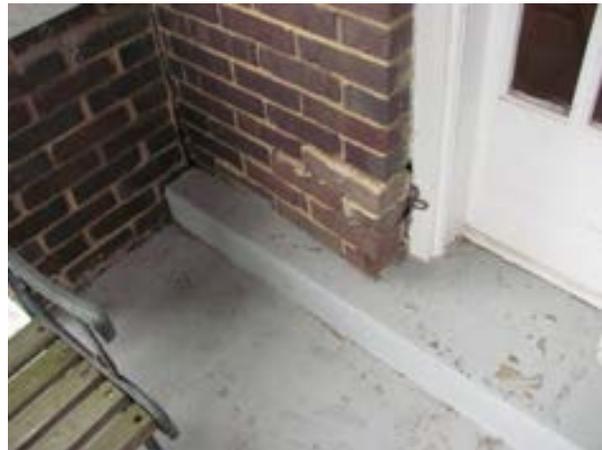
FIGURE 368. Location of loose bricks at north elevation where an inspection opening was made to view the condition behind the brick veneer, view looking southeast. Photograph by WJE, October 16, 2012.

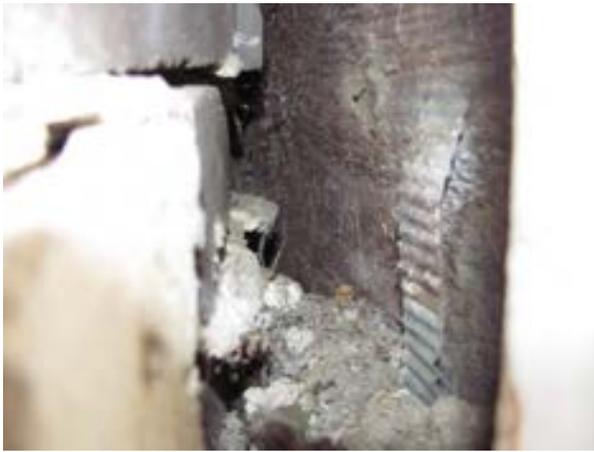
FIGURE 369. Close-up view of wood planking observed behind a the brick veneer at the location shown in Figure 368. The corrugated metal tie at right was intended to secure the veneer. Photograph by WJE, October 16, 2012.

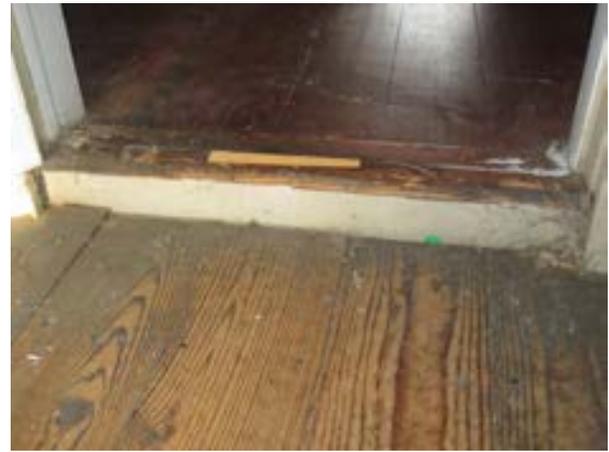
FIGURE 370. Location where floor framing steps down from 2 by 10 joists to 2 by 6 joists at the west area of the second floor. A similar condition exists at the east area, view looking east. Photograph by WJE, October 16, 2012.

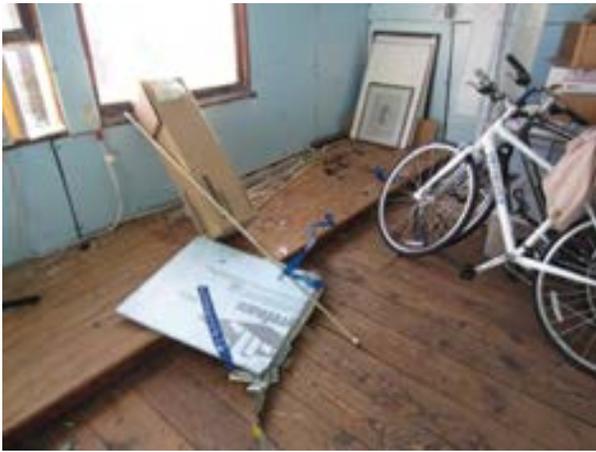
FIGURE 371. Plywood platform framed out at the east end of the second floor, view looking southeast. Photograph by WJE, October 17, 2012.

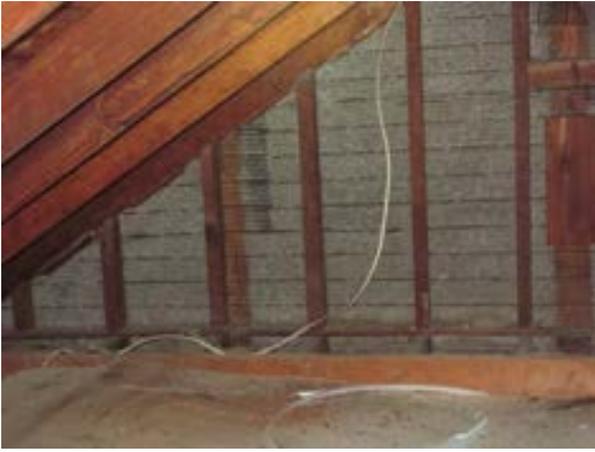
FIGURE 377. Partial view of a typical gable end wall framed with 2 by 4 studs to support stucco cladding, view looking west. Photograph by WJE, October 16, 2012.

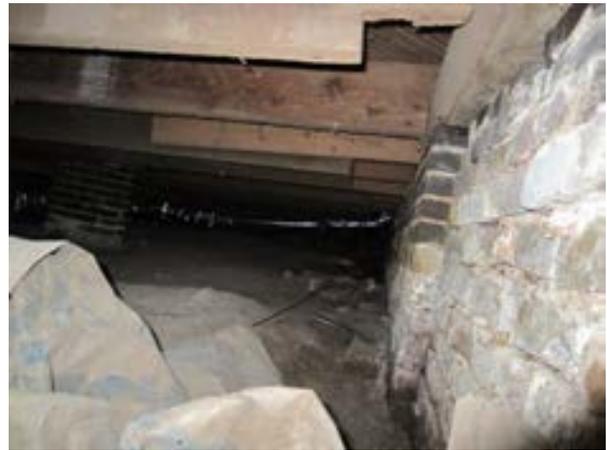
FIGURE 378. Brick deterioration and staining due to water damage at the interior of the perimeter foundation wall. Note, some mortar joints are eroded, view looking east. Photograph by WJE, October 17, 2012.

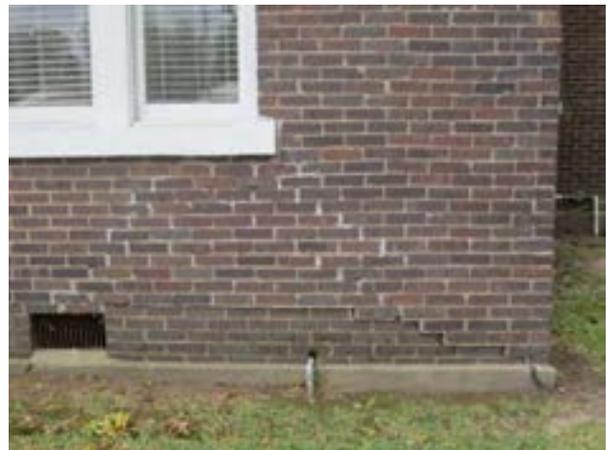
FIGURE 379. Step cracking and displacement in excess of 1 inch typically noted at the masonry foundation and facade, view looking south. Photograph by WJE, October 17, 2012.

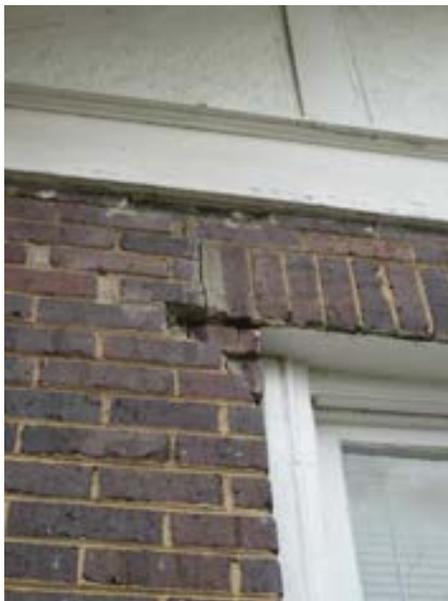
FIGURE 380. Typical step cracking and displacement observed at the masonry facade, view looking west. Photograph by WJE, October 17, 2012.

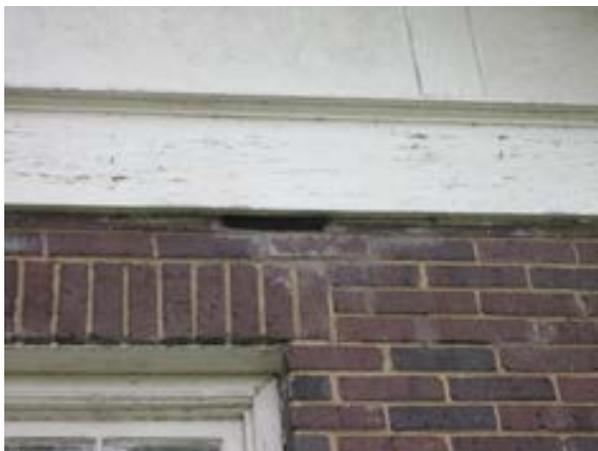
FIGURE 381. Missing brick at the west elevation, view looking east. Photograph by WJE, October 17, 2012.

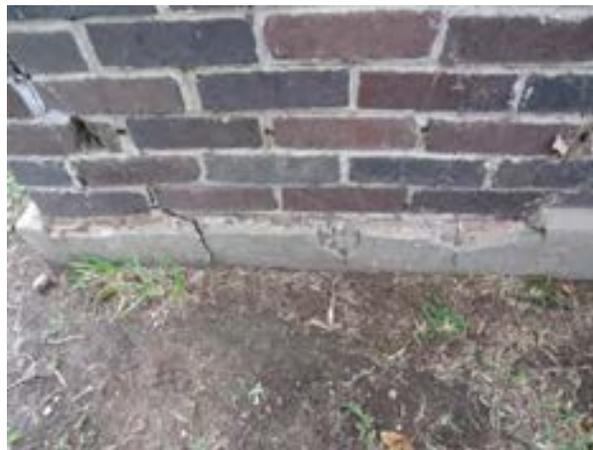
FIGURE 382. Typical cracking and displacement seen at foundation parge coat. Note, bricks beneath parge are also cracked, view looking east. Photograph by WJE, October 17, 2012.

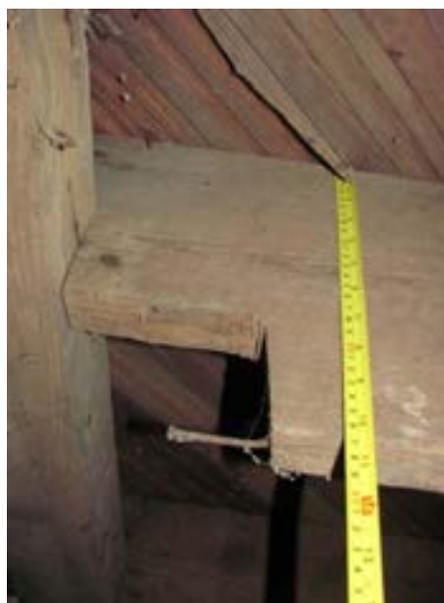
FIGURE 383. Two joists were noted to have a second notch at the tension face, view looking west. Photograph by WJE, October 17, 2012.

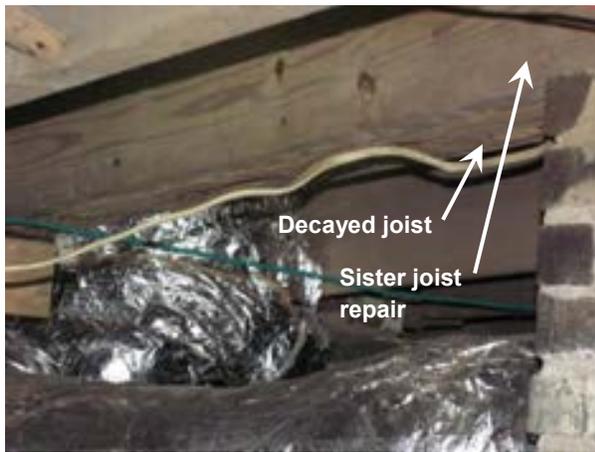
FIGURE 384. Decayed joist with sister joist repair and supported on masonry pier at midspan, view looking northeast. Photograph by WJE, October 17, 2012.

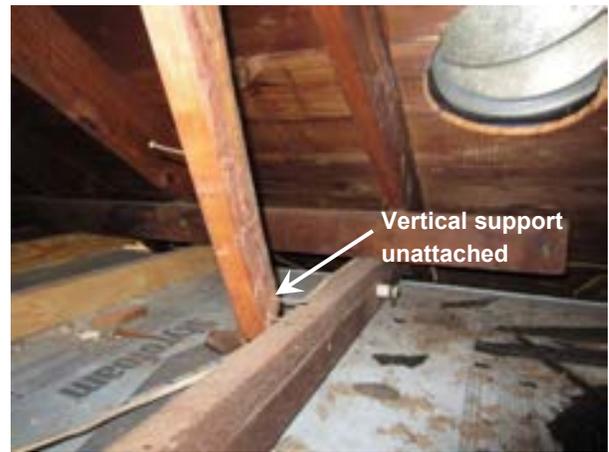
FIGURE 387. Supplemental vertical support assumed to be installed during chimney modification is detached at the collar tie connection, view looking north. Photograph by WJE, October 17, 2012.

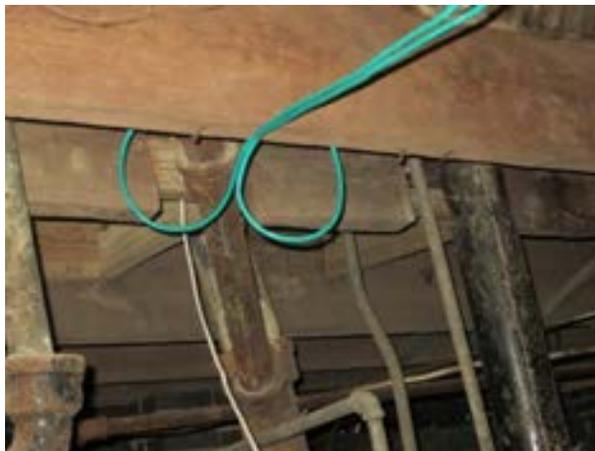
FIGURE 385. One location was observed where a significant portion of the joist had been notched in two locations to accommodate plumbing, view looking west. Photograph by WJE, October 17, 2012.

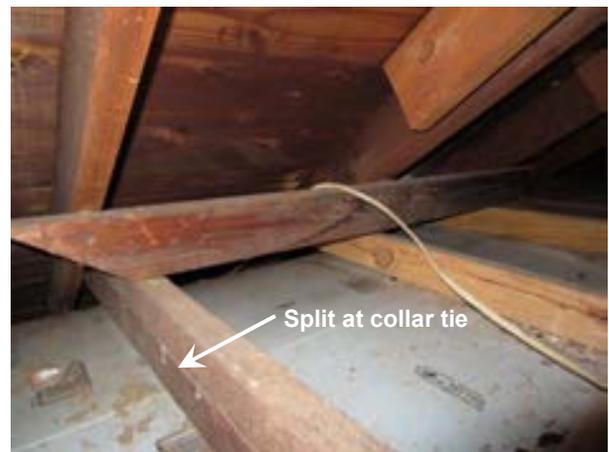
FIGURE 388. Splitting and checking observed at roof collar tie, view looking east. Photograph by WJE, October 17, 2012.

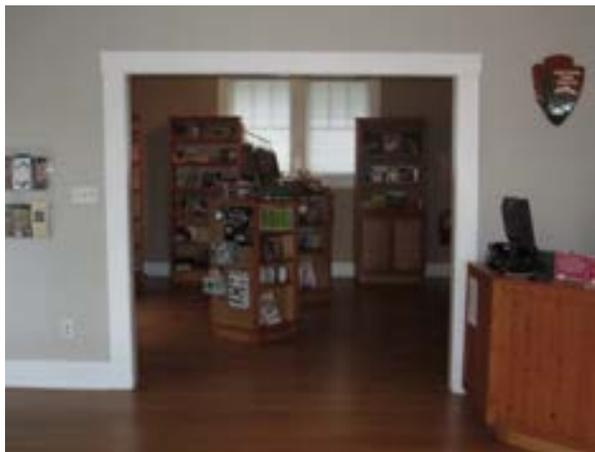
FIGURE 386. Skewed doorway at location of interior bearing wall. Architecture finishes were observed to be intact at this location, view looking south. Photograph by WJE, October 16, 2012.

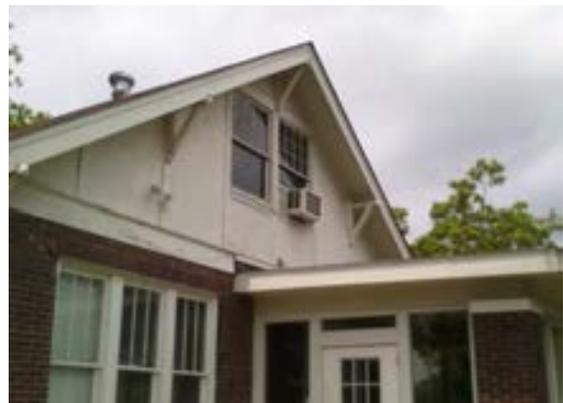
FIGURE 389. Window air conditioner at east storage 202 of the second floor of the visitor center. Photograph by Alvine, May 15, 2013.

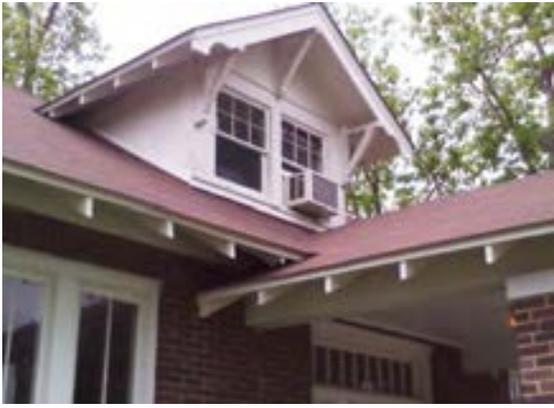
FIGURE 390. Window air conditioner at north/south center storage room 201 of the second floor of the visitor center. Photograph by Alvine, May 15, 2013.

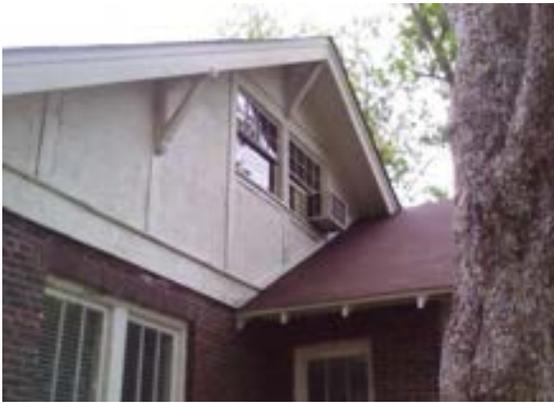
FIGURE 391. Window air conditioner at west storage 203 of the second floor of the visitor center. Photograph by Alvine, May 15, 2013.

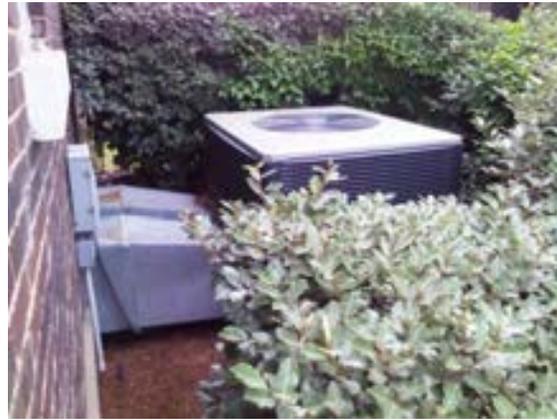
FIGURE 392. Grade-mounted packaged heating and cooling unit serving the visitor center. Photograph by Alvine, May 15, 2013.

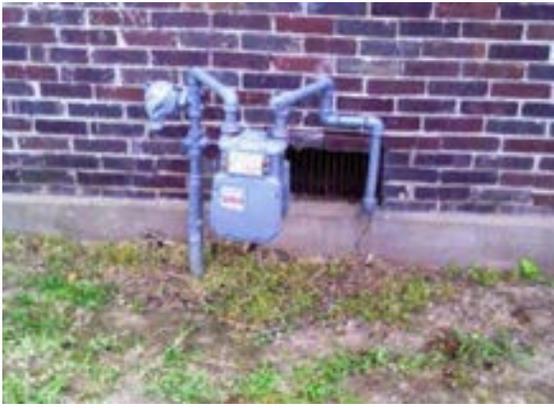
FIGURE 394. Gas meter and service entrance location at west side of the visitor center. Photograph by Alvine, May 15, 2013.

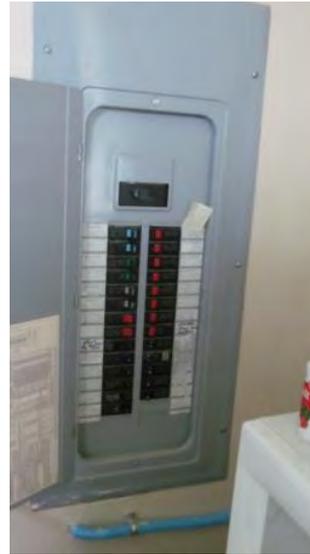
FIGURE 398. Electrical panel in office 108. Photograph by Alvine, May 15, 2013.

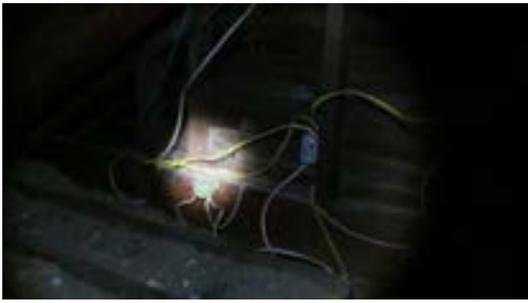
FIGURE 399. Electrical wiring in attic with incorrectly routed and unsupported cables. Photograph by Alvine, May 15, 2013.

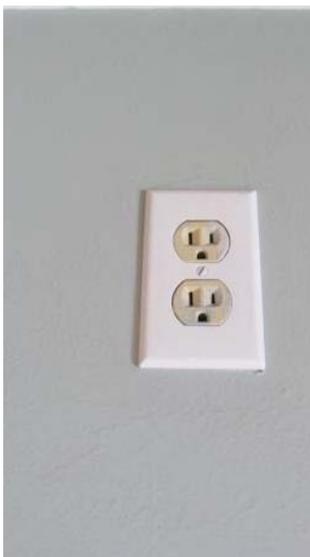
FIGURE 410. Receptacle showing ivory colored device with white cover plate. Photograph by Alvine, May 15, 2013.

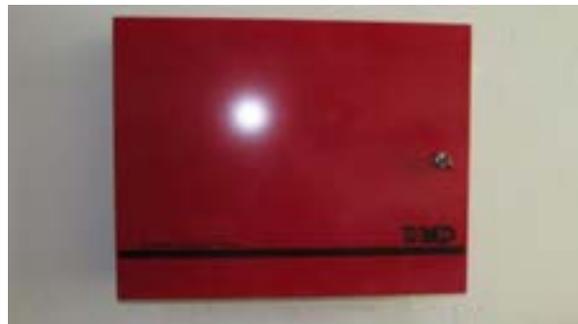
FIGURE 411. Intrusion alarm panel in the copy machine room. Photograph by Alvine, May 15, 2013.

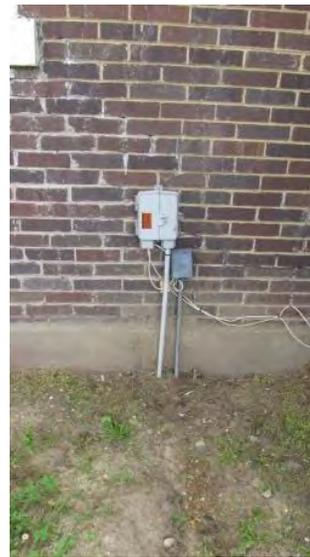
FIGURE 416. Outside telephone DeMark service entrance location. Photograph by Alvine, May 15, 2013.

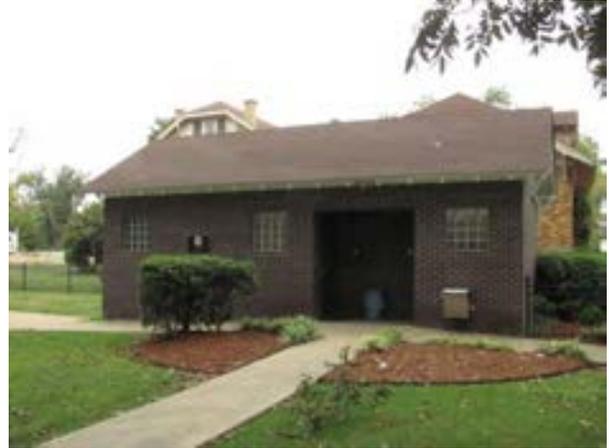
FIGURE 420. A view of the west elevation of the comfort station. Photograph by WJE, October 16, 2012.

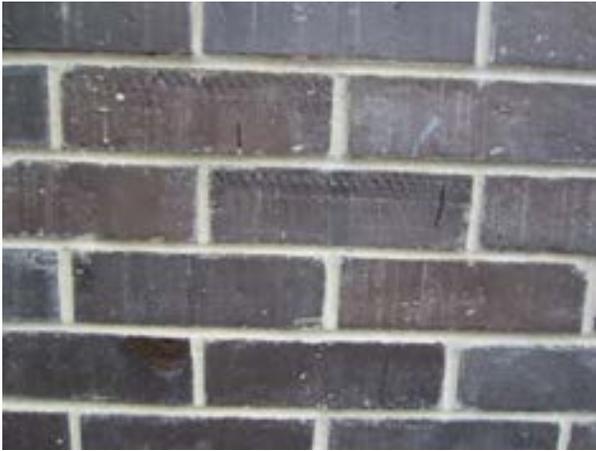
FIGURE 421. Typical location where bricks exhibit vertical splitting, a likely manufacturing defect, was observed with no signs of related distress in the mortar. Looking north. Photograph by WJE, October 17, 2012.

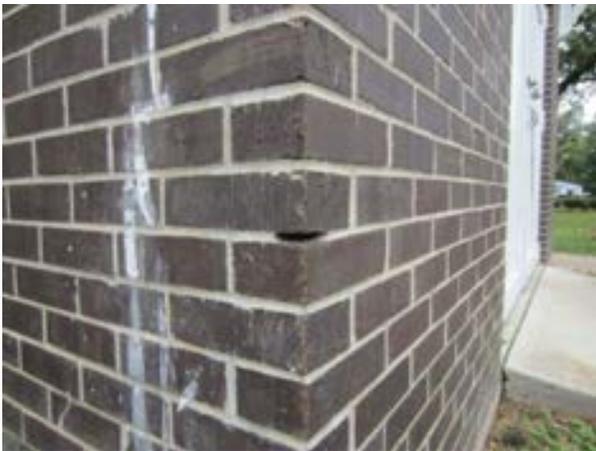
FIGURE 422. Missing mortar at northeast corner masonry joint. Looking southwest. Photograph by WJE, October 17, 2012.

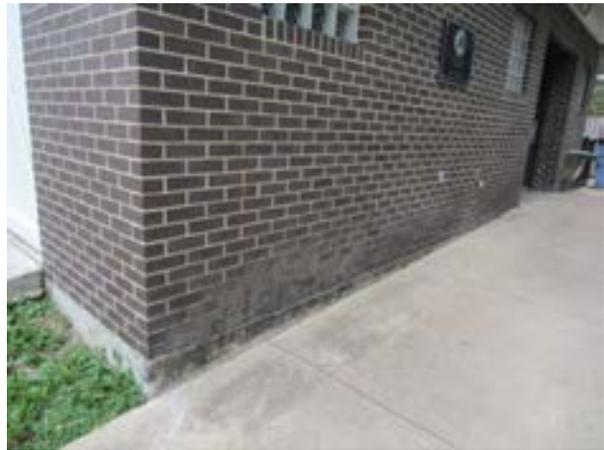
FIGURE 423. Staining observed at the concrete edge and the first six courses of brick at the west elevation. Photograph by WJE, October 17, 2012.

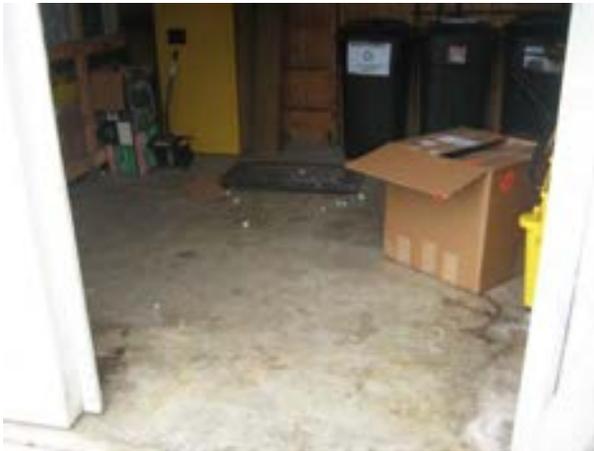
FIGURE 424. Concrete slab floor of the maintenance storage room, looking south. Photograph by BVH, October 16, 2012.

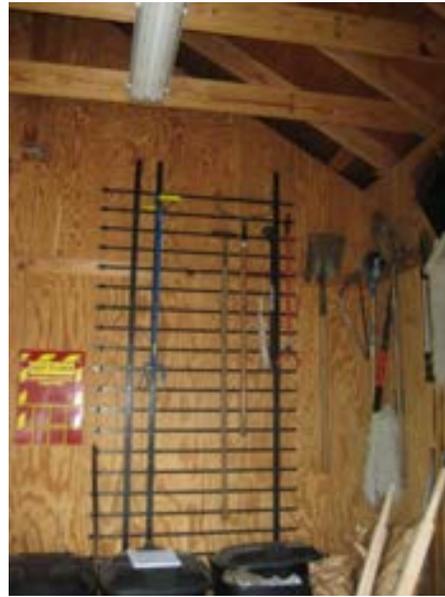
FIGURE 425. Plywood south wall assembly. Photograph by BVH, October 16, 2012.

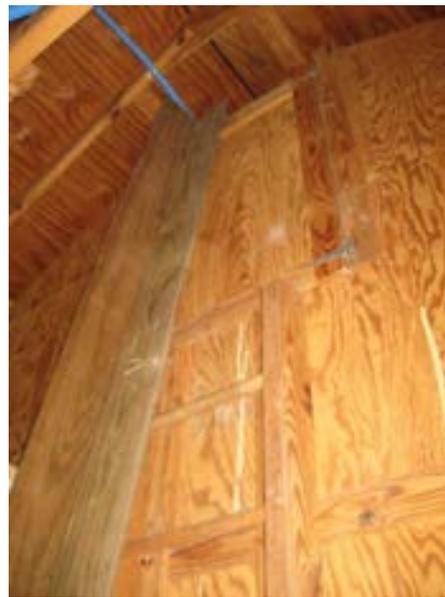
FIGURE 426. Ladder accessing the attic space above the restrooms on the south wall. Photograph by BVH, October 16, 2012.

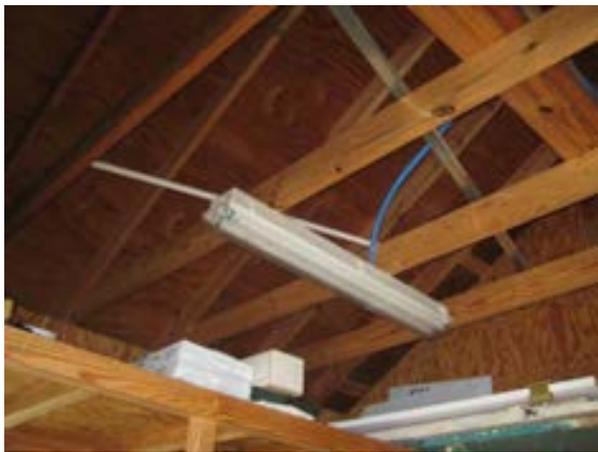
FIGURE 427. Exposed roof structure in the maintenance storage room, looking south. Photograph by BVH, October 16, 2012.

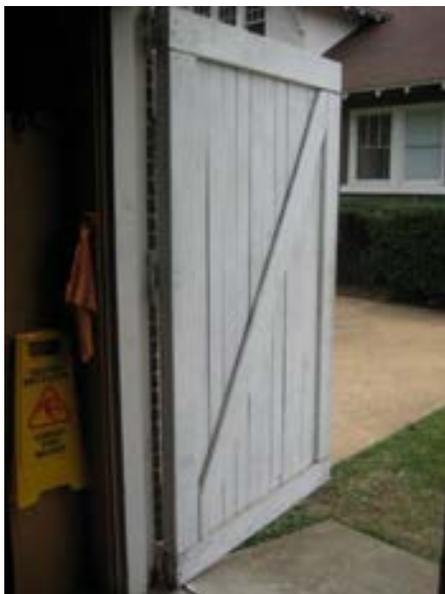
FIGURE 428. One leaf of the double doors on the north side of the space. Photograph by BVH, October 16, 2012.

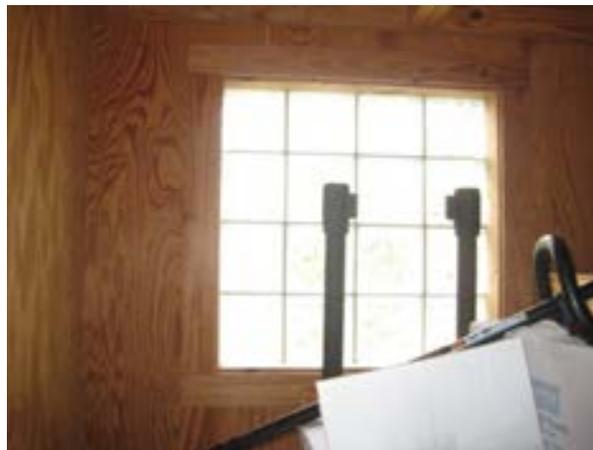
FIGURE 429. Glass block windows, one on each of the east and west sides of the room. Photograph by BVH, October 16, 2012.

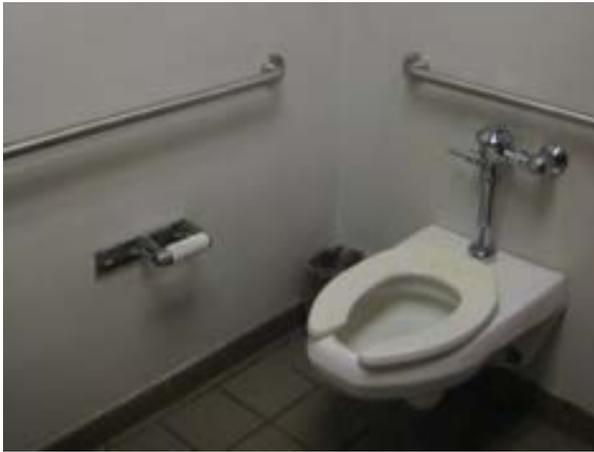
FIGURE 431. Accessible stall in the women's room in the south east corner of the room. Photograph by BVH, October 16, 2012.

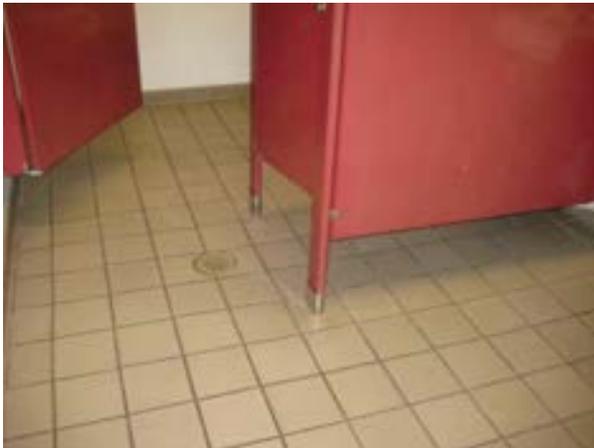
FIGURE 432. Ceramic tile floor of the women's room looking east. Photograph by BVH, October 16, 2012.

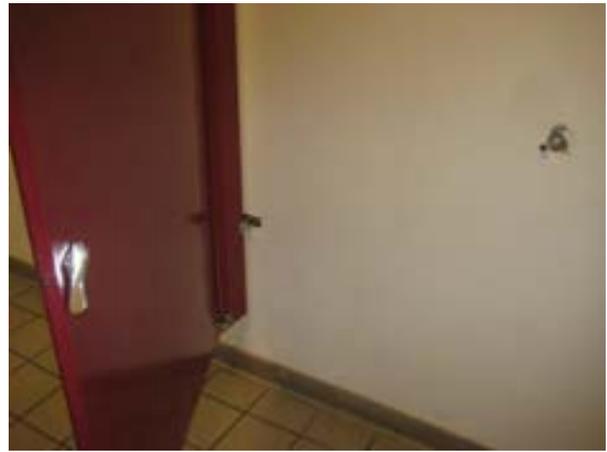
FIGURE 433. Damage to the gypsum board of the south wall due to the water closet door hardware puncturing the wall. Photograph by BVH, October 16, 2012.

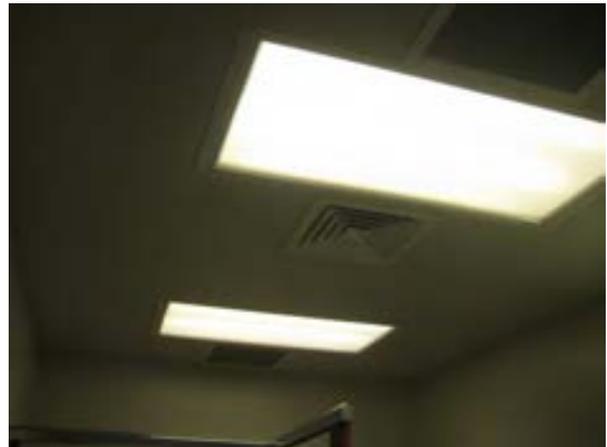
FIGURE 434. Ceiling with mechanical openings and fluorescent light fixtures, looking east. Photograph by BVH, October 16, 2012.

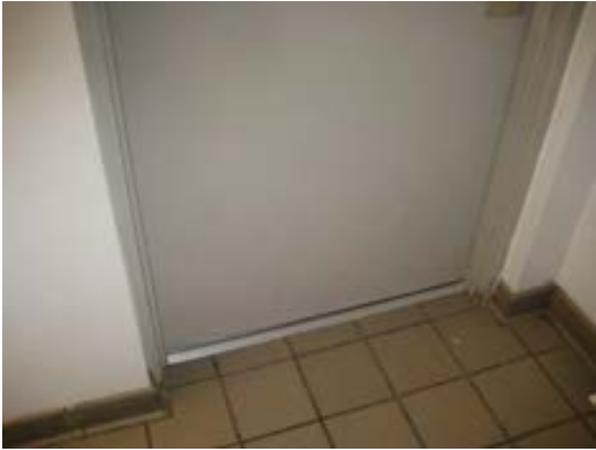
FIGURE 435. The steel outswing door of the women's room, looking south. Photograph by BVH, October 16, 2012.

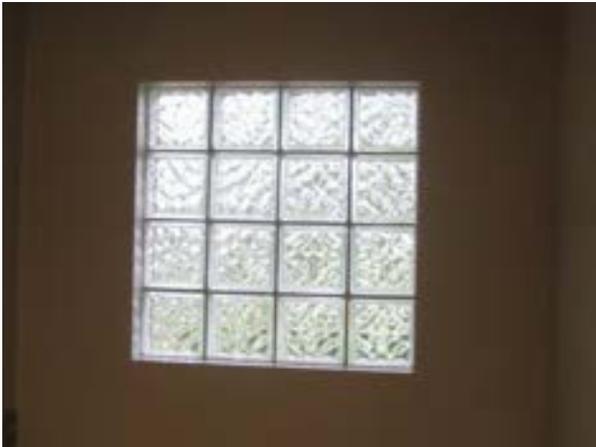
FIGURE 436. The glass block window of the women's room on the west wall. Photograph by BVH, October 16, 2012.

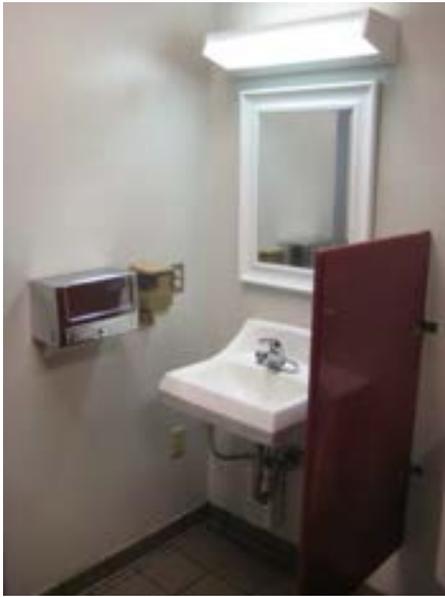
FIGURE 439. Men's room sink on the north wall. Photograph by BVH, October 16, 2012.

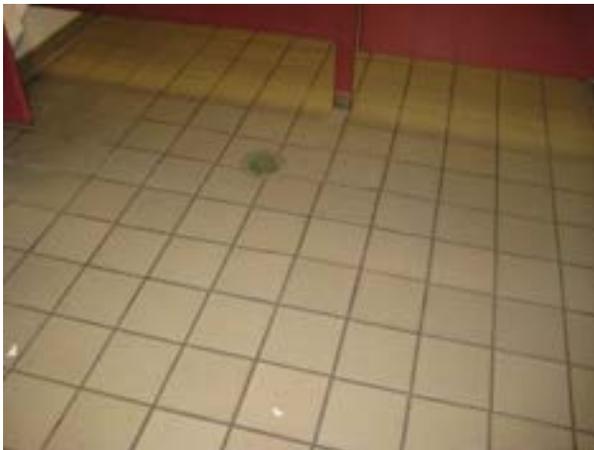
FIGURE 440. ceramic tile floor in the men's room looking east. Photograph by BVH, October 16, 2012.

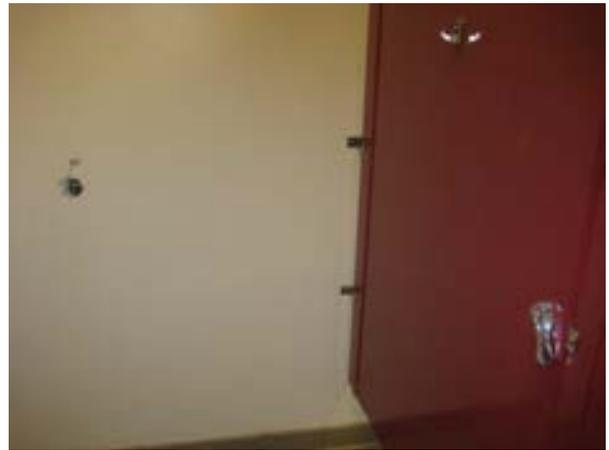
FIGURE 441. damaged south wall in the men's room. Photograph by BVH, October 16, 2012.

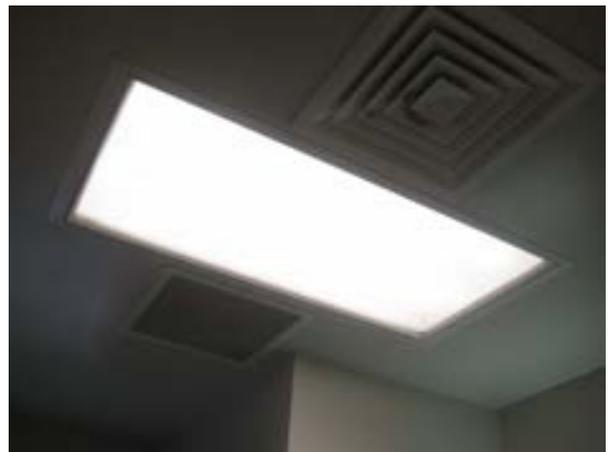
FIGURE 442. ceiling of the men's room looking west. Photograph by BVH, October 16, 2012.

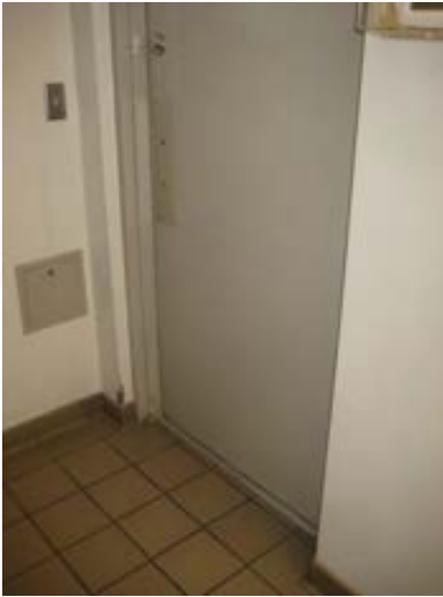
FIGURE 443. The steel outswing door of the men’s room on the north wall. Photograph by BVH, October 16, 2012.

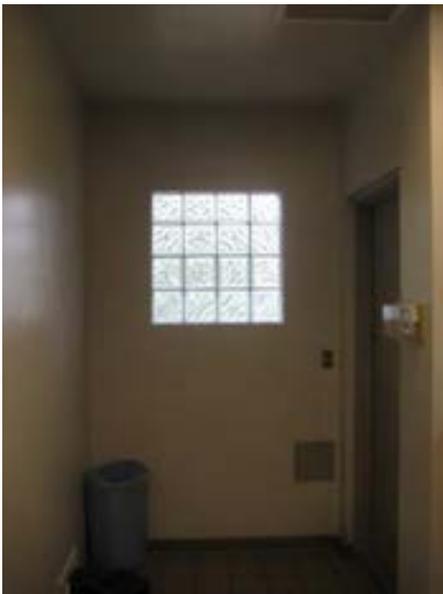
FIGURE 444. The glass block window of the men’s room on the west wall. Photograph by BVH, October 16, 2012.

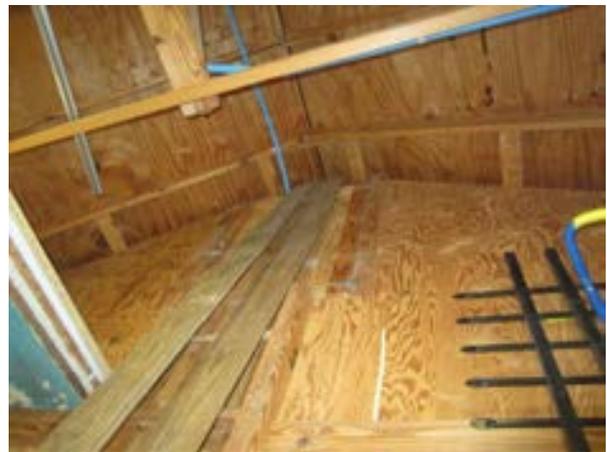
FIGURE 446. Condition noted at the fifth rafter where 2x4 purlins replace the horizontal tie due to a conflict at the plywood wall hatch. Looking south. Photograph by WJE, October 17, 2012.

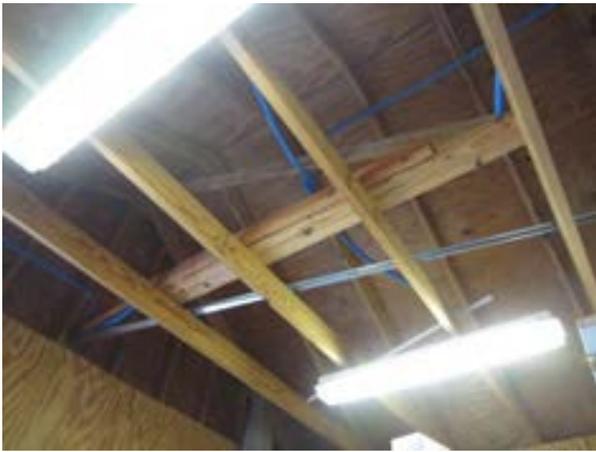
FIGURE 447. 2 by 4 gable end wall braced by 2 by 4 and 2 by 6 wood members framing over the roof rafter horizontal ties. Looking north. Photograph by WJE, October 17, 2012.

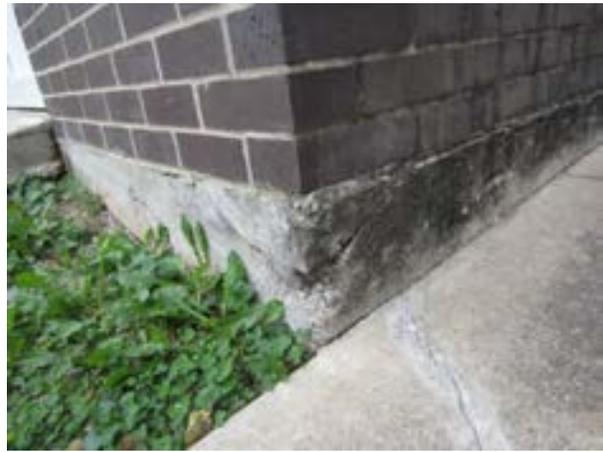
FIGURE 448. Cracking and spalling at northwest corner of concrete slab-on-grade. Looking southeast. Photograph by WJE, October 17, 2012.

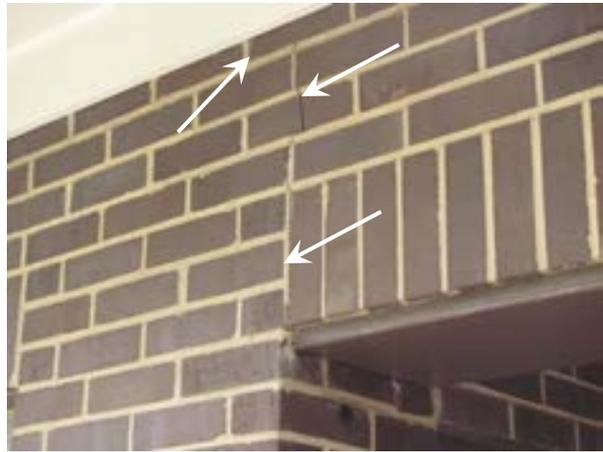
FIGURE 449. Vertical step crack propagating from the north corner of the lintel at the west building entrance. Looking east. Photograph by WJE, October 17, 2012.

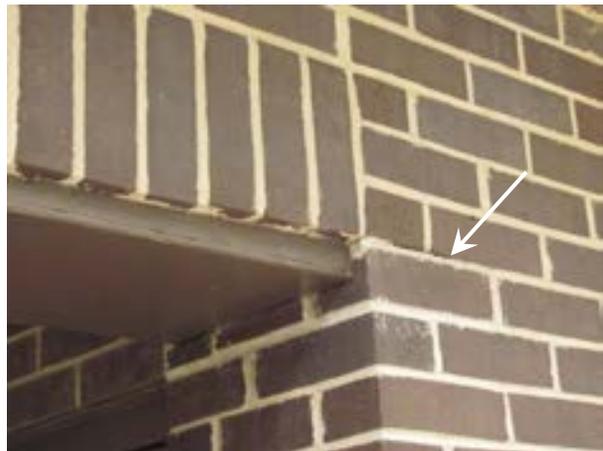
FIGURE 450. Horizontal crack in the mortar joint to the south of the lintel at the west building entrance. Looking east. Photograph by WJE, October 17, 2012.

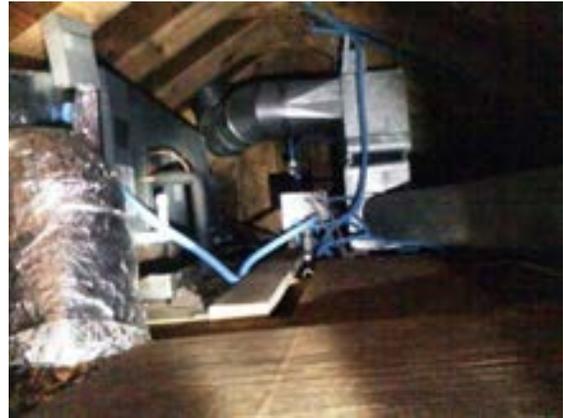
FIGURE 451. HVAC unit (left side of photo) at attic of the . Photograph by Alvine, May 15, 2013.

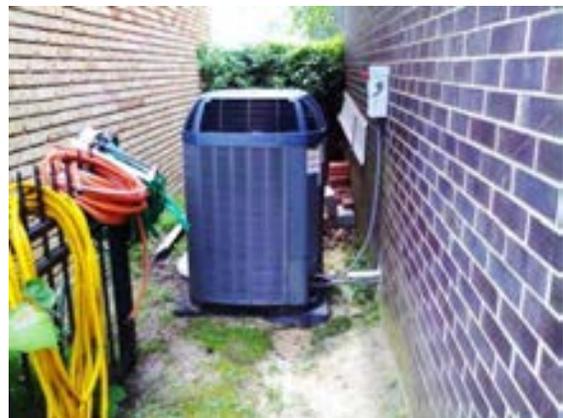
FIGURE 452. Grade-mounted air-cooled condensing unit located at east side of the comfort station. Photograph by Alvine, May 15, 2013.

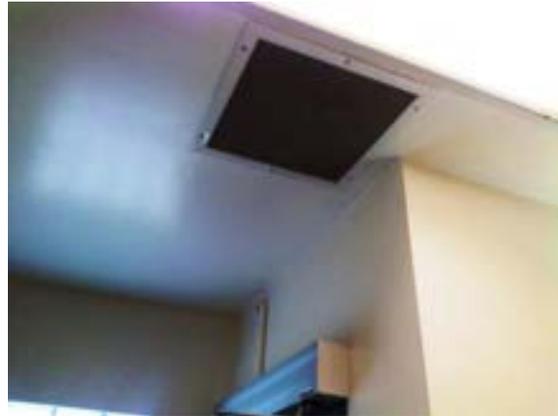
FIGURE 455. Ceiling exhaust air grille at women's restroom 102 of the comfort station (men's restroom 103 grille is similar). Photograph by Alvine, May 15, 2013.
