**President William Jefferson Clinton
Birthplace Home National Historic Site**
Hope, Arkansas

Historic Structures Report

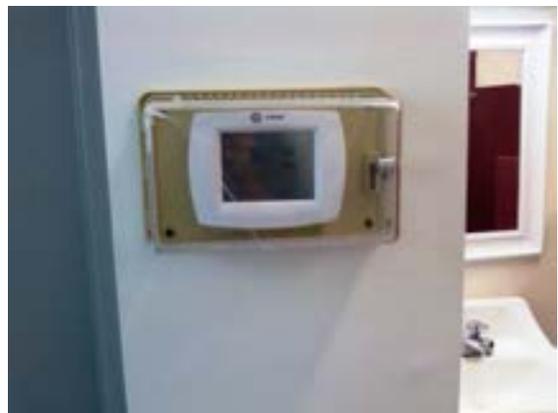
FIGURE 456. HVAC system control thermostat at men's restroom 103. Photograph by Alvine, May 15, 2013.

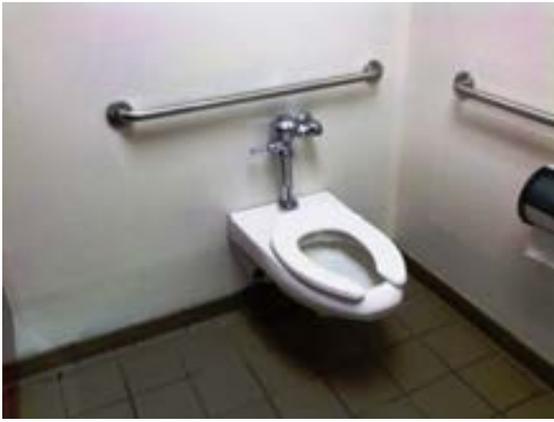
FIGURE 457. Wall-mounted flush valve water closet at men's restroom 103. Photograph by Alvine, May 15, 2013.

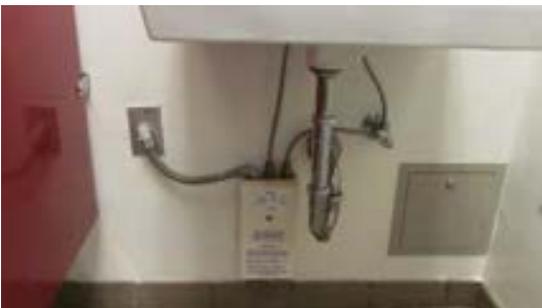
FIGURE 473. Instantaneous electric water heater in toilet room. Photograph by Alvine, May 15, 2013.

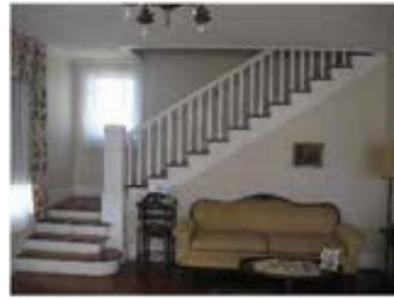
Character-defining Features of the Cassidy House

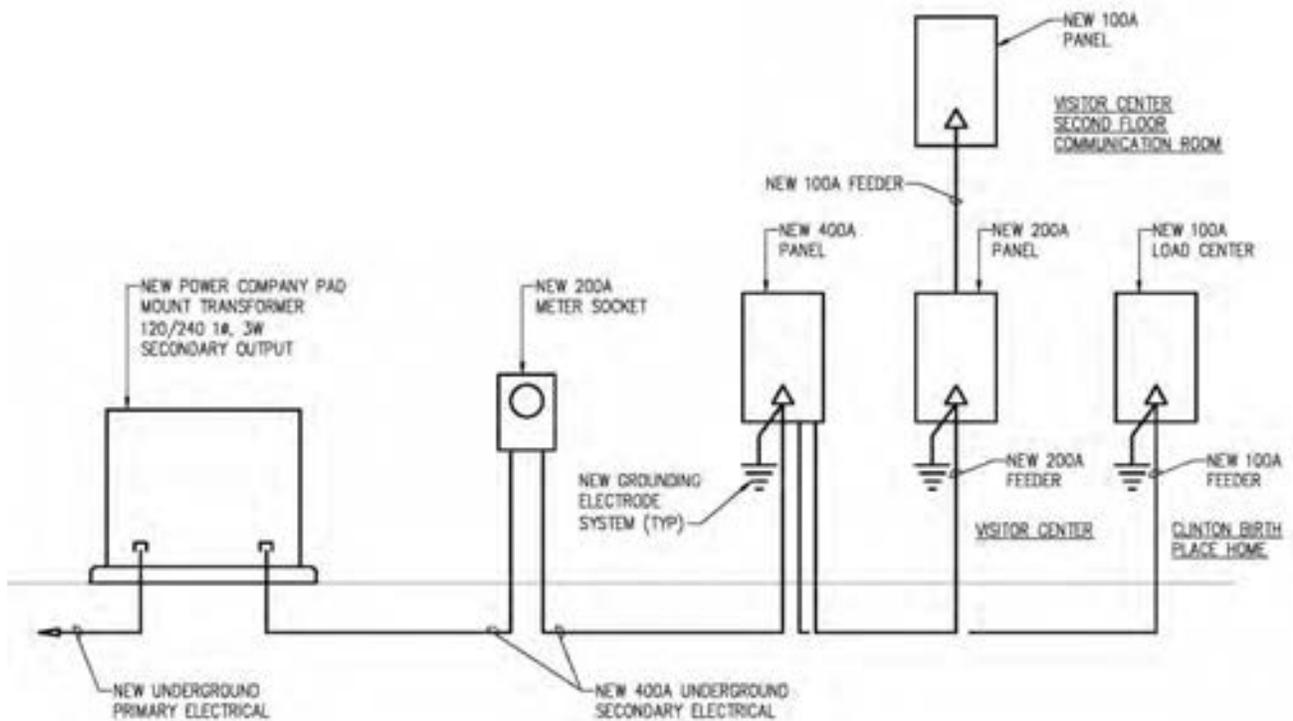
FIGURE 485. Proposed new power distribution system for the site. The new 400 amp panel would be located in the comfort station.

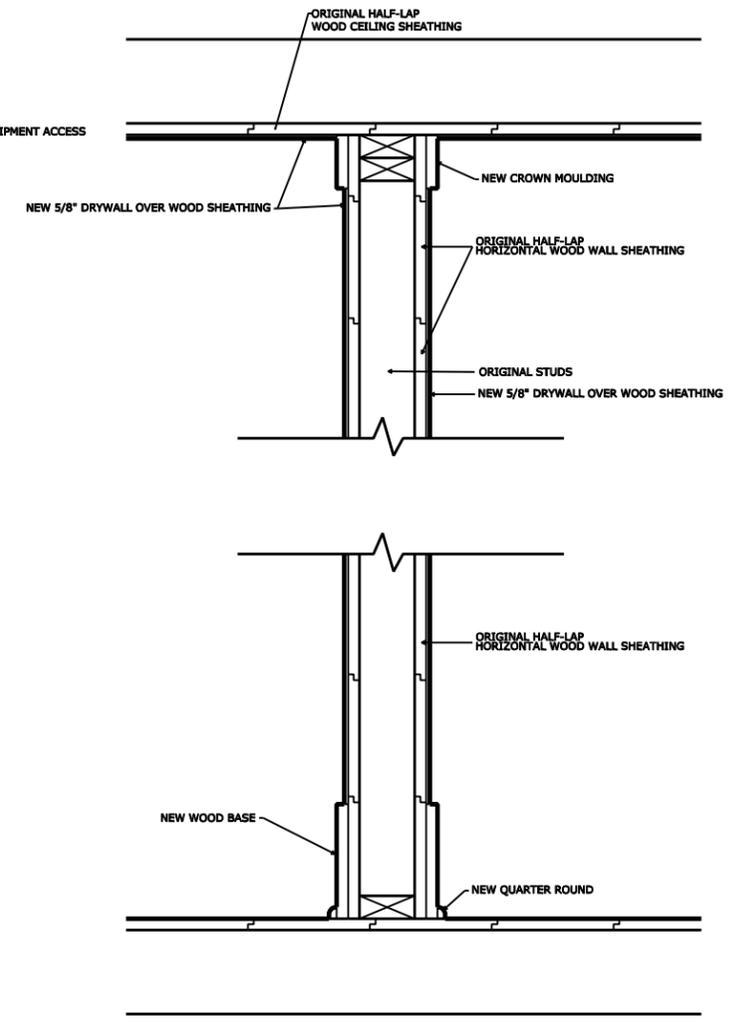
3 CASSIDY HOUSE WALL SECTION
SCALE: 1"=1'-0"

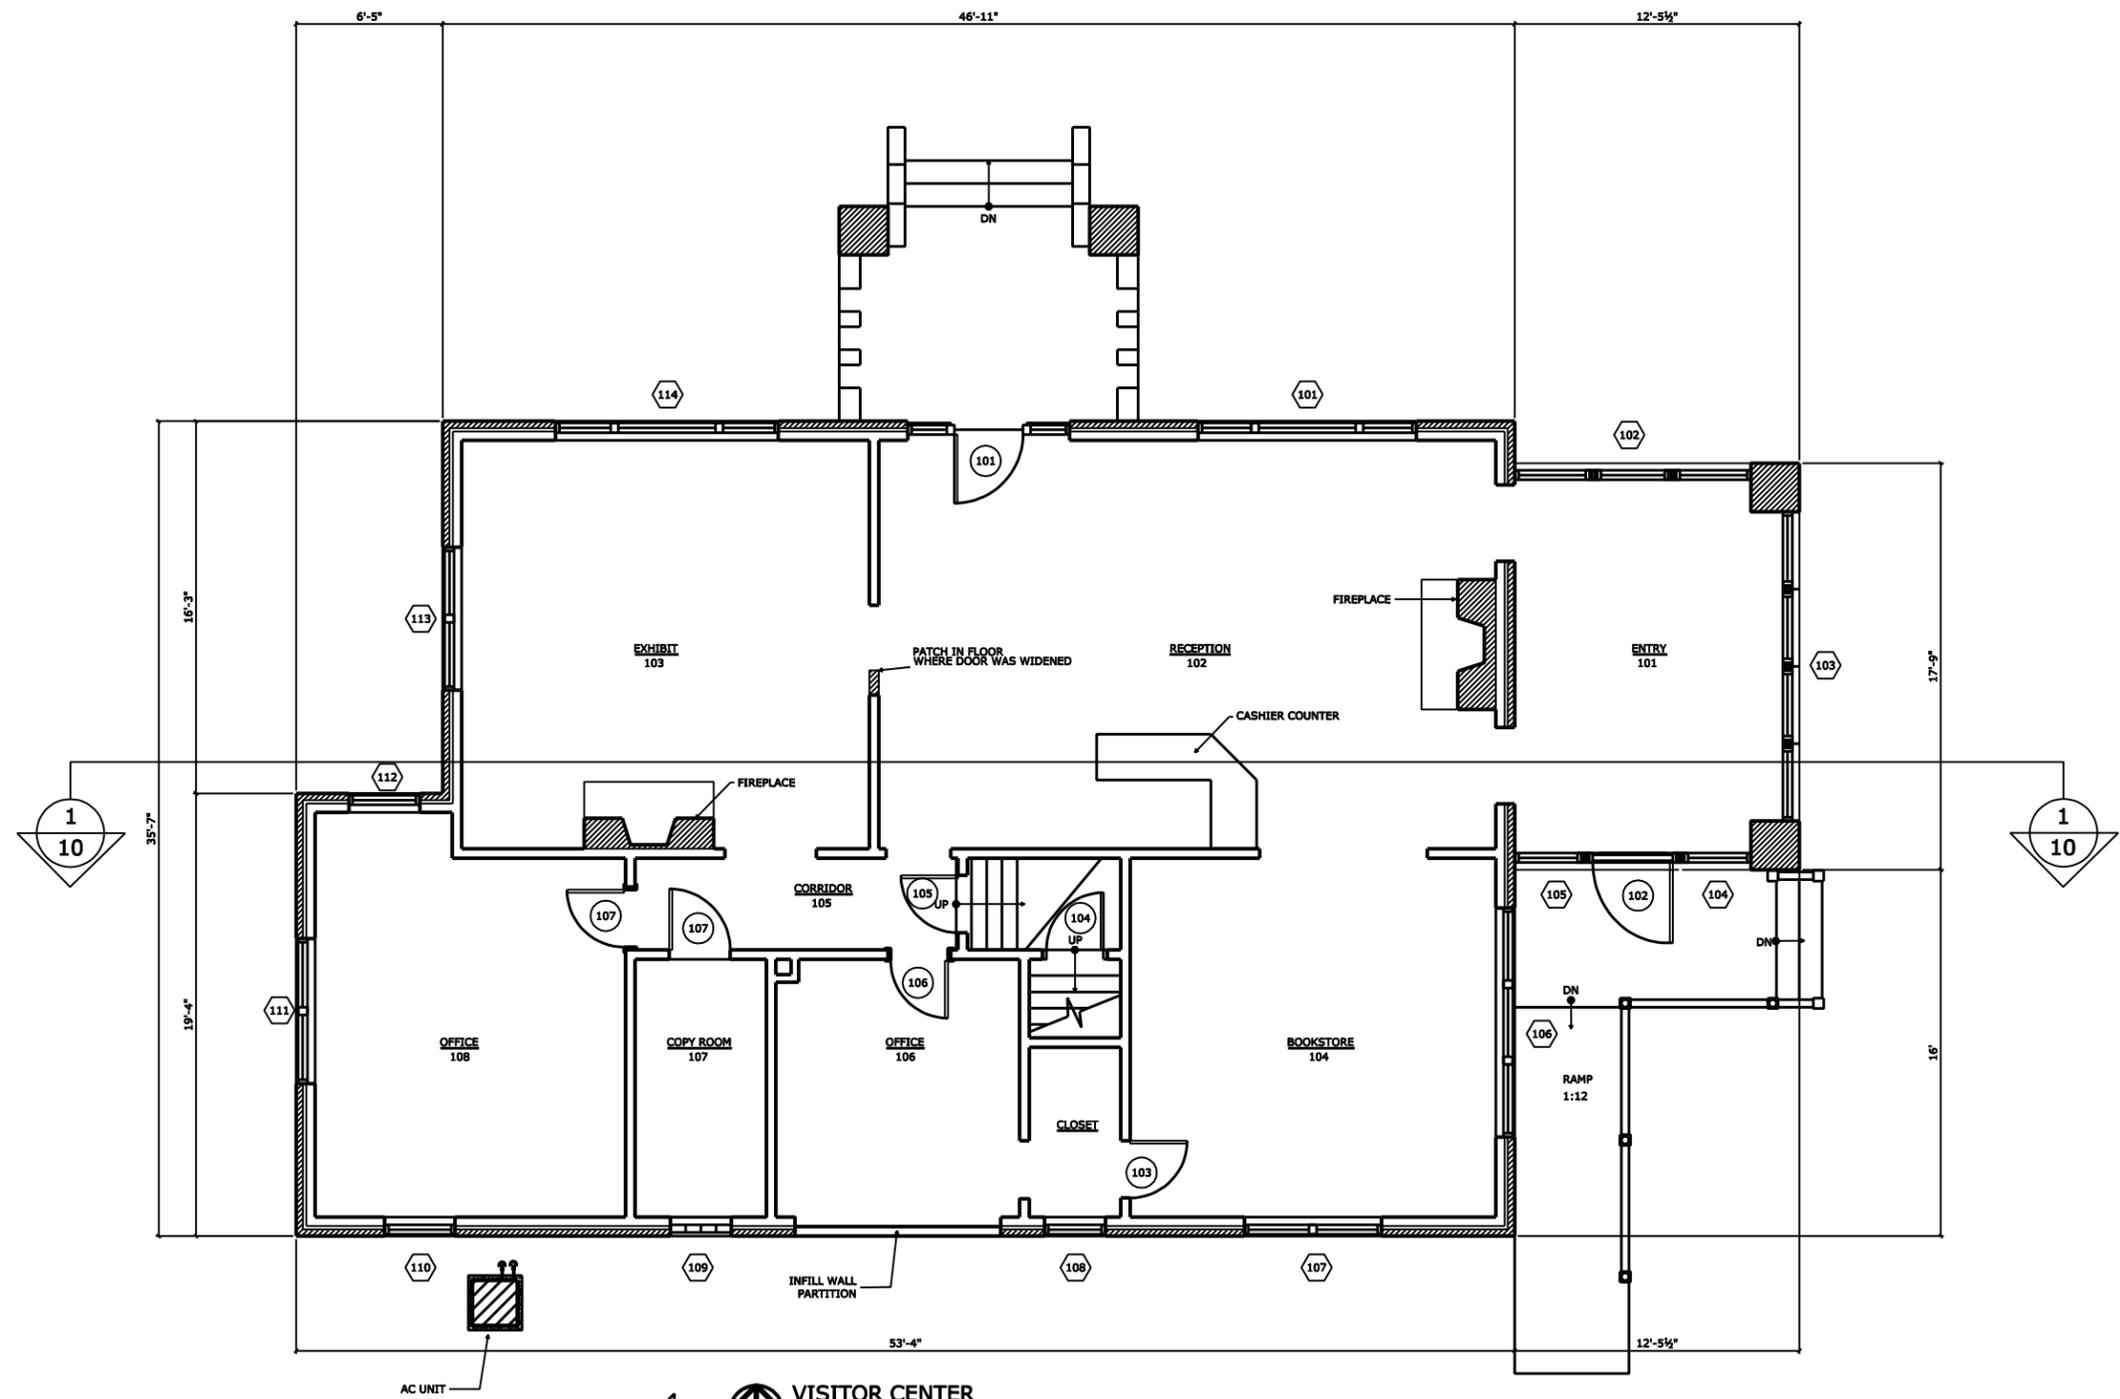
DESIGNED* GM	SUB SHEET NO. A3	TITLE OF SHEET PRESIDENT WILLIAM JEFFERSON CLINTON BIRTHPLACE HOME NATIONAL HISTORIC SITE	DRAWING NO. 732
TECH. REVIEW* K1			PMIS/PKG NO.
DATE* 11/01/13		CASSIDY HOUSE EXISTING CONDITIONS	SHEET 4 OF 9

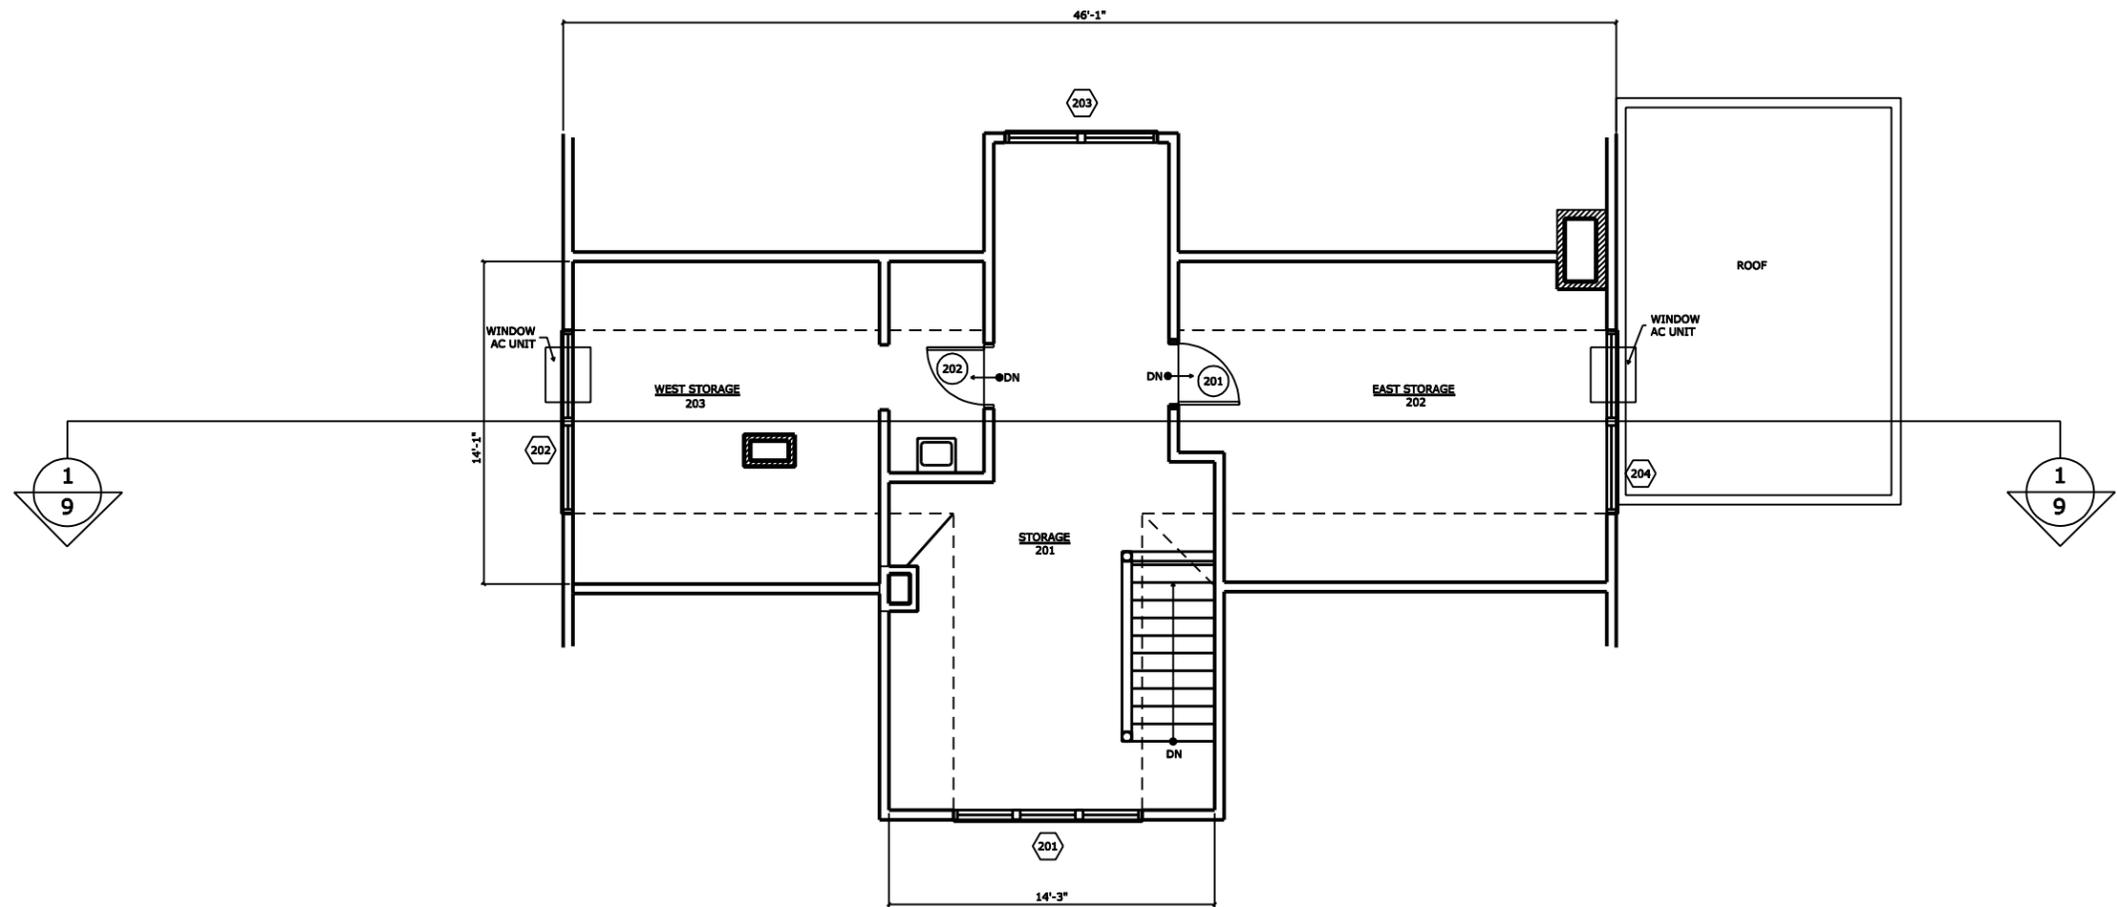
DESIGNED: GM GM TECH. REVIEW: K1 DATE: 11/01/13	SUB SHEET NO. A4	TITLE OF SHEET PRESIDENT WILLIAM JEFFERSON CLINTON BIRTHPLACE HOME NATIONAL HISTORIC SITE VISITOR CENTER EXISTING CONDITIONS	DRAWING NO. 732 116051 PMIS/PKG NO. SHEET 5 OF 9
---	--------------------------------	---	---

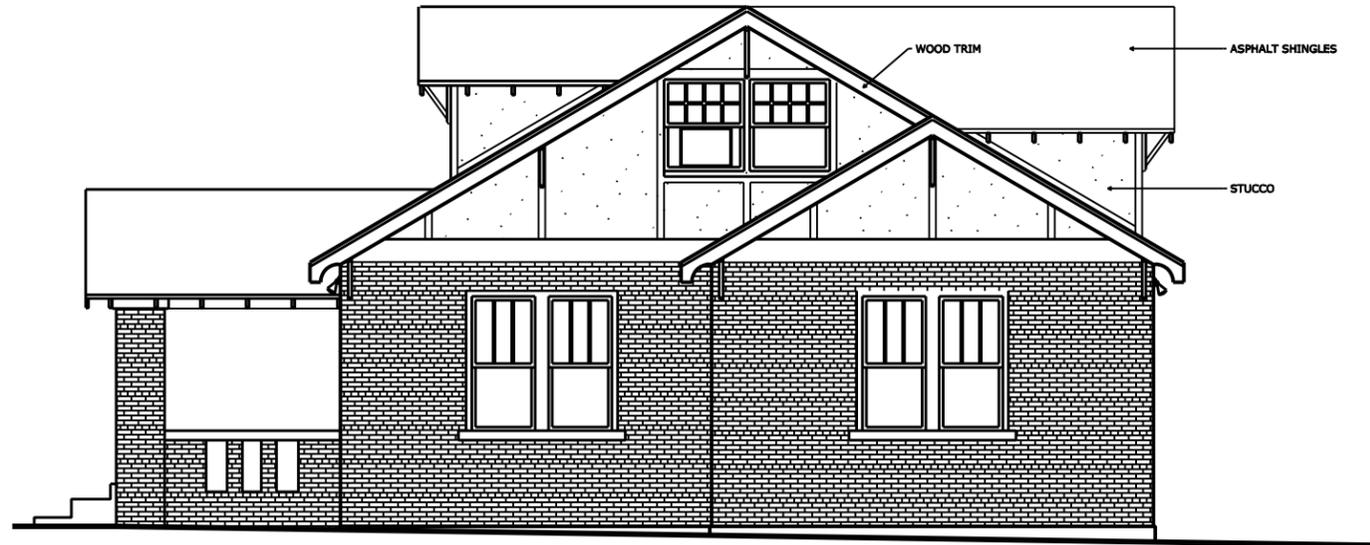
1 VISITOR CENTER
WEST ELEVATION
SCALE: 1/8"=1'-0"

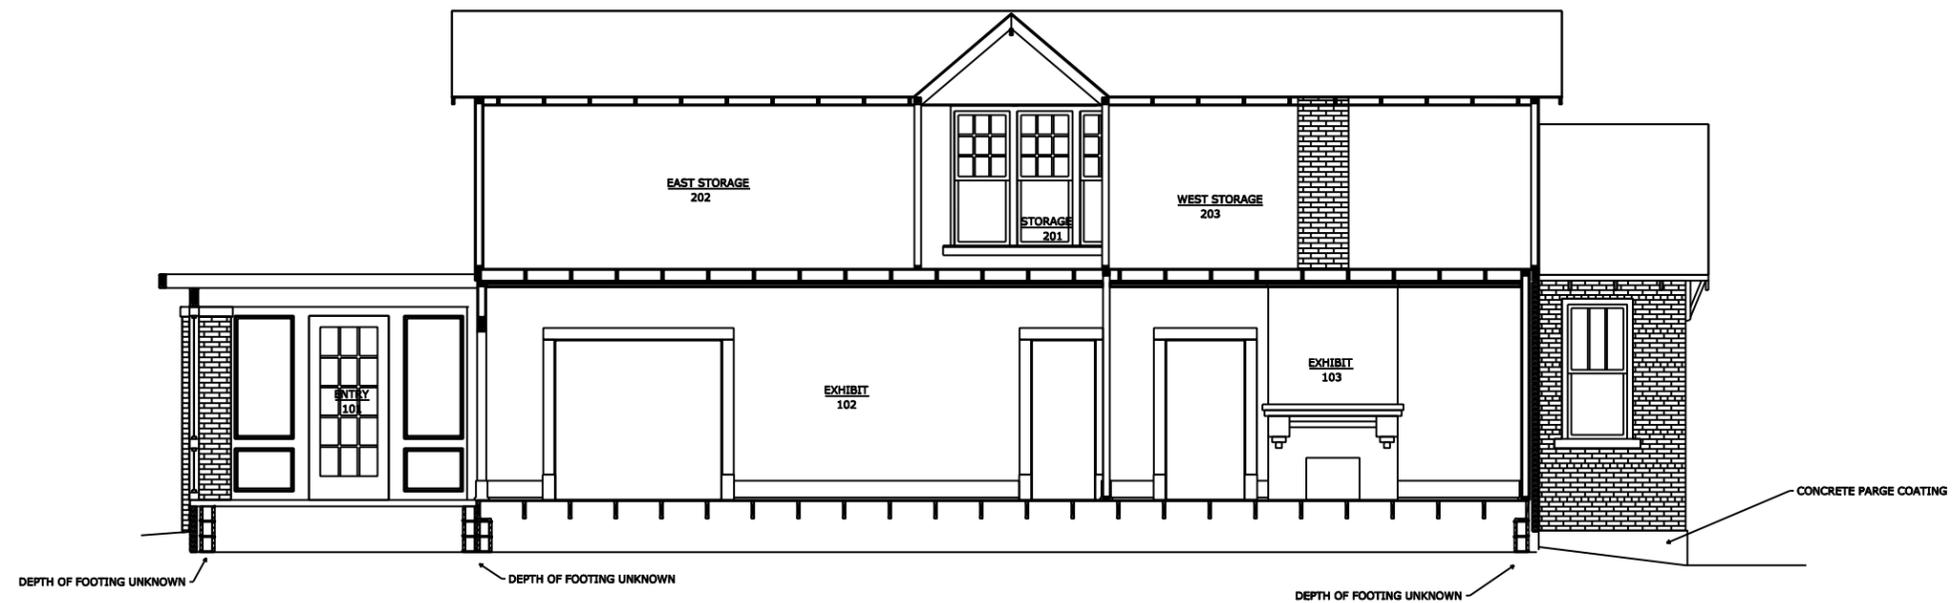
1 VISITOR CENTER SECTION
SCALE: 1/8"=1'-0"

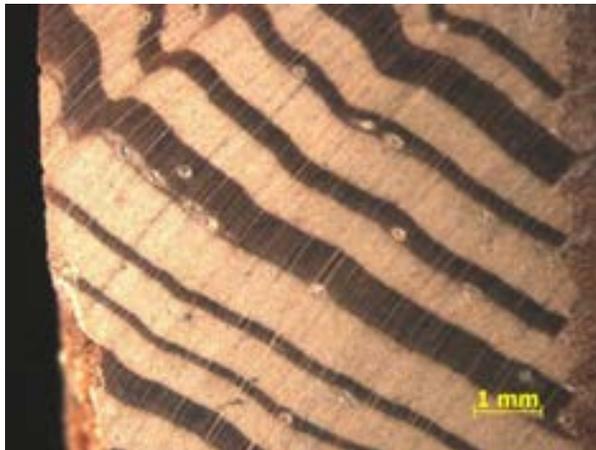
FIGURE D-1. Left: Magnified view of Sample 3.
