HUNT HOUSE

Women's Rights National Historical Park Seneca Falls and Waterloo, New York

Historic Structure Report

January 2009

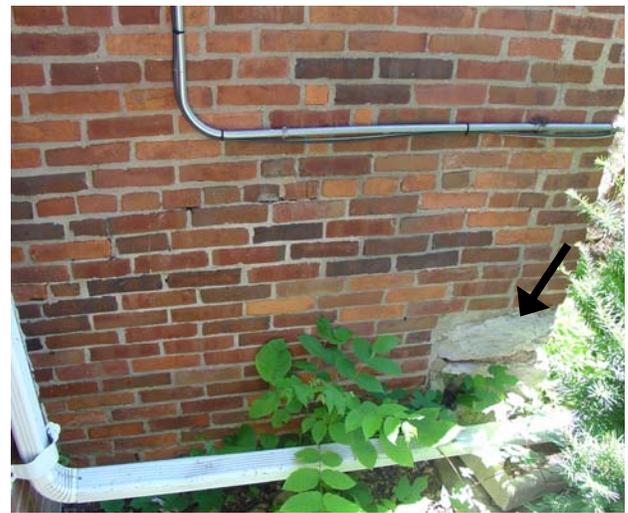
Figure 47. Limestone foundation stones are noticeably absent from the west side of the north elevation, except at the northwest corner (at arrow).

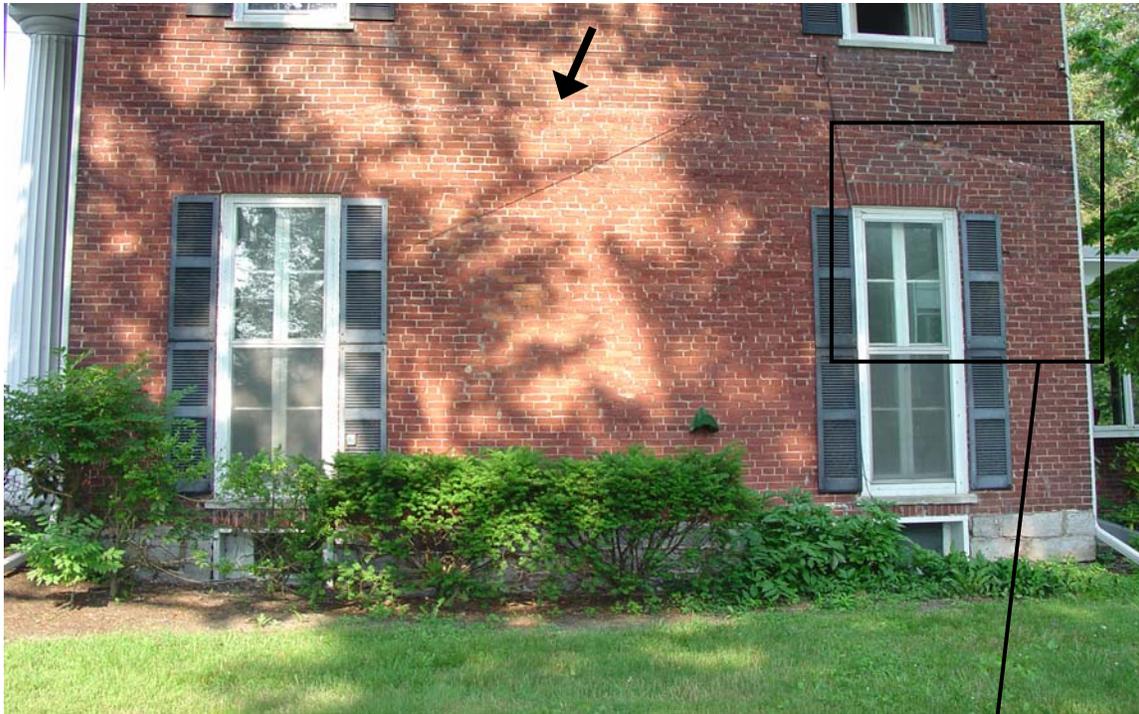
Figure 51. Detail of later French doorways at east elevation and shadow evidence of missing veranda roof (at arrows), June 2007.

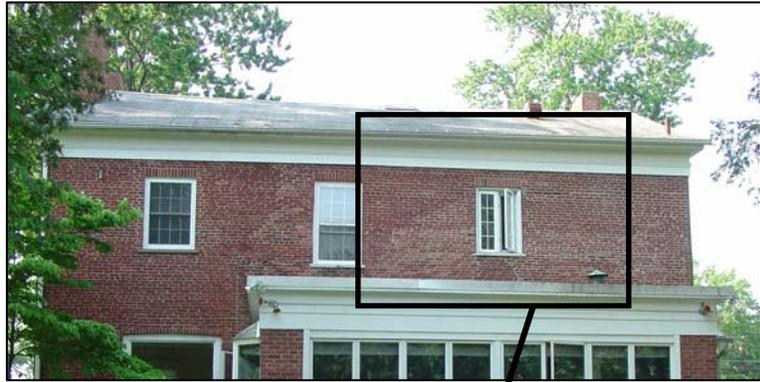
Figure 52. Detail of north elevation in the vicinity of the missing north-wing roof (at arrows). April 2008.

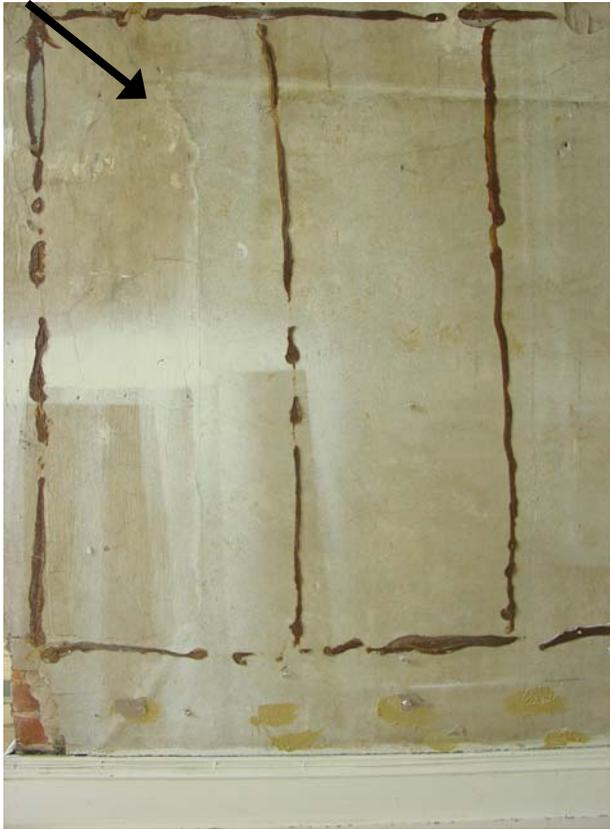
Figure 116. Room 202: Detail of the chimney breast showing plaster patch (at arrow) that preserves the outline of the missing fireplace mantel, August 2007.

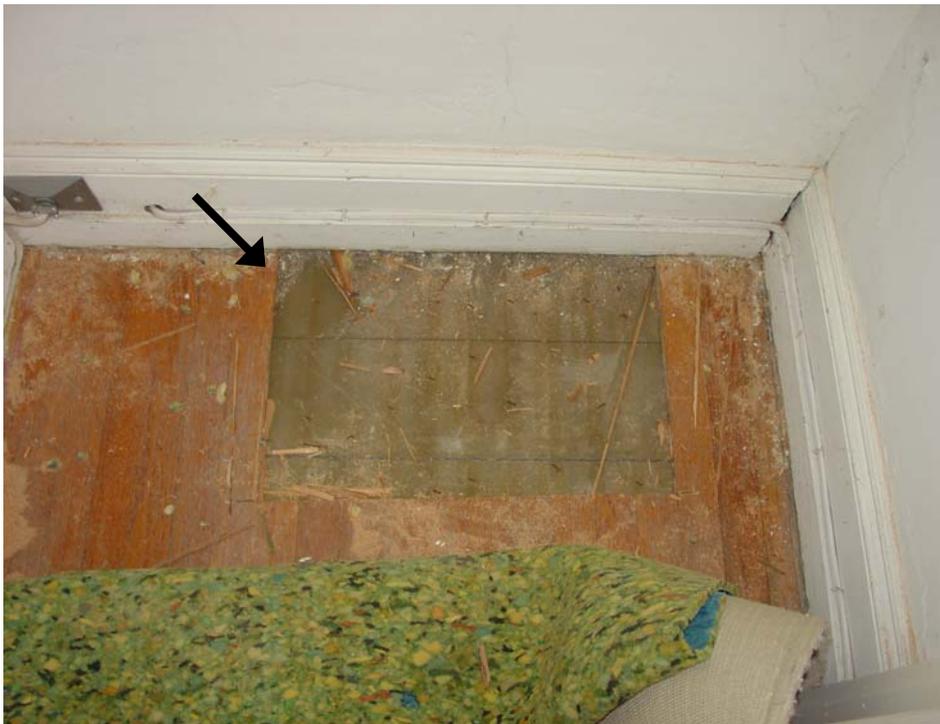
Figure 117. Room 202: Original floorboards (at arrow) uncovered beneath the later oak flooring in the southeast closet, August 2007.

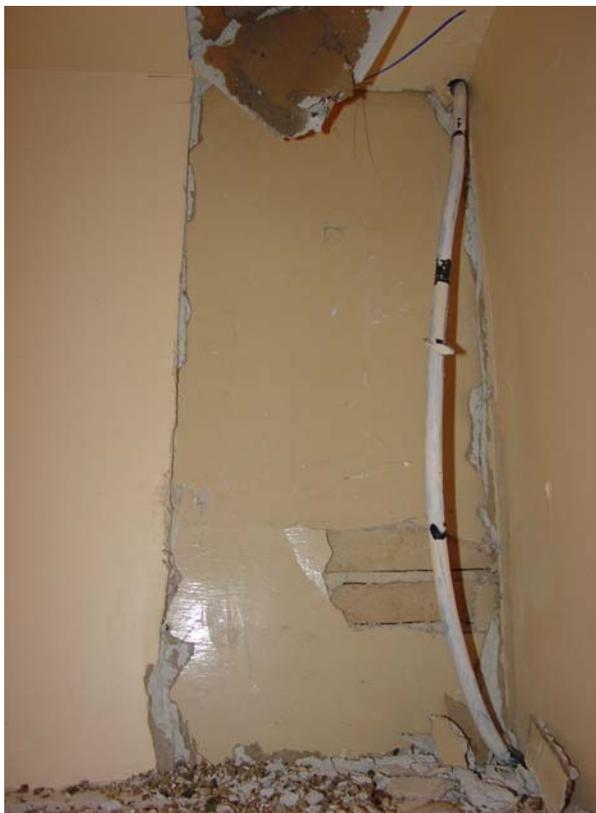
Figure 123. Room 203: South wall of linen closet with circa-1950 plasterboard partially removed to reveal original lath and plaster, August 2007.

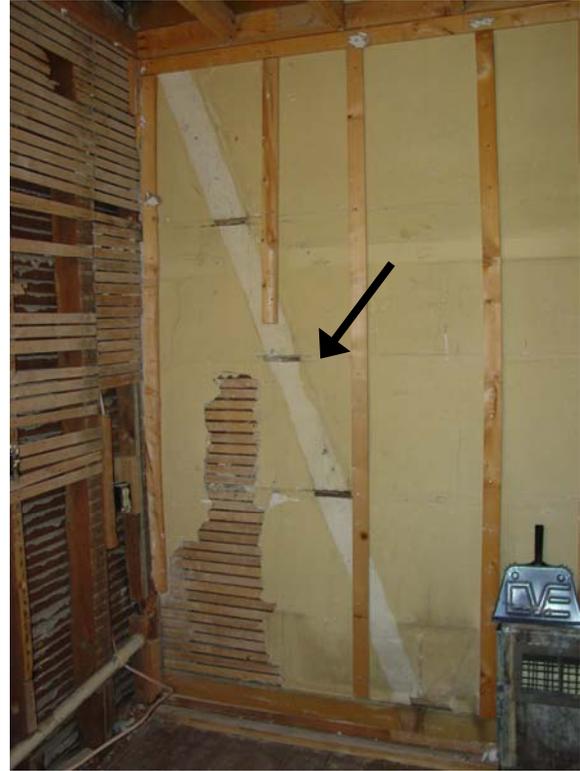
Figure 133. Room 204: Shadow of the missing attic stair on original plaster (at arrow) discovered beneath later plasterboard at the south wall, southeast corner, April 2008. (Compare with pre-demolition photograph at fig. 129.)

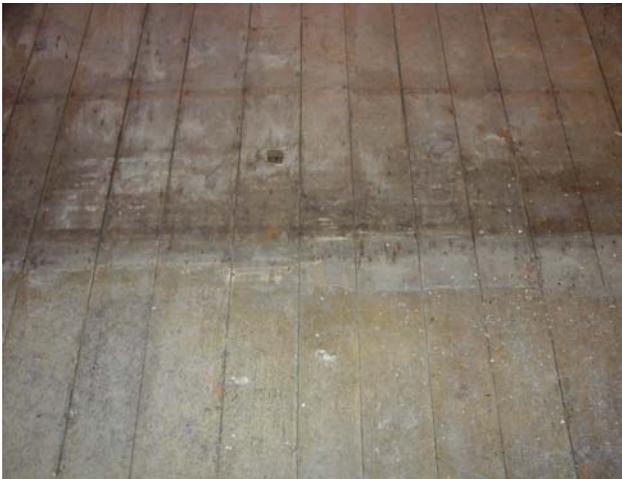
Figure 134. Room 204: Original floorboards revealed beneath later sheet flooring, view looking north, April 2008.

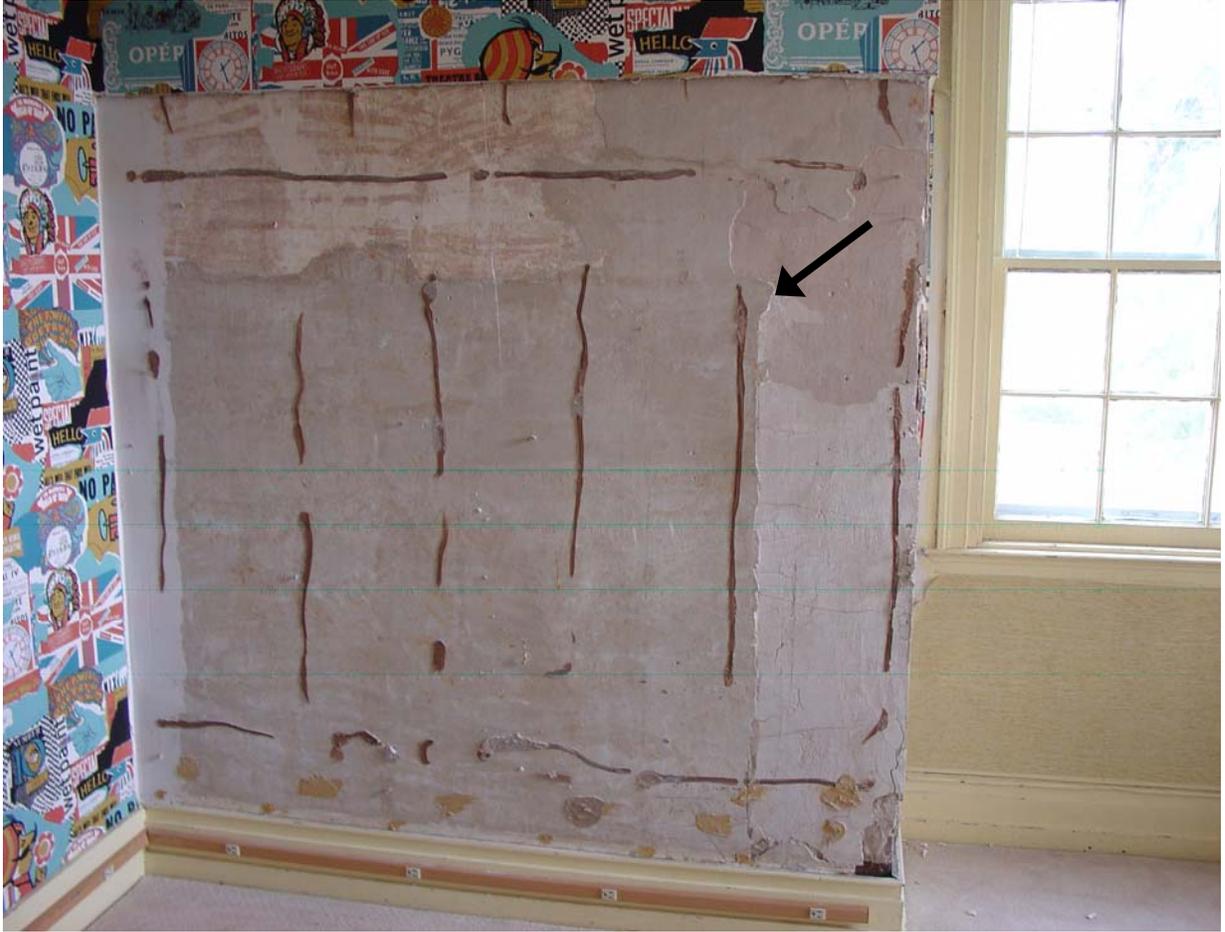
Figure 150. Room 206: Detail of the chimney breast beneath later plasterboard, August 2007. Note the cement-plaster patch (at arrow) that preserves the outline of the missing fireplace mantel.

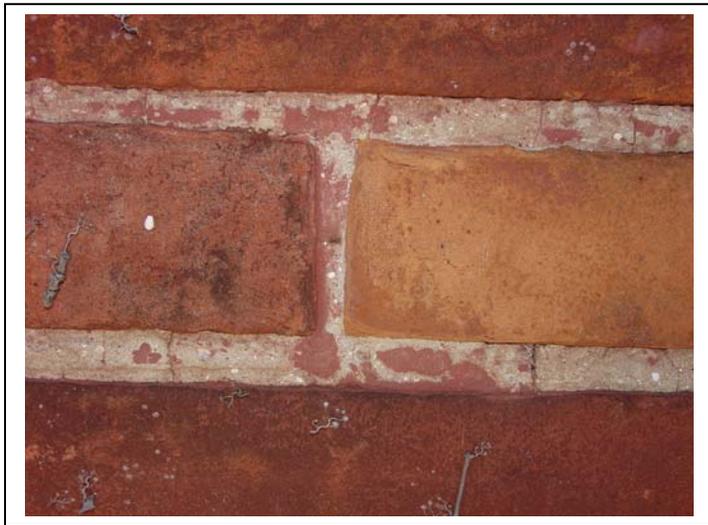
Figure B-1.
Hunt House: Detail of exterior brickwork with original lime mortar. Note the pink-beige color of the mortar and white lime inclusions. Remnants of red paint date to circa 1920. Photograph by Barbara Yocum, June 2007.

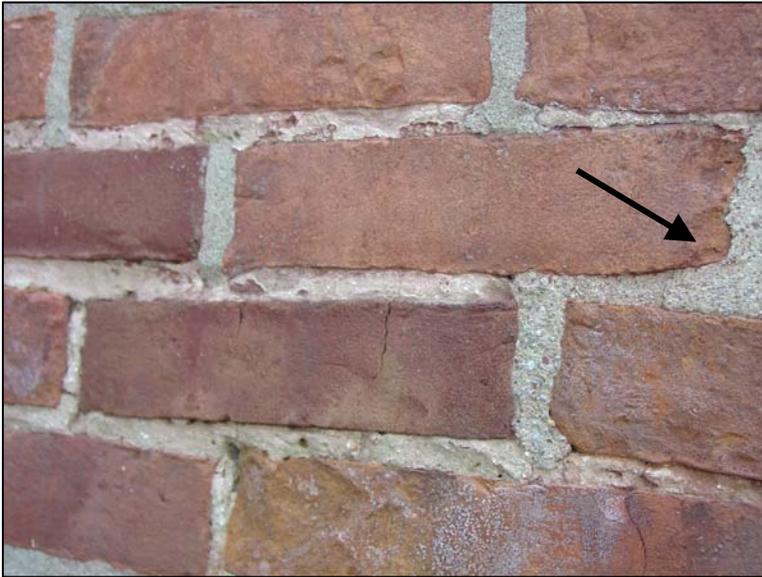
Figure B-3.
Hunt House: Detail of exterior brickwork with gray repointing mortar (at arrow). Photograph by Barbara Yocum, April 2008.
