WESLEYAN CHAPEL

Historic Structure Report

WESLEYAN CHAPEL
HISTORIC STRUCTURE REPORT
Women's Rights National Historical Park
Seneca Falls, New York

Written 1988
Published 1992

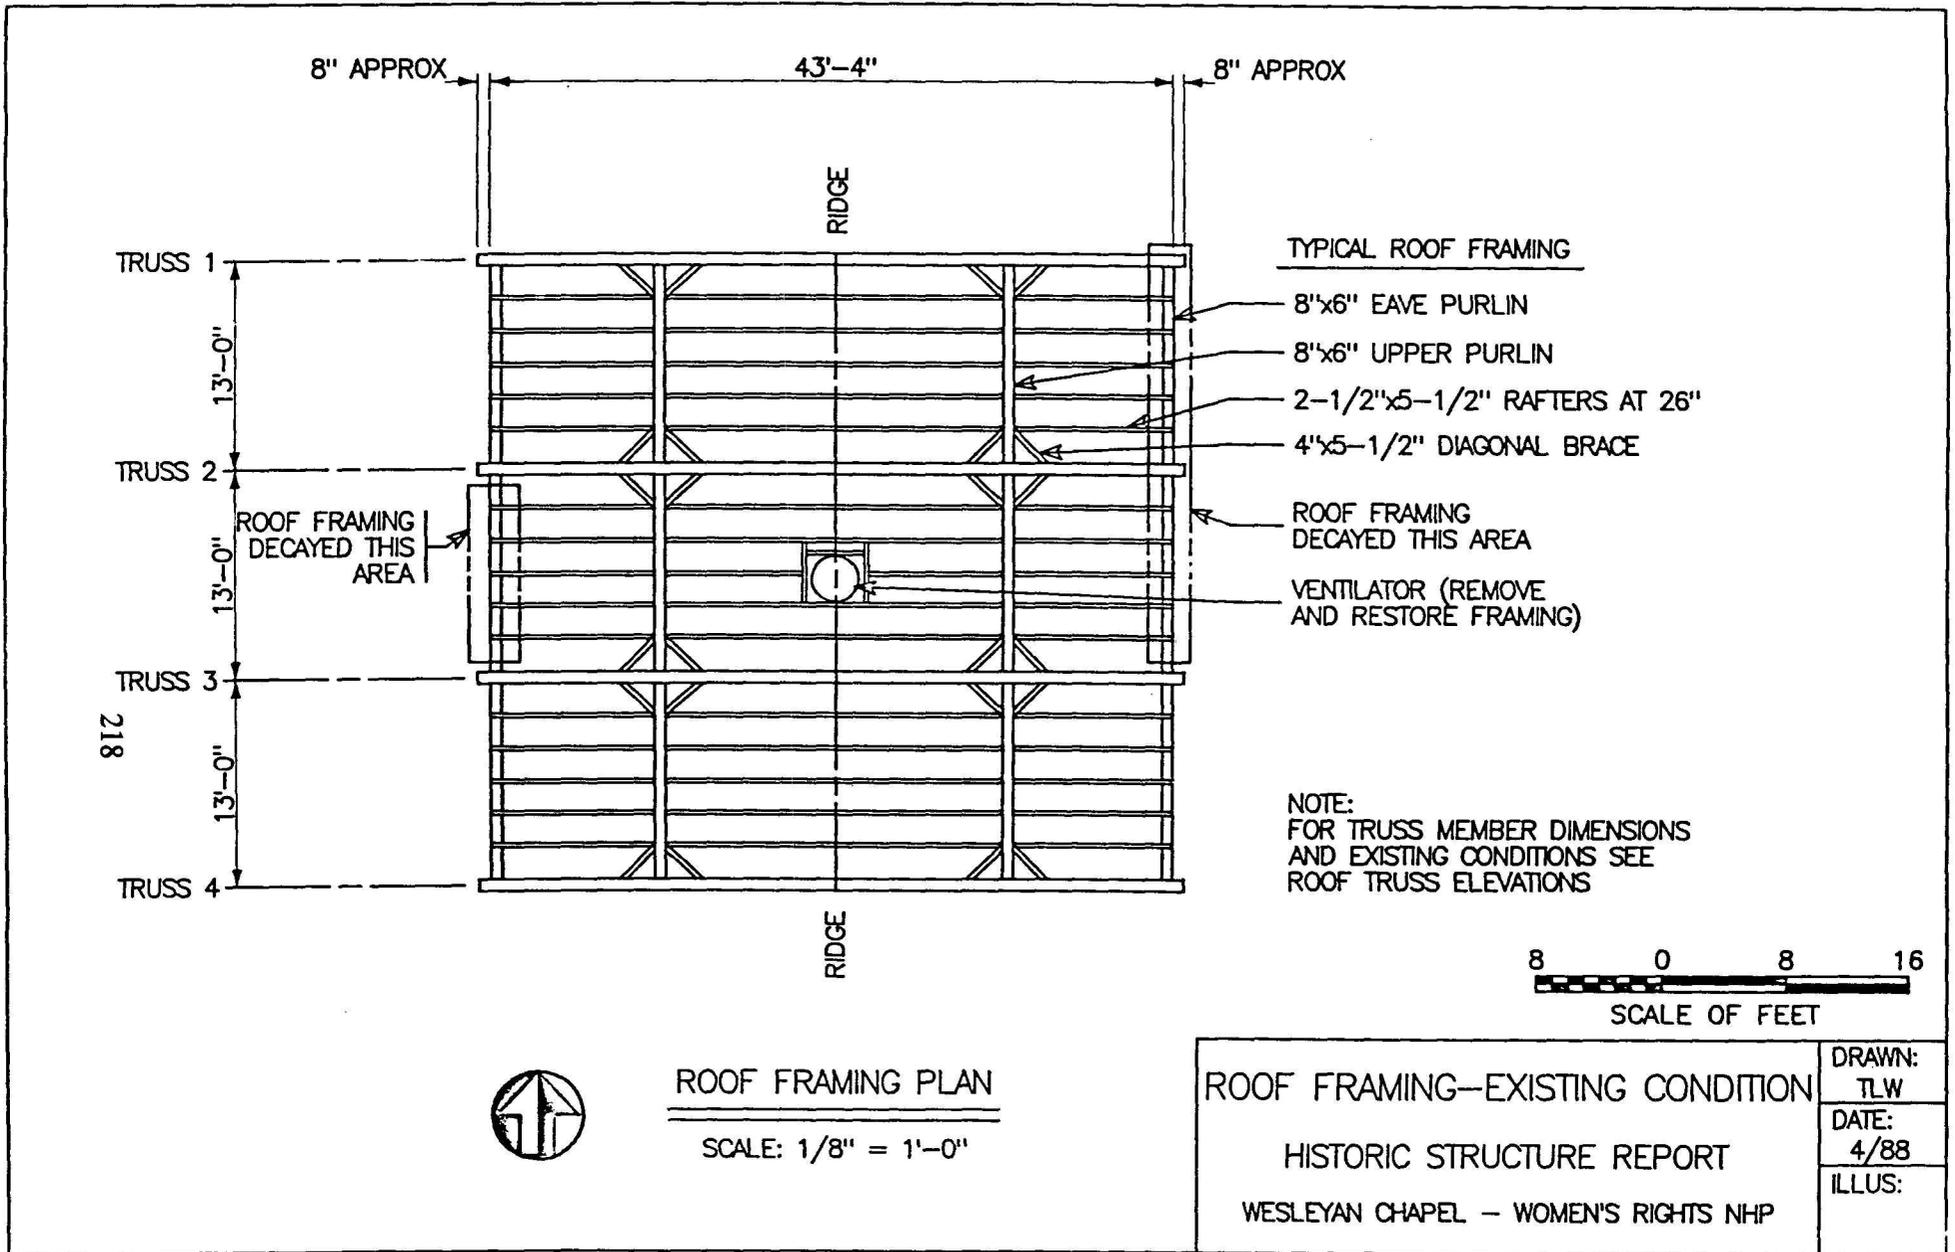
Figure 74. Wesleyan Chapel: Existing Condition, Roof Framing Plan, 1988.

The roof sheathing boards exhibit water staining in many areas, but they appear to be in fair condition, except at the eaves. Here moisture has deteriorated the sheathing as well as the supporting structural members mentioned earlier.
