NPS Preliminary Assessment Report

Wrangell-St. Elias National Park and Preserve (WRST)

Kennecott Mill Site
EDL# 5AKR3347

3/29/2018

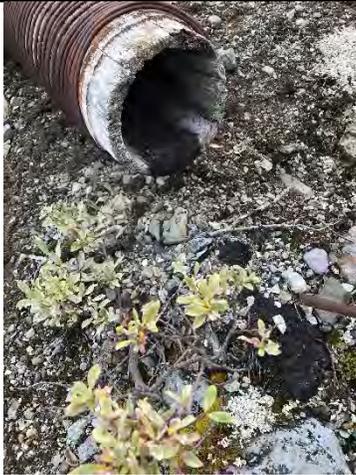
Photo 11 – Sewer line and soil staining. Orientation: east.
Date: 8/22/2017. Time: 1018.

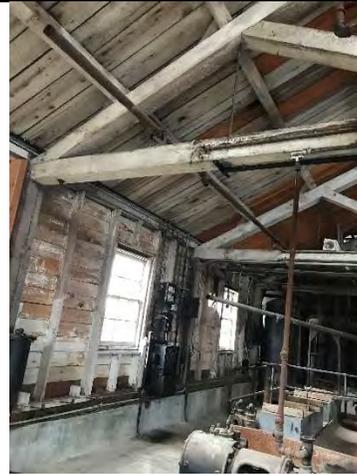
Photo 12 – Power house interior with peeling lead-based paint. Orientation: west.
Date: 8/22/2017. Time: 1022.

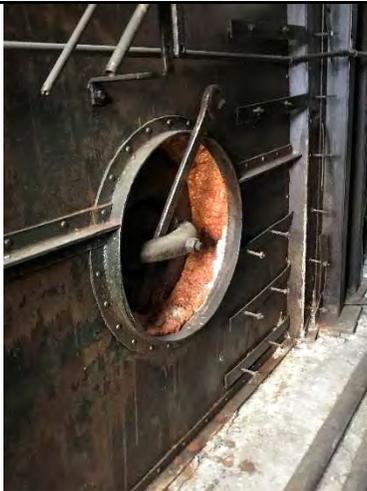
Photo 13 –The seal on a boiler containing asbestos in the Powerhouse. Orientation: south.
Date: 8/22/2017. Time: 1036.

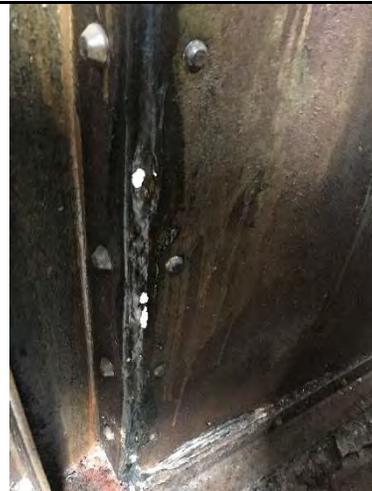
Photo 14 – Cracking of a sealed boiler containing asbestos in the Powerhouse. Orientation: south.
Date: 8/22/2017. Time: 1037.

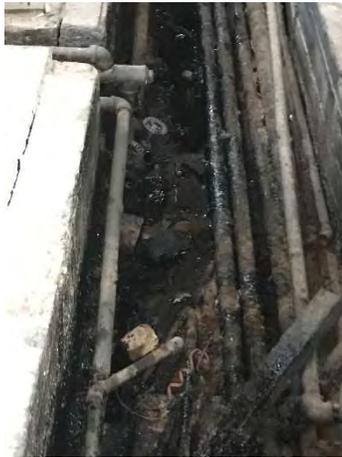
Photo 15 – Utilidor stained with Bunker C in the Powerhouse. Orientation: south.
Date: 8/22/2017. Time: 1030.

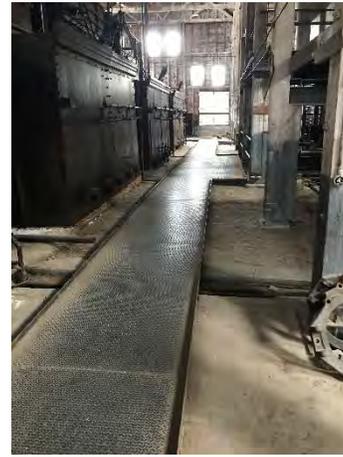
Photo 16 – Guided tour path through the Powerhouse. Note the boilers which contain asbestos on the left.
Orientation: south. Date: 8/22/2017. Time: 1031.

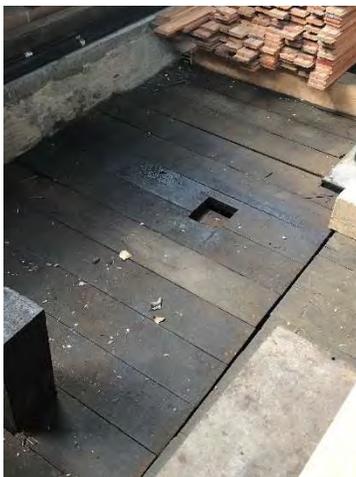
Photo 17 – Bunker C staining underneath the day tank in the powerhouse. Orientation: west.
Date: 8/22/2017. Time: 1026.

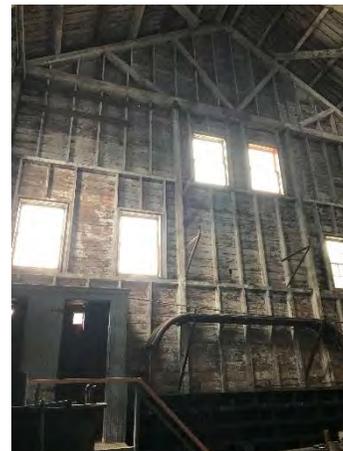
Photo 18 – Power house interior with peeling lead-based paint. Orientation: west.
Date: 8/22/2017. Time: 1040.

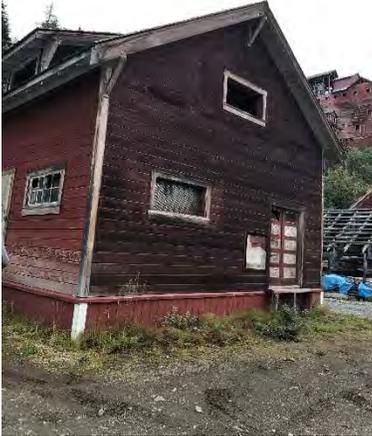
Photo 19 –Exterior of transformer house, painted with lead-based paint. Orientation: northeast.
Date: 8/22/2017. Time: 1049.

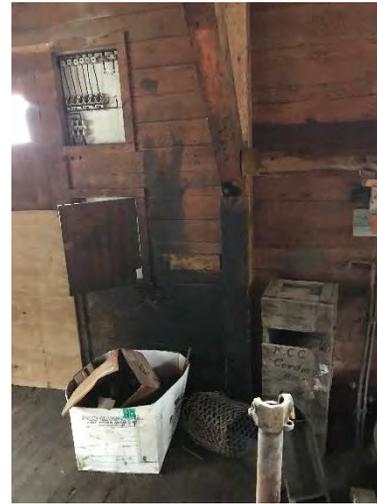
Photo 20 – Asbestos in wall of transformer house.
Orientation: north.
Date: 8/22/2017. Time: 1050.

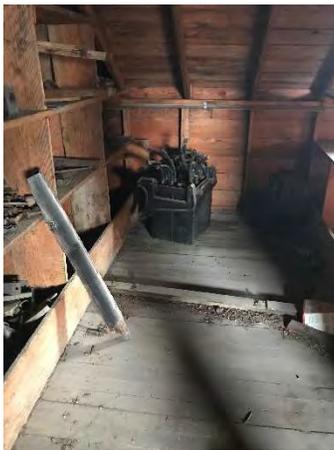
Photo 21 – Lead battery in transformer house.
Orientation: north.
Date: 8/22/2017. Time: 1052.

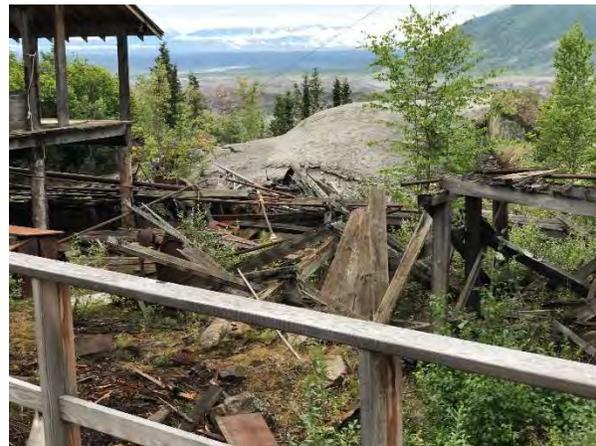
Photo 22 – Debris next to the Machine Shop which represents a physical hazard.
Orientation: south. Date: 8/22/2017. Time: 0919.

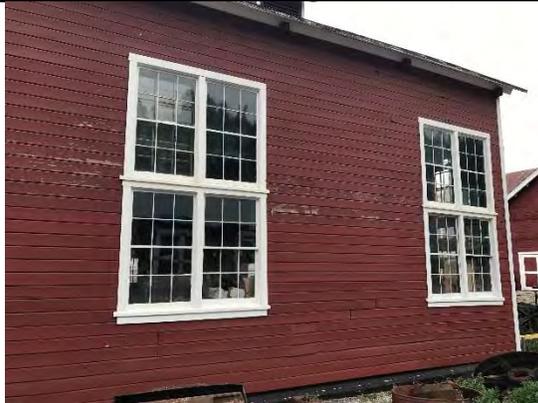
Photo 23 – Peeling lead-based paint on Machine Shop.
Orientation: east.
Date: 8/22/2017. Time: 1058.

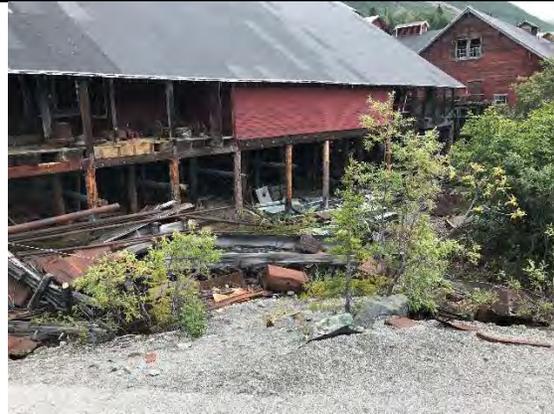
Based on locations shown in historical reports and the location observed during the site walk, the boiler ash cap was observed during the site walk (refer to Photo 24 of Appendix B). The observed concrete area had visible signs of deterioration, and the integrity of the underlying plastic liner is uncertain.

Photo 24 – Boiler Ash cap (foreground), machine shop, and
leach plant (right). Orientation: south.
Date: 8/22/2017. Time: 1007.

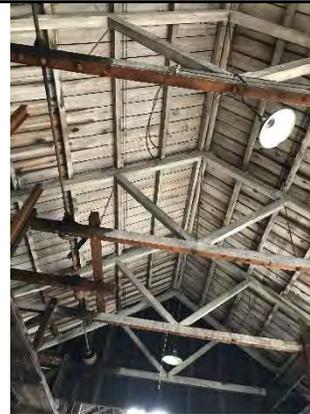
Photo 26 – Peeling lead-based paint on ceiling of Machine
Shop. Orientation: NA.
Date: 8/22/2017. Time: 1100.

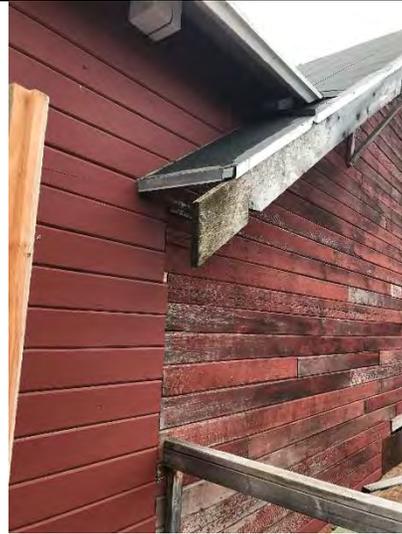
Photo 28 – North end of Leach Plant showing repainted (left) and original lead-based paint (right).
Orientation: south. Date: 8/22/2017. Time: 1105.

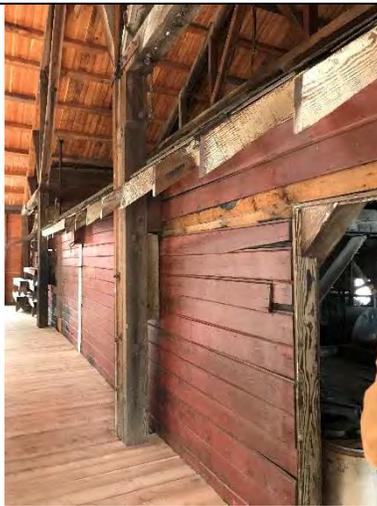
Photo 29 – Leach Plant interior with new ceiling and original lead-based paint. Orientation: southeast.
Date: 8/22/2017. Time: 1105.

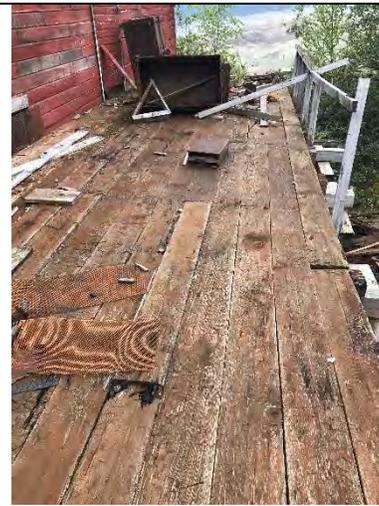
Photo 30 – Western end of the Leach Plant. Note the lack of railing (right) representing a physical hazard.
Orientation: west. Date: 8/22/2017. Time: 1007.

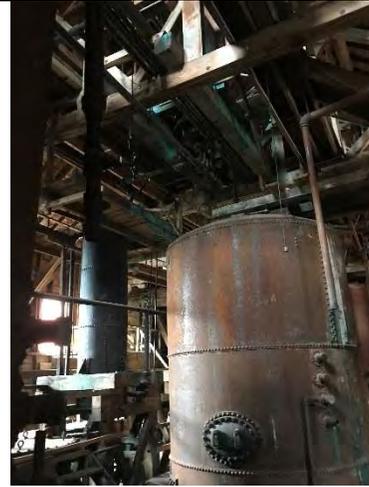
During the 2017 site reconnaissance, green staining was observed on the ammonia leaching tanks and the surrounding wood joists and support beams (Photo 32, Appendix B). Visual observation inside the tanks was not possible due to inaccessibility.

Photo 32 – Ammonia tanks in Leach Plant. Note green staining on ceiling beams. Orientation: northwest.
Date: 8/22/2017. Time: 1122.

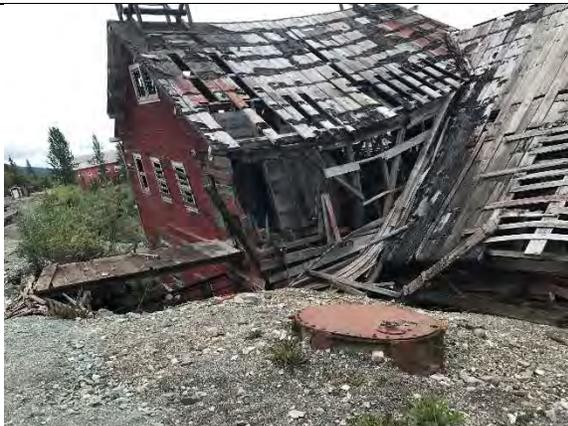
Photo 33 – Exterior of Leach Plant. The collapsing structure is a physical hazard. The wall contains original lead-based paint. Orientation: south.
Date: 8/22/2017. Time: 1125.

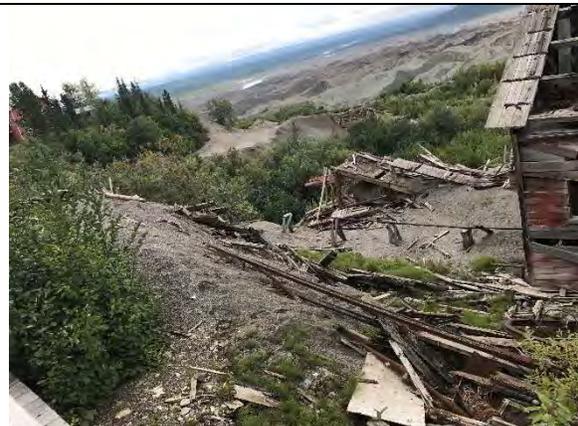
During the 2017 site reconnaissance, the maintenance supervisor mentioned that a portion of the bank of National Creek consists of tailings, that ore concentrates may be transported downstream during flood events, and that at one point green tailings could be observed all the way to the surface water ponding locations in National Creek south of the leach plant (surface water ponding location shown in Photos 34 and 62 in Appendix B).

Photo 34 – Debris by west end of Leach Plant (foreground) and unknown surface water feature (background) downgradient of the Mill Site.
Orientation: south. Date: 8/22/2017. Time: 11218.

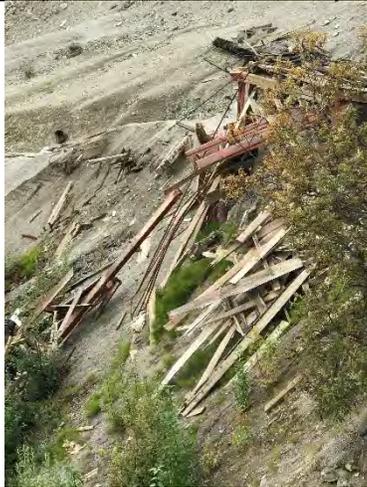
Photo 35 – Slope west of Leach Plant. A seep (left) runs under the Leach Plant creating a collapse potential. Orientation: southeast. Date: 8/22/2017. Time: 1130.

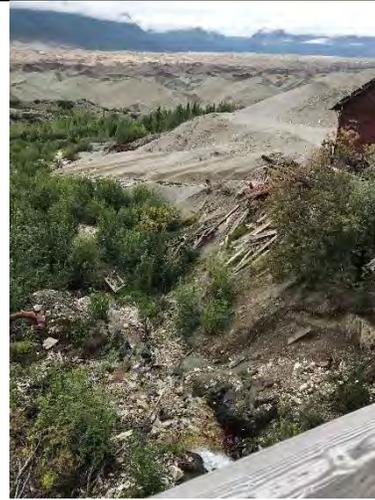
Photo 36 – National Creek (center) and Leach Plant (right). Building debris is actively falling into the creek. Orientation: east. Date: 8/22/2017. Time: 1131.

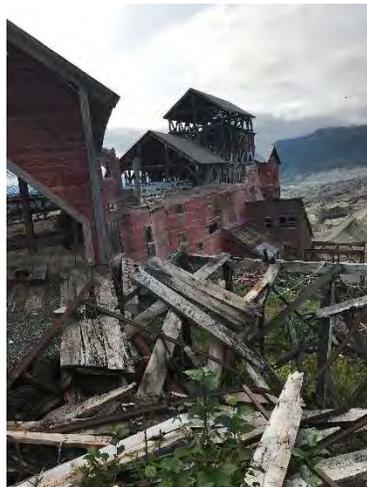
Photo 37 – Tramway building and Mill Building. Field contains debris, and building exterior contains lead-based paint. Orientation: south. Date: 8/22/2017. Time: 1344.

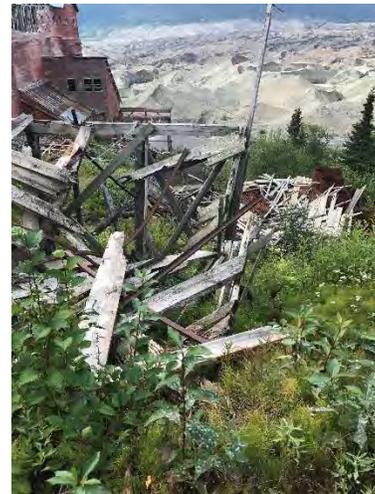
Photo 38 – Field west of Mill Building. This was the location of recent NPS employee exposure incident. Orientation: south. Date: 8/22/2017. Time: 1122.

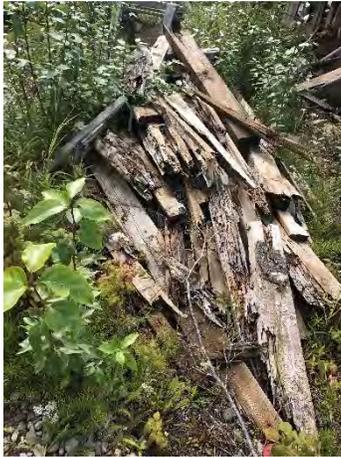
Photo 39 – Debris west of Mill Building that caused recent NPS employee exposure incident. Orientation: south.
Date: 8/22/2017. Time: 1345.

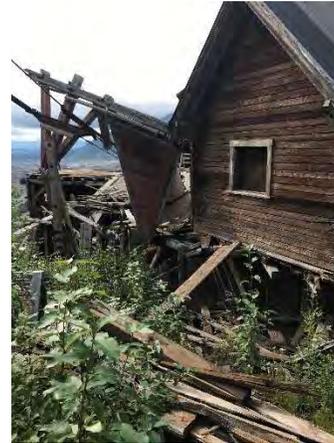
Photo 40 – South side of Mill Building. The debris and collapse potential are physical hazards.
Orientation: northwest. Date: 8/22/2017. Time: 1345.

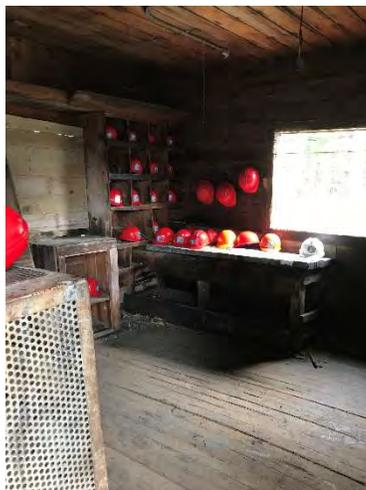
Photo 41 – Start of guided tours in the Mill Building. The room has had historically high lead concentrations.
Orientation: southwest. Date: 8/22/2017. Time: 1350.

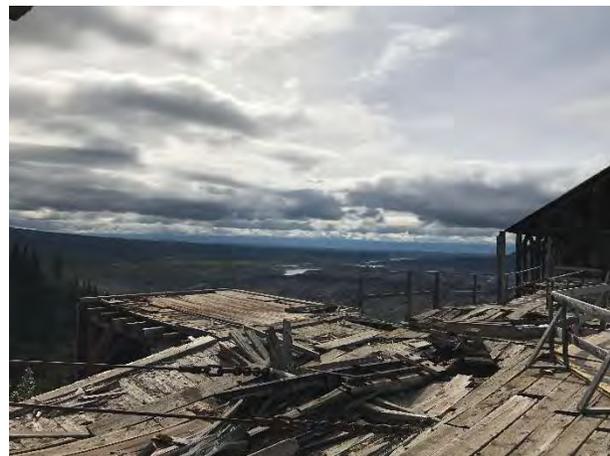
Photo 42 – Collapsing deck of the Mill building, which represents a physical hazard.
Orientation: south. Date: 8/22/2017. Time: 1352.

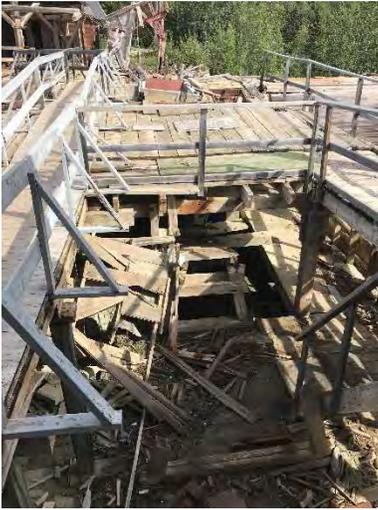
Photo 43 – Collapsing deck of the Mill Building, representing a physical hazard. Orientation: south. Date: 8/22/2017. Time: 1354.

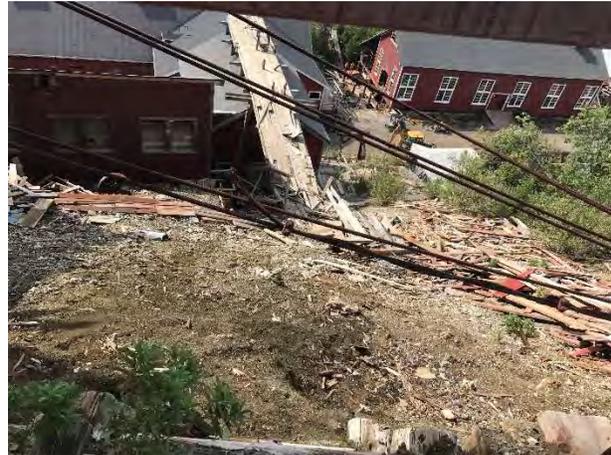
Photo 44 – Debris by the Mill Building. Blasting caps, representing an explosive hazard, have been found in the debris. Orientation: west. Date: 8/22/2017. Time: 1429.

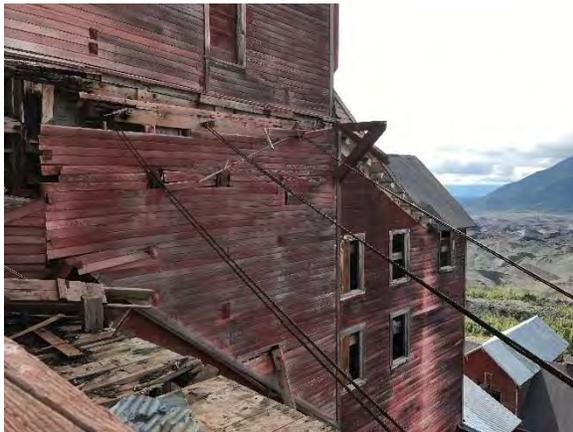
Photo 45 – North side of Mill Building. Note the original lead-based paint. Orientation: south. Date: 8/22/2017. Time: 1433.

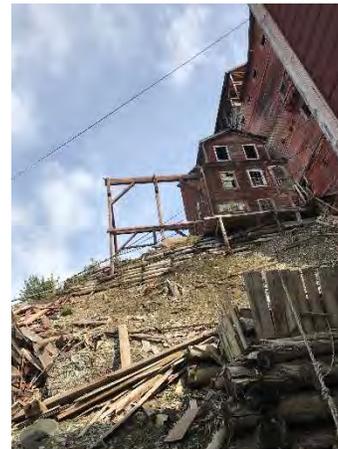
Photo 46 – Debris field west of the Mill Building which contains blasting caps. Orientation: northeast. Date: 8/22/2017. Time: 1447.

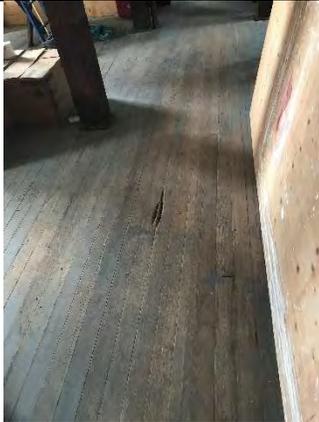
Photo 57 – Gray paint that contains arsenic on the floor of the West Bunkhouse.
Orientation: north.
Date: 8/22/2017. Time: 1149.

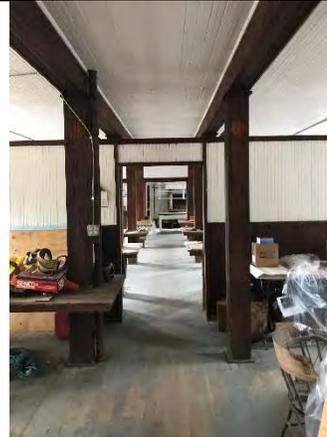
Photo 58 – Peeling white paint on ceiling and grey arsenic-containing paint on floor of the West Bunkhouse. Orientation: southwest. Date: 8/22/2017. Time: 1149.

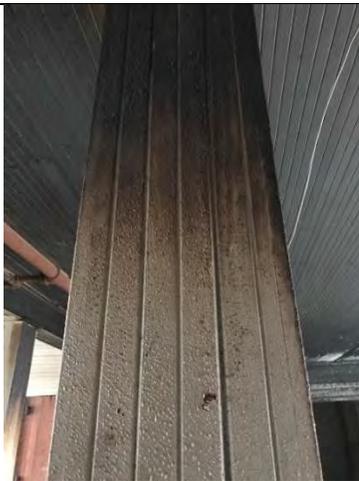
Photo 59 – Basement of the West Bunkhouse. A historic fire caused the white paint to “boil.”
Orientation: NA. Date: 8/22/2017. Time: 1200.
