National Park Service
Cultural Landscapes Inventory
2004

South Entrance Station
Yosemite National Park

Cultural Landscape Inventory Level II:
South Entrance Station
Yosemite National Park

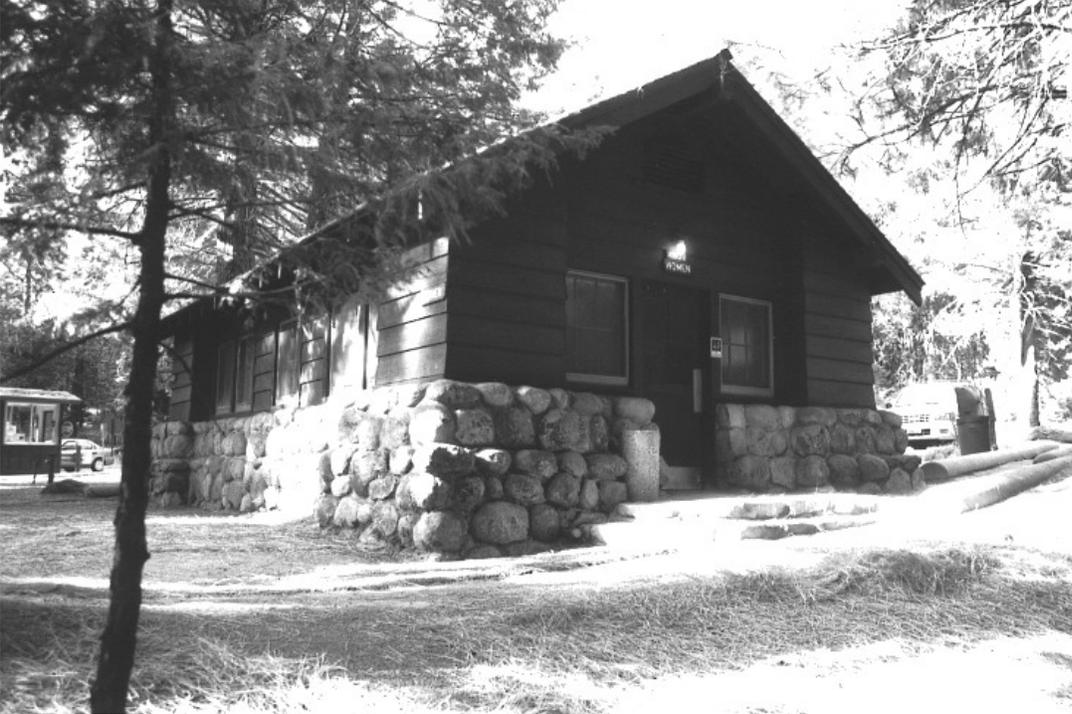
Looking NW at the south and east elevations of the comfort station (WA04606). HRA, 1999.

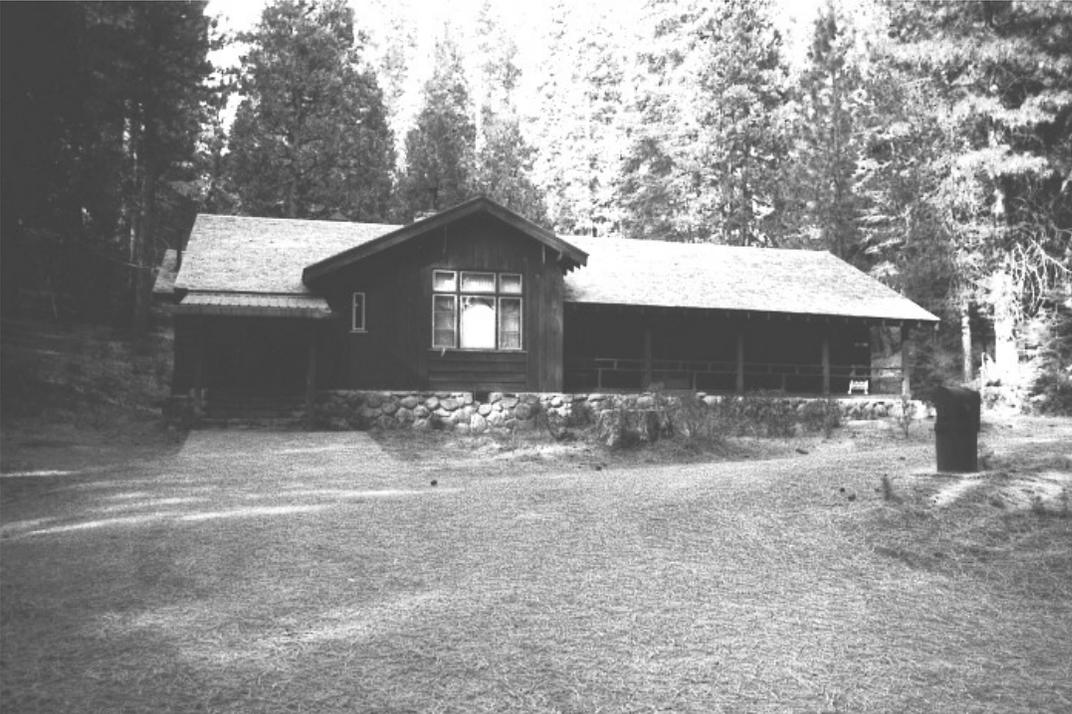
Looking north at the south (front) elevation of the rangers' duplex (WA04600). HRA, 1999.

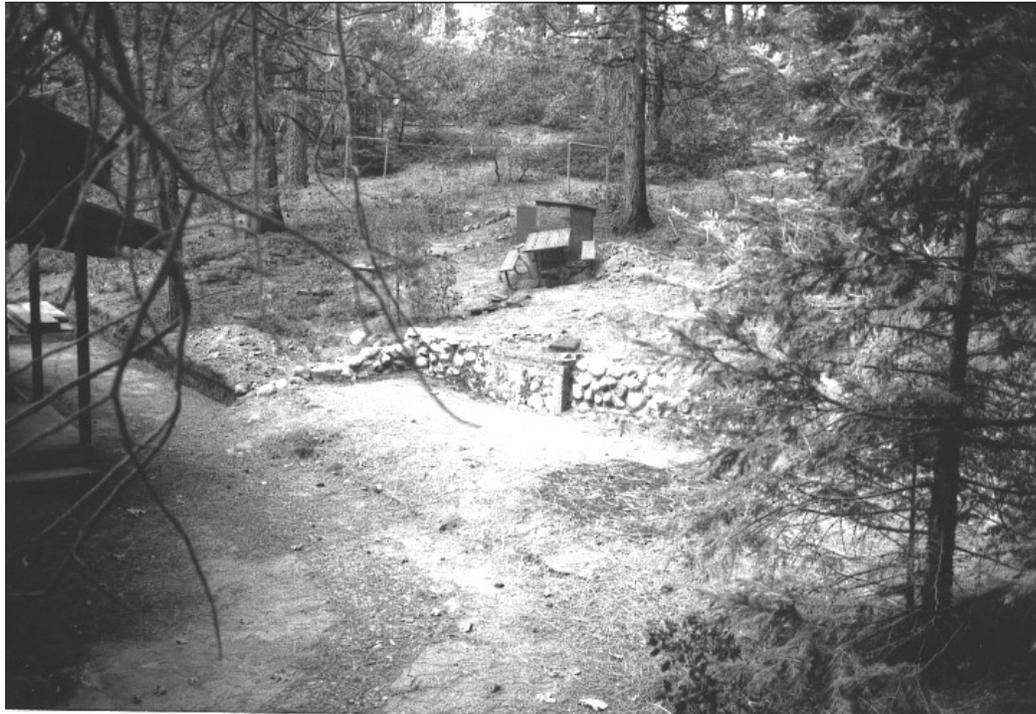
Looking NW towards the cobblestone retaining wall at the rear of the rangers' duplex (WA04600). HRA, 1999.

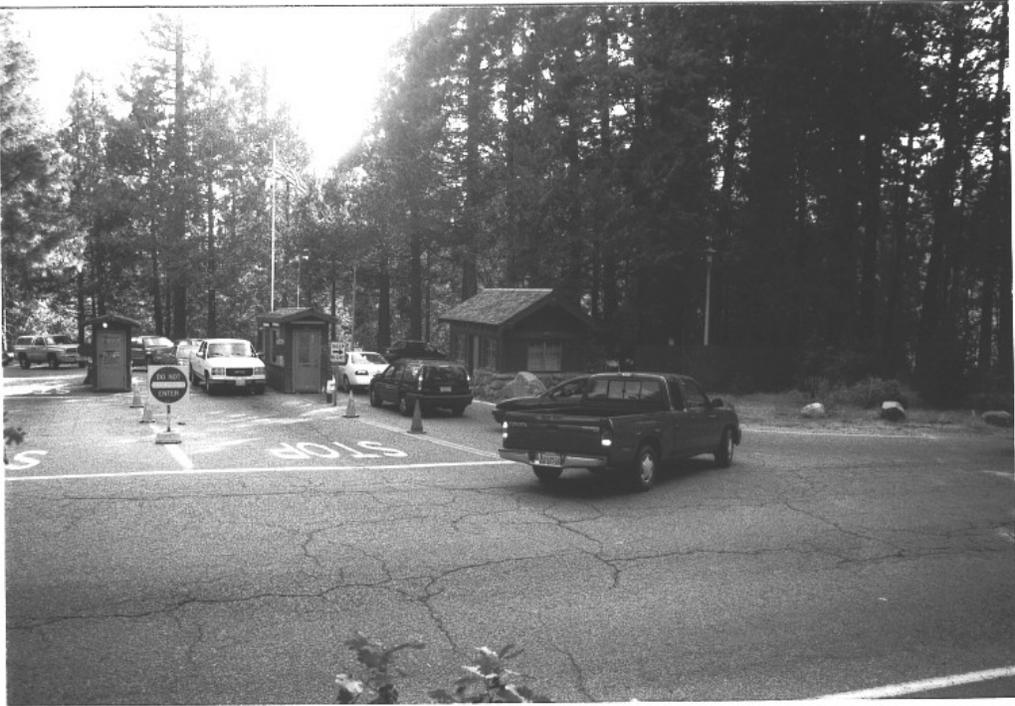
Looking SSW to the existing intersection. Note the three lanes of traffic. HRA, 1999.

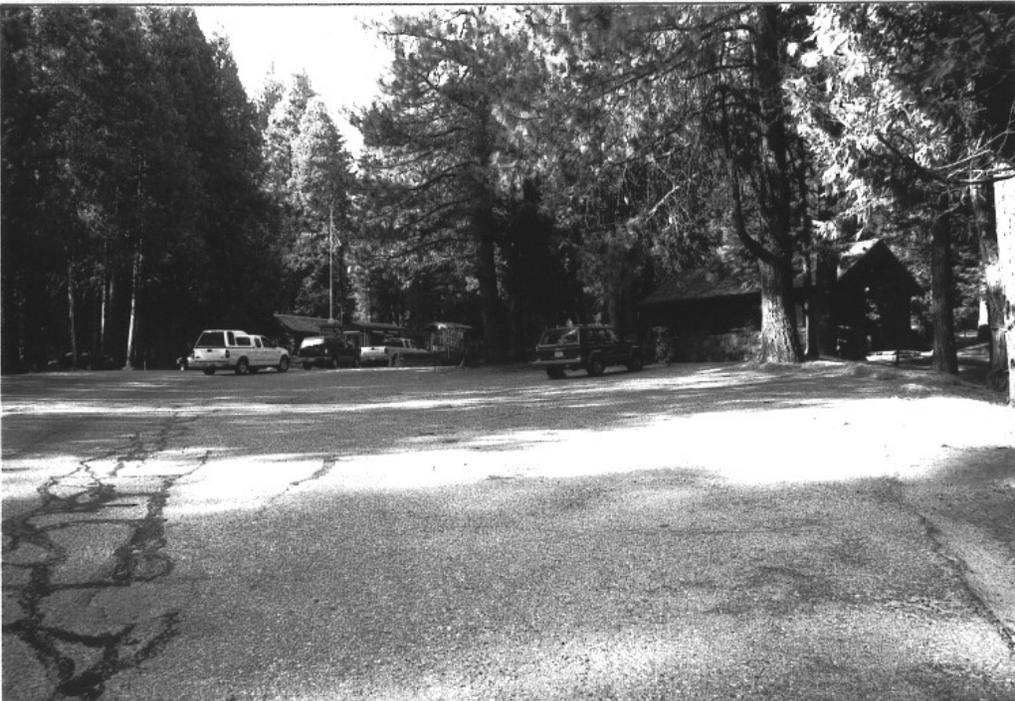
Looking NNW to the entrance station. Note the continuous asphalt extending from the northbound driving lane through the parking area south of the comfort station. HRA, 1999

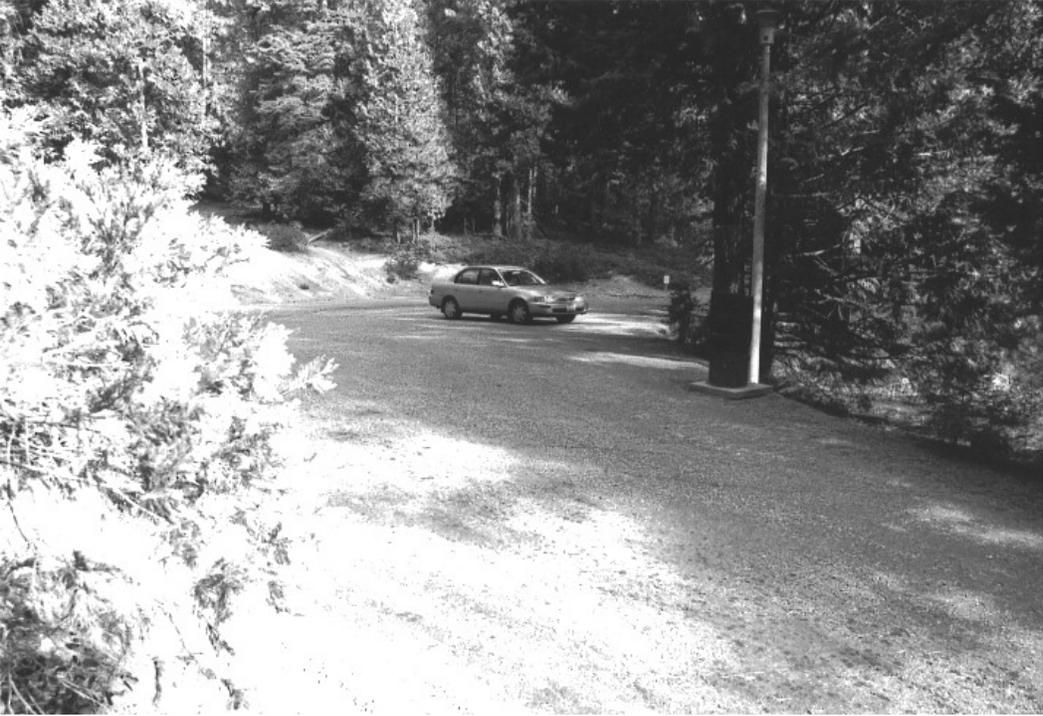
Looking NE towards the modern parking area NE of the comfort station. HRA, 1999.

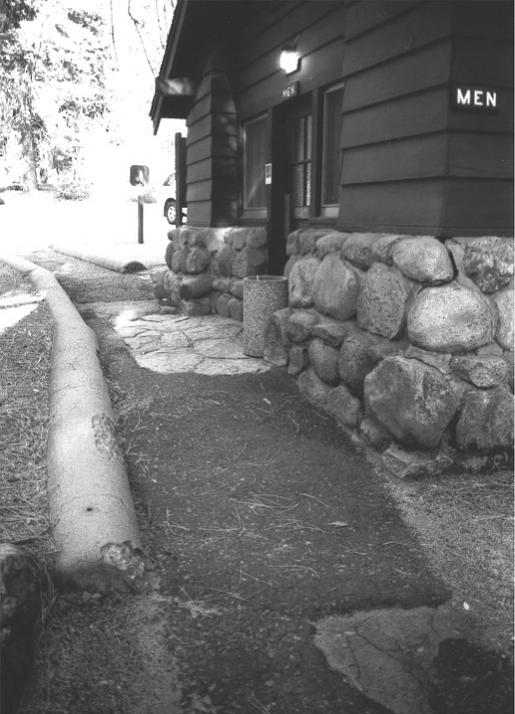
Looking N along the asphalt path west of the comfort station (WA04606). HRA, 1999.

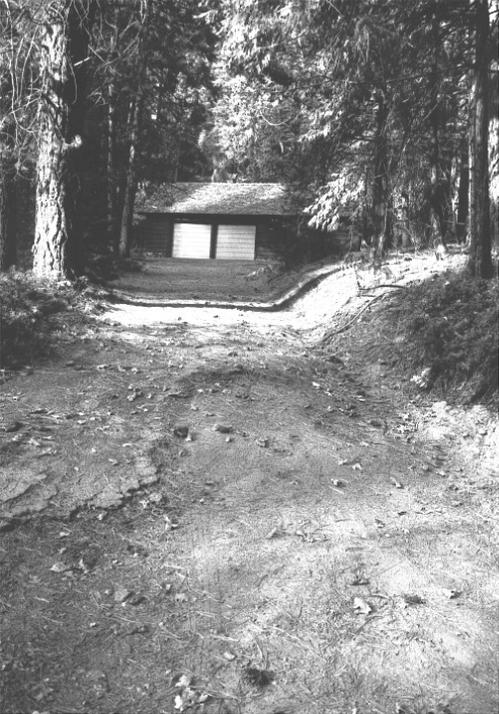
Looking N along the driveway to the garage (WS04601). HRA, 1999.

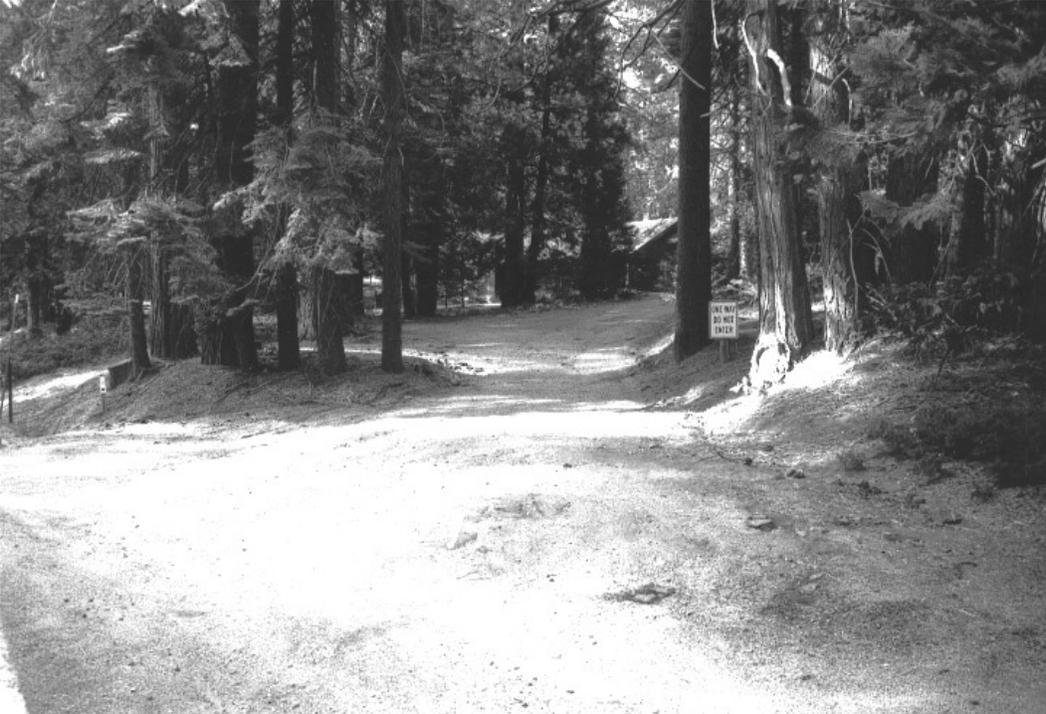
Looking NW towards the entrance to the residential area. HRA, 1999.

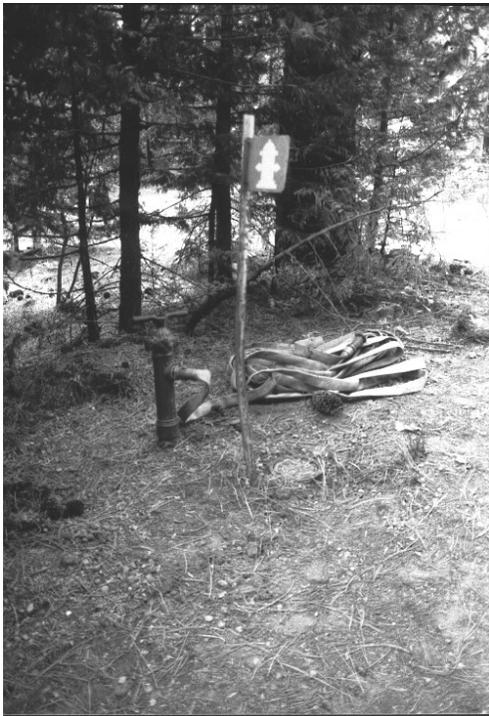
Fire hydrant and hose in the vicinity of the rangers' dormitory. HRA, 1999.

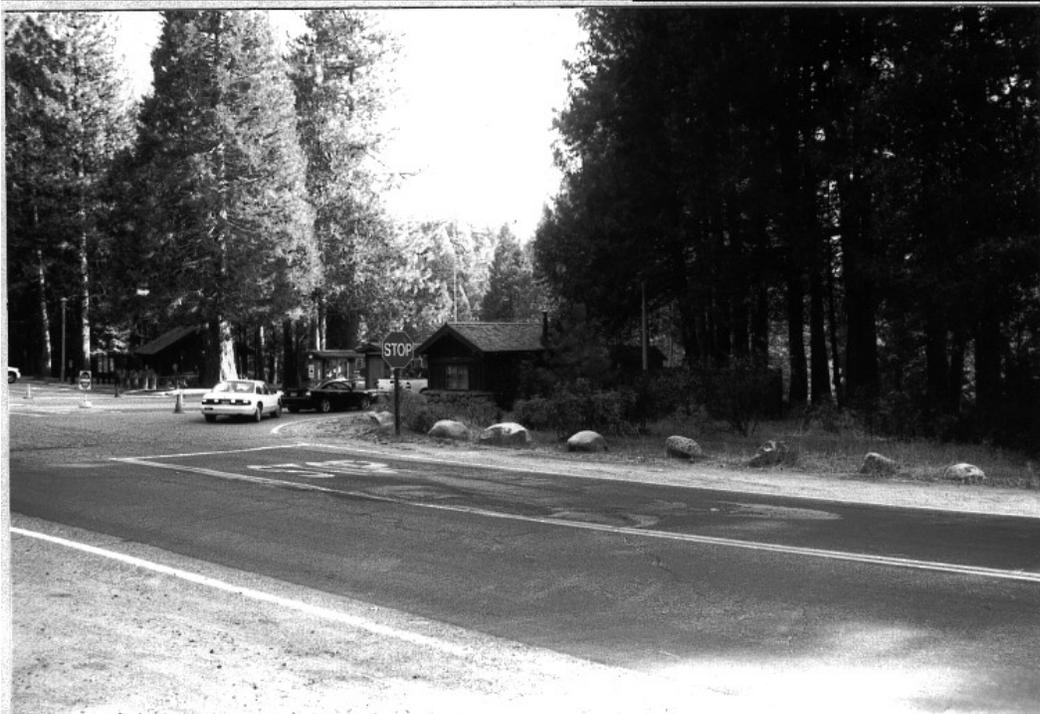
Looking SE towards the existing intersection. Note the boulder barrier on the south shoulder of the eastbound lane. HRA, 1999.
