Progressive failure of sheeted rock slopes: the 2009–2010 Rhombus Wall rock falls in Yosemite Valley, California, USA

Greg M. Stock,^{1*} Stephen J. Martel,² Brian D. Collins³ and Edwin L. Harp⁴

Earth Surface Processes and Landforms

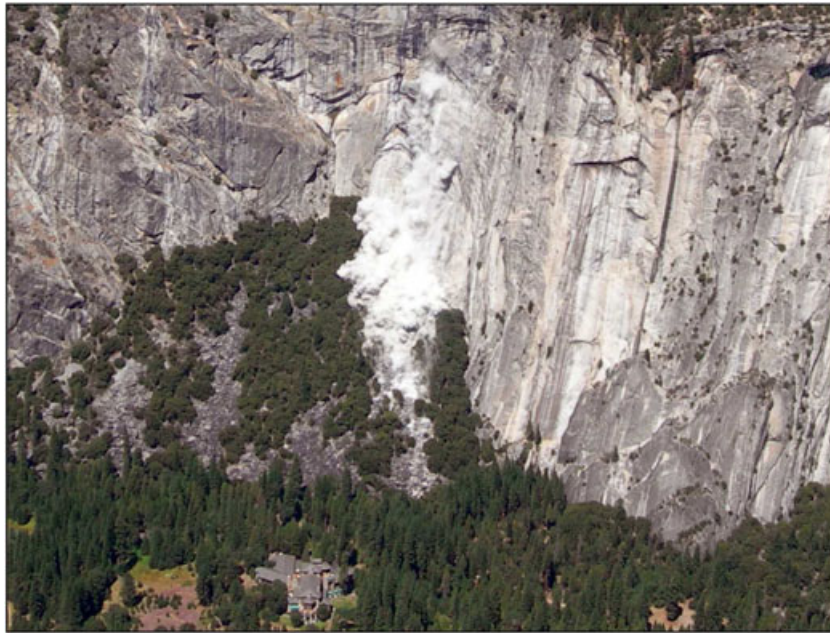
Figure 2. Photograph of the largest rock fall that occurred on 26 August 2009, at 13:09 PST. Note location of Ahwahnee Hotel at bottom left. Photo by Nissen Jaffe. This figure is available in colour online at wileyonlinelibrary.com/journal/espl

At 13:09 PST, a much larger rock fall occurred above and west of the earlier failures (area 1e in Figure 5), along the same sheeting joint surface. This slab had a volume of approximately 558 m³, the largest of all of the 2009–2010 Rhombus Wall rock falls (Table I). This rock fall was widely documented by park visitors, employees, and residents throughout eastern Yosemite Valley (Figure 2). Rock debris, including boulders as large as 2 m in diameter, bounced and rolled to the base of the talus slope and damaged unoccupied vehicles in the parking lot of the Ahwahnee Hotel.

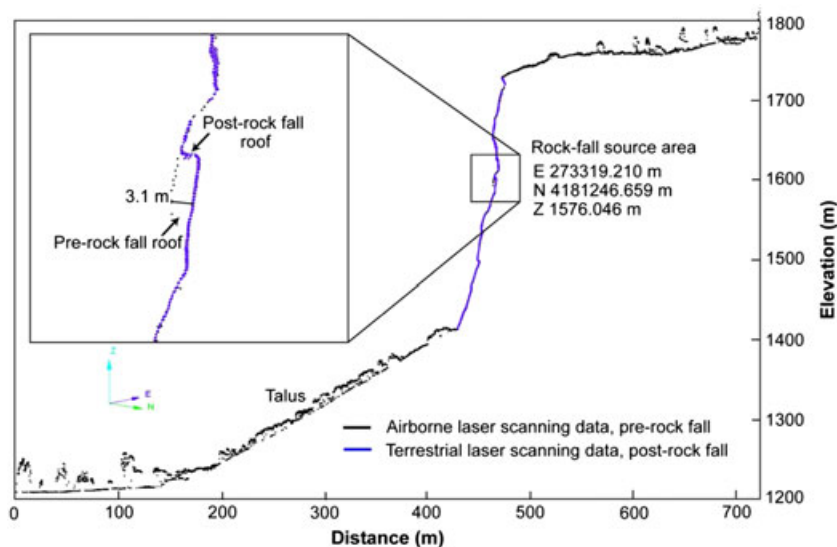
Figure 3. Cross-section through the Rhombus Wall area showing position and thickness of the slab that failed on 26 August 2009 by comparing airborne terrestrial laser scanning data collected before the rock falls (black) against terrestrial laser scanning data (blue) collected after the rock falls.

with calculations from overlapping cross-sections of airborne and terrestrial lidar data (Figure 3), but thinned to 1.0 m in the upper western corner where the last rock fall of the 26 August 2009 sequence occurred (Table I). The upper edge of the failure area was defined by a pre-existing discontinuity dipping moderately to the east-southeast (dip/dip direction = 38°/106°). Several discontinuities with similar orientations are present on the cliff face immediately above the failure area (Figure 8) and correspond to the ‘J2’ joint set prevalent in eastern Yosemite Valley (Wieczorek and Snyder, 1999; Wieczorek *et al.*, 2008; Matasci *et al.*, 2011; Stock *et al.*, 2011). Another set of discontinuities

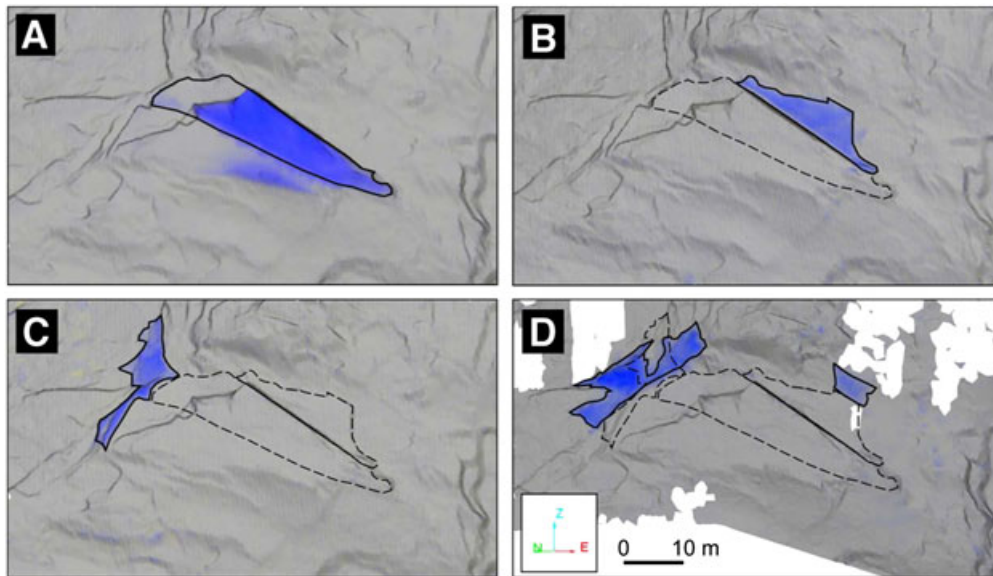
Figure 4. Difference analysis of interpolated surface models derived from airborne and terrestrial laser scanning data for the Rhombus Wall rock-fall source areas. Black lines delineate rock-fall perimeters (dashed for previous failures) and blue areas show areas of volume change between scans. (A) Failure area of the 26 August 2009 rock falls, with a cumulative volume of 740 m^3 . Detected change below the source area is partially an artefact due to gaps in the airborne laser scanning data, but also represents some actual volume loss from a ledge below the source area due to impact of the main failure mass. (B) Failure area of the 14 September 2009 rock fall, with a volume of 108 m^3 . (C) Failure areas of the 30 August and 27 September 2010 rock falls, with a cumulative volume of 73 m^3 . (D) Failure areas of the 28 October, 12 November, 13 November, and 20 November 2010 rock falls, with a cumulative volume of 110 m^3 , are shown on the left; 14 m^3 rock fall that occurred at an unknown date is shown on the right. White areas in (D) represent cliff surfaces that were wet when scanned, scattering the laser and yielding poor data returns.

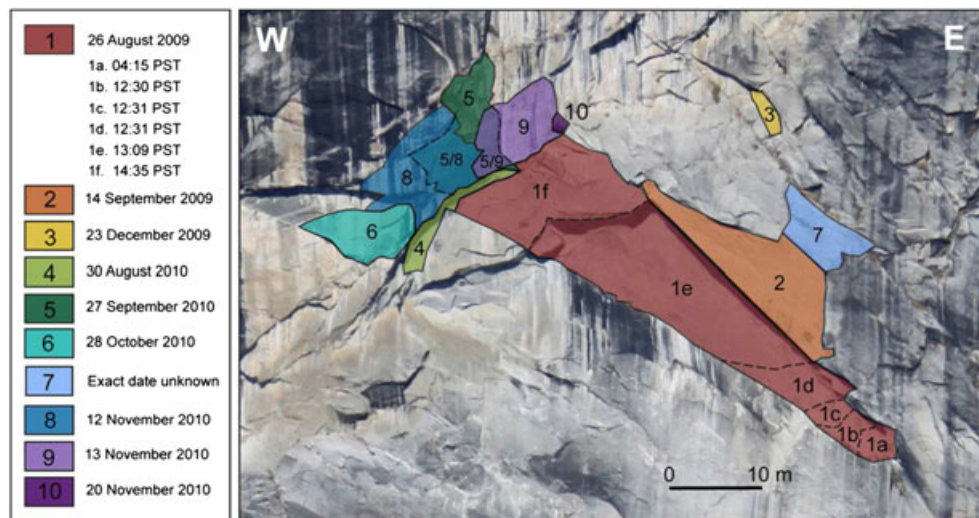
Several hours later, beginning at approximately 12:30 PST, a series of three rock falls, separated in time by approximately 20–60 seconds, began at the initial failure area and propagated up and to the west (areas 1b, 1c, and 1d in Figure 5) along a sub-planar, near-vertical sheeting joint (Table I) that closely mirrored the orientation of the cliff face prior to failure. A park visitor captured the rock fall at 12:31 PST on high-definition video (Figure 7). Analysis of this video reveals a sudden

Figure 5. Spatial and temporal patterns of rock fall from the Rhombus Wall derived from observations, repeat digital photography, and repeat laser scanning. The failures progress in time from warm to cool colors, with red marking the first failures on 26 August 2009 and purple the most recent failure on 20 November 2010. Rock fall number 7 (light blue) was not documented at the time of occurrence, and thus lacks an exact date. Except for the failure of 23 December 2009 (yellow), all of the failures are adjacent to a previous failure, a pattern also revealed in the progressive failures of 26 August 2009 (red). These progressive failures are consistent with stress concentrations associated with a given fracture event initiating subsequent adjacent failures. This figure is available in colour online at wileyonlinelibrary.com/journal/espl

Rock-fall activity resumed at 01:45 PST on 30 August 2010 (area 4 in Figure 5), with failure generally progressing up and to the west. The failure involved a vertical slab of rock 0.8 m thick with a total volume of 30 m³ on the western edge of the failure surface of the 26 August 2009 failures (Figure 5; Table I).

Approximately one month later, at 13:30 PST on 27 September 2010, a 0.8 m thick sheet 43 m³ in volume (area 5 in Figure 5) detached from a position directly above the 30 August 2009 failure. This event reflects fracture propagation along the western margin of the failure area, predominantly upward behind the cliff face but also slightly to the west.

One month later, at 20:05 PST on 28 October 2010, another rock fall occurred from the far western margin of the failure area (area 6 in Figure 5). As with the previous rock falls from this area, the failed sheet was thin (0.6 m), with a total volume of 33 m³ (Table I).

Approximately three weeks later, at 16:42 PST on 12 November 2010, another rock fall occurred along the western margin of the failure area (area 8 in Figure 5). This rock fall again involved a thin (0.6 m) rock sheet and had a volume of 40 m³. The failure surface connected those of previous rock falls, and partially overlapped the failure surface of the 27 September 2010 rock fall (Figure 5). We interpret this overlap as progressive failure along stacked, thinly spaced sheeting joints with nearly identical orientations (dip/dip direction).

The following day at 12:04 PST, another rock fall occurred on the western margin of the failure area (area 9 in Figure 5). This rock fall, involving the same thin (0.6 m) sheet that failed the previous day, extended farther up the cliff. Its failure surface partially overlapped the failure surface of the 27 September 2010 rock fall (Figure 5). Cracking noises were heard from the Rhombus Wall approximately one hour prior to this failure, and the rock fall was widely witnessed throughout eastern Yosemite Valley.

The final rock fall of the 2009–2010 Rhombus Wall sequence occurred at 22:55 PST on 20 November 2010. This failure (area 10 in Figure 5), which had a volume of approximately 2 m³ (Table I), involved a very thin (0.2 m) sheet located on the eastern side of the 13 November 2010 failure.

Difference analysis following a terrestrial laser scan on 14 December 2010 revealed one additional rock fall that had not been previously documented (area 7 in Figure 5). This failure consisted of a thin (0.5 m) sheet with a volume of 14 m³, located above the 14 September 2009 failure surface (Figure 5). Repeat photographs show that this sheet was in place on 28 October 2010, but missing on 12 November 2010. Although there were no reports of rock falls from the Rhombus Wall during this time, many small rock falls that occur in Yosemite Valley are not reported. Perhaps this sheet also failed on 12 November 2010, along with area 8 on the western margin (Figure 5), but we are unable to test that possibility with the available data. Therefore, we cannot identify an exact date or time for this rock fall (Table I). However, its position adjacent to an earlier failure, and its occurrence during a period of high rock-fall activity on the Rhombus Wall, strongly suggest that it was related to the other failures. This failure was interesting in that it occurred on the eastern side of the rock-fall source area after a hiatus in activity on that side of more than one year.

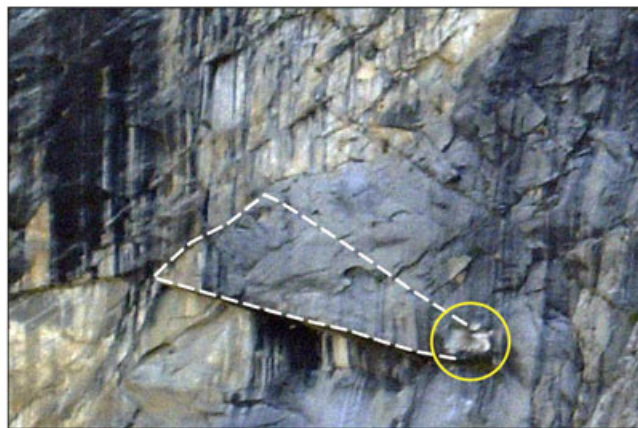
with the gigapixel panoramic images of the Rhombus Wall acquired prior to the rock fall (Figure 1(B), 1(C)) reveals that the failure occurred at the inside corner of an alcove roof beneath an overhanging rock slab (area 1a in Figure 5; Figure 6). Stress concentrations can be expected at corners such as this in rock (Holister, 1967; Muller and Martel, 2000; Barber, 2002). The failure surface showed mostly freshly broken rock with ragged edges and no clearly defined pre-existing structural discontinuities. Local water staining on the newly exposed surface, however, indicates that a fracture behind the rock mass was open and conducting water, and had partially detached the rock mass from the cliff prior to failure.

Figure 6. Photograph taken at 07:30 PST on 26 August 2009, following the first rock fall of the sequence (see area 1a in Figure 5). Comparison with high-resolution photographs taken prior to the rock fall (Figure 1(C)) highlights a small (5 m³) failure (yellow circle) located at the tip of a triangular-shaped overhanging slab, a likely point of stress concentration. Subsequent failures later that day resulted in failure of the triangular slab (white dashed line). This figure is available in colour online at wileyonlinelibrary.com/journal/espl

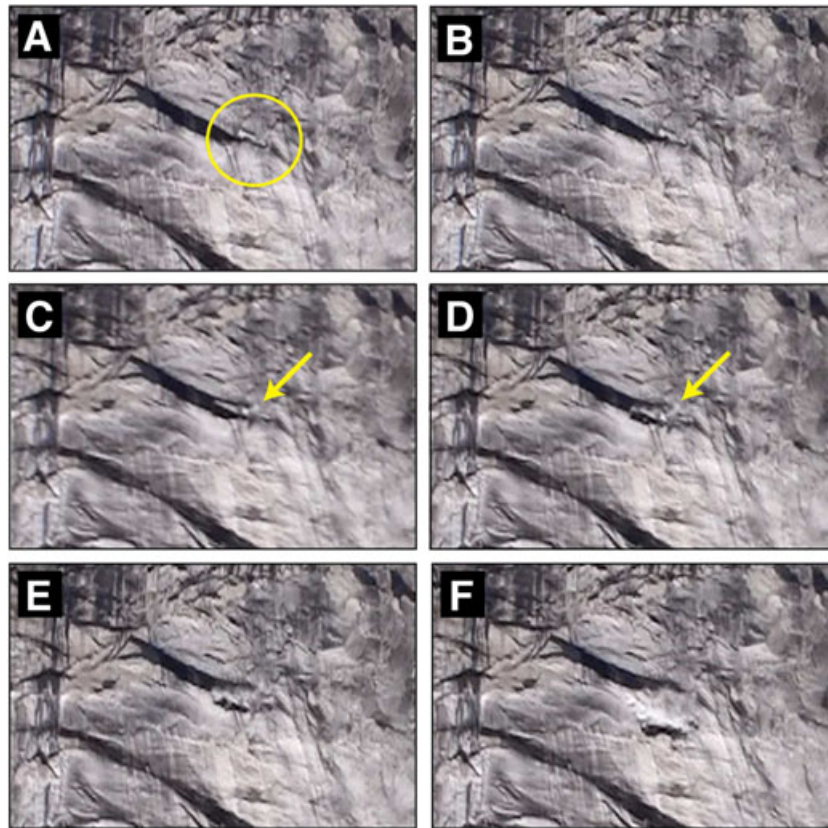
distinctive ejection of rock dust just as a rock sheet begins to slip along the underlying sheeting joint surface, with associated tensile failure within the slab (Figure 7). The apparently explosive behavior indicates the presence and rapid redistribution of high stresses at the failure surface. The detached sheet subsequently slid down a steeply inclined face below the failure surface (dip/dip direction: 69°/217°) for ~20 m and then struck a bedrock ledge. The sheet fragmented into about 14 large pieces and free-fell approximately 140 m to the talus slope at the base of the cliff.

Figure 7. Image sequence showing detachment of 78 m³ sheet at 12:31 PST on 26 August 2009 (area 1d in Figure 5). (A) Cliff surface immediately before detachment. Yellow circle marks detachment area. (B–D) Failure initiation, with forceful ejection of dust (yellow arrow) accompanying sudden slip along the underlying sheeting joint. Total elapsed time of image sequence is 1.2 seconds. Images from high-definition video taken by Robert Atkinson. This figure is available in colour online at wileyonlinelibrary.com/journal/espl

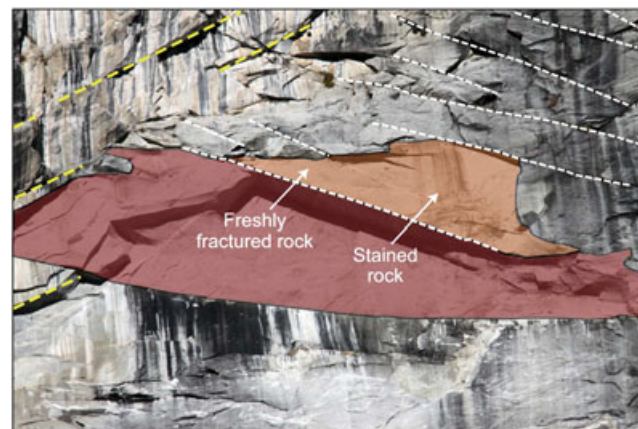
Figure 8. Photograph of the 14 September 2009 rock fall site (orange), which consisted of a thin (0.8 m) sheet located immediately above the failure area of the 26 August 2009 rock falls (red) and along a parallel surface. The 14 September rock fall occurred after approximately three weeks of audible cracking and visual observations of sheeting joint opening. Note the staining in the middle of the failure surface and the freshly fractured rock along the edge. White dashed lines mark moderately east-dipping discontinuities that dip moderately to the east and form the upper margins of failure surfaces. Yellow dashed lines mark discontinuities that dip moderately to the northwest.

At 17:12 PST on 14 September 2009 a rock mass with a volume of 108 m³ detached along the aforementioned sheeting joint. This joint was essentially parallel to the failure surface of the 26 August 2009 rock falls, but located at a much shallower depth (0.8 versus 3.1 m; Table I). The failure surface of the 14 September 2009 rock fall (area 2 in Figure 5) is an eastward continuation of the failure surface of the last rock fall that occurred on 26 August 2009 (area 1f in Figure 5). As with the earlier failures, the exposed failure surface showed some water staining, primarily near its center, with freshly fractured rock along the perimeter (Figure 8). Although the failure surface was dry when observed within 10 minutes after the rock fall occurred, the presence of water staining indicates that the sheeting joint was at least partially open and transmitting water behind the sheet for some time prior to failure (Figure 8).
