Subject: Installing New Systems in Historic Buildings

January 2008, ITS Number 51

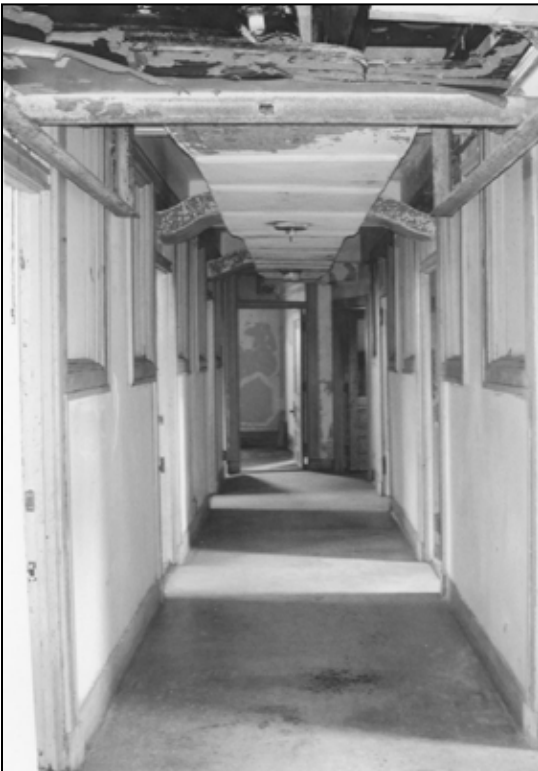
Above: The dropped ceiling has been partially removed, revealing the old ductwork running through the center of the hallway and branching into each office. The ceiling had been lowered from its historic height of 10 feet to just 7 feet.

network of ceiling distribution ducts. As a cost-cutting measure, the main distribution ducts were run along the corridors, below the existing ceiling, and branched off into the individual offices. Rather than cutting through the walls to add the necessary room vents, the vents were installed through the transoms above the office doors. The very low suspended ceiling that was added to conceal the ductwork also obscured the transoms and cut across the windows in the corridors. This dropped ceiling dramatically and negatively impacted the historic appearance of the corridors.

In the current rehabilitation, the design team took an alternative and very sensitive approach to provide climate control in the office spaces. The new HVAC ductwork was routed along the building's perimeter walls at floor level

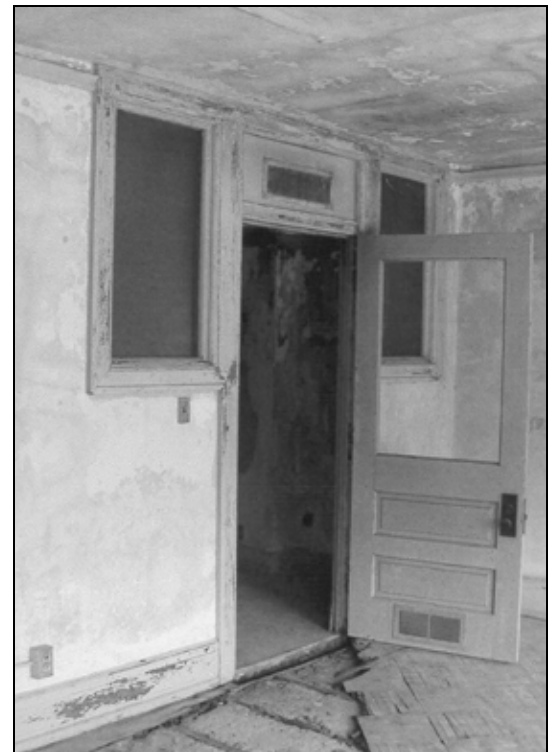
Above: Prior to rehabilitation the offices had air supplied through vents installed in the original door transoms.

and concealed in a new built-in feature that contained not only the air supply and return, but also included new electrical service and voice and data lines. The design for the new interior built-in feature drew on the appearance of the old window seat-styled radiator covers that were common in buildings of the era and even incorporated the original, historic baseboards in its design. This design provided for an unobtrusive and aesthetically pleasing appearance for the new built-in feature.

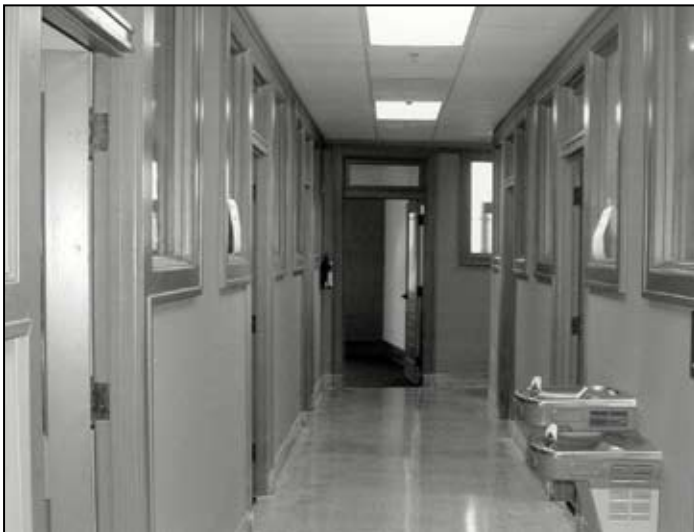
Top left: The rehabilitation raised the ceiling above the door transoms. This not only uncovered the historic, character-defining transoms, but also allows more natural light into the corridors.

This treatment enabled the offices to retain their historic ceiling height. And, by removing the existing ductwork from the corridors, it was possible to significantly raise the corridor ceiling height, even though the corridor ceilings could not be raised to their full original height due to the sprinkler piping and lay-in light fixtures above. Removing the ductwork and raising the ceiling in the corridors also uncovered the door transoms and fully exposed the hallway windows. This HVAC installation not only recaptured the historic character of the corridors but also retained the character of the office spaces and, therefore, meets the Standards for Rehabilitation.

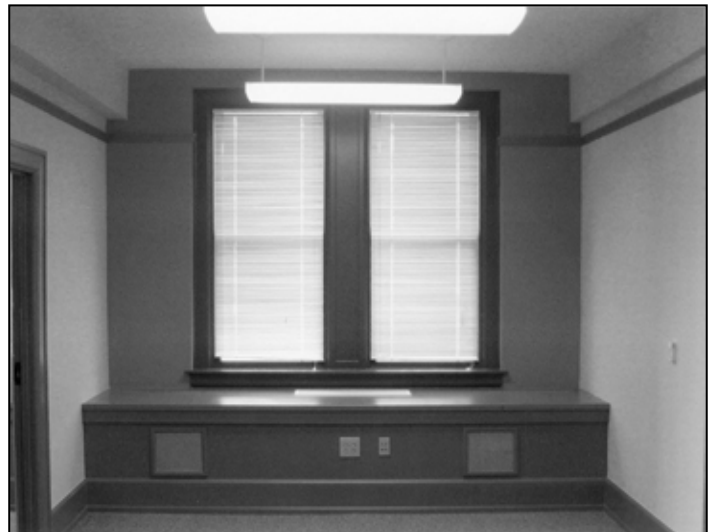
Top right: The offices now have heating/cooling vents located in a window seat-like feature which also incorporates the original baseboard. Note the integrated electrical outlets and voice and data jacks on the front of this built-in feature.

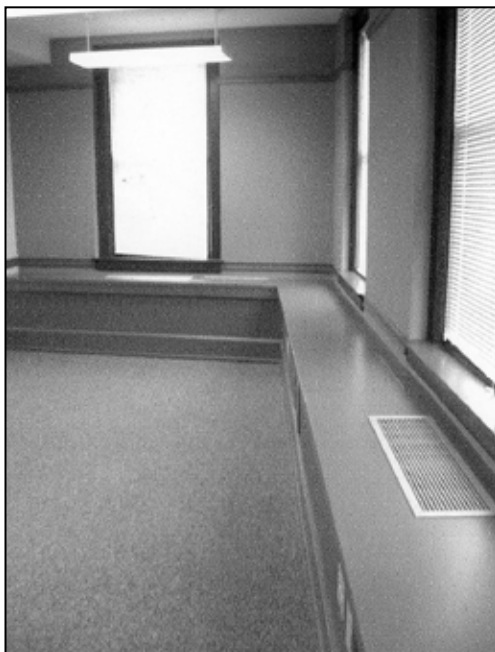
Bottom: In this corner office the multiple vents are installed in a single, wrap-around feature that provides a continuity of design and allows for even air distribution.
