CULTURAL LANDSCAPE REPORT, AQUATIC PARK

SAN FRANCISCO MARITIME, NATIONAL HISTORICAL PARK

**NATIONAL PARK SERVICE
PACIFIC WEST REGION
2010**

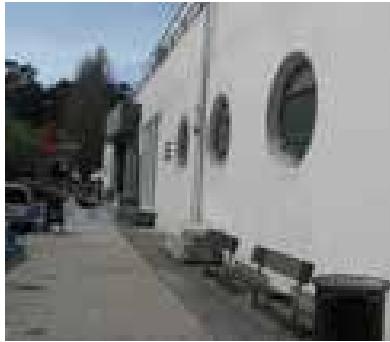
Figure 88. Northeast side of the entrance to the Bathhouse with a variety of non-compatible features such as benches, trash cans, city street signs, utilities, and public mailbox. (NPS, 2010)

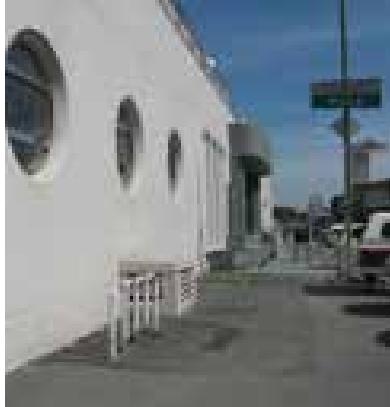
Figure 89. On the west side of the front entrance to the Bathhouse, a bicycle rack, accessibility ramp, and various small-scale features and utilities create a cluttered appearance. Note asphalt paving where planting bed was originally located. (NPS, 2010)

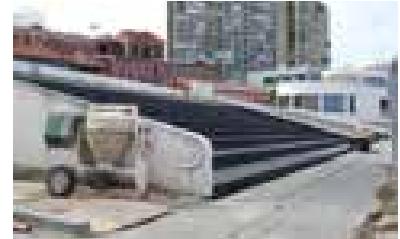
Figure 90. View of the East Bleachers showing new waterproofing material applied during rehabilitation. Note mildew on the concrete wall. Cleaning and repainting this portion of the structure is important to the character of the structure, and should be integrated into overall maintenance. (NPS, 2009)

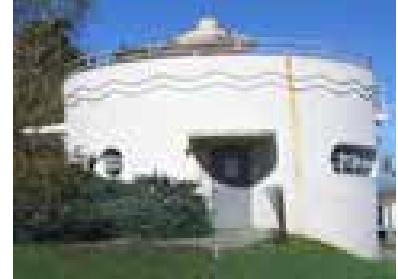
Figure 92. Staining on the exterior of the West Convenience Station. (NPS, 2007)

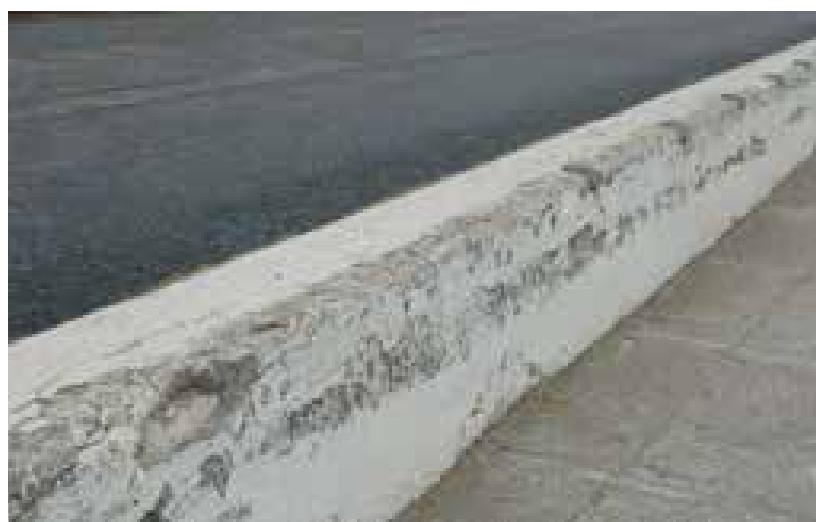
Figure 96. Flaking and loss of material along the concrete wall occurs as deterrent bolts fail and water penetrates the under layers of the concrete. Repair may require patching, reapplication of a skim-coat, or some combination. View of the east end of the wall, looking west. (NPS, 2007)

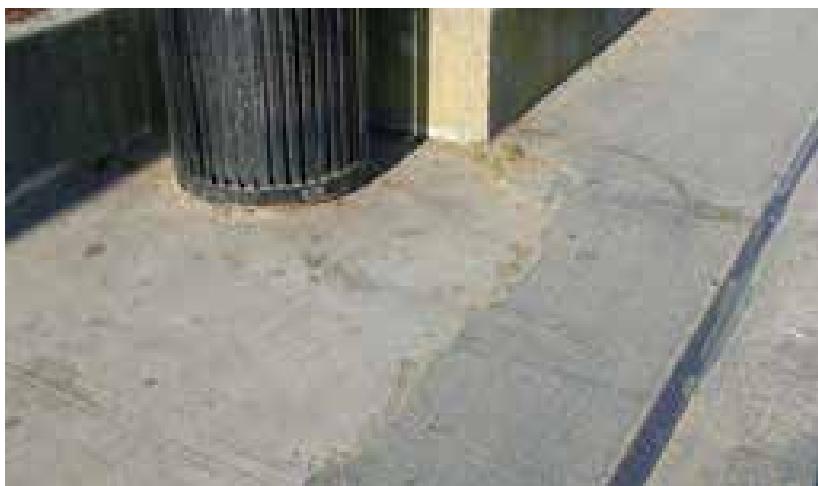
Figure 100. In some areas walkways have been resurfaced with paving added over existing layers creating a patchwork of materials. (NPS, 2008)

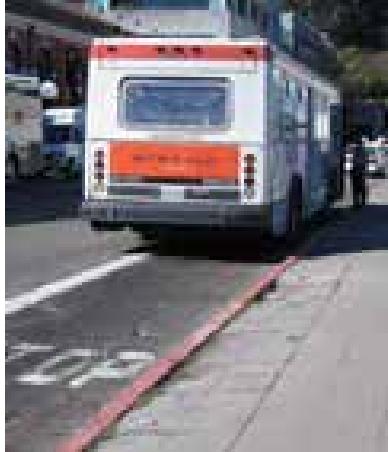
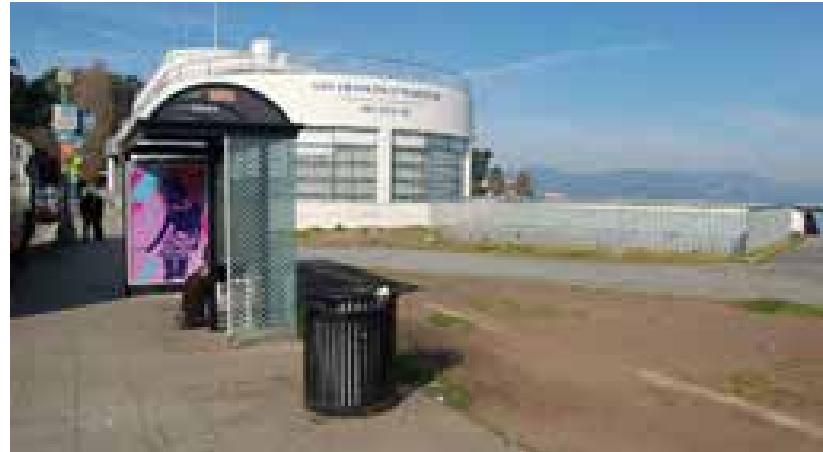
Figure 107 a&b. The bus stop located on the east side of the Bathhouse is an area significantly impacted by heavy use in a relatively compact zone. Overall, the combination of degraded concrete sidewalks, denuded vegetation, damaged concrete curbs, visually incompatible structures, and a diverse variety of small-scale features create an adverse impact to the NHL district. View from the shelter looking east along Beach Street. (NPS, 2006)

- Relocate the bus shelter north of the current sidewalk to create additional space for pedestrians waiting for the bus.
- Work with the city to relocate or remove the current bus stop as a way to mitigate impact to Aquatic Park and the NHL district.

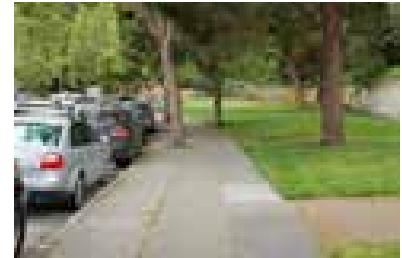
Figure 108. Displaced, cracked, and patched sidewalk along Van Ness Avenue next to Pocket Park. At a certain point, rather than patching, a holistic approach to rehabilitation of the sidewalk will assure a more uniform character. View looking south. (NPS, 2008)

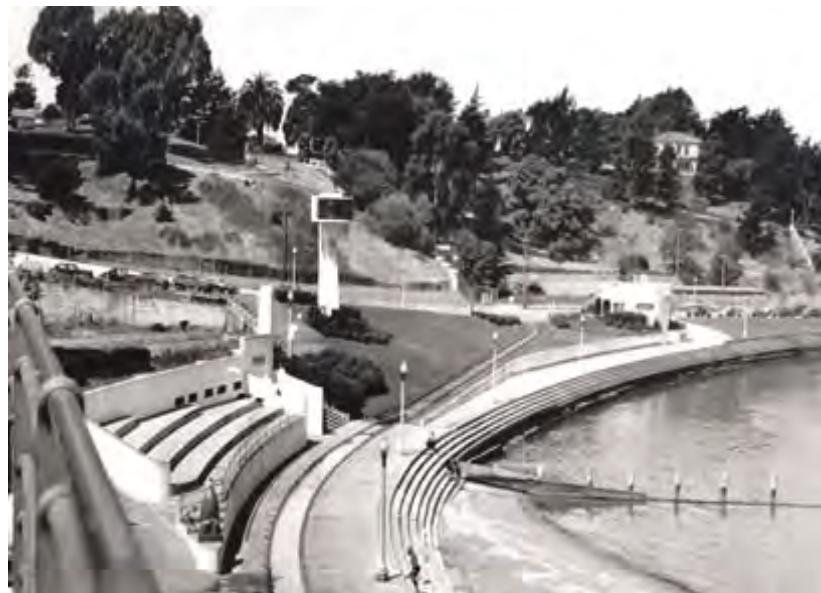
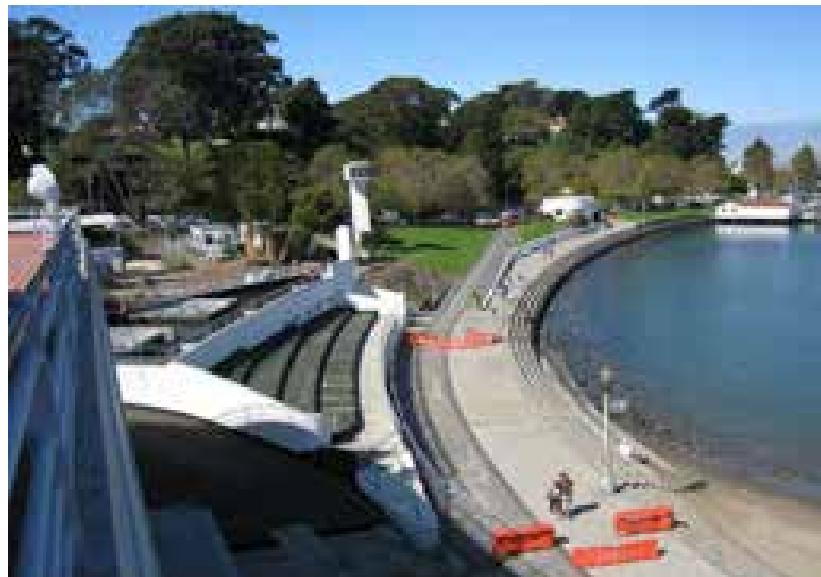
Figure 109 a&b. Comparison showing the degree to which vegetation has encroached on the slope above Van Ness Avenue (Fort Mason). Historically this area had a more open vegetative character during the period of significance for Aquatic Park. Top: view looking west, 1946. (Courtesy of the San Francisco History Center, San Francisco Public Library AAA 6697; bottom: view looking west, 2009 (NPS, 2009)
