Weekly work updates from February 2004 through December 2004 on the restoration of the 1895 lumber schooner *C. A. Thayer*

November 8 – 12, 2004

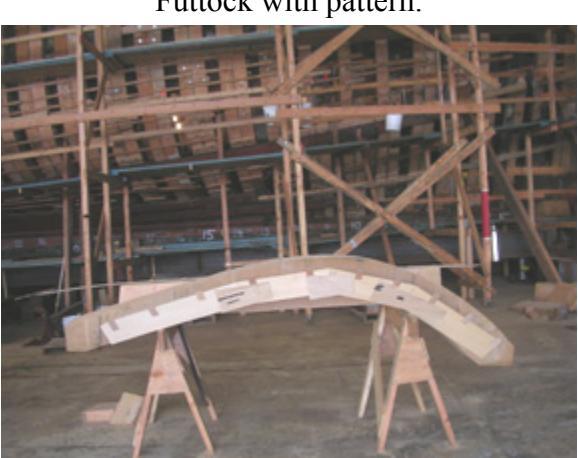
Futtock with pattern.

The framing work became to some extent routine. The process was worked out in the mid-body, where there is relatively little bevel in the frame futtocks. Light plywood or "doorskin" templates were made for each futtock, based normally on the space between the outer ribbands and the inner ceiling plank. Whenever possible, one of the futtock pairs was retained initially, so that the doorskin pattern lay directly against the retained futtock. In every case, the changing bevels of the futtock to be replaced were carefully noted on the doorskin pattern. Bill Elliot, the CEO and majority owner of Bay Ship and Yacht was out there regularly checking the bevels and the accuracy of the taking-off process. Tim Mahan, a graduate of the Northwest School of Wooden Boatbuilding at Port Townsend, has been the lead in pattern making.

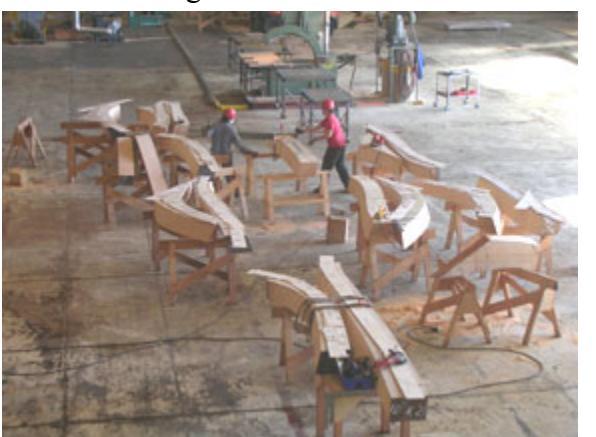
Trimming exact butts on futtocks.

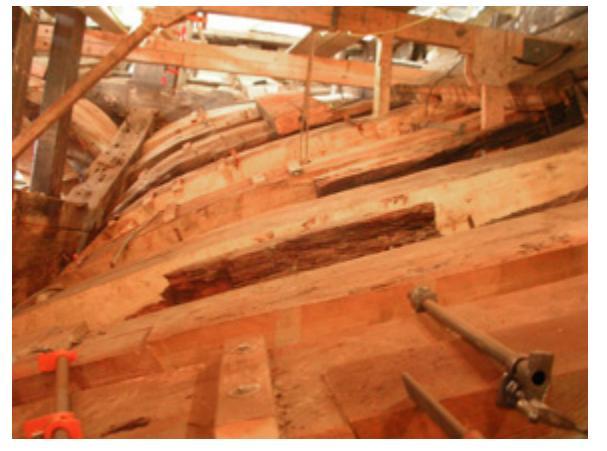
The framing becomes trickier as you move toward the ends, and the work has slowed a bit. The curves and the bevels become more extreme, and working the futtocks into place become more difficult. The hull, however, has now achieved a reassuring level of structural solidity.

Looking aft, note progressive change in frame shape.

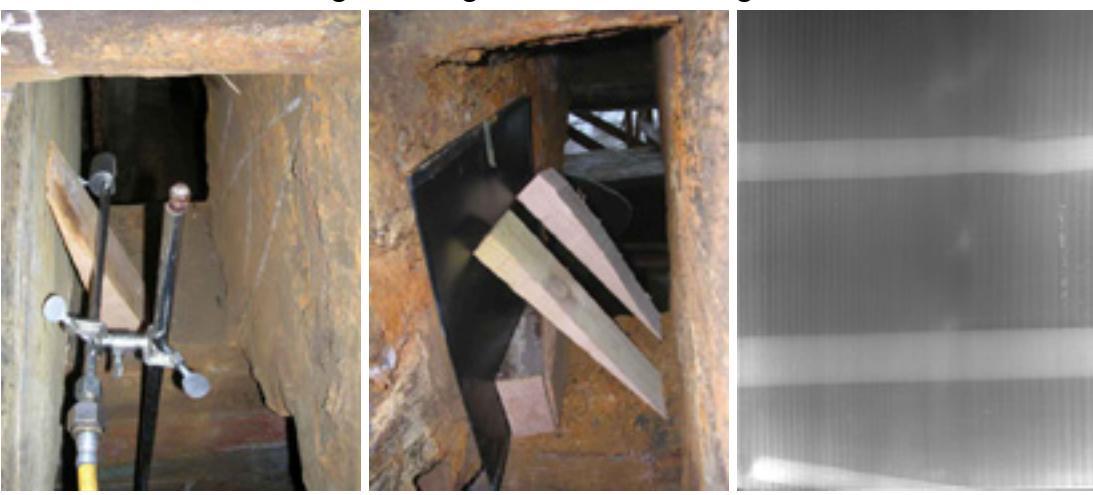
From left: x-ray source, x-ray film, and image showing steel rod and wood grain.

We contracted with an industrial X-ray company to have a look at the condition of the fastenings and surrounding timber in the rider and main keelsons, and through the frames into the keel. Our x-ray guys were inexperienced in working in wooden structures. Their normal work is on welded seams, steel castings, and concrete structures. Initial tests on a section of eight-inch ceiling plank indicated, however, that we would be able to see both the condition of the drifts and the relative soundness of the surrounding timber. A long Saturday yielded about 40 images, taken at three locations. We are still examining the images, but it looks like only the forward portion of the rider keelson shows notable deterioration of the fastenings.

On the keelsons, we have been trying to determine whether or not to lift out the rider keelson. Bill Elliot suggested that it would be prudent to do this, in view of the condition-found of the upper sister keelsons. He also suggested that the steel drift fastenings were likely much weakened and would compromise the strength of the keelson structure. However, taking out the rider keelson would require taking down all of the centerline stanchions and stripping off the centerline salt pocket. We are not eager to get into this, and would prefer to live with the rider keelson in place.

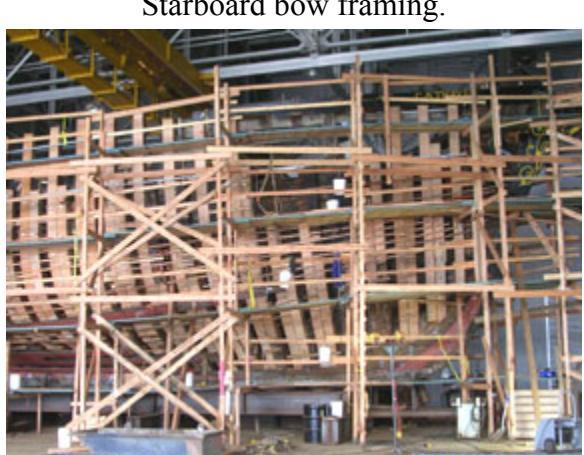
Starboard bow framing.
