Subject: Replacement of Missing or Altered Storefronts

December 2007, ITS Number 48

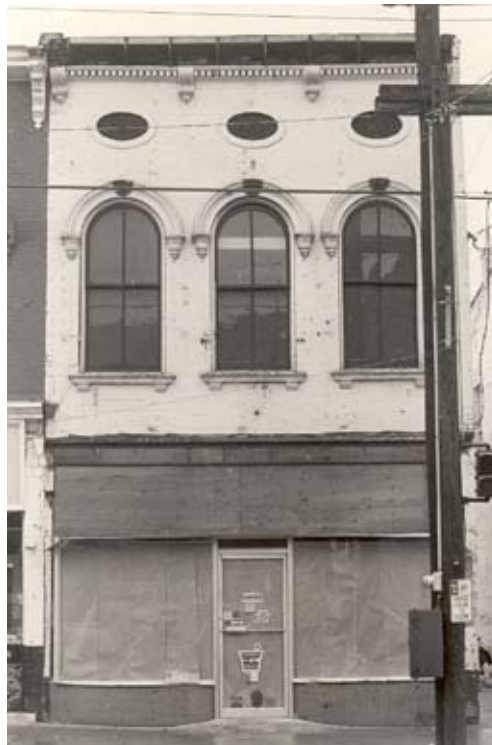
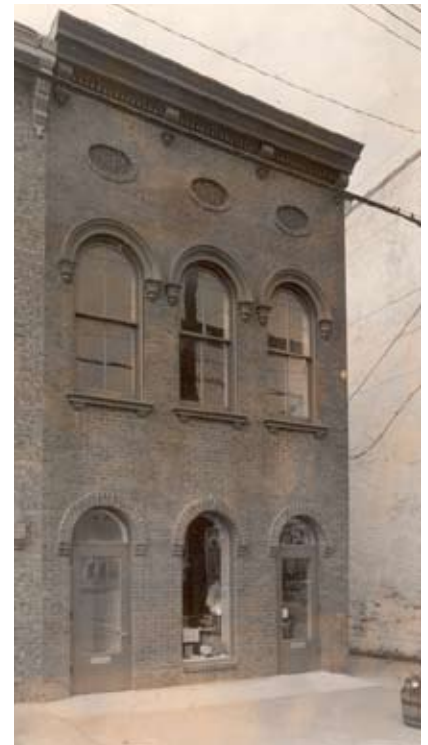
Application 1 (*Incompatible treatment*): This late-19th century, two-story, brick commercial building was rehabilitated for office use. The existing storefront, which was not original, was in poor condition but could have been retained and repaired. The owner did not wish to keep the non-historic storefront and could find no information to document its historic appearance. Instead of designing a compatible new storefront, the owner constructed three separate arched openings that copied the arched windows on the second floor. Generally, the first floor of a historic commercial building did not reflect the design of the second floor openings, but typically featured a storefront with large glass windows to display merchandise. Replacing the storefront with residential-type openings resulted in a loss of the historic commercial character of this building. The project does not meet the Standards.

The storefront on this Victorian building prior to rehabilitation was a later replacement (left). During rehabilitation the storefront was removed and replaced with three residential-type openings that are incompatible with the building's retail character (right).

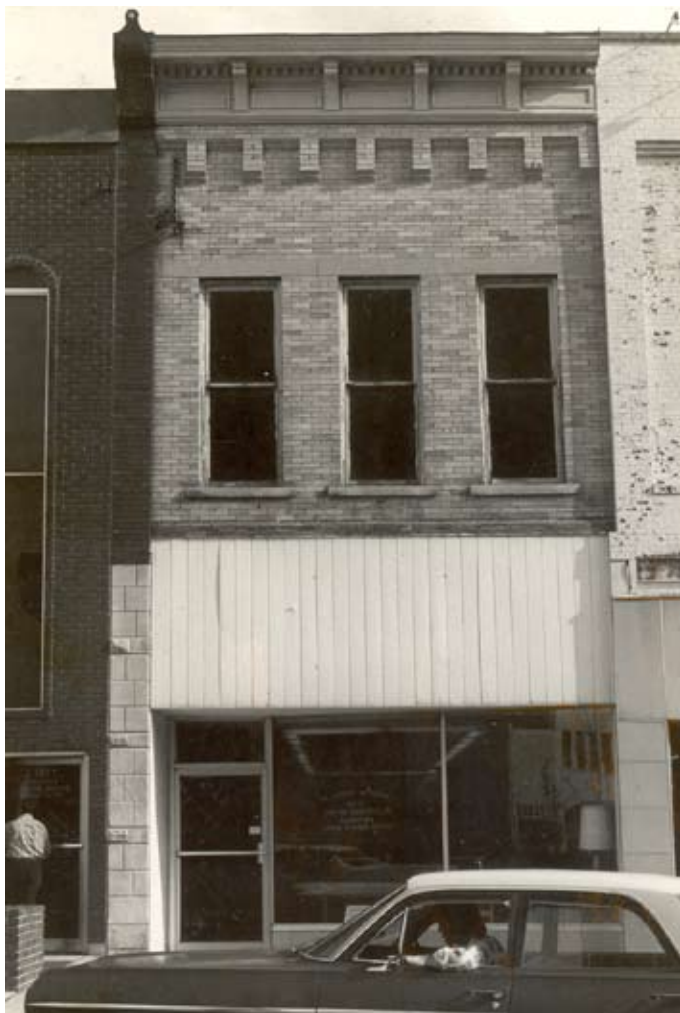
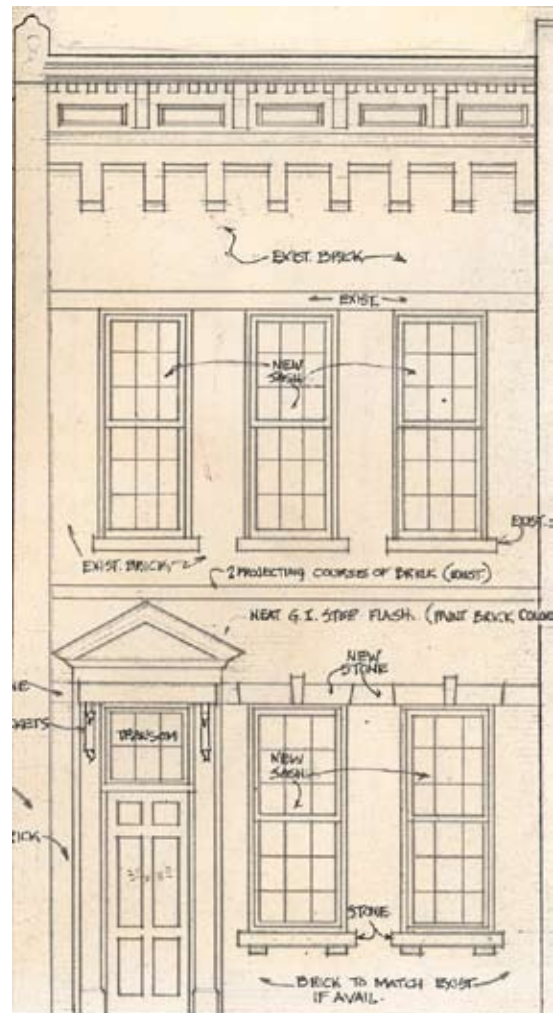
Application 2 (*Incompatible treatment*): Another historic commercial building constructed c. 1900 with a 1950s storefront was to be converted into offices. This rehabilitation also proposed to replace the storefront with residential-type openings, but with nine-over-nine windows, keystone lintels and a pedimented doorway in an 18th century

“Georgian” style inappropriate for this early-20th century building. (The one-over-one sash on the second floor windows was proposed to be replaced with nine-over-nine sash to match the new first floor windows.) Not only is installing residential-type openings to replace a storefront an incompatible treatment, but removing original windows and replacing them with historically inaccurate windows is also not a compatible rehabilitation treatment. Accordingly, this proposal does not meet the Standards.

Prior to rehabilitation this early-20th century commercial building had a 1950s storefront (left). Rehabilitation plans proposed replacing the storefront with 18th century-style residential-type openings, inappropriate for this commercial building and its period of construction (right).
