Subject: Adding Awnings to Historic Storefronts and Entrances

- Applicable Standards:**
2. Retention of Historic Character
 6. Repair/Replacement of Deteriorated or Missing Features Based on Evidence
 9. Compatible New Additions / Alterations
 10. Reversibility of New Additions/Alterations

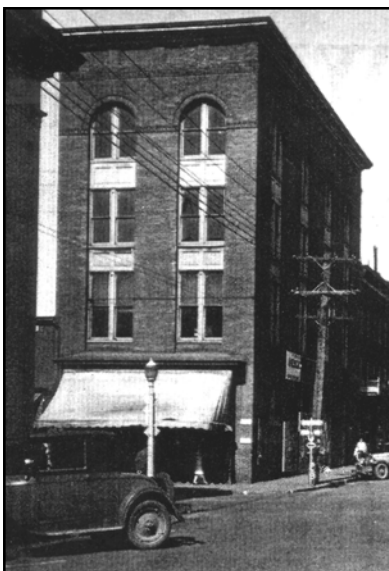
Historic photo showing retractable canvas awning.

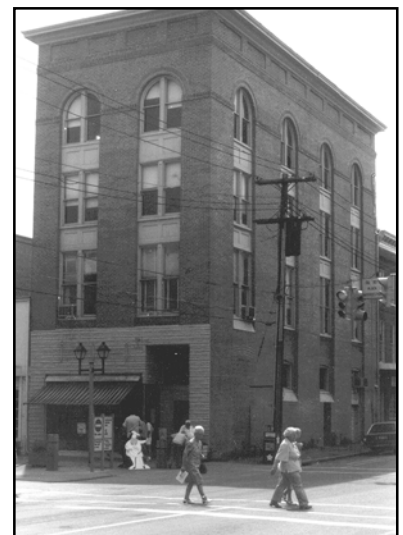
Application 1 (*Incompatible treatment later corrected to meet the Standards*): This relatively modest, four-story commercial structure was built in the 1890s on a corner in a small-town business district. A decorative cornice, arched window openings and wood windows and spandrel panels on the upper stories survived to the period of rehabilitation, but the main entrance and display area had been replaced with a permastone storefront. Historic photographs indicated that the storefront was originally topped by a narrow projecting roof with a large shed-shaped canvas awning below.

Building with permastone storefront prior to rehabilitation.

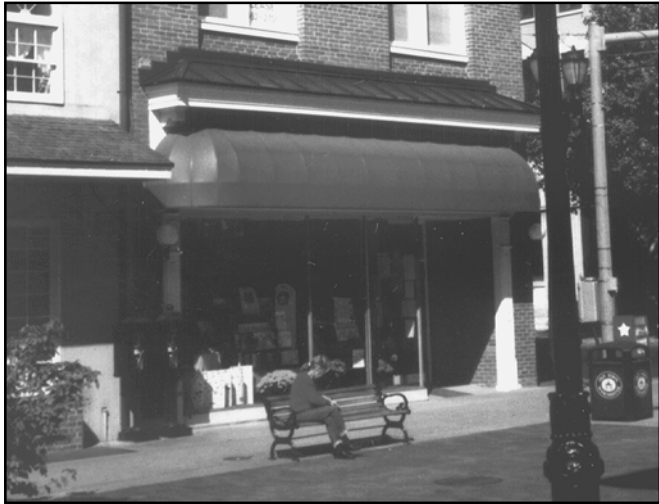
As part of the rehabilitation, a compatible storefront was installed consisting of a simple glass display window with a standing-seam metal shed roof above it. The replacement awning, however, was a contemporary "long dome" awning with a glossy vinyl covering.

Original "long-dome" treatment for replacement awning.

To conform with the **Secretary of the Interior's Standards for Rehabilitation**, the inappropriate awning was replaced with a type that more accurately resembled the shape and material shown in the historic documentation and known to be common among turn-of-the-century storefronts. The replacement awning is a standard, shed shape that is sold by many companies as a stock product. Although a functioning, retractable awning would have been the most appropriate solution, the fixed, shed awning was an acceptable compromise.

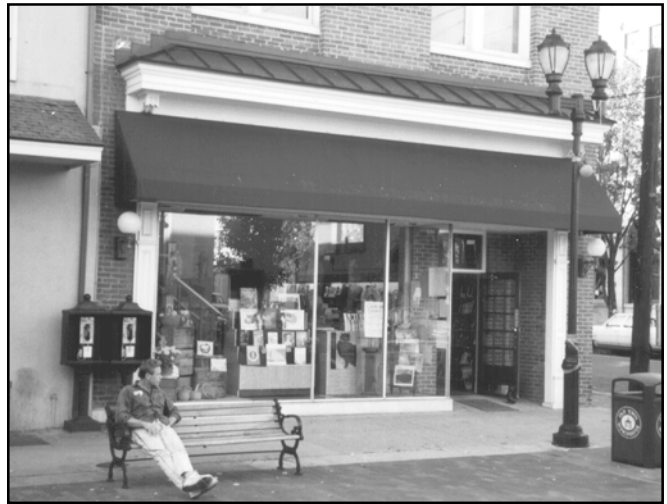
Revised solution matches historic awning shape and material.

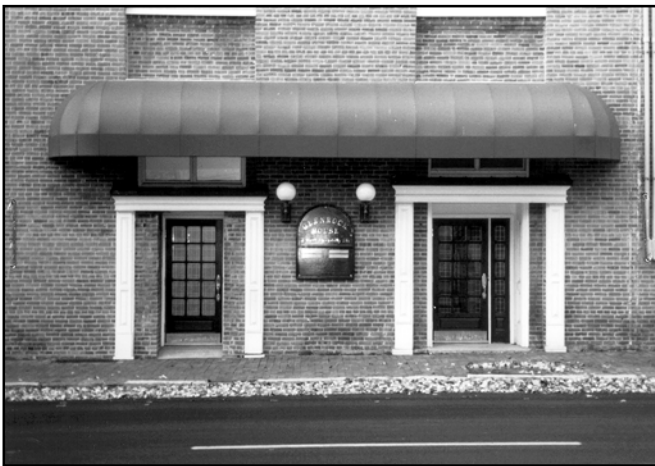
Application 2 (*Incompatible treatment corrected to meet the Standards*): The same rehabilitation project converted two doors on the side of the building to main entrances for upper floor tenant space. A long dome awning, like that used on the front of the building, was installed over the two doors and decorative wood surrounds were applied on the sides of both entrances. The awning was not a traditional style that would have been used historically, nor would a single awning have been placed over two separate entrances. The new surrounds were also not based upon historic documentation. These two treatments were incompatible with the historic character of the building. Together they gave this secondary facade a prominence it never had.

Side entrances with single continuous awning.

In order to meet the **Secretary's Standards**, the surrounds were removed and the long dome awning was replaced by two individual awnings. The revised treatment was more in keeping with traditional awning arrangement, shape and material. This approach identified the entrances but did not group them into a single arrangement that was contrary to the building's historic design and appearance.

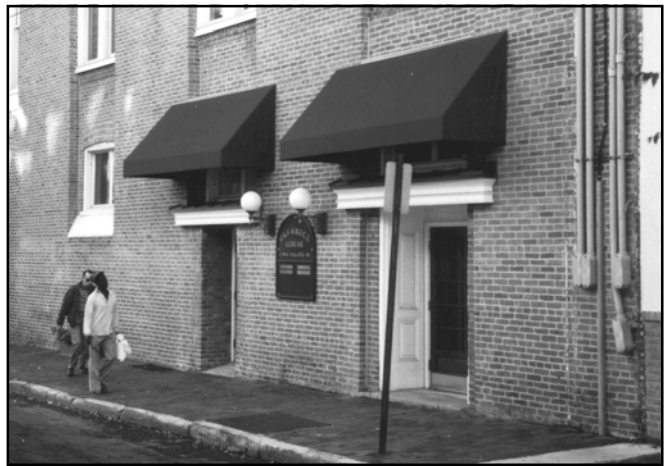
Revised treatment with a shed awning over each entrance.
