# ITS NUMBER 4

## Interpreting The Secretary of the Interior's Standards for Rehabilitation

### Subject: Inappropriate Replacement Doors

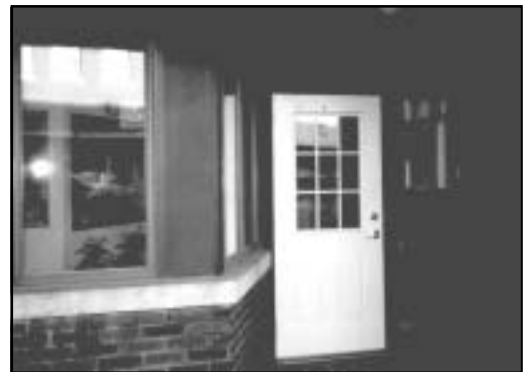
Incompatible "stock" door.

The storefront windows were replaced with simple, contemporary windows with dark-colored frames that were compatible with the historic building. But the "stock" white entrance door with its nine-pane glass and snap-in muntins above two vertical panels was not compatible with the historic building. In order to bring the project into compliance with the Standards, remedial work involved replacing the stock door with a simple glazed wood door that was compatible in both design and color with the historic building.

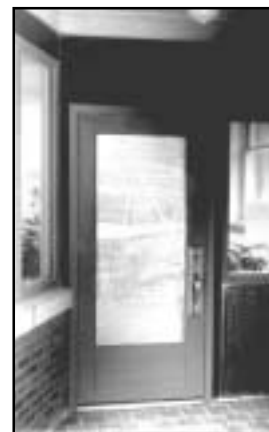
Appropriate replacement door.

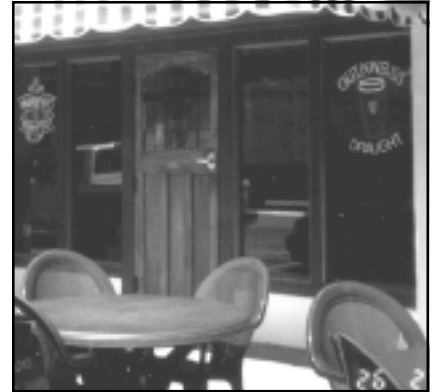
**Application 2** (*Incompatible treatment, later corrected to meet the Standards*): Another two-story vernacular masonry commercial building, also dating from the 1920s, that features three, one-bay storefronts on the first floor was rehabilitated for continued use as a restaurant and bar with rental apartments on the second floor. The original, historic storefronts had been replaced in the 1950s with aluminum frame windows and doors. Although, the Standards would also have allowed these later storefronts to be retained in the rehabilitation, the owner chose to install a new wood storefront with a simple, contemporary design, compatible with the building's historic character. However, the replacement wood doors had large stained glass windows and three vertical panels below, and

were found to be inconsistent with both the plain character of the 1920s facade and with the replacement storefront. To meet the Standards, the owner replaced the doors with a simpler wood door with full length glass panel like the one shown in the accompanying sketch.

*Rehabilitated storefront with incompatible stained glass door.*

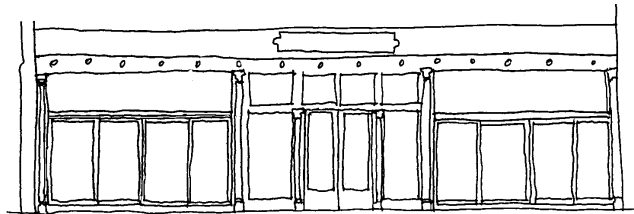
ELEVATION

*Suggested design for compatible, contemporary replacement door.*

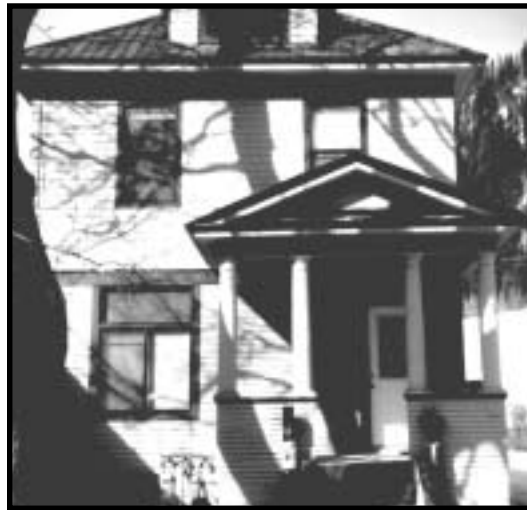
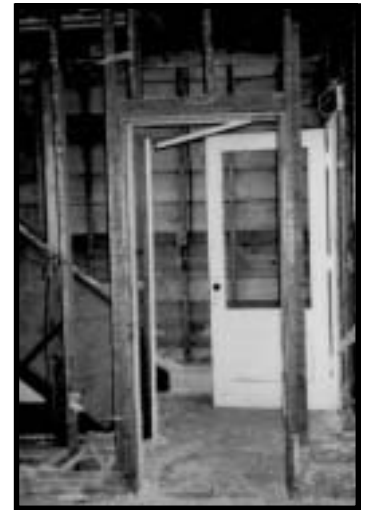
**Application 3** (*Incompatible treatment*): In a third project, a two and one-half story Foursquare house with Colonial Revival-style details built in the first decade of the 20th century was rehabilitated for continued residential use. Although most of the interior finishes and features, including all lath and plaster, had been removed by a previous owner, the original front door still remained. In the course of the rehabilitation, however, this historic door was replaced with a new door featuring multi-paned glass with two vertical panels below, the same “stock” door, in fact, that was used in the dairy conversion project. This multi-paned door is no more compatible with the character of this early-20th century house, than it was with the 1920s dairy building. To meet the Standards, the owner would have had to have a new door fabricated based on photographs of the original to match the historic door which had been discarded in the rehabilitation. A compatible, contemporary door could also have been installed to meet the Standards.

In general, generic or “stock” doors with multi-paned glass, are not appropriate to use as exterior replacement doors in historic rehabilitation projects.

*Rehabilitated Foursquare house with inappropriate “stock” door (left) and no longer extant historic door (right) that was discarded in the rehabilitation.*
