Propeller Scarring of Seagrass in Florida Bay

South Florida Natural Resources Center
Everglades National Park

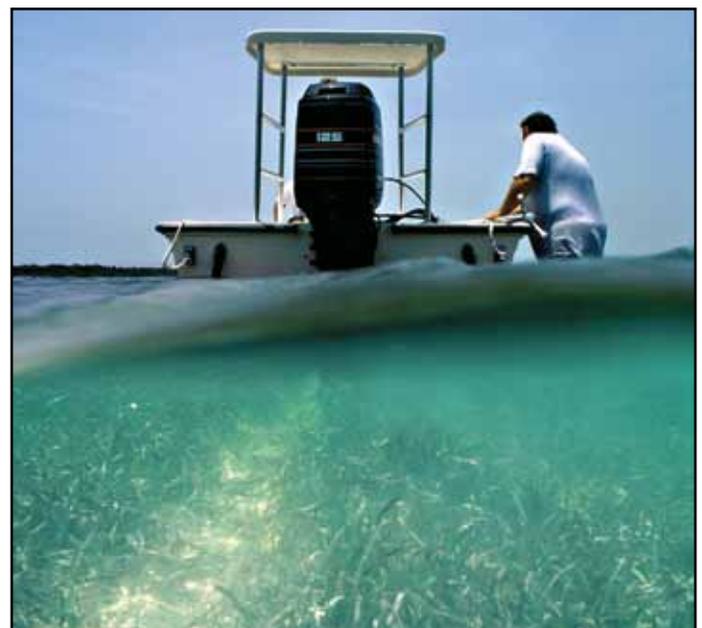
Propeller scar from boat. Photo by Brett Seymour, NPS

Upper Photo: Scars surrounding the north end of Lower Arsnicker Key
Photo by Lori Oberhofer, ENP

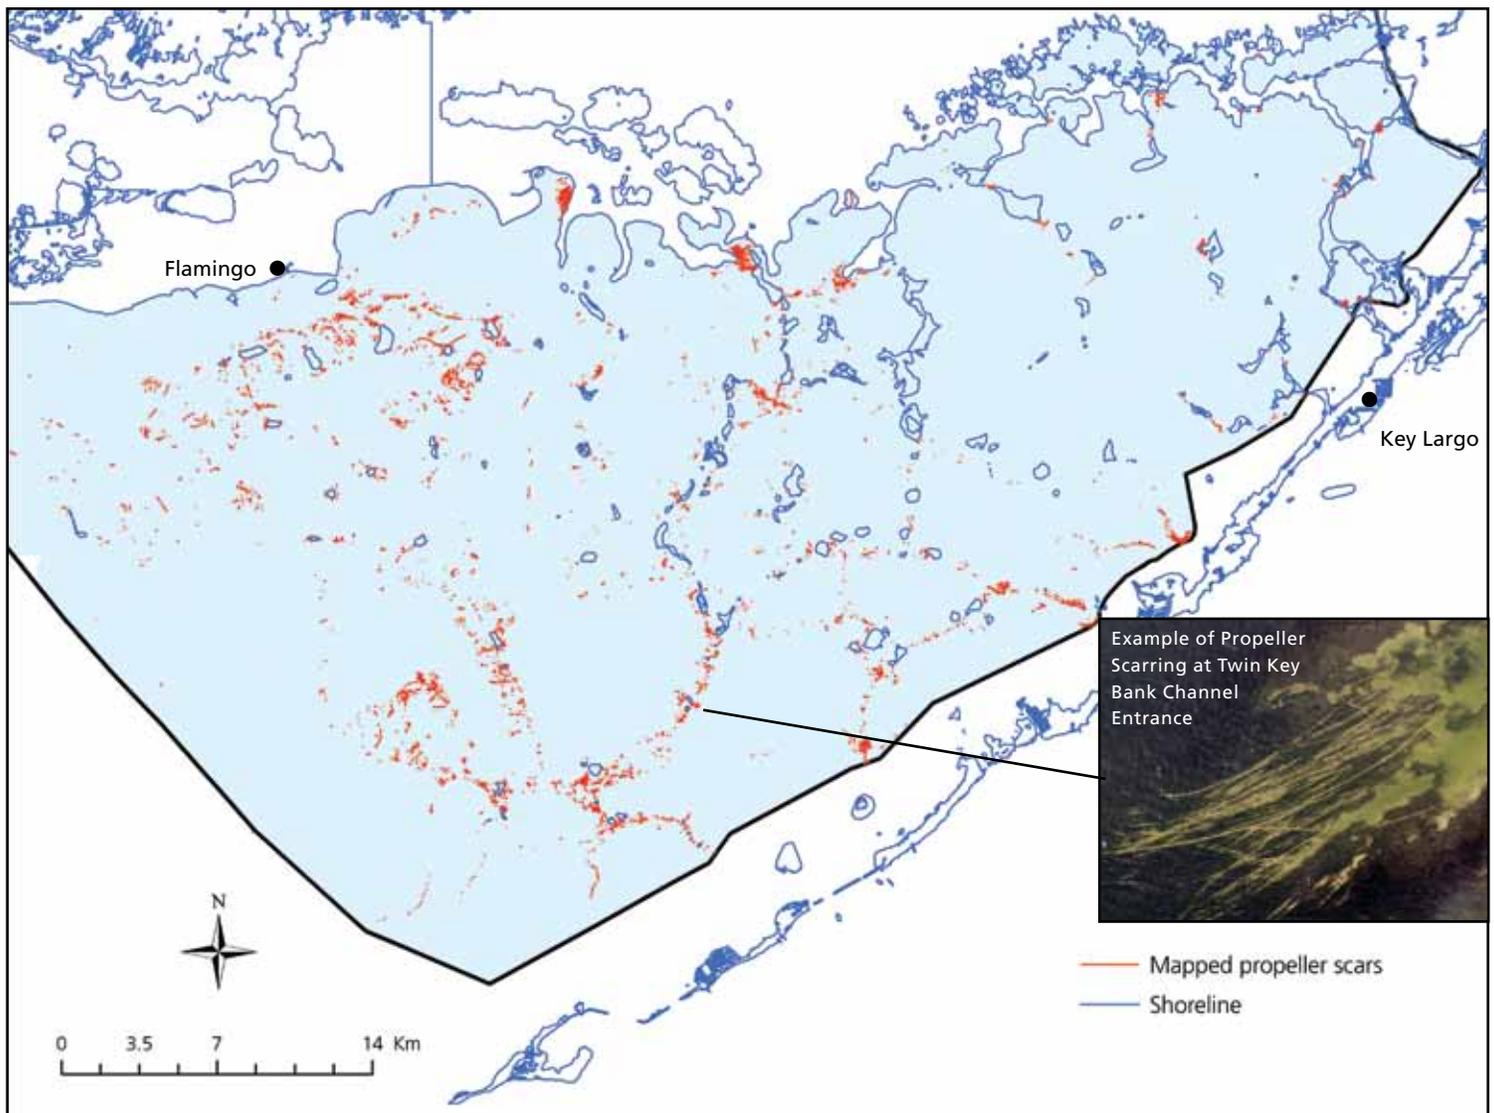
- Seagrass scarring in Florida Bay is widespread with dense scarring found in shallow depths, near all navigational channels, and around areas most heavily used by boaters.

Overview of propeller scarring in Florida Bay, Everglades National Park.

- Because scarring may be increasing over time, new management strategies are warranted to protect submerged wilderness resources and reduce stressors as part of an overall approach to ecosystem management in Florida Bay.

- An adaptive approach, initially focused on the most heavily scarred areas, should consider monitoring scarring at specific indicator sites in response to a variety of management techniques including new education, signage, and enforcement efforts; and boating restrictions, such as pole/troll zones.
