Breezy Point Surf Club

## 1. System Summary

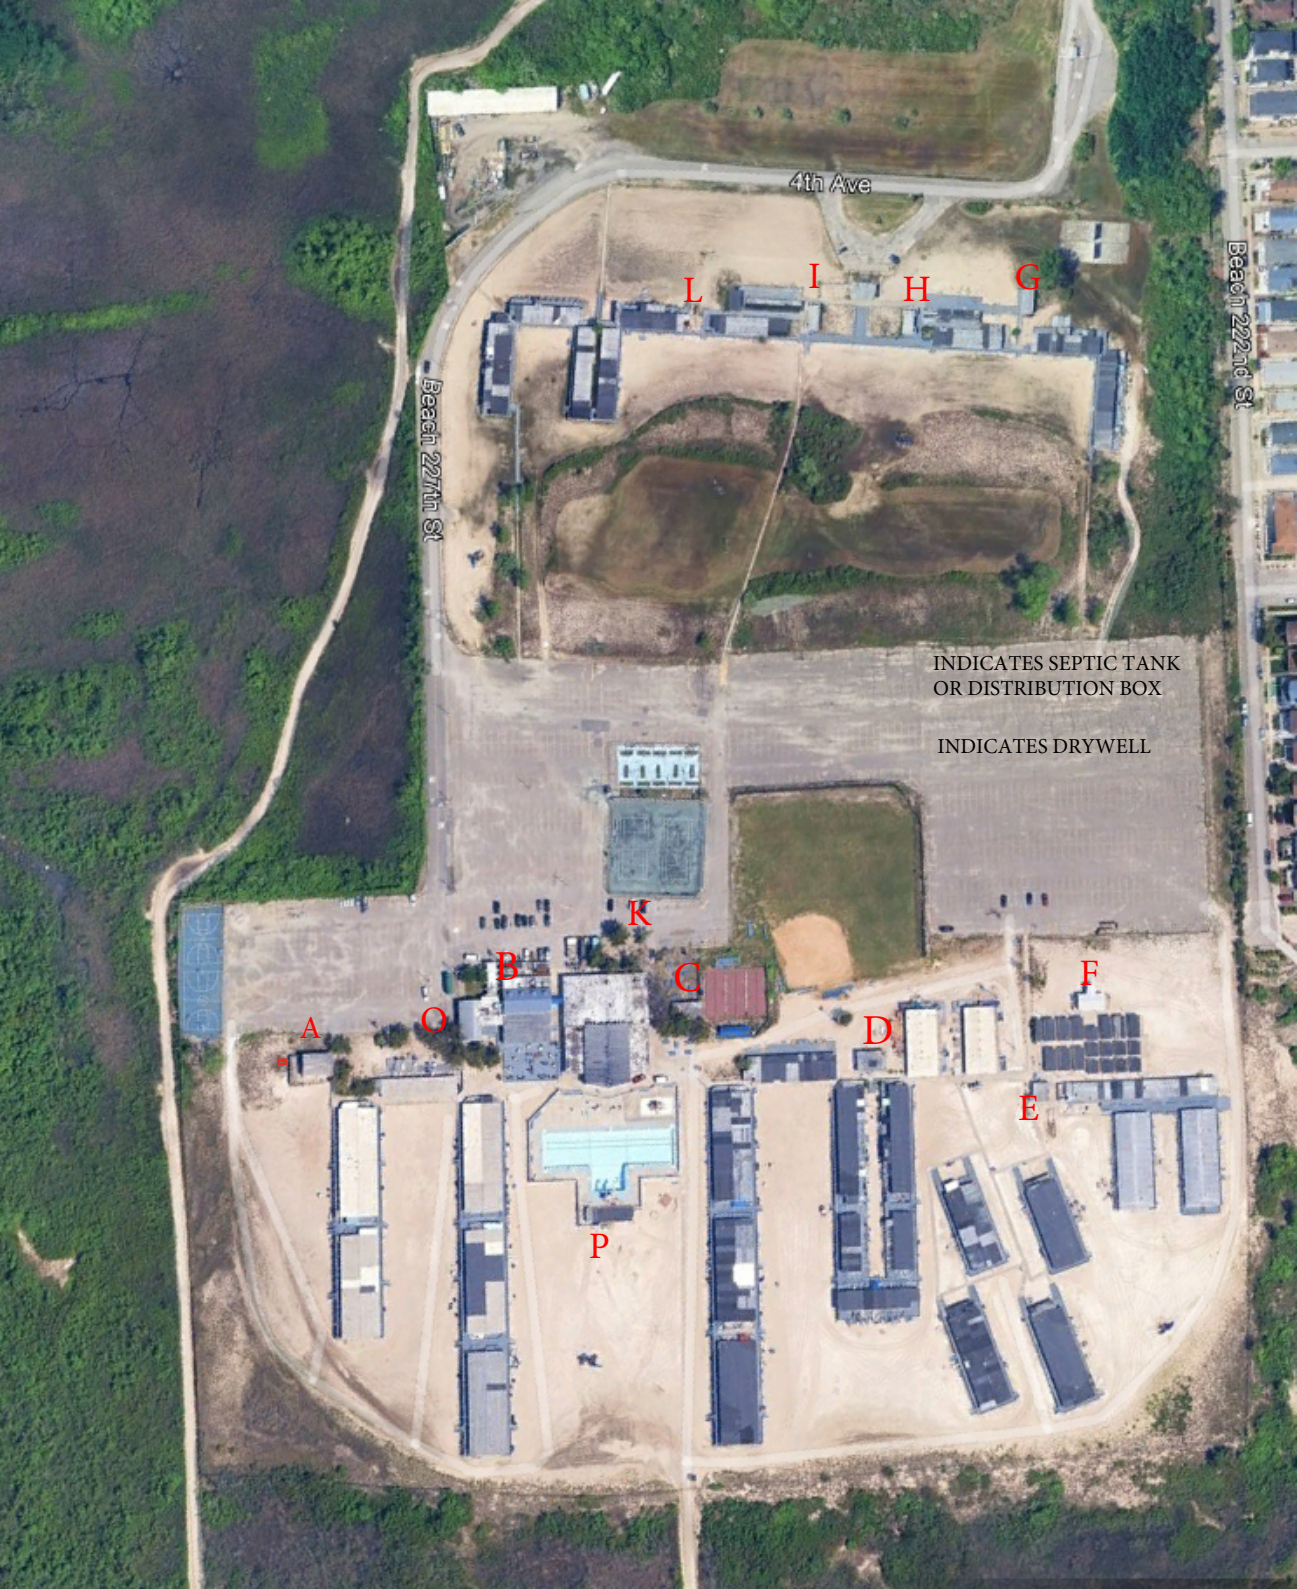
Several abandoned drywells, and likely abandoned septic tanks, are located throughout the property.

The exact number, location, and condition of these structures are not fully documented and should be verified through field investigation.
