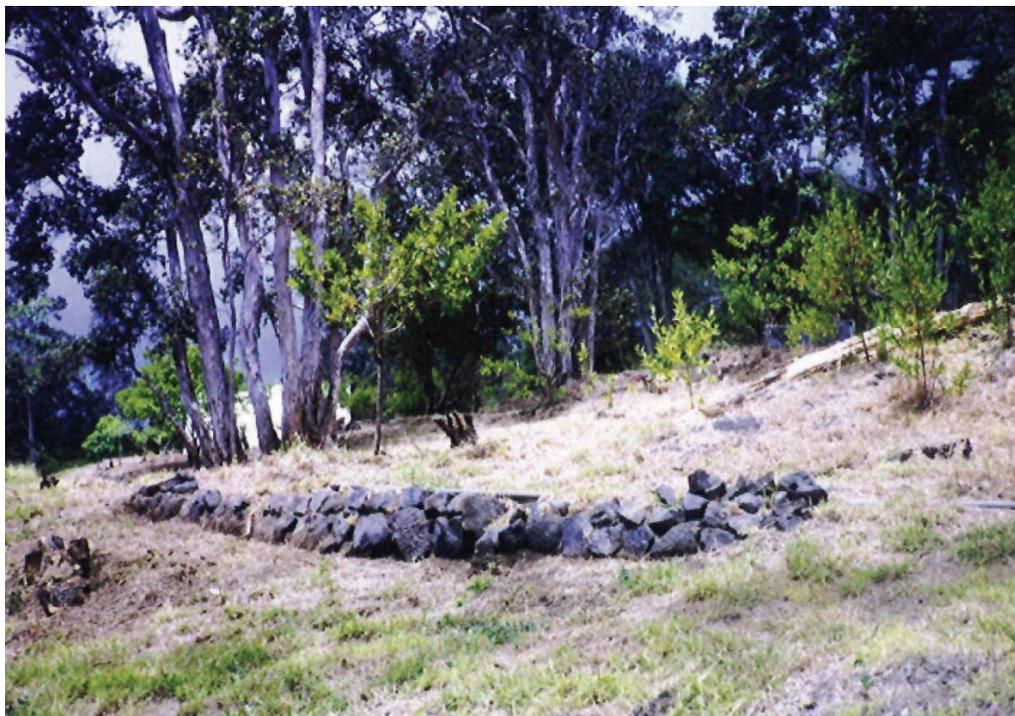
Two stretches of a dry-laid retaining wall run from the nursery area towards the ranch house (see Buildings and Structures map in Appendix). The first stretch of the retaining wall is 24' long and 1' wide. The height of the wall ranges from 6" to 16". The second stretch of wall (the one that is closer to the ranch house) runs 49' long and has the same width and height as the first wall (see photo, Buildings and Structures # 6). Although the construction date of these walls is unknown, they should be considered to be contributing features until further research can be completed.

Buildings and Structures # 6: A dry-laid lava rock retaining wall located between the nursery area and the ranch house (PWR, HAVO, CLI files, 2003).

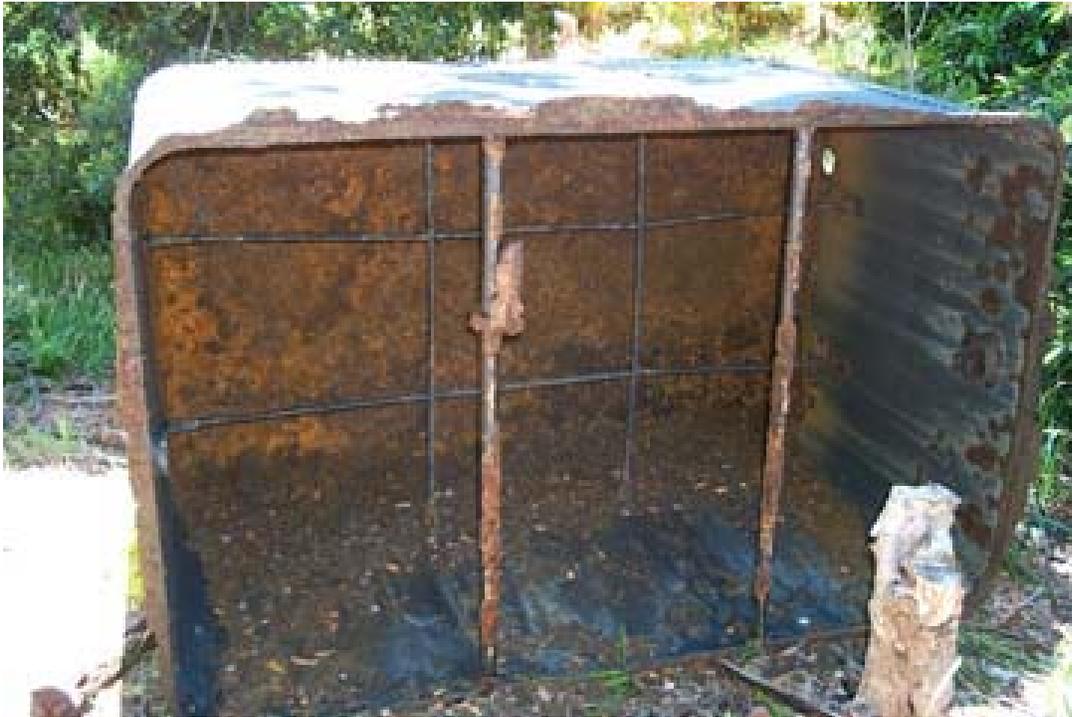
The functions of three other rusted metal containers in the vicinity of the 33,000 gallon redwood tank and the generator shed foundation are poorly understood. It is possible that they may have been associated with water storage before the water system was fully developed. It is also possible that they may have contained fuel for the generator or even grain for Shipman's livestock. One tank is rectangular, containing cross-bars within (see photo, Buildings and Structures # 7). Another feature is short and cylindrical with a removable lid (see photo, Buildings and Structures # 8). The last feature is rusted beyond recognition, but has apparently fallen off of a small, mortared rock foundation bearing the inscription "Peter" with an illegible date (probably 1941). These features should be considered contributing until more research regarding their functions can be completed.

Buildings and Structures # 7: A rusty metal container near the generator shed foundation. Historical function unknown (PWR, HAVO, CLI files, 2003).

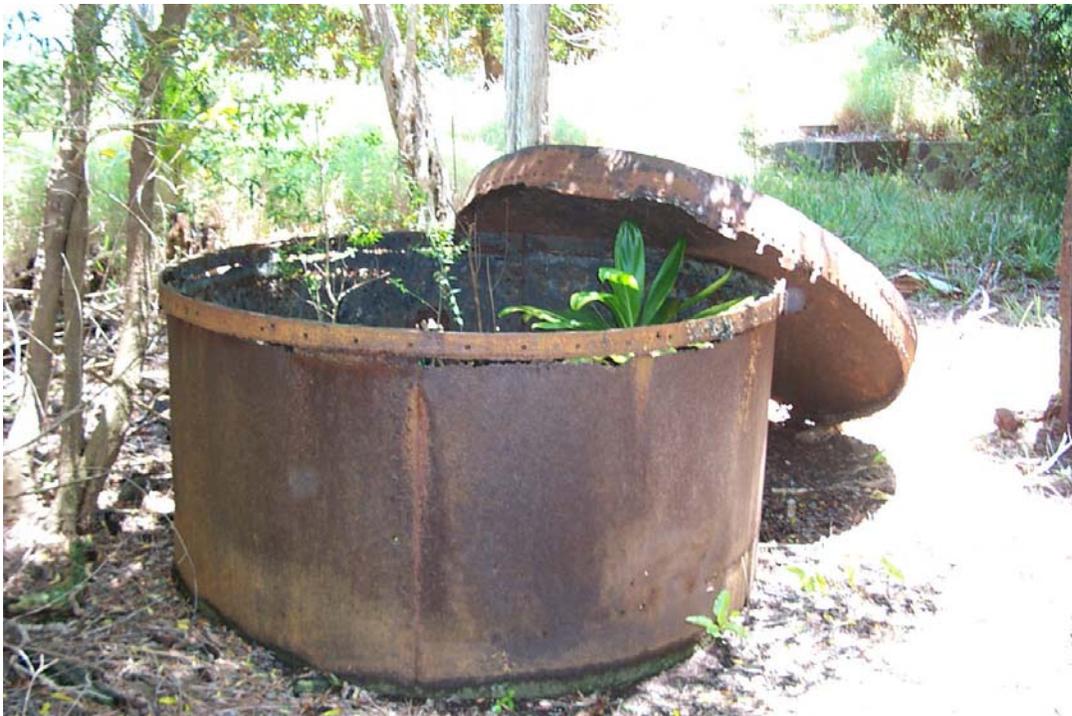
Buildings and Structures # 8: A rusty metal container w/ lid near the generator shed foundation. Historical function unknown (PWR, HAVO, CLI files, 2003).

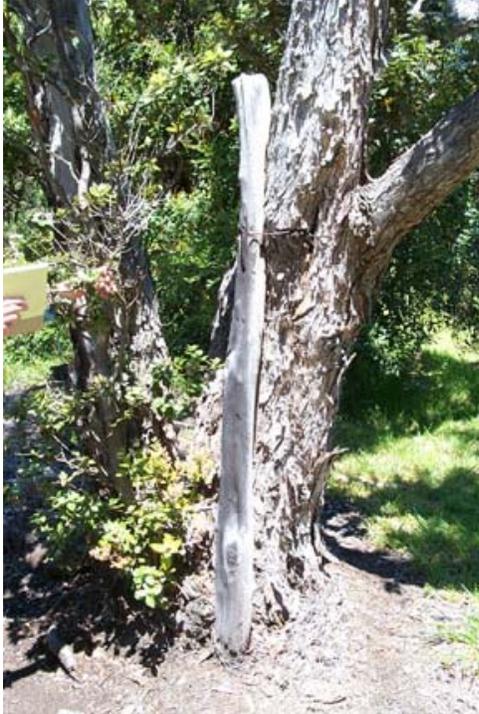
Small-scale features consist of fence-posts associated with cattle fences in the component landscape. These fences have been removed, but evidence of their spatial arrangement and construction techniques is found in the remaining features (see photos, Small-Scale Features # 1 & # 2). In some cases the features amount to little more than a few pieces of rusting wire attached to a living 'ohi'a tree. In other cases there is an 'ohi'a log attached to either side of a tree in a manner that would allow considerable tension to be applied without killing the tree. The locations of trees that display evidence of being used as a fence post are shown on the Site Plan (see Supplemental Information). Only a few specimens exhibit the 'ohi'a log attachments. It is not known whether such attachments were included on all trees that were used as posts. However, considering the extensive removal and deterioration of fences, it is likely that many may have been removed or fallen off after their bindings corroded.

Small-Scale Features # 1: Remnant fence post displaying use of live 'ohi'a trees (PWR, HAVO, CLI files, 2003).

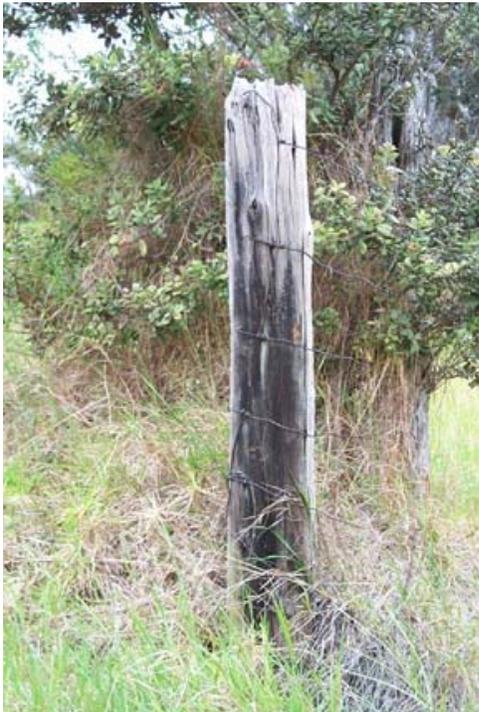
Small-Scale Features # 2: Remnant conventional-type 'ohi'a fence post (PWR, HAVO, CLI files, 2003).
