RESTORATION OF UNDESIGNATED VEHICLE ROUTES (UVRs)

Department of Interior Lands in Western Pima County, Arizona Bureau of Land Management Ajo Block (BLM) Cabeza Prieta National Wildlife Refuge (CPNWR) Organ Pipe Cactus National Monument (OPCNM)

FINAL PROGRESS REPORT

REPORTING PERIOD: June 8 – June 26, 2015

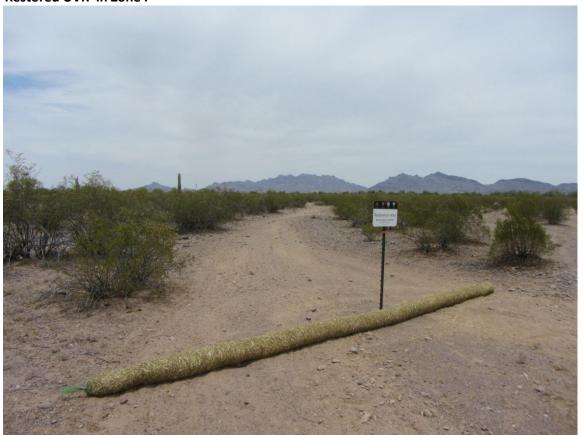
SOVA-2014-0002AE_010_20150512 - Post mechanical treatment

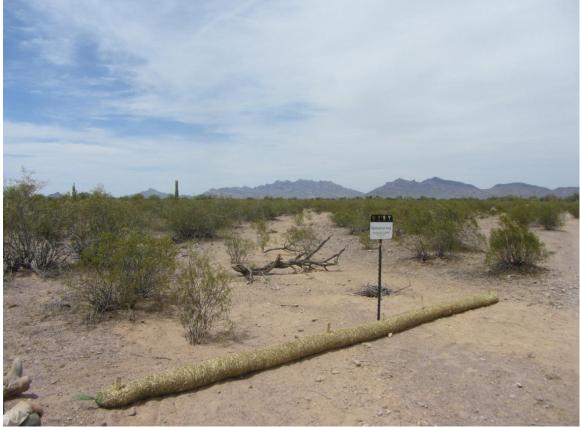
SOVA-2014-0002AE_010_20150512 - Post vertical and horizontal mulching
