Dry Tortugas Light Station

Keeper's Residence Historic Structure Report

by Lord, Aeck & Sargent Architecture

2009

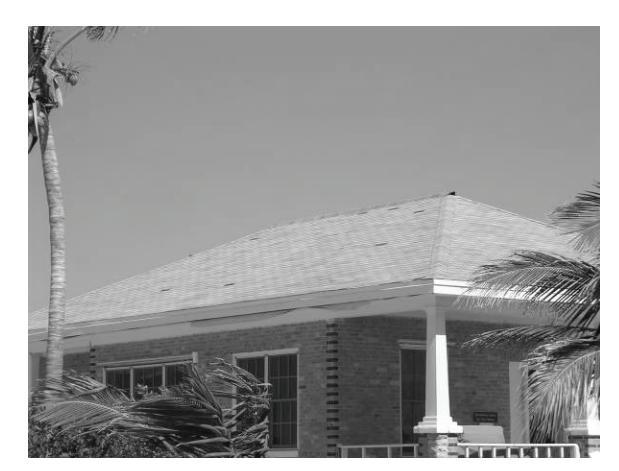
Figure 67: Torn and missing asphalt roofing shingles.

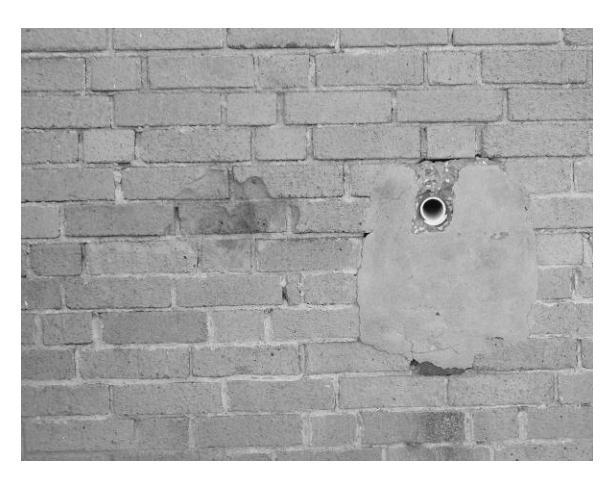
Figure 73: Erosion of mortar and brick spalling at north elevation.

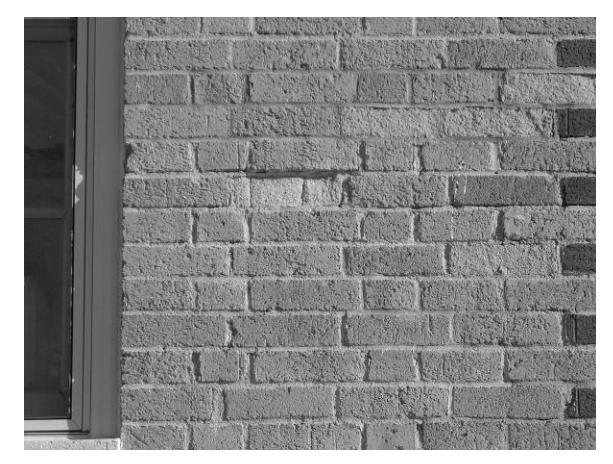
Figure 75: Spalling brick at west elevation.

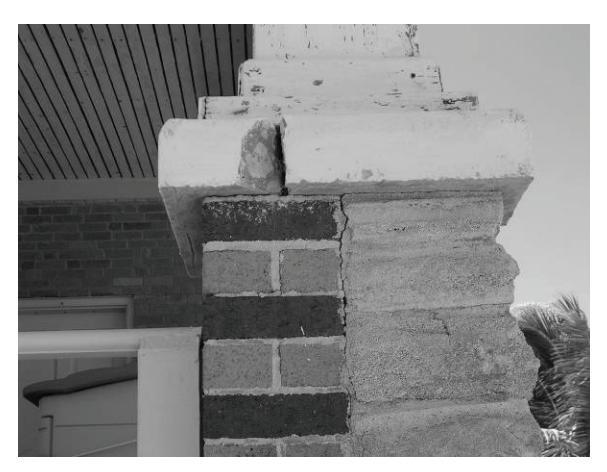
Figure 85: No. 3: Crack in the east side of plinth on the far right porch pier at east elevation.

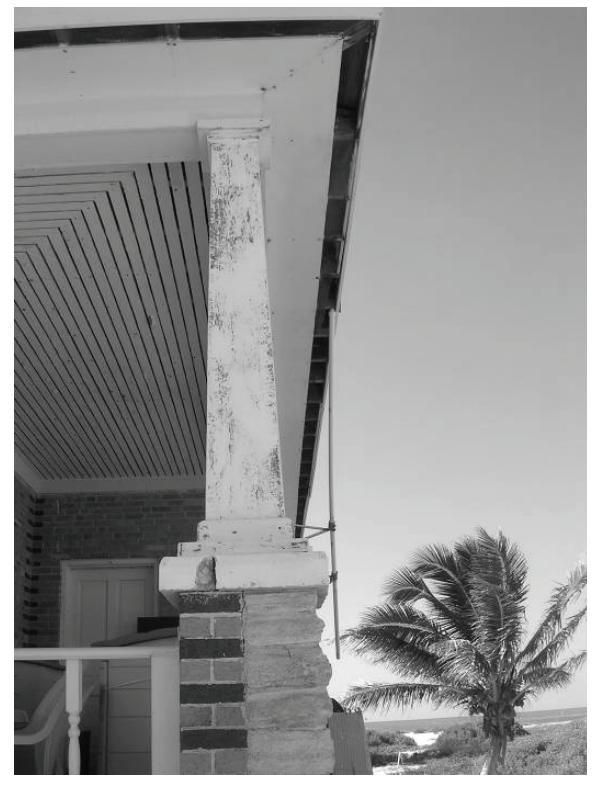
Figure 88: Weathered paint finish on the far right porch column at east elevation.

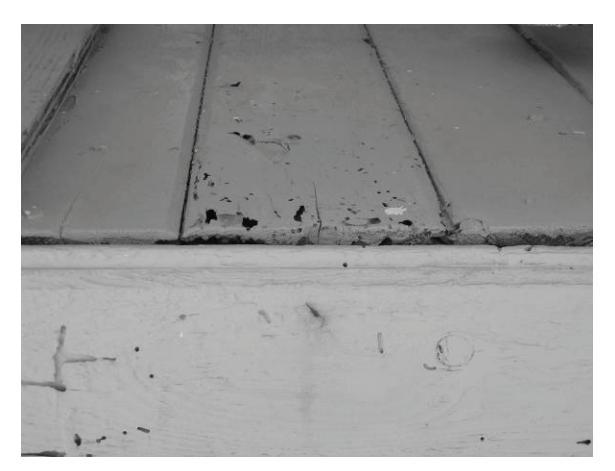
Figure 94. Rot damage to tongue and groove flooring of front porch.

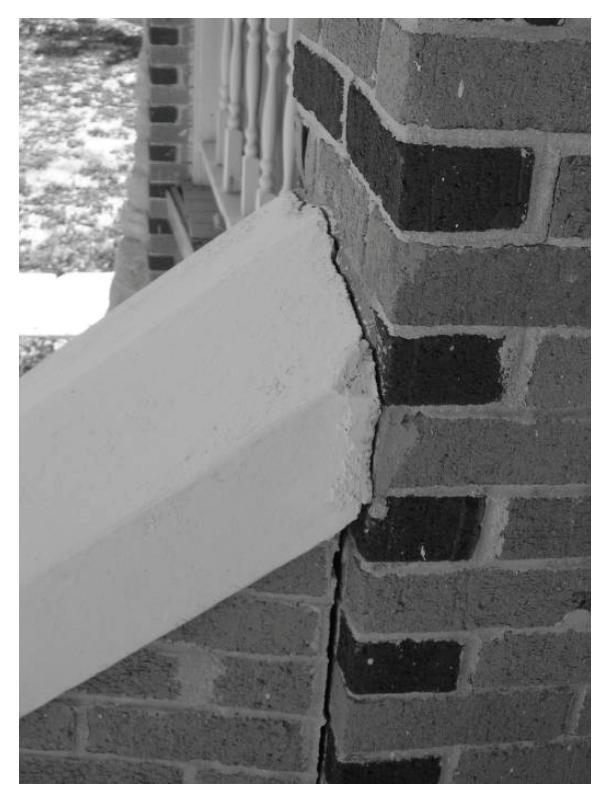
Figure 96: Separation of joint between cheek wall and pier at top of stairs.

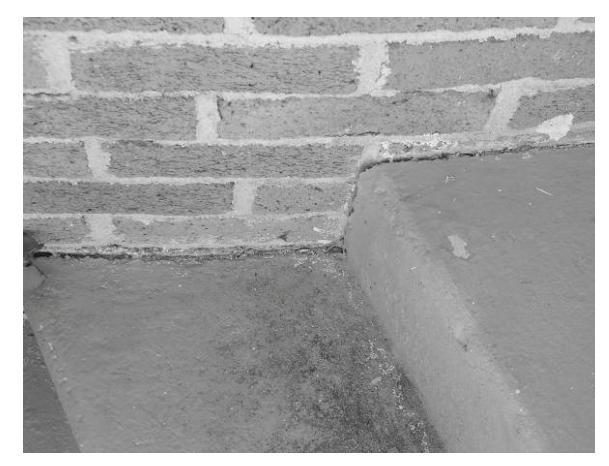
Figure 97: Separation of joint between stairs and cheek wall.

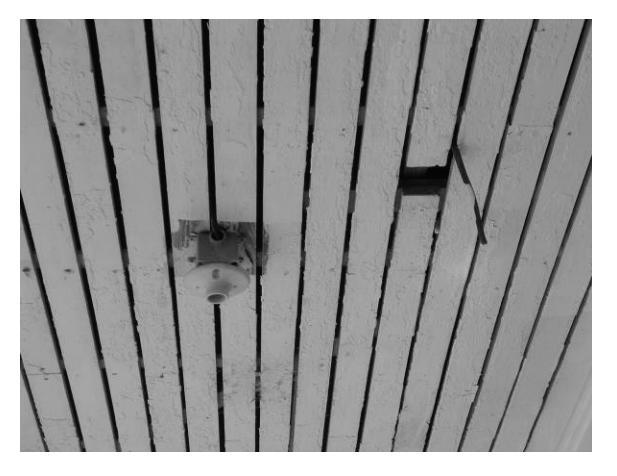
Figure 100: Deteriorating paint finish and rusted nail heads on side porch ceiling.

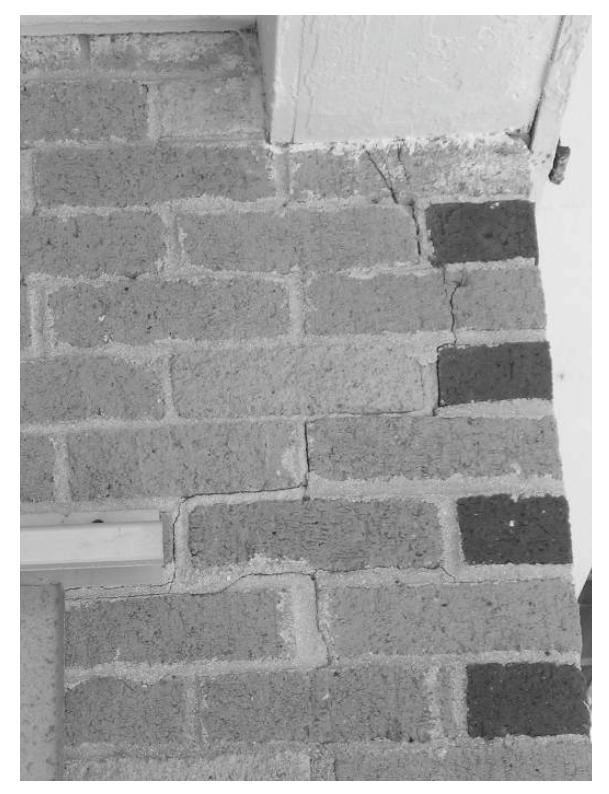
Figure 101: Hairline cracks in masonry joints at the northwest porch wall.

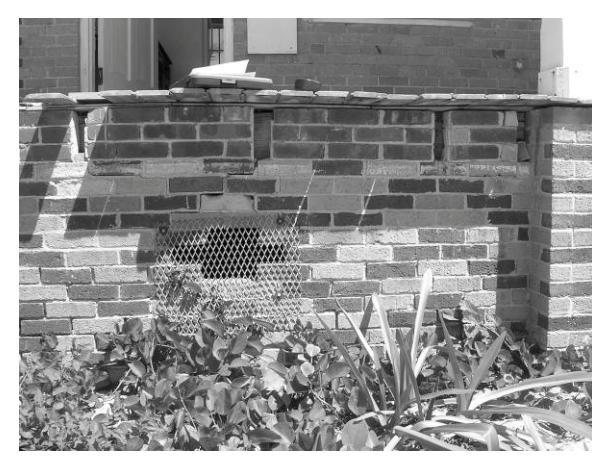
Figure 102: Eroded and cracked mortar joints in side porch foundation wall.

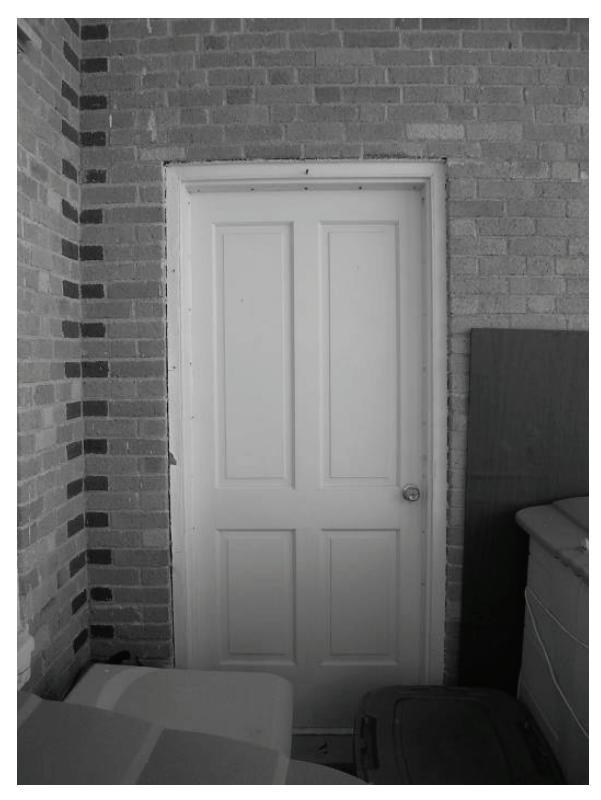
Figure 111: Non-historic door at side entrance on east elevation (D-2). National Park Service 67

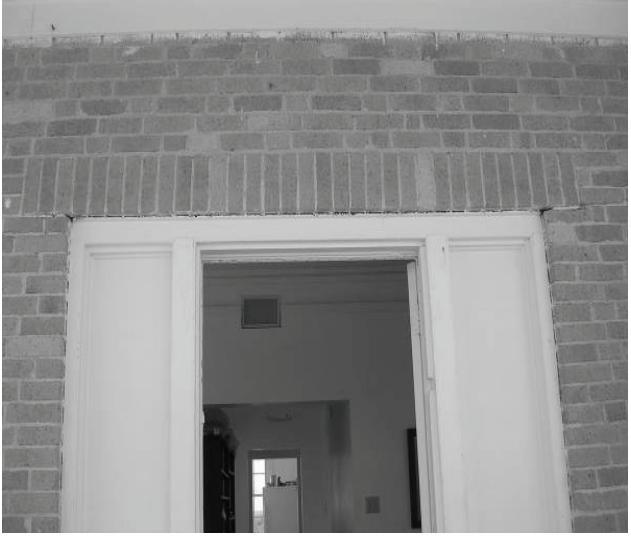
Figure 115: Steel lintel above primary door (D-1) exhibits minor corrosion.

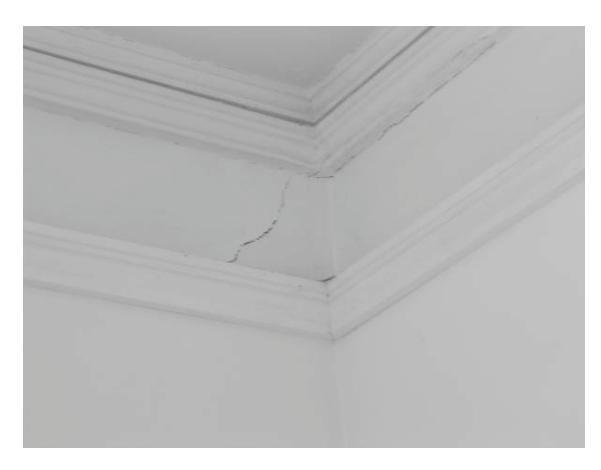
Figure 127: Hairline crack in the plaster wall at the east corner in living room.

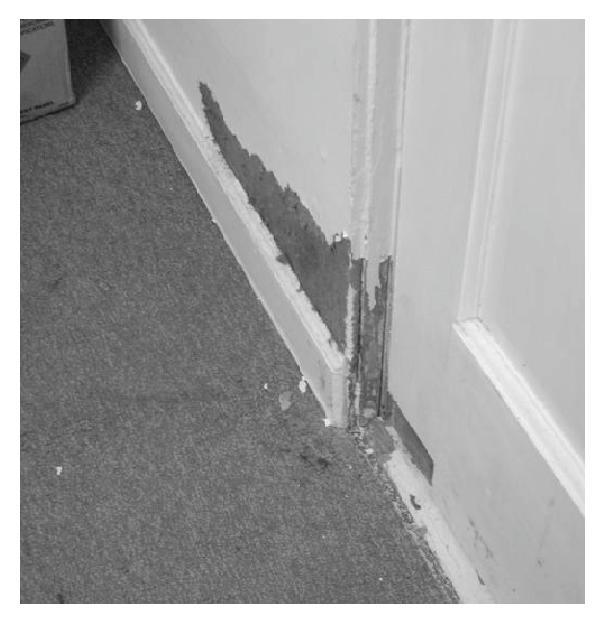
Figure 134: Torn gypsum wall board at the southeast wall.

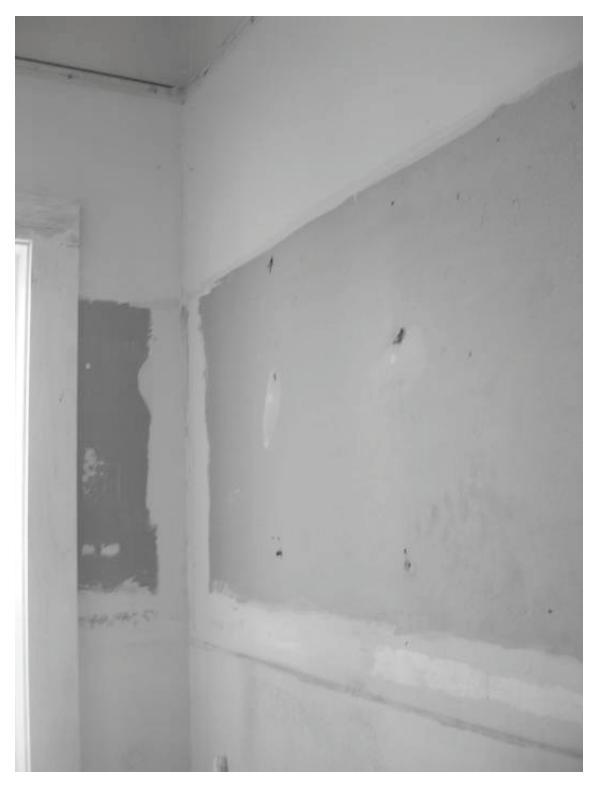
Figure 136: Gouges and holes in the gypsum wall board in the Laundry Room.

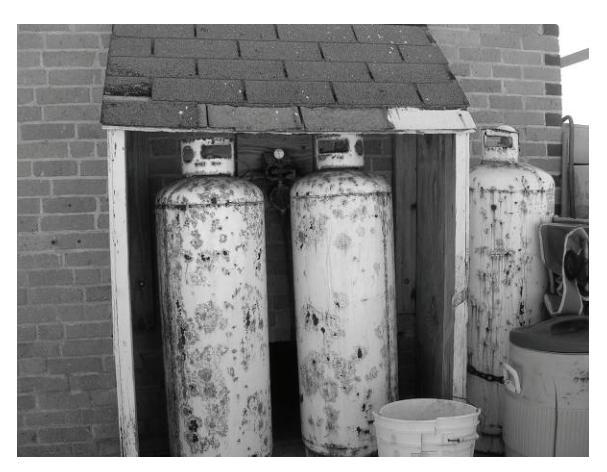
Figure 147: Propane tanks exhibit rust and corrosion.

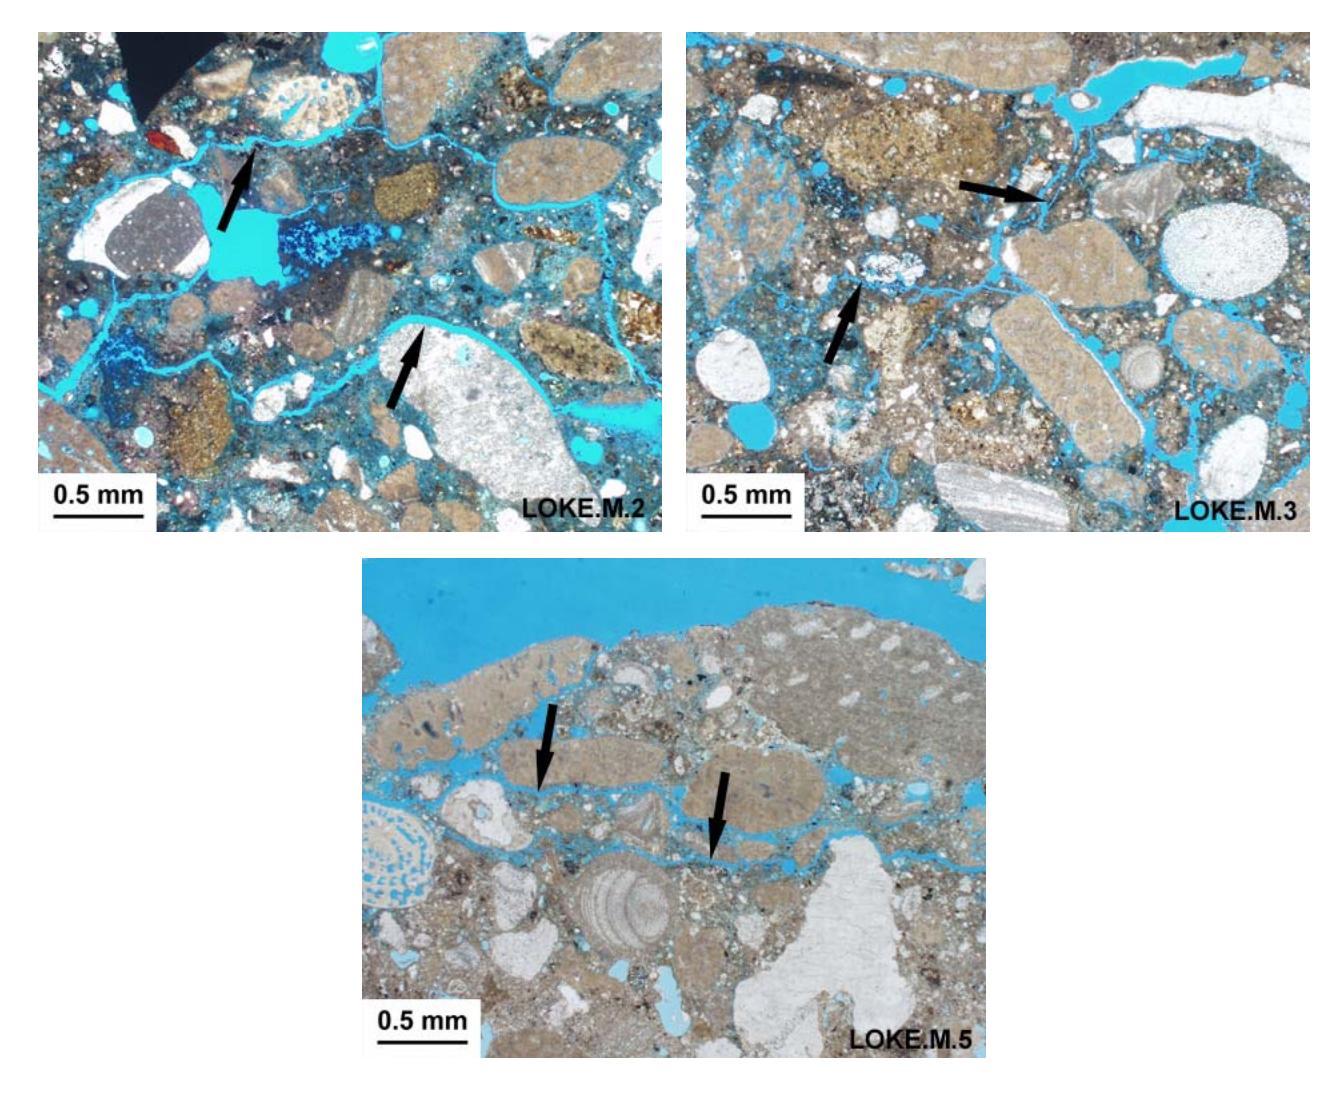
Figure 25: PPL photomicrographs illustrating microcracks in the cistern samples and one of the Lighthouse samples (arrows). These are minor and no sample in the examined suite exhibits any significant cracking distress.

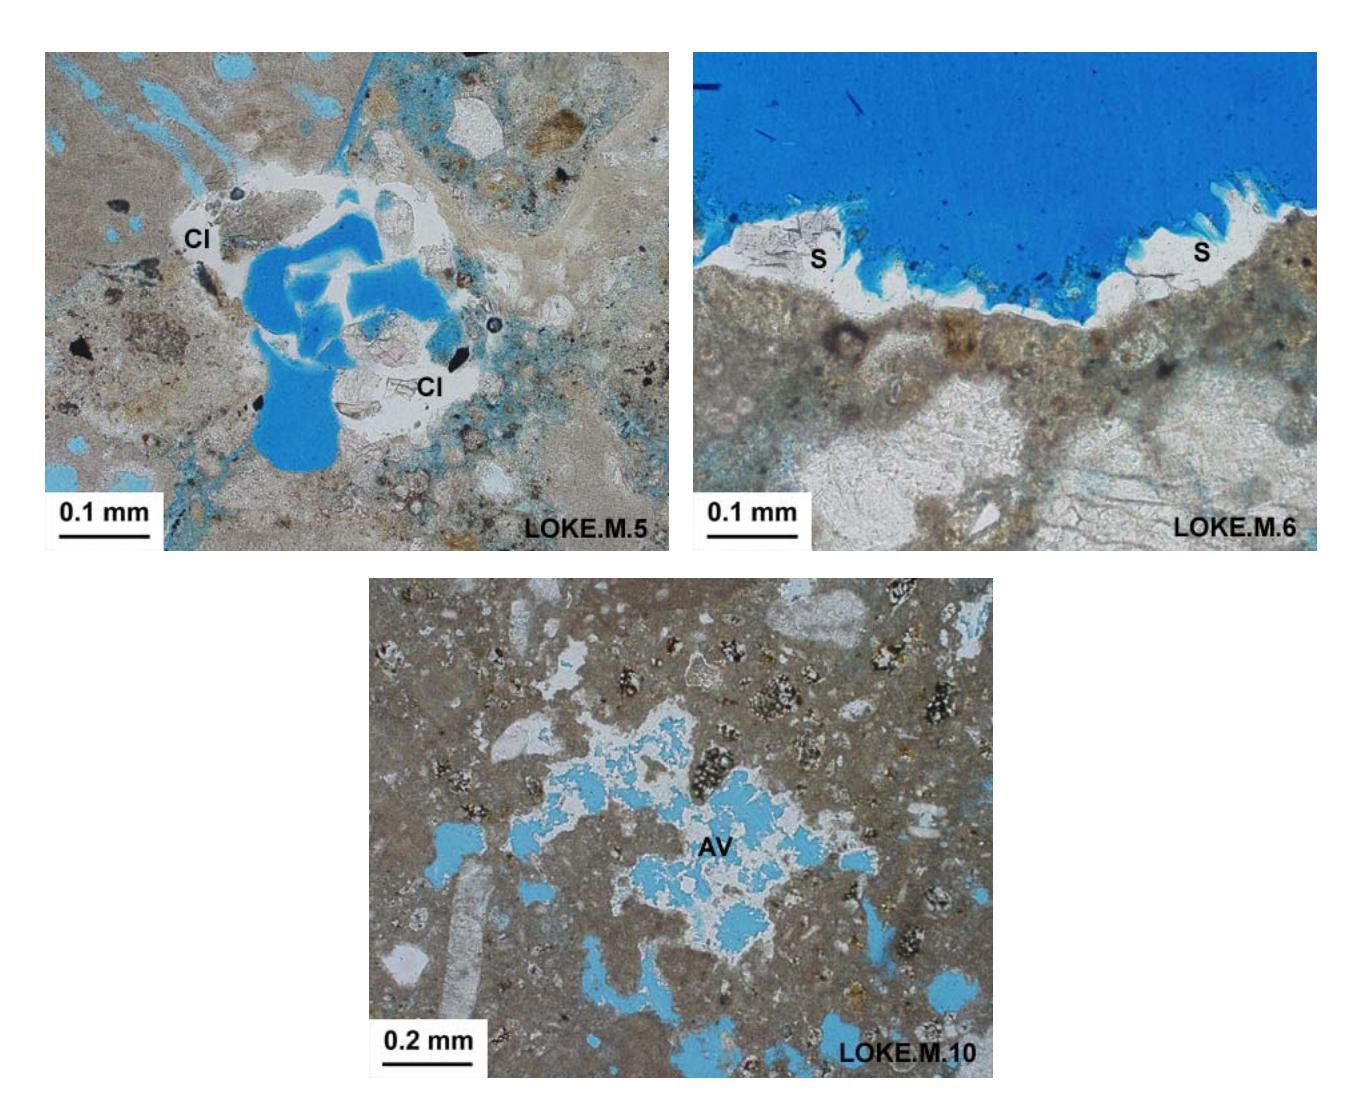
Figure 26: PPL photomicrographs illustrating the few secondary chemical deposits detected petrographically in the examined sample suite. No visible distress is associated with any of these deposits. (Top left) Isotropic mineral deposits consistent with chlorides (Cl) are found in low abundance in samples LOKE.M.5 and LOKE.M.6. (Top right) Fine secondary deposits consistent with sulfates (S) are quite rare. (Bottom) Some air-voids in the portland cement mortar of sample LOKE.M.10 contain linings of secondary gypsum but again, no associated distress is noted.
APPENDIX C.
