Sara JK Hansen
Biological Science Technician
Vegetation Management
Crater Lake National Park

September 2, 2013

Rim Village Cable Reroute Report

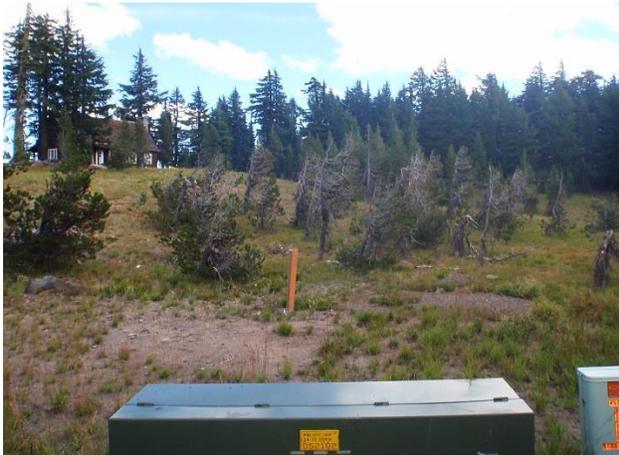
Current conditions: This section is very well vegetated, with no noticeable barren path along the route. Total vegetation cover for the section is 70% on average, except for two large bare patches filled with gravel just east of the cable box. Dominant vegetation in this section includes *Carex sp.*, *Phlox diffusa*, *Ericameria greenii*, and *Boechnera howellii*.

Figure 1. View toward Community House to the NE from start of cable reroute.

Secondary challenges include bare areas persisting at the beginning of Section 1 and the beginning of Section 2. The bare patch in Section 1 (Figure 1) is currently filled with gravel and will likely not revegetate naturally without removal of the gravel. Recommendations for this site include removal of the gravel and reseeding. This area is more an eyesore than anything because it is located directly across from the Rim Café and is visible to visitors walking from the Café and parking area to the caldera rim. The other bare patch that warrants attention is the area in Section 2 (Figure 5). This area, as noted in both 2009 and 2011, continues to be a heavily used shortcut between the Community House. Natural revegetation of the impacted area is unlikely without direct intervention and would require extended use of barricades to provide adequate protection for any meaningful revegetation to occur. However, remediation efforts might be more efficient if initiated after the Rim Drive Rehabilitation project, expected to commence in 2015, is completed. During the Rim Drive Rehab, a temporary road is expected to be constructed in the direct vicinity of this area and will result in further disturbance to the area of interest.

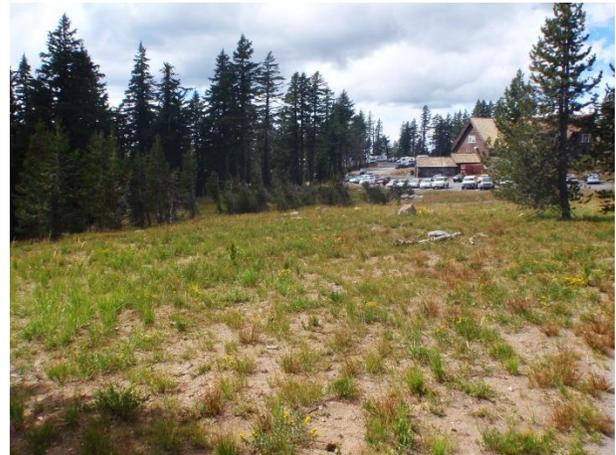
Figure 2. View from SE corner of Community House toward Rim Café.

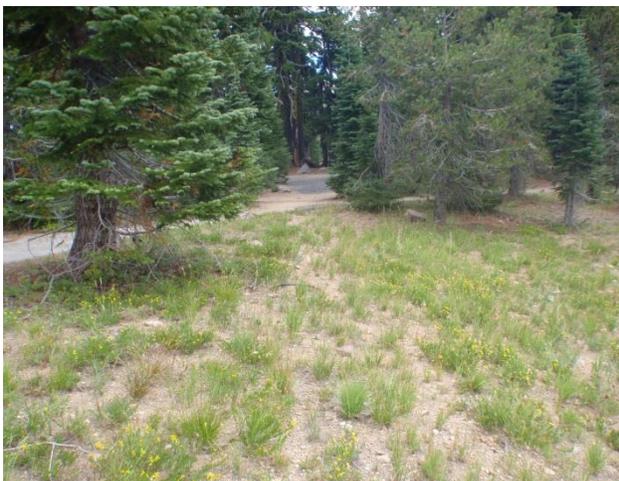
Figure 3. View from SE corner of Community House toward picnic area.

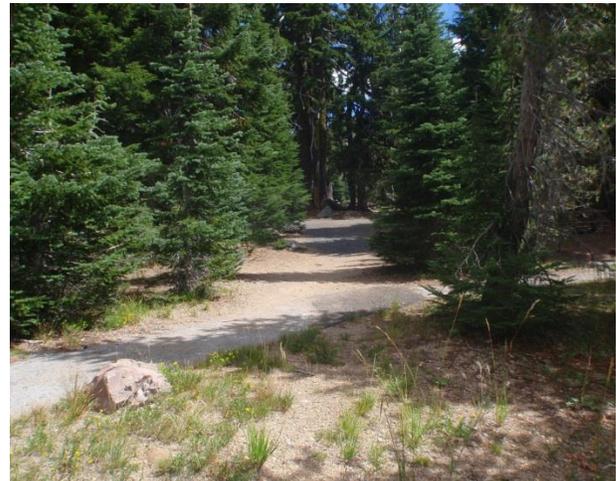
Figure 4. Sparse but increasing vegetation at end of Section 1 near paved walkway.

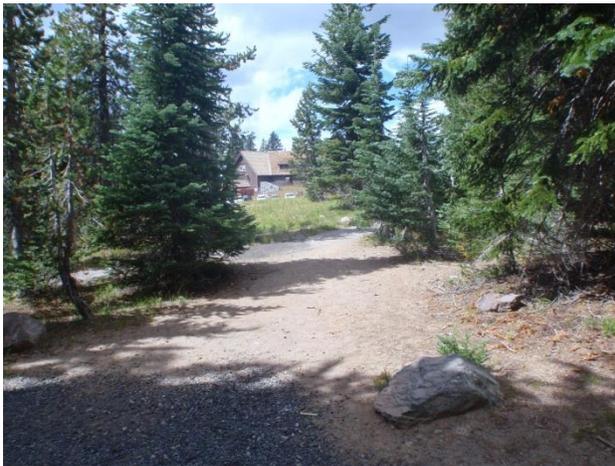
Current conditions: The start of Section 2 is unvegetated and still used as a footpath between the community house and the gravel picnic parking. There remains minimal vegetation near the large concrete vault, most likely due to the influence of *Tsuga mertensiana* trees. Overall, the majority of this section is almost completely revegetated (~85-90% cover) with the dominant species being *Carex sp.*, *Elymus elmoides*, *Elymus glaucus*, and *Veratrum viride*.

Figure 5. West facing view of Rim Café from start of Section 2 where the reroute path is now used as shortcut to the picnic area.

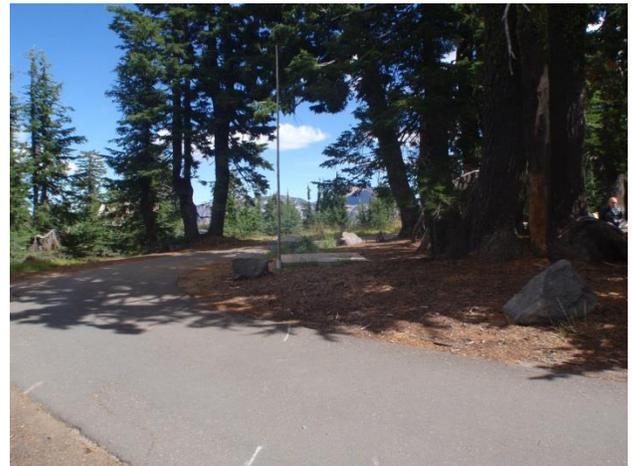
Figure 6. Reroute under picnic area road toward large concrete vault, continuing NE under roadway.

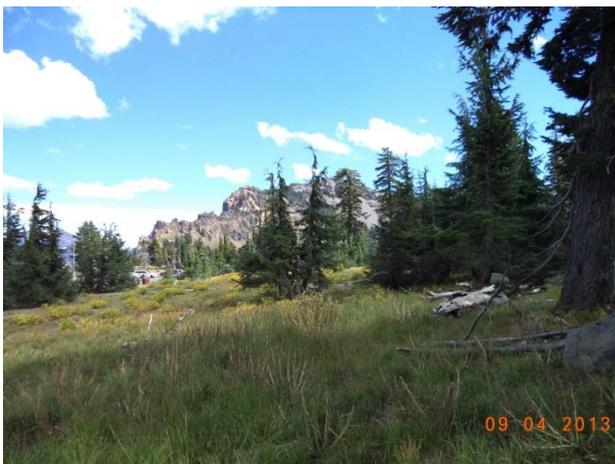
Figure 7. Abundant vegetation throughout middle of Section 2.

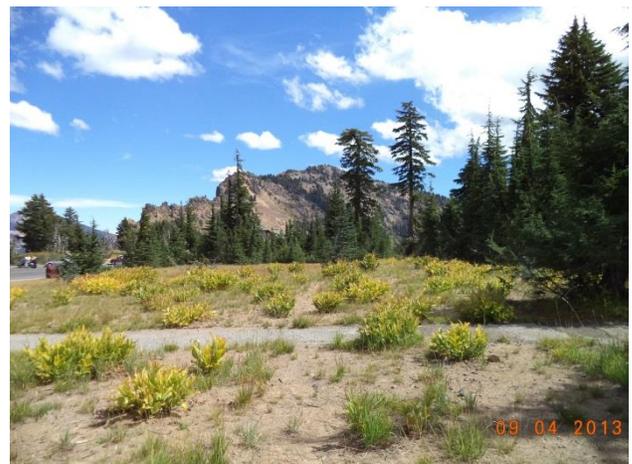
Figure 8. East facing view of paved pathway #2 where Section 2 ends and Section 3 begins.

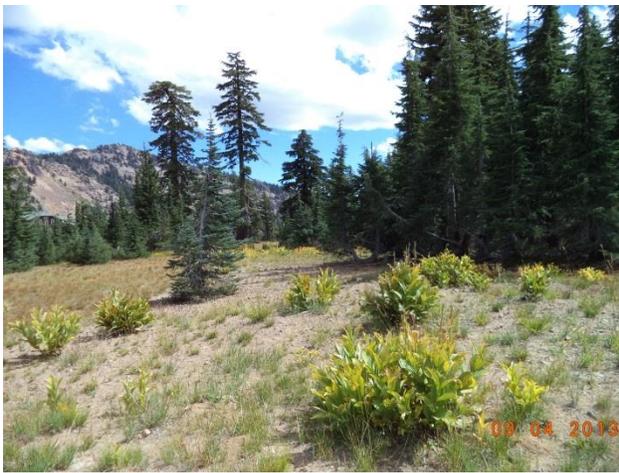
Current conditions: The large disturbed area noted in 2009 at the beginning of Section 3 has substantially improved and is now largely revegetated. Vegetation along the spur route to the tie-in box on Rim Drive is also increasing but does show signs of erosion (see recommendations section for more). Natural vegetation near the middle and end of this section is abundant and dominant species include *Carex sp.*, *Ericameria greenii*, *Elymus elmoides*, and *Achnatherum occidentale*. One young *Pinus contorta* and one young *Tsuga mertensiana* are now growing within the reroute area as well and total vegetation cover in Section 3 is ~60%.

Figure 9. Regrowth of vegetation at beginning of Section 3.

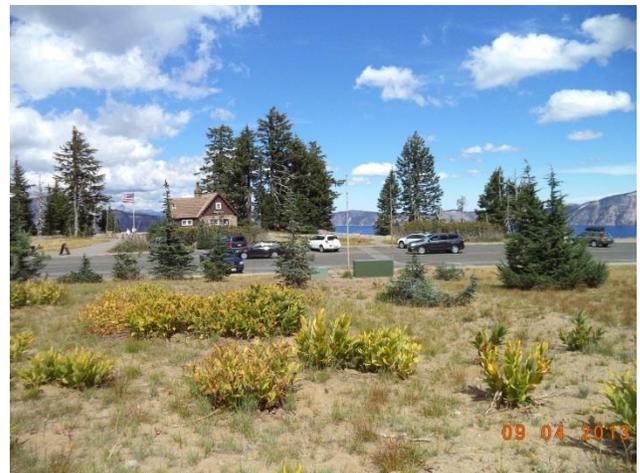
Figure 10a. North facing view of spur to green utility box near visitor center.

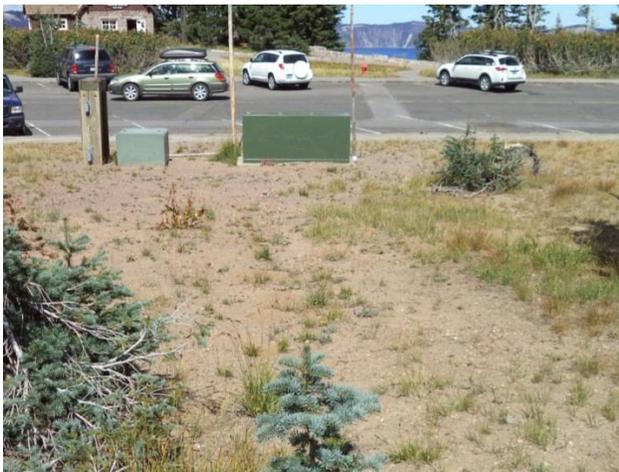
Figure 10b. North facing view of erosion beginning near green utility box.

The primary revegetation challenge is erosion, occurring at two locations. Recent, minor erosion is evident above the tie-in box along the spur in Section 3 (Figure 10b). While the area does have vegetation naturally taking hold, and there is a visible increase in cover since 2011, I recommend reseeding the length of the spur in the near future. This would require minimal effort and speed along dispersal of soil retaining vegetation, preventing further erosion and eliminating the issue entirely. More concerning is the marked, persistent erosion at the end of Section 5 (Figure 17). Though plants are colonizing the erosion gully in Section 5, the soil is unconsolidated and remains highly susceptible to further erosion. I recommend, at the very least, reseeding the area but, the steep slope of the gully would likely benefit more from application of erosion mats or other more direct interventions.

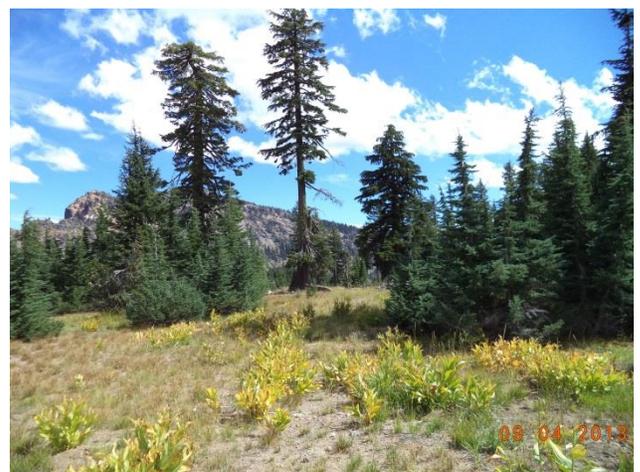
Figure 11. East facing view of vegetation at midpoint of Section 3.

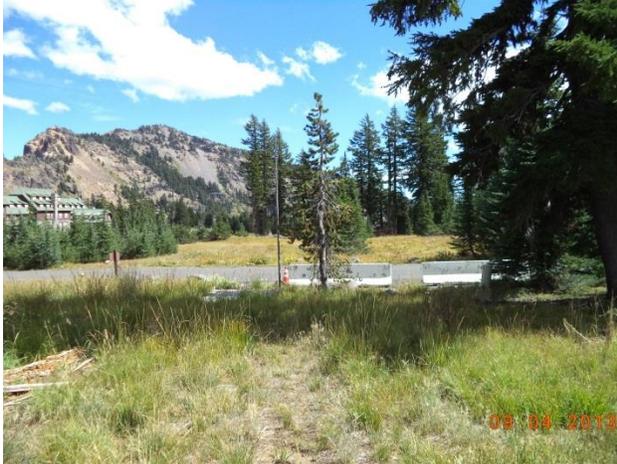
Figure 12. East facing view of concrete vault and walkway at end of Section 3, some evidence of reroute is still visible.

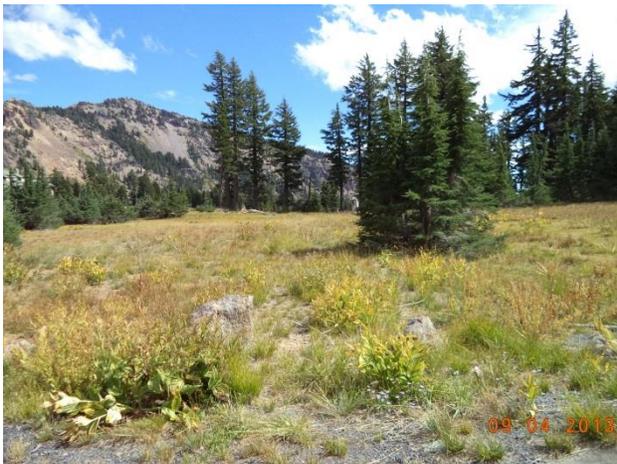
Current conditions: Section 4 is ~90% revegetated and dominant species include *Anaphalis margaritacea*, *Carex sp.*, *Elymus elmoides*, *Poa sp.*, and *Veratrum viride*.

Figure 13. East facing view from paved pathway #3 at beginning of Section 4, area is almost completely revegetated.

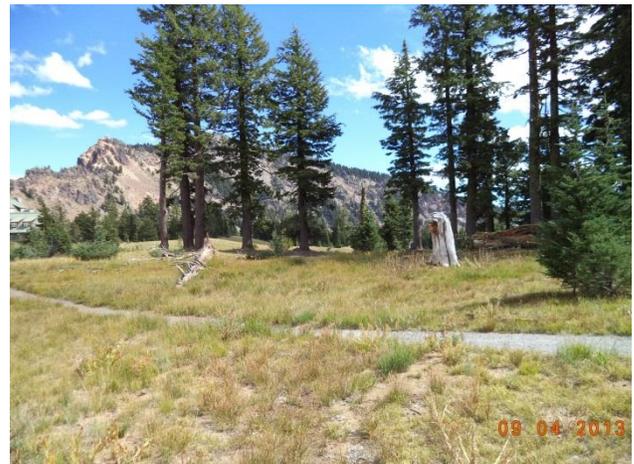
Figure 14. Revegetated area near end of Section 4 at paved pathway #4.

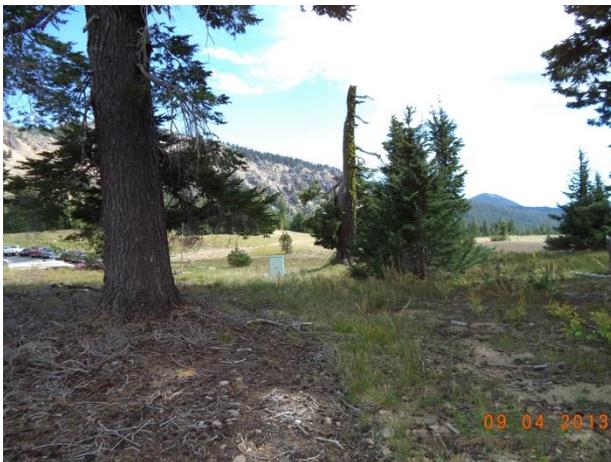
Current conditions: Revegetation is progressing naturally throughout this section and total cover is ~80%. The area directly under the *Tsuga mertensiana* tree at the end of the section remains sparse and is likely because of the tree. The steep slope near the Rim Dorm access road continues to erode though revegetation has progressed around the eroded area with a few plants still growing within the gully itself. However, there is still not enough cover to mitigate further erosion. Dominant vegetation includes *Achnatherum occidentale*, *Carex sp.*, *Elymus elmoides*, and *Erigeron perigrinus* with one *Agoseris retrorsa* occurring near the tie-in box.

Figure 15. East facing view of *Tsuga mertensiana* near end of Section 5.

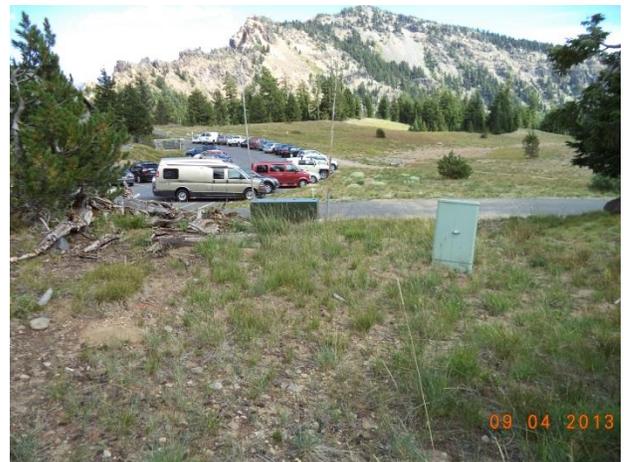
Figure 16. East facing view of end of Section 5 at tie-in box.

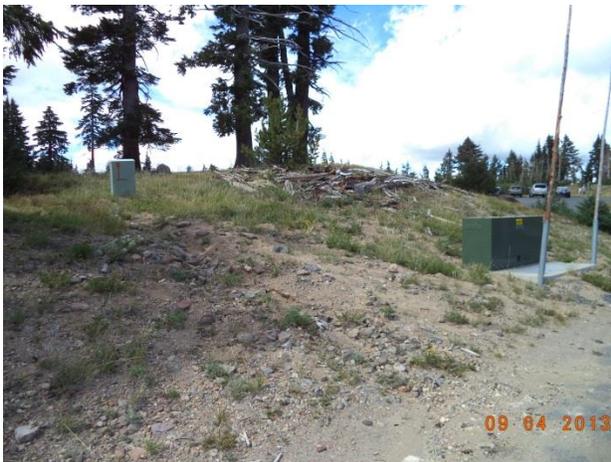
Figure 17. North facing view of erosion at end of cable reroute. Revegetation remains slow with no improvement in soil stabilization.
