Hogcamp Branch Stream Stabilization Project

Introduction

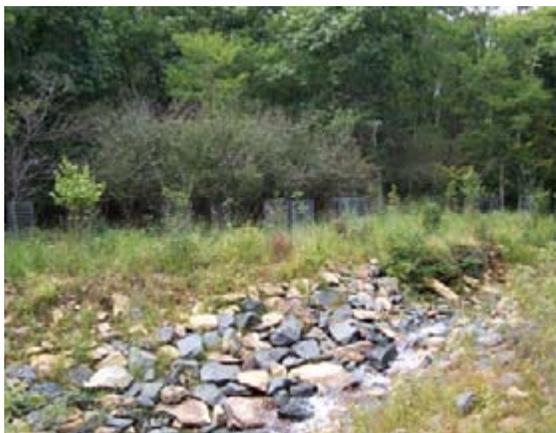
Lower Sloping Drop Structure with re-vegetated bank areas (2004)
