Subject: New Infill for Historic Garage Openings

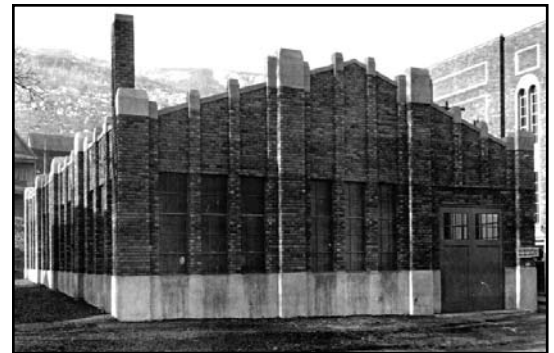
The original garage door as it appeared in 1940 was an oversized pair of hinged wood doors with no outside handles. Each door was divided into two segmented panels with the top sections infilled with eight true-divided lights.

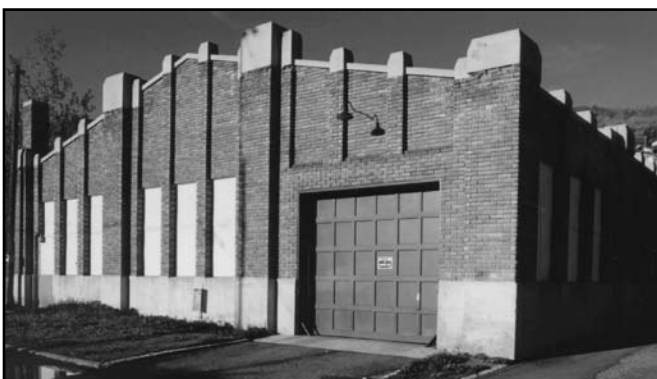
Just prior to rehab, the existing garage door was a single wood roll-up style, divided into thirty segmented solid panels by intersecting stiles and rails.

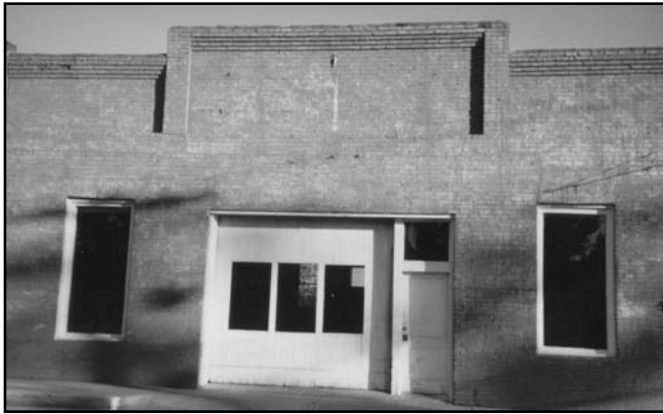
Before the work began, the original 1930 garage door opening had an operable garage door and a pedestrian door surmounted by a glazed transom installed as infill.

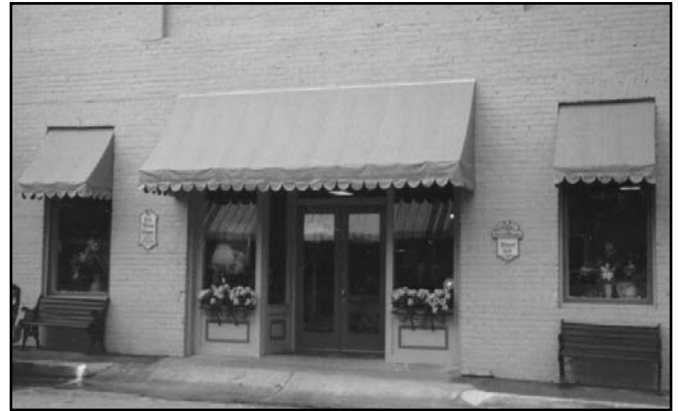
During rehabilitation the owner infilled the garage door opening with a storefront reminiscent of those used in the early-20th century, which is not in keeping with the historic character of the building.

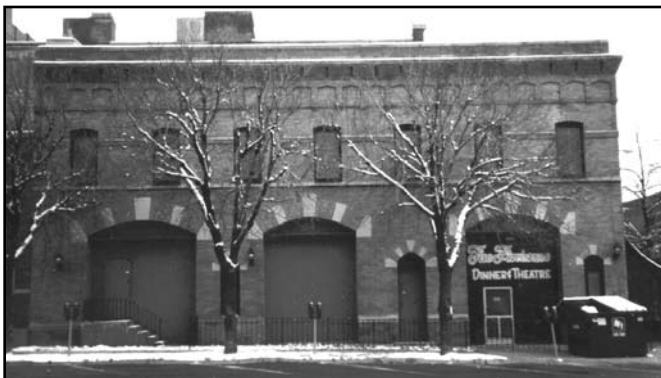
The south elevation of the 1903 firehouse is dominated by three large garage door openings. This photo was taken just prior to rehab and shows the existing infill treatments.
