RESTORATION STRATEGY FOR THE MERCED RIVER THROUGH YOSEMITE VALLEY

June 2019

UC Santa Barbara Project Team

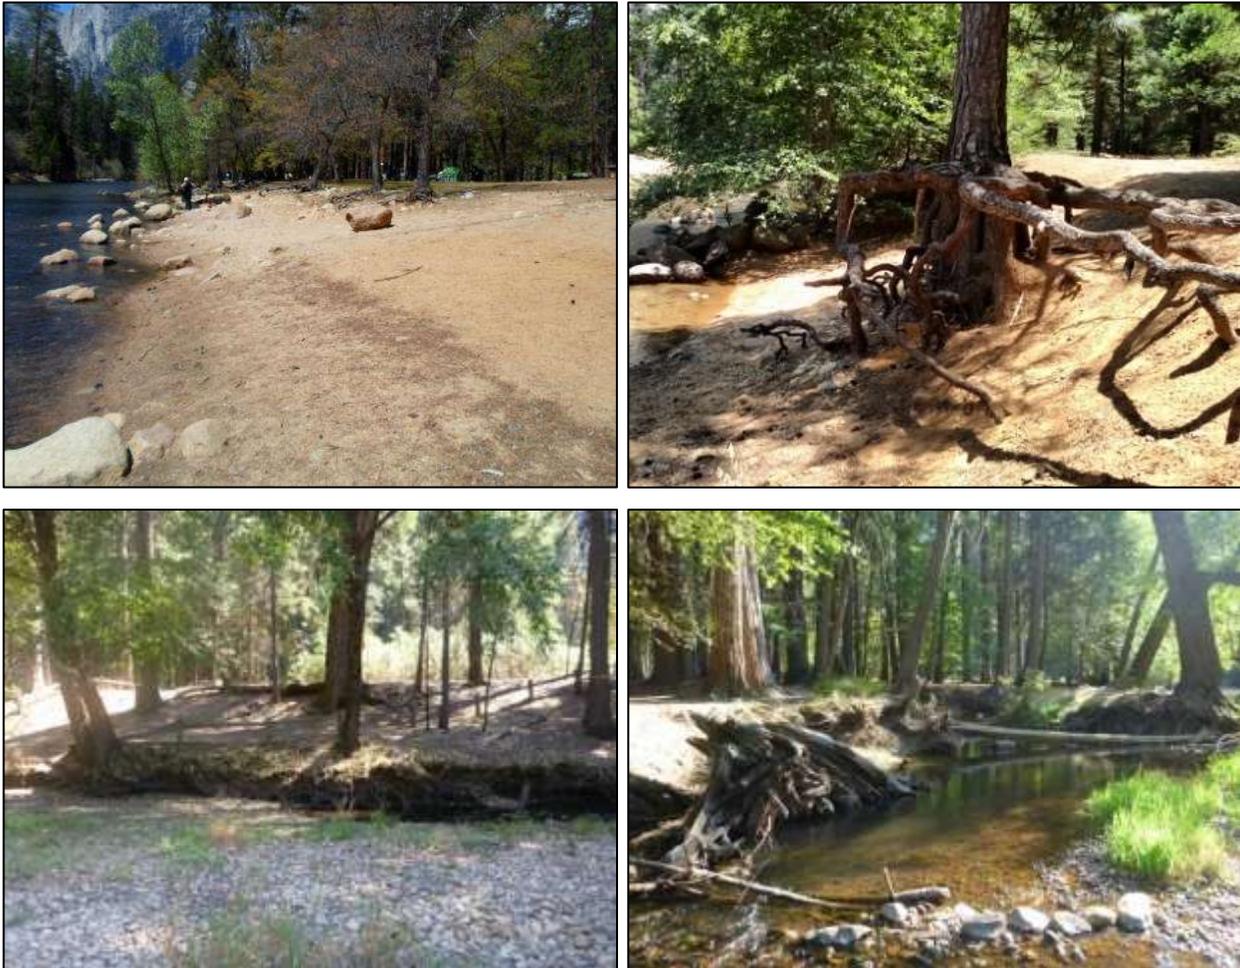
Figure 2. Views of degraded riparian zones and associated bank erosion. Clockwise from top left: downstream of Clarks Bridge, between Stoneman and Housekeeping Camp bridges, along lower Tenaya Creek, and upstream of Sugar Pine Bridge.

1. **Restoration of the riparian zone** (Figure 2), including the reconstruction of streambanks trampled by unrestricted visitor access and reestablishment of a more diverse, native-species riparian vegetation community. Natural processes of vegetation succession and geomorphic adjustment would eventually achieve many of these goals, but the period of recovery without active intervention would likely extend for many decades or centuries.

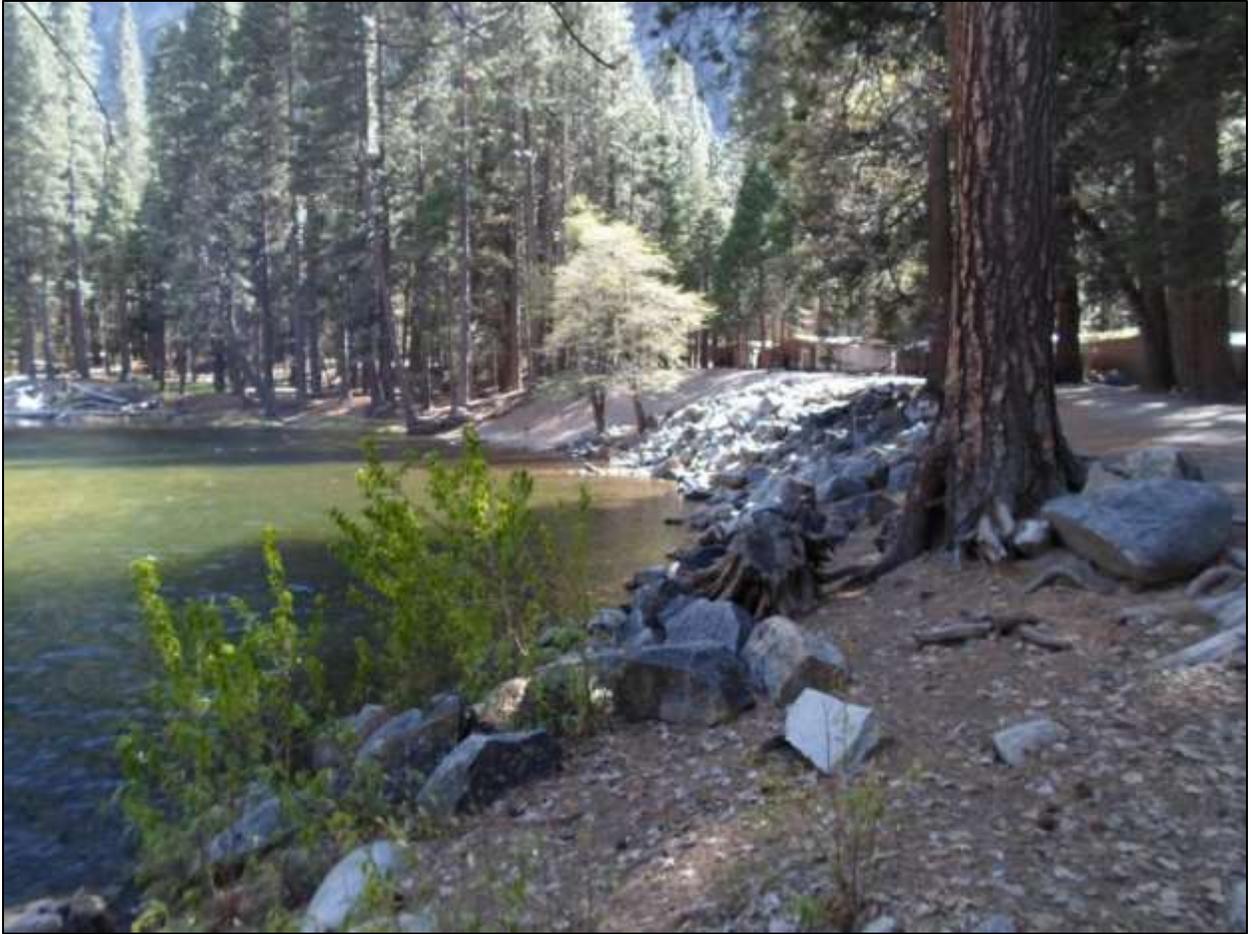
Figure 3. Bank armoring adjacent to Housekeeping Camp (river flow is towards the camera).

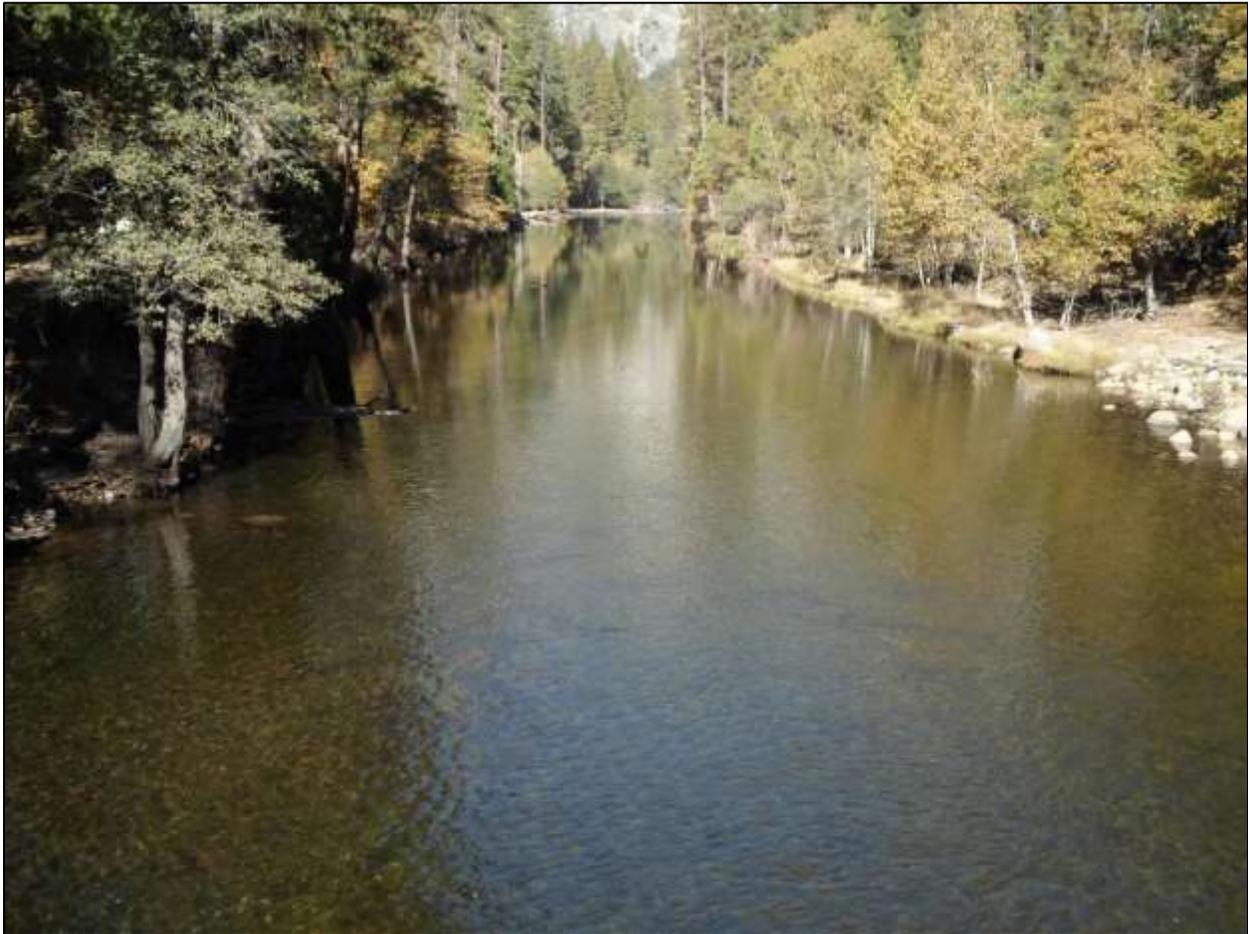
Figure 4. View downstream along the Merced River below Clarks Bridge, displaying a long reach of homogenous channel form.

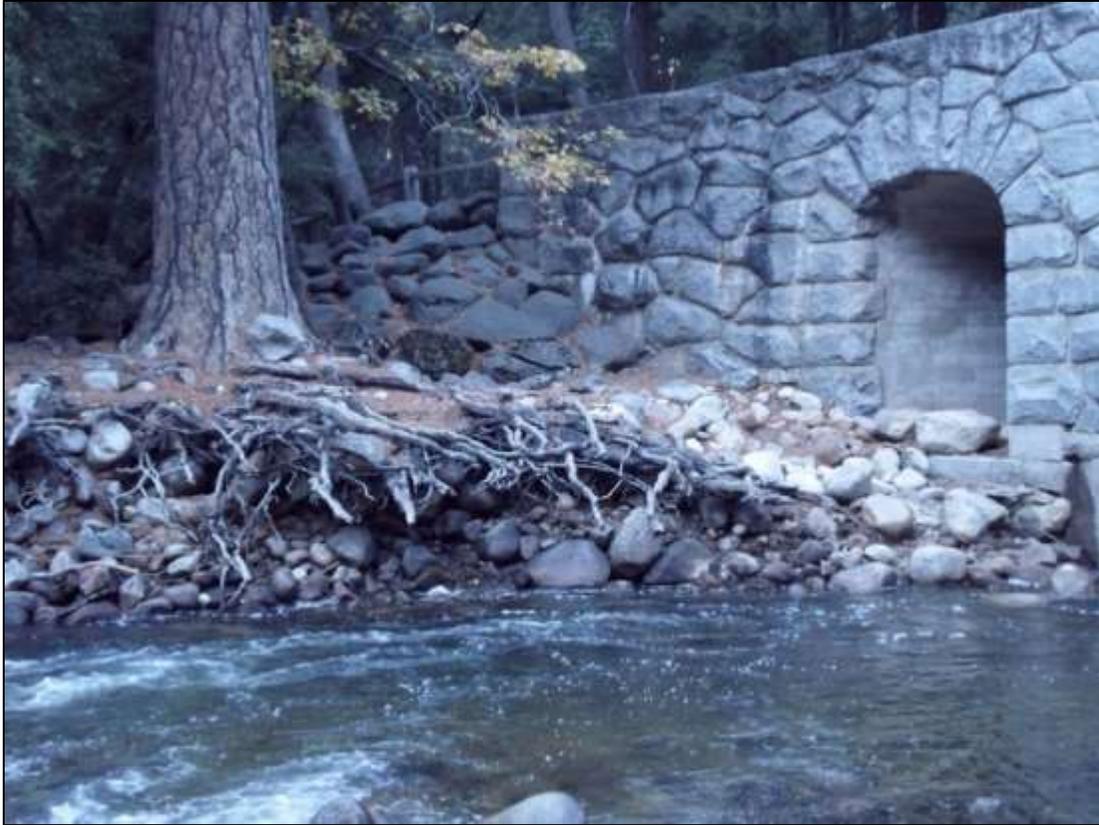
Three main issues provide the focus for restoration here: locally eroding, unstable streambanks associated with downcutting; simplified vegetation structure; and abandonment of previously occupied left-bank side channels. Because the sediment is so coarse the streambanks here are not as susceptible to the impacts of visitor traffic as farther downstream (any revegetation, however, would nonetheless require protection from visitors); instead, bank erosion appears to be primarily a consequence of enhanced sediment transport and associated downcutting, augmented by the resulting confinement of high flows within the main channel. Happy Isles Bridge also appears to offer some hydraulic constriction at high flows, with a modest narrowing of the flow (about 12%^(Ms)) and an oblique orientation to the channel that enhances downstream deposition on the left bank, in the lee of the bridge, and more directed flow and thus erosion downstream along the right bank (Figure 10.2).

Figure 10.2. Just downstream of the right abutment of Happy Isle Bridge showing localized bank erosion, likely induced by bridge orientation and flow constriction.

In addition to these major prospective projects, the right bank immediately downstream of Happy Isles (Figure B) and elsewhere along this side of the river would benefit from selective riprap removal and revegetation (10-1, 10-2, 10-3).

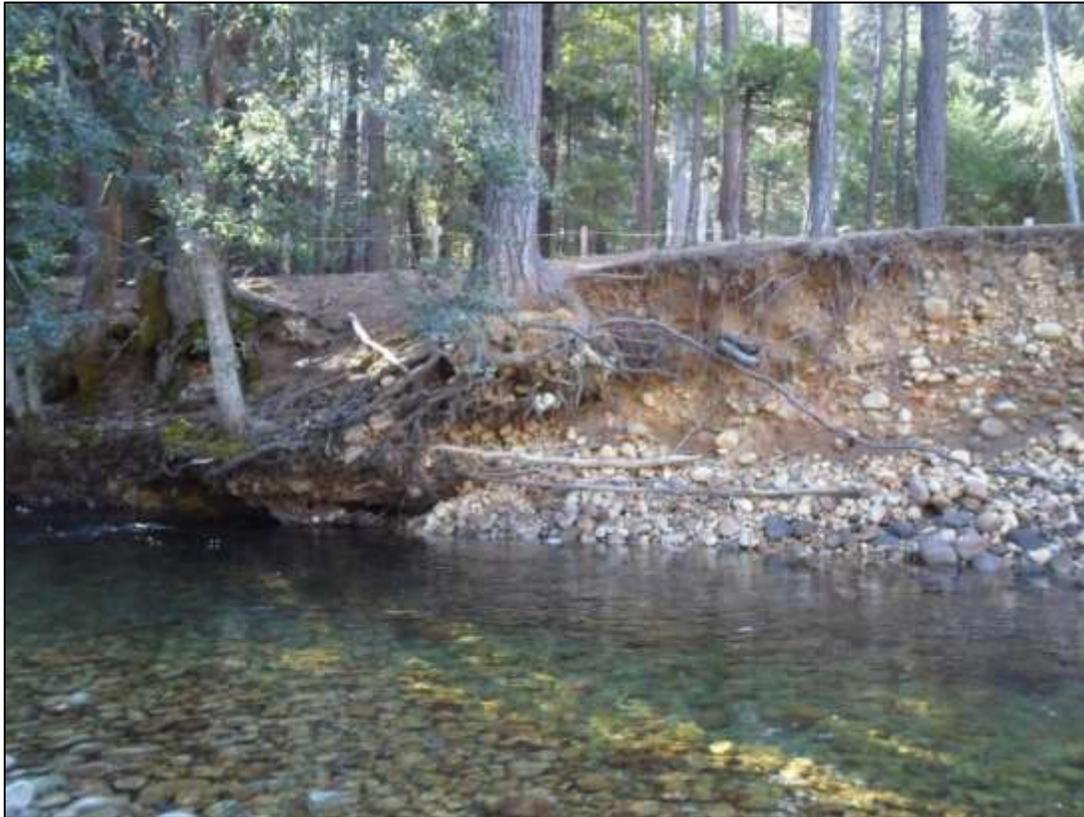
Figure 9.1. Active erosion into the terrace bounding this reach.

Issues within this reach include eroding streambanks and a riparian corridor with reduced structural complexity, species diversity, and functionality. Milestone (1978) found that Clarks Bridge narrowed the channel by about 40%, but Madej (1991) believed that the steep channel slope minimized the impacts of this constriction on the river. Potential treatments to improve overall conditions would seek to reduce foot traffic within the riparian corridor and along the banks, particularly along the left bank of the river at the upper and lower ends of this reach (treatments 9-1 and 9-3). Also beneficial would be the removal of the Upper Pines Dump Station (also proposed in the MRP, and for which bank erosion in 2018 has necessitated emergency repairs). Restoration here would require soil decompaction, regrading, and vegetation planting (treatment 9-2).

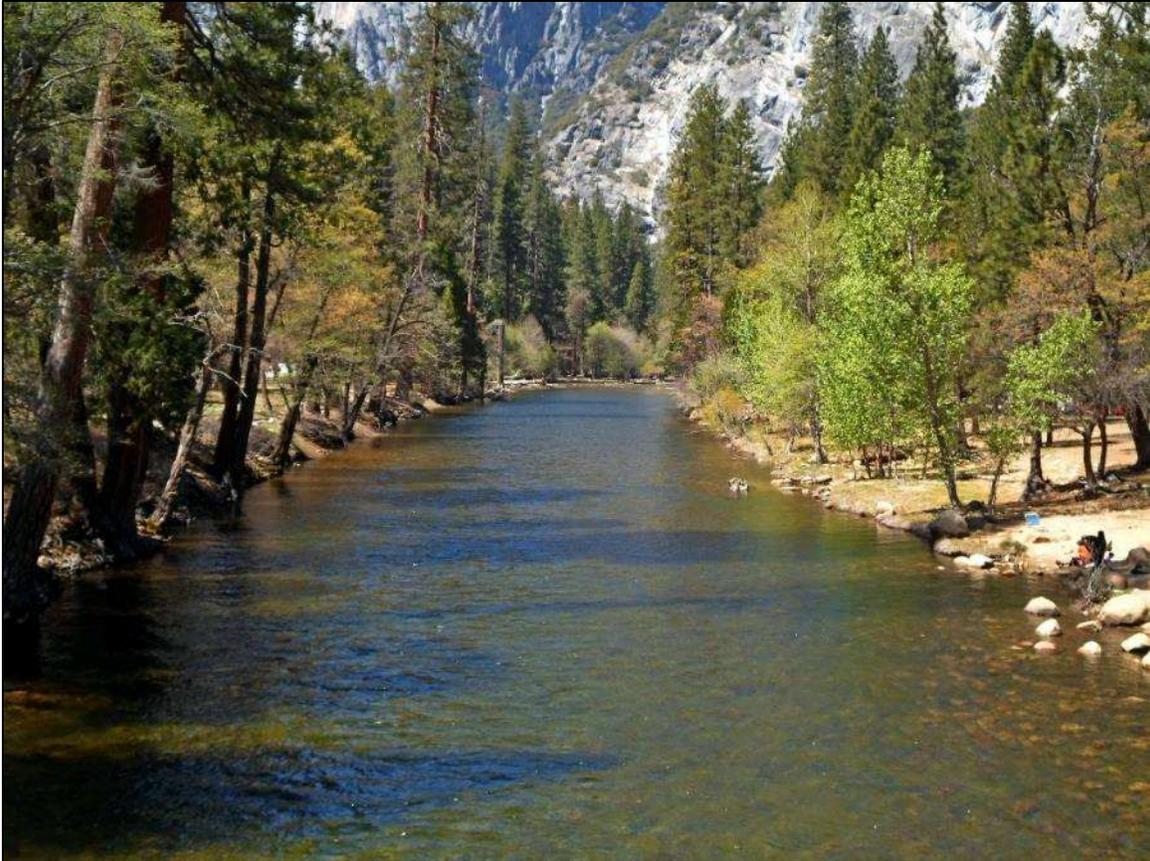
except in the immediate vicinity of Clarks Bridge. The absence of significant variations in the planform and a lack of woody material in the channel has resulted in a near-homogenous channel form (Figure 8.1). This geomorphic setting, which lacks both steep banks on the outside of bends (which would discourage foot traffic) and active point bars along inside bends (which turn over frequently and so are resilient to transitory disturbances), results in a homogenous straight reach whose margins are neither inaccessible nor resilient. Thus, this reach displays some of the clearest evidence throughout the Study Area of visitor activity (Figure 8.2). Channel widening since 1919 is typically modest (<30%) but ubiquitous^(Mj), although the downstream-most cross section in this reach had nearly doubled in width between 1919 and 2007^(Mr).

Figure 8.1. Homogenous channel form, looking downstream from Clarks Bridge.

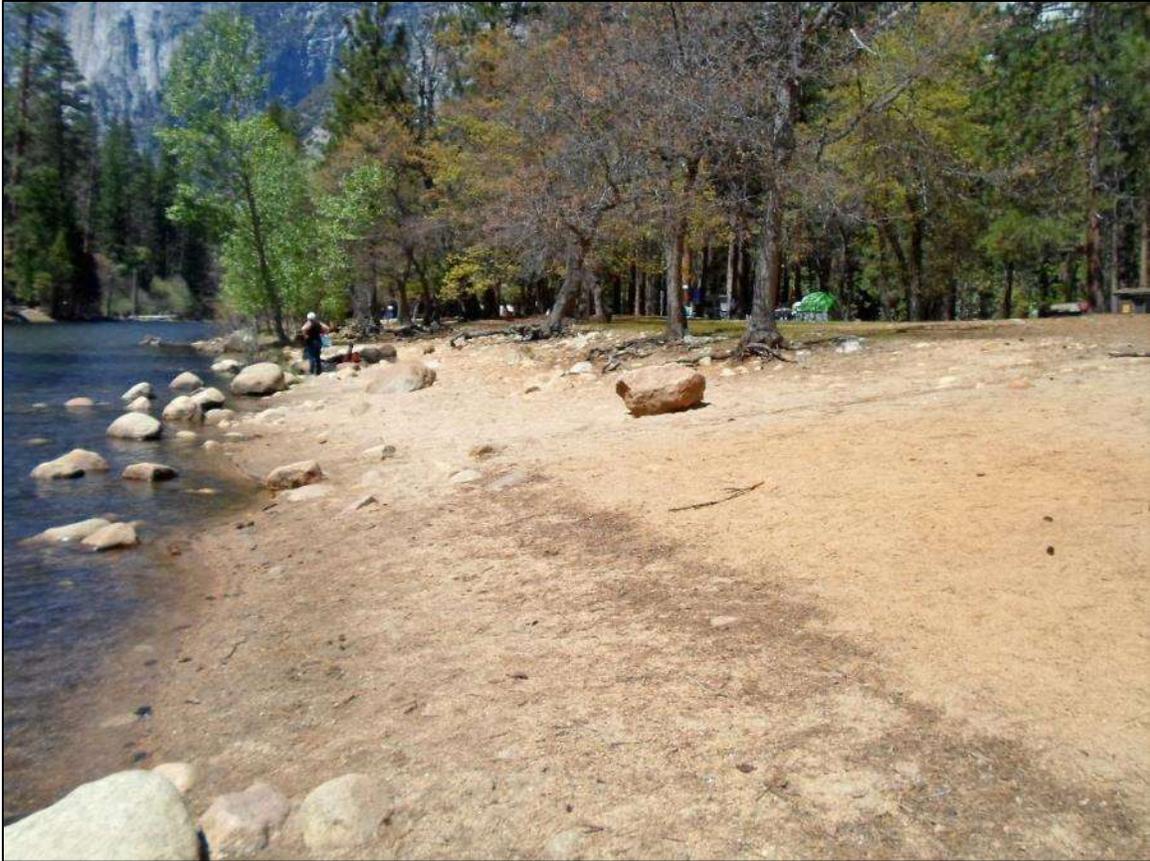
Figure 8.2. Extensive bank trampling adjacent to North Pines campground.

Issues here are similar to but even more severe than along Reach 9, particularly associated with the adjacent campgrounds. Success of any potential treatments to rebuild the riparian zone would need to exclude and redirect river access to specified locations. Some initial work, mainly installation of split-rail fencing in 2006 to encourage natural revegetation^(C12), reflects the long-standing recognition of restoration needs in this area. More active revegetation and brush layering could enhance the riparian corridor, reestablishing a more natural degree of bank stability that could begin to counteract the widening that has occurred over the past century (treatments 8-1, 8-2, 8-3).

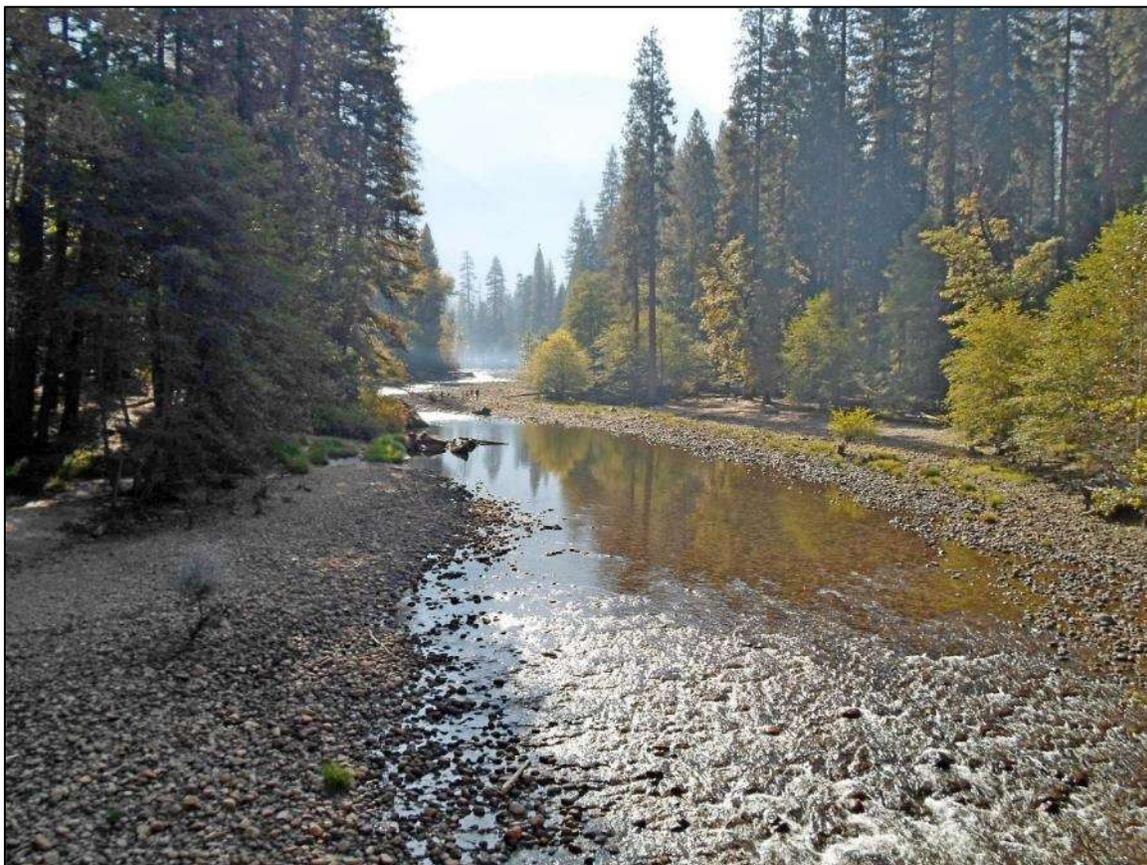
From 1919 to 1989 the channel widened by almost 50%^(Mj), resulting in a near-featureless channel (Figure 7.1) that is grossly oversized with respect to both its natural form and the downstream opening beneath Sugar Pine Bridge that it must pass (Figure 8.2). A subsequent resurvey in this reach in 2007 also suggests that the channel has shallowed by nearly three feet, in addition to having widened^(Mr).

Figure 7.1. Widened channel between the Tenaya Creek confluence (in middle distance, opposite the figures on the gravel bar) and Sugar Pine Bridge.

The primary issue in this reach is the extreme widening of the channel, primarily a function of visitor access from Lower Pines campground. Although removal of the lower loops following the 1997 flood has surely reduced the rate of visitation, trails from the still-active campground down the river are ubiquitous and well-worn, and many areas along the left side of the river have almost no defined streambanks at all. The prominent left-bank gravel bar in the middle of the reach (with visitors on it in the middle distance of Figure 7.1) could offer a fairly resilient access point to the river, but its very existence is anomalous—it is on the *outside* of a bend, not the inside, and owes its development to the widening of the river, likely coupled with the backwater effects of the abrupt narrowing of high flows imposed by Sugar Pine Bridge.

Potential treatments to address channel widening and bank instability (7-1, 7-4, 7-5, 7-6, 7-7) are similar to those recommended upstream. They are central to the broader restoration goal of reducing impacts to the river from the present configuration of Sugar Pine Bridge, and their success will require a level of engineering design that has not yet been completed. They will also require attention to limiting visitor access to reconstructed and replanted areas (all treatments in this reach) with at least as much vigor as the actual restoration itself. Reactivation of historic swale features on the left floodplain, engineered in-channel features to direct flows, and floodplain lowering are additional measures that represent progressively more intensive efforts that could help redirect high flows into overbank areas, reducing the degree of hydraulic constriction from the downstream bridge while enhancing floodplain function and conditions along the riparian corridor (treatments 7-2, 7-3). Their prospective locations and design are only

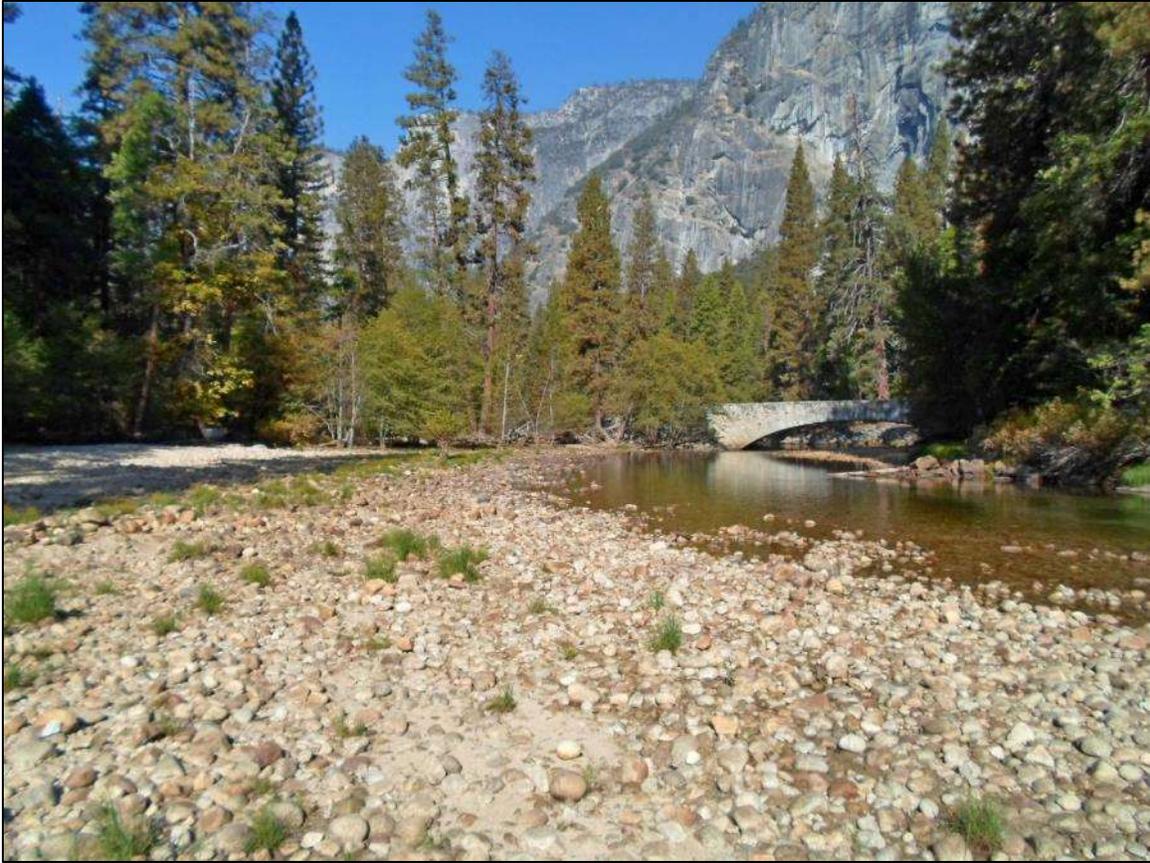
Figure 7.2. View downstream from opposite the Tenaya Creek confluence towards Sugar Pine Bridge, showing the offset in the bridge relative to the main direction of flow.

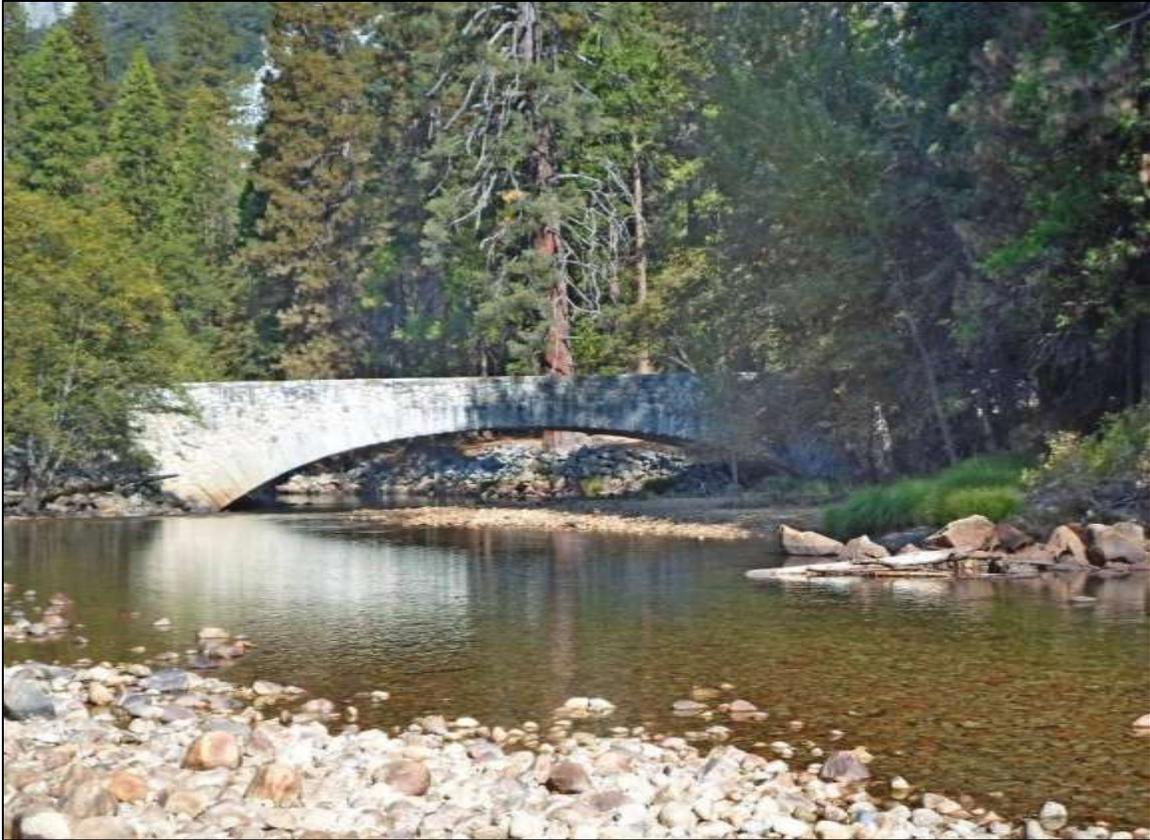
Figure 6.2. Downstream view of Sugar Pine Bridge from immediately upstream. Rock armoring of the sugar pine tree is evident through the bridge opening.

The greatest restoration challenge in this reach is posed by the historical efforts to preserve the sugar pine tree itself (visible in the center of Figure 6.2, through and above the bridge opening). Given the concentration and orientation of flows through the bridge, only robust artificial bank

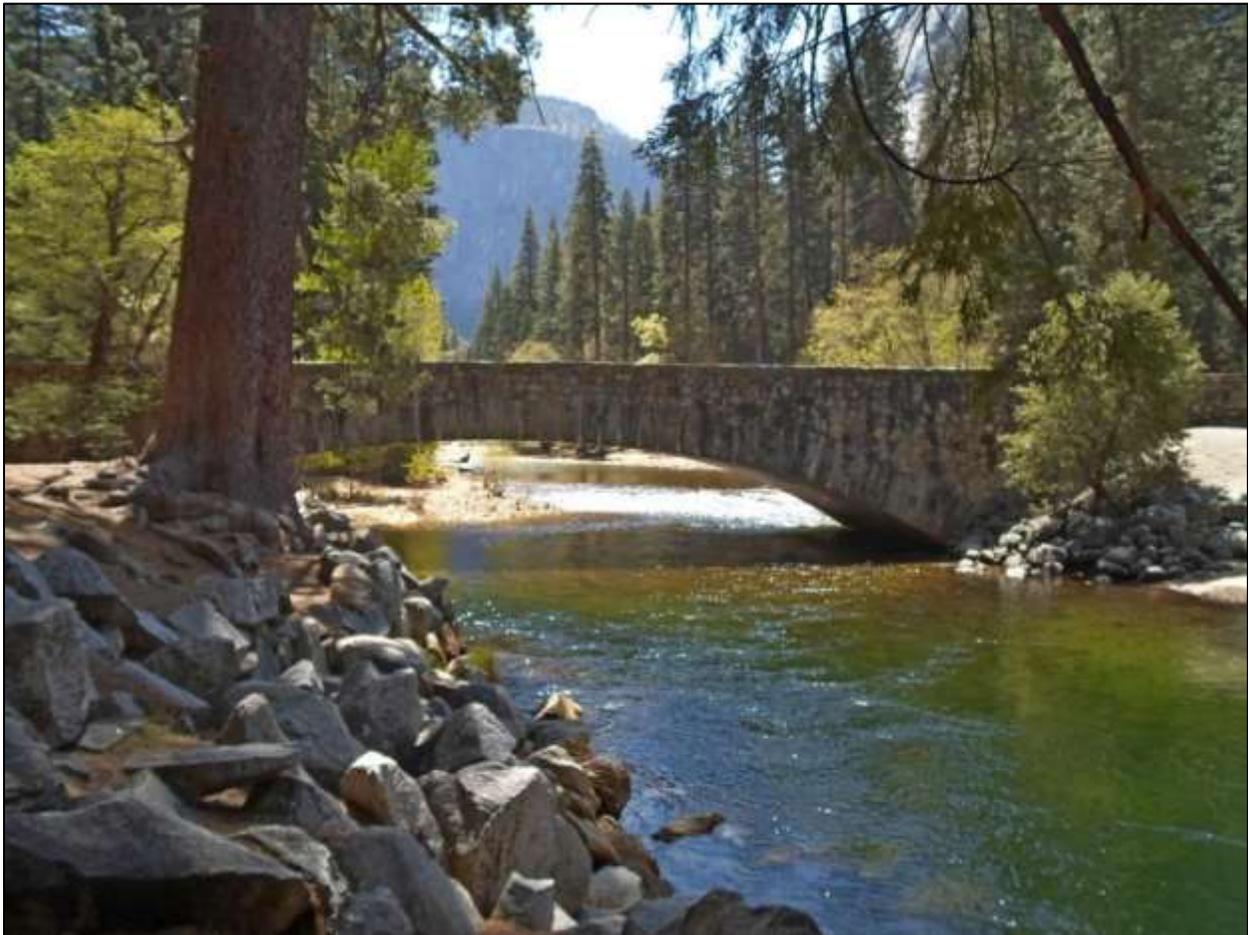
Figure 6.3. View upstream; the Sugar Pine tree and associated rock armoring visible in the left foreground, with Sugar Pine Bridge about 60 feet beyond.

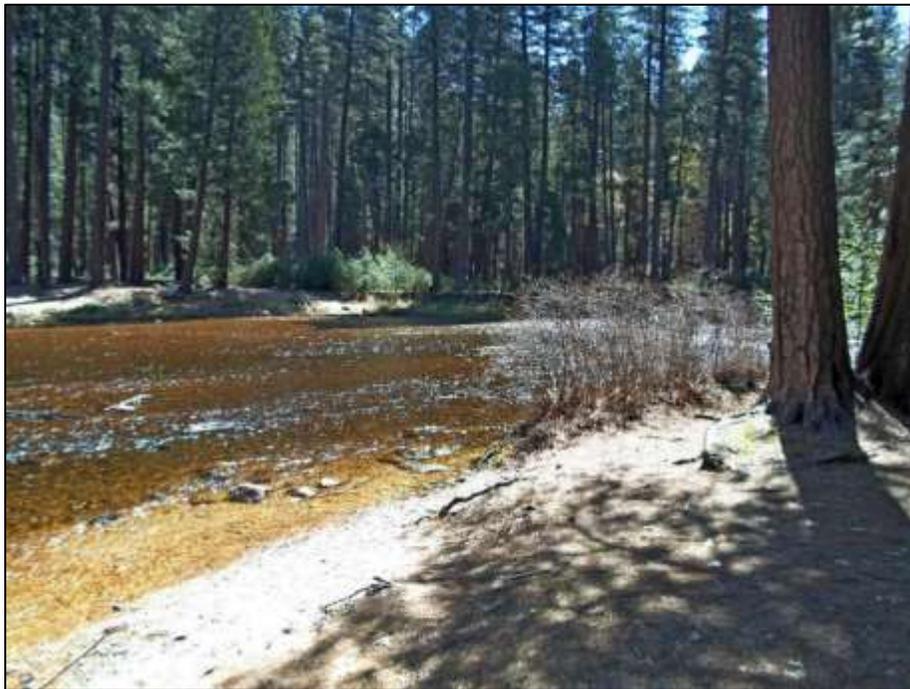
Figure 5.1. Trampled, denuded banks on both sides of the river just downstream of Ahwahnee Bridge. Project 5-5 was built in 2017 just downstream of this photograph; Project 5-4 was built in 2018 across the river just out of view to the right.

This reach is well-suited to bioengineered treatments to stabilize banks and re-direct flows, with the goals of reversing the historical trends in channel widening, local bridge-induced scour, and simplified channel morphology. Although the predictions of the migration modeling and the lack of critical infrastructure or roads west of the channel would both encourage the removal of bank constraints in this area, these considerations are rendered moot by the extreme widening that has occurred here over the past century, involving erosion along both sides of the channel. To address this acute impact, two restoration projects have been recently constructed with the objectives of narrowing the channel and reinforcing the banks to allow riparian vegetation to reestablish more structurally diverse and robust margins. The first restoration project based on these recommendations was constructed along the right bank at RM 1.4 in 2016 (treatment 5-5); the second along the left bank in 2017 (treatment 5-4; Figure 5.3). Both are visible from Ahwahnee Bridge (Figure 5.4); a similar, third project that will also replace an extent of barren rock riprap is planned for the left bank just upstream of Stoneman Bridge in 2019 (treatment 5-3), with an additional site identified for future implementation where the floodplain swales from Reach 7 return to the mainstem channel (treatment 5-7). Other potential treatments include extensive riparian revegetation and management of visitor access (5-1, 5-2, 5-8), and more intensive efforts to increase in-channel diversity (5-6).

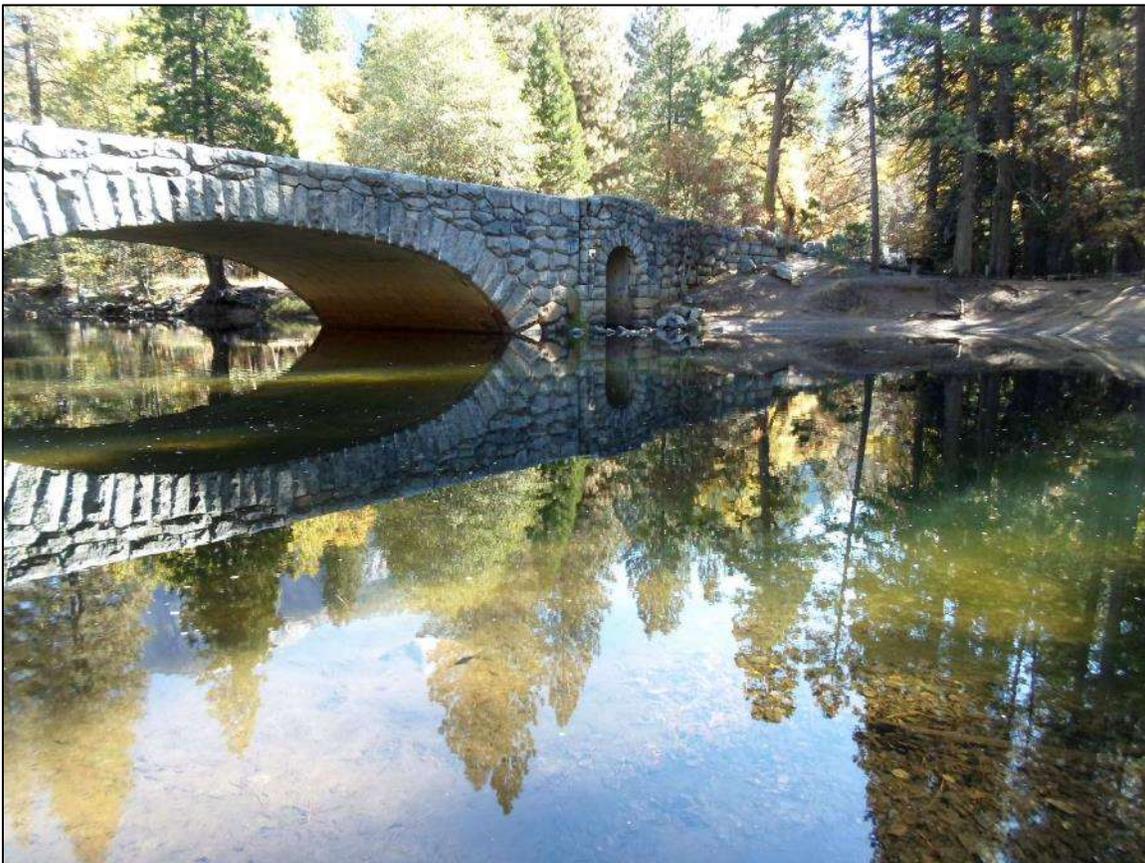
Figure 4.1. Downstream face of Stoneman Bridge, with a view of the heavily impacted left-bank river access area.

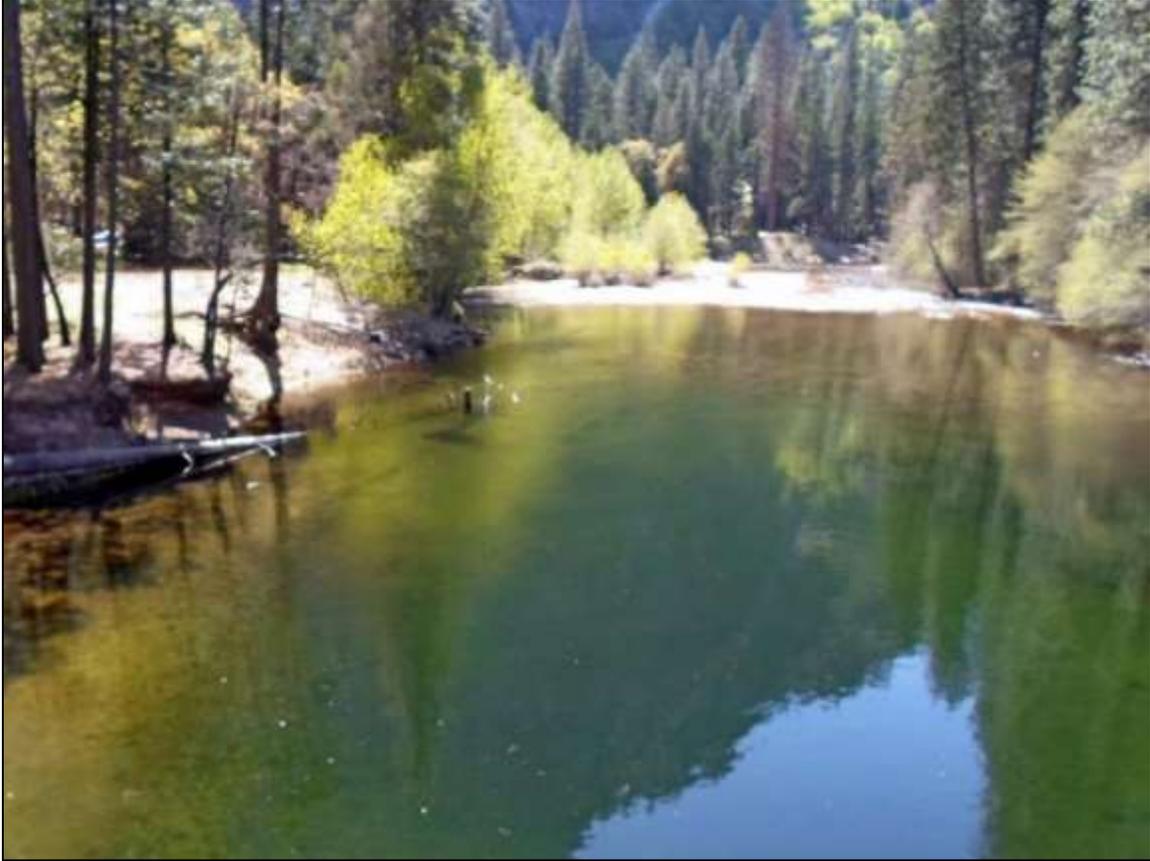
Figure 4.2. View downstream from Stoneman Bridge in a zone of substantial channel widening. The armored bank below Housekeeping Camp visible in the far distance.

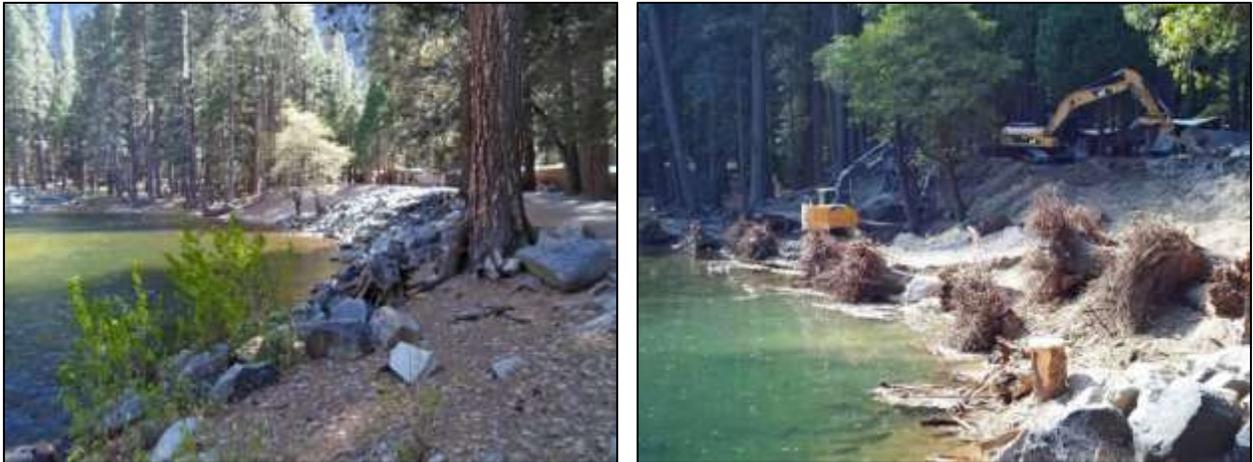
Towards the downstream end of this reach, Housekeeping Camp sits above the steep outer (left) bank on talus and alluvial-fan deposits well above both the modern and historical floodplain. The inside of this bend is occupied by an extensive sand and gravel bar, well-trafficked by visitors but largely inundated and reworked by 5- to 10-year (and larger) floods. Meander modeling shows that this area is second only to Reach 5 in the tendency for the channel to shift position towards the outside of the bend, and so a robust rock riprap had been installed to protect Housekeeping Camp; it has been replaced by bioengineered bank protection (as of autumn 2018) to improve the condition of the riparian zone and near-bank channel conditions while maintaining protection for the infrastructure above (treatment 4-3; Figure 4.3).

Figure 4.3. Upstream view of the Housekeeping Camp riprapped embankment in 2015 (left) and during construction of Project 4-3 in 2018 (right).

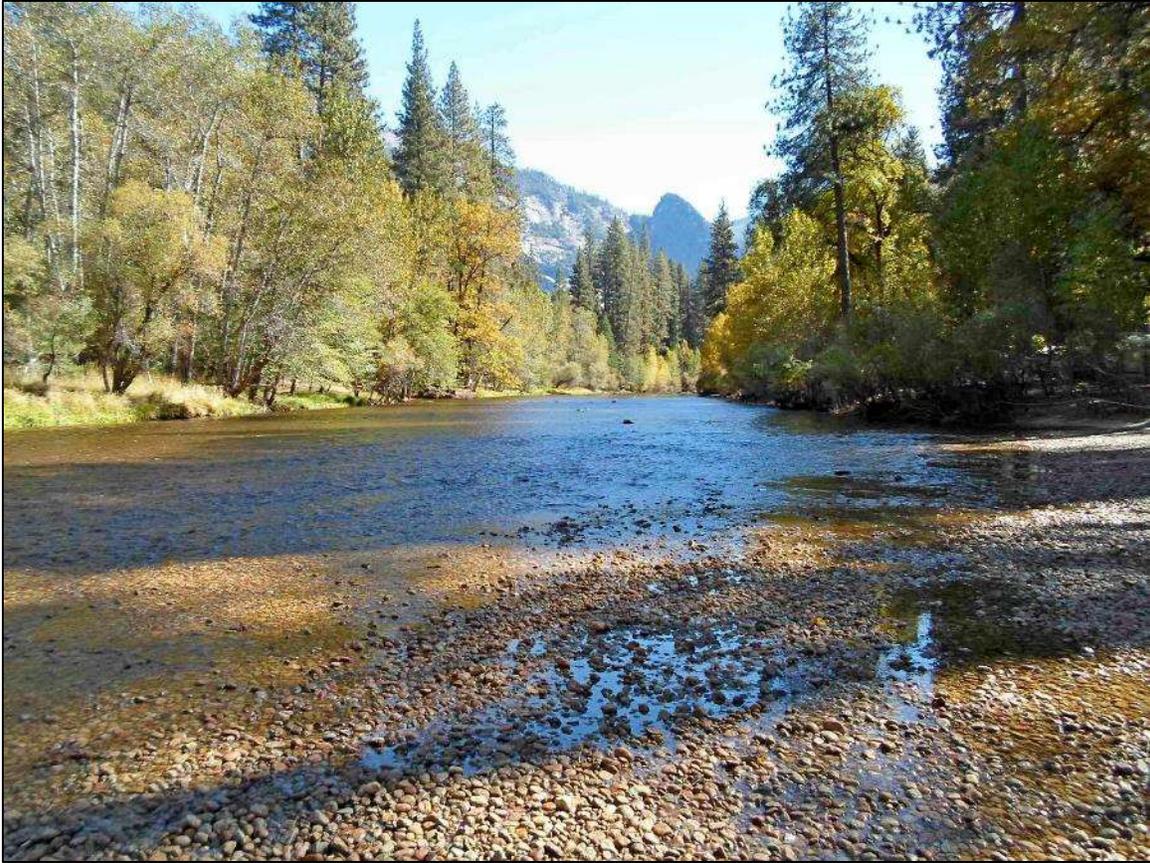
This reach is not without its human impacts, however; the extension of Housekeeping Camp along much of the left bank has resulted in a broadened channel with a degraded riparian zone along the upper half of the reach (Figure 3.2). Although Housekeeping Camp footbridge does

Figure 3.2. View upstream towards Housekeeping Camp footbridge, displaying the widened and simplified channel upstream of the S-bend in the river.

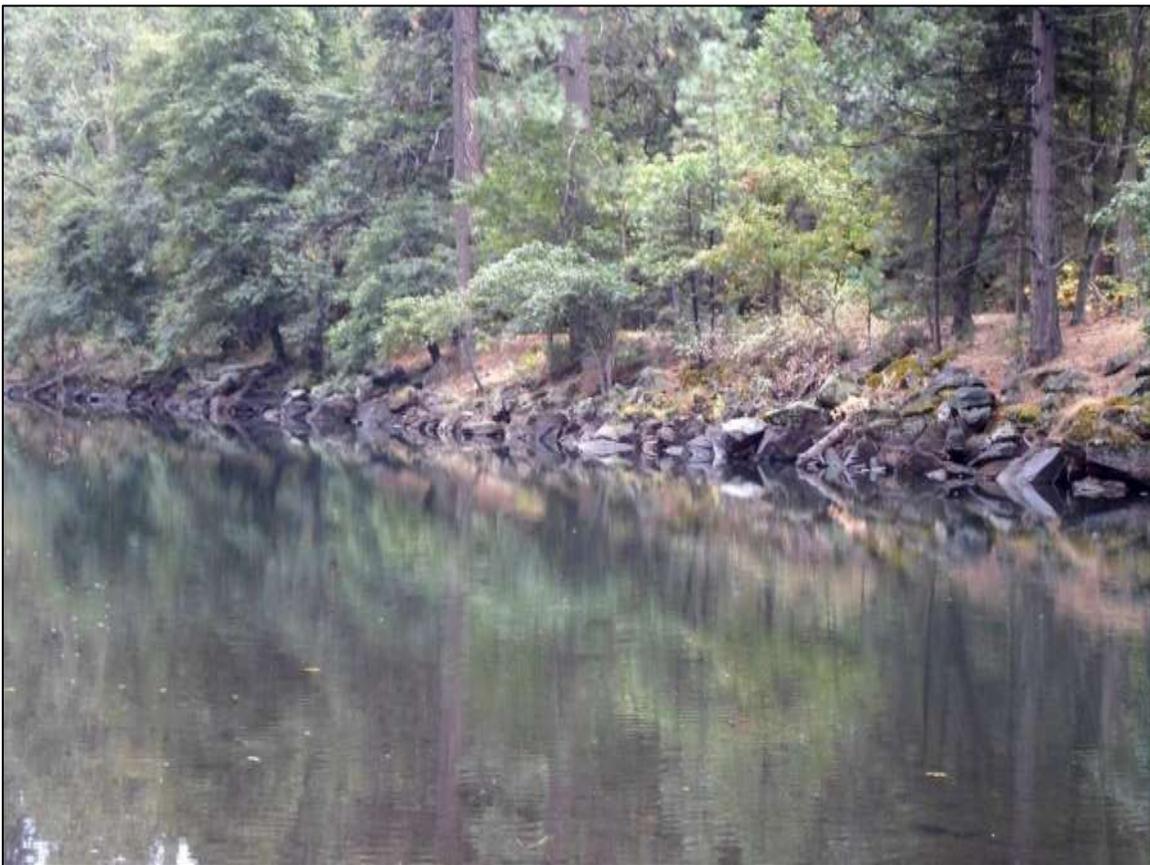
The Merced River is moderately constrained throughout most of this reach, particularly along the left (south) bank by the steep north face of Sentinel Dome. On the right bank it has only locally carved into the same terrace that borders the modern channel upstream to Tenaya Creek, and which also forms the surface now hosting the iconic meadows of Yosemite Valley. Formerly the active floodplain of the Merced River, channel incision has now rendered this surface too high above modern river level for frequent inundation. The channel through this reach has been virtually stable for the last 80 years, although meander modeling highlights the tendency of the channel to erode its left bank as it emerges from the S-bend of Reach 3, particularly if the potential upstream avulsion pathway were ever occupied. As a result, the Southside Road is protected by near-continuous armoring in this area (Figure 2.1), constituting the longest extent of continuous bank armoring in the entire Study Area^(C12).

Figure 2.1. Riprap along the left bank of the river, adjacent to the Southside Road.

the left streambank riparian corridor is also confined and degraded, the need to protect Southside Drive limits the degree to which additional benefits to river functions and ecology can be implemented to address impacts there (treatment 2-4).
