Merced River Riparian Corridor Restoration in Yosemite Valley

Restoration Concept
Designs

March 2016

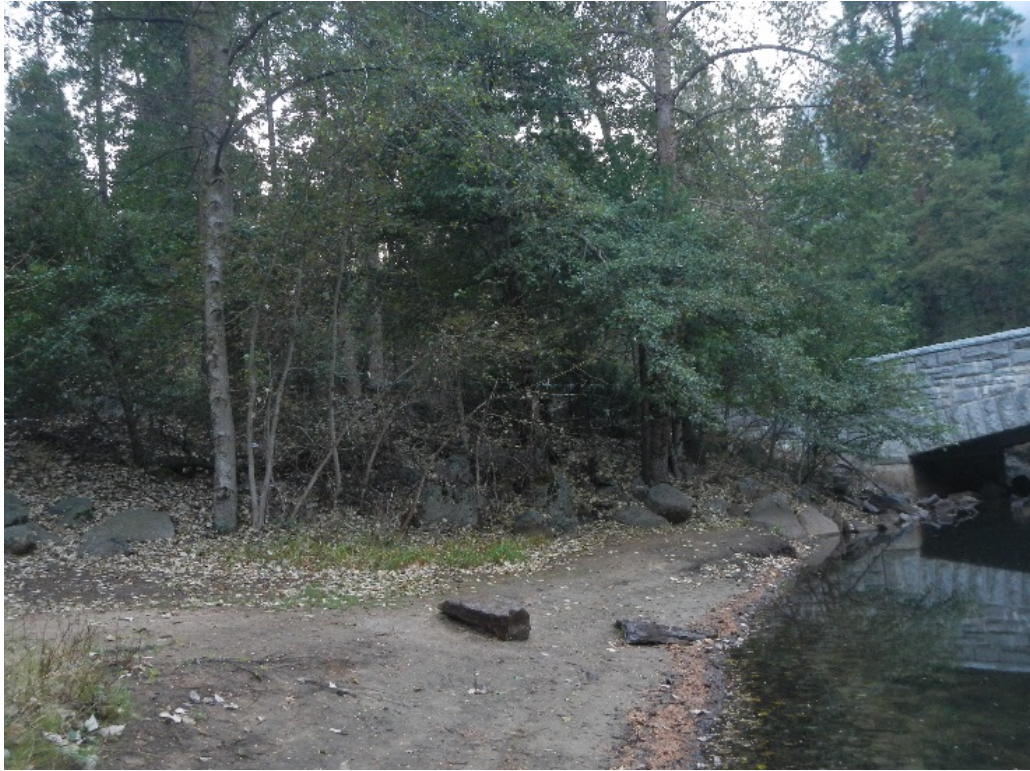
<p data-bbox="380 1045 1503 1100">LB facing DS: Soil compaction and vegetation trampling from recreation access (foreground); confinement by stable, vegetated artificial bank protection upstream of Sentinel Bridge (background)</p>   <p data-bbox="406 1898 1477 1927">RB facing DS: Confinement by stable vegetated artificial bank protection upstream of Sentinel Bridge</p>

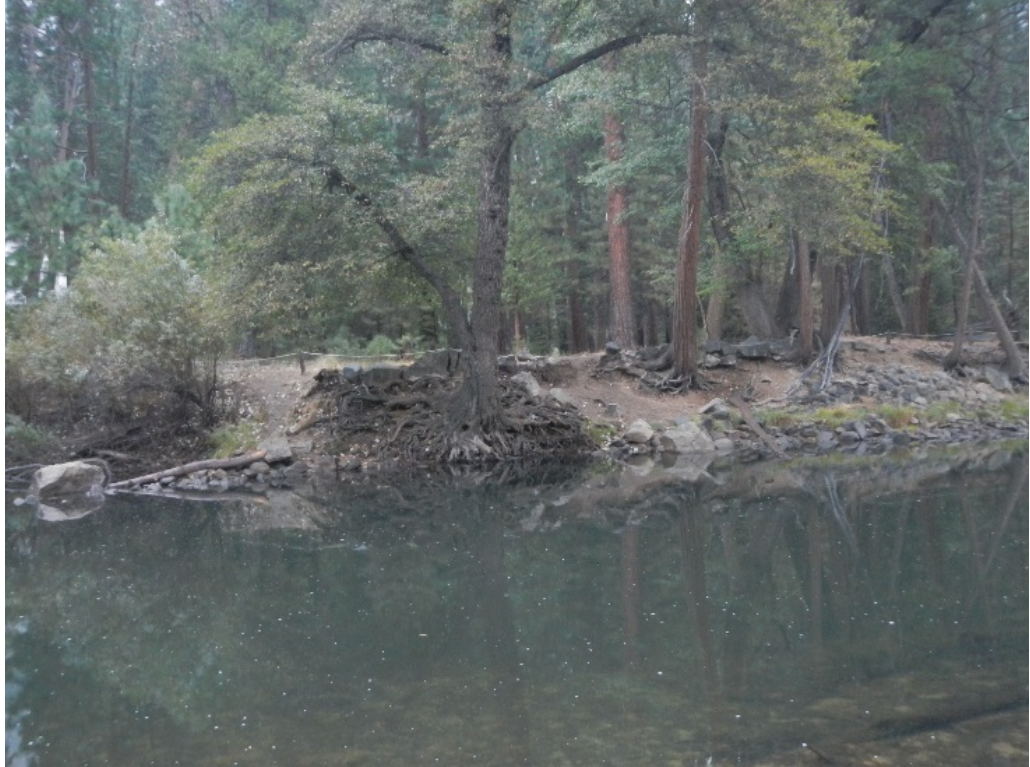
<p data-bbox="363 974 1520 1031">RB facing DS: Artificial bank protection along overflow channel return area; bank face erosion on upper bank; toe of bank erosion under mature tree roots</p>
0.05 (RB)

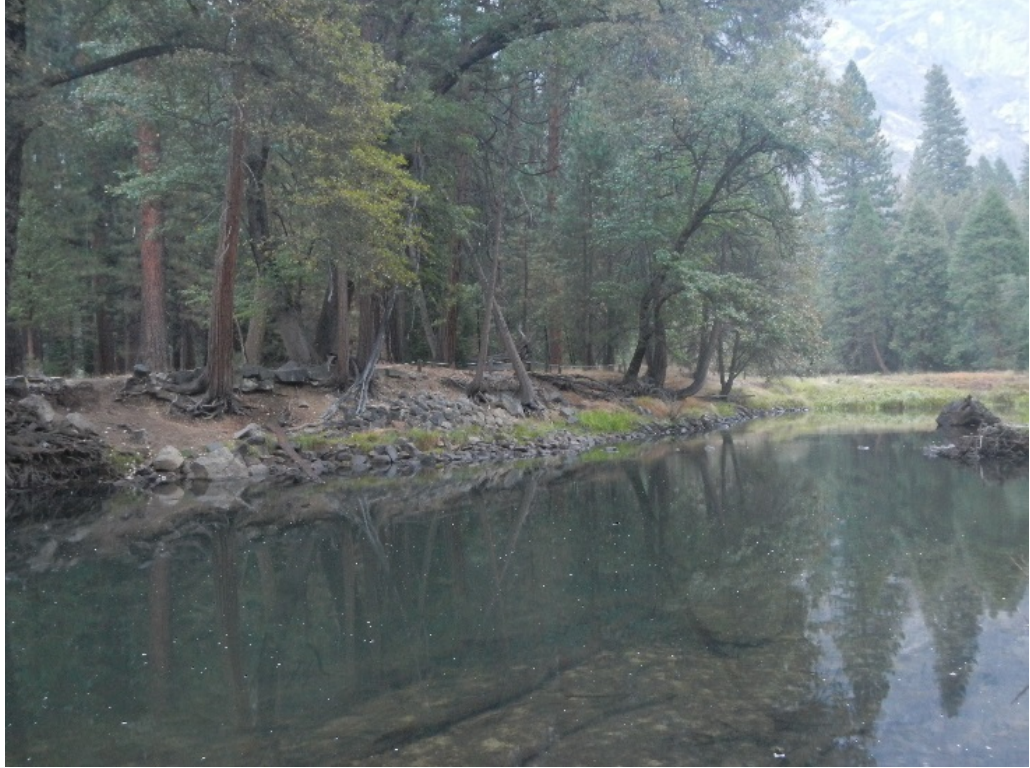
<p data-bbox="347 1850 1536 1906">RB view up overflow channel: Artificial bank protection along overflow channel return area; Bank face erosion on upper bank</p>

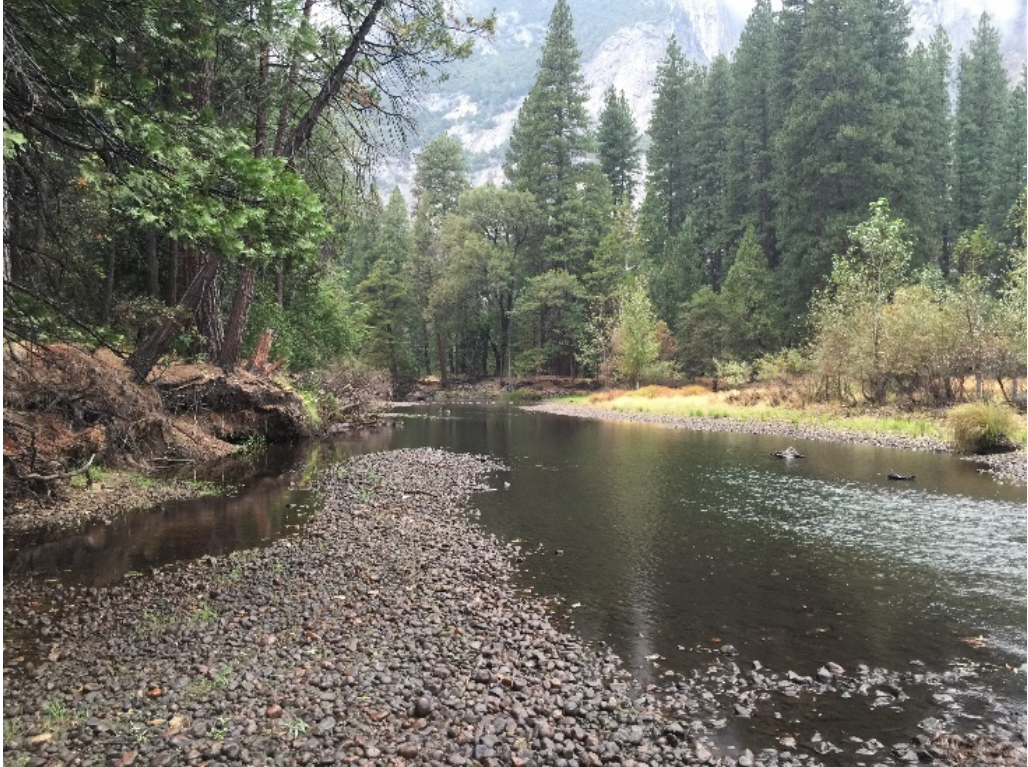
<p data-bbox="527 989 1354 1018">LB view DS: Overwide channel and mid channel bar; excess channel capacity</p>
0.07-0.19 (LB)

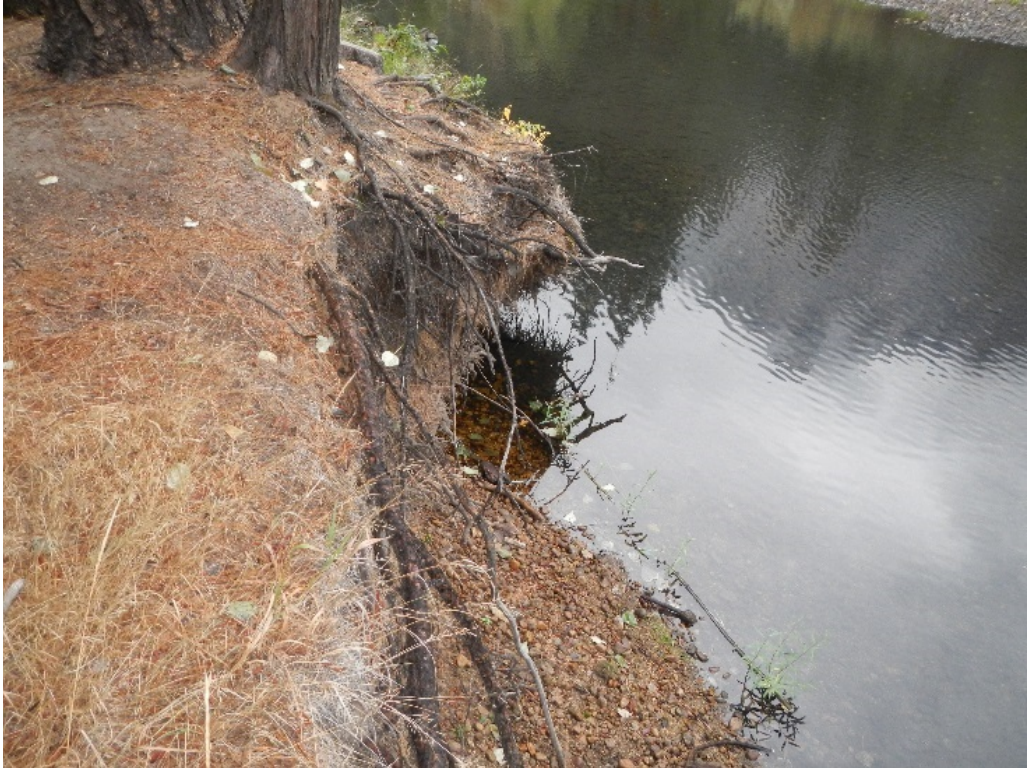
<p data-bbox="781 1843 1101 1873">LB view DS: Bank toe erosion</p>

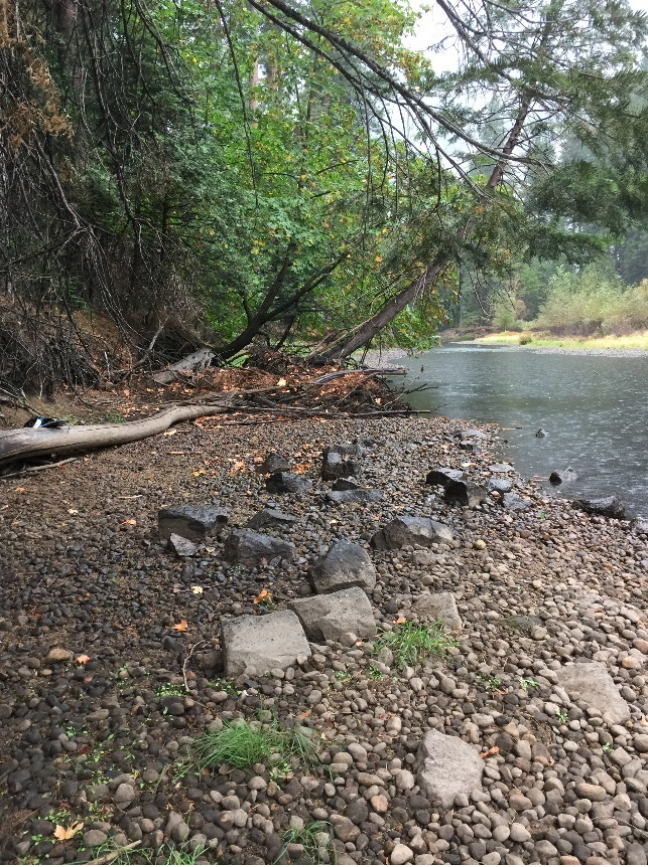
<p data-bbox="381 1081 1502 1144">LB view DS: Bank toe erosion, lateral channel expansion (note old riprap), height of bank; living trees and LWM to incorporate in reconstructed bank</p>

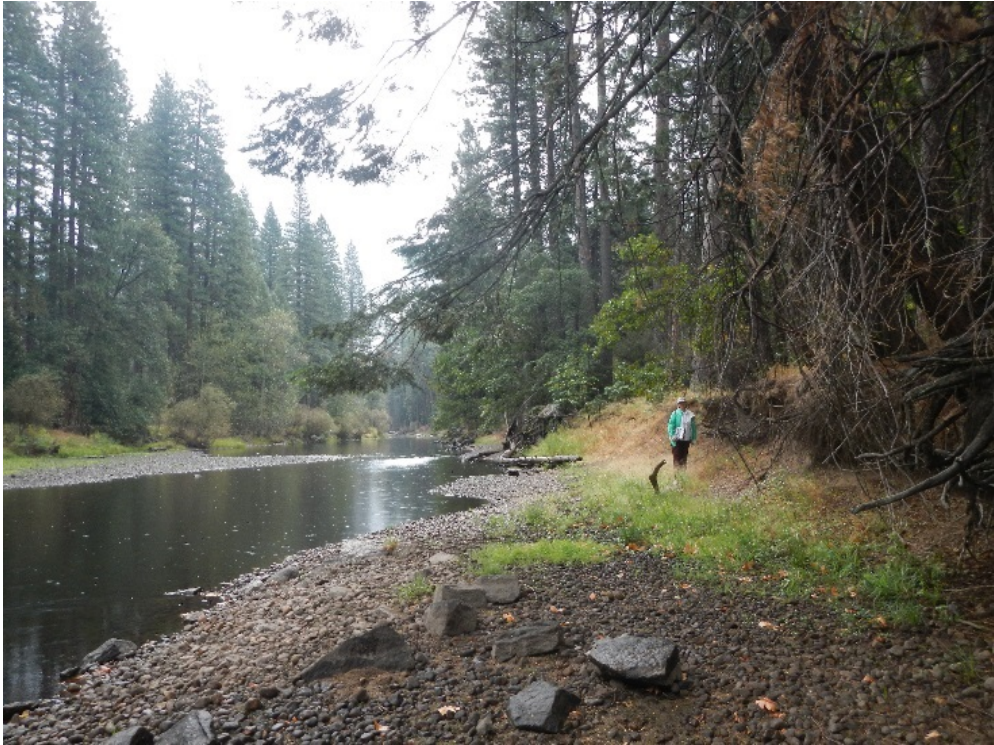
<p data-bbox="406 1906 1474 1969">LB view US: High bank with active toe erosion, lateral channel expansion (note old riprap); overwide, shallow channel</p>

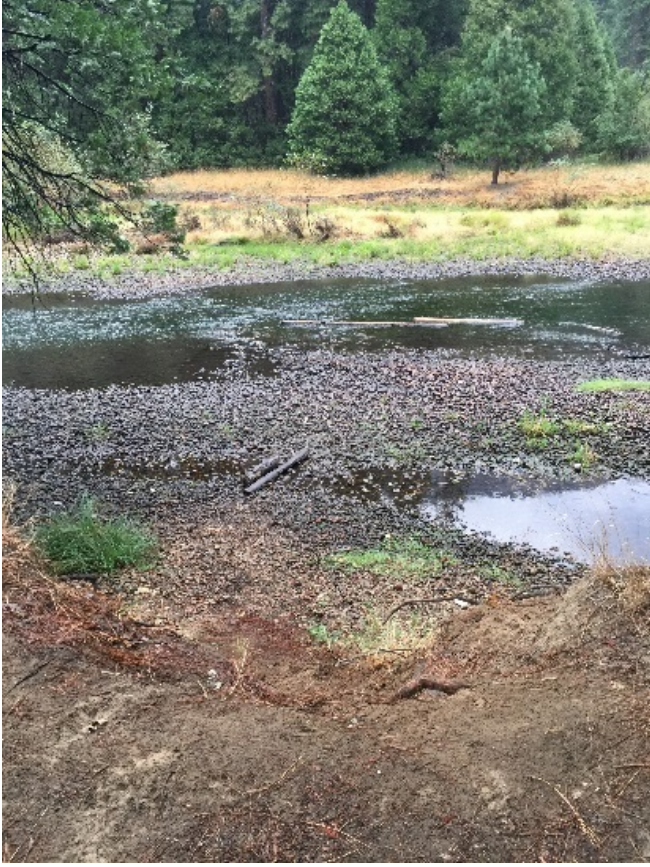
<p data-bbox="337 1087 1544 1115">LB view to RB: Overwide channel, mid-channel bar and incipient floodplain development; disconnected floodplain</p>

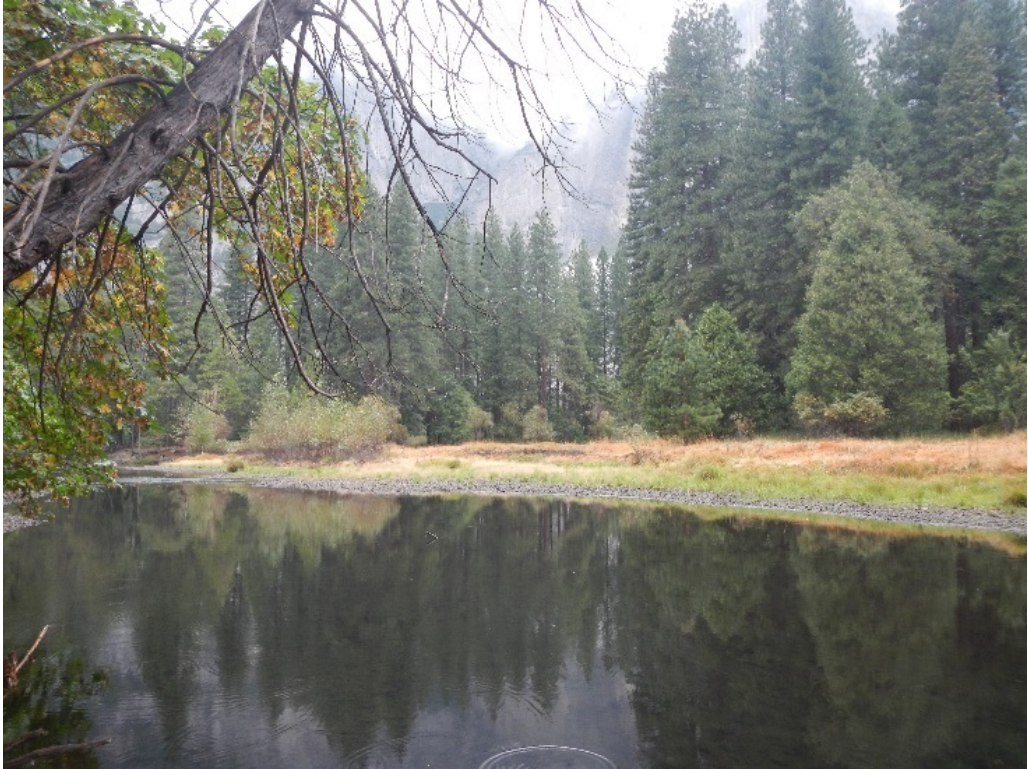
<p data-bbox="337 1906 1544 1961">LB view to RB: Overwide channel, mid-channel bar and incipient floodplain development; disconnected floodplain; opportunity to reactivate</p>

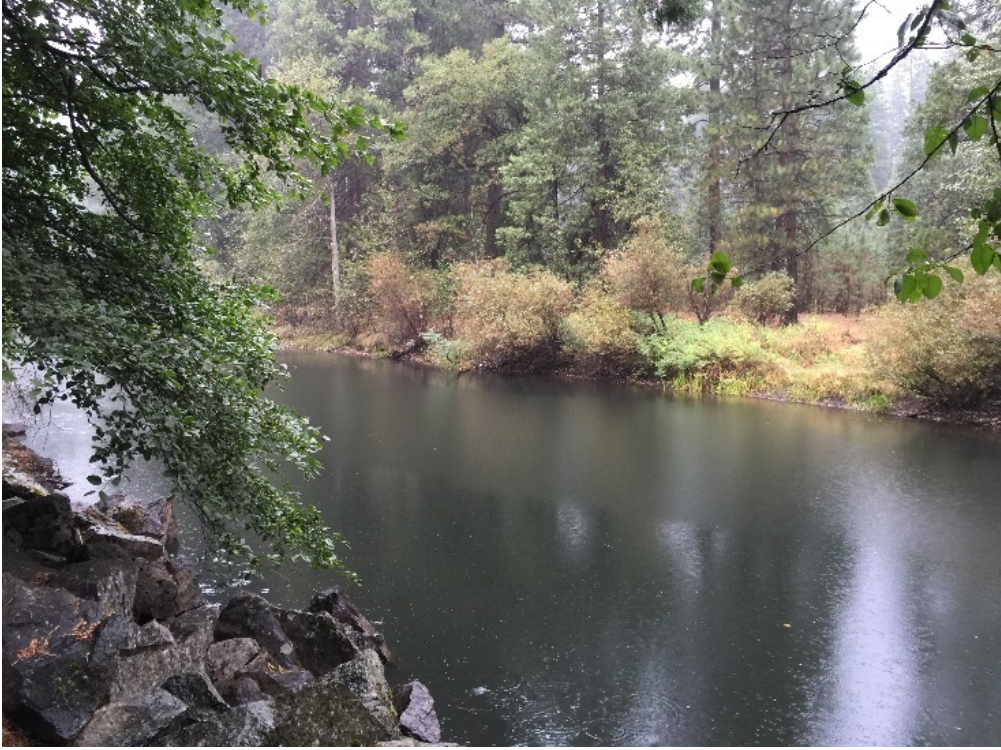
<p data-bbox="394 1837 1487 1892">RB view DS to LB: Artificial bank protection (foreground) and lateral confinement; floodplain fill removal opportunities in the right overbank (background)</p>

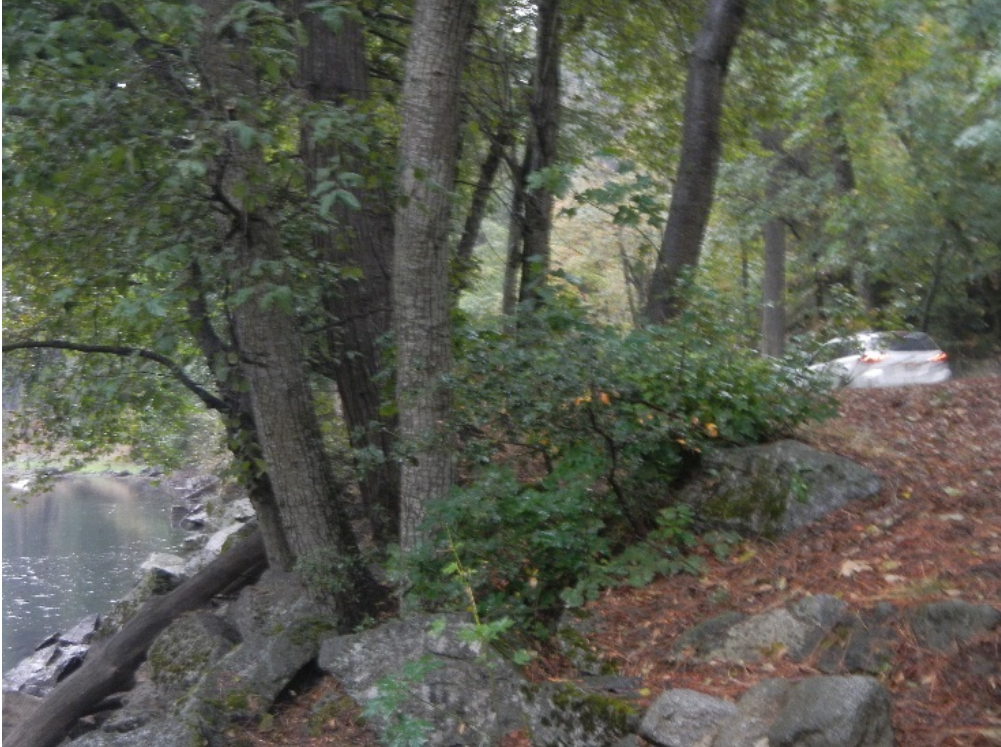
<p data-bbox="383 1913 1500 1969">LB view US: Artificial bank protection and lateral confinement (road in background); mature vegetation on compacted soils; limited recruitment, low species diversity and simplified structure</p>

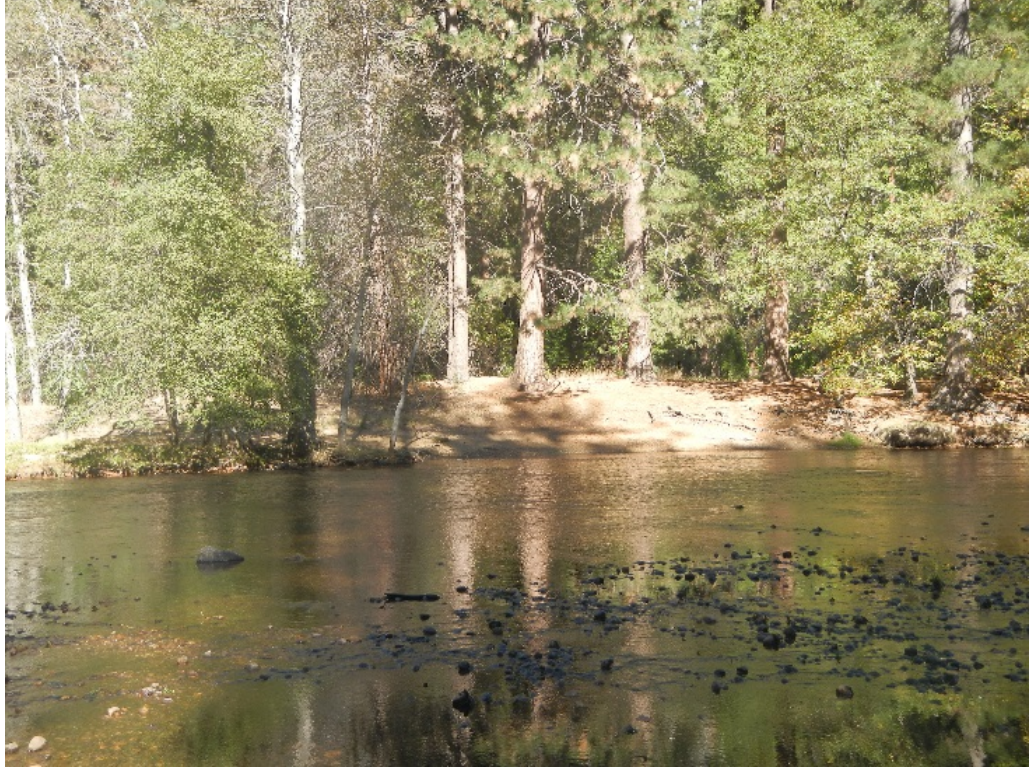
<p data-bbox="743 989 1138 1016">Bank damage from recreation access</p>
0.67 (RB)

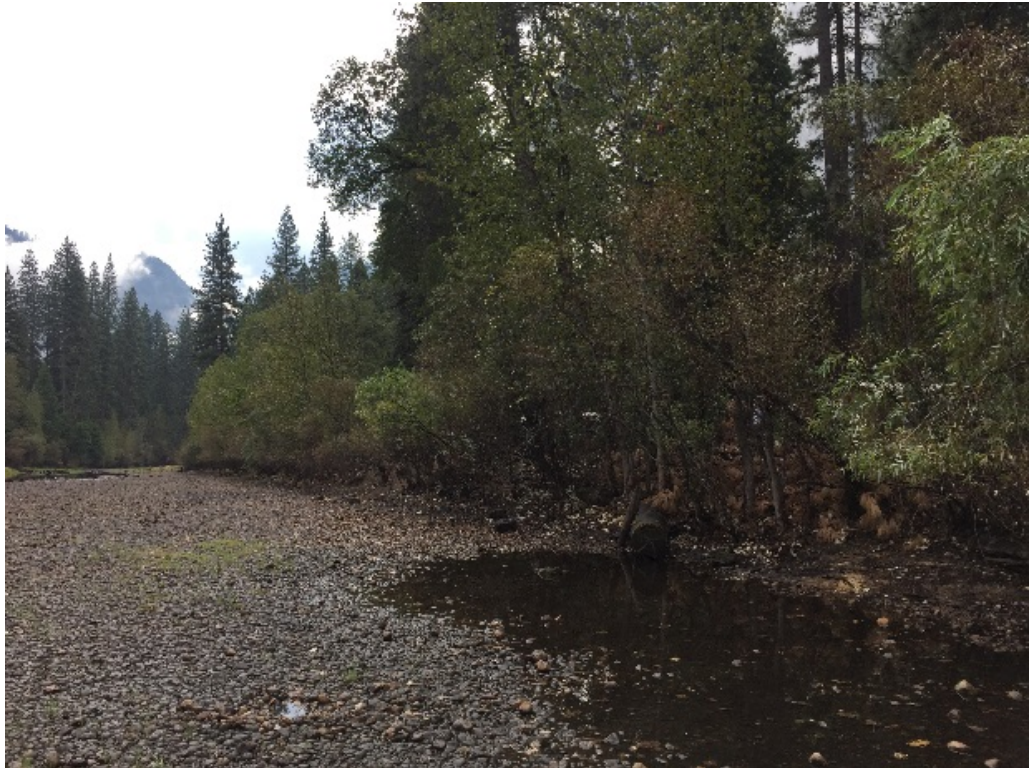
<p data-bbox="378 1835 1507 1892">DS view of planar bed channel and disconnected floodplain (RB foreground); possible channel reactivation (background)</p>

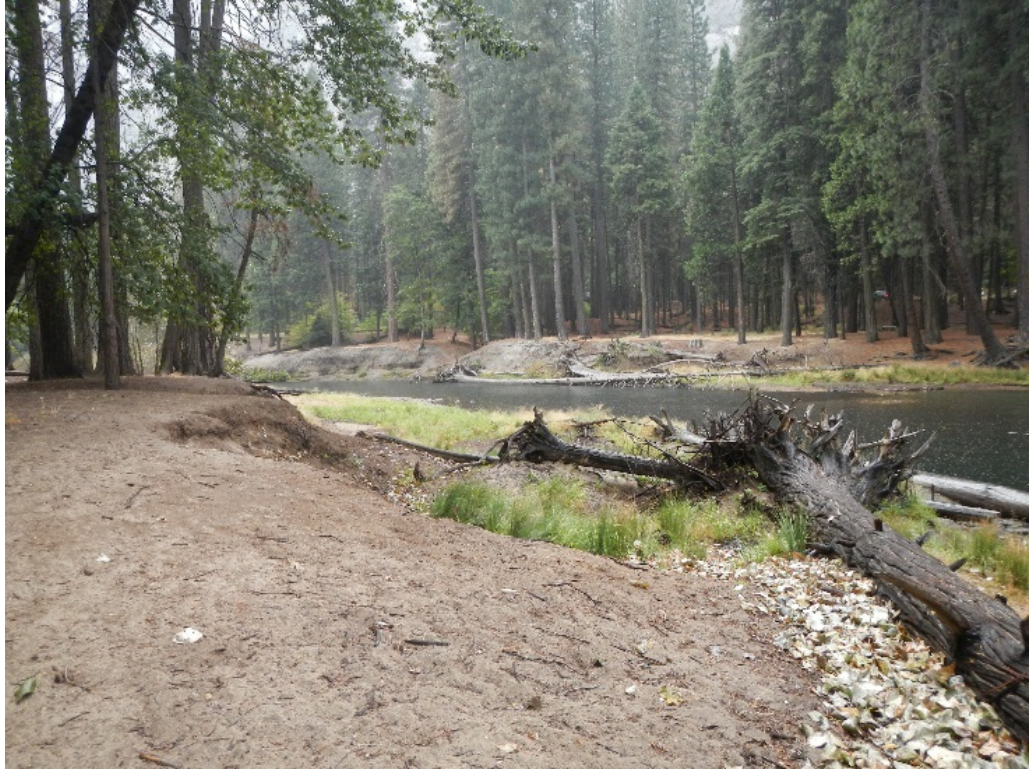
<p data-bbox="370 989 1511 1045">View US along RB towards LB: Widened channel with incipient floodplain; eroding banks with denuded and compacted soils and lack of vegetation diversity</p>

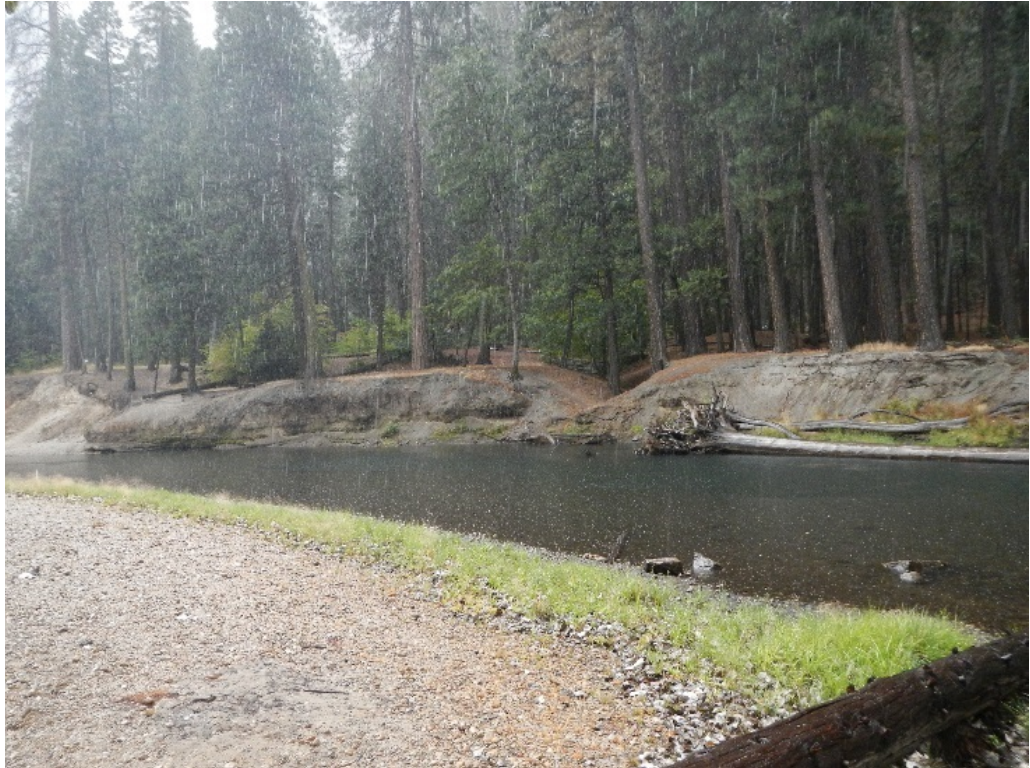
<p data-bbox="326 1835 1555 1871">View from RB to LB: High, eroding banks with simplified vegetation structure and low species diversity (old conifers)</p>

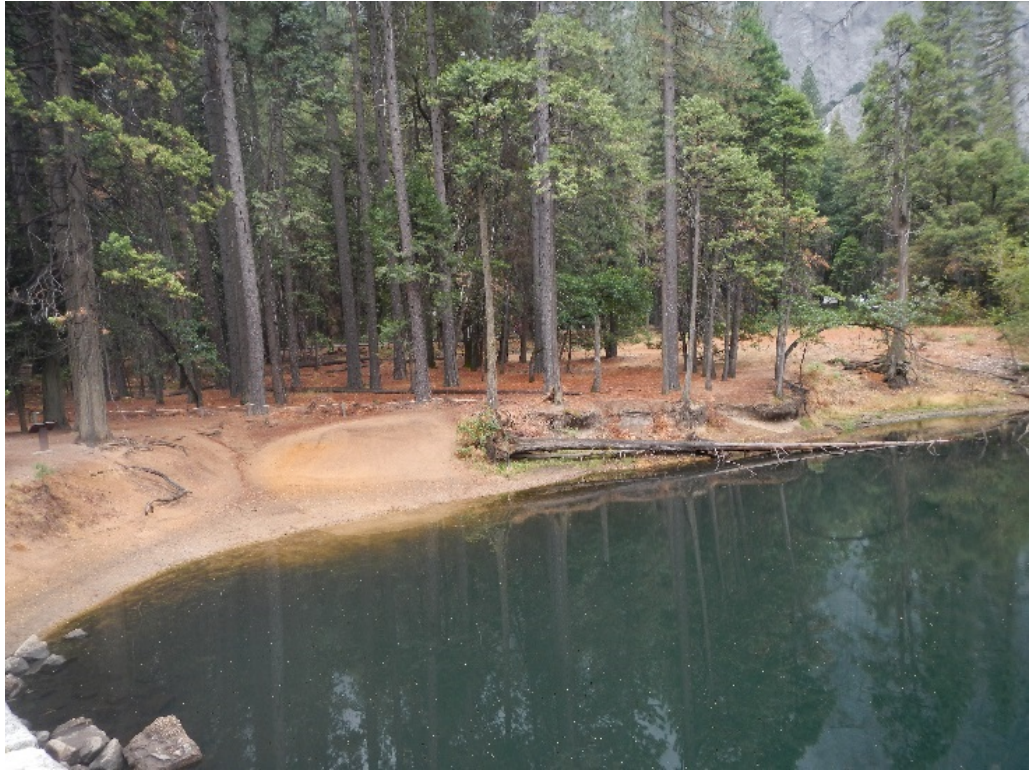
<p data-bbox="347 1835 1533 1919">LB viewed DS from Stoneman Bridge: High, eroding banks; localized scour downstream of bridge; denuded and compacted soils from recreation/boat access; simplified vegetation structure, low species diversity and minimal recruitment</p>

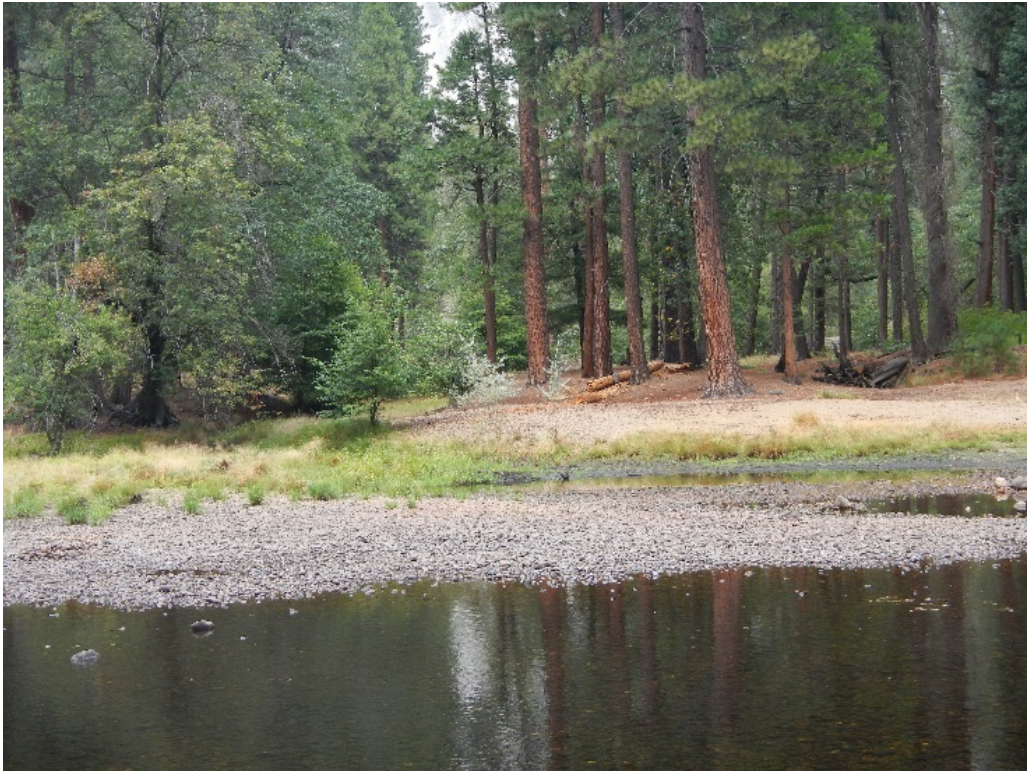
<p data-bbox="386 1493 1495 1545">View of RB from LB: Simplified vegetation structure, minimal vegetation recruitment, and denuded and/or compacted soils in the overbank</p>

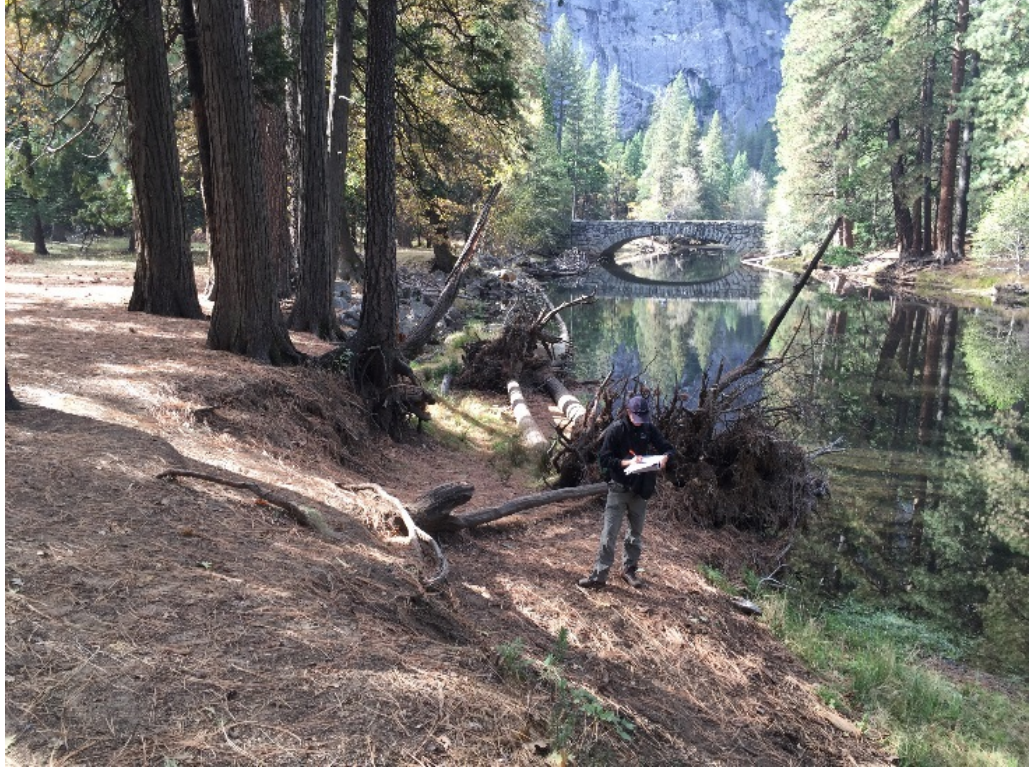
<p data-bbox="347 989 1536 1045">LB view DS to Stoneman Bridge: Opportunities for partial riprap removal and strategically located flow deflecting ELFs</p>
1.3-1.37 (LB)

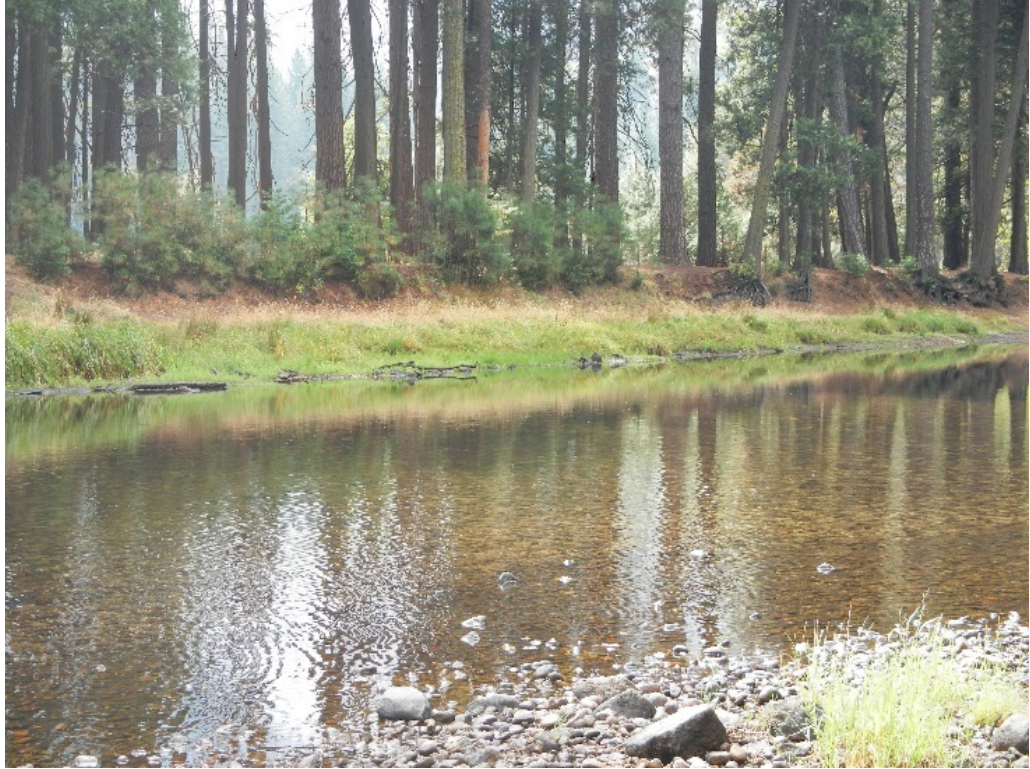
<p data-bbox="347 1864 1536 1921">DS view of LB from RB: Overwide channel disconnected from floodplain, with incipient floodplain; denuded and/or compacted soils at top of bank</p>

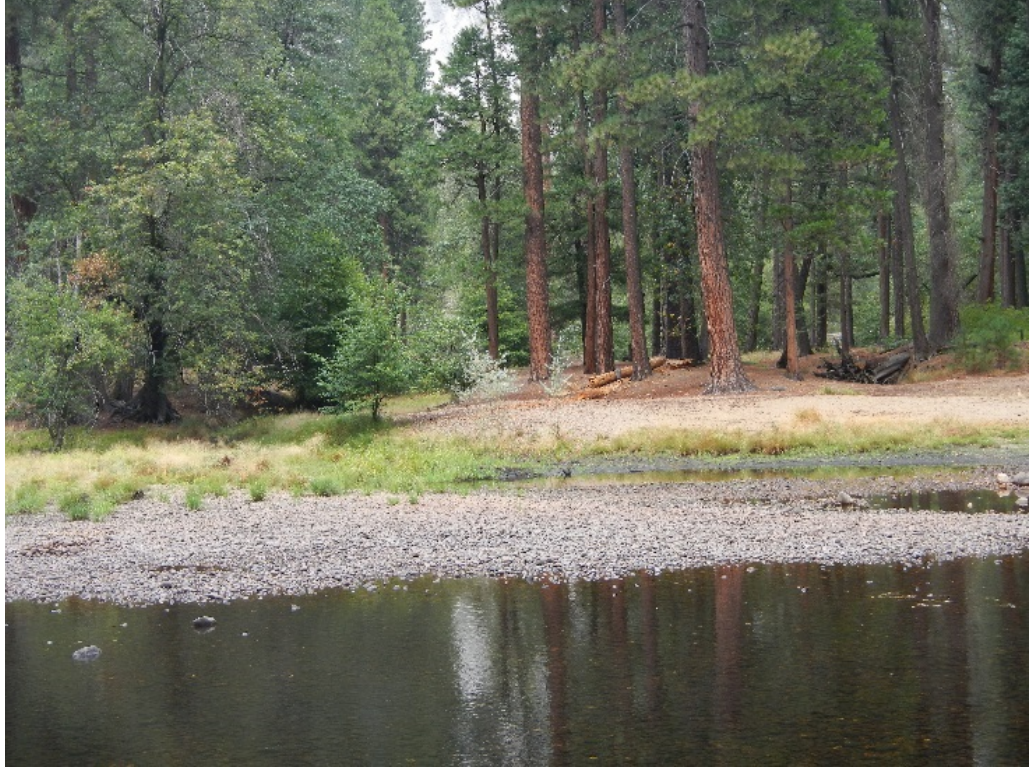
<p data-bbox="358 989 1528 1045">View of RB from LB: Overwide channel disconnected from floodplain, with incipient floodplain; denuded and/or compacted soils at top of bank</p>

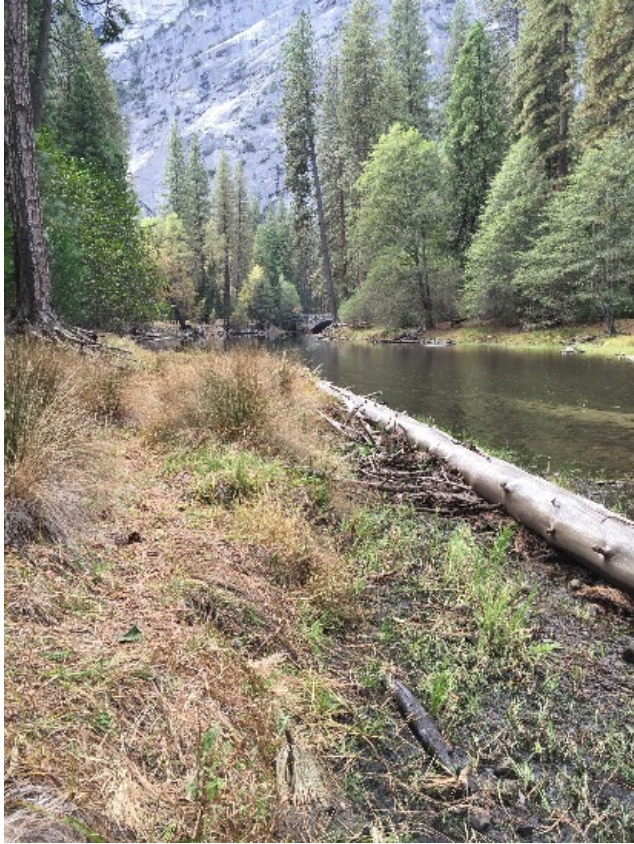
<p data-bbox="469 1913 1414 1940">RB view US: Incipient floodplain with analog for channel toe protection/sediment trapping</p>

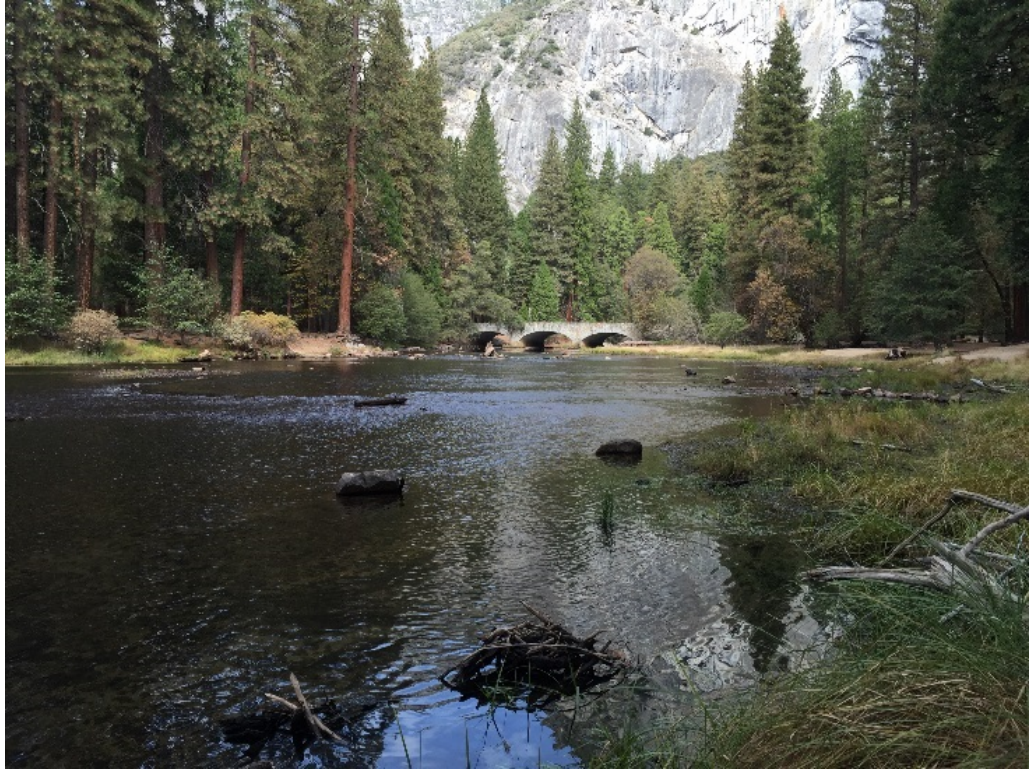
<p data-bbox="511 987 1372 1018">US view: Overview, simplified channel with no distinct bedform or profile diversity</p>

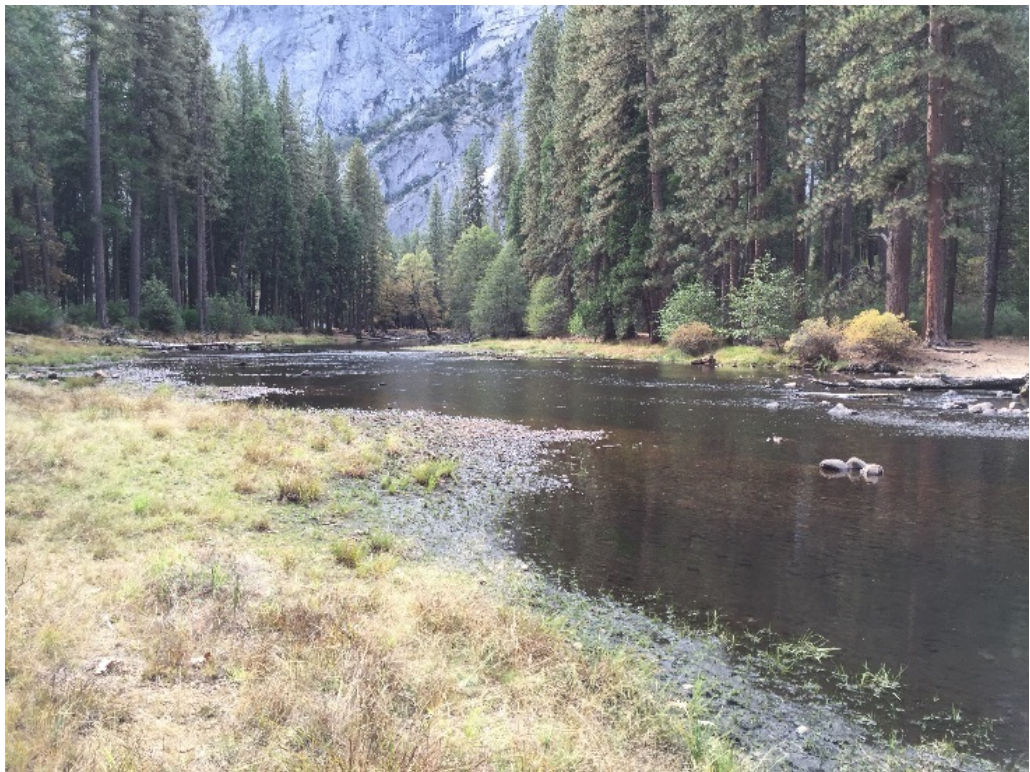
<p data-bbox="511 1806 1372 1837">DS view: Overview, simplified channel lacking distinct bedform or profile diversity</p>

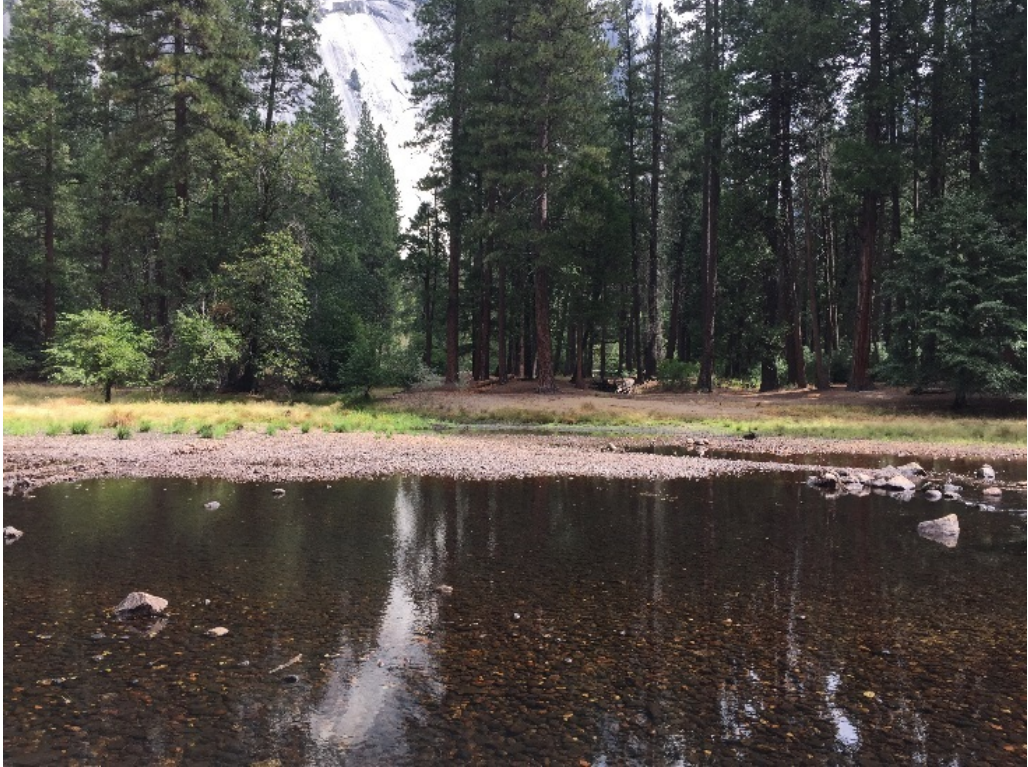
<p data-bbox="350 989 1531 1045">View from mid-channel to LB: Disconnected floodplain/overflow swale discharge; denuded and compacted soils from recreation access on LB</p>

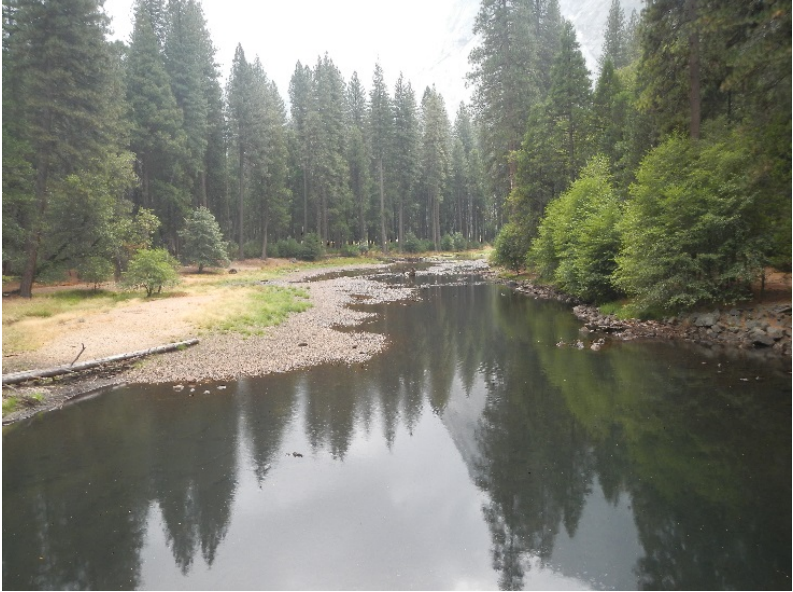
<p data-bbox="354 814 1533 869">DS view from Ahwahnee Bridge: Asymmetrical channel shape upstream of LB overflow channel outfall opposite vegetated artificial protection on RB</p>
RM 1.51 – 1.74	<i>Reach 6 – Ahwahnee Bridge to Sugar Pine Bridge</i>
	Pending investigation of reach-specific study
RM 1.74 – 1.97	<i>Reach 7 – Sugar Pine Bridge to RM 1.97²</i>
1.81-1.83 (RB)

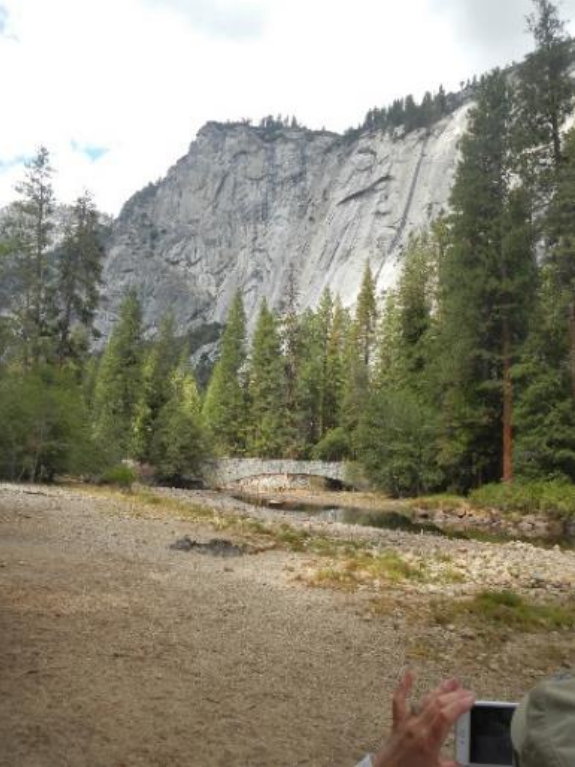
<p data-bbox="334 993 1549 1045">DS view to Sugar Pine bridge from LB; disconnected LB floodplain and entrenched channel; Racked LWD blocking overflow swale entrance on LB US of the bridge</p>

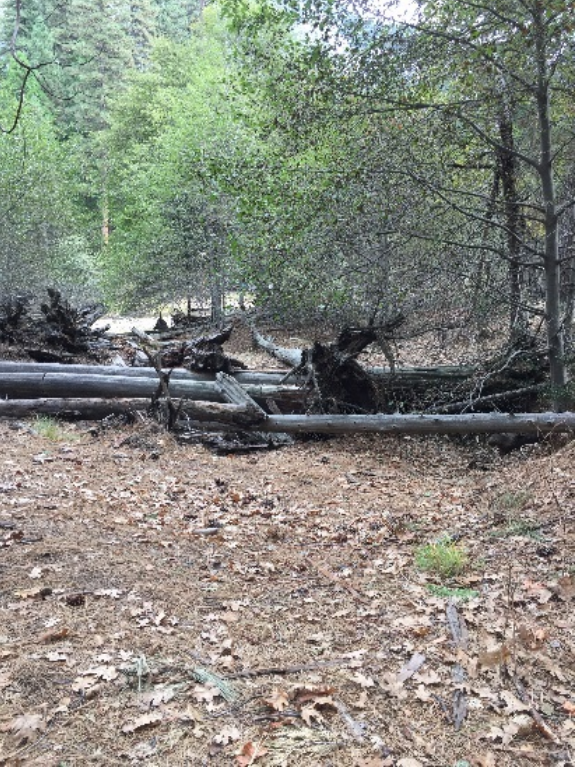
<p data-bbox="621 1841 1239 1871">View from LB onto floodplain: Example swale to reactivate</p>

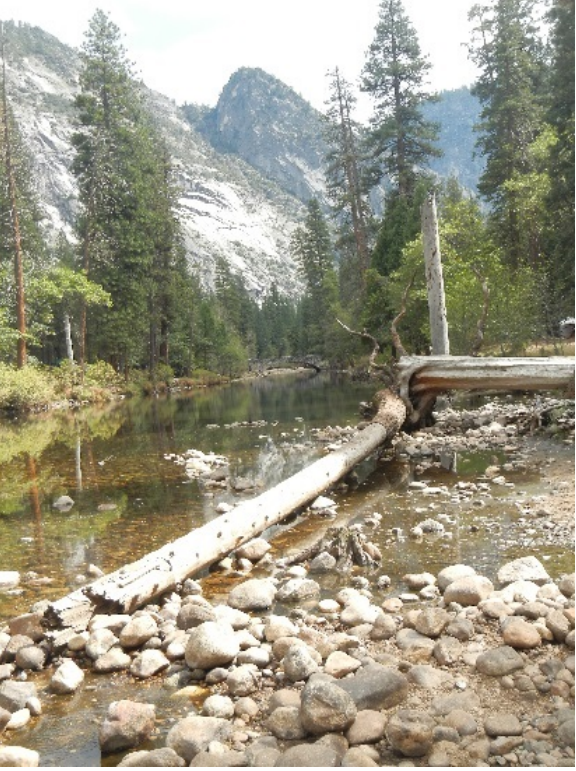
<p data-bbox="337 993 1549 1045">US view along LB: Overwide channel with remnant standing and fallen trees, limited sediment storage; opportunity for reconstructed bank</p>
1.95-1.98 (RB)

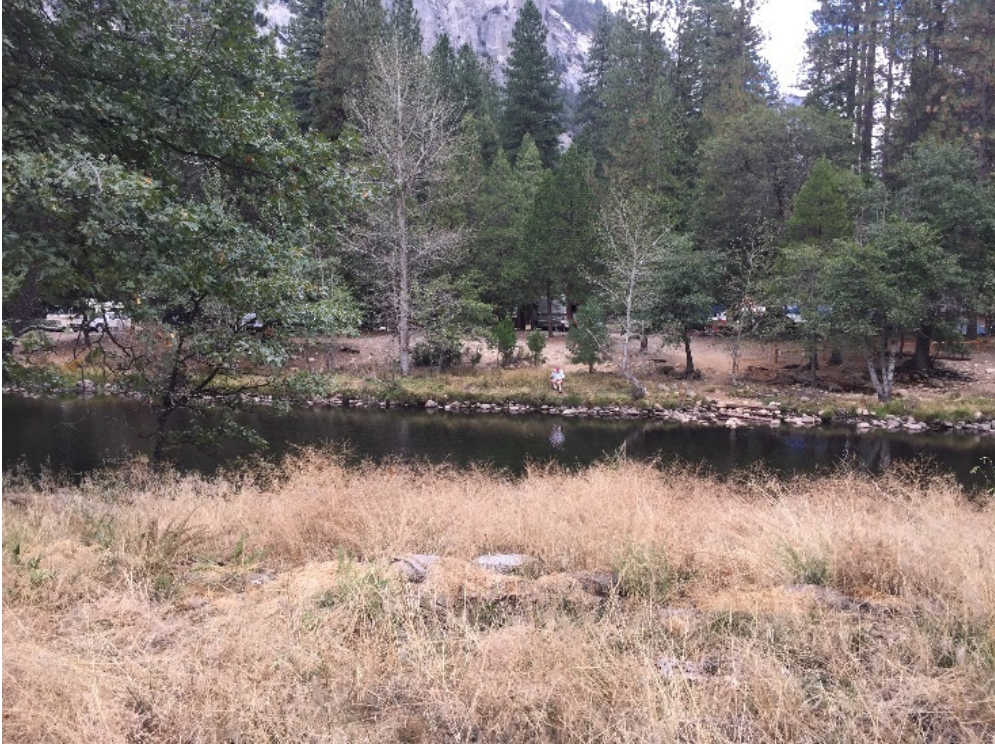
<p data-bbox="435 1843 1453 1875">View RB to LB: Recreation access impacts on floodplain soils and vegetation and within channel</p>

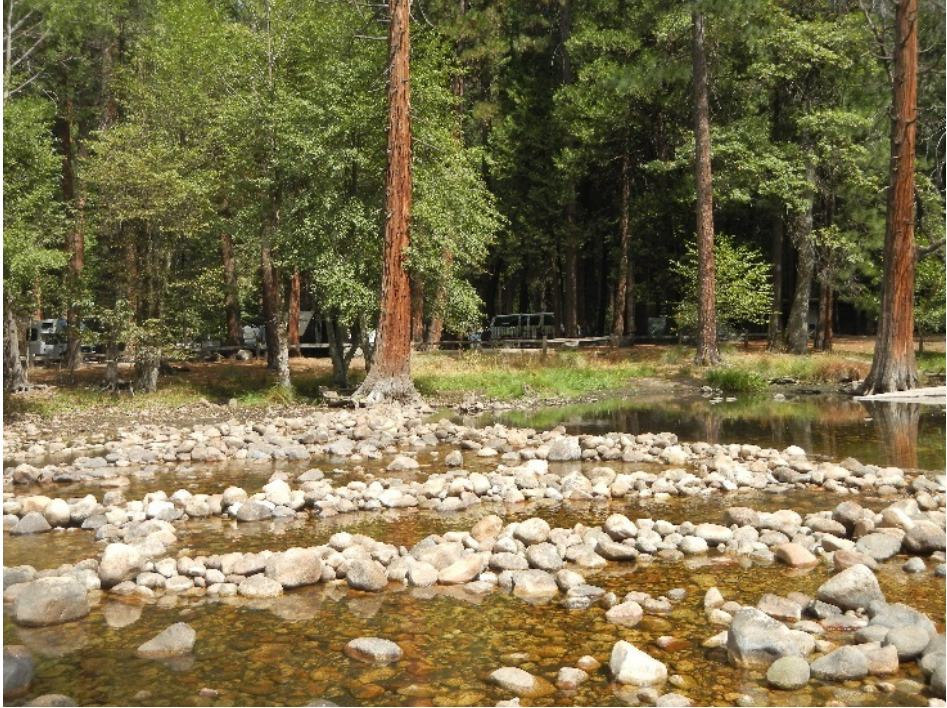
<p data-bbox="431 930 1451 957">View RB to LB: Recreation access impacts on floodplain soils and vegetation and within channel</p>
<p>RM 1.97 – 2.18 Reach 8 – RM 1.97 to Clarks Bridge</p>	
1.97-2.14 (RB)
