Merced River Riparian Corridor Restoration in Yosemite Valley

Restoration Concept
Designs

March 2016

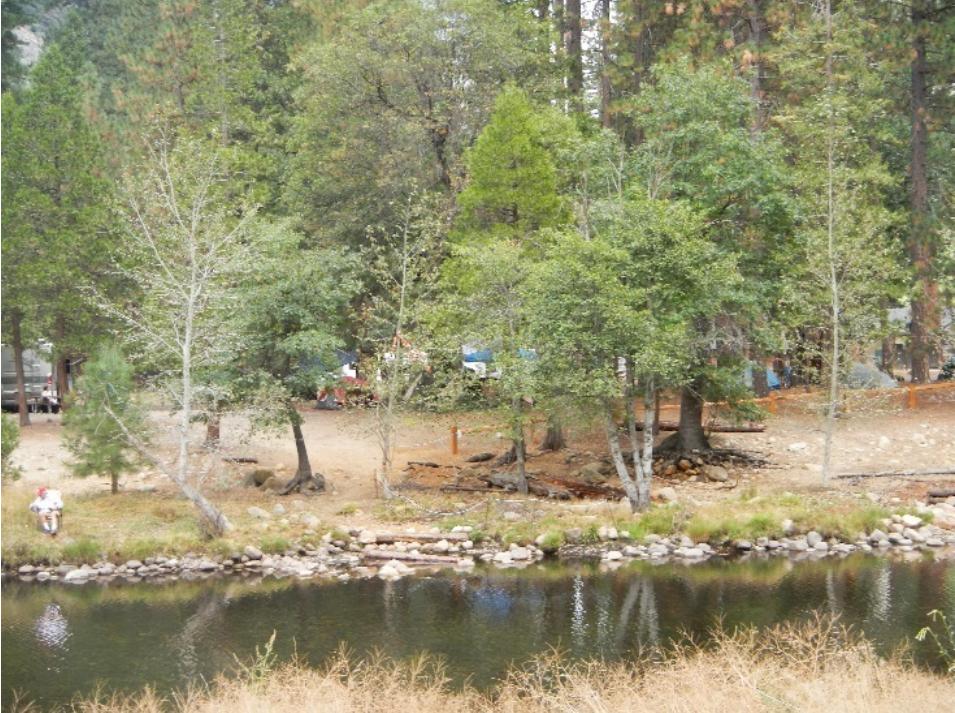
<p data-bbox="362 1759 1520 1816">RB viewed from LB: Stabilized bank toe and plantings (foreground); denuded and compacted soils, recreation access impacts (background)</p>

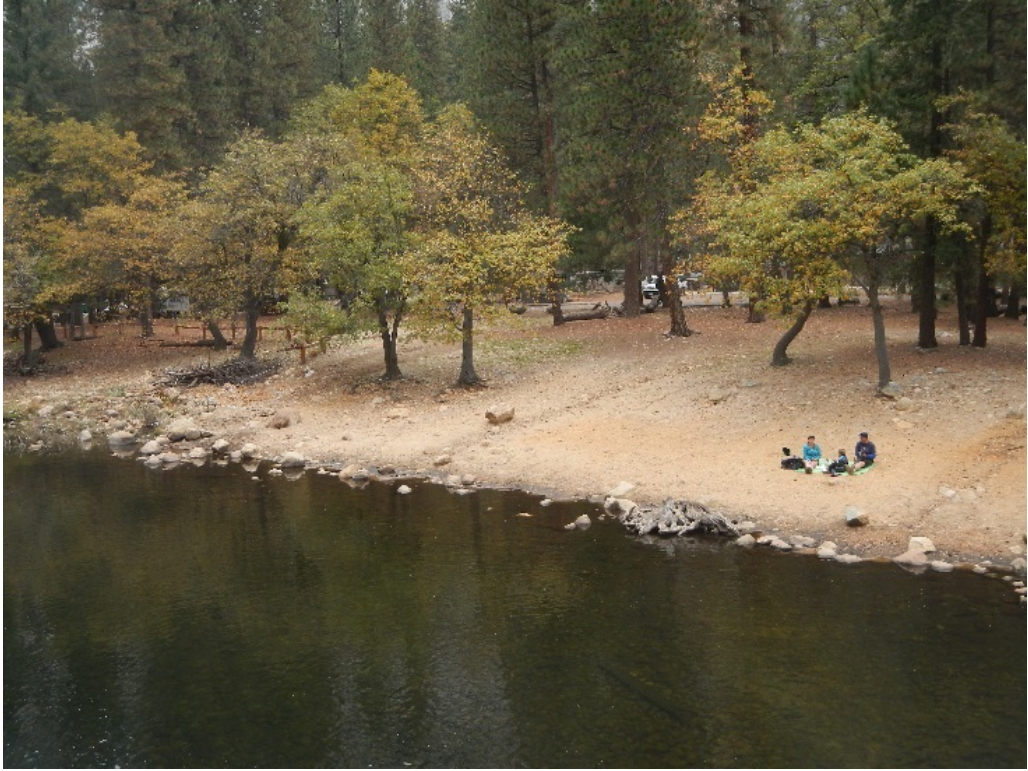
<p data-bbox="349 1906 1536 1959">View DS to RB from Clark's Bridge: Denuded and compacted soils downstream of Clarks Bridge; hardened river access needs</p>

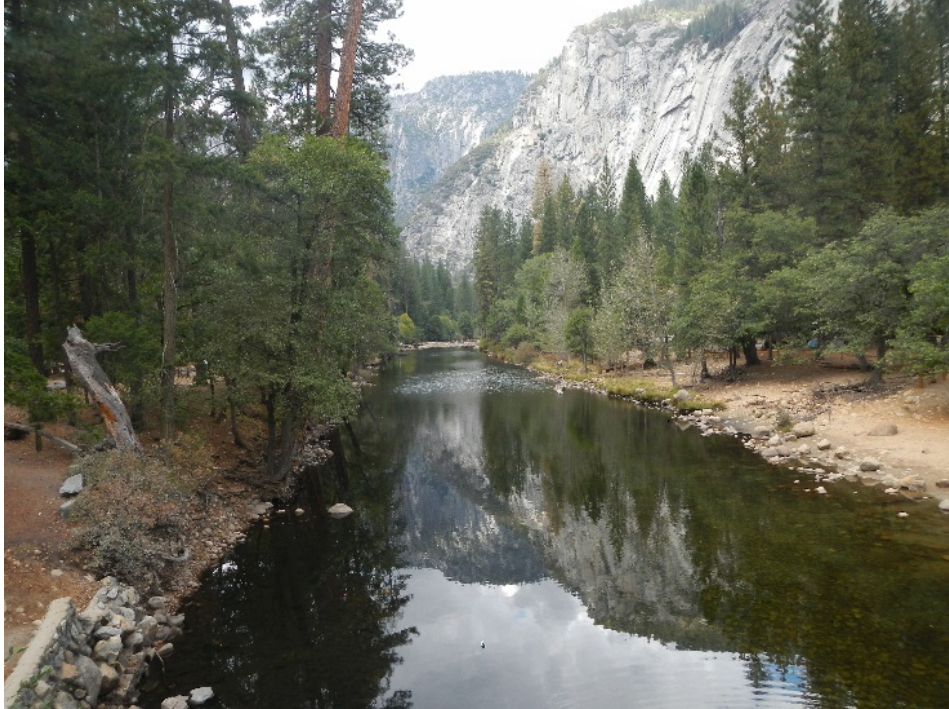
<p data-bbox="355 1740 1528 1793">DS view from Clarks Bridge: Straight, uniform and simple channel, artificial bank protection (LB); Denuded and compacted soils from recreation access (both banks); bank plantings (RB, background)</p>

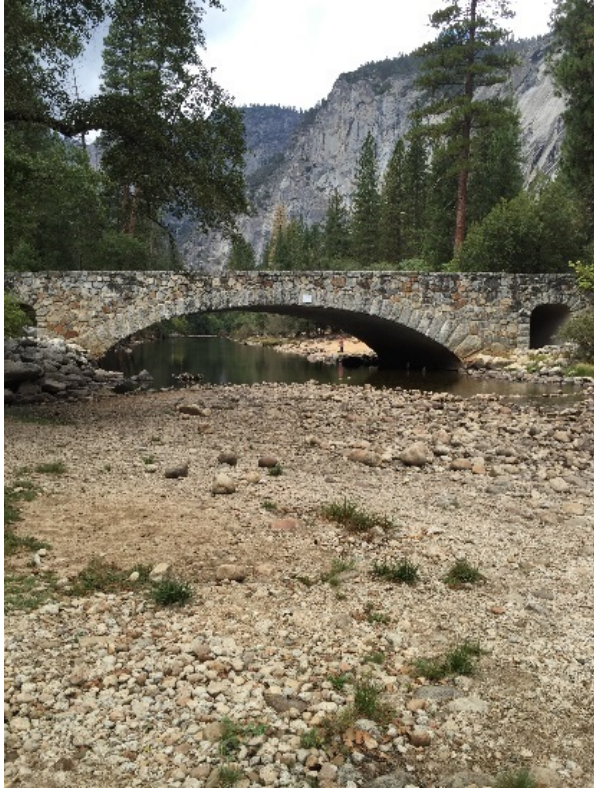
<p data-bbox="493 1045 1390 1073">DS view to Clarks Bridge from LB: Retain riprap at bridge approaches on both banks</p>
2.21-2.24 (LB)

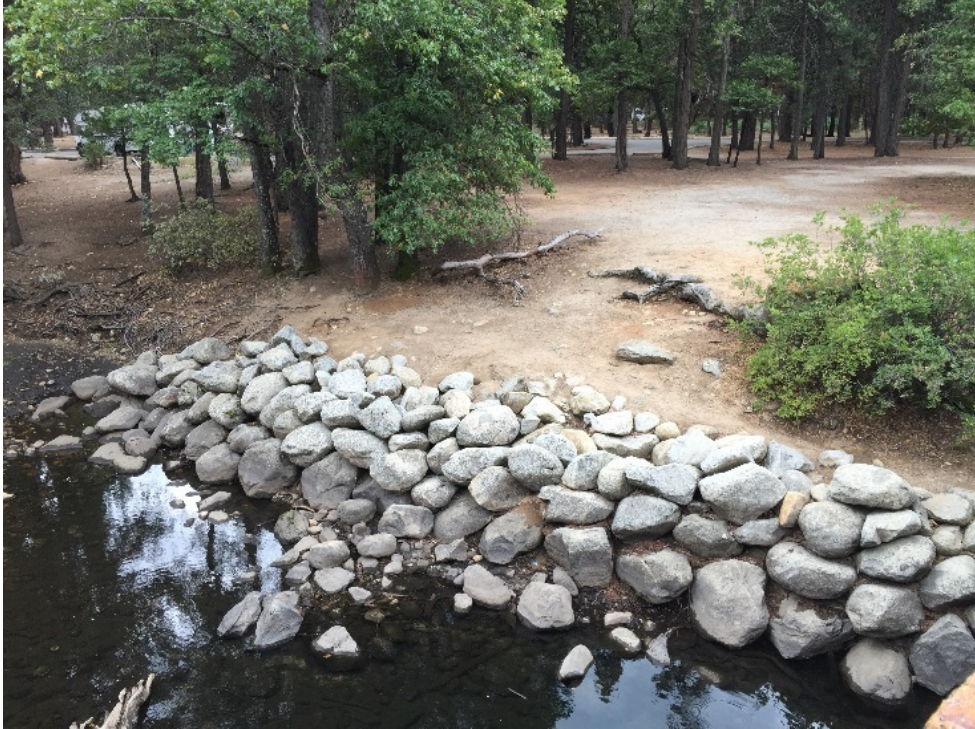
<p data-bbox="375 1856 1487 1913">US view from Clarks Bridge to LB: Bank riprap to retain (foreground); denuded and compacted soils from recreation access; Dump station removal and stormwater management issues (background)</p>

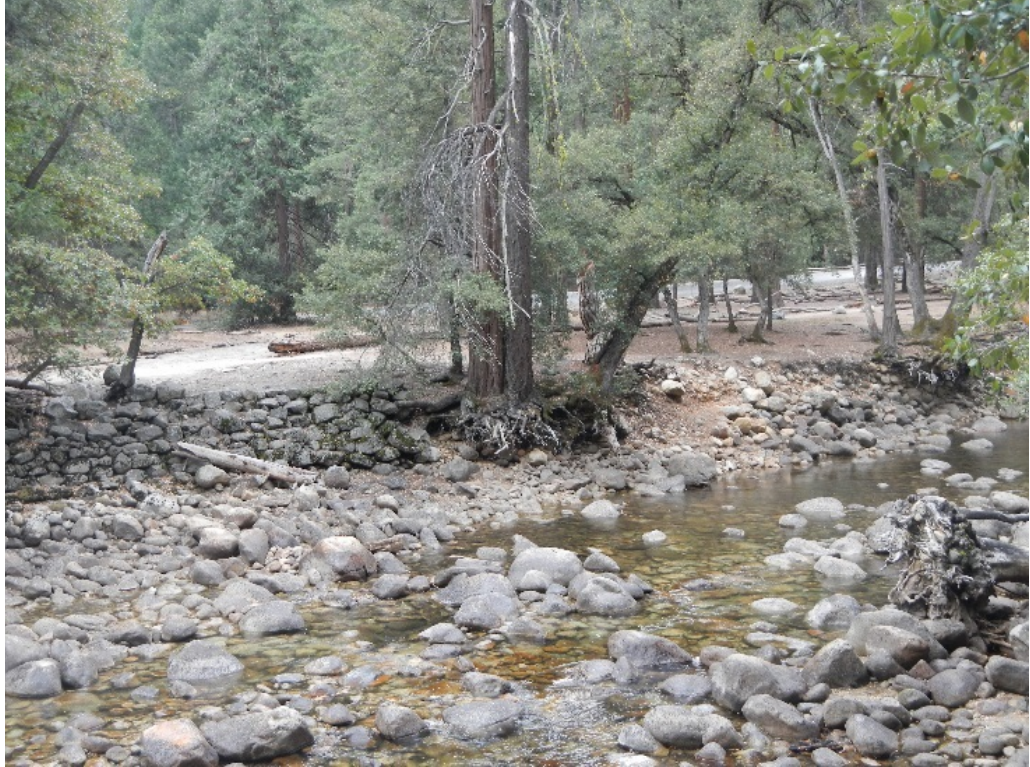
<p data-bbox="342 989 1539 1045">View from LB to RB: Artificial bank protection and bank face erosion (foreground); denuded and compacted soils, lack of vegetation recruitment and simplified vegetation structure</p>
2.93-2.95 (RB)

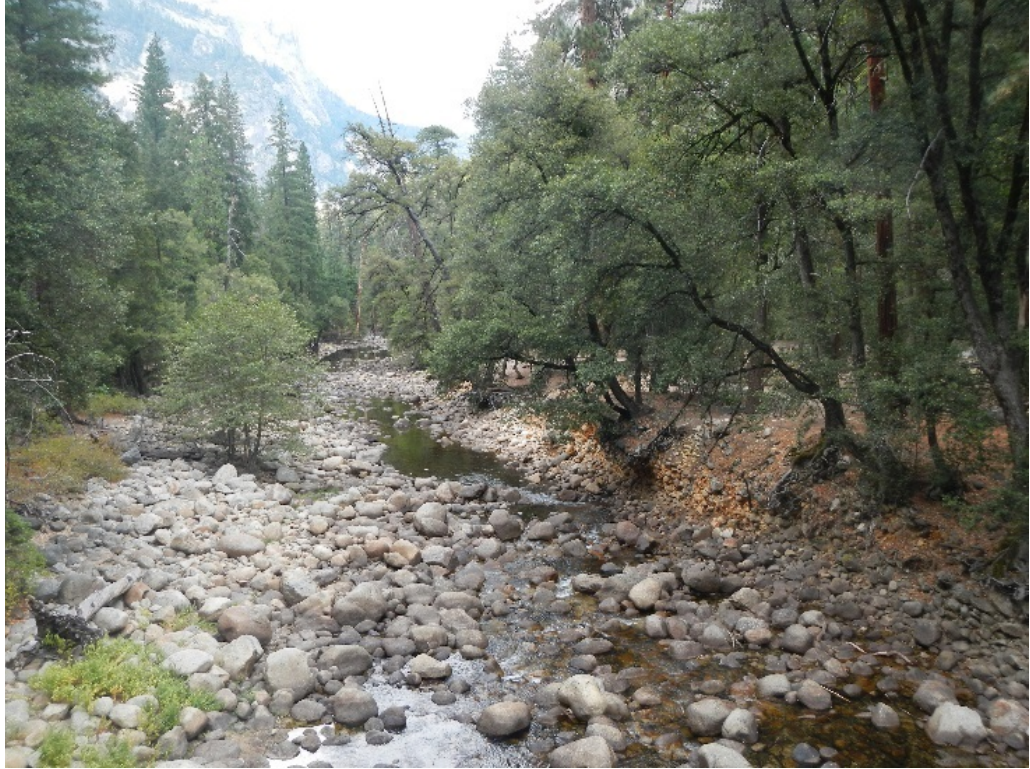
<p data-bbox="326 1864 1555 1921">DS view of RB from Happy Isles Bridge: Entrenched channel with high, eroding banks, artificial bank protection, and minimal vegetation recruitment</p>

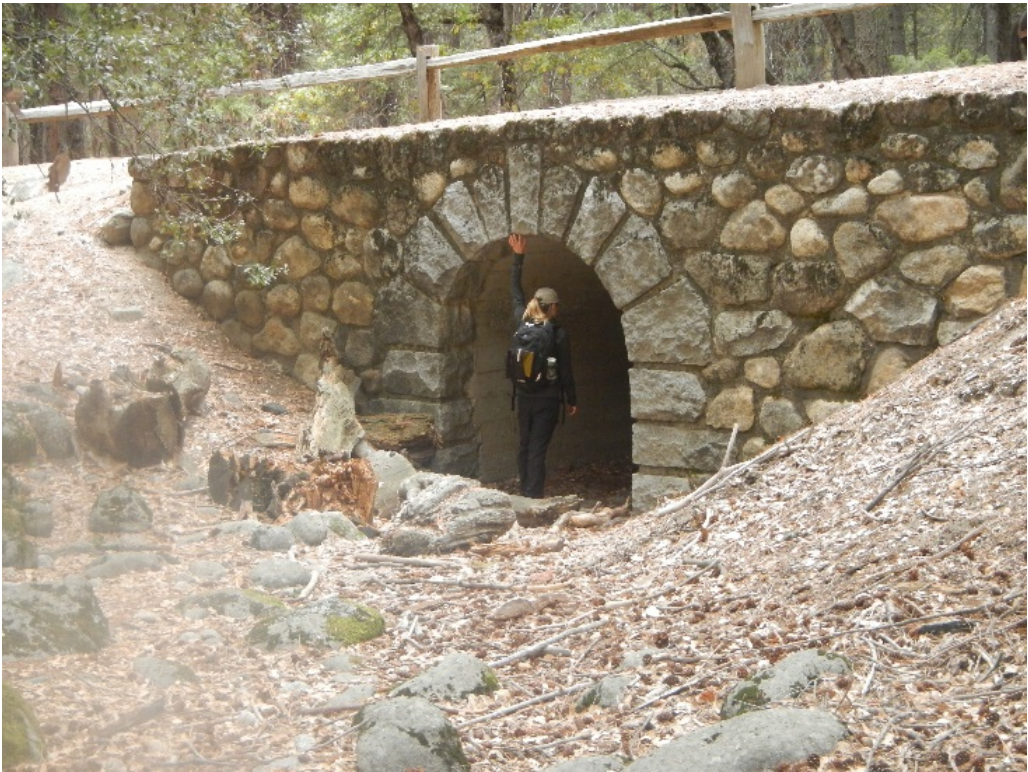
<p data-bbox="682 976 1201 1008">DS view of the blocked overflow channel culvert</p>
