# Little Round Top

Cultural Landscape Report, Treatment & Management Plan

**March 2nd , 2012**

**Einhorn, Yaffee Prescott**  
Architecture & Engineering  
Albany, New York

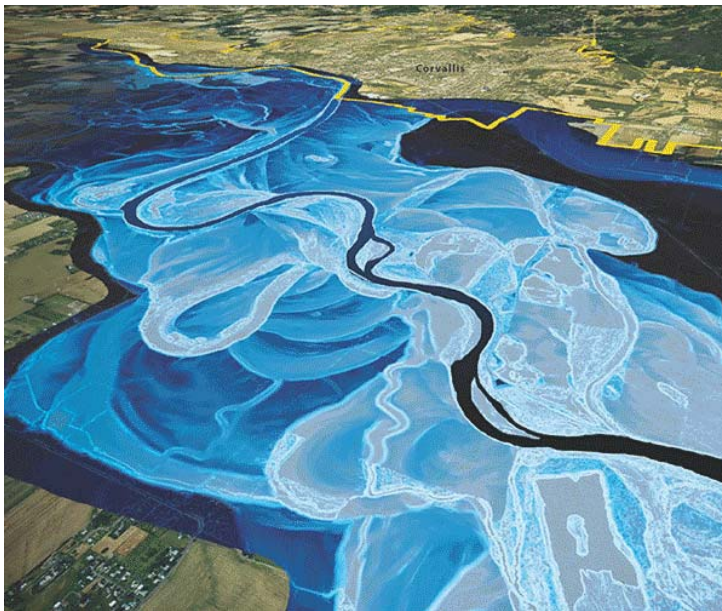
Figure 1.08. LIDAR topography mapping used to document the historic channels of the Willamette River near Corvallis, Oregon (Image by Oregon Department of Geology and Mineral Industries, 2010).

- Conduct LIDAR topography mapping at Little Round Top.** LIDAR (Light Detection and Ranging) is an optical remote sensing technology used to measure distance (Figure 1.08). When mounted on an aircraft, downward-looking LIDAR instruments can be used to map topography and landscape features with an extremely high resolution. A National Aeronautics and Space Administration (NASA)/United States Geological Survey (USGS) collaboration known as the Experimental Advanced Airborne LIDAR (EAARL) system has yielded highly detailed topographic maps for several National Park Service properties along the east coast.<sup>8</sup> This data has been used to monitor changes in vegetation, terrain and water levels as well as to discover potential archaeological sites. A LIDAR survey of Little

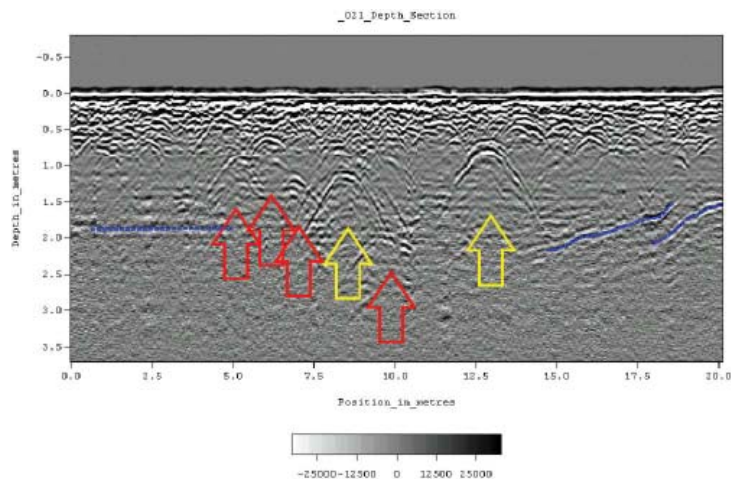
Figure 1.09. Ground-penetrating radar profile collected on an historic cemetery in Alabama. Yellow arrows indicate distinct reflections, probably associated with human burials. Red arrows indicate less distinct reflections, which may be associated with human burials. Blue lines are smaller deflections, possibly instances of bedrock or tree roots (Image by Tapatio, 2007).

- Utilize ground-penetrating radar at Sykes Avenue.** Although historic research has found references for the “obliteration” of the original Sykes Avenue and Chamberlain Avenue alignments, the design team found nothing to document the provenance of the retaining walls constructed along the Sykes Avenue original alignment. There is speculation amongst park historians that portions of the historic retaining walls remain beneath Skyes Avenue as it is currently aligned. Ground-penetrating radar is a noninvasive detection method that sends high-frequency radio waves into the ground (Figure 1.09). Whenever a wave bounces off of a buried object that has a different density from the materials around it, that variation is recorded. A ground-penetrating radar survey of Sykes Avenue could help determine whether the historic Sykes Avenue retaining walls are still extant without having to disturb the potentially archaeologically sensitive sites beneath the roadway.

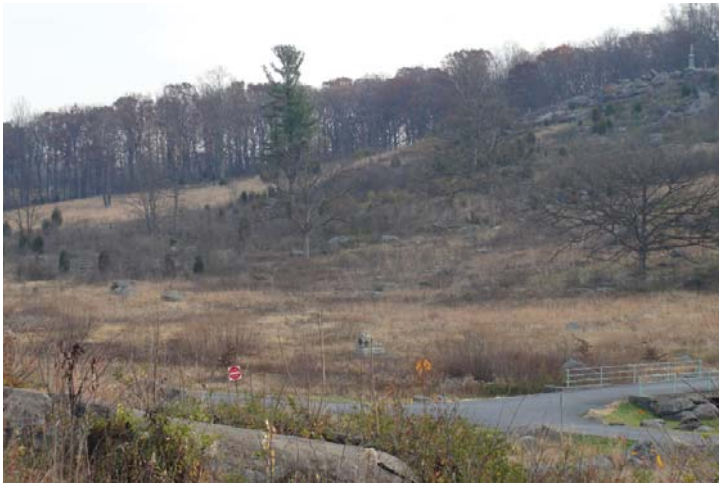
Figure 2.04. View from Devil's Den to Little Round Top. The intersection of Crawford and Warren Avenues is in the foreground, with the Warren Avenue bridge across Plum Run at the extreme right. An area of moderate sensitivity for prehistoric archeological resources lies between Plum Run and the beginning of the steeper rock-strewn slopes. The 1893/4 - 1917 electric railroad (GETT 00035) ran from left to right across this landform in the area to the rear of the 40th New York Infantry monument (Photo by Hunter Research, 2010).

In terms of prehistoric potential, the fairly level areas of Watchung silt loam on slightly elevated ground on the west side of Plum Run are however considered to have the highest potential to contain archeological resources. Some disturbance of any such earlier resources can be expected from the 1893 to 1917 electric railroad (GETT 00035; 36Ad282) (Figures 2.04-2.05).

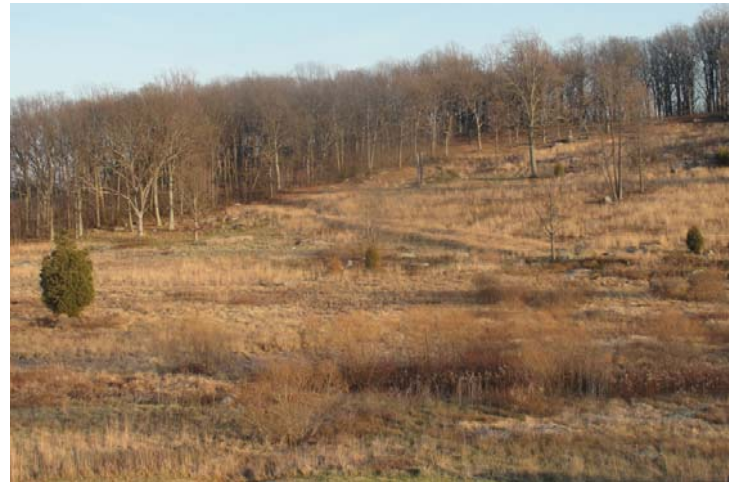
Figure 2.05. View from Houck's Ridge towards the northern end of Little Round Top with Plum Run in the center foreground. The bed for the 1893/4 - 1917 electric railroad is clearly visible crossing from the lower right to the upper left. An area of moderate sensitivity for prehistoric archeological resources lies between Plum Run and the railroad bed. (Photo by Hunter Research, 2010).

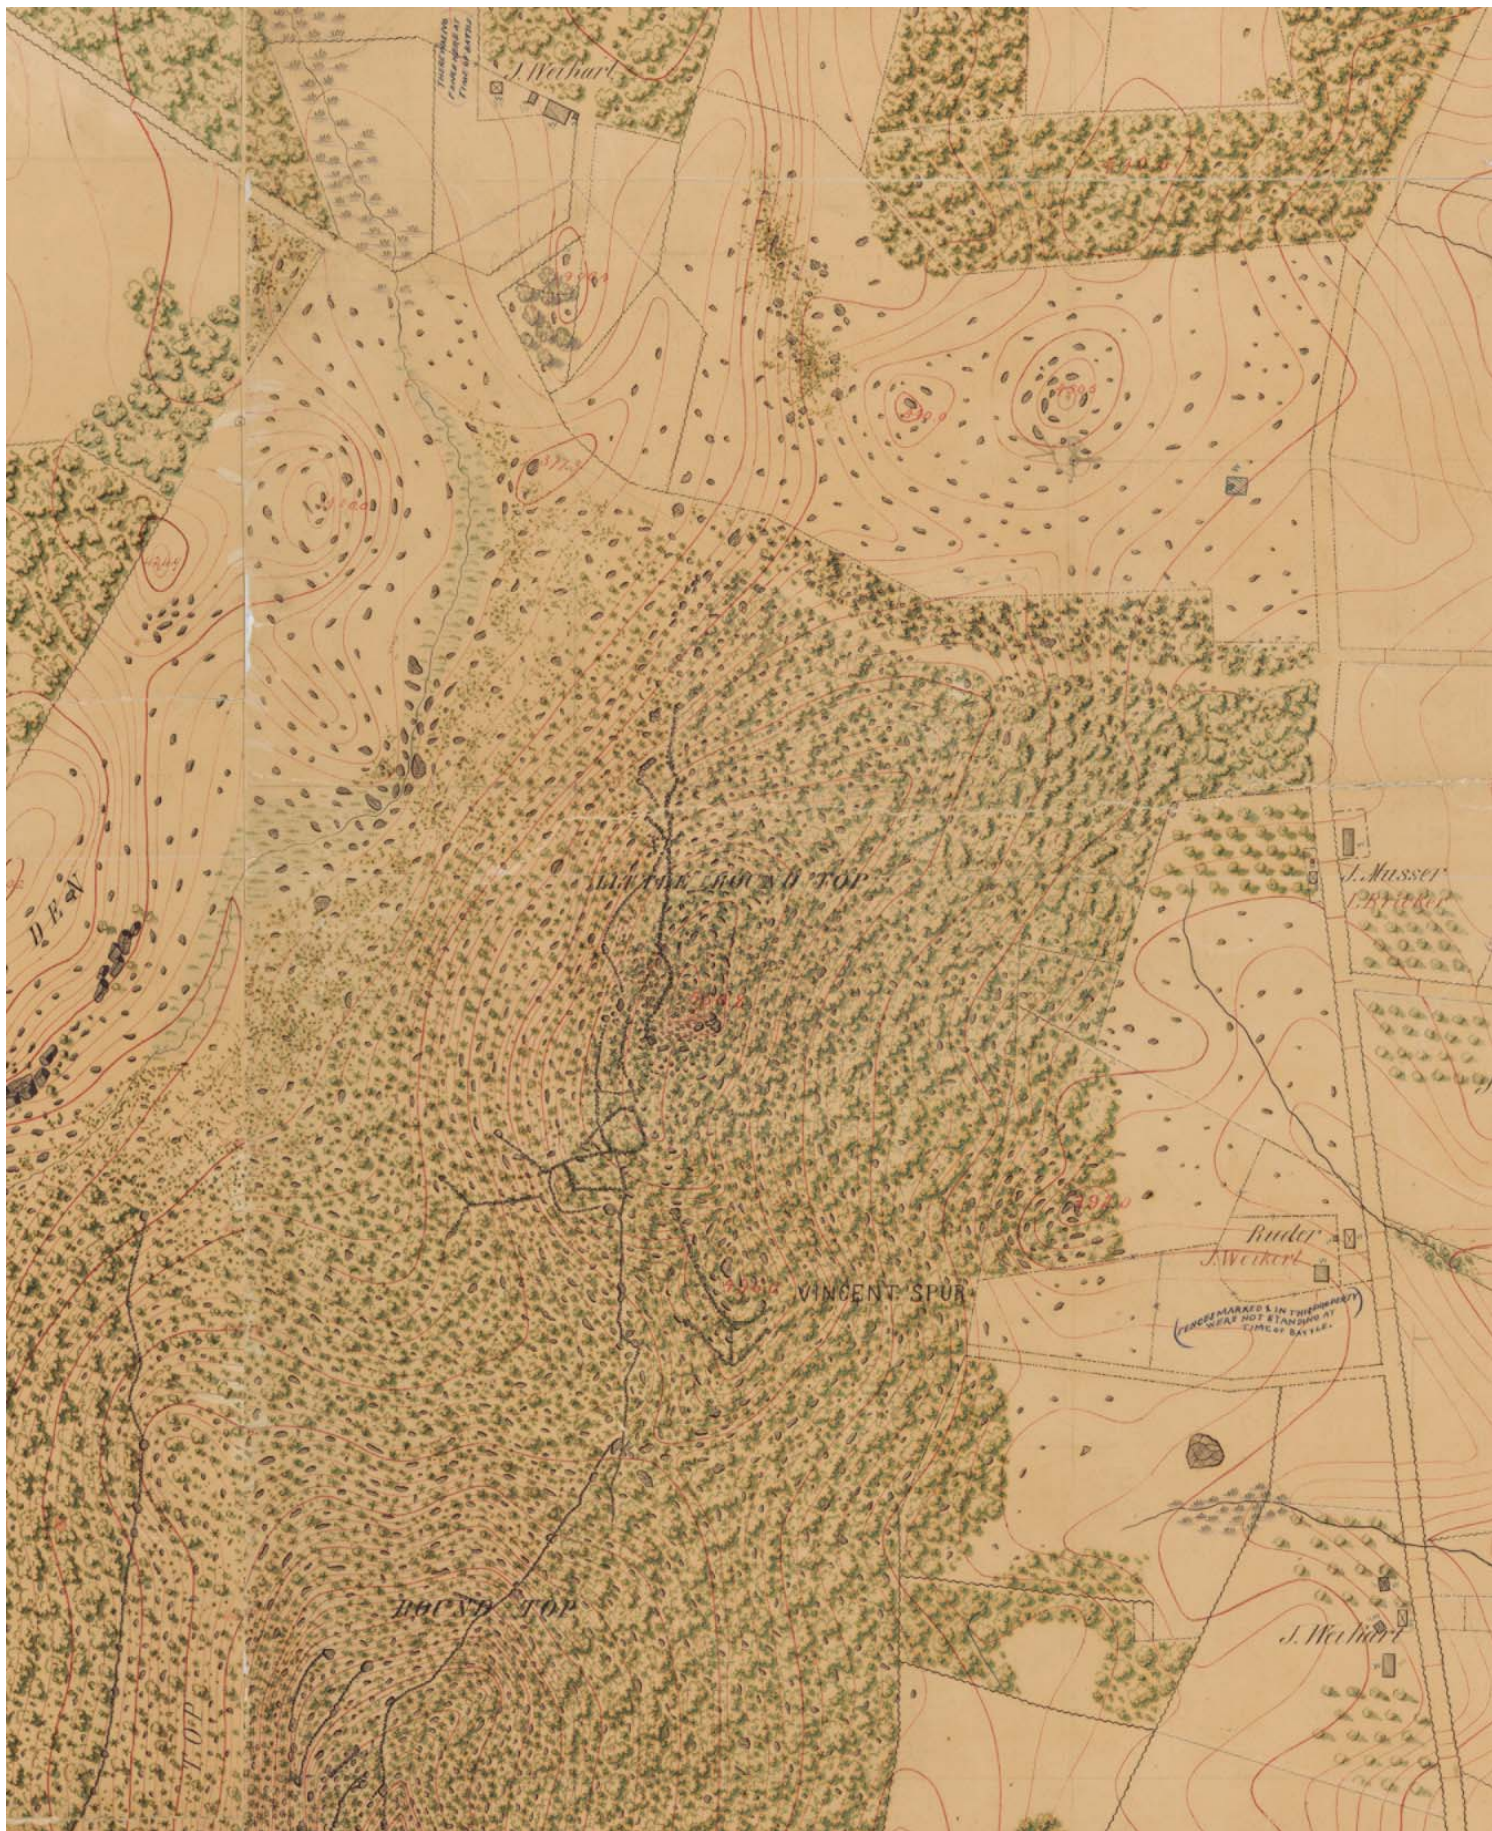
Figure 2.12. Detail of Little Round Top study area from Warren's Map of the Battle Field of Gettysburg, 1868-69 (GNMP General Maps Collection GETT 41137).

However, it is another set of maps that is widely regarded as the most accurate of the maps created after the battle. These are the topographic maps made under the direction of General Warren, a West Point trained engineer, in 1868-69 (Figure 2.12). The Warren maps portrayed the woods, fields, fence lines, streams, and topography of the battlefield in a fashion as precisely as could be achieved using the tools available at the time. The Warren maps are still used as the primary source for locating the original breastworks, fence lines, wood lots and other battle-era landscape features at Little Round Top and throughout the park. Warren's maps were available in time for a reunion of Union officers at Gettysburg in August 1869. The principal subject of the gathering was making field views to drive stakes in the ground marking the precise flank positions of the units in the Union battle line. Later these stakes were replaced by the stone flank markers found in the park today.<sup>25</sup>

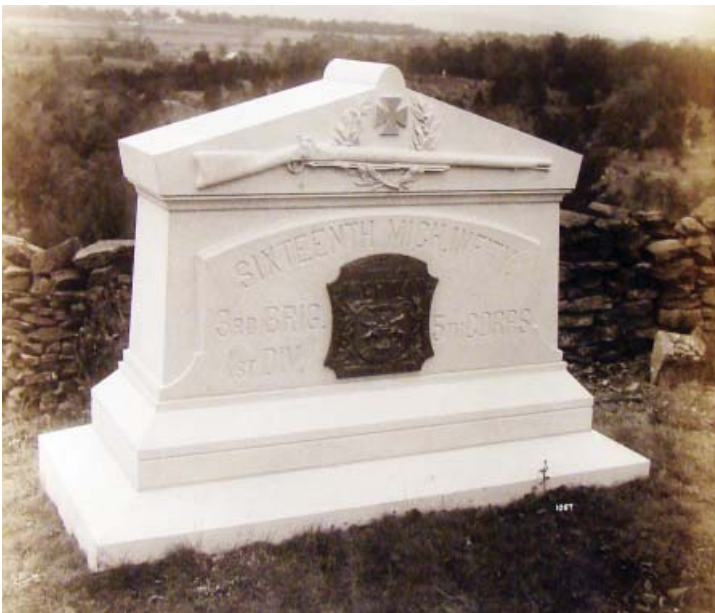
Figure 2.17. 16<sup>th</sup> Michigan Infantry Monument, looking west from original location with rebuilt stone breastworks behind it. Photograph by Tipton, 1889 (GNMP Tipton Photographic Prints GETT 41136 #OS-5036).

Despite this promising beginning, the GBMA was before long working against a variety of threats to its stated goal of holding “in perpetuity the most interesting portions of the illustrious Battlefield that we may retain them in the actual form & condition they were in during the battle.”<sup>21</sup> On Little Round Top field defenses eroded, vegetation took over, and tourists wore unwanted paths and took home relics. The preservation challenges of the late 19th century were strikingly similar to those of today, although approached with fewer resources and different attitudes toward revealing battle-era appearances. There was also a vast difference in the number of visitors between then and now. The stone breastworks on Little Round Top, for example, were restacked between 1882 and 1887, and the rehabilitated walls presented a much more refined appearance than the original battle works, and individual soldier barricades that peppered the boulders on the face of Little Round Top (Figure 2.17).<sup>22</sup>

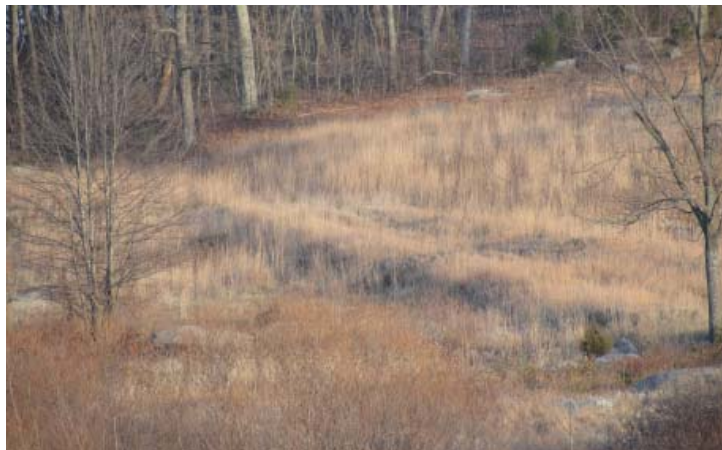
Figure 2.22. Photograph of the north slope of Little Round Top showing contours that mark the former location of the Gettysburg Electric Railway (Hunter Research, 2010).

In April 1893, construction began on the Gettysburg Electric Railway, a tourist trolley line that cut through Devil's Den, the Valley of Death and Cemetery Ridge (Figures 2.19-2.22). The grading damaged sensitive areas, including a swath of right-of-way that ran along the GBMA's property at the western foot of Little Round Top. The trolley line cut an angle across the Valley of Death from Plum Run east of Devil's Den to near the present-day intersection of Wheatfield Road and Sykes Avenue. The trolley marked an important moment in

obliterating evidence of the grade; the section of right-of-way through the Little Round Top study area can still be identified by contour lines and the large rocks that were used to fill portions of the grade along the north slope (Figure 2.22).<sup>27</sup>

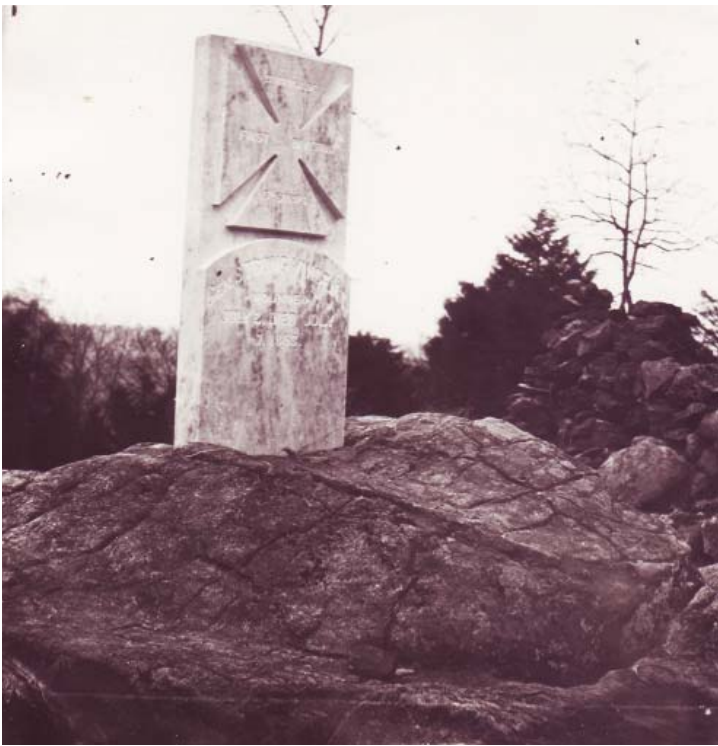
Figure 2.24. General Strong Vincent Tablet. Stereoview by Tipton, ca. 1879-1880 (GNMP Tipton Photographic Prints GETT 41136 #1874).

Placed atop a boulder at the southern tip of Little Round Top in 1878, the Gen. Strong Vincent Marker is regarded as the battlefield's first documented monument outside of the Soldiers' National Cemetery (Figure 2.24). It is a simple tablet bearing the Maltese cross symbol of the Fifth Corps and an inscription to Vincent. Whether this monument or an older inscription carved into a boulder north of the 44th and 12th New York Monument actually marks the spot where Vincent was mortally wounded has been a matter of debate for more than a century.

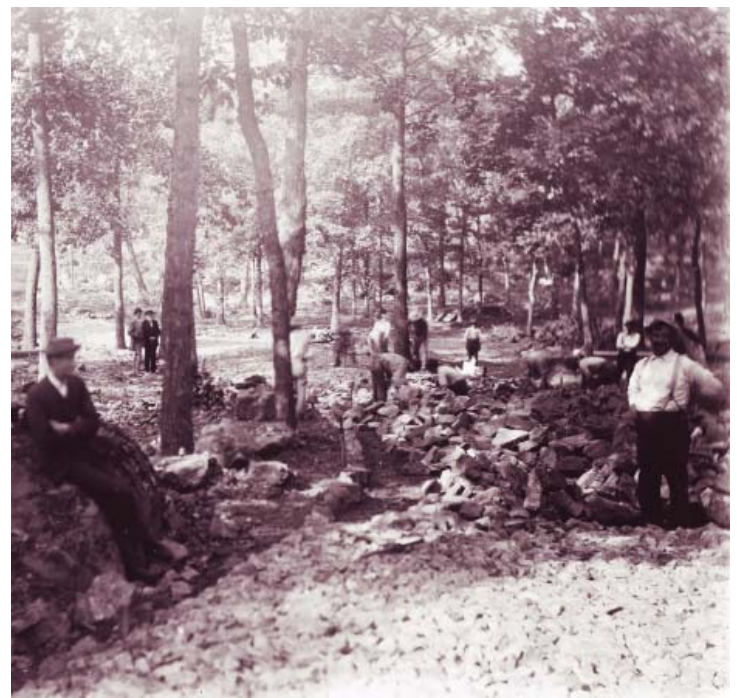
Figure 2.30. Construction of Sykes Avenue at the foot of Big Round Top, showing men laying base stones, looking in the direction of Vincent Spur. Photograph by Tipton, 1897 (GNMP Tipton Photographic Prints GETT 41136 #3098).

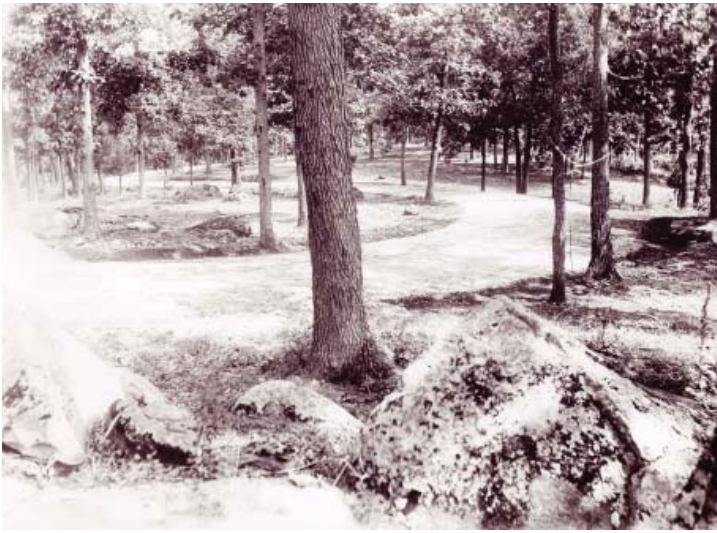
Figure 2.31. Sykes Avenue at the north slope of Little Round Top, showing the paving surface and sweeping curves that made for a smooth and interesting carriage ride. Photograph by Tipton, 1897 (GNMP Tipton Photographic Prints GETT 41136 #3106).

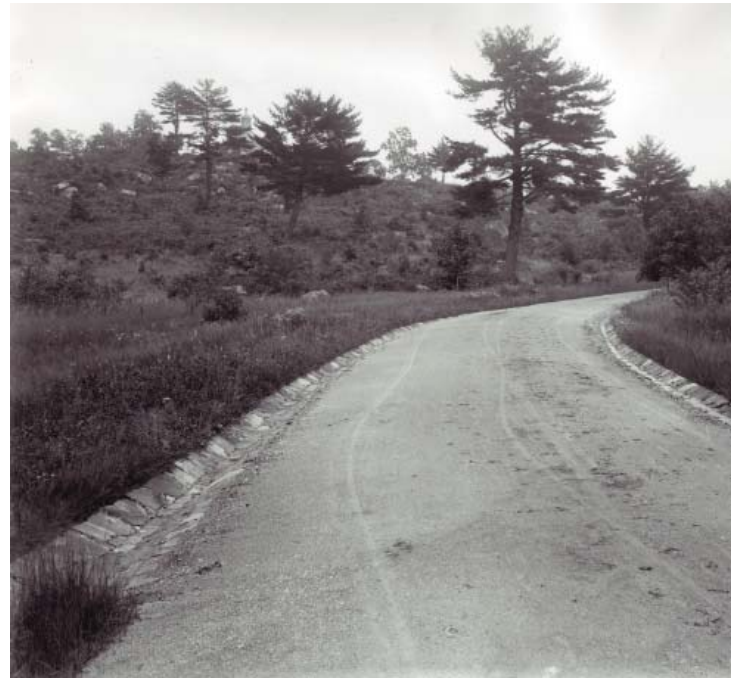
Figure 2.32. Detail of flagstone gutter paving on Warren Avenue. Photograph by Tipton, 1904 (GNMP Tipton Photographic Prints GETT 41136 #3140).

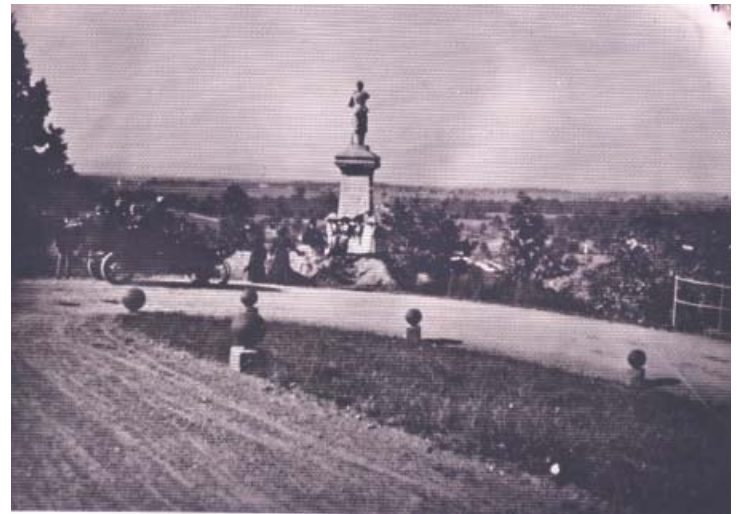
Figure 2.34. Shell stones (mounted cannonballs) along Sykes Avenue at the 155<sup>th</sup> Pennsylvania monument, ca. 1905-1910. Unknown photographer (GNMP General Historic Photographic Prints GETT 41135 #SF-21P-2141).

The avenues featured a number of standard roadside treatments including cast-iron hitching posts at popular stopping points, cast-iron avenue identification tablets, identification tablets for park features, and shell stones (cannonballs mounted on granite posts) to mark the road edges (Figures 2.34 and 2.38). The latter were found along the edge of avenue curves on Little Round Top and other sites throughout the park. A small one-room, one-story, gable-roofed, guard station was placed on the east side of Sykes Avenue, northeast of the present-day parking lot where the concrete-base of the building can still be seen. The guard on duty during high tourist season provided information services and protected the resources of the park. Bridges carrying Warren and Crawford Avenues over Plum Run at the foot of Little Round Top were standard steel I-beam bridges on rusticated ashlar abutments (Figure 2.35). The bridges were finished with wood-plank decks and simple pipe railings. These bridges were widened in the mid-1930s, encasing the original steel beams in concrete decks. The Commission also took a standardized approach to erecting cast-bronze markers and tablets, most set so that they were visible from the avenues, indicating battery, brigade, division and corps locations (Figure 2.38). On Little Round Top markers were placed to the 5th Corps in 1906-07; Battery D, 5<sup>th</sup> U.S. Artillery in 1907-08; 3<sup>rd</sup> Brigade, 1<sup>st</sup> Division, 5<sup>th</sup> Corps (Vincent's Brigade) in 1911-12; 3<sup>rd</sup> Brigade, 2<sup>nd</sup> Division, 5<sup>th</sup>

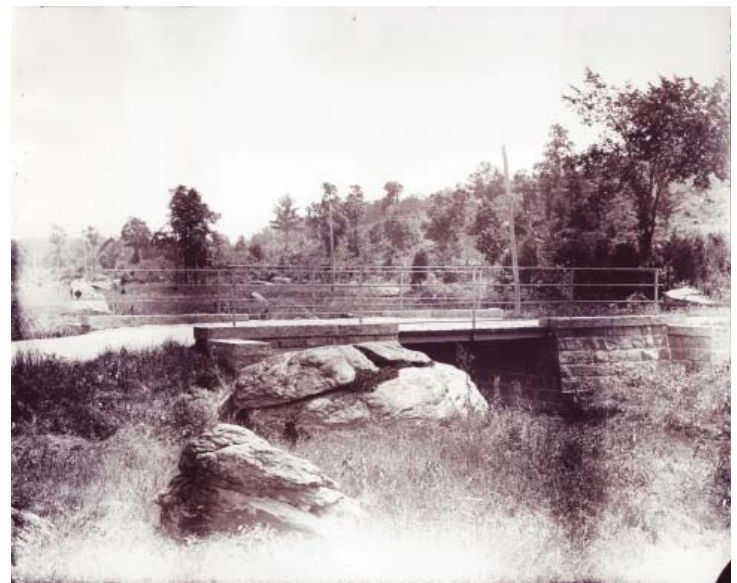
Figure 2.35. View of completed bridge on Warren Avenue over Plum Run. Photograph by Tipton, 1903. (GNMP Tipton Photographic Prints GETT 41136 #3020).

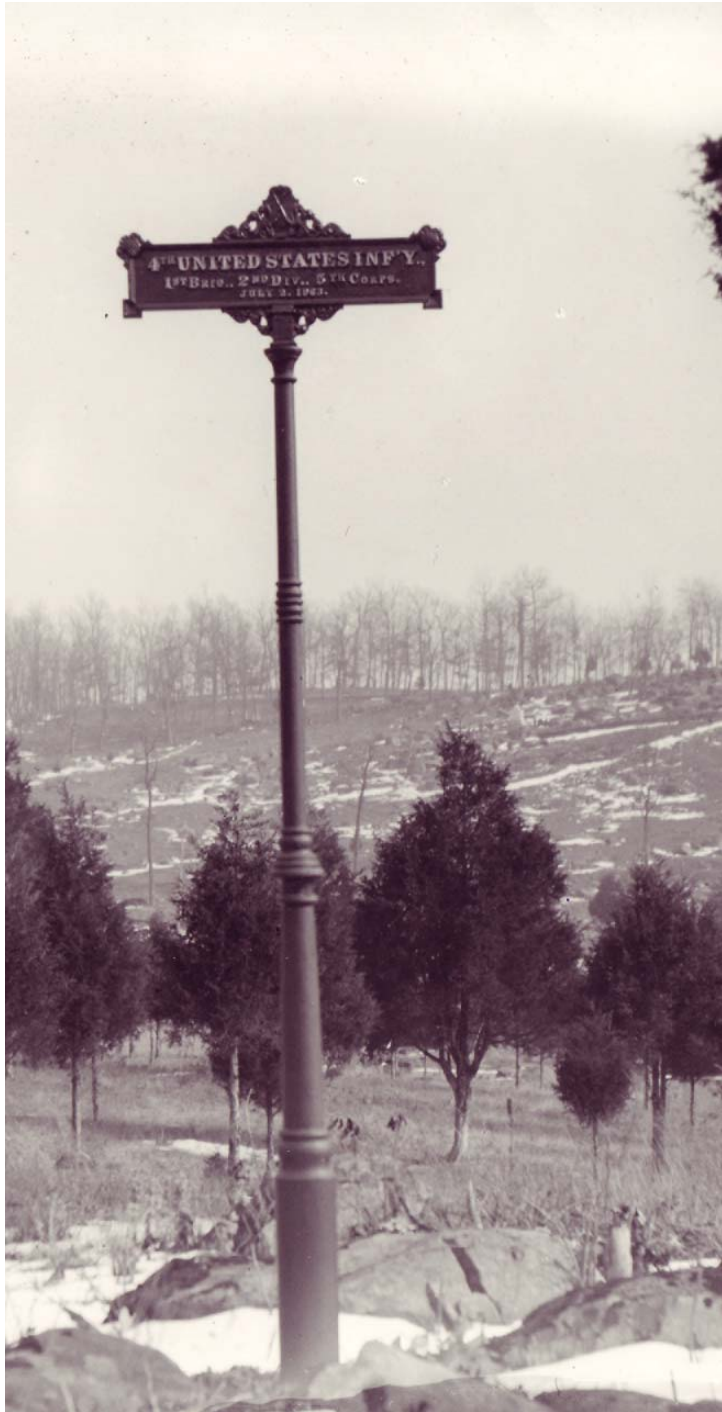
Figure 2.38. Cast-iron tablet identifying the 4th U.S. Infantry, with Little Round Top in the background. Photograph by Tipton, 1897 (GNMP Tipton Photographic Prints GETT 41136 #4728).

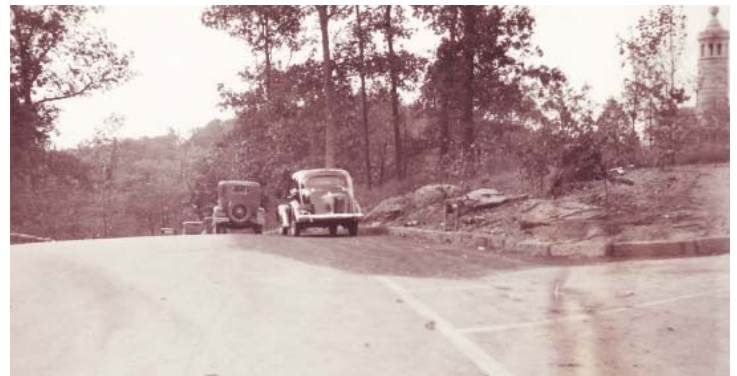
Figure 2.40. New Sykes Avenue parking lot, cut into the east slope of Little Round Top, ca. 1936 (GNMP General Historic Photographic Prints GETT 41135 #SF-22R-068).

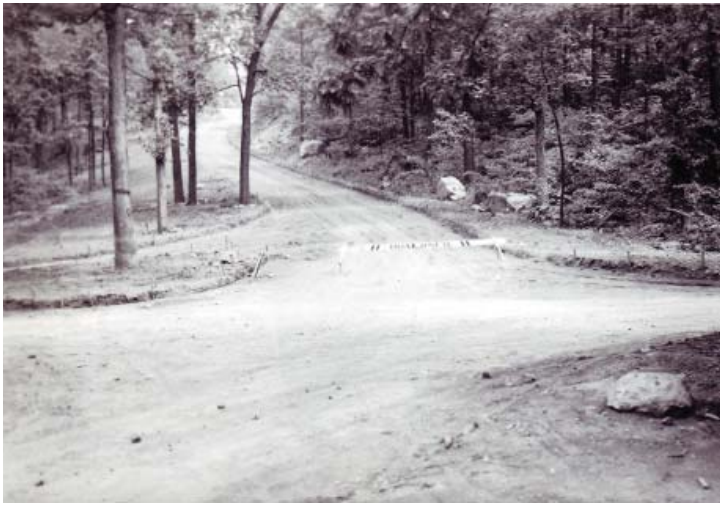
Figure 2.41. Relocating and preparing to resurface roads at the intersection of Sykes and Warren avenues, ca. 1935 (GNMP General Historic Photographic Prints GETT 41135 #SF-17M-002).

Also associated with the avenue improvement program were the straightening and widening of Warren and Wright Avenues, and the reworking of their intersection with Sykes in the gap between the two Round Tops (Figure 2.41). The previous intersection had awkward turning angles and thus was modified into a more typical four-way intersection. Engineering drawings for the Sykes Avenue by-pass also called for the "obliteration" of the old Sykes and Chamberlain Avenues. This perhaps was an indication of the desire to ensure that old avenues were no longer available to motor vehicles. In practice, however, some large portions of the old Telford roadways were abandoned in place and, as with the upper part of Chamberlain Avenue, used as the basis for level pedestrian pathways that are still in use today. Plans called for the removal of the stone retaining walls, although the final disposition of the masonry is currently unknown. There is an unproven possibility that the several piles of stone debris in the Bushman-Weikert Woods are the remains of these walls. The NPS was assisted in the avenue improvement projects by workers from other federal agencies including highway engineers of the U.S. Department of Agriculture's Bureau of Public Roads (BPR, precursor to the Federal Highway Administration) and laborers of the Civilian Conservation Corps (CCC), a New Deal works program for unemployed young men. Between 1933 and 1937, the CCC operated two camps in the military park, housing over 400 men at its peak.<sup>34</sup>

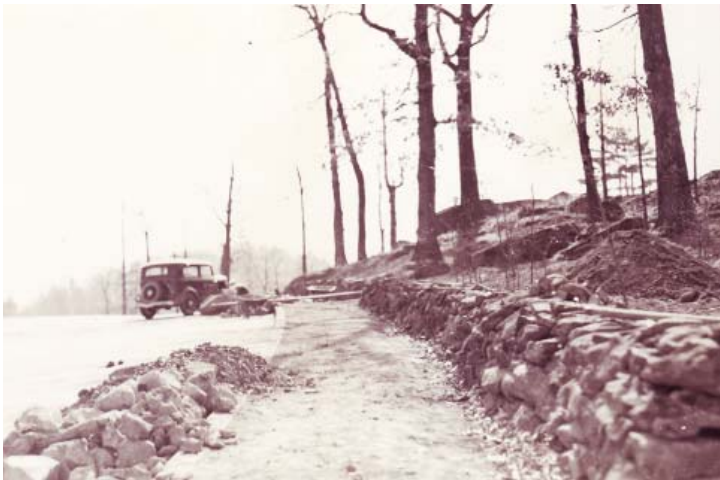
Figure 2.42. Construction of walkways and retaining wall at the Sykes Avenue parking lot on Little Round Top, ca. 1936-1937 (GNMP General Historic Photographic Prints GETT 41135 #SF-30W-093).

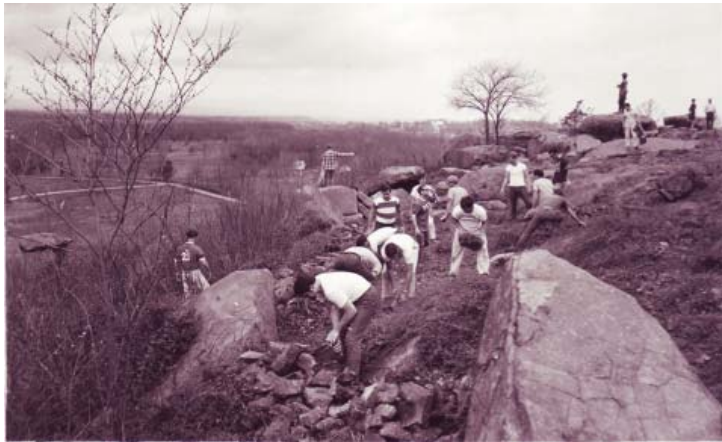
Figure 2.45. Rebuilding stone works on Little Round Top by a Gettysburg College fraternity, 1969 (GNMP General Historic Photographic Prints GETT 41135 #SF-17M-222)).

Another Mission 66-era initiative was the restoration of fences and breastworks. This work was guided by historical research identifying four types of fences for use within the park based on historic types in use by farmers at the time of the battle in 1863. The four fence types adopted were Virginia worm fence, post-and-rail fence, stone-and-rider fence and stone wall. Efforts were made to restore these fences to locations indicated by the Warren map, although they were also sometimes used for other reasons such as to enclose pasture for the park's agricultural lease program. Breastworks on Little Round Top were researched and their locations compared against the Warren map. In the late 1960s, volunteer labor from a fraternity at Gettysburg College was used to restack the breastworks (Figure 2.45).<sup>37</sup>

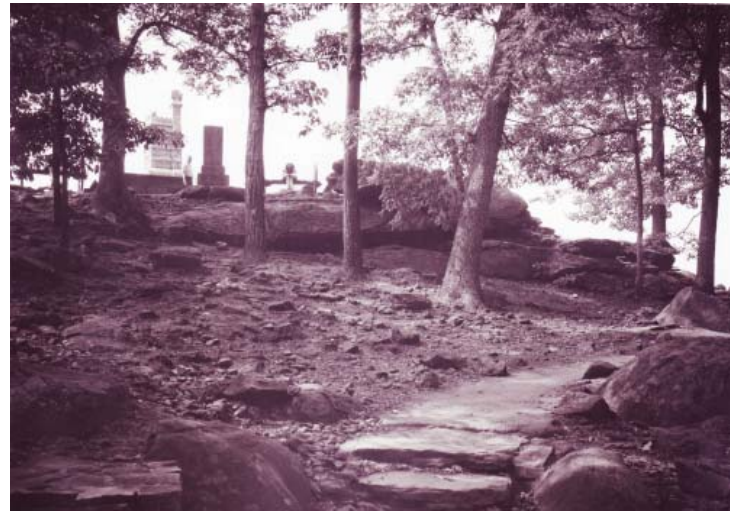
Figure 2.46. Eroded area on east slope of summit at Little Round Top, 1967-1970. Erosion has been noted and an on-going challenge to landscape management for more than 40 years. (GNMP General Historic Photographic Prints GETT 41135 #SF-17M-143).

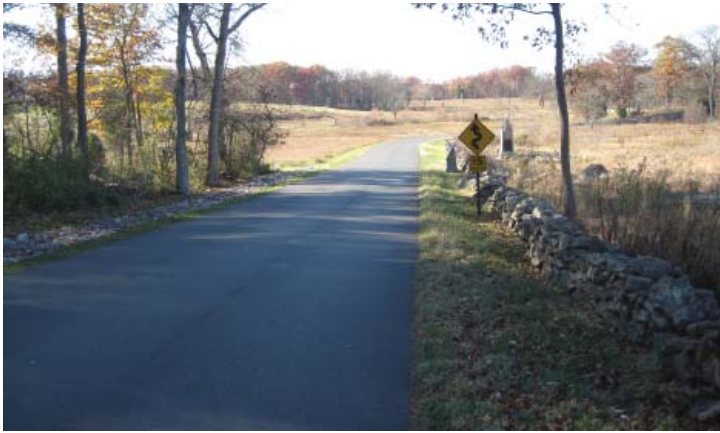
Figure 3.02. Wheatfield Road, looking west (Photo by RHI, 2010).

Running east to west along the study area’s northern boundary, Wheatfield Road is the only roadway in the study area that predates the Battle of Gettysburg (Figure 3.02).<sup>3</sup> The roadway is often used by commuters as a shortcut between Emmitsburg Road to the west and Taneytown Road to the east. The 18-foot wide asphalt roadway is unstriped within the study area, but beyond, to the west of the study area, a double yellow stripe denotes the road’s center line. The corridor itself is characterized by open, gently rolling terrain, offering views in all directions.

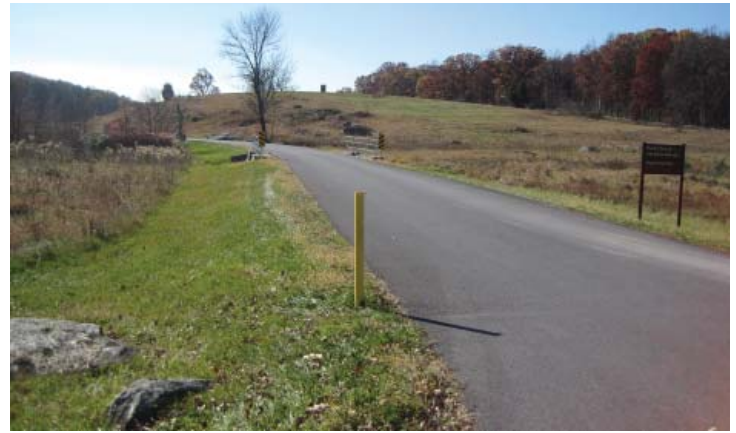
Figure 3.03. Crawford Avenue, looking south (Photo by RHI, 2010).

Originally built in 1887 and Telfordized in 1897, Crawford Avenue occupies a portion of the property purchased by the Battlefield Commission from General Crawford in May, 1893 (Figure 3.03).<sup>4</sup> The 18-foot wide roadway runs one-way south from Wheatfield Road to the Devil’s Den and forms the study area’s western boundary as it runs parallel to Plum Run, which flows just to the east. The relatively flat, gently curving roadway crosses a bridge over Plum Run and allows expansive views up to the summit of Little Round Top.

Because it only permits one-way traffic, Crawford Avenue is wide enough to allow cars to pull over so visitors can explore the monuments on both sides of the roadway. Furthermore, an asphalt pull-off midway along the west side of the avenue provides space for one tour bus to pull off.

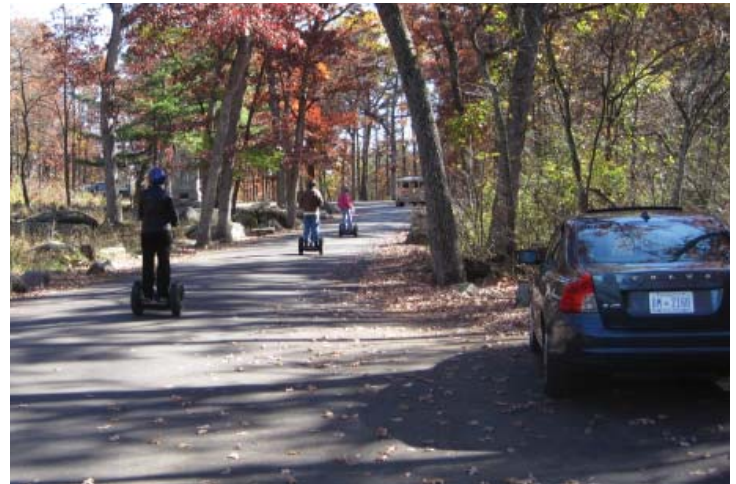
Figure 3.04. Warren Avenue, looking north, with asphalt pull-offs in the foreground (Photo by RHI, 2010).

Warren Avenue first appears in an 1887 map of Gettysburg advertising the Smith Granite Company of Boston Massachusetts, which produced many of the monuments within the park. As late as 1899, the roadway was described by E.B. Cope as a “poor earth road.” It was finally paved by the Gettysburg National Park Commission and shifted to the alignment seen today in 1902.<sup>5</sup> Running from Crawford Avenue at the base of the Devil’s Den to a four-way intersection with Sykes Avenue, Wright Avenue and South Confederate Avenue, the 18-foot wide, two-way road changes character as it climbs the slope of Little Round Top. At the base of Little Round Top,

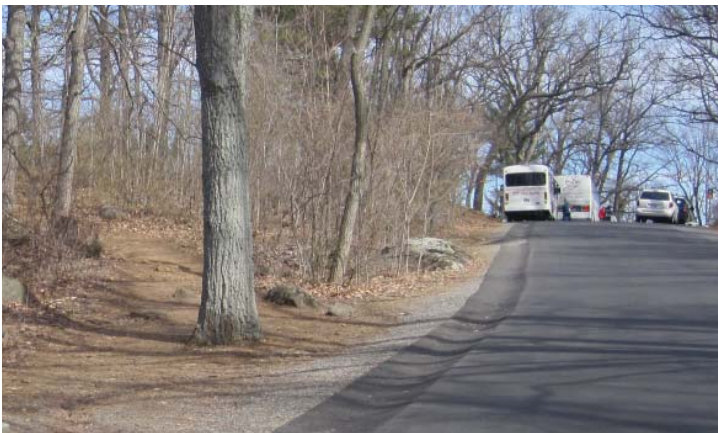
Figure 3.05. An unpaved trail follows the historic alignment of Sykes Avenue as it approaches the 44<sup>th</sup> and 12<sup>th</sup> New York Infantry Monument (Photo by RHI, 2011).

Sykes Avenue to take a straighter path just east of the summit, where it remains today. Remnants of the old Sykes Avenue alignment as it approached the summit of Little Round Top are still apparent today and are used as unpaved pedestrian trails from the Sykes Avenue Parking Area to the monuments above (Figure 3.06). The steeply sloping, 18-foot wide one-way roadway brings vehicles up to a parking area just behind the summit before bringing them back down to an intersection at Wheatfield Road (Figure 3.05). A rutted, compacted area just south of the point where Chamberlain Avenue meets Sykes Avenue is the result of visitors often parking their cars here and walking to the 20<sup>th</sup> Maine Infantry monument.

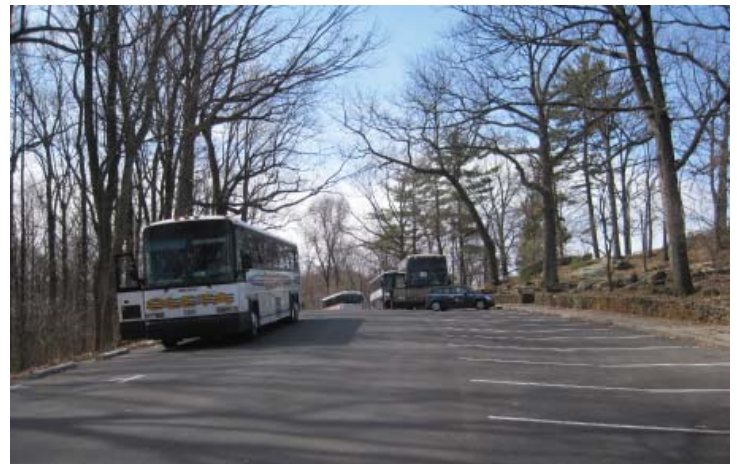
Figure 3.07. Sykes Avenue parking area, looking south along Sykes Avenue (Photo by RHI, 2010).

**Sykes Avenue Parking Area:** Located just behind the summit of Little Round Top along Sykes Avenue, this parking area allows visitors to leave their cars and walk up to the monuments, interpretive signage and panoramic vistas on the summit (Figure 3.07). The asphalt parking lot is striped to allow for 24 pull-in spaces on the west side of Sykes Avenue and another 12 parallel parking spaces on the east side. The single bus

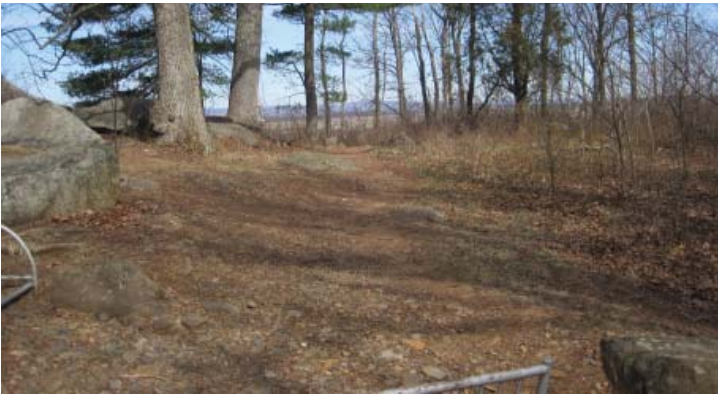
Figure 3.06. Just north of the Sykes Avenue parking area, a trace of the historic Sykes Avenue alignment is still visible and is used as a pedestrian trail leading to the 155<sup>th</sup> Pennsylvania Infantry Monument (Photo by RHI, 2011).

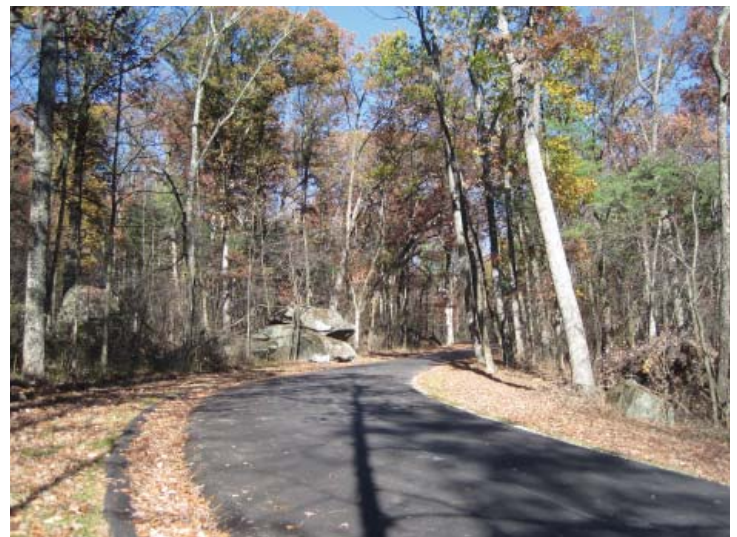
Figure 3.08. Looking north along Wright Avenue (Photo by RHI, 2010).

Initially surveyed in 1887, Wright Avenue remained an unimproved avenue until 1903. Coming from the four-way intersection with Warren Avenue, Sykes Avenue and South Confederate Avenue, the 16-foot wide roadway twists and turns to avoid the several large boulders strewn throughout the forested landscape (Figure 3.08). Combined with the hilly terrain and forested enclosure, the curving roadway allows only limited sight distances, requiring drivers to slow down or risk hitting one of the boulders that comes within feet of the edge of pavement. Toward the southern tip of the project area, the roadway begins to straighten out as it is aligned between two fieldstone fences used to delineate property lines and enclose the farm-woodlot lane.

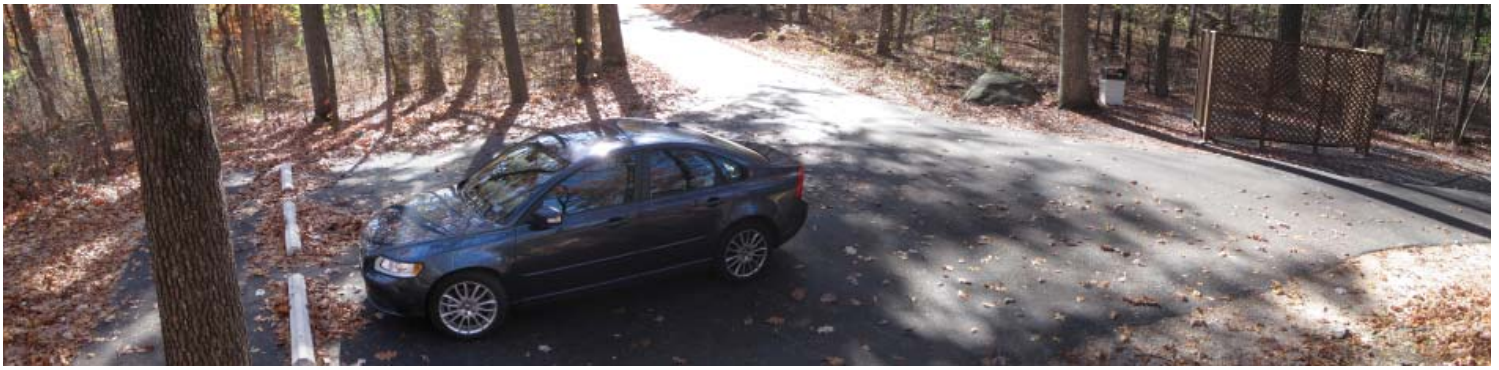
Figure 3.09. Parking area at the south end of Chamberlain Avenue (Photo by RHI, 2010).

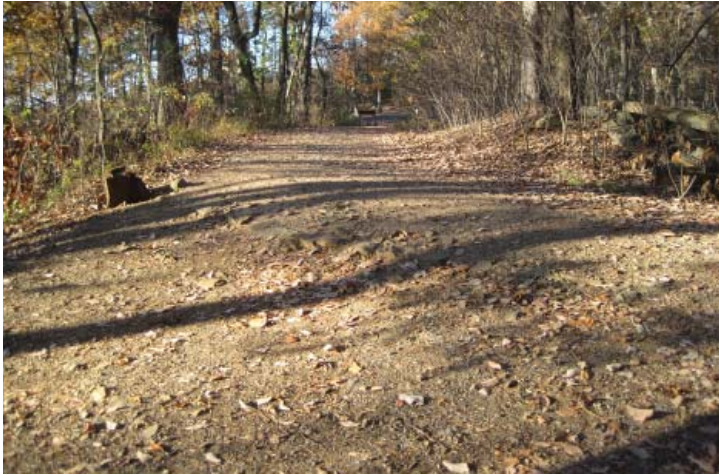
Figure 3.10. Chamberlain Avenue road trace. All that remains is the Telford base (Photo by RHI, 2010).

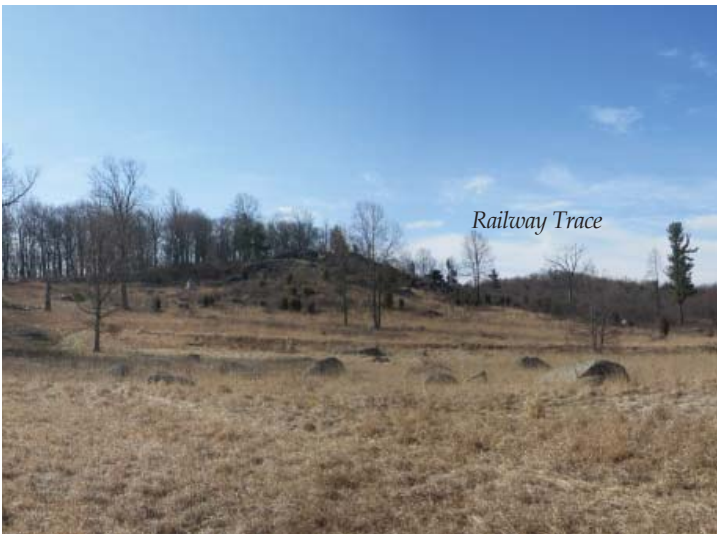
Figure 3.13. Remnant of the Gettysburg Electric Railway rail bed, slightly elevated from the surrounding terrain. (Photo by RHI, 2011).

Gettysburg Electric Railway Trace: Operating from 1893 to 1916, the Gettysburg Electric Railway was a privately owned trolley system that provided tours of the battlefield. Although extensive efforts have been undertaken to restore the natural topography disrupted by the construction of the trolley line, the trace of the line as it cuts through the Valley of Death just east of Plum Run Can still be seen (Figure 3.13).

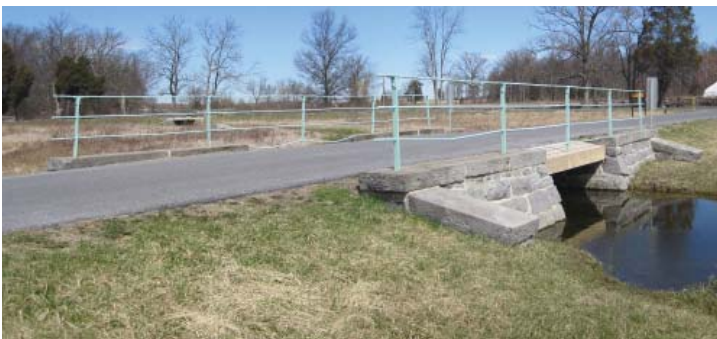
Figure 3.11. War Department Era bridge over Plum Run at Crawford Avenue, near the intersection with Wheatfield Road (Photo by RHI, 2011).

Bridges: War Department Era bridges at the northwest end of Warren Avenue and the northeast end of Crawford Avenue carry traffic over Plum Run (Figures 3.11 and 3.12). Constructed of mortared stone with metal bar and pipe railings, these bridges remain largely unmodified from their original appearance, although their construction has been modified to meet contemporary safety standards.

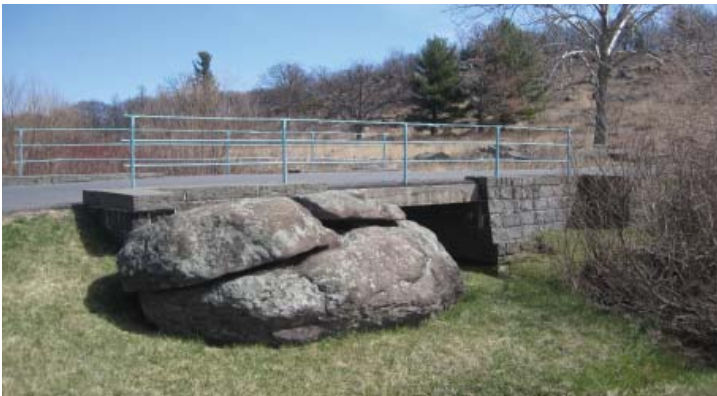
Figure 3.12. War Department Era bridge over Plum Run at Warren Avenue, near the intersection with Crawford Avenue (Photo by RHI, 2011).

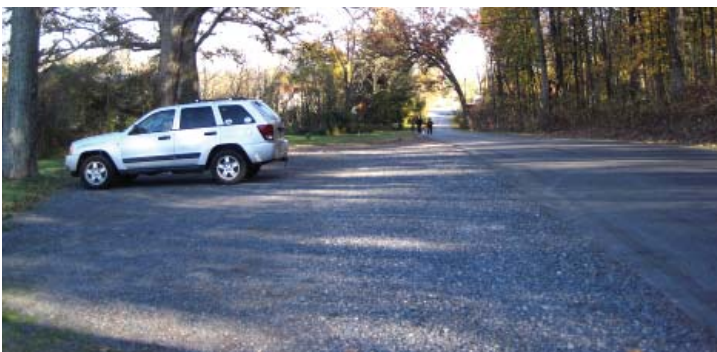
Figure 3.14. Gravel parking area at Wheatfield Road. (Photo by RHI, 2010).

**Gravel Parking Areas:** Two gravel parking areas provide opportunities for visitors to park their cars at the edges of the project area and experience Little Round Top on foot. On the eastern side of Wright Avenue, toward the southern edge of the project boundary, a small, flat, gravel paved clearing approximately 50 feet by 30 feet allows for cars to pull off the side of the road. Along the north side of Wheatfield Road, just east of Sedgwick Avenue, an approximately ten-car gravel parking area is a remnant from the old Round Top Museum building (Figure 3.14). The little-used lot has recently been incorporated into vehicular parking for some ranger programs.

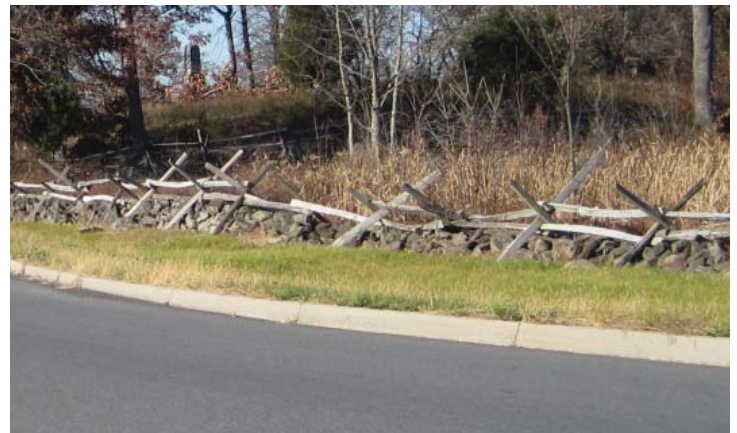
Figure 3.15. Concrete curb along the northern edge of Wheatfield Road. (Photo by RHI, 2010).

**Concrete Curb:** Approximately 200 feet of cast-in-place concrete curb (without gutter) retains the inside corner of Wheatfield Road, allowing the adjacent grade to rise six inches and slope away from the roadway (Figure 3.15). Constructed in the 1990s as part of Federal Highways improvements within the park, this section of curb is noteworthy in that it is one of two curbed portions of roadway within the project area, and the only concrete curb.

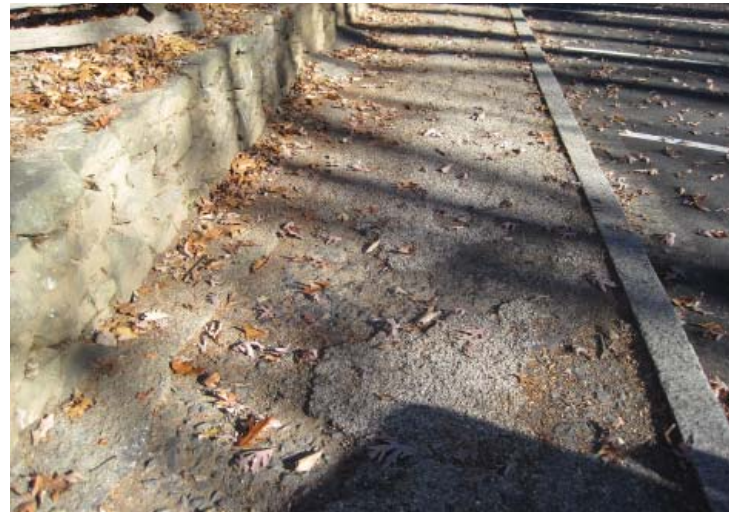
Figure 3.16. Granite curb and asphalt sidewalk at the Sykes avenue parking area (Photo by RHI, 2010).

**Granite Curb and Asphalt Sidewalk:** Along the west side of the Sykes Avenue parking area a four-inch tall monolithic granite curb acts as a barrier between the parking stalls and the adjacent asphalt sidewalk that leads to the summit (Figure 3.16). Originally constructed by the National Park Service, the curb appears to have once been taller (likely six inches), but the grade of Sykes Avenue was likely raised slightly against it every time it was repaved. The adjacent asphalt sidewalk is severely degraded; several areas have worn away completely, exposing the aggregate base below.

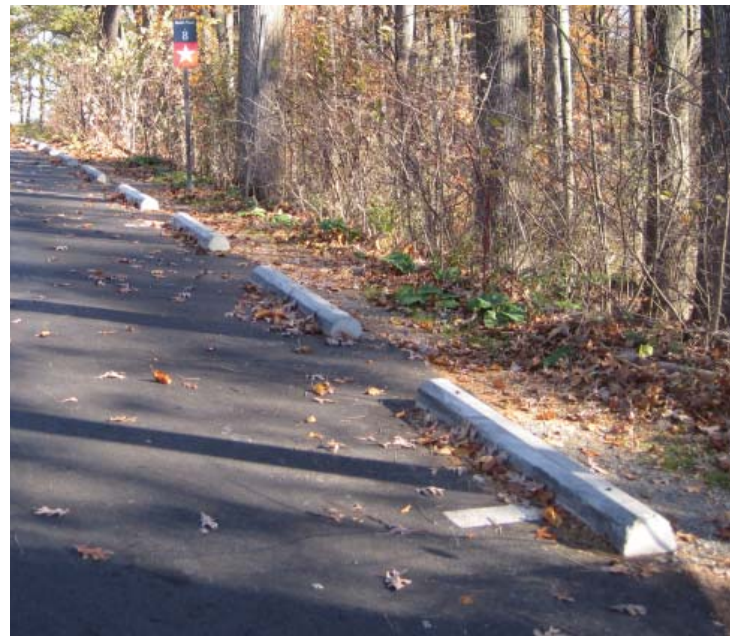
Figure 3.17. *Concrete wheel stops prevent vehicles from driving off the side of Sykes Avenue and down the adjacent slope. (Photo by RHI, 2010).*

**Concrete Wheel Stops:** An NPS Era introduction, concrete wheel stops are used in several locations as barriers against vehicular traffic (Figure 3.17). In addition to being far less expensive than cast-in-place curbs, the wheel stops do not require foundations, which would cause unnecessary subsurface disturbance to this archaeologically sensitive site.
