# Little Round Top

Cultural Landscape Report, Treatment & Management Plan

**March 2nd , 2012**

**Einhorn, Yaffee Prescott**  
Architecture & Engineering  
Albany, New York

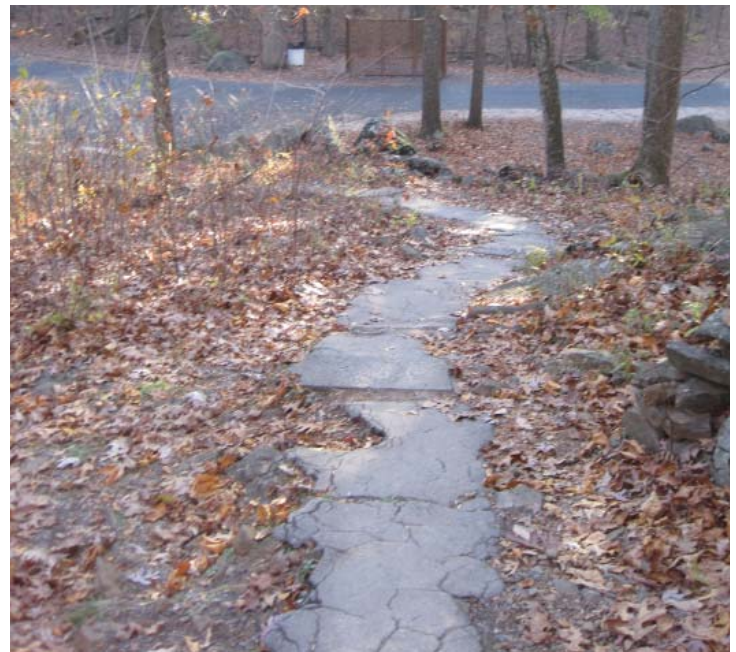
Figure 3.18. *Asphalt path leading from the top of Vincent Spur to Wright Avenue (Photo by RHI, 2011).*

**Asphalt Paths:** Networks of asphalt pathways weave their way through the most heavily visited areas of Little Round Top (Figure 3.18). Although initially installed by the NPS to help mitigate erosion and compaction from the site's many visitors, the paths themselves are now the victim of heavy degradation (Figure 3.19). Ranging from three to seven feet wide, these paths are often quite steep and constricted by overgrown vegetation.

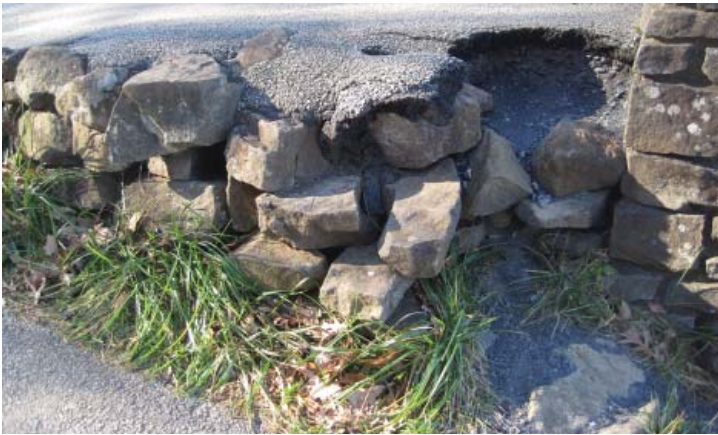
Figure 3.19. Asphalt paths show significant erosion at the edges. These paths line the summit of Little Round Top (Photo by RHI, 2010).

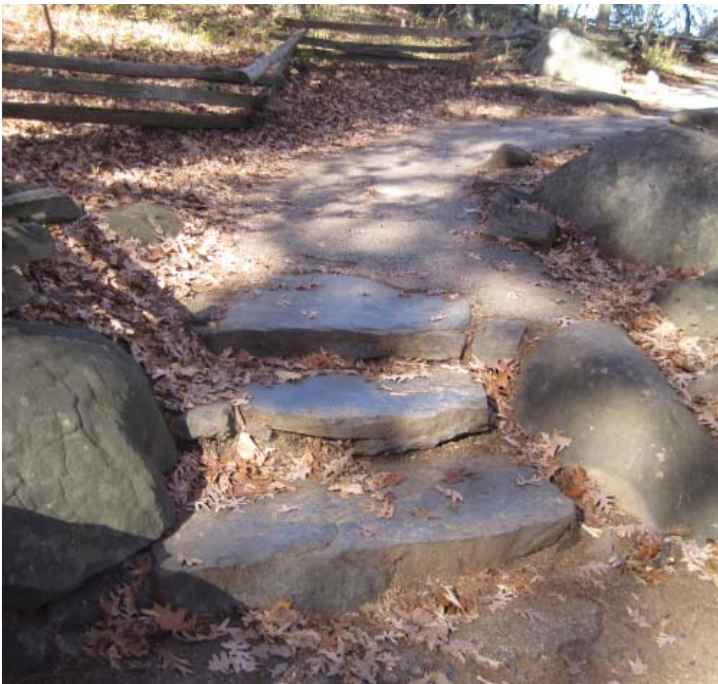
Figure 3.20. Smooth **stone steps** along the asphalt path leading to the summit of Little Round Top (Photo by RHI, 2010).

**Stone Steps:** Ranging from relatively flat natural boulders to quarried stones specifically cut for the purpose and consisting of no more than three risers, stone stairs are used along asphalt pathways in areas of excessively steep grades (Figure 3.20). Excessive foot traffic has worn many of these steps smooth, making them dangerous, particularly in wet conditions.

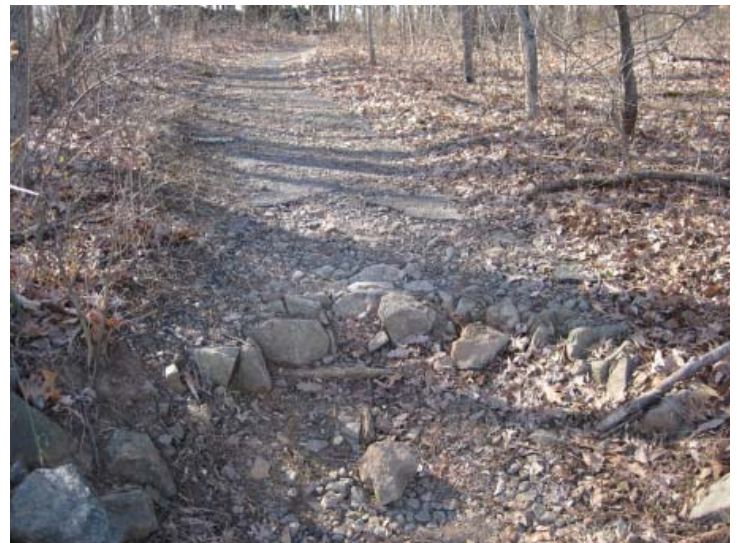
Figure 3.23. The **maintained horse trail** that traverses Little Round Top's eastern slope utilizes a portion of the historic Sykes Avenue alignment. At the intersection with Wheatfield Road, a portion of the Telford road base and asphalt paving is still apparent. (Photo by RHI, 2011).

**Maintained Trails:** The horse trail that bisects the forested eastern slope of Little Round Top is part of a network of maintained trails that allows hikers and horseback riders to connect to various sections of the park without having to travel on the vehicular roadways (Figures 3.22 and 3.23). These trails are cleared of brush and fallen trees and marked with small aluminum signs.

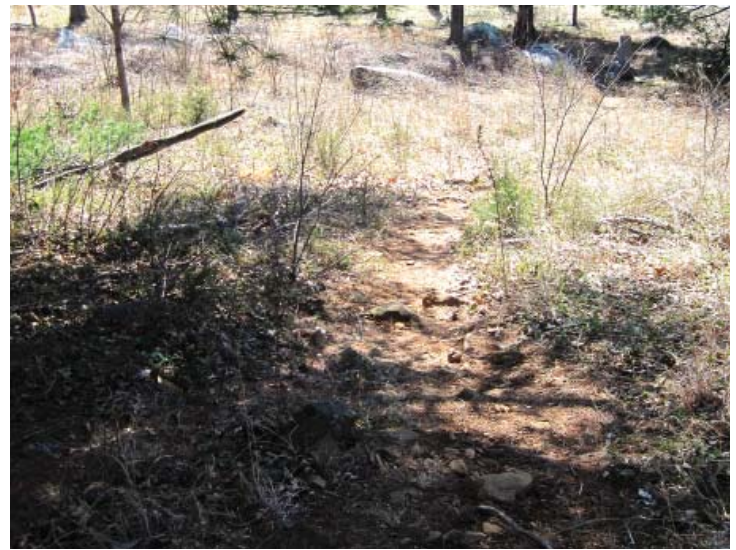
Figure 3.24. Heavily rutted **social trail** leading from the Strong Vincent marker to Warren Avenue. Trails like this, formed from repeated visitor use, are found throughout the project area (Photo by RHI, 2011).

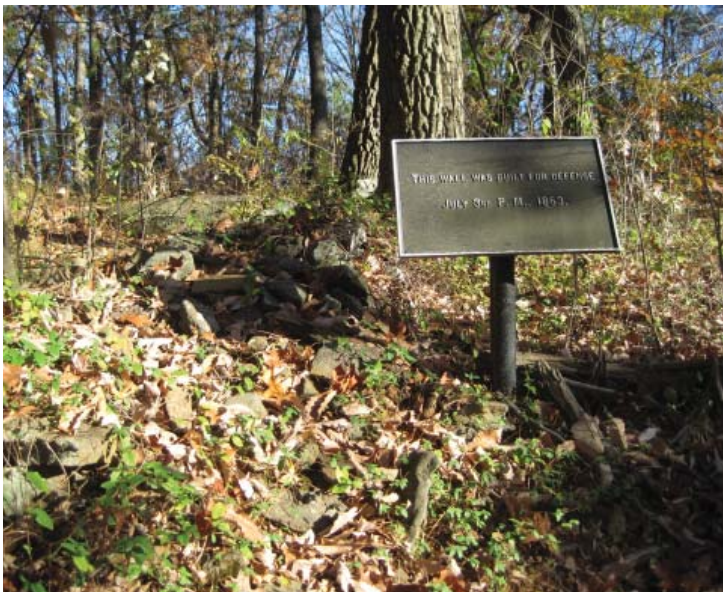
Figure 3.26. Commemorative Era sign reads, “This wall was built for defense, July 3rd P.M. 1863” (Photo by RHI, 2010).

**Commemorative Era Signage:** Installed during the Commemorative Era and designed by long time park engineer E.B. Cope, these cast iron tablets on metal posts mark the name of commemorative avenues and significant sites within the park (Figure 3.25). Six such tablets exist within the project area, including one identifying Little Round Top. Additionally, a smaller tablet stands at the edge of a breastworks just to the east of Sykes Avenue and reads: "This wall was built for defense, July 3rd P.M., 1863." (Figure 3.26)

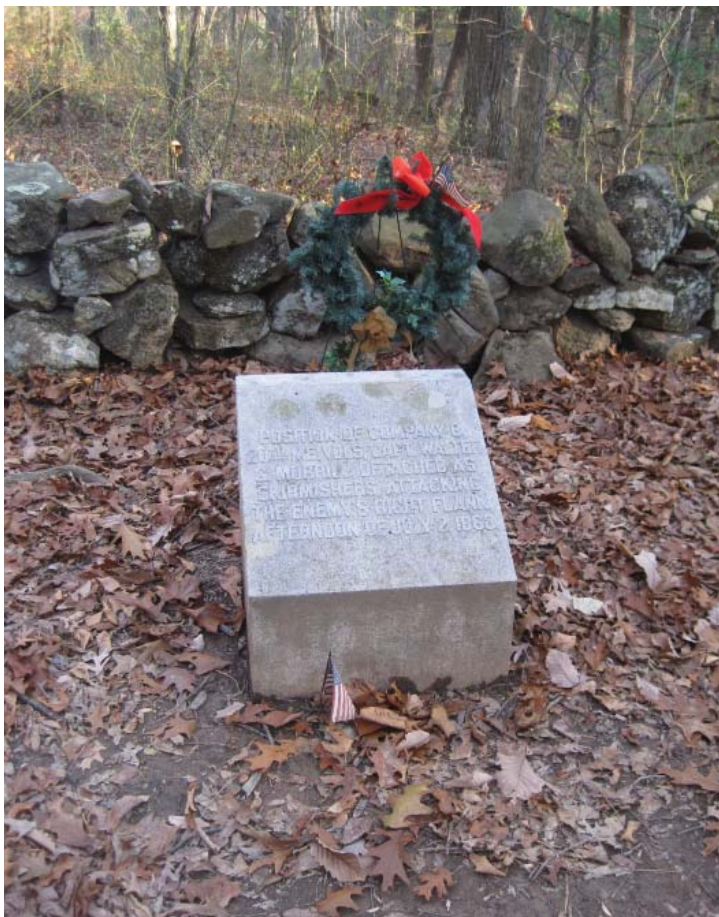
Figure 3.32 (Photo by RHI, 2010).

The clearing around the marker is heavily compacted, the result of four groups gathering in this location to hear the story of the 20<sup>th</sup> Maine Infantry.

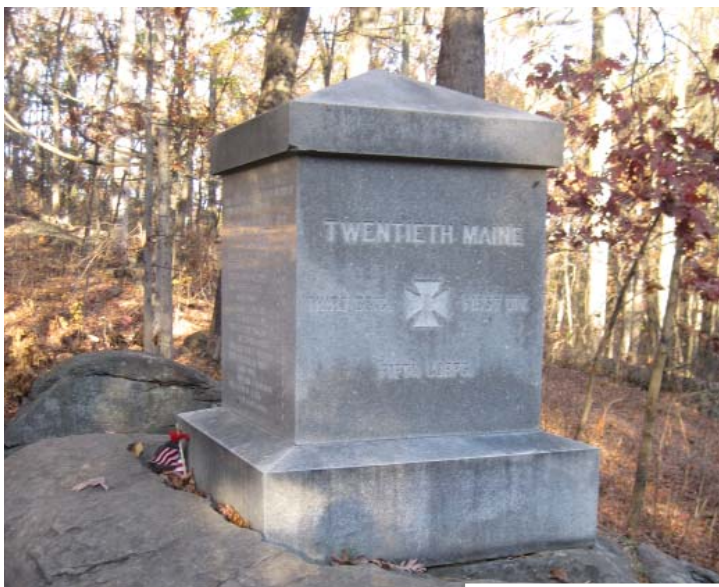
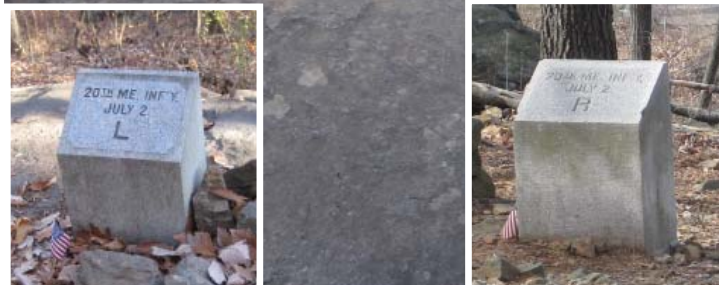
Figure 3.33 (Photos by RHI, 2010).

For many years it was mistakenly purported that this monument marked the apex of the "V" formed by Col. Joshua Chamberlain as he prepared to meet the oncoming Alabamans on the evening of July 2, 1863. The actual location of the apex is approximately 20 yards northwest of the monument. The monument was erected by survivors of the 20<sup>th</sup> Maine Infantry.

There is a small chip in the left corner of the monument's peaked cap. There are also several small chips on the face of the right flank marker.

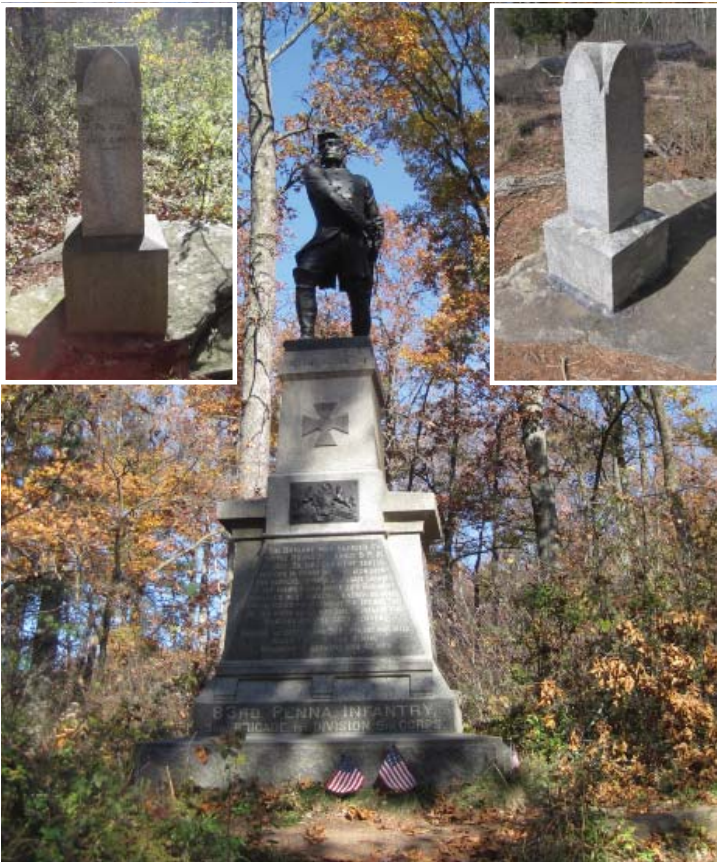
Figure 3.35 (Photos by RHI, 2010).

This sculpture of Col. Vincent marks the general position held by the 83<sup>rd</sup> Pennsylvania Infantry as it was attacked by Confederate troops on the evening on July 2, 1863. After driving the Confederate troops back, the infantry was sent to Big Round Top before being withdrawn around noon on July 3 and moved to a position farther north.

The ground around the monument is severely compacted, the result of social trails created by park visitors.

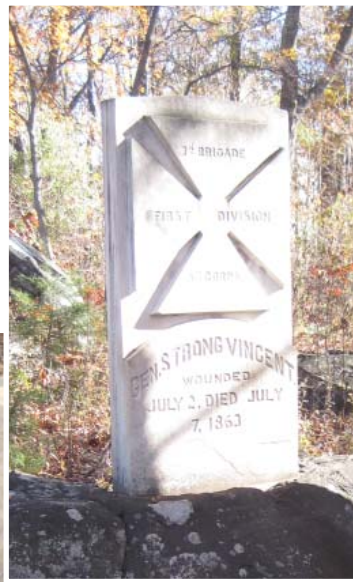
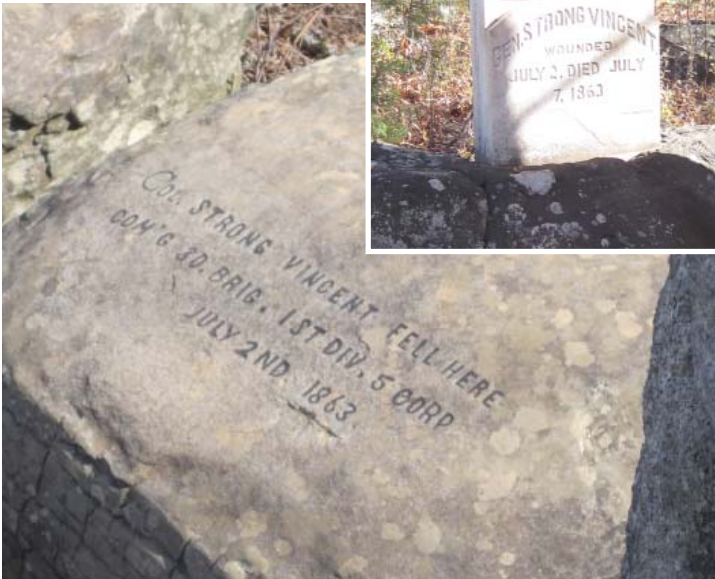
Figure 3.39 (Photos by RHI, 2011).

**Description:** Marble tablet approximately 3" thick, 2' wide and 4' tall. A Maltese cross adorns the top half of the tablet with an inscription below. This inscribed boulder and tablet mark the location where Col. Strong Vincent was mortally wounded in combat on July 2, 1863. He died on 7 July, 1863. Mentioned in a 1864 written account from an early battlefield visitor, the inscribed boulder is one of the two first battlefield monuments.

Dating to 1864 or earlier, the inscribed boulder is one of the park's earliest known memorials. Placed in 1878, the marble tablet is one of the park's earliest constructed monuments. The tablet that exists today is a replica; the original tablet was replaced in 1978 when vandals broke it in half. The original tablet was installed with the inscription facing Devil's Den, while the existing replica was installed incorrectly, with the inscription facing Sykes Avenue.

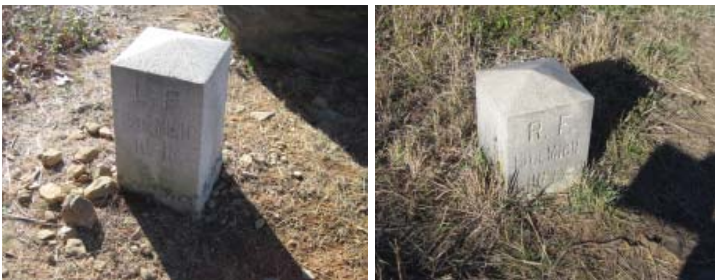
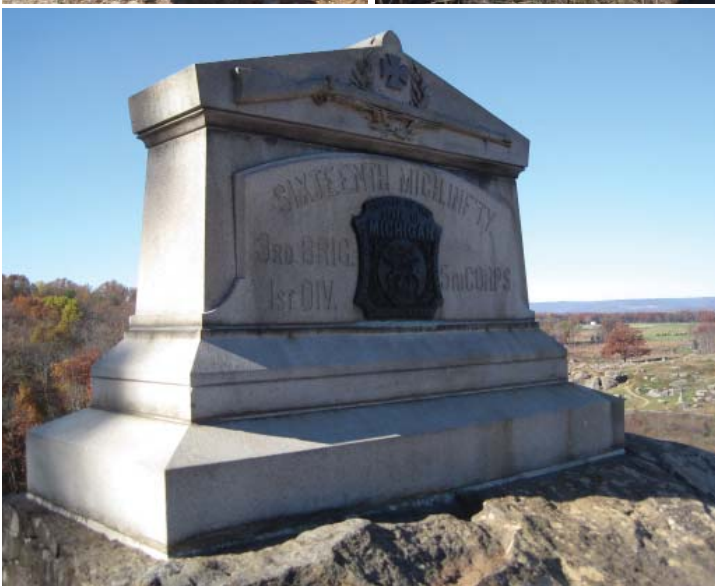
Figure 3.40 (Photos by RHI, 2010).

Marking the position held by the regiment on July 2 1863, the siting of this monument affords clear views all the way to the Devil's Den. After suffering many casualties at this advanced position, the regiment was moved into a position farther north on July 3.

This monument was originally placed at ground level and later moved to its current location. The monument's original base remains approximately 10 yards southeast of its current location.

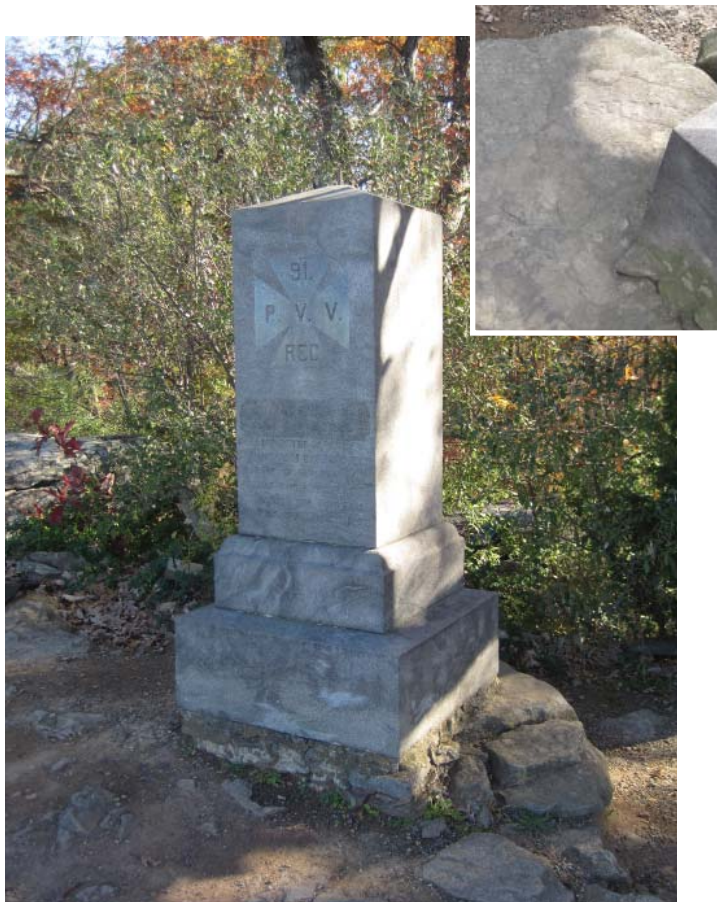
Figure 3.45 (Photos by RHI, 2010).

A granite sphere that topped the monument was vandalized and has been missing since at least 1960.

The inscribed text on the monument and boulder are illegible because of the composition of the granite. Later monuments did not use this type of granite, resulting in much more legible inscriptions.

The ground around this tablet is heavily compacted due to overcrowding of visitors on the asphalt paving on Little Round Top's summit.

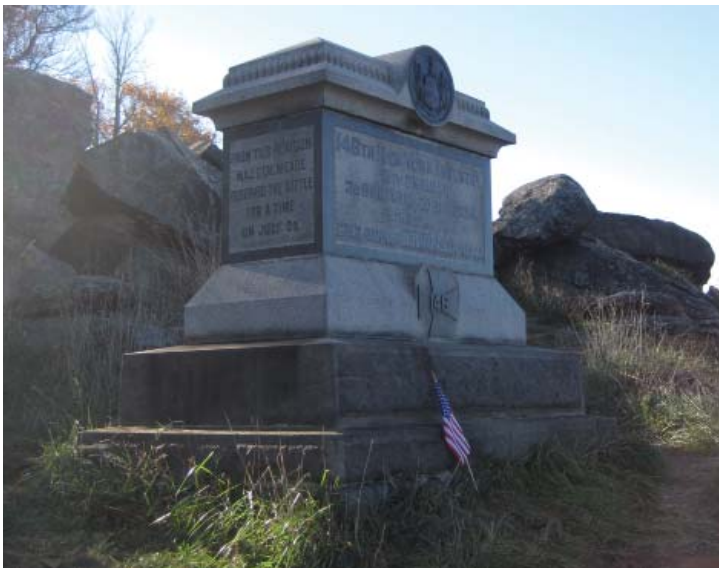
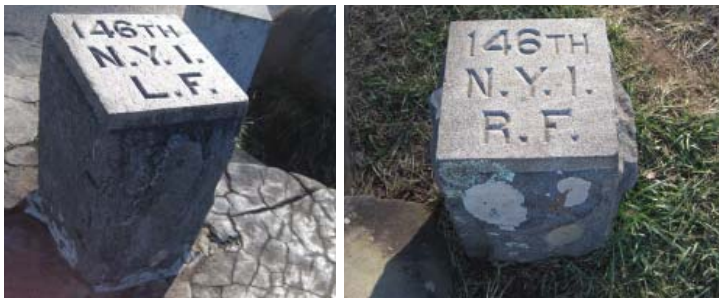
Figure 3.50 (Photos by RHI, 2010).

Erosion and compaction from excessive pedestrian traffic in the area has resulted in the tablet's concrete foundation becoming exposed.

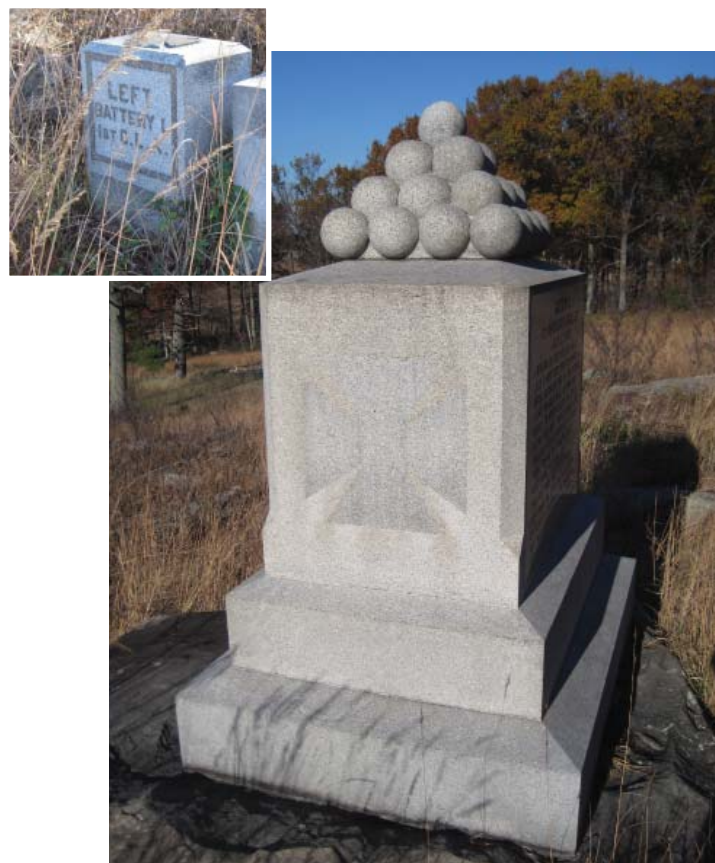
Figure 3.51 (Photos by RHI, 2010).

The stone right hand of the Zouave, and the upper part of his rifle's muzzle are broken off.

Heavy visitor traffic in this area has caused the ground immediately around this monument to become compacted. The foundation of the left marker is exposed from erosion.

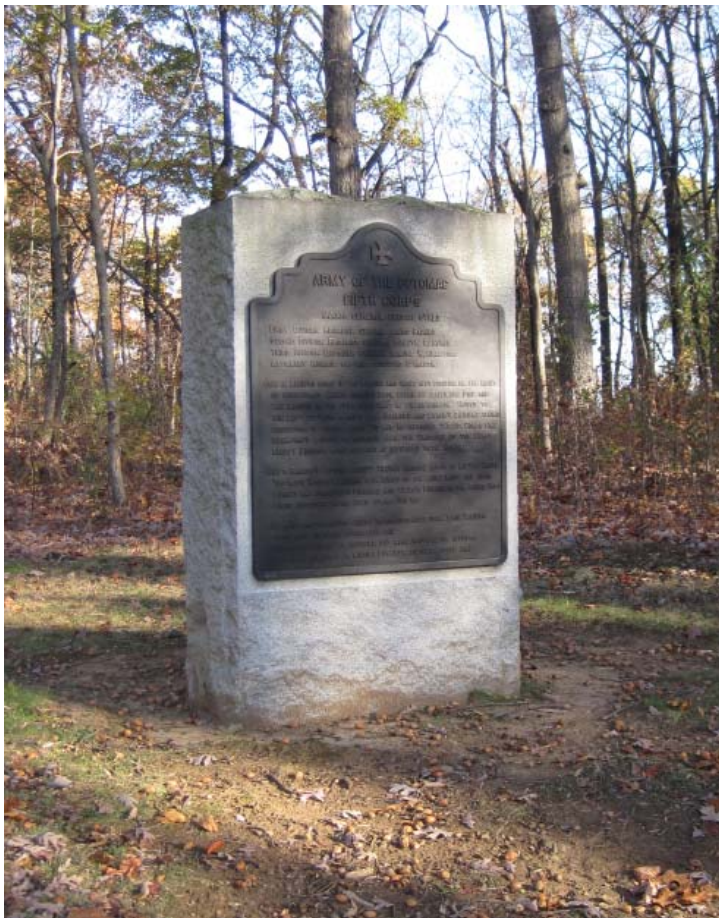
The ground around the monument has become worn and compacted as a result of heavy pedestrian traffic.

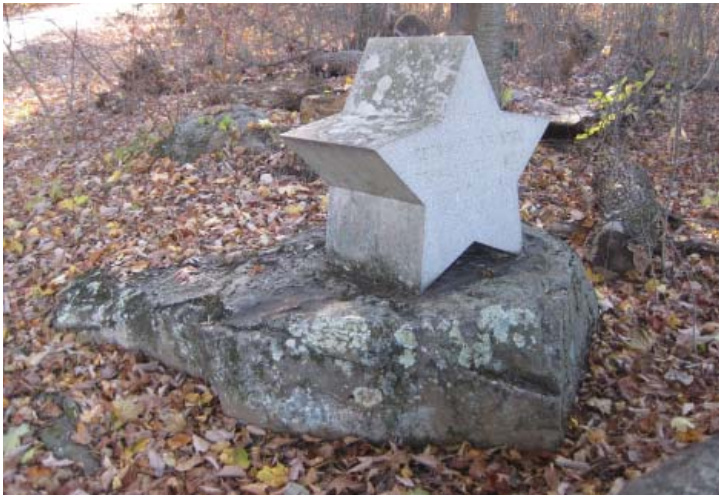
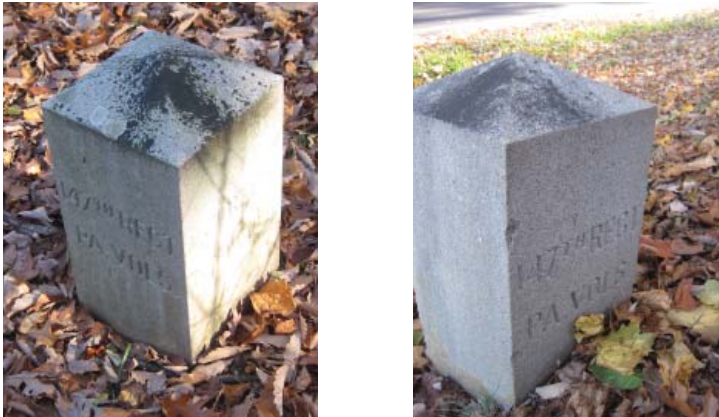
Figure 3.56 (Photo by RHI, 2011).

In 1934, this monument was rotated about its base to face the newly realigned Sykes Avenue. Today, the granite pedestal still rests askew of the base, indicating the monument's original orientation. The base has since been exposed, the result of regrading efforts related to the Sykes Avenue realignment.

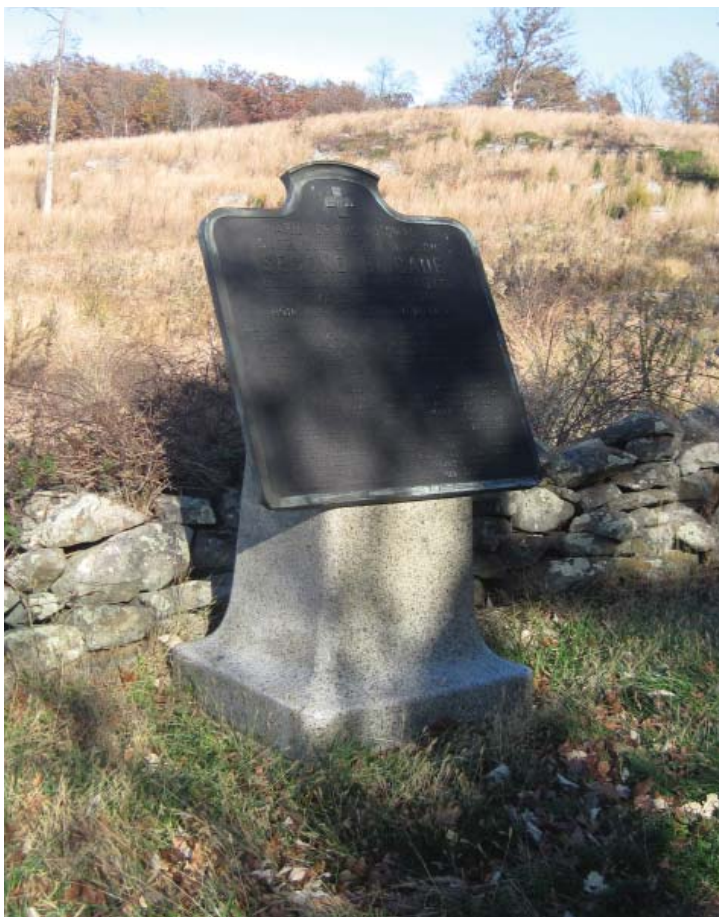
The edges of this marker are chipped and worn, most likely the result of vehicles veering off the roadway and damaging the marker. This marker's position has fallen victim to grade creep. It should be approximately 1.2' high, similar to the 5<sup>th</sup> Maine Infantry's right flank marker, which sits outside of the project boundary.

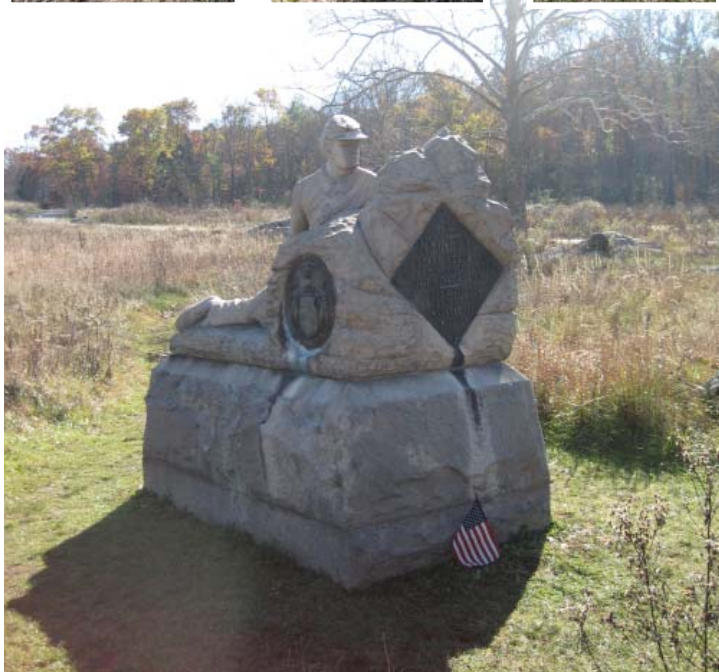
Figure 3.68 (Photos by RHI, 2011).

The 40<sup>th</sup> New York Infantry took up position here at approximately 4 p.m. on July 2, 1863, where they drove the Confederate troops back into the Devil's Den. The monument was later raised onto a larger base when the state of New York contributed additional funds. The monument still bears the marks of a 1913 act of vandalism that struck the hammer off of the soldier's gun.

An adjacent boulder features a diamond insignia of the Union's 3<sup>rd</sup> Corps and "40 NYV" carved into its face. This carving predates the formal monument.

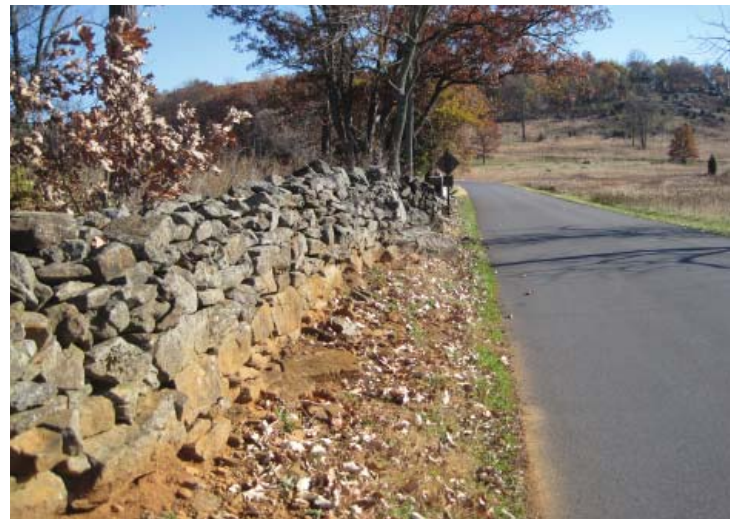
**Fieldstone Fence:** These low (30 to 36 inches tall), dry-stacked walls were historically used to delineate property lines (Figure 3.70). Although most have been reconstructed over the course of the park's history, many of these fences mark historic property boundaries and would have been in place during the Battle of Gettysburg.

Figure 3.70. Fieldstone fence along Wheatfield Road (Photo by RHI, 2010).

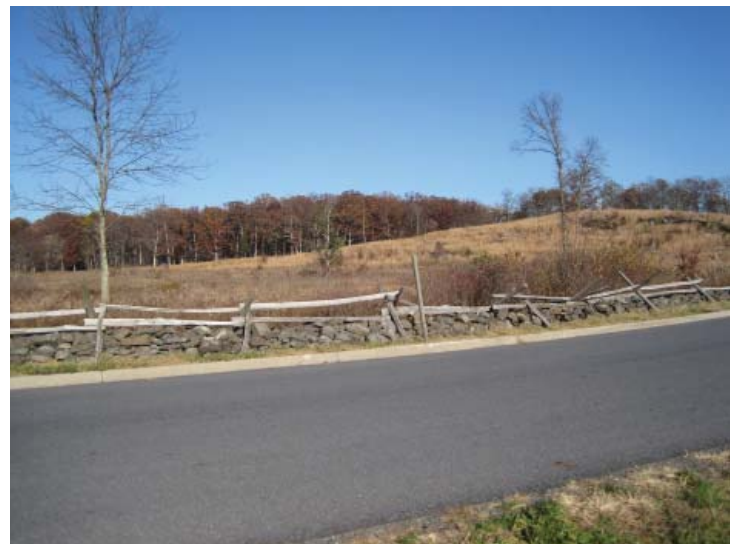
Figure 3.71. Fieldstone fence with rider along Wheatfield Road (Photo by RHI, 2010).

Fieldstone Fence with Rider: A portion of the fieldstone fence north of Wheatfield Road is topped with a wood split rail fence (Figure 3.71). The field enclosed by this fence was likely grazing land for livestock, as the additional height created by the wood rails would have kept animals from escaping from or intruding on a private field.

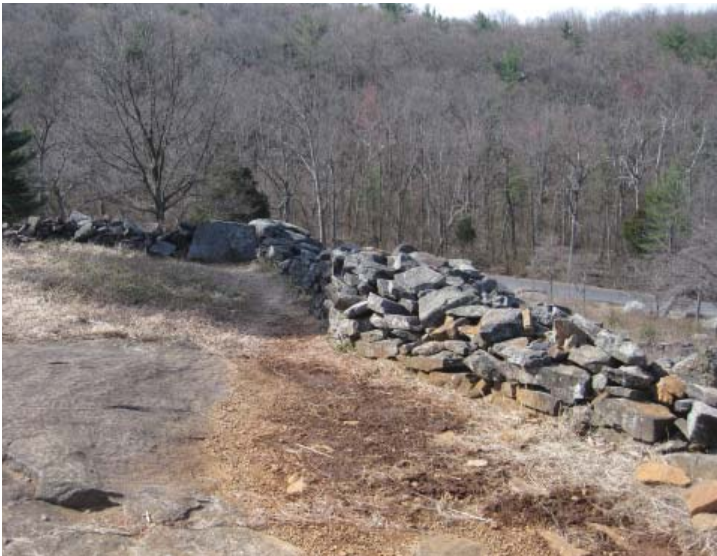
Figure 3.72. Stone breastworks surrounding the 16<sup>th</sup> Michigan monument. These neatly stacked stone walls have been rebuilt several times in the years following the battle (Photo by RHI, 2011).

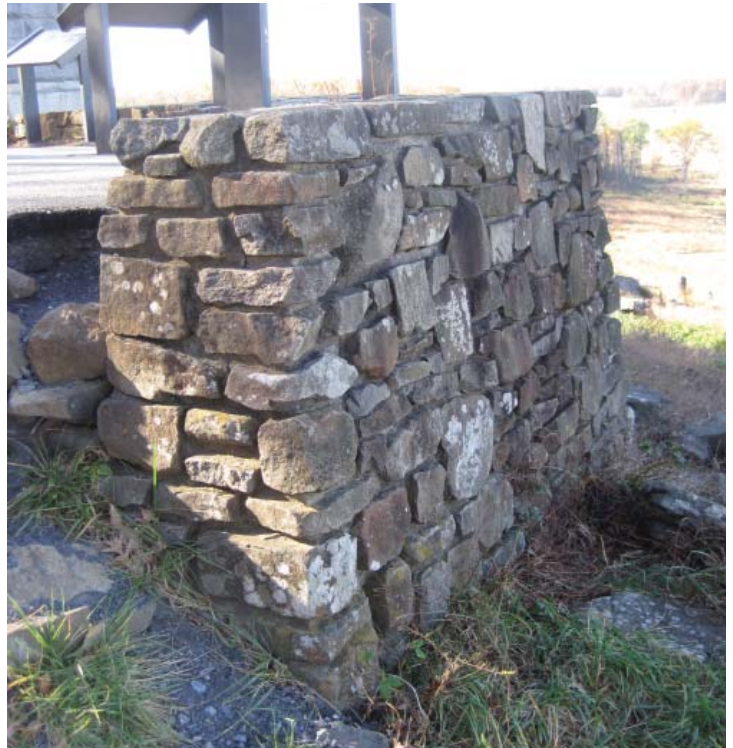
Stone and Mortar Retaining Walls: Within the most heavily trafficked areas of Little Round Top (the parking area and the summit), stone retaining walls are used to expand the amount of flat, usable space (Figure 3.74). The wall that lines the parking area along Sykes Avenue was constructed in the

Figure 3.74. Stone and mortar retaining wall at the summit of Little Round Top (Photo by RHI, 2010).

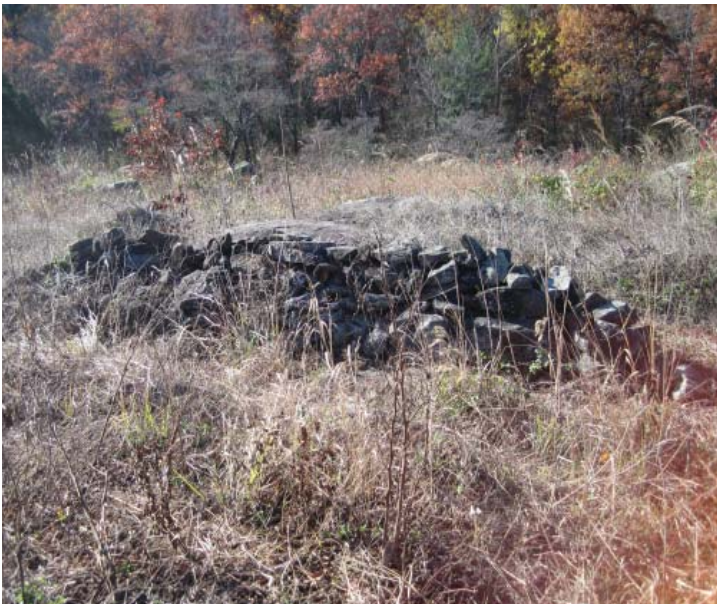
Stone Breastworks: Hastily constructed on the night of July 2, 1863, in preparation for the next day's battle, these low fieldstone barricades provided a modest amount of cover for Union troops defending Little Round Top when battle resumed on the morning of July 3 (Figures 3.72 and 3.73). Throughout its occupation until July 5, Union forces extended and revined these stone wall breastworks. The nearly continuous lines of breastworks just south and west of the summit of Little Round Top provide evidence of the location of troops during

the battle. Nearly all of the breastworks that are extant today have been rebuilt or restored several times throughout Little Round Top's post-war history, usually in the same location as they appeared during the battle. Breastworks are in various physical conditions: those that are most accessible to visitors have suffered varying degrees of damage and some nearly eradicated, while the more inaccessible breastworks are regularly overgrown with vegetation and sometimes dislodged by vines and roots.

Figure 3.73. Stone breastworks along Little Round Top's steep western face. This breastworks is only visible in winter, as dense old field vegetation obscures it during the warmer months (Photo by RHI, 2010).

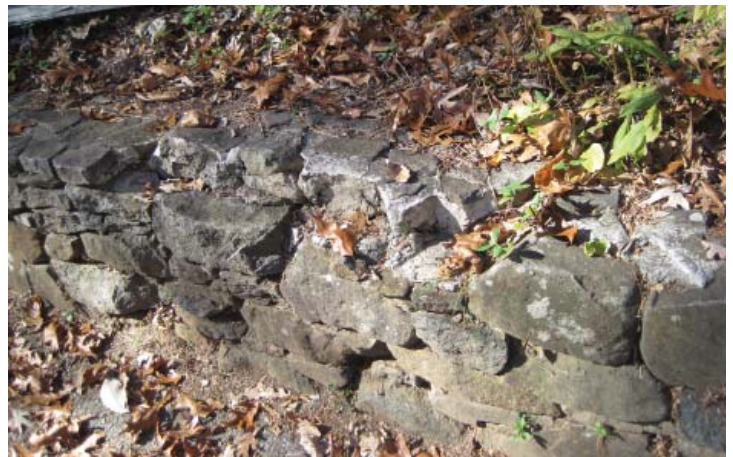
Figure 3.75. Damage to the cap of the stone and mortar retaining wall at the Sykes Avenue parking area (Photo by RHI, 2010).

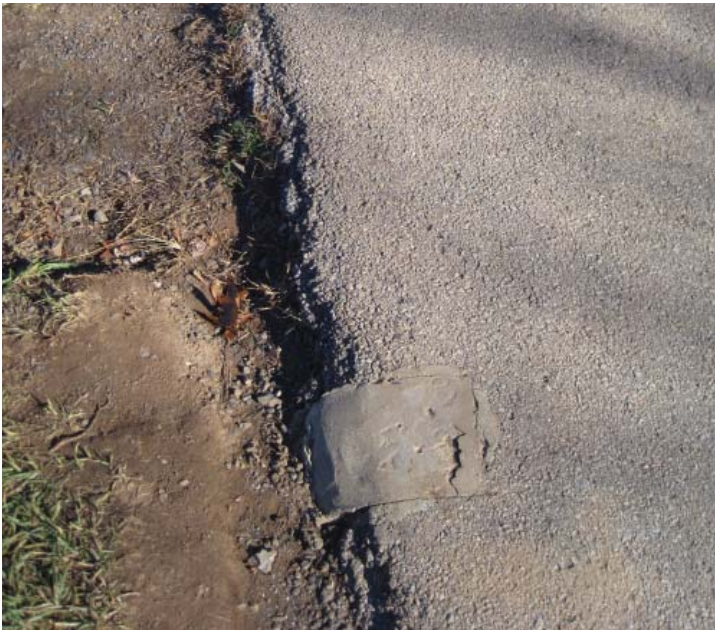
Figure 3.78. Remnant of the post-and-chain system installed to keep visitors on the asphalt paths at the summit of Little Round Top (Photo by RHI, 2010).

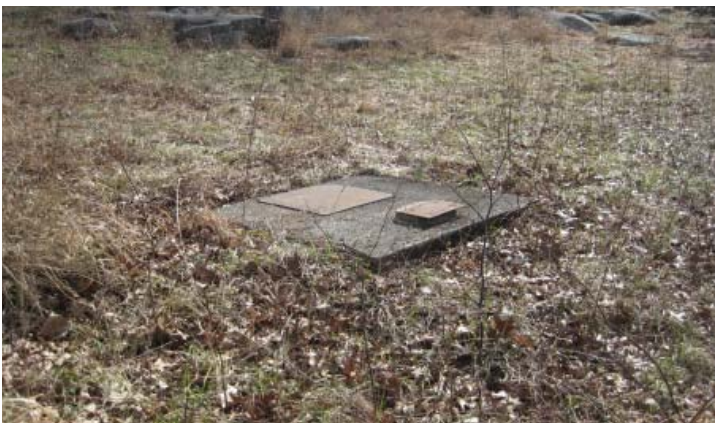
Figure 3.80. Concrete well cap near the asphalt pull-off on Warren Avenue (Photo by RHI, 2011).

**David Weikert Well:** Just north of the asphalt pull-off along Warren Avenue, a concrete pad covers the well that once serviced David Weikert's relic shop that operated nearby for several years during the War Department Era (Figure 3.80). The well has been capped by a concrete pad with an unattached steel cover over an opening in the pad, posing a visitor safety issue.

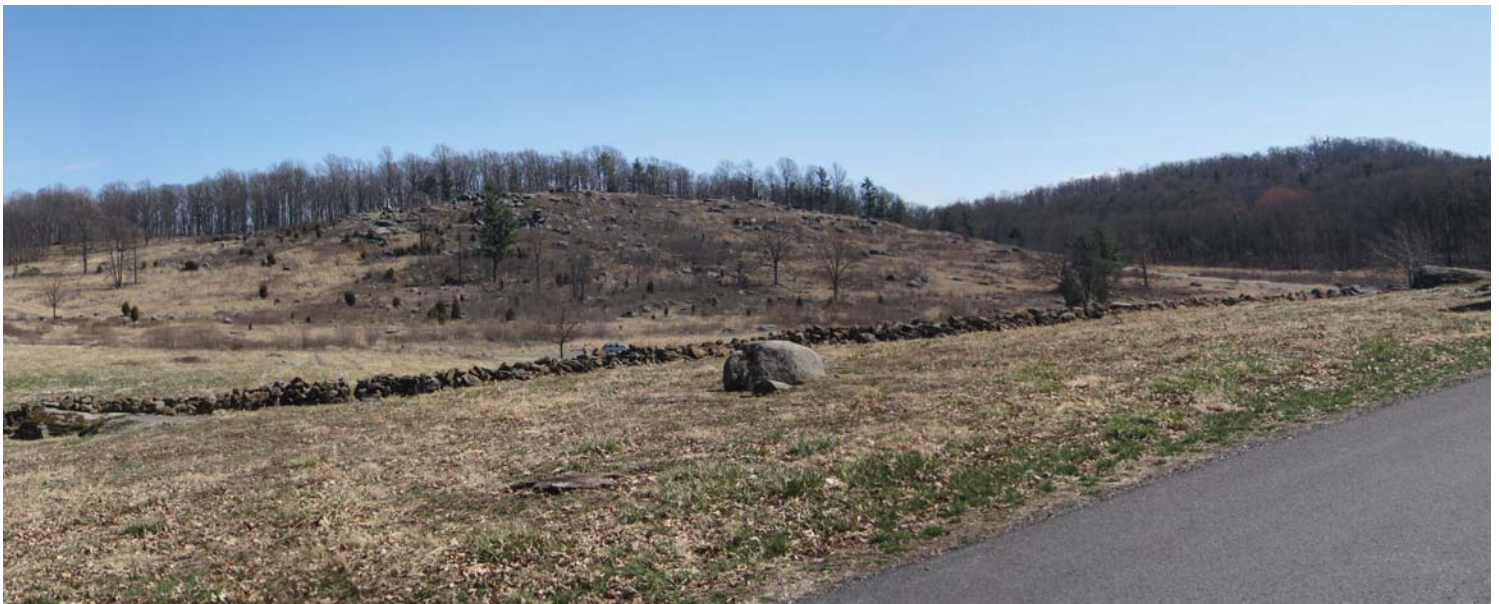
Figure 3.81. View up the steep, rocky western slope of Little Round Top. The exposed character of this slope sets it apart from the much taller Big Round Top, beyond and to the right. (Photo by RHI, 2010).

**Geology:** Little Round Top is part of a dense, 2,000 foot thick igneous rock formation known as the Gettysburg Sill, which extends from Big Round Top north to Cemetery Ridge before turning east to underlie Cemetery Hill and Culp's Hill. The large rock outcrops that define much of the landscape of Little Round Top are the result of the gradual erosion of the softer rock and soil layers that covered the sill during the course of about 180 million years (Figure 3.81).<sup>13</sup>

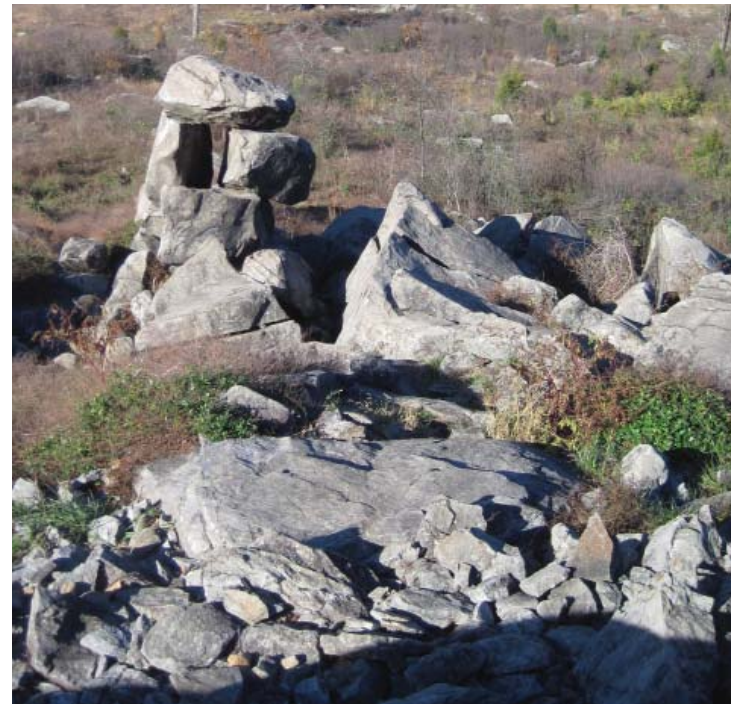
Figure 3.86. Prominent rock outcrop on Little Round Top's west slope. Large boulders like these characterize the entire project area. (Photo by RHI, 2010).

**Prominent Rock Outcrops:** The large, weathered boulders that cover the landscape of the project area are exposed portions of the Gettysburg Sill (Figure 3.86).

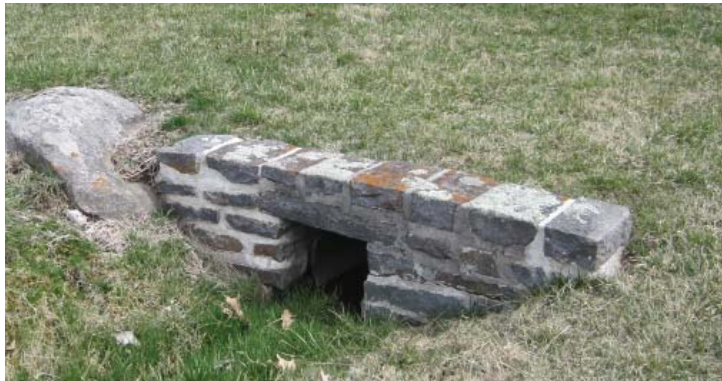
Figure 3.88. War Department Era square-topped stone culvert (Photo by RHI, 2011).

**Stone Culverts:** Two types of stone culvert convey stormwater beneath the site's roadways: the square-top culverts were constructed during the War Department Era, while the arched-top culverts were part of the Civilian Conservation Corps' efforts during the early portion of the NPS Era (Figures 3.88 and 3.89).

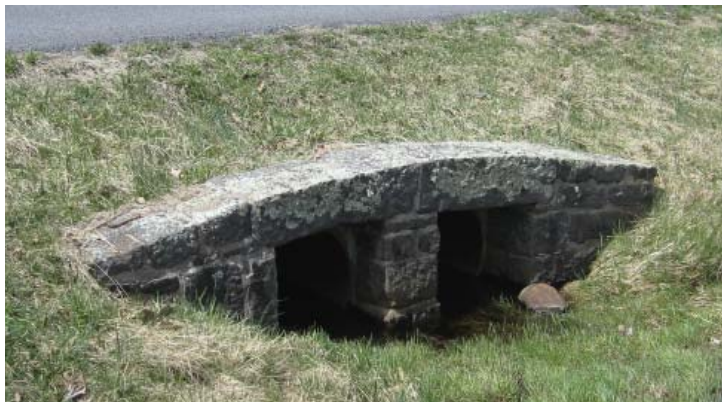
Figure 3.89. NPS Era round-topped stone culvert, constructed by the Civilian Conservation Corps (Photo by RHI, 2011).

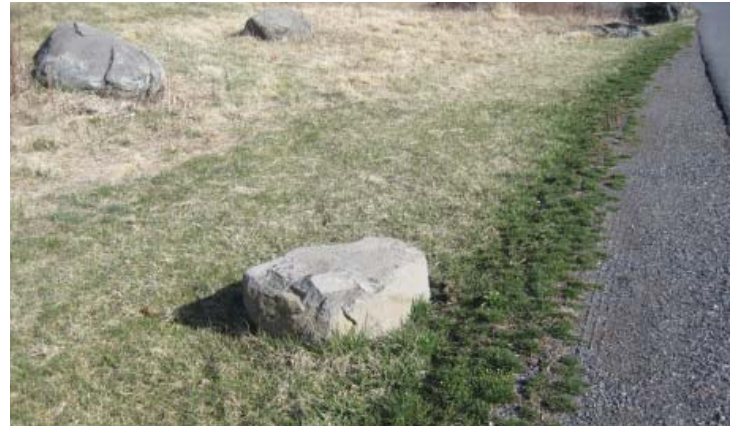
Figure 3.90. Grass swale lining Crawford Avenue (Photo by RHI, 2011).

**Grass Swale:** Two- to three-foot wide mown grass swales line the east and west sides of Crawford Avenue and the north and south ends of Sykes Avenue, where stormwater is captured and allowed to infiltrate back into the water table (Figure 3.90).

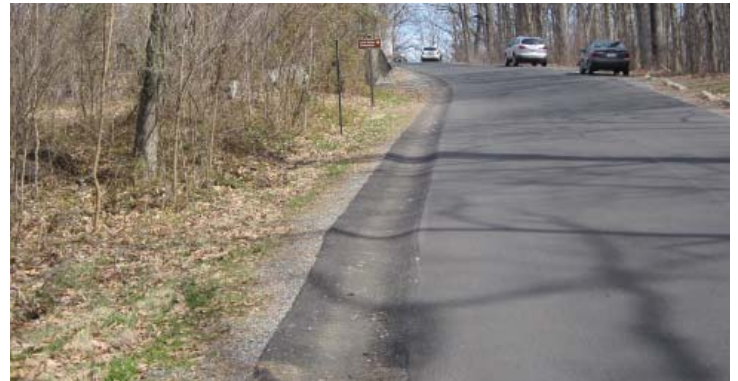
Figure 3.91. Asphalt gutter on the west side of Sykes Avenue (Photo by RHI, 2011).

**Asphalt Gutters:** 12- to 18-inch wide asphalt channels were constructed by the National Park Service along portions of Wright and Sykes avenues as a means of protecting areas of the site that are susceptible to erosion (Figure 3.91). Before the NPS Era, gutters were constructed of hand-laid cobbles, whose rough texture was effective in slowing runoff and preventing washouts.

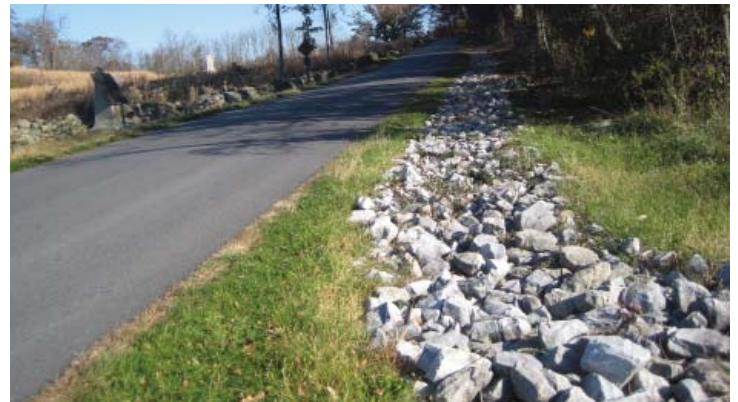
Figure 3.92. Rip-rap lined drainage channel along Wheatfield Road (Photo by RHI, 2010).

**Rip-Rap Lined Drainage Channel:** In order to handle the heavy, fast-moving stormwater that runs off of Little Round Top's north slope, a three foot wide channel of 8- to 12-inch stones was placed by NPS along the south side of Wheatfield Road (Figure 3.92). This channel slows the flow of water into Plum Run, reducing erosion and siltation that can occur during big storms.

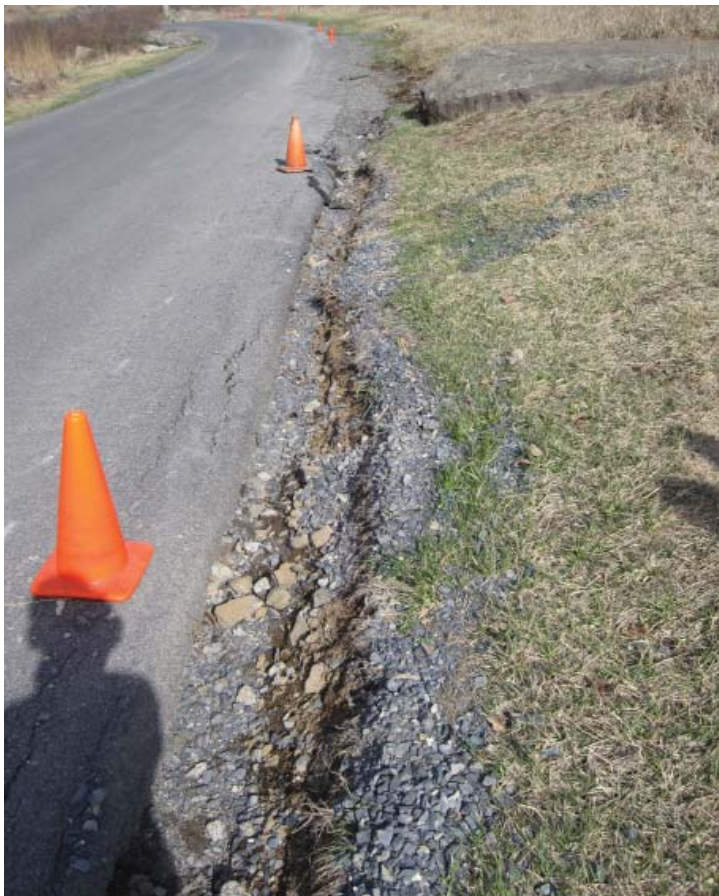
Figure 3.93. Undercutting of the roadbed along the north side of Warren Avenue has caused a partial failure of the roadway (Photo by RHI, 2011).

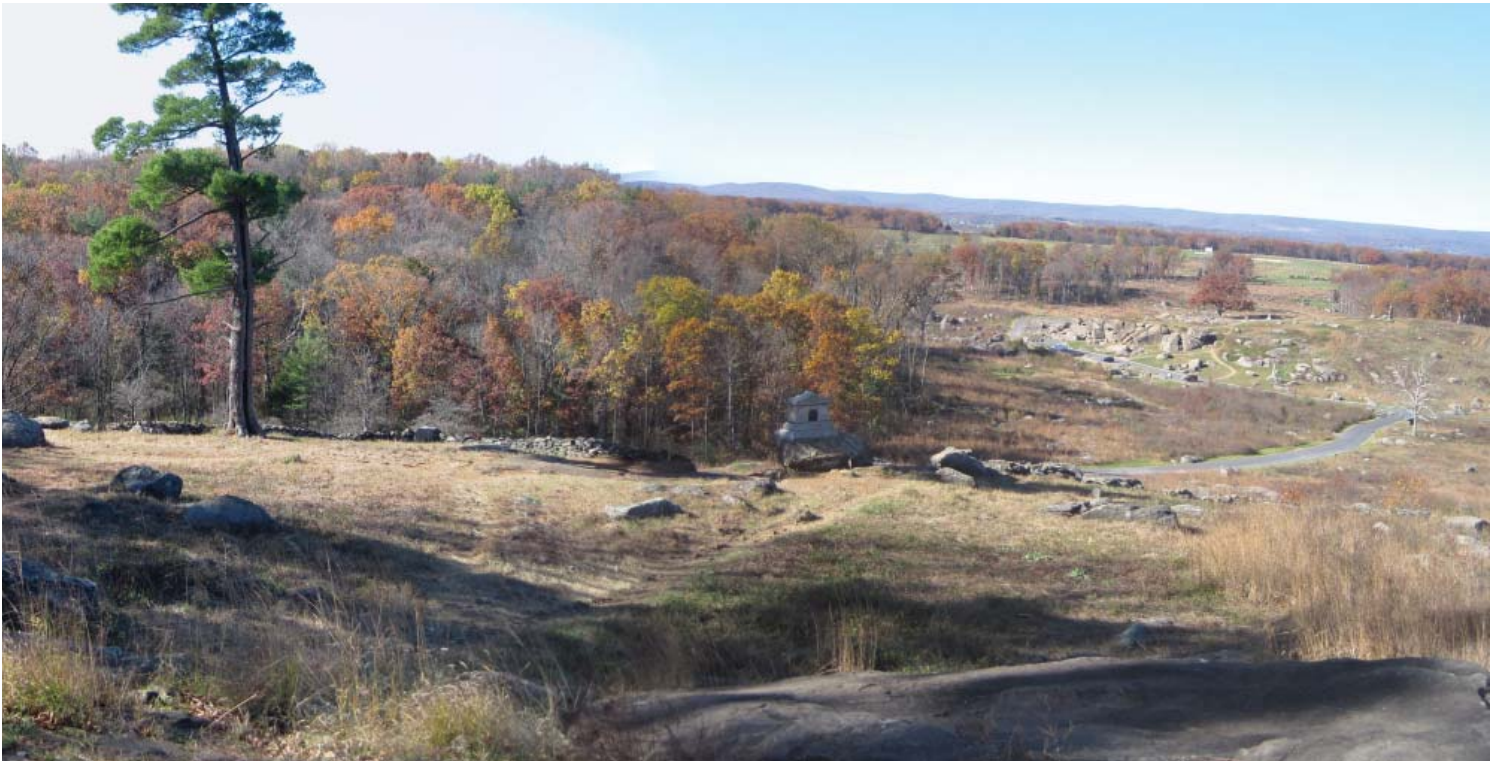
Figure 3.119. View of the triangular-shaped plateau that forms the 16<sup>th</sup> Michigan Character Area. The Slaughter Pen and Devil's Den can be seen in the background (Photo by RHI, 2010).
