# Little Round Top

Cultural Landscape Report, Treatment & Management Plan

**March 2nd , 2012**

**Einhorn, Yaffee Prescott**  
Architecture & Engineering  
Albany, New York

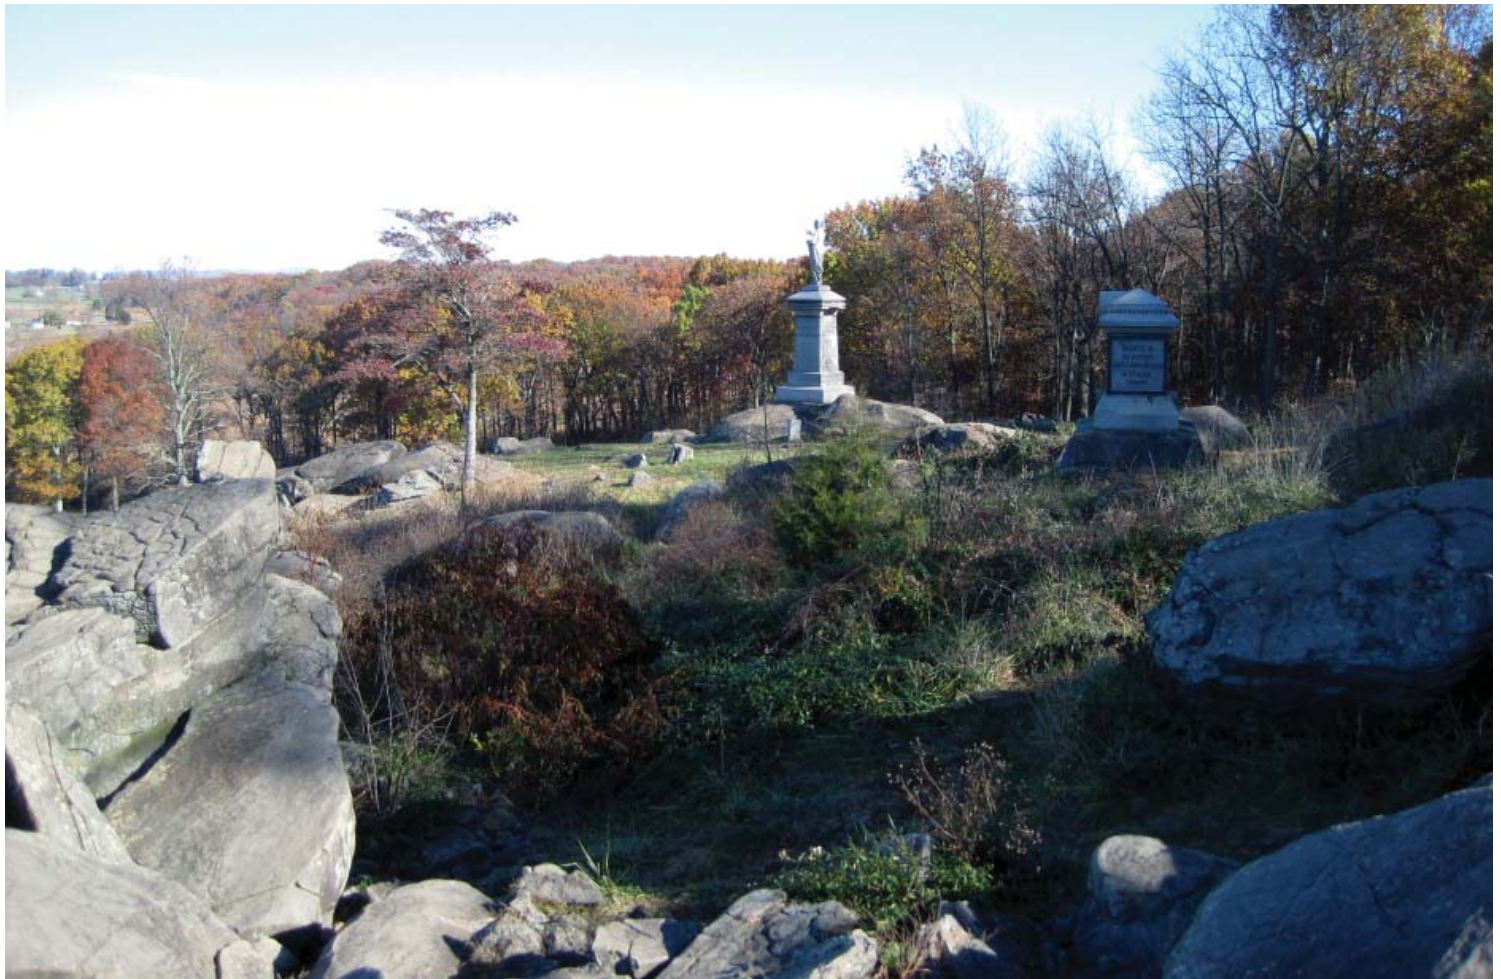
Figure 3.120. The boulder-strewn plateau that forms the North Slope Monuments Character Area. The Flowering Dogwood (left), 155<sup>th</sup> Pennsylvania Infantry monument (center) and 146<sup>th</sup> New York Infantry monument are all visible (Photo by RHI, 2010).

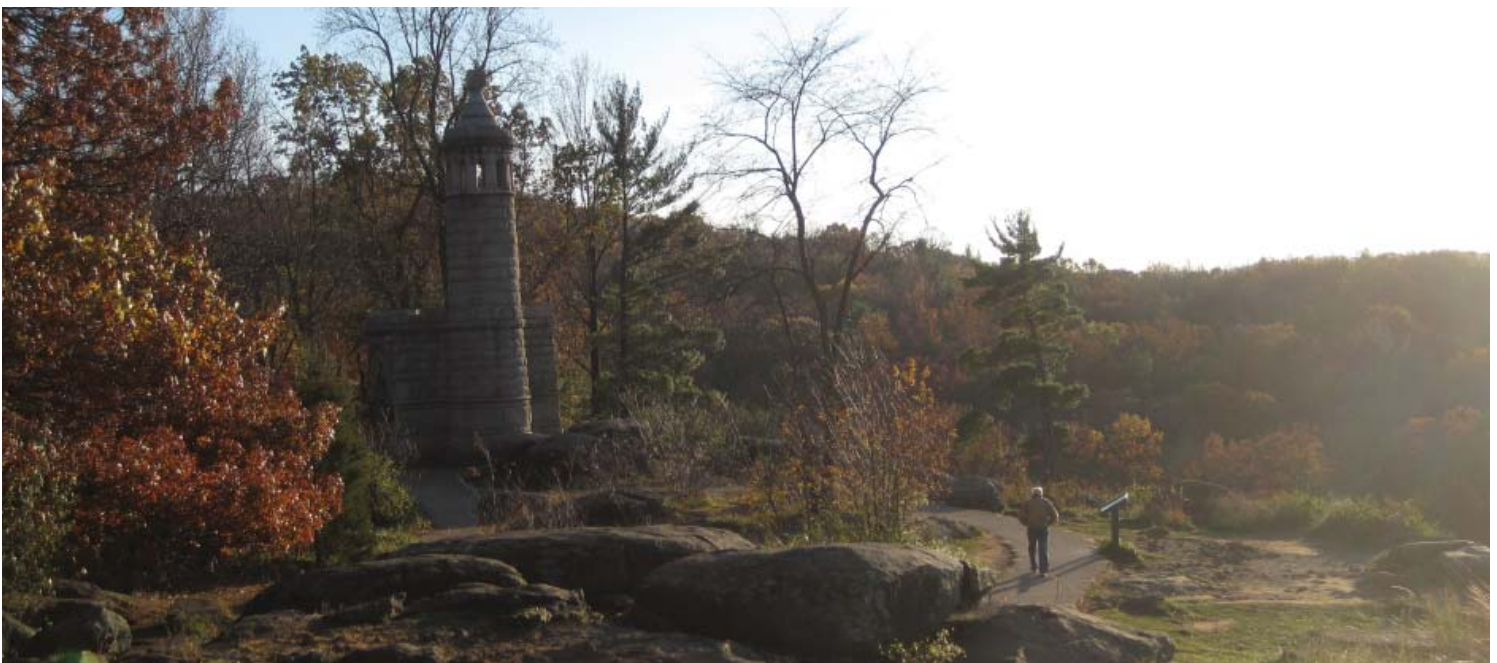
Figure 3.121 Looking south along the summit of Little Round Top toward the 44<sup>th</sup> and 12<sup>th</sup> New York Infantry Monument, within the Core Interpretive Character Area. Note the degradation to the landscape on either side of the asphalt path (Photo by RHI, 2010).

The exposed summit of Little Round Top is the main attraction for most visitors to the area surrounding Little Round Top, because of its high concentration of monuments, relative ease of accessibility and panoramic views to much of the rest of Gettysburg National Military Park (Figure 3.121). Although it is one of the few character areas with asphalt-paved paths, the high volume of visitors exceeds the capacity of the paths, causing heavy compaction and erosion throughout the character area.

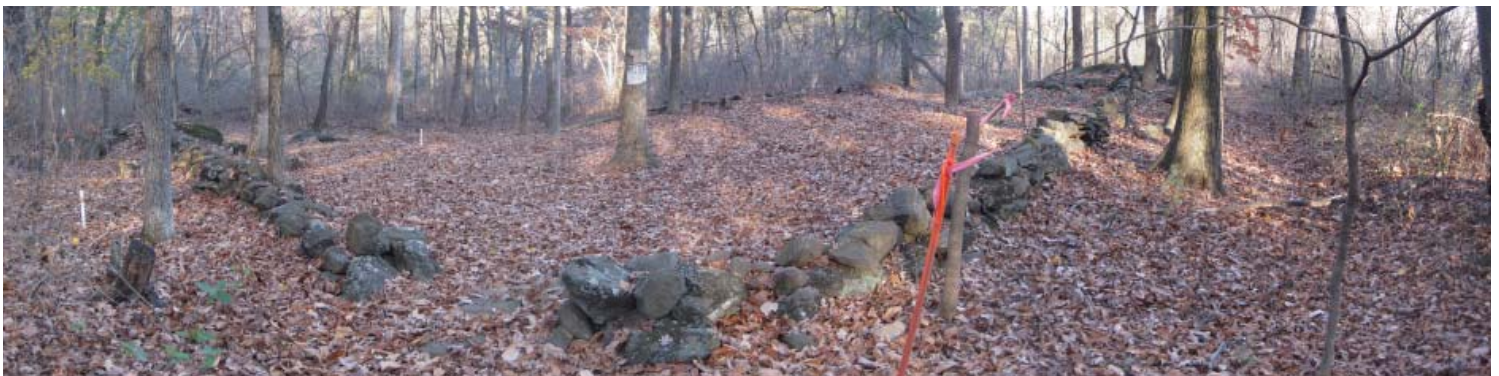
Figure 3.123. Fieldstone fence that marks the edge of the NPS property within the Dense Forest Character Area (Photo by RHI, 2010).

The dense forest that covers Little Round Top's eastern slope defines the eastern edge of the battle while isolating the area around Little Round Top from the open agricultural fields to the east. Traversed only by a horse path, this character area is largely inaccessible due to its dense vegetation and steep slopes (Figures 3.122 and 3.123).

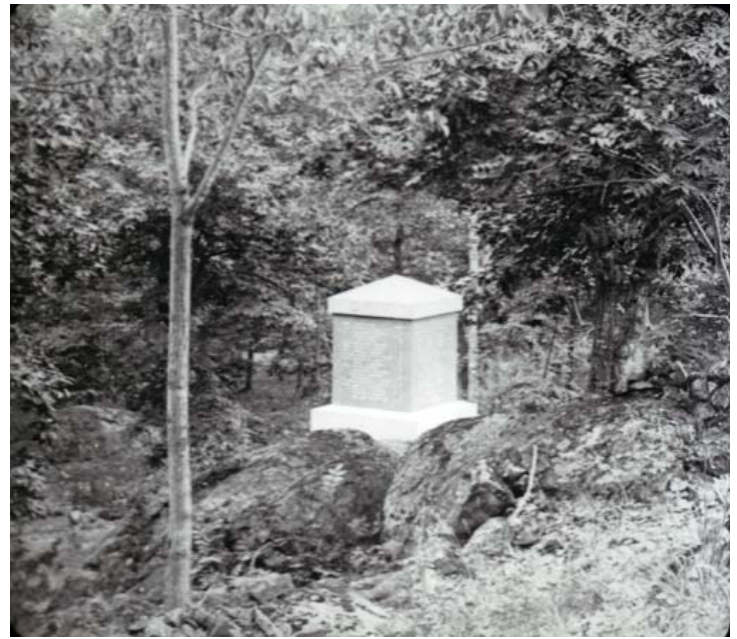
Figure 4.08. 20th Maine Monument at Vincent Spur, showing boulders and stone breastworks. Photography by Tipton, ca. 1886 (GNMP Tipton Photographic Prints GETT 41136 #6101).

**05.** A field officer in the 20<sup>th</sup> Maine regiment of Vincent's Brigade recalled how his unit moved into position on the left flank of the brigade at Vincent Spur on the afternoon of July 2, 1863 (Figure 4.08). "**We moved along this wooded [eastern] slope, the 16<sup>th</sup> Michigan leading and the 20<sup>th</sup> [Maine] following, until we left the lower ground or base between the south end of Little Round Top and the north end of Big**

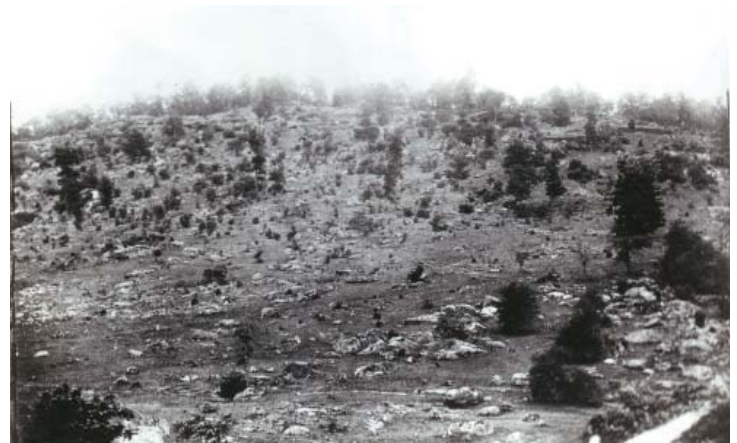
Figure 4.09. Little Round Top from the Devils Den, showing the landform's rough, rocky western face. Photography by Gibson, 6 July 1863 (GNMP General Historic Photographic Prints GETT 41135 #SF-28-2083).

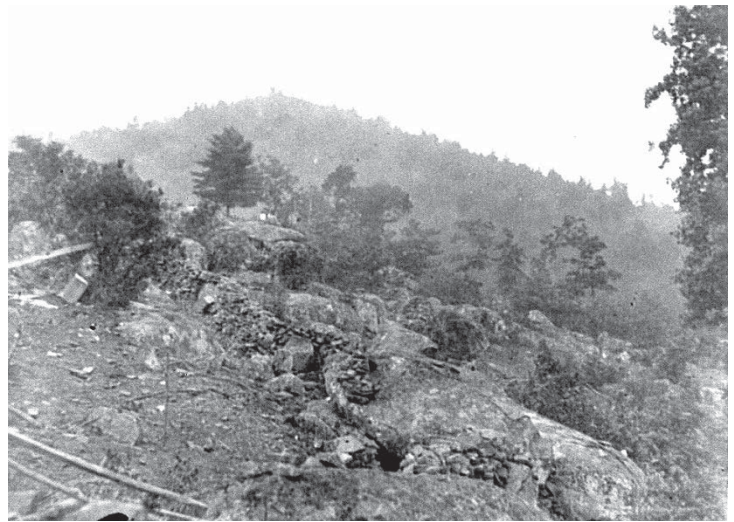
Figure 4.11. Breastworks on Little Round Top with Big Round Top in the background, July 1863 (Library of Congress, HAER Collection #4a40122u).

18. A veteran of Company G, 140<sup>th</sup> New York Infantry recalled constructing breastworks after the first day of fighting came to a close (Figure 4.11). **"[We] picked up our dead and buried them; then we built stone walls in the dark to protect us from the sharpshooters the next day."**<sup>28</sup>

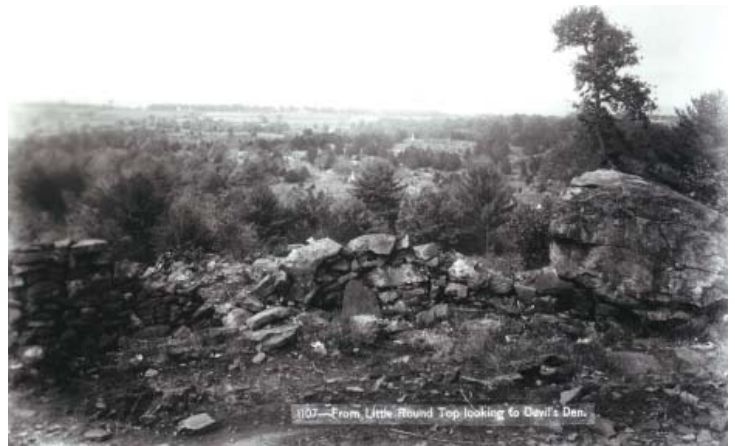
Figure 4.12. “From Little Round Top looking to Devil’s Den.” Stone breastworks near the position of the 16<sup>th</sup> Michigan. The breastworks to the left of the photograph were reconstructed several years after the battle. Photography by Tipton, 1888 (GNMP Tipton Photographic Prints GETT 41136 #1896).

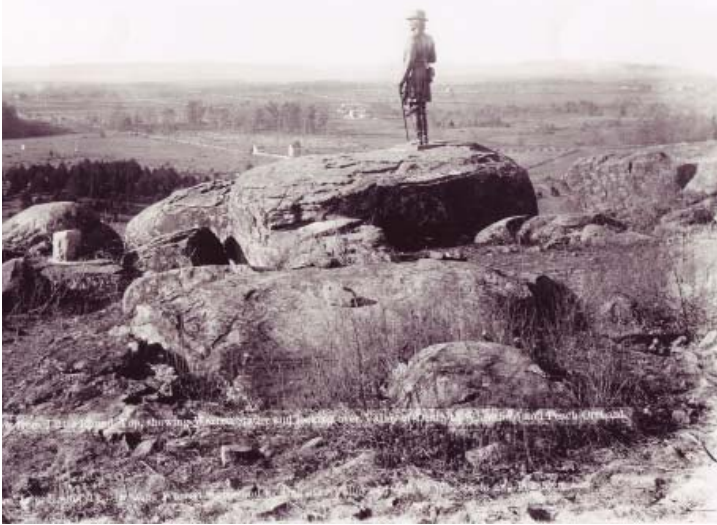
Figure 5.01. View from Little Round Top showing Warren statue and looking over Valley of Death to the Wheatfield. Photograph by Tipton, ca. 1890 (GNMP Tipton Photographic Prints GETT 41136, #2444).

The management recommendations and treatment plans presented in the following two chapters provide the maximum possible level of access to, and interpretation of, key battle and commemorative features, while ensuring the protection and stewardship of this highly significant site. Furthermore, the recommendations proposed below conform with the NPS philosophy of allowing natural processes to run their course, only intervening to preserve cultural resources and historically significant viewsheds (Figures 5.01 and 5.02).

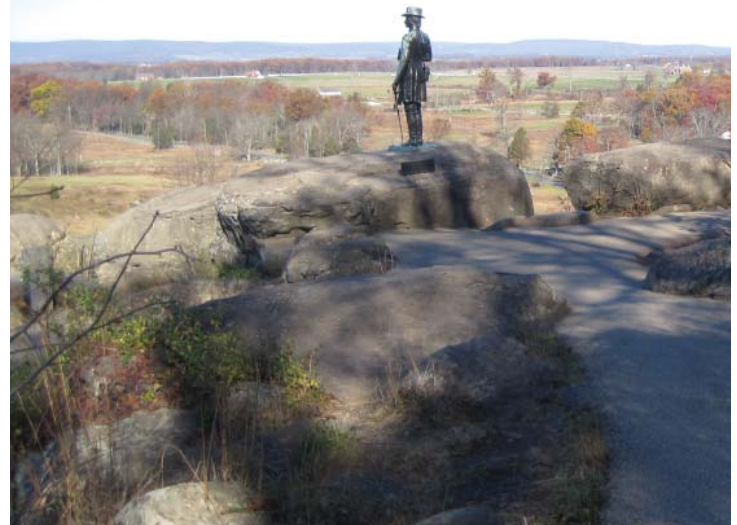
Figure 5.02. View from Little Round Top at the same location as Tipton's 1890 photograph. (Photo by RHI, 2010). Note how forest management efforts have preserved this historic view across the Wheatfield for 120 years.

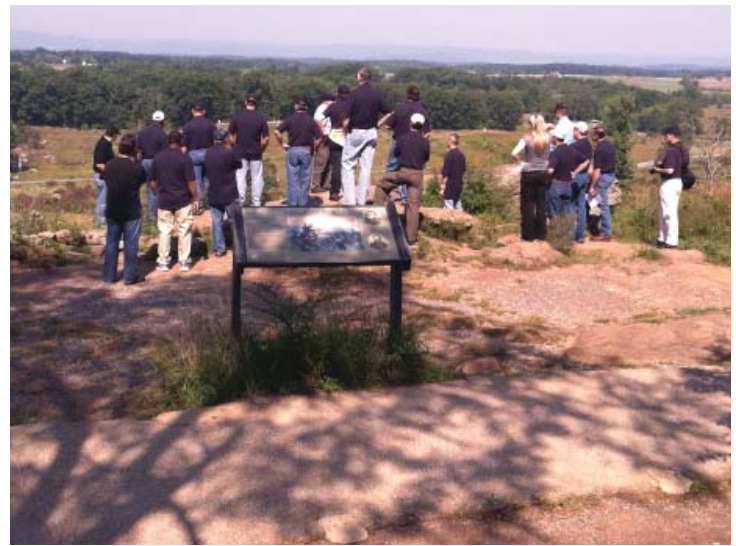
Figure 5.03. The terrain along the summit of Little Round Top has suffered significant deterioration from heavy foot traffic, on and off of existing pathways, and is in need of rehabilitation. (Photo by RHI, 2010).

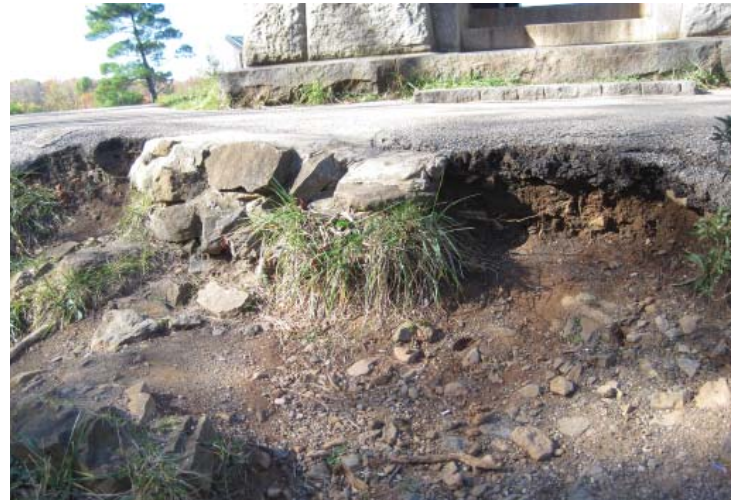
Figure 5.04. An example of degradation to the pathway system at the summit of Little Round Top. Deteriorating conditions such as this cause damage to the surrounding unimproved terrain through increased erosion and compaction from visitors stepping off the path (Photo by RHI, 2010).

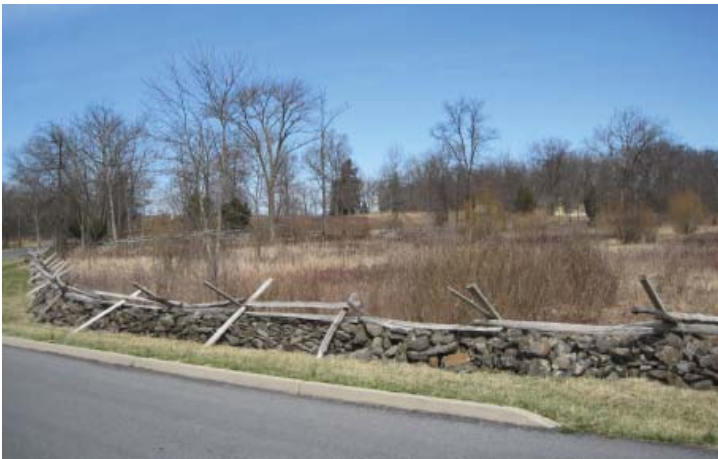
Figure 5.05. Fences, such as this stone fence with rider along Wheatfield Road, are regularly restored in their original locations, using historic methods and materials. Restoration projects like this are crucial to providing visitors with the most accurate interpretive experience possible. (Photo by RHI, 2010).

Throughout the site's history, many of the built elements that existed during the Battle of Gettysburg, such as breastworks, stone walls and wooden fences, have been restored in order to give visitors the most accurate interpretive experience possible (Figures 5.05-5.07). The continued, meticulous restoration and maintenance of these elements through study of their materials, location, size and configuration is crucial to accurately portraying Battle-Era conditions.

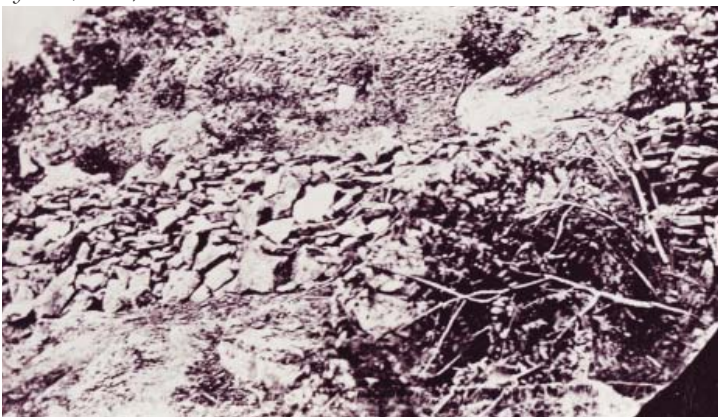
Figure 5.06. Stone breastworks as they appeared immediately following battle. Breastworks were hastily erected during battle to provide immediate protection for defending Union troops. Photograph by O'Sullivan (GNMP General Historic Photographic Prints GETT 41135 #SF-2B-2095).

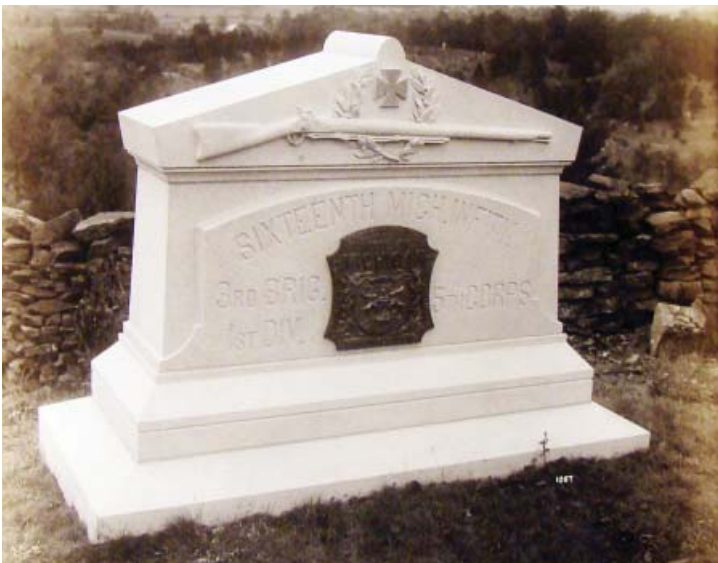
Figure 5.07. Rehabilitated stone breastworks behind the 16th Michigan Infantry Monument. Although more structurally sound than the original construction, the rehabilitated breastworks often do not convey the haste with which the original breastworks were constructed. Photograph by Tipton, 1889 (GNMP Tipton Photographic Prints GETT 41136 #5036).

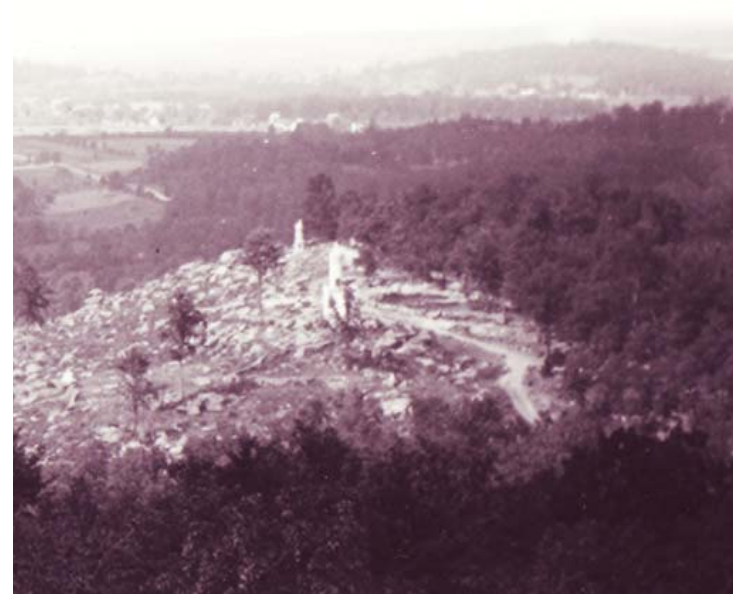
Figure 5.08. View of the historic Sykes Avenue alignment as it extended near the 12<sup>th</sup> and 44<sup>th</sup> New York Infantry Monument. This roadway alignment can be reconstructed as a pedestrian path in order to interpret a significant, lost Commemorative Era resource. Photograph by Tipton, 1896 (GNMP Tipton Photographic Prints GETT 41136, #4239).

This report has identified a number of historic resources that have been lost over time as a result in changes to management philosophies and operational practices throughout the park's history. One such example is the historic roadway alignment of both Sykes and Chamberlain Avenues (Figure 5.08). The re-establishment of these road alignments as pedestrian trails would be a useful part of efforts to interpret the historic roadways. Opportunities exist to reconstruct or interpret several additional Commemorative Era resources that have been lost over time.

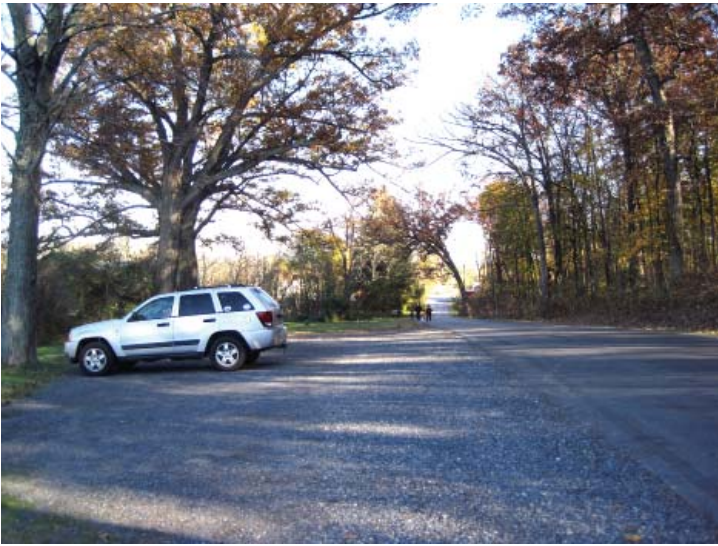
Figure 6.02. Existing gravel parking area along Wheatfield Road (Photo by RHI, 2010).

- **Utilize areas of relatively low historic integrity for remote visitor parking facilities.** Relocating a majority of visitor parking away from the summit of Little Round Top will ease vehicular congestion during peak visitation times. The gravel area along the north side of Wheatfield Road, between Sedgwick Avenue and the old Round Top Schoolhouse, provides an opportunity for expanded visitor parking, with adequate room for planting and visual buffering from Wheatfield Road (Figure 6.02).

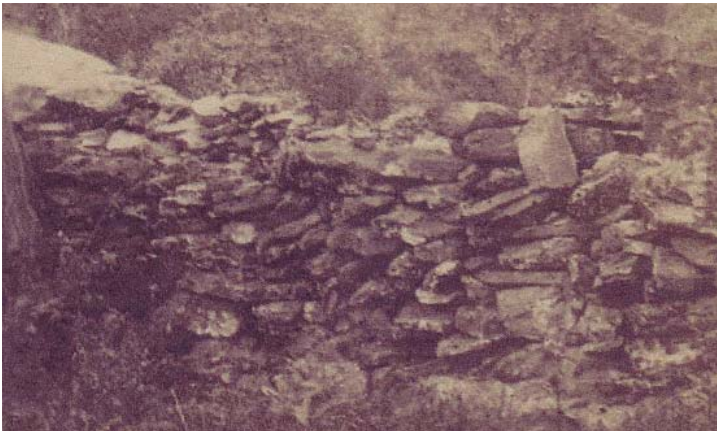
Figure 6.04. Reconstructed breastworks on Little Round Top, circa 1880. Breastworks constructed during battle would have been much simpler than the high stone wall depicted here. The need to interpret this key battle-era feature was recognized early, however, and breastworks have been continually rebuilt throughout the park's history (Susan Boardman Collection of Historic Stereographic Views #SV-713).

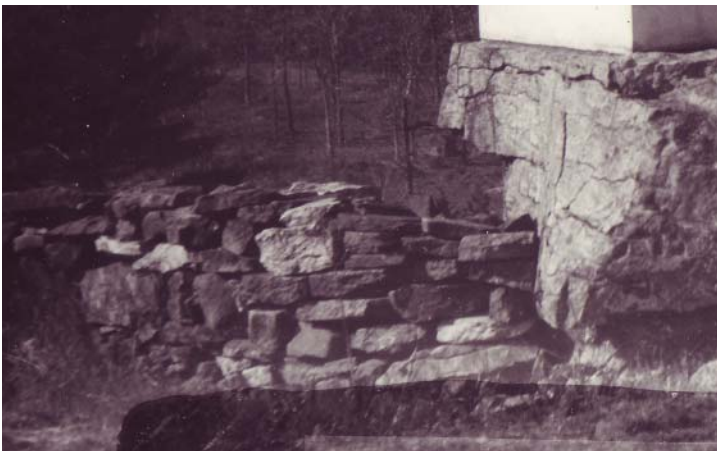
Figure 6.05. Reconstructed breastworks at the 16<sup>th</sup> Michigan Infantry monument, 1896 (GNMP Tipton Photographic Prints GETT 41136 #4419).

- **Restore and stabilize breastworks as they deteriorate.** Nearly all of the breastworks on Little Round Top today have been rebuilt or reconstructed since they were initially created during the Battle of Gettysburg. Despite this fact, their proportions and locations are relatively accurate to Battle Era conditions and they convey the Battle Era visual character of the western slopes of Little Round Top. NPS staff should continue to regularly monitor the condition of the stone breastworks throughout Little Round Top in an effort to ensure natural processes or visitor interaction do minimal harm to these contributing features. The policy of rebuilding damaged breastworks should continue (Figures 6.04 and 6.05).
- **Remove overgrown vegetation from breastworks.** Several of the breastworks that line Little Round Top's western

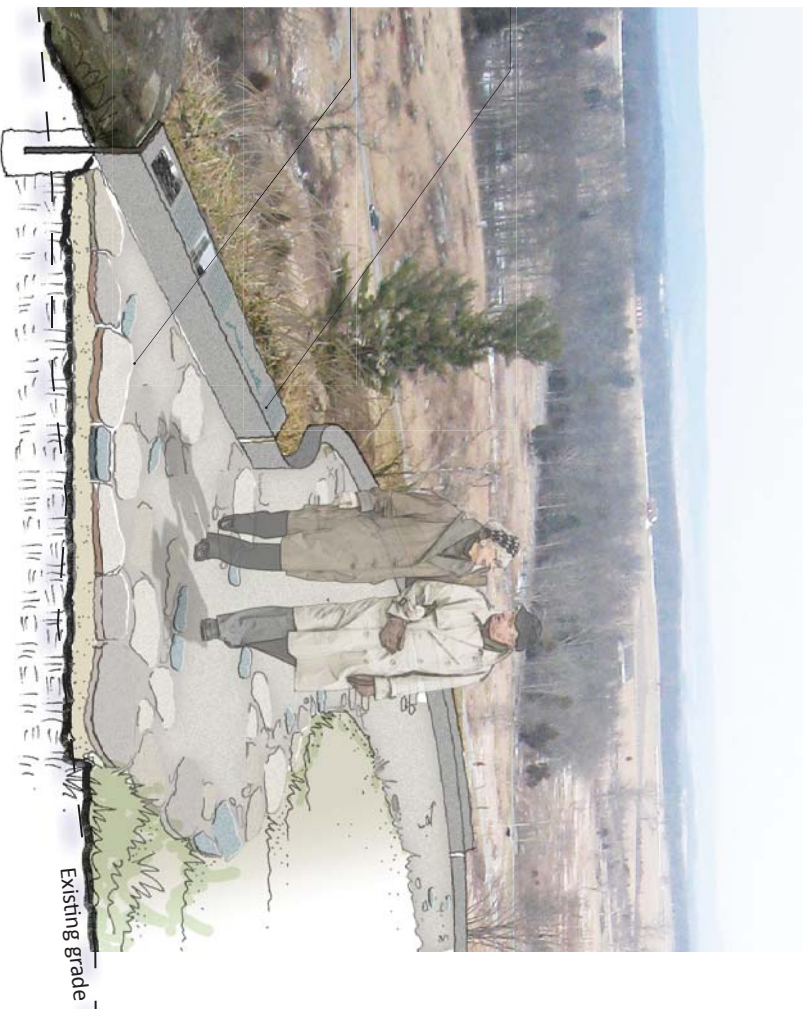
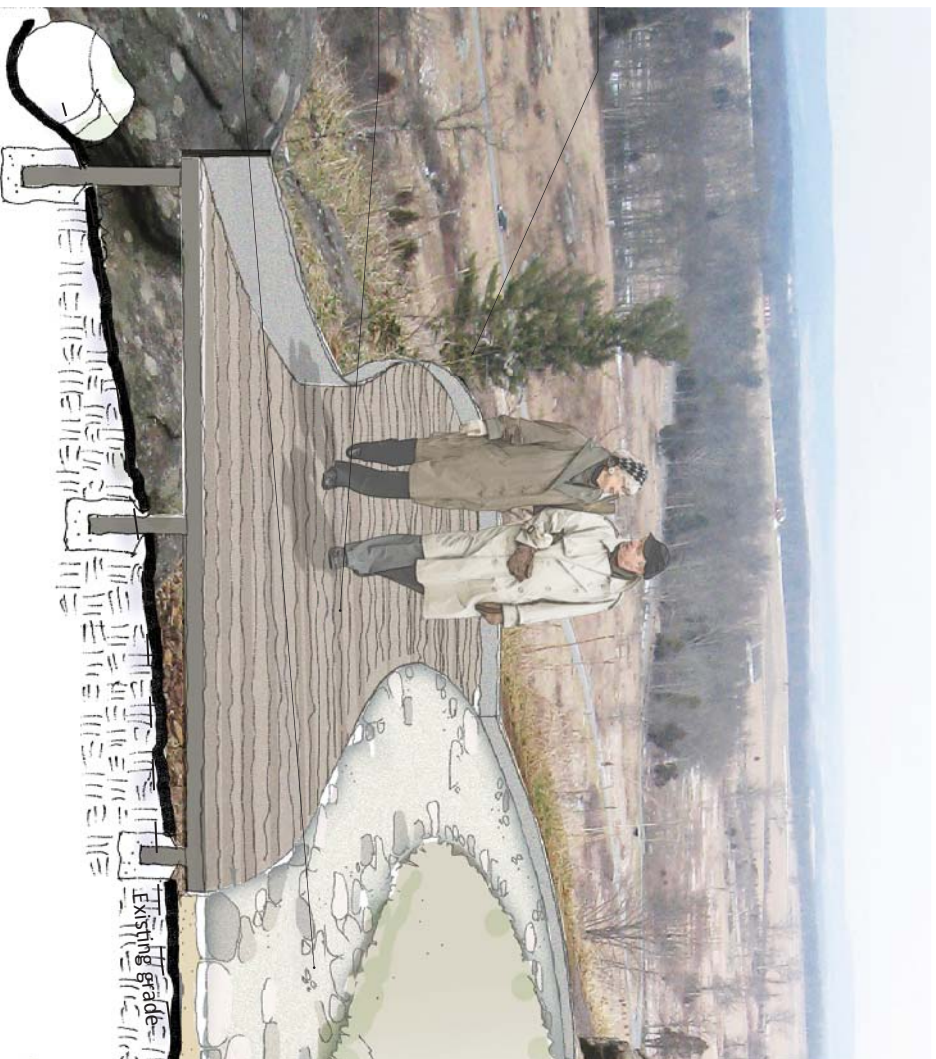
Figure 7.03. Summit Trail and Gathering Areas

Toe rail acts as a discreet barrier while providing interpretive opportunities

Random stone paving

Toe rail acts as a discreet barrier

Where slopes are steep, platforms or decking could be considered for visitor gathering areas

Gentle pedestrian containment and management is a key component of successfully protecting Little Round Top while allowing the public intimate access to the site (Figure 7.03). Numerous options, such as cable railing and improved signage, are potentials and should be studied during detailed design. The method suggested in this alternative provides a low 'toe rail' which can fulfill the functions of creating a visual reminder as well as a place for signage, both interpretive and for gentle behavior management.

- **Materials.** The gathering areas are designed to comfortably support 60-visitors at one time. Gathering areas are paved with stone, blending with the existing landscape, set on a porous surface to aid in stormwater management. In some cases, where slopes are steep, platforms or decking should be considered as a means of extending visitor gathering space to appropriate capacity, without relying on heavy earthwork and intrusive construction. Platforms or path edges should be less than 30 inches above adjacent grade to avoid the requirement for railings. Low, subtle signage, in addition to standard ADA signage requirements, can be a further opportunity for interpretive story lines and gentle reminders for proper behavior at the site (Figure 7.03).
