ITS NUMBER 7

Interpreting The Secretary of the Interior's Standards for Rehabilitation

Subject: Painting Previously Unpainted Woodwork

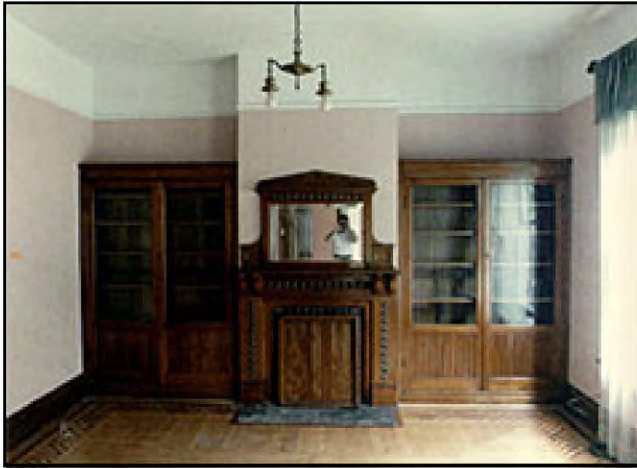
This view, taken before rehabilitation, shows the fine built-in cabinetry in one of the formal rooms on the first floor. Its natural color harmonizes with the designs of the parquet flooring.

The woodwork was particularly fine in two of the first-floor formal rooms and its natural color complemented the intricate designs of the parquet flooring.

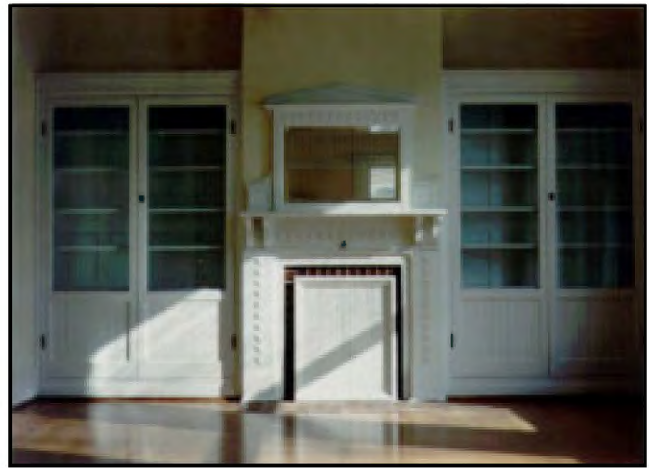
During rehabilitation most of the naturally-finished woodwork was painted white, resulting in a drastic change of character to this late-nineteenth century interior.

As part of the rehabilitation all the previously unpainted wood trim throughout the house was painted white. Because the interior trim with its unpainted natural-colored finish was such an important historic feature of the house, painting it white resulted in a drastic change and loss of historic character. The extensive interior woodwork with the tone and grain of the natural finish had given a distinctive quality to the house, furthering the sense of time and place associated with the historic district. Painting of the woodwork lessened significantly the historic character of what had been a virtually intact late-nineteenth century house, and the rehabilitation does not meet the Secretary's Standards for Rehabilitation.

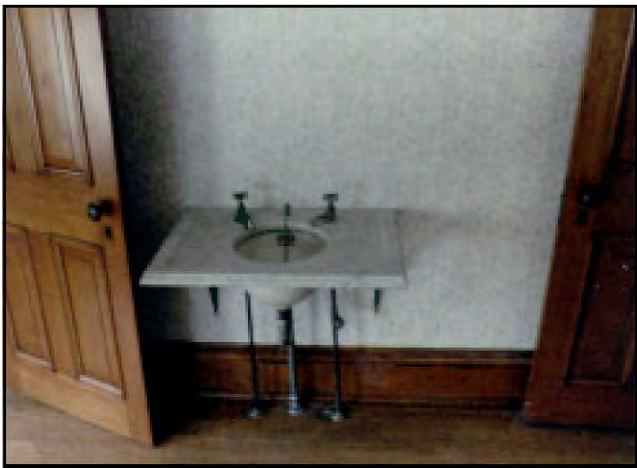
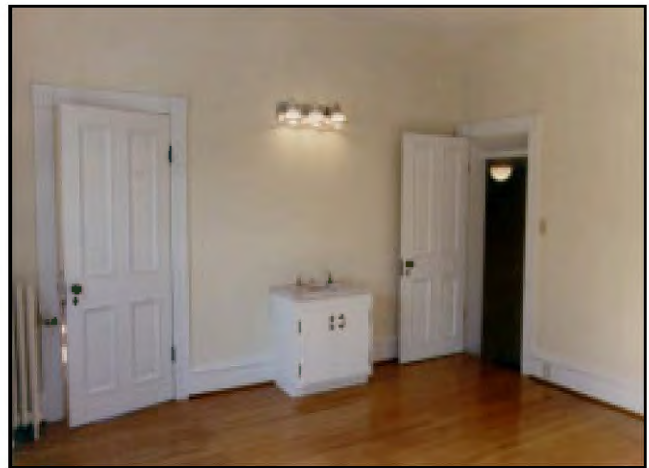
These "before and after" photographs of an original sink in an upstairs bedroom also show how dramatically the painted woodwork has changed the character of the room.
