THE SECRETARY
OF THE INTERIOR'S
**STANDARDS FOR
THE TREATMENT
OF HISTORIC
PROPERTIES**

WITH
**GUIDELINES FOR
PRESERVING,
REHABILITATING,
RESTORING &
RECONSTRUCTING
HISTORIC
BUILDINGS**

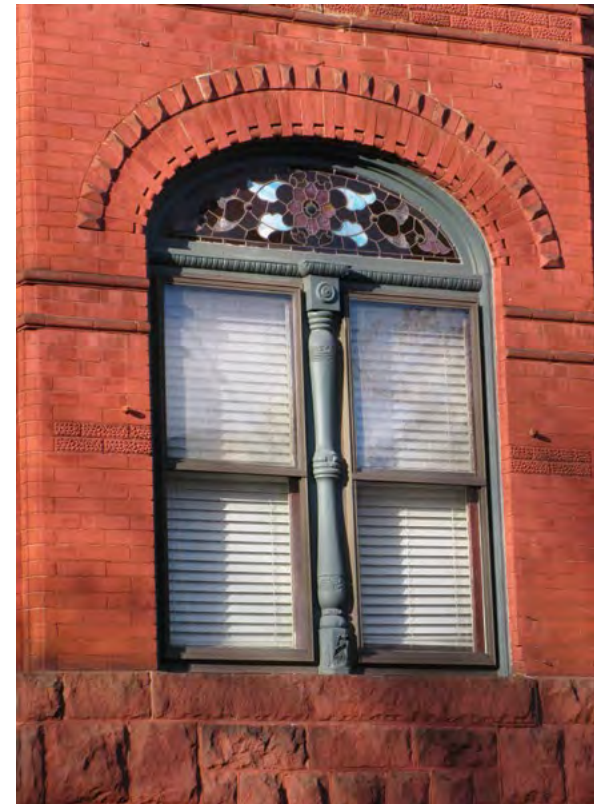
Entrances and Porches

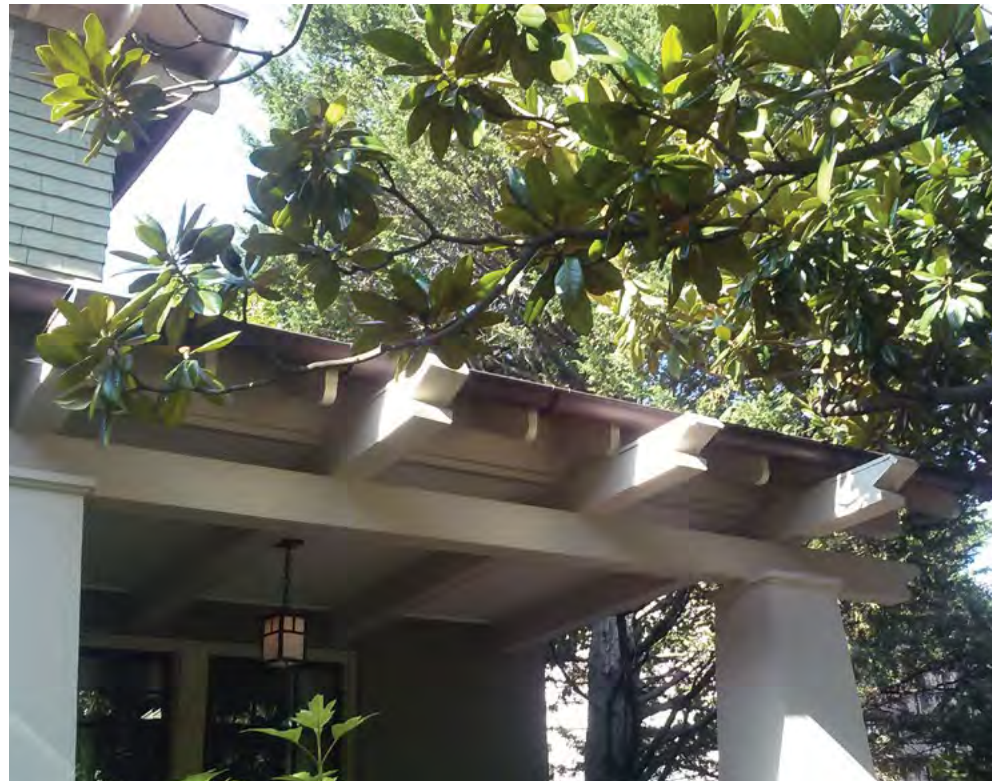
ENTRANCES AND PORCHES

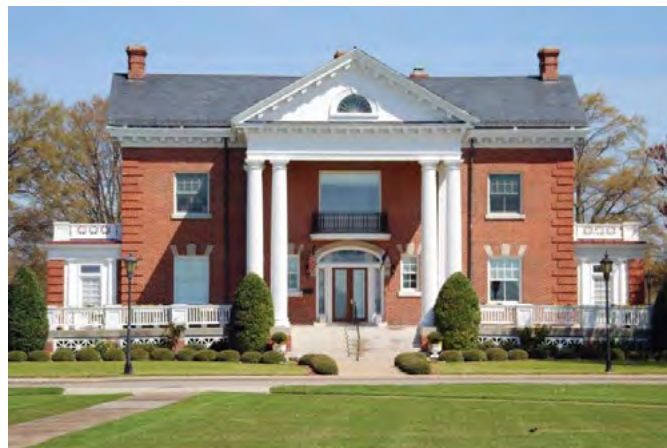
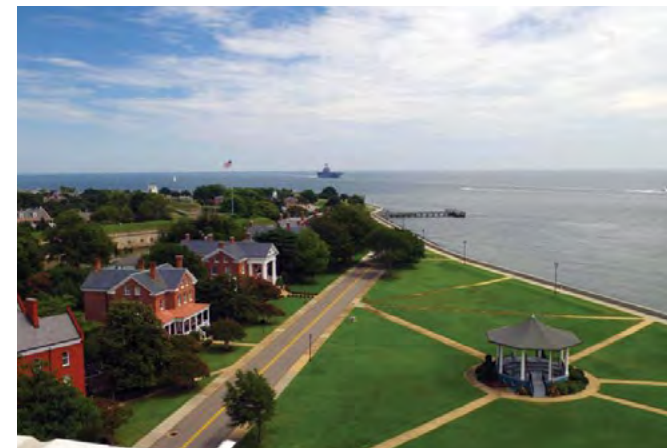
SETTING (DISTRICT / NEIGHBORHOOD)

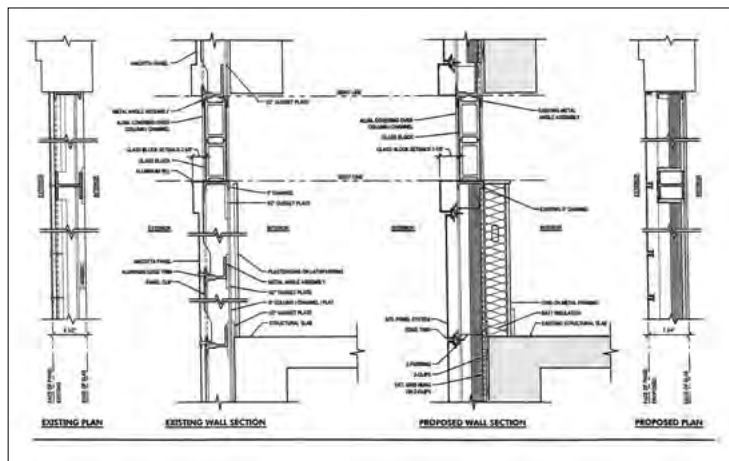
MASONRY: STONE, BRICK, TERRA COTTA, CONCRETE, ADOBE, STUCCO, AND MORTAR

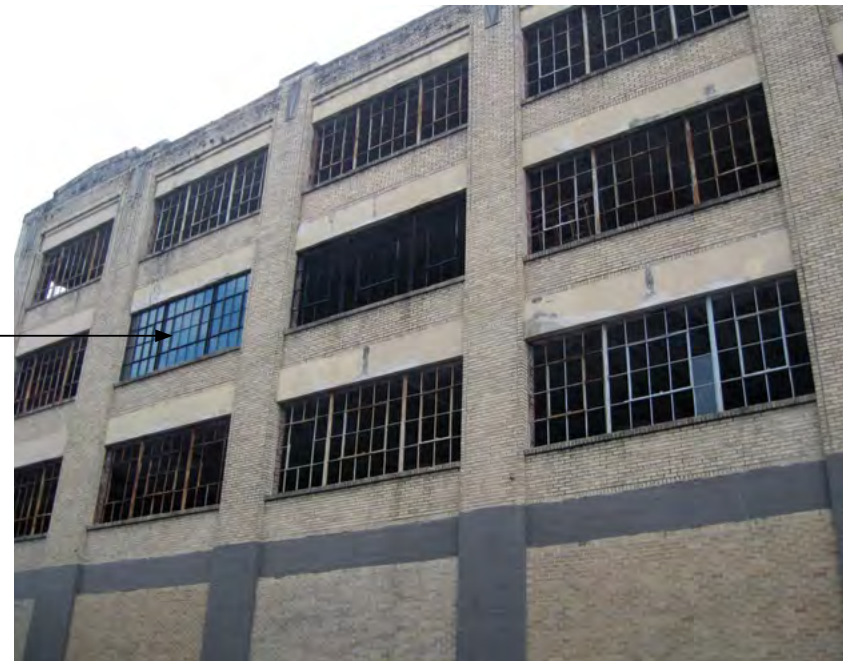
[19] Installing a mockup of a proposed replacement window can be helpful to evaluate how well the new windows will match the historic windows that are missing or too deteriorated to repair.

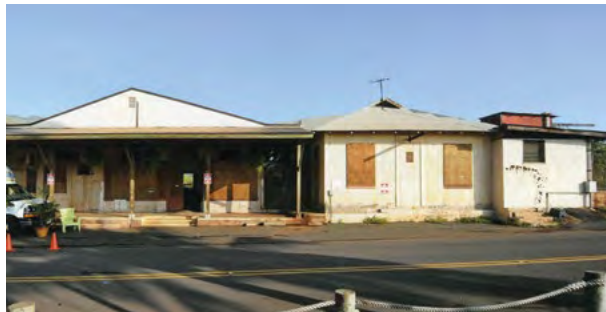
[29] The rehabilitation of the 1910 Māālaea General Store (a), which served the workers' camp at the Wailuku Sugar Company on the Hawaiian island of Maui, included the reconstruction of the original parapet (b).

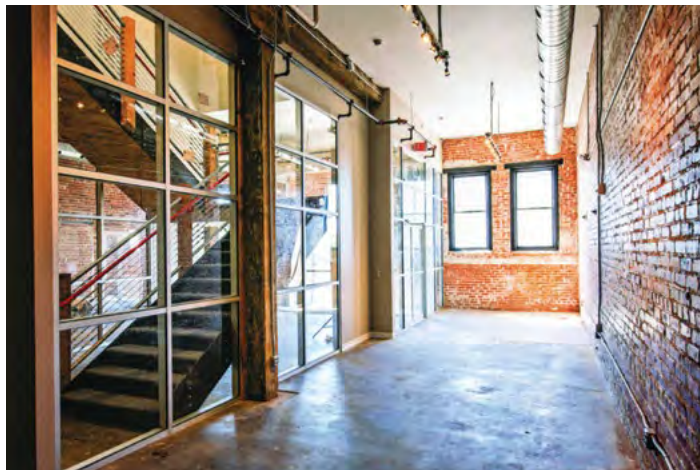
[39] Leaving the ceiling structure exposed and installing exposed ductwork where it does not impact the windows, are appropriate treatments when rehabilitating an industrial building for another use.

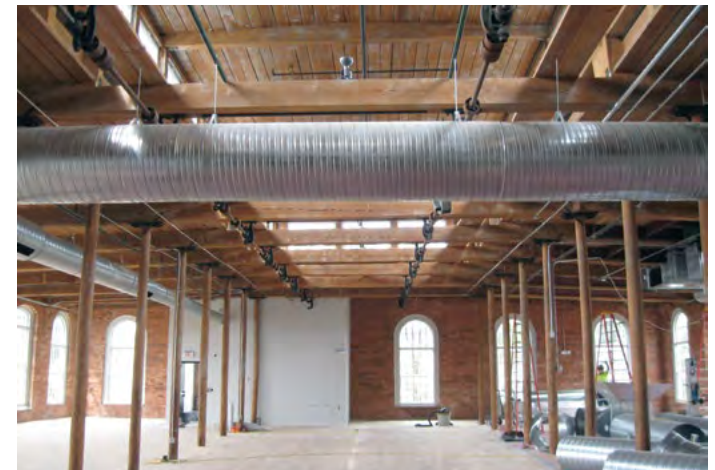
INTERIOR SPACES, FEATURES, AND FINISHES

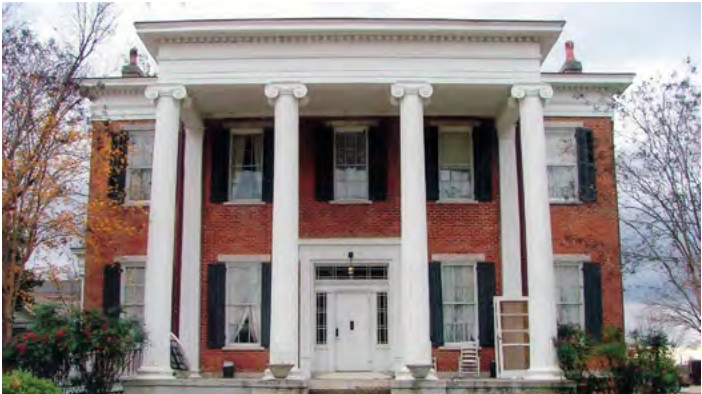
[44] **Not Recommended:** (a-b) The historic character of this plantation house (marked in blue on plan on opposite page) and its site was diminished and adversely impacted when multiple new buildings like this (#3 on plan) were constructed on the property (c).

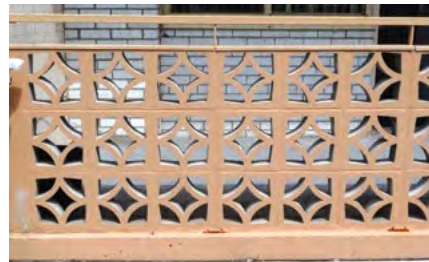
[59] (a-b) The decorative concrete balcony railings on this 1960s building did not meet life-safety code requirements. They were replaced with new glass railings with a fritted glass pattern matching the original design—a creative solution that satisfies codes, while preserving the historic appearance of the building when viewed from the street (c-d). Photos: (a, b, d) ERA Architects, Inc.; (c) Nathan Cyprys, photographer.

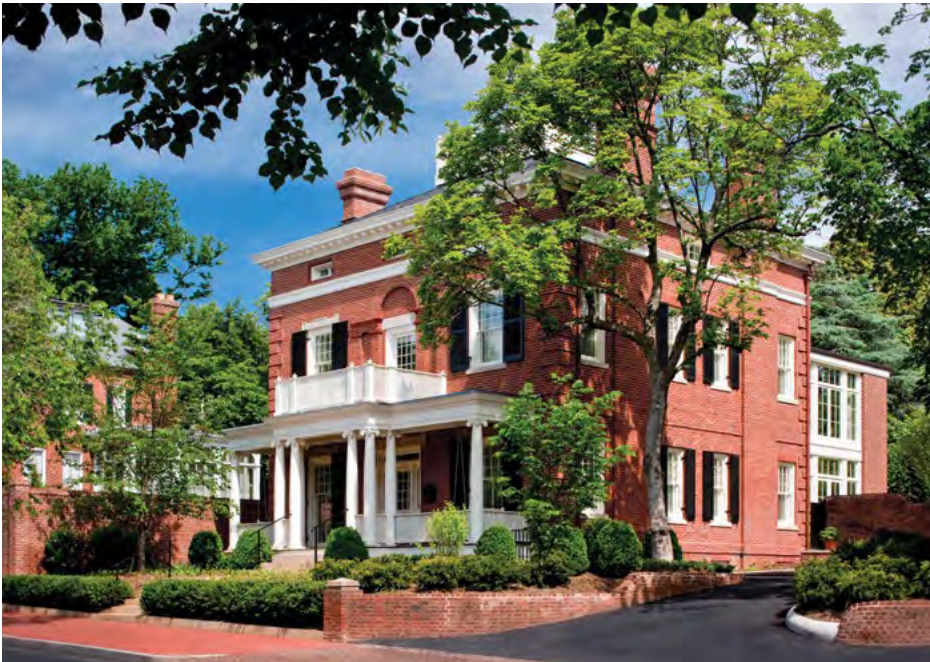
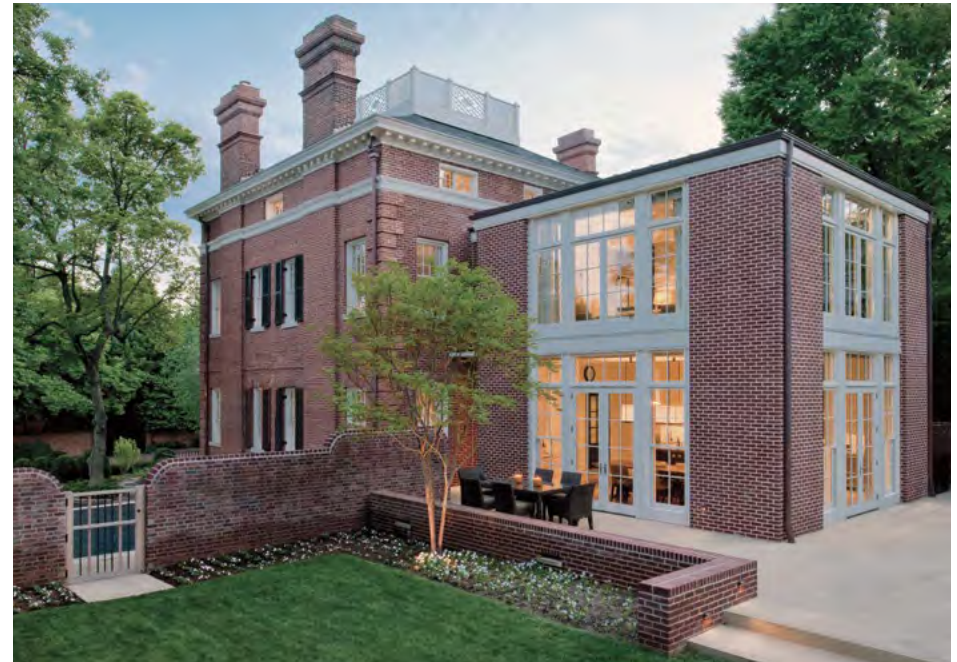
NEW EXTERIOR ADDITIONS TO HISTORIC BUILDINGS AND RELATED NEW CONSTRUCTION

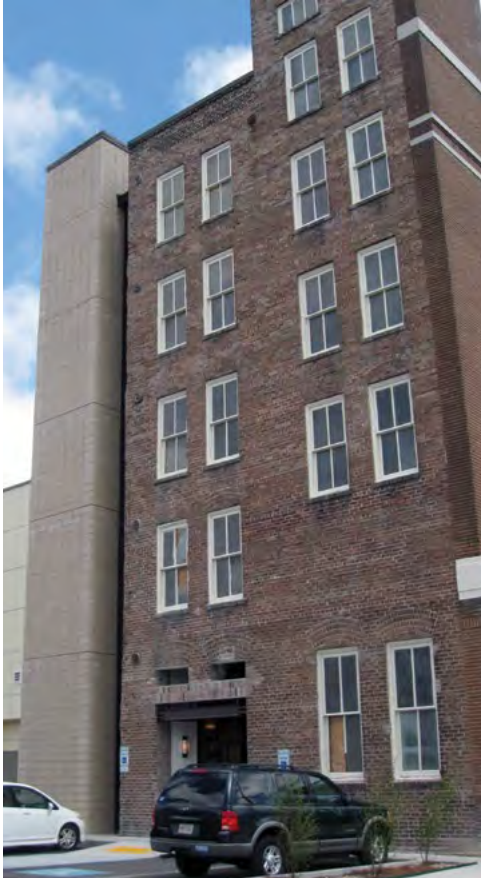
[62] The stair tower at the rear of this commercial building is a compatible new addition.

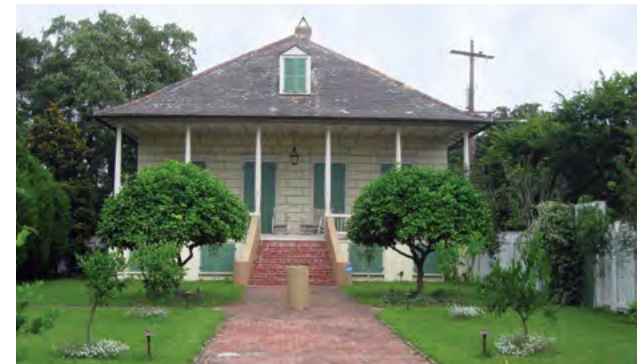
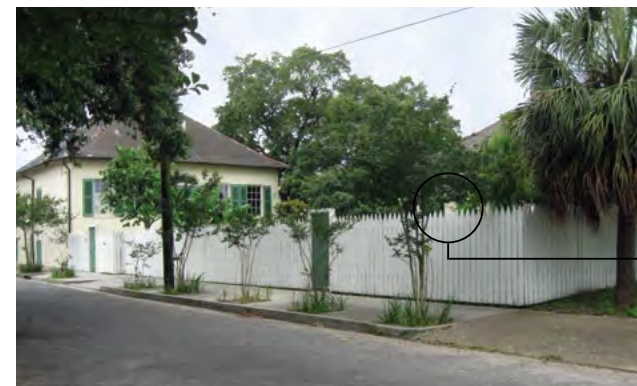
NEW EXTERIOR ADDITIONS TO HISTORIC BUILDINGS AND RELATED NEW CONSTRUCTION
