Fort Jefferson Then and Now

Dry Tortugas National Park

Rodman Cannon and Gun Platform

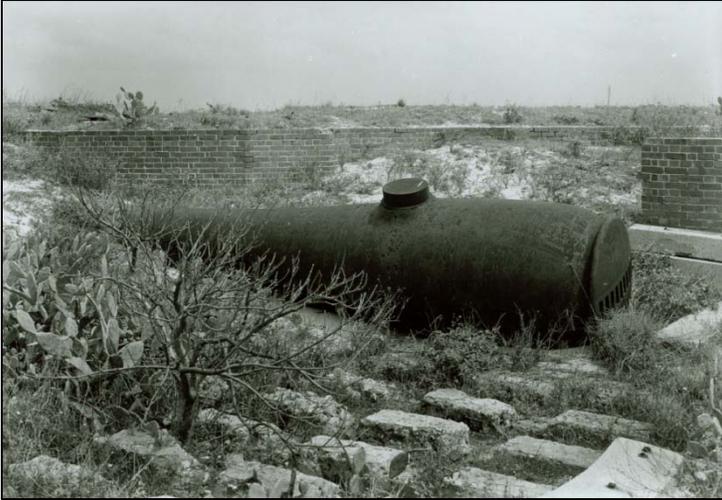
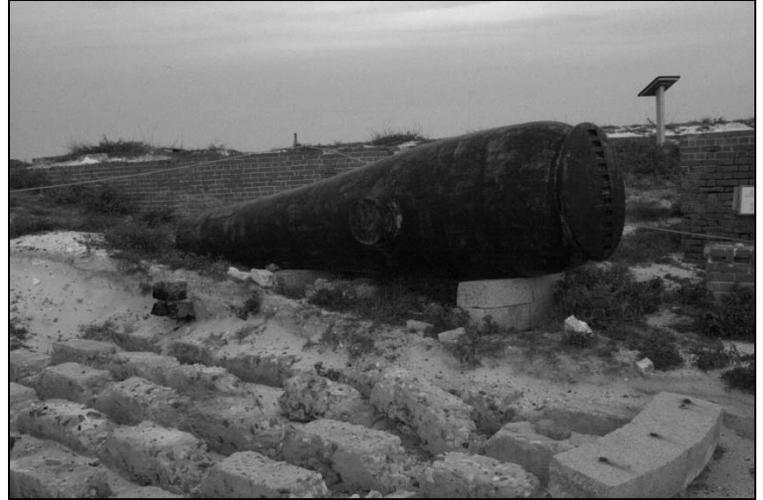
The six 15-inch Rodman smoothbore guns at Fort Jefferson were made by Cyrus Alger & Company in 1871. They were installed on the terreplein in 1873 as part of a 'modernization' of the fort's armament. Each gun weighs approximately 50,000 lbs. The guns were mounted on iron center-pintle carriages. The guns and the carriages were to be mounted on platforms of timber laid upon a bed of concrete. When the timbers arrived, however, they were poorly made and badly creosoted. To compensate for this, it appears that additional concrete was used to provide better support for these large guns. These efforts were unsuccessful, however, and by 1877 the wooden platforms were described as being in "an advanced stage of decay and . . . are worthless in consequence."

In the 1937 photograph the remains of the platform are visible in the foreground and the cannon is in the background, sitting directly on the sand. The visible part of the platform shows only the concrete support structure; the wood has rotted away. The 482nd Civil Engineers Squadron of the Homestead Air Reserve Base lifted all of the cannon, including this one, out of the sand to aid in their preservation. Over time, erosion on the terreplein covered up the remains of the original gun platform and it was 'lost'.

In December 2009, NPS archeologists excavated the platform to study it as a model for reconstructing a gun platform to support a new reproduction carriage. The 2010 photograph shows the cannon lifted onto blocks and the excavated platform in the foreground. Look for the exposed timbers near the tip of the cannon. An unexcavated portion of the platform continues under the cannon. The excavation provided information about the basic size and shape of the historic gun platform. One of the Rodman guns will be mounted on a full reproduction carriage in November 2010 as part of the park's 75th anniversary celebration.

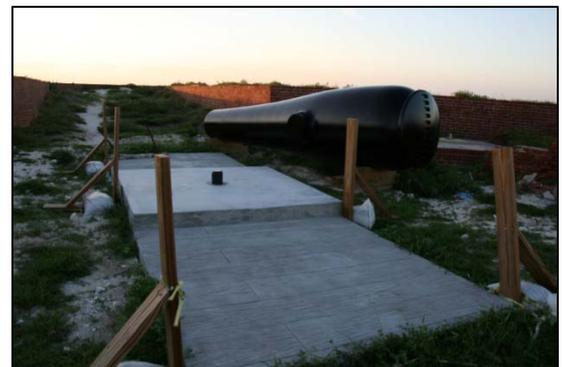
Photograph of treated Rodman cannon and partial construction of the replicated gun platform.

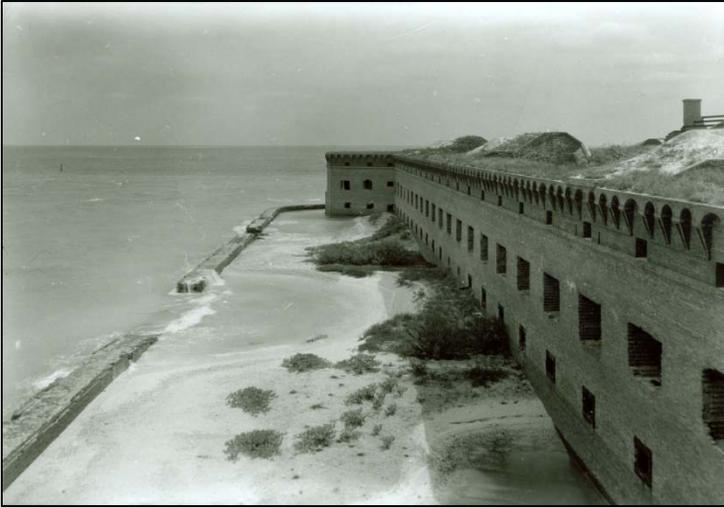
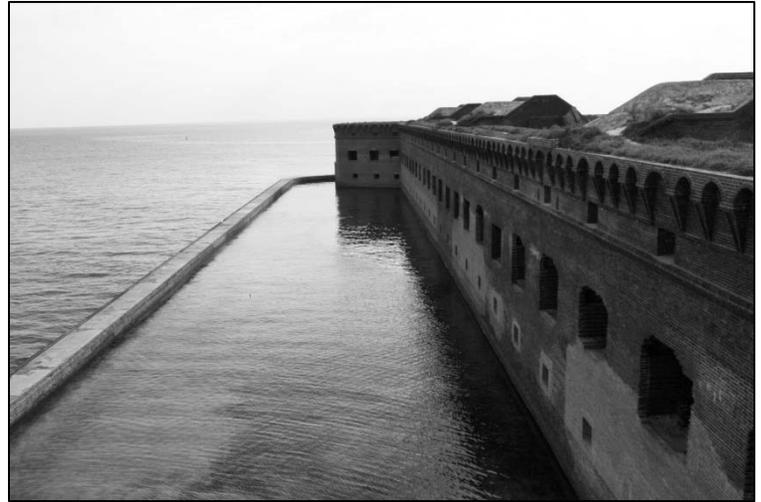
Front 4 Counterscarp and Wall Stabilization

Fort Jefferson has six fronts, referred to by numbers in a clock-wise manner. Front One is the south facing front where the sally port or entrance is located; Front Four is the northerly facing front. In both images looking northeast you see the counterscarp, more commonly referred to as the moat wall. The moat wall is the first line of defense against attacking enemies and the relentless action of the sea. Construction on the counterscarp began in 1849 and was not completed until 1873. The wet moat is roughly 70-feet wide. George Grant's image looking northeast down Front Four shows extensive damage to the counterscarp. Due to multiple breaches in the counterscarp sand has built up within the wet moat and created areas for brush to grow. On the scarp wall of the fort many of the lower embrasure openings still have the original iron Totten Shutter breast plates around the exterior openings. Also note the chimney and roof framing from the Officers' Quarters on the right peeking up above the terreplein level. Since 1937 the counterscarp has continually been damaged and continually been repaired. In this 2010 image the counterscarp is intact and the growth and sand have been removed, restoring the wet moat. The original Totten Shutter breast plates are no longer in place but all of Front Four has been recently stabilized through extensive masonry work. The NPS intends to replicate the historic breast plates and install them for interpretation as key identifying features of this fortification. The Officers' Quarters were removed in 1962. The second tier embrasure openings were never completed during the original construction of the fort. They are preserved in their incomplete state and are virtually identical in both images.

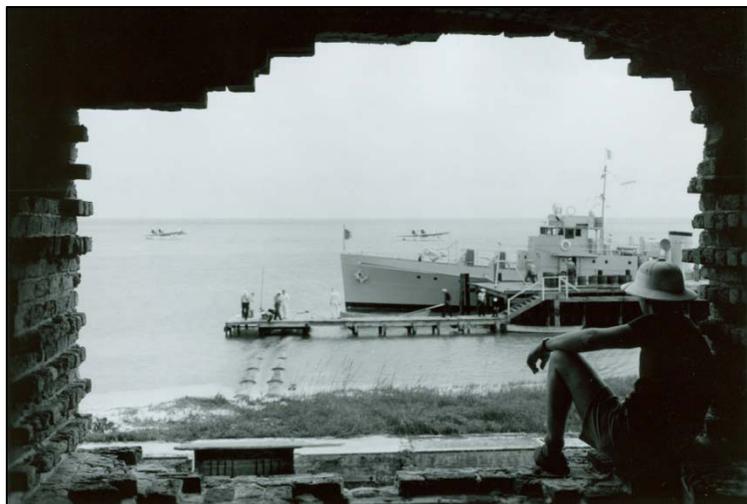
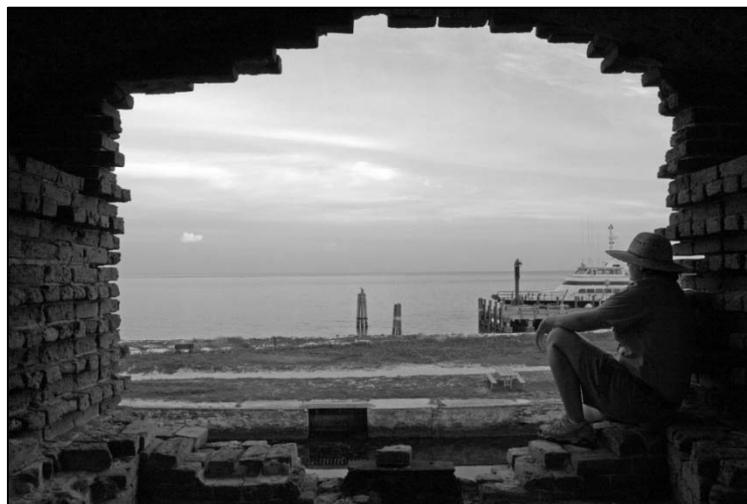
In 1937 a man looks south out of a second tier embrasure opening at the busy Garden Key Harbor. Out in the harbor are two seaplanes and at the dock is the US Coast Guard vessel *Nemesis*. The original cut in the counterscarp wall visible in both images was constructed to allow the moat to flush in and out with the tides. Kelly Clark, the photographer looks out at the harbor in the 2010 images. Although not in this modern photograph, seaplanes still visit the park and land in the Garden Key Harbor daily. The motor vessel at the dock in the 2010 photograph is the NPS supply vessel Fort Jefferson. The M/V Fort Jefferson brings supplies to the fort and transports crew back and forth between Key West and the Dry Tortugas every couple of weeks. The dock construction today is very similar to that in 1937 except the extension finger pier is no longer in place. Today, the dock is being repaired once again to improve the visitors' experience. One other great comparison to make between the two photographs is the dramatic shift in the location of the shoreline. This is a great visual record of how the islands are constantly shifting and changing at the Dry Tortugas.

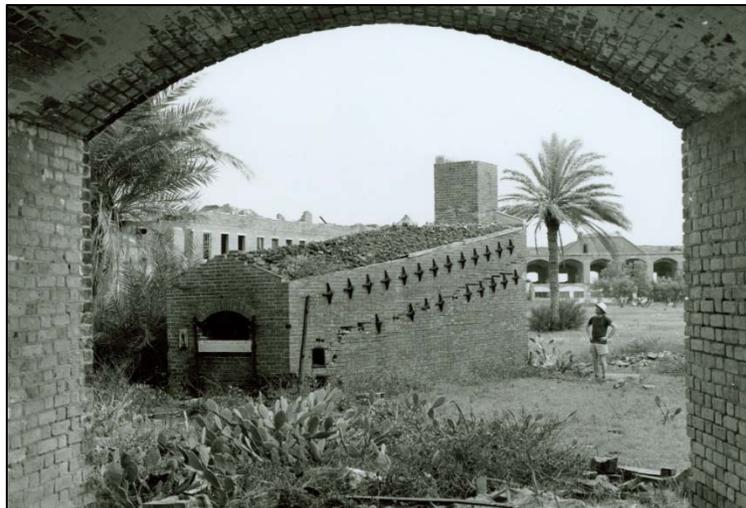
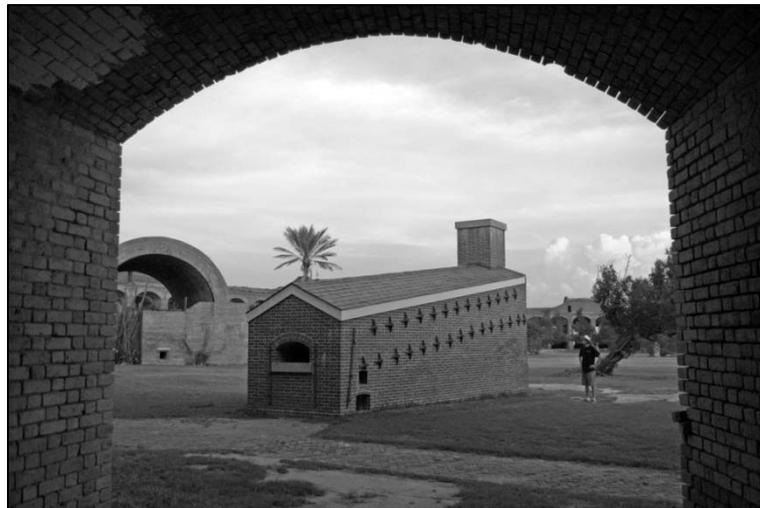
The hot shot furnace located within the parade ground of Fort Jefferson was originally constructed from 1862 to 1863. The Hot Shot Furnace would have been used to heat up solid projectiles to be fired at wooden ships. The Restoration of the Hot Shot Furnace began in May of 2001 and was completed in March of 2004 by NPS workers. In the 1937 photograph the coral concrete infill above the main furnace chamber is visible due to the missing roof structure, parts of the granite chimney cap are missing and the corroded iron tie rods are broken and have displaced many bricks on the sidewall. Behind the furnace to the left is the partially ruined Enlisted Men's Quarters. The 2010 photograph shows the completely restored hot shot furnace with a slate roof. The iron tie rods have been replicated with silicon bronze to withstand the elements and prevent corrosion and the brick work has been repaired using mostly salvaged bricks from the original Hot Shot. The Enlisted Men's Quarters was removed in 1962. The Large Powder Magazine is also visible behind and to the left of the Hot Shot Furnace in 2010 image. The magazine structure was built from 1861-1866.

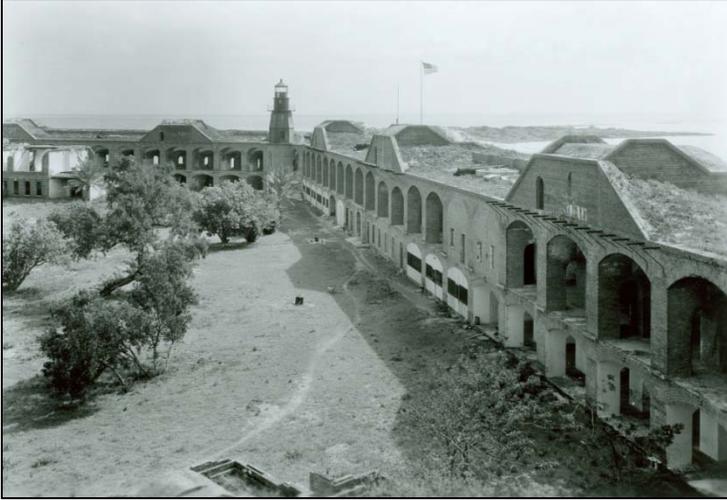
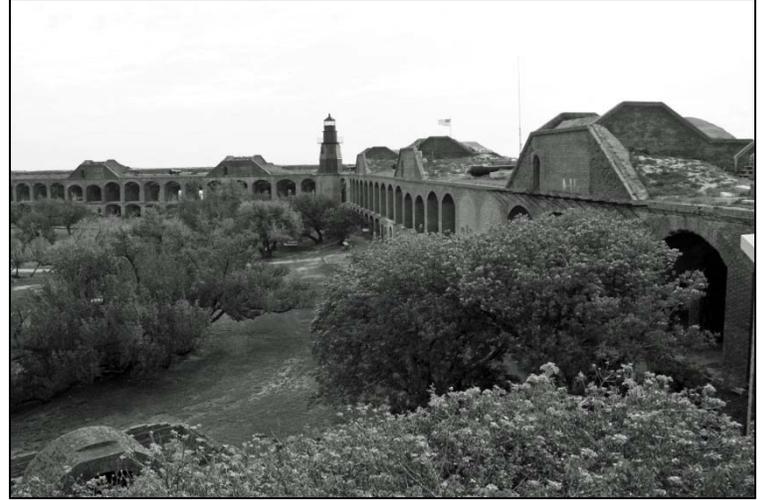
Parade Ground and Front One

The most noticeable difference between these two photographs is the foliage. The Gumbo Limbo trees in the bottom right of the 2010 image have matured along with the Buttonwoods and Seaside Mahoes located towards the center of the parade ground. The Garden Key Harbor Light located on top of the far bastion was constructed in 1876. This iron lighthouse is no longer an active aide to navigation but still illuminates each night. In 2009 the NPS restored historically accurate doors and shutters on this structure. In the 1937 photograph the Enlisted Men's Quarters is in ruins and visible in the background on the left side of the image. Along Front One on the right side of the image from 1937 the interior faces of the casemates on the first tier are all whitewashed and park housing and office space can be seen. A small portion of the Small Powder Magazine can be seen in the bottom left foreground of both photographs and in the 2010 image you can see the remnants of the historic pathway that is so visible in 1937.
