# Cultural Landscape Report for Fort Baker

## Golden Gate National Recreation Area

Fort Baker, Barry and Cronkhite Historic District  
Marin County, California

July 2005

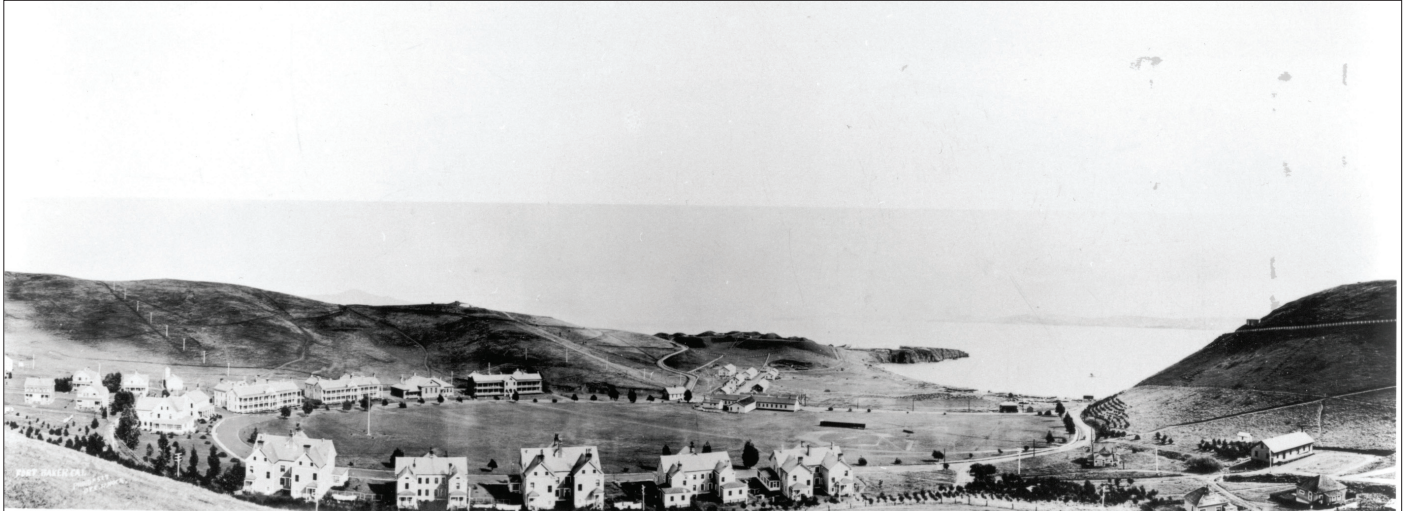
**SH8** An early view of the windbreak and parade ground tree plantings, looking southeast. Circa 1909 (San Francisco History Center, San Francisco Public Library, Negative 6453.).

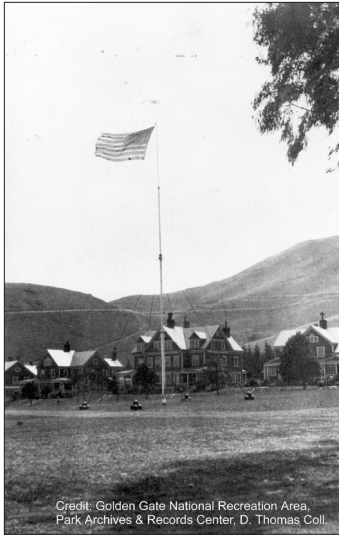
**SH10** The post flagstaff was sited near the head of the parade ground with cannonballs as decorative furnishings. Looking north. 1915 (GGNRA Park Archives and Record Center, 3311.008).

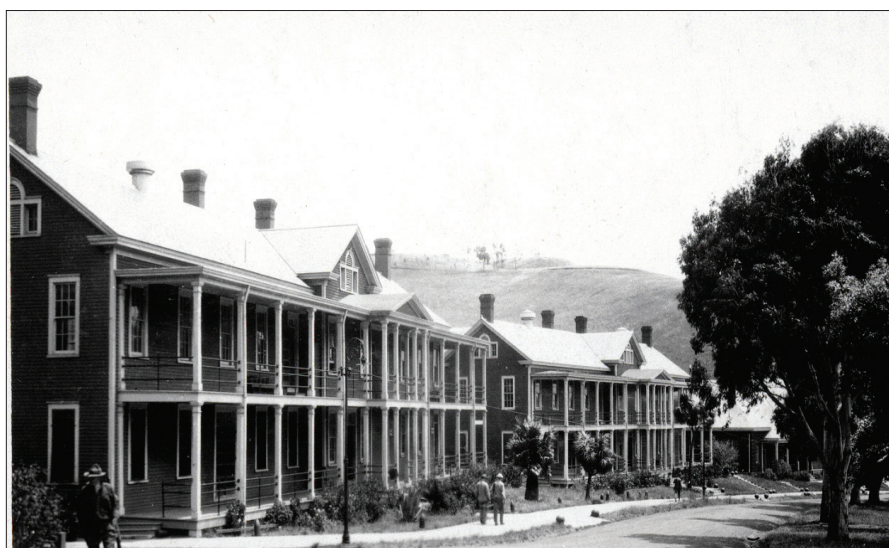
VG5 A view of plantings in front of buildings along the east side of Murray Circle which included a mix of specimen trees and foundation plantings. Circa 1923 (GGNRA Park Archives and Record Center, 40096).

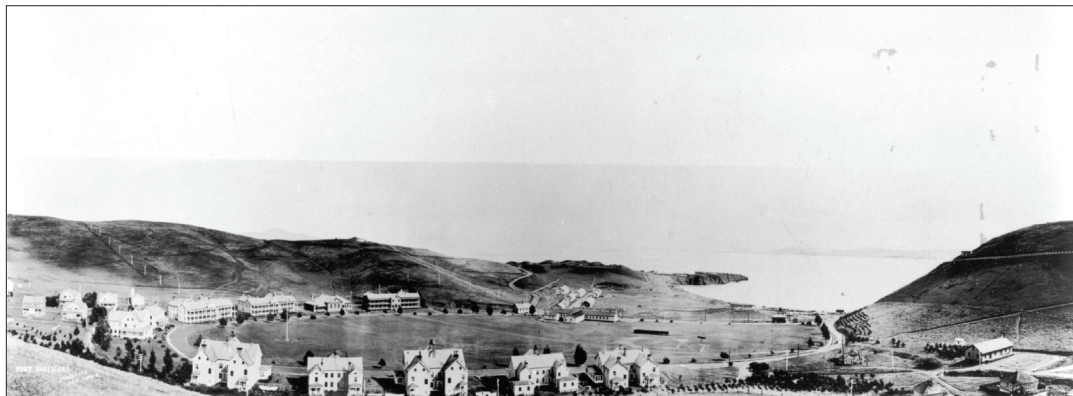
VG6 Early photograph showing the trees around parade ground and planting of Monterey cypress windbreak in foreground and right. Circa 1909 (San Francisco History Center, San Francisco Public Library, Negative 6453).

A 1909 photo shows a similar planting pattern using smaller trees on the south end of the parade ground. A short row of trees extended along Moore Road from its intersection with the parade ground towards the bay. (Photo VG6)

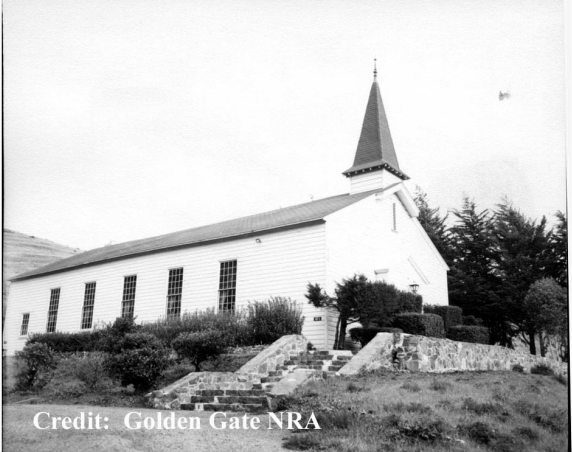
A mix of flowering and evergreen foundation plantings are visible in front of and around the building. (NPS photo, 1956)

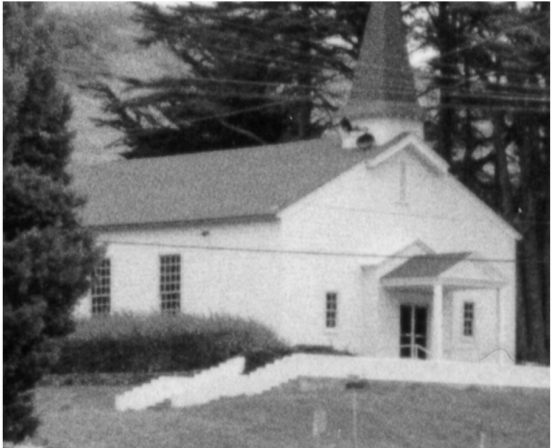
Building FB519, view looking west. Removal of historic vegetation has altered the landscape character. (NPS, 2001)

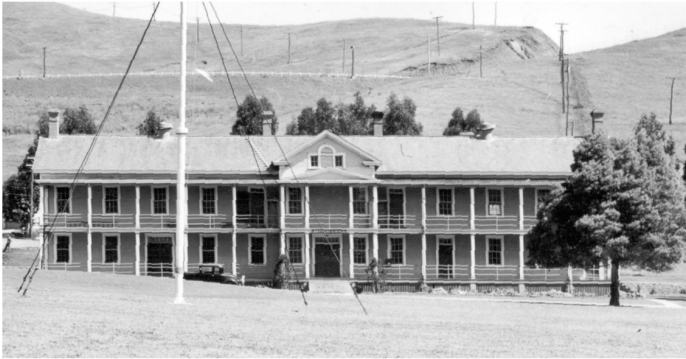
Foundation plantings are visible along the front porch and on the south side of the building. Columnar shrubs marked the building entrance. (NPS photo, 1941)

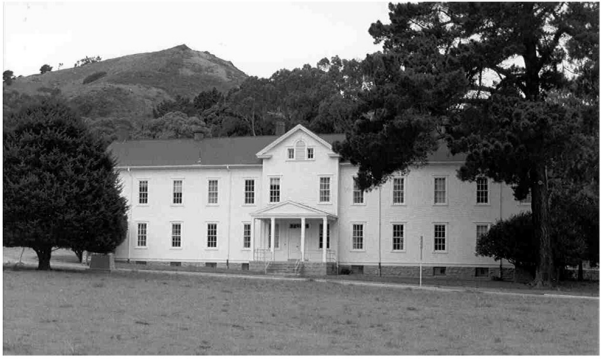
Building FB601, looking west. The foundation plants have all been removed.

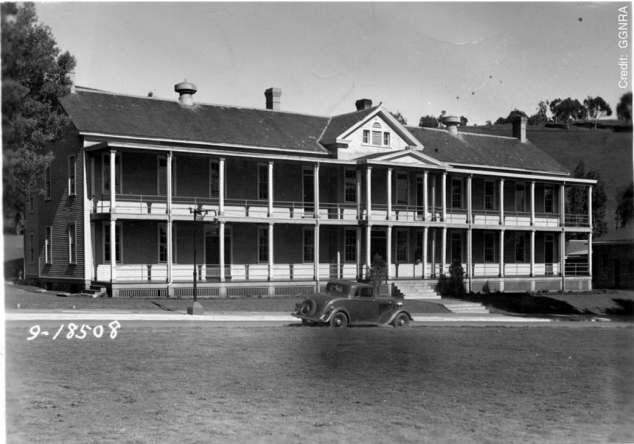
Building FB602, circa 1938. Columnar shrubs which flank the entry steps are the only visible foundation plantings . (NPS photo, 1938 Quartermaster Report)

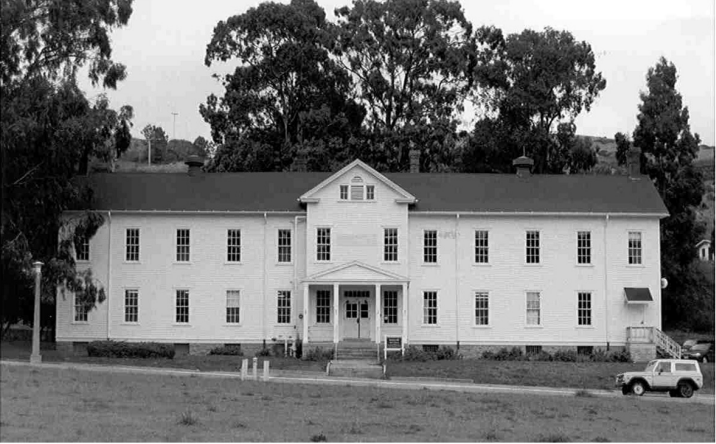
Building FB602, looking east. The front porch was removed in 1959. A sporadic foundation planting exists today. (NPS, 2001)

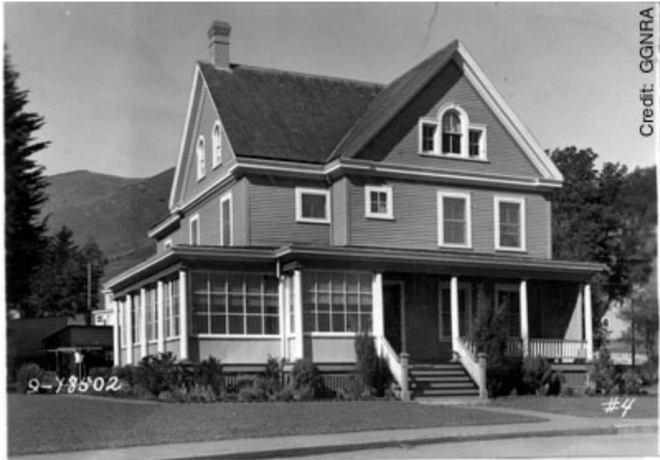
The foundation plantings around the commanding officer's residence contained a mix of flowering herbaceous and evergreen shrubs.(NPS photo, 1938 Quartermaster Report)

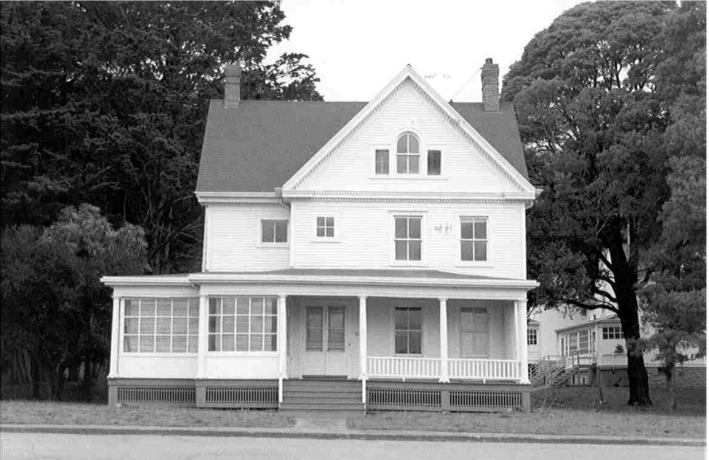
Building FB604, looking north. The foundation plants have all been removed.

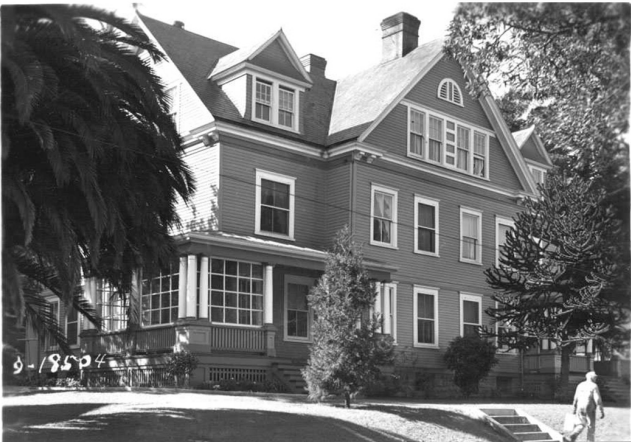
Building FB605, circa 1938. Flowering foundation plantings are visible in front of and around the building. (NPS photo, 1938 Quartermaster Report)

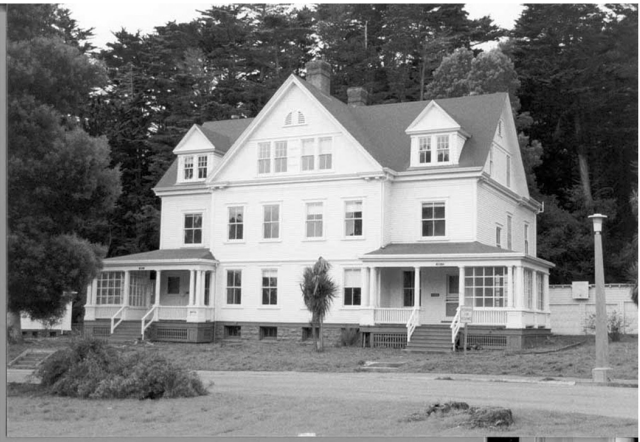
Building FB605, view looking west. Removal of historic vegetation has altered the landscape character. (NPS, 2001)

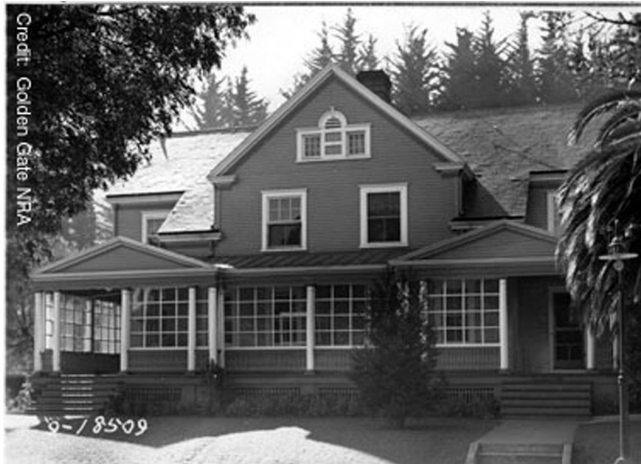
A mix of flowering and evergreen foundation plantings are visible in front of and around the building. (NPS photo, 1938 Quartermaster Report)

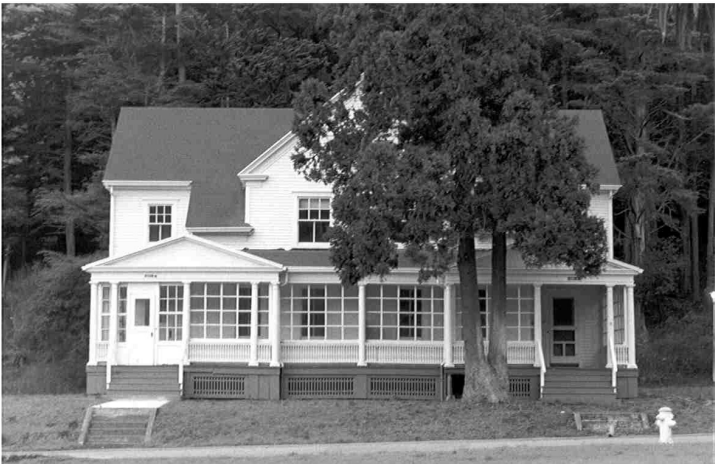
Building FB606, view looking west. Removal of historic vegetation has altered the landscape character. (NPS, 2001)

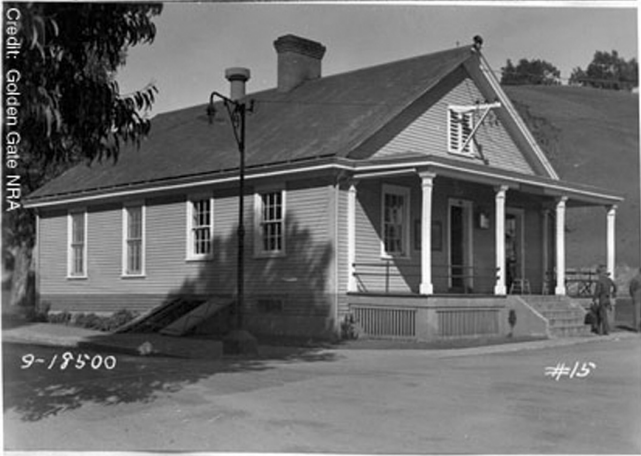
Foundation plantings were primarily located on the west side of FB615, facing the parade ground. (NPS photo, 1938 Quartermaster Report)

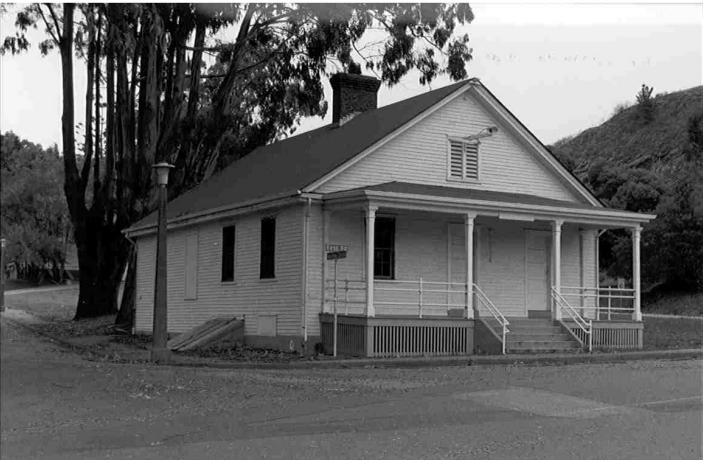
Building FB615, view looking north. The historic vegetation has been removed. (NPS, 2001)

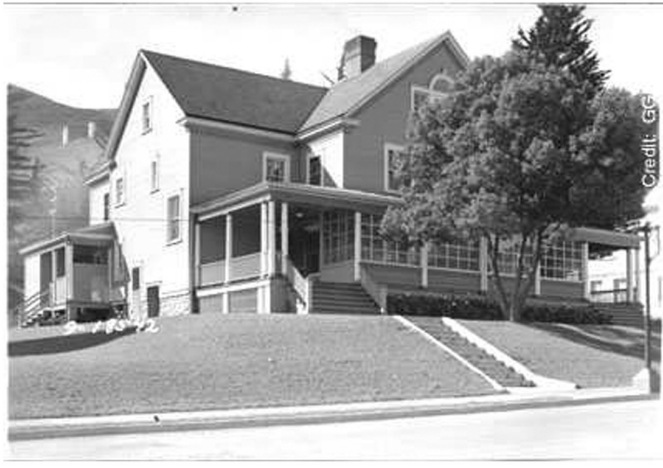
A mix of flowering and evergreen foundation plantings are visible in the foundation planting along the front facade. (NPS photo, 1938 Quartermaster Report)

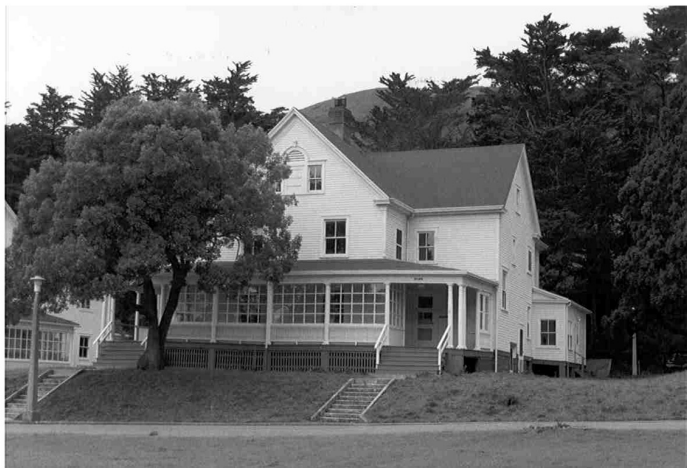
Building FB629, view looking west. Removal of historic vegetation has altered the landscape character. (NPS, 2001)

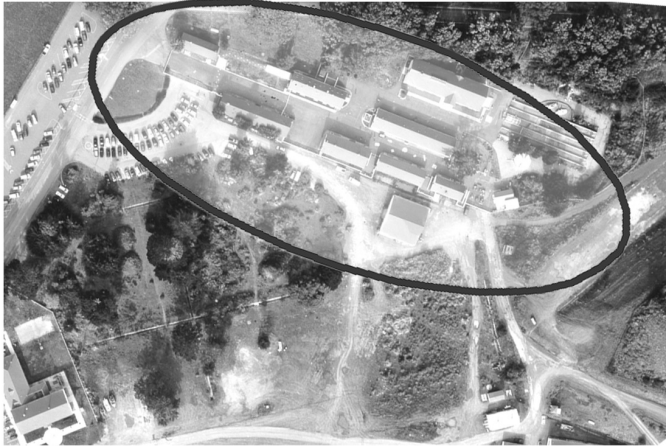
Contemporary view of the service area depicts an increase in tree cover. (1997, Towil Survey)
