Historic Furnishings Report

Golden Gate National Recreation Area
San Francisco, California

Alcatraz Island: Main Prison Building

Mary Grassick
Staff Curator

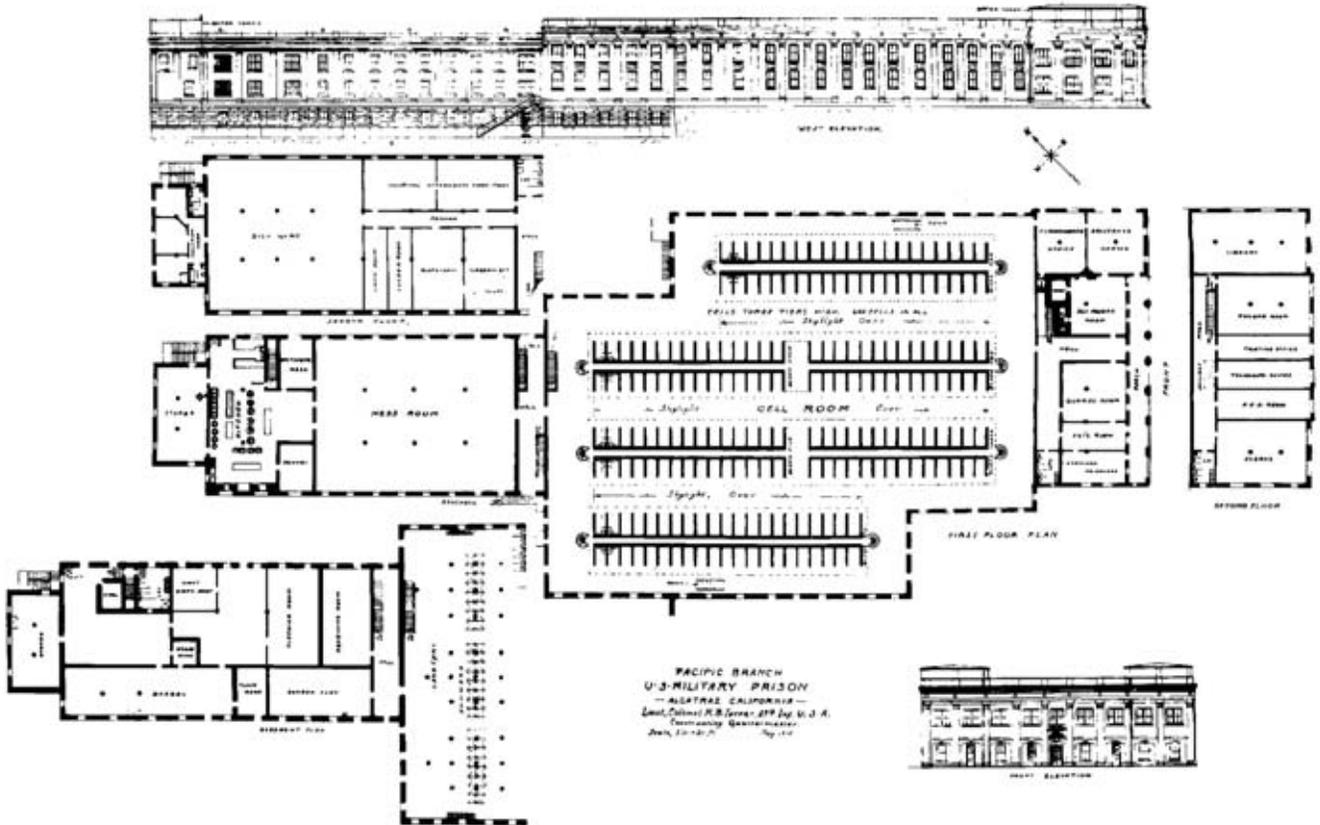
BP1

Plan of Cell House, Lt. Colonel R. B. Turner, Constructing Quartermaster, May, 1908. National Archives and Records Administration (NARA), Record Group (RG) 92, Records of the Office of the Quartermaster General.

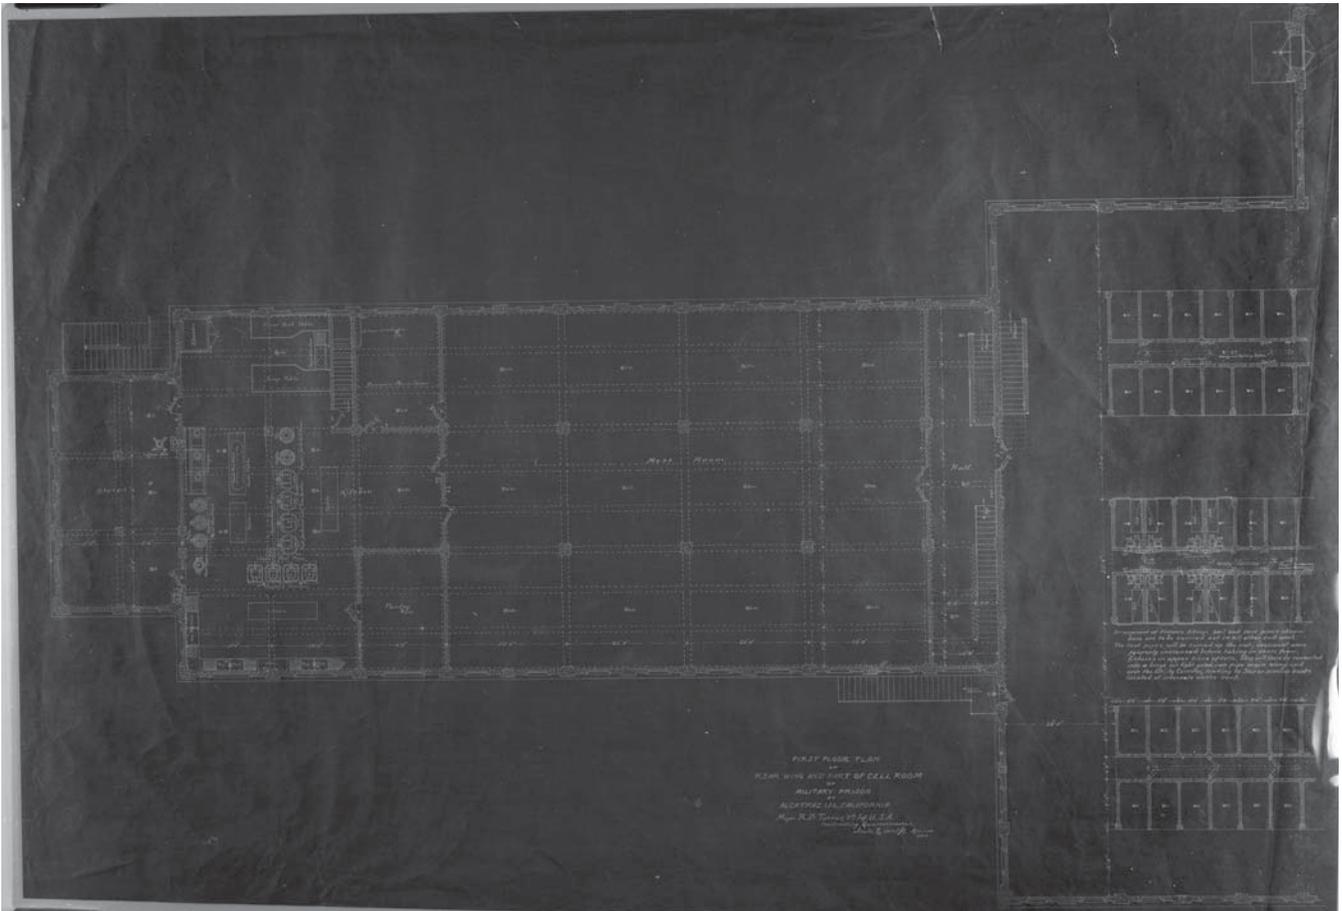
BP2

“First Floor Plan of Rear Wing and Part of Cell Room of Military Prison at Alcatraz Isl. California,” Maj. R. B. Turner, April 1908. NARA, RG 92.

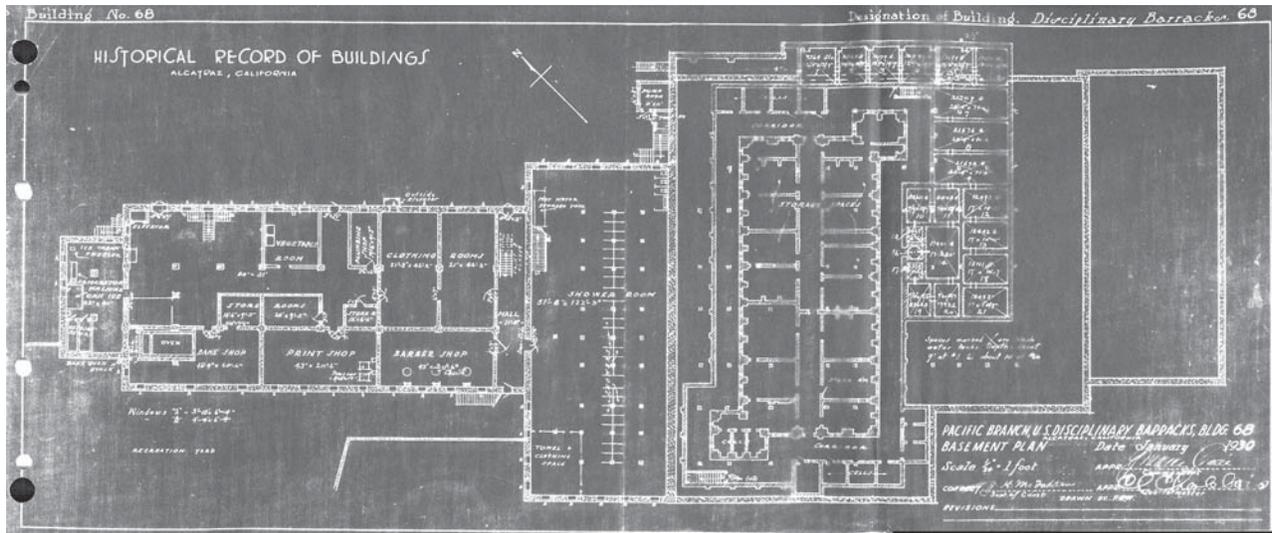
BP5 "Pacific Branch, U.S. Disciplinary Barracks, Bldg. 68, Basement Plan," January 1930. NARA, RG 77, Records of the Office of the Chief of Engineers.

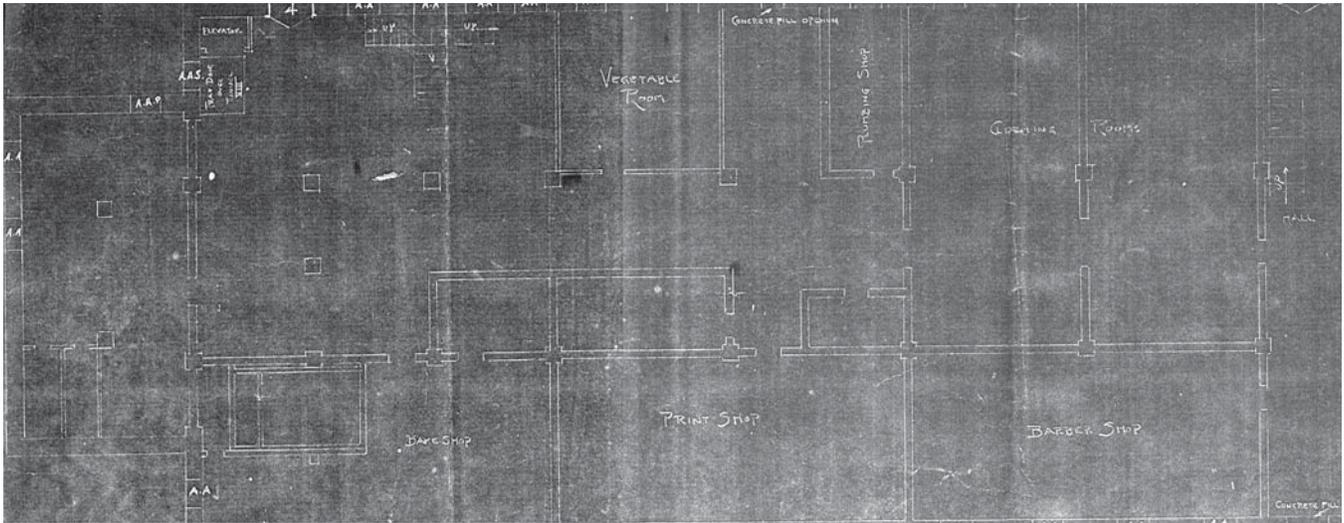
**BP6**

Building 68, Basement Plan, U.S. Penitentiary, Alcatraz, Calif. The Stewart Iron Works Co., ca. 1933-34. Golden Gate National Recreation Area (GGNRA) Park Archives Collection.

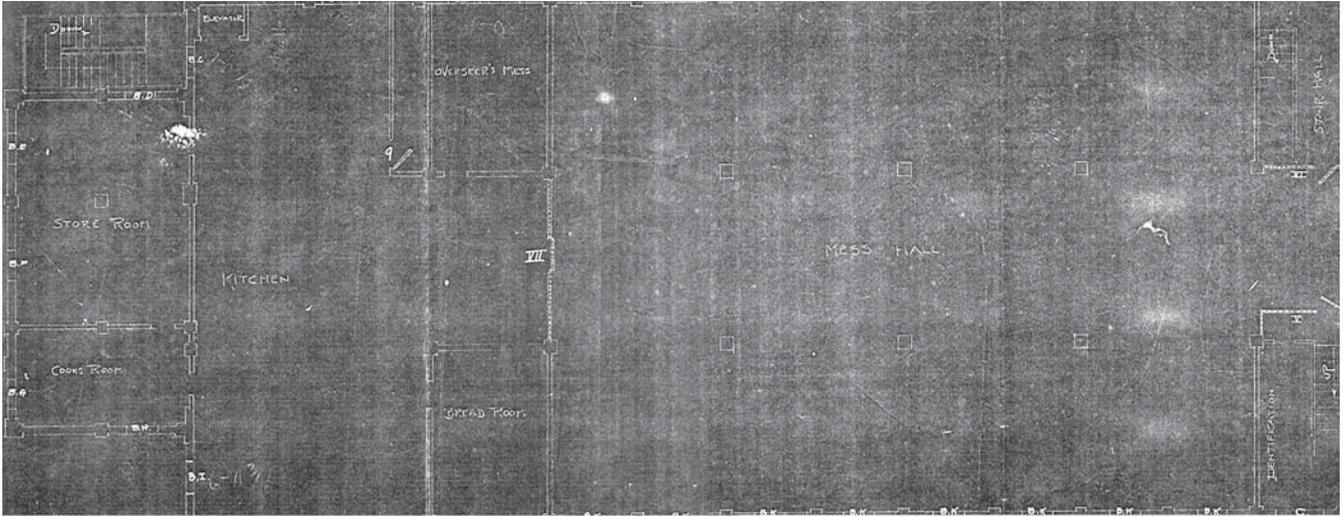
BP7

Building 68, First Floor Plan, U.S. Penitentiary, Alcatraz, Calif. The Stewart Iron Works Co., ca. 1933–34. GGNRA Park Archives Collection.

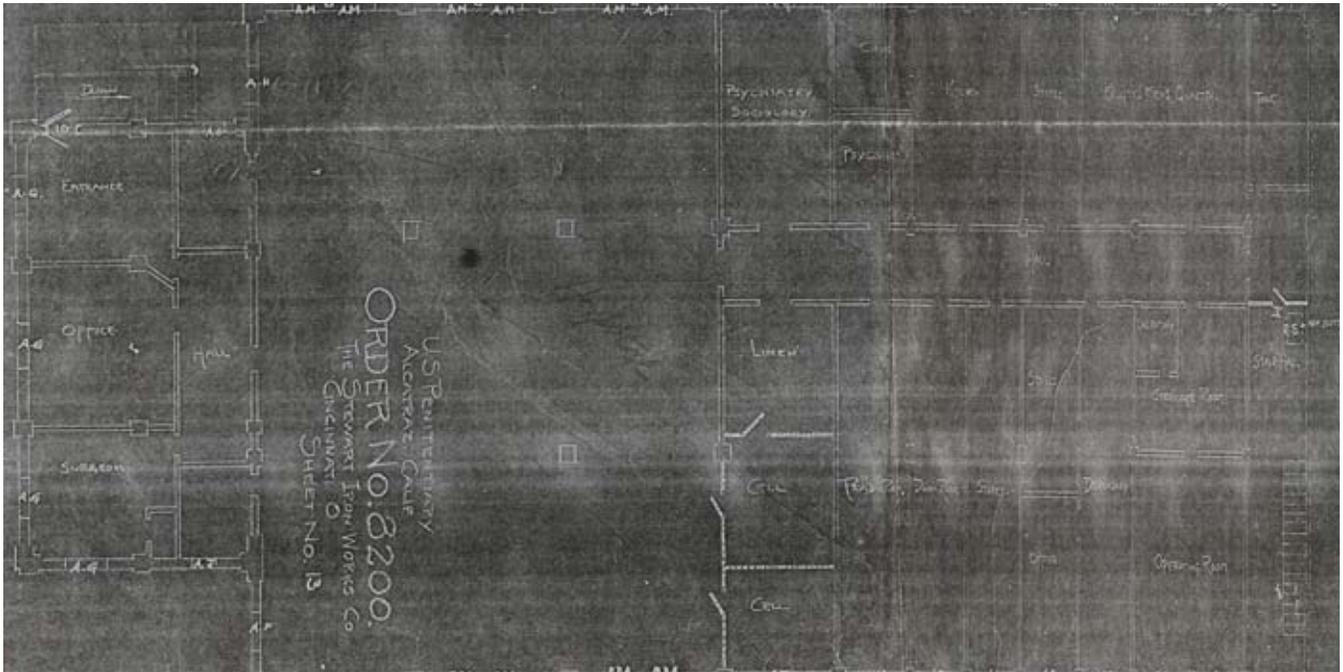
**BP8**

Building 68, Second Floor Plan, U.S. Penitentiary, Alcatraz, Calif. The Stewart Iron Works Co. ca. 1933–34. GGNRA Park Archives Collection.

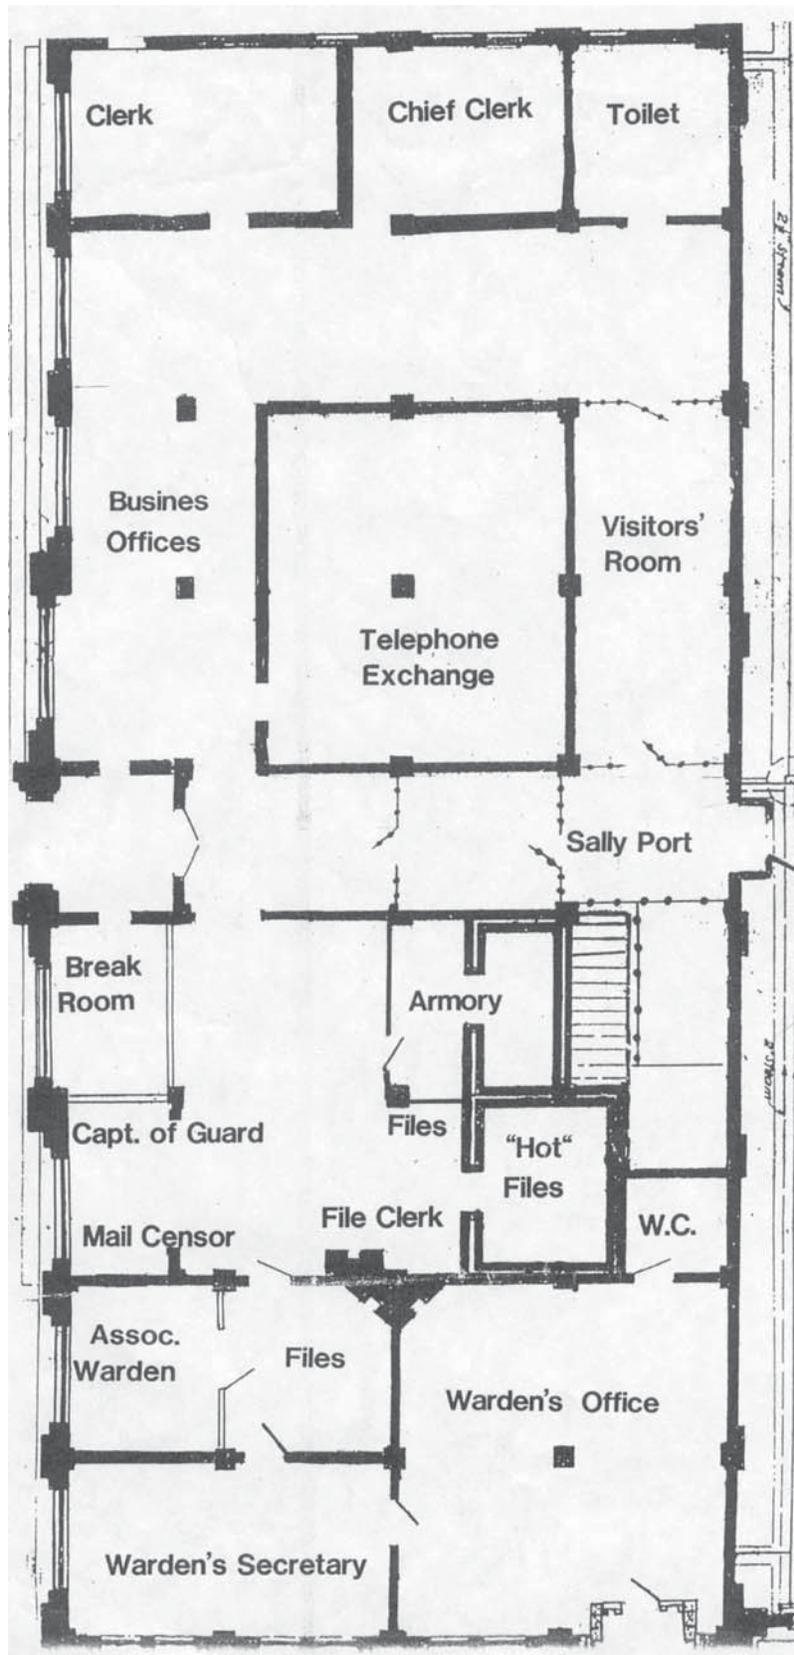
BP9

“U.S.P. Alcatraz—Administration Area,” ca. 1940, drawn by Philip Bergen, former Captain of the Guard. NPS staff files, Alcatraz Island.

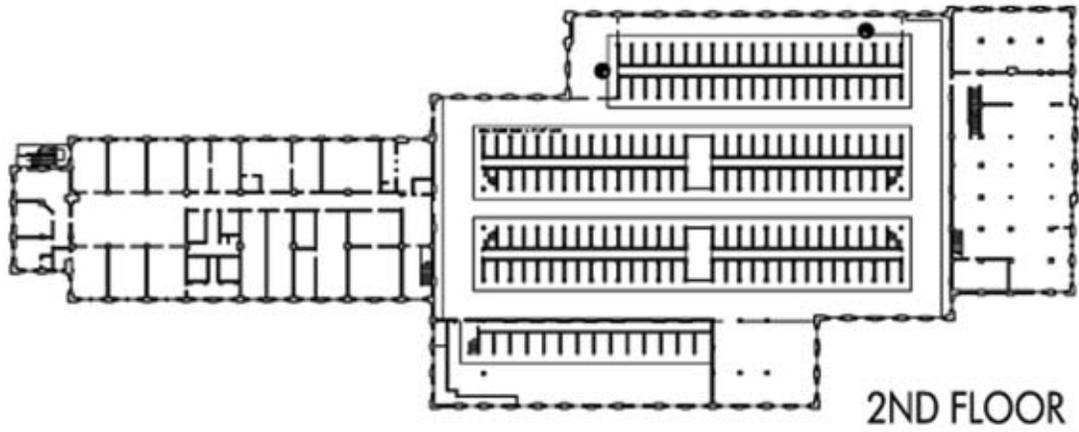
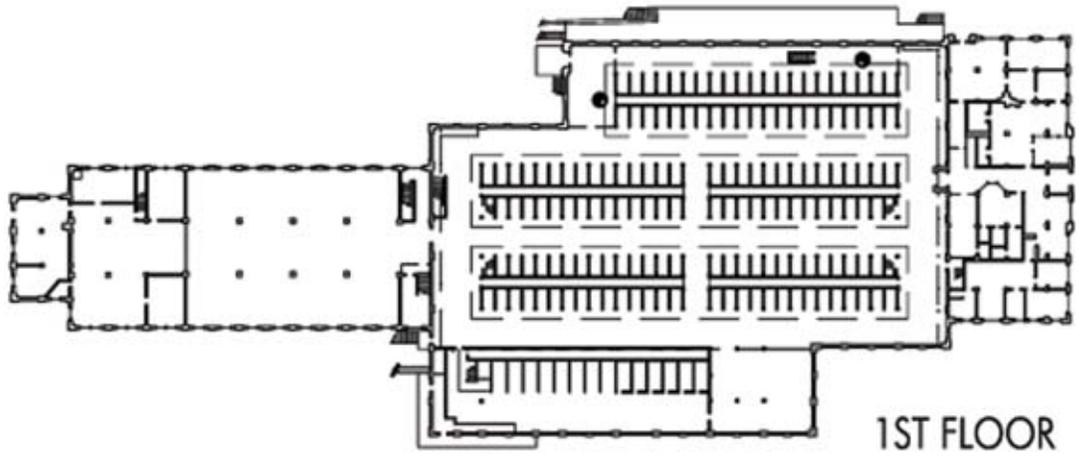
BP10

Alcatraz Main Prison Building floor plan, 2004. Golden Gate National Recreation Area files.

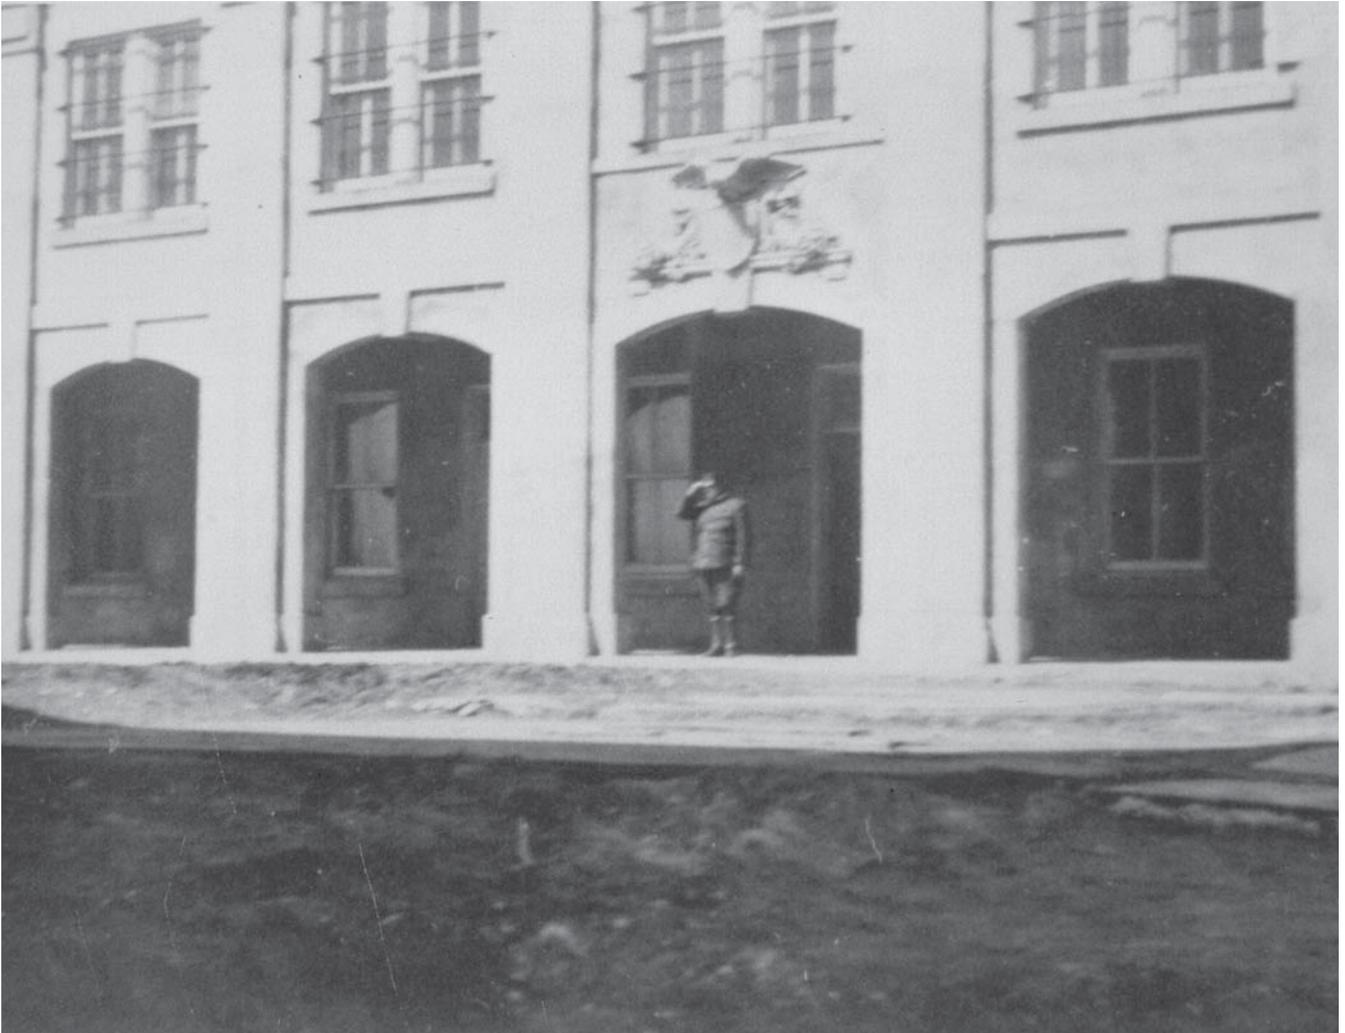
EX1

Cell House under construction, south facade, 1911. GGNRA Park Archives Collection, GOGA 3078.

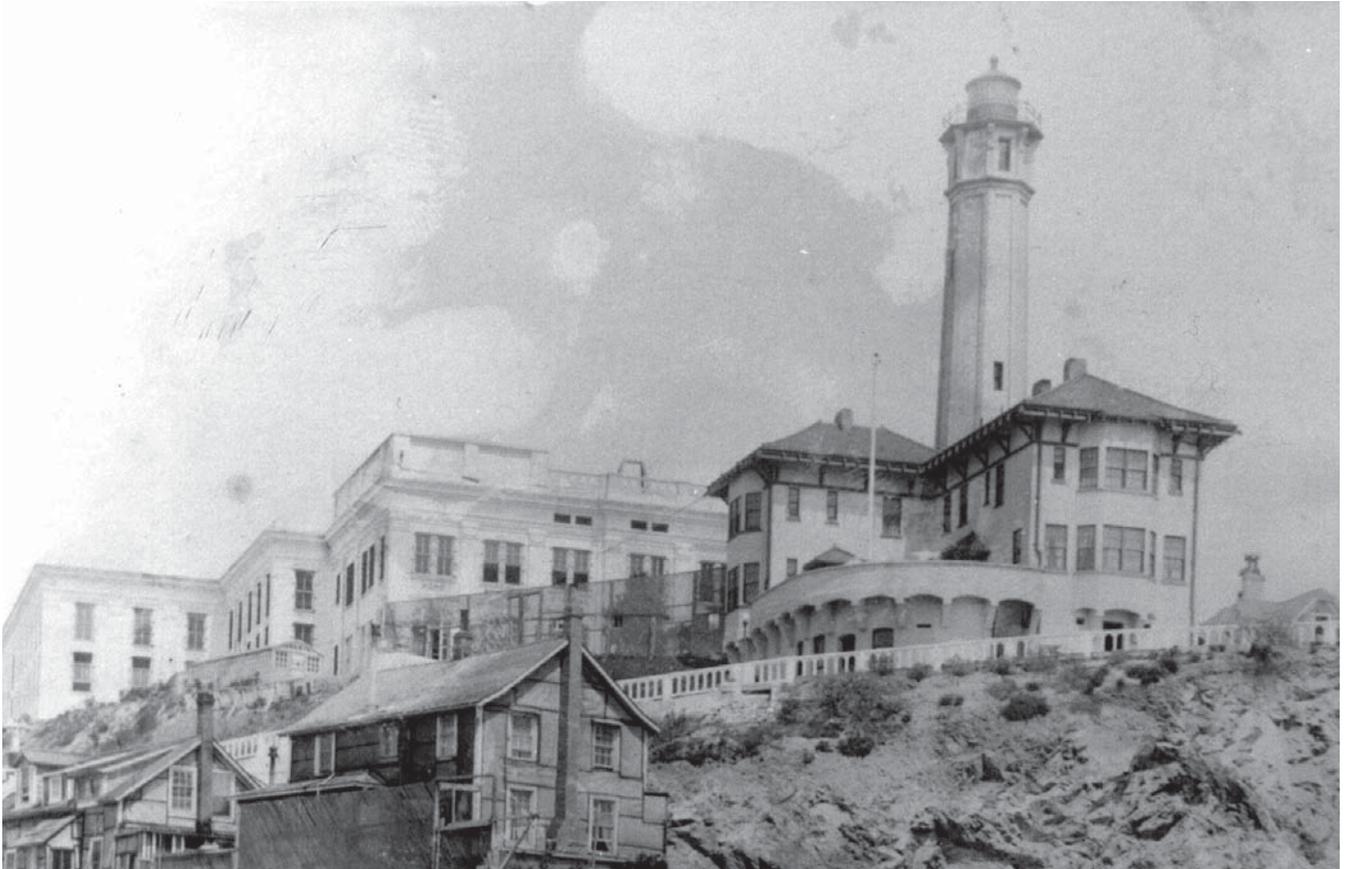
EX5

Cell House, southwest view, 1910s. Jack Fleming Alcatraz Collection, GGNRA Park Archives Collection. Shows “Hope Springs” motto.

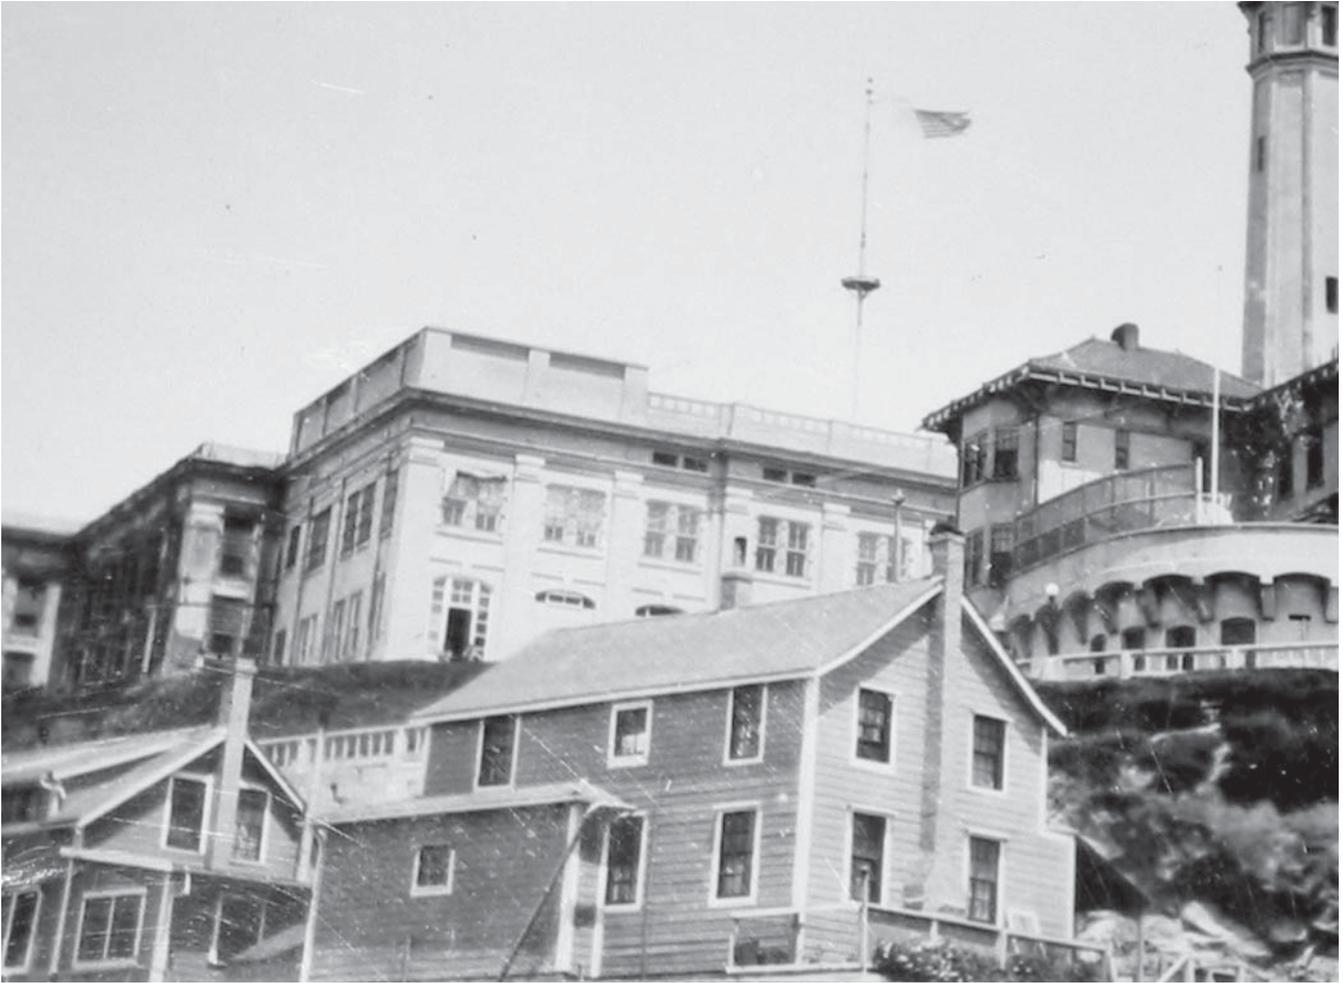
EX8 Prison, southwest view, Army-era. San Francisco History Center, SFPL. Shows second-floor awnings.

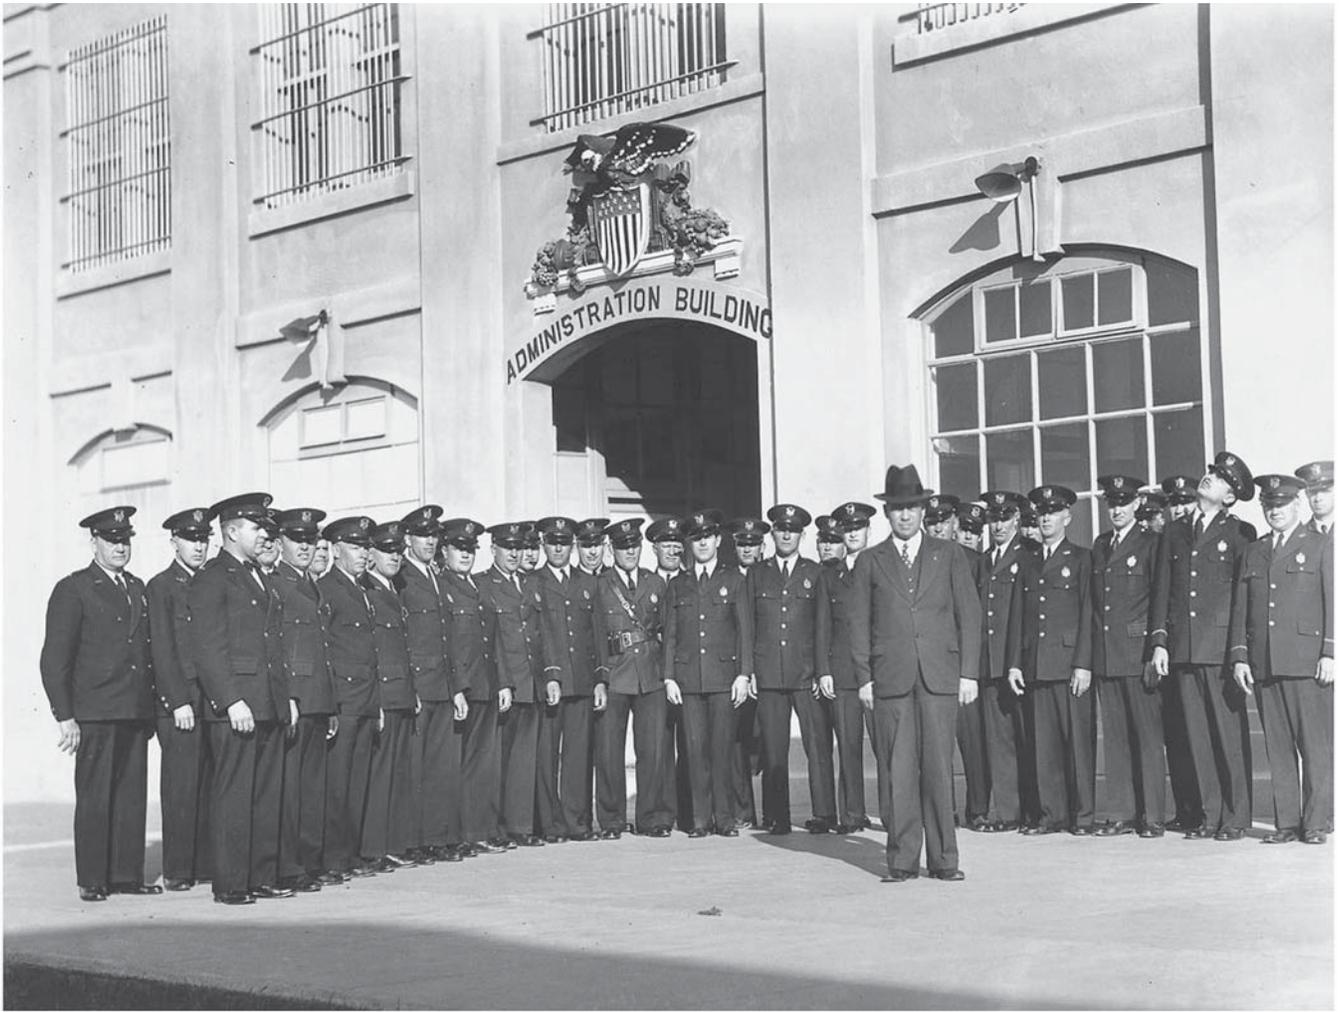
EX11 South facade, with guard force, ca. 1935. Courtesy Chuck Stucker Collection. Note old windows.

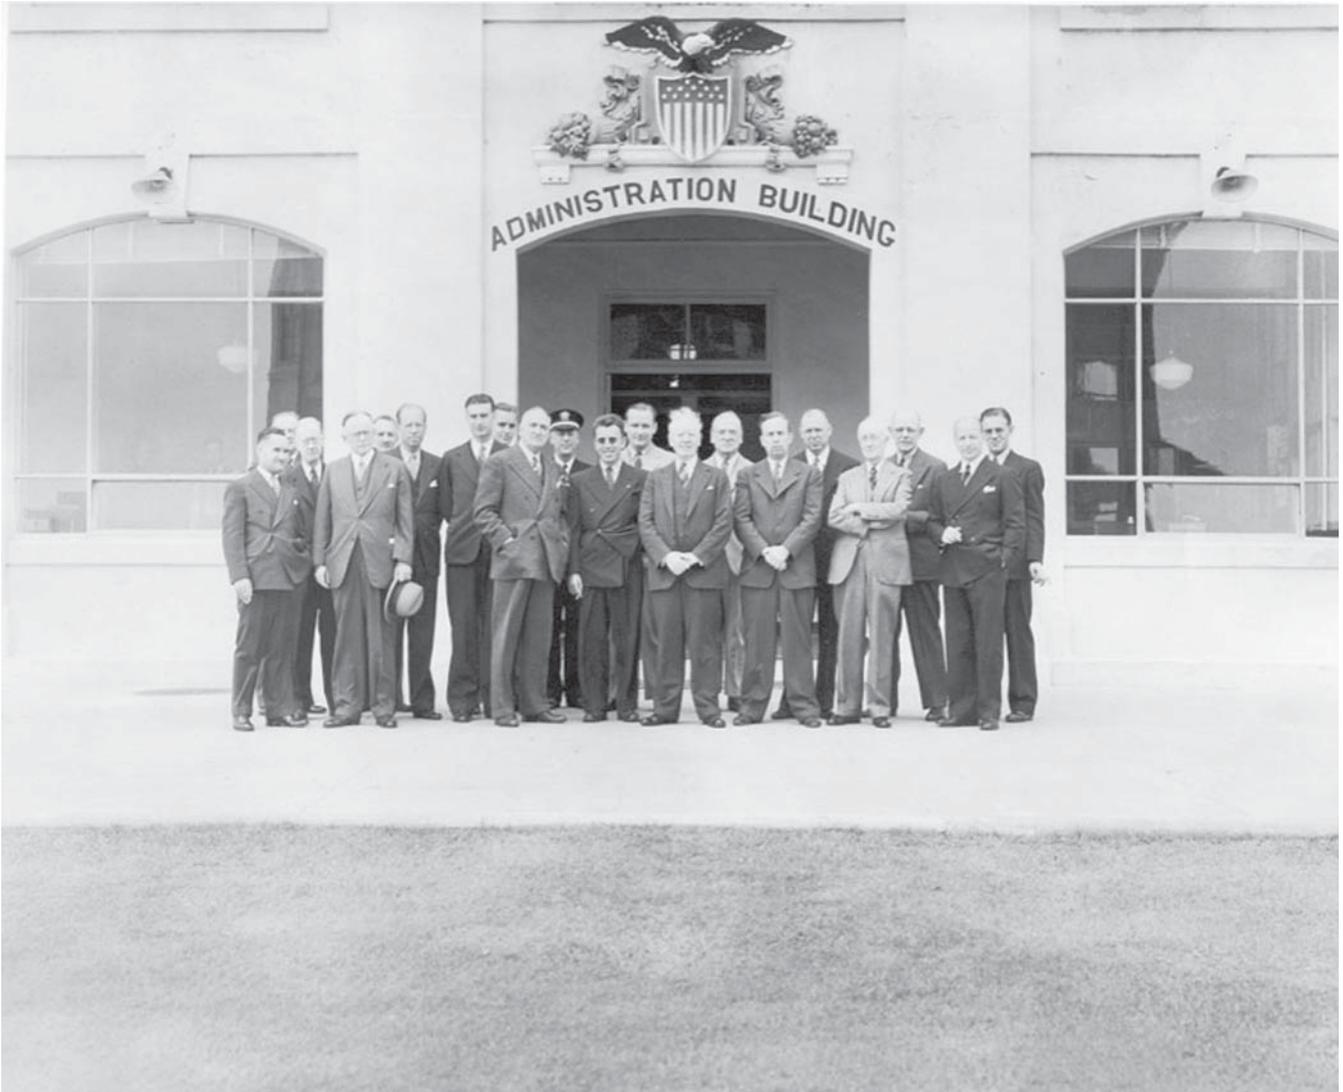
EX15

South facade with group, ca. 1940. Note venetian blinds and light fixtures. SFMNH, P83-170.298.

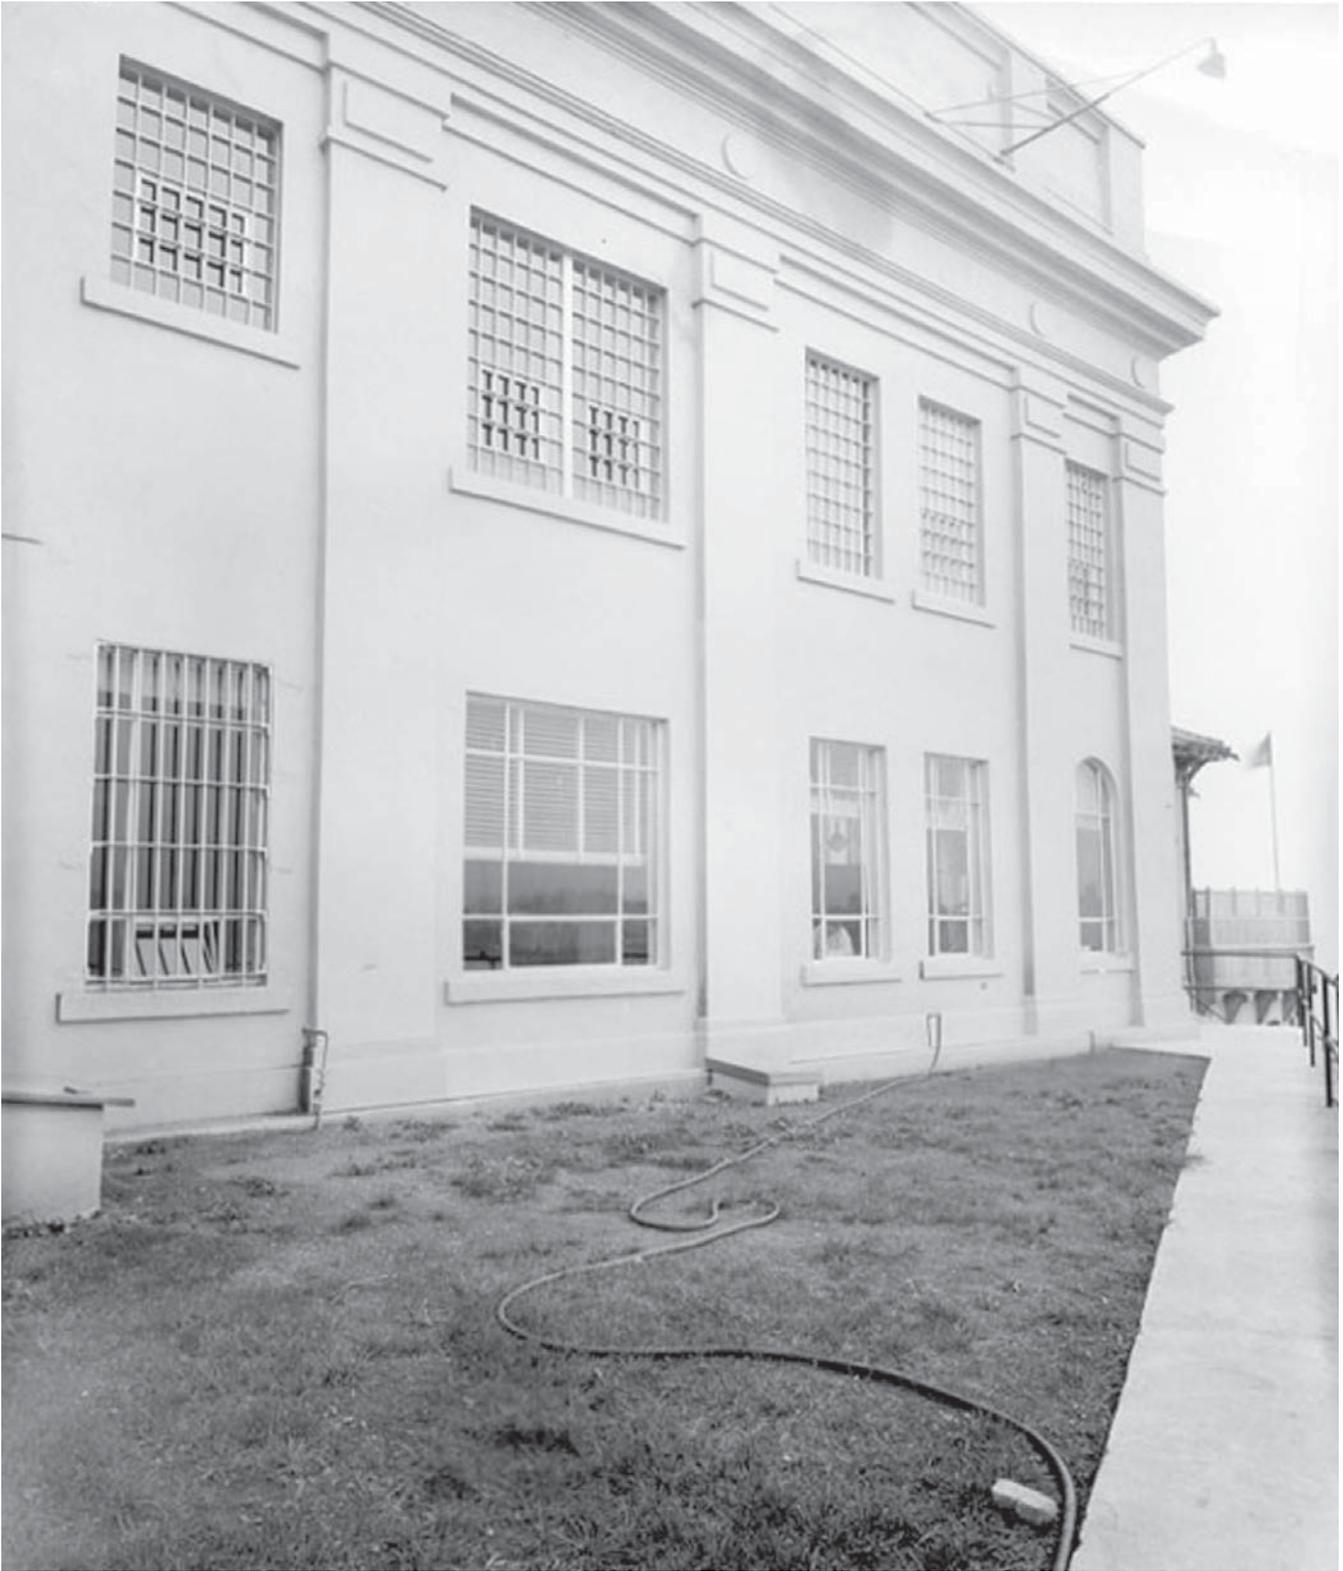
EX16 Western exterior, Administration Wing, ca. 1941. SFMNHP, P83-170.76. Note light fixtures and blinds.

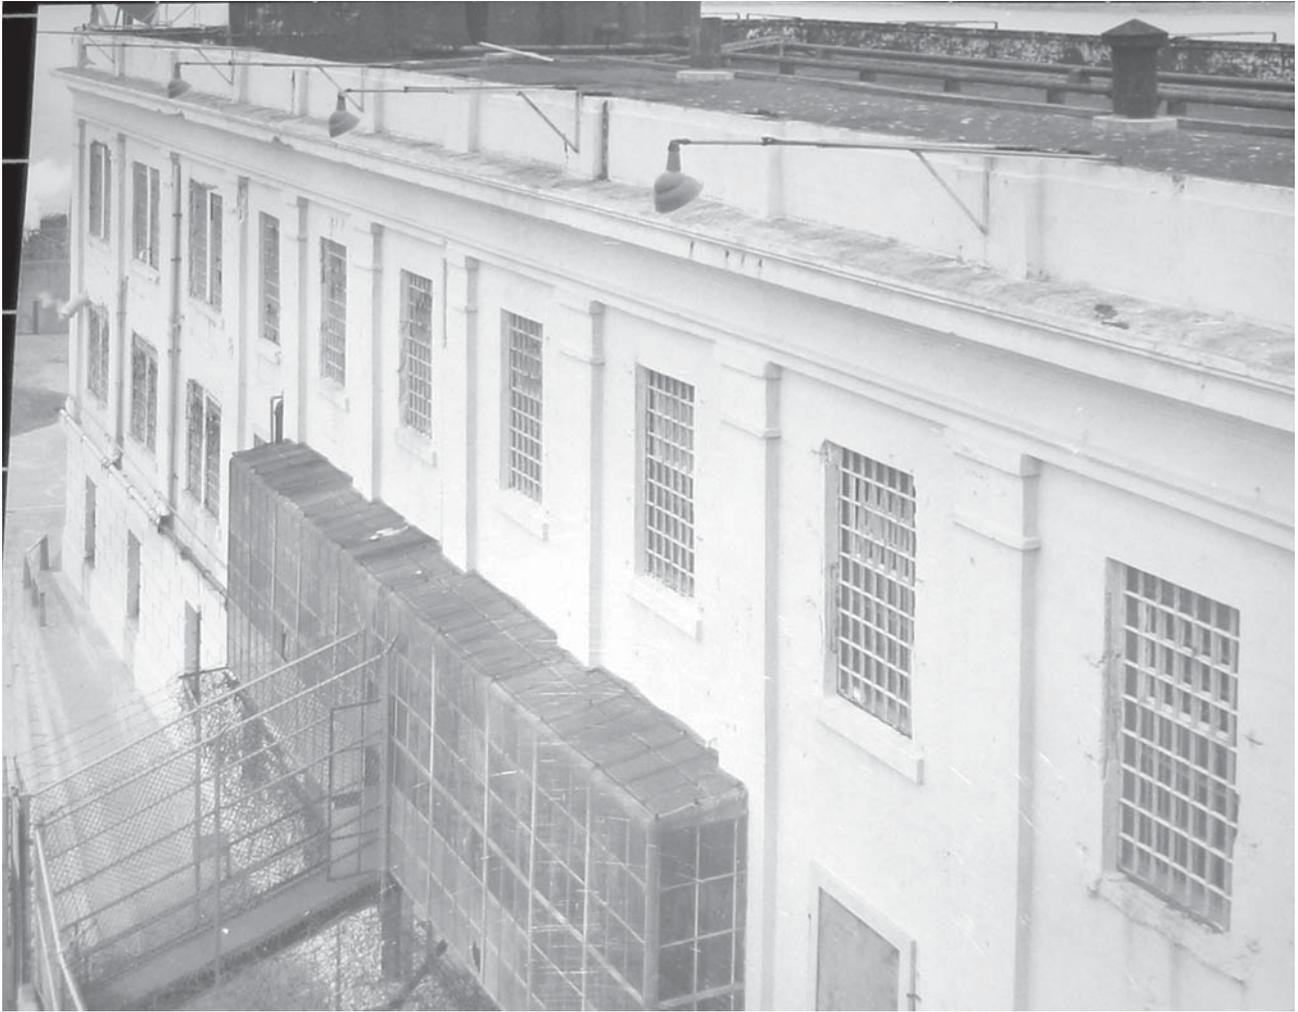
**EX20**

West side, Mess Hall Wing, ca. 1957. NARA, RG 129, Records of the Bureau of Prisons. Note mess hall gun cages.

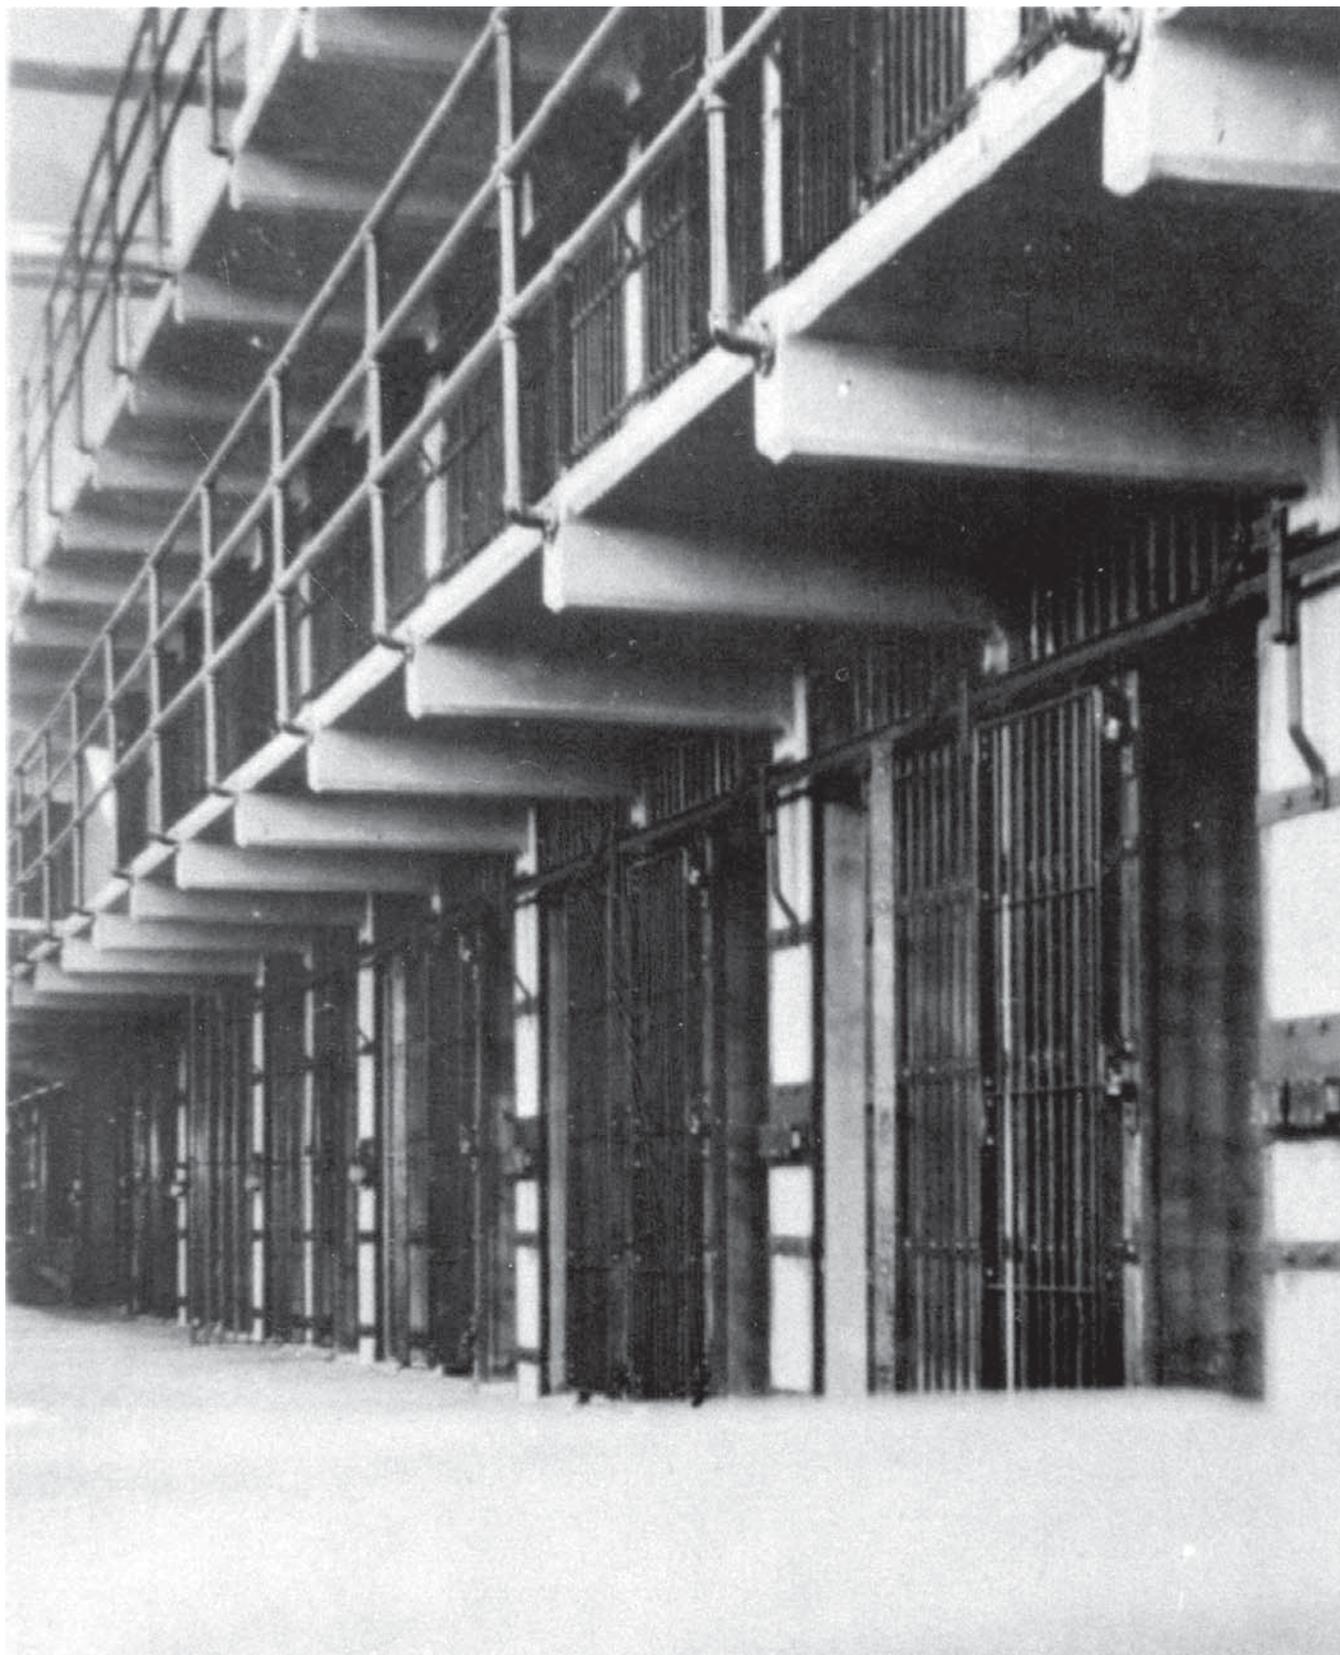
DB1 Interior of Cell House during construction, ca. 1911. GGNRA Park Archives Collection, GOGA 3078.

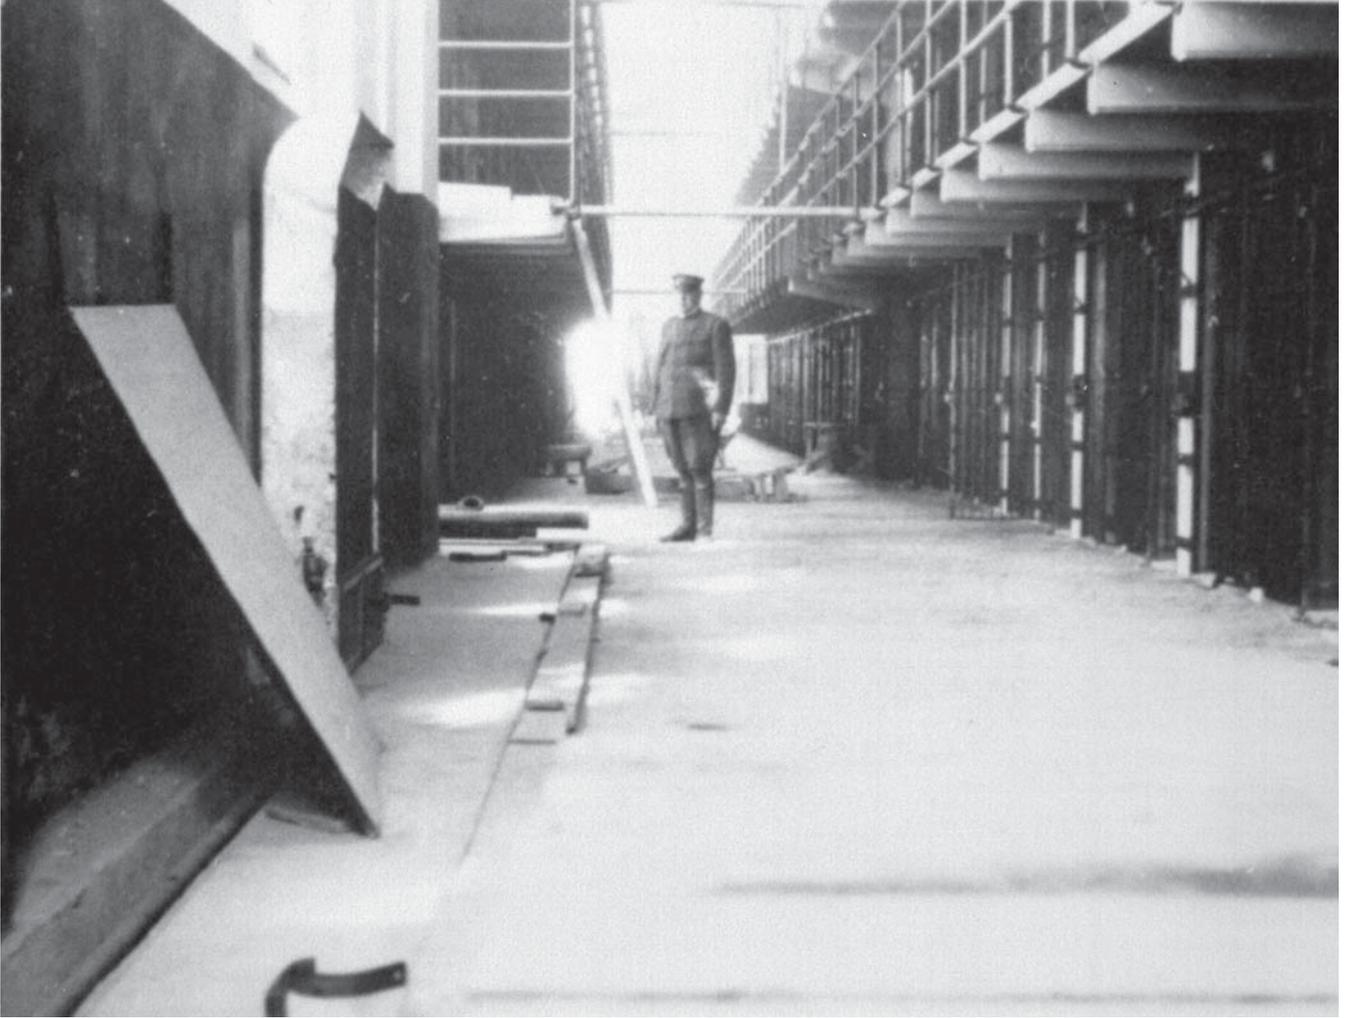
DB2 Interior of Cell House during construction, ca. 1911. GGNRA Park Archives Collection, GOGA 3078.
